Report on the watching brief and standing
building survey, Duthie Park, Aberdeen
AB11 7WA

Alison Cameron
Cameron Archaeology Ltd
29 May 2012

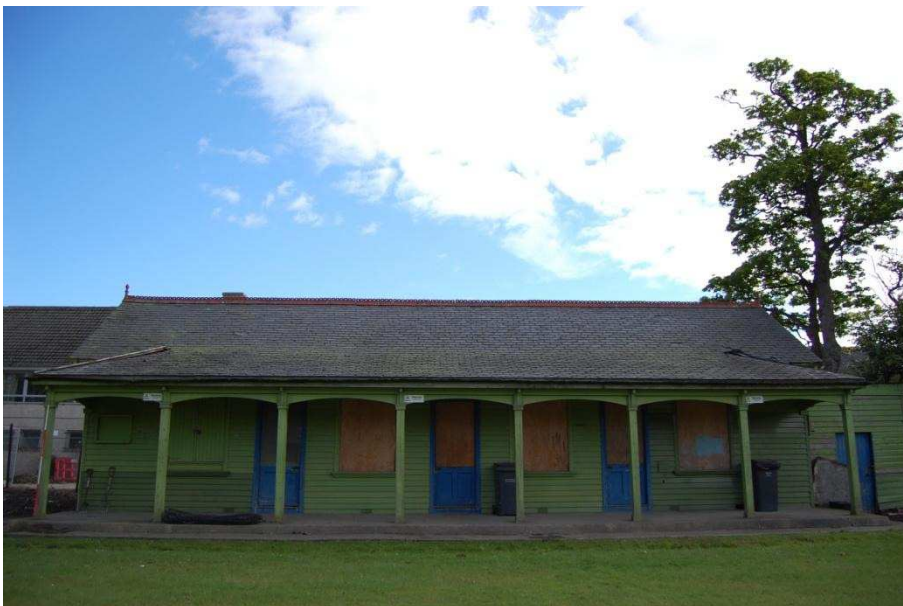
Illus 5 Pavilion front SW facade; from SW

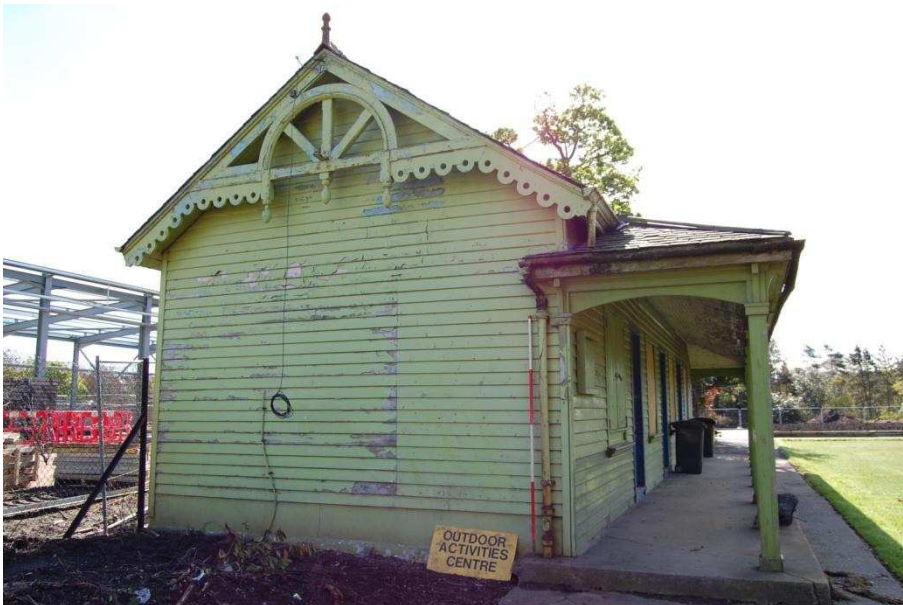
Under the roof on the exterior gables there is decorative wood fretwork (Illus 4, 7)

Illus 7 Pavilion from NW

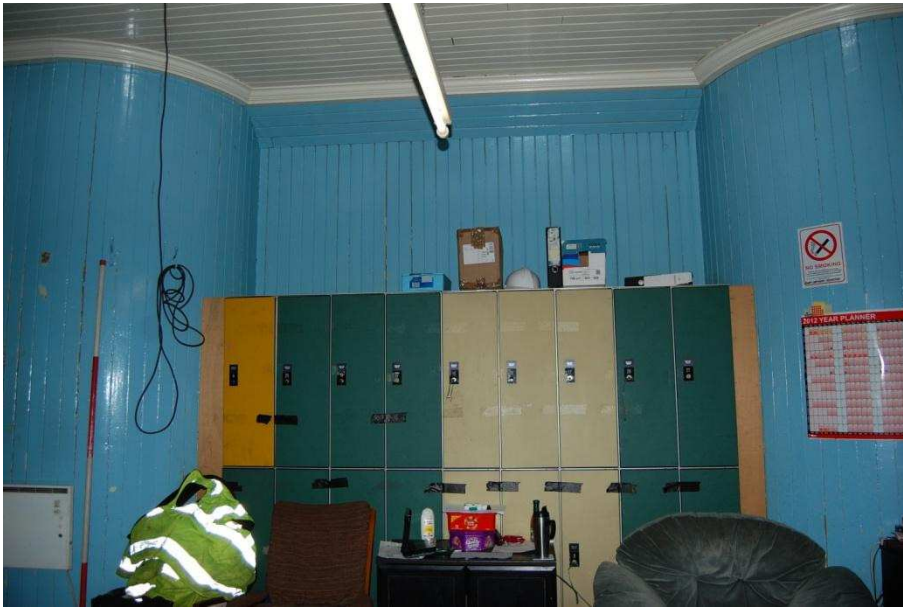
The pavilion is a wooden structure on the NE side of Duthie Park adjacent to the Bowling Green. It is Listed Category C and was constructed prior to 1926 where it appears on the Ordnance Survey map (Sheet 075.15); it may have been an original feature of the park when it opened in the 1880s. It is 16m long and 6.6m wide (Illus 4). There are three main rooms with sub rooms for toilets. There is a veranda along the full length of the SW front facade which is supported by wooden pillars (Illus 5, 6). The building is constructed of wood panelling which survives in good condition on the exterior and also the interior (Illus 7, 9). The exterior panelling is horizontal and the interior vertical. The panelling on the NE wall is moulded around two small rooms adjacent to Room 2 (Illus 9)

Illus 9 Pavilion Room 2 NE wall; facing NE

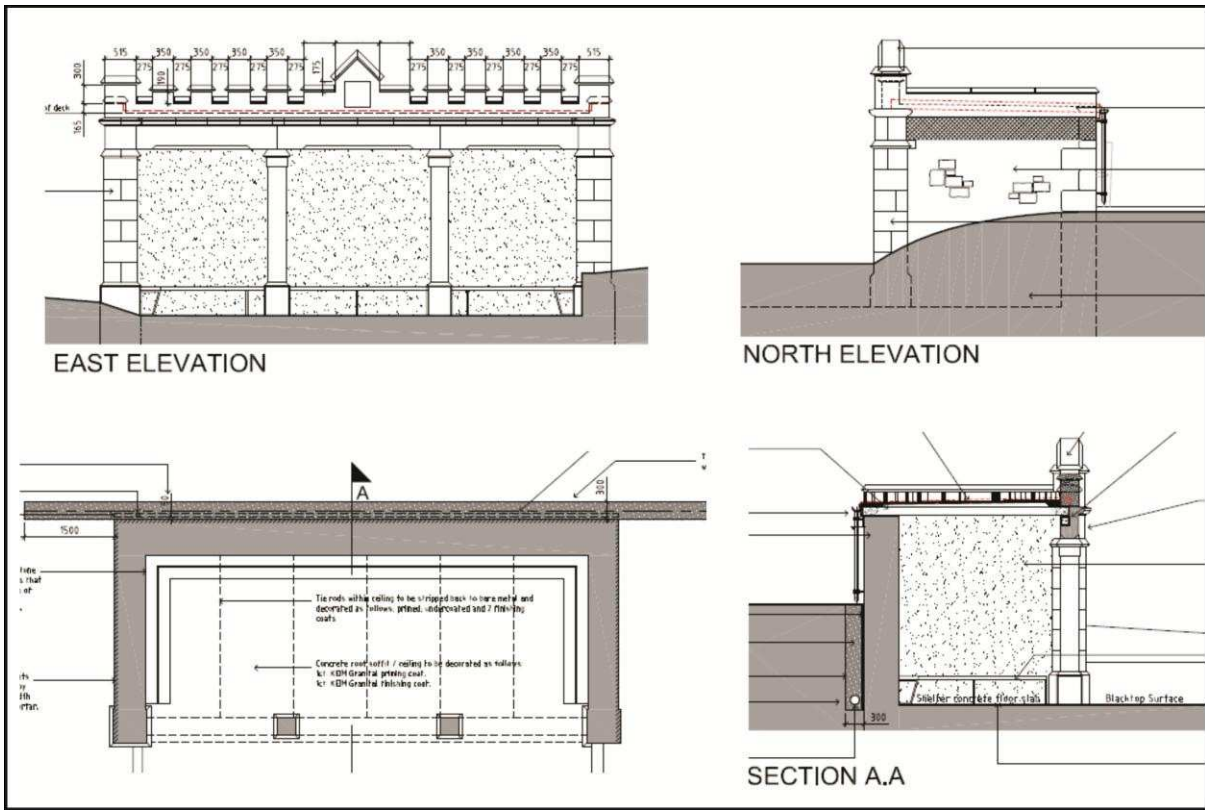
Illus 11 Stone shelter plan and elevations (copyright James F Stephens Architects)

The granite built shelter is 8.3m long and 3.8m wide. It is an open shelter with the open side facing east adjacent to the Upper Pond. The east face of the structure is supported by granite pillars with rusticated granite bases (Illus 11, 14). The shelter has been constructed into an earthen bank (Illus 13). The roof and floor are constructed of poured concrete and the walls of granite rubble; there are wooden seats along the interior of the north, west and east walls (Illus 14). The shelter is seen on the 1926 OS map and probably formed an original feature of the park when it opened in the 1880s.

The stone shelter is being restored as part of the current work.

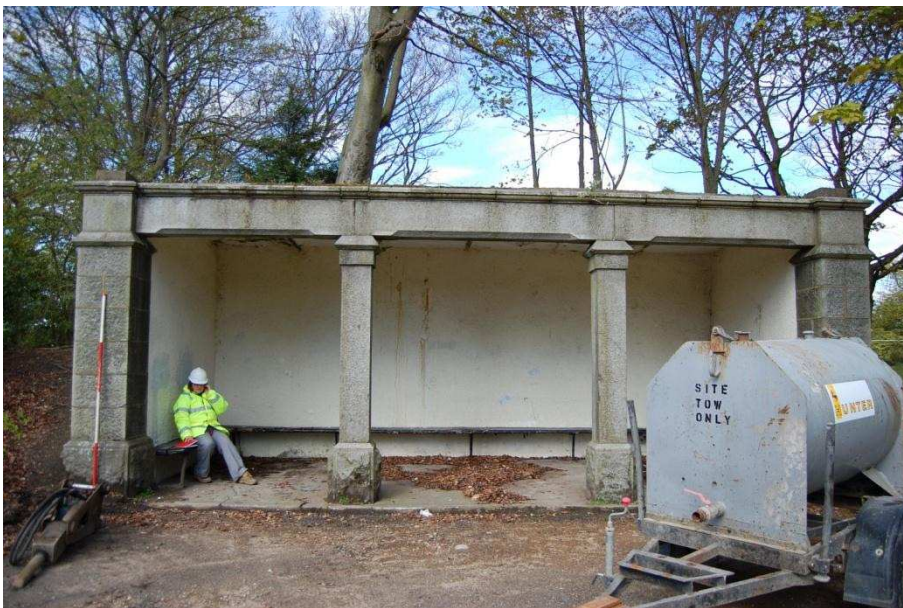
Illus 12 Stone shelter east facade; facing west

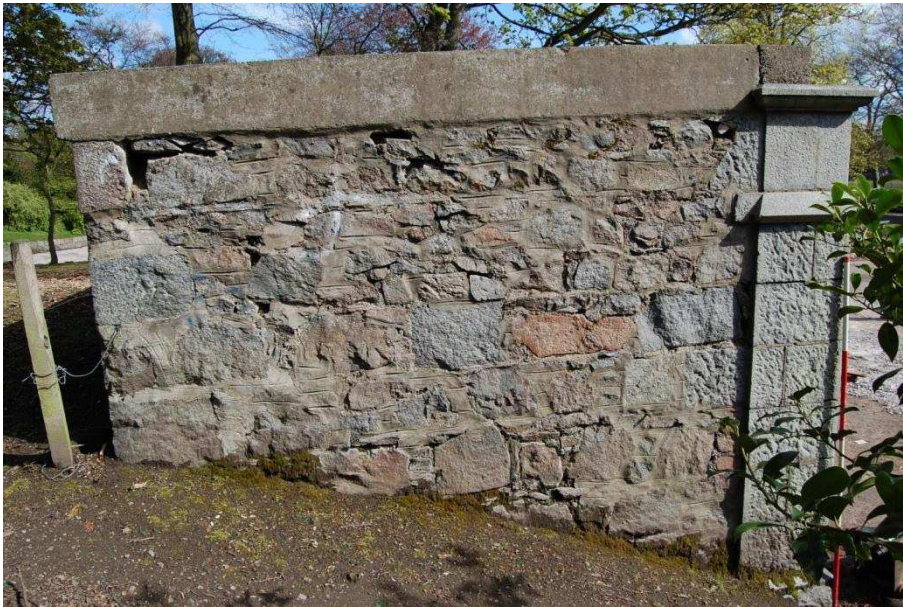
Illus 13 Stone shelter south wall, facing north

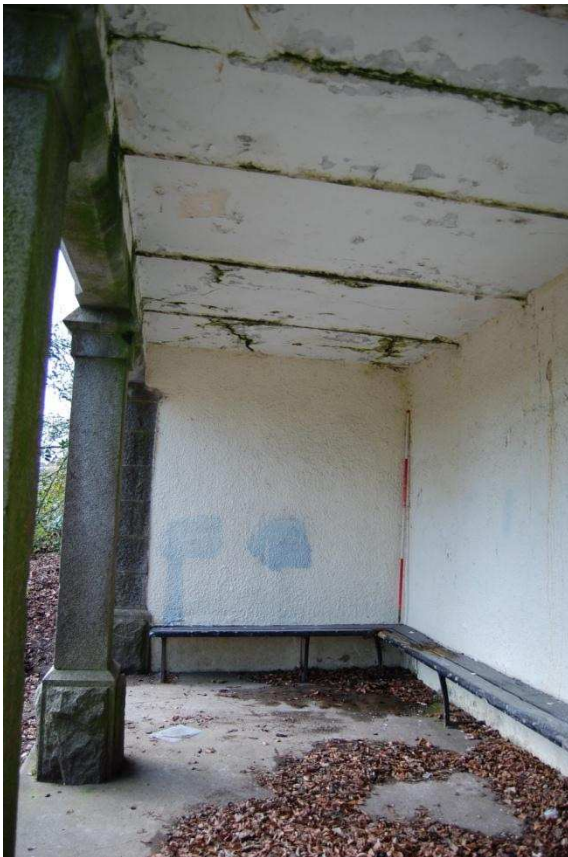
Illus 14 Stone shelter interior, facing south

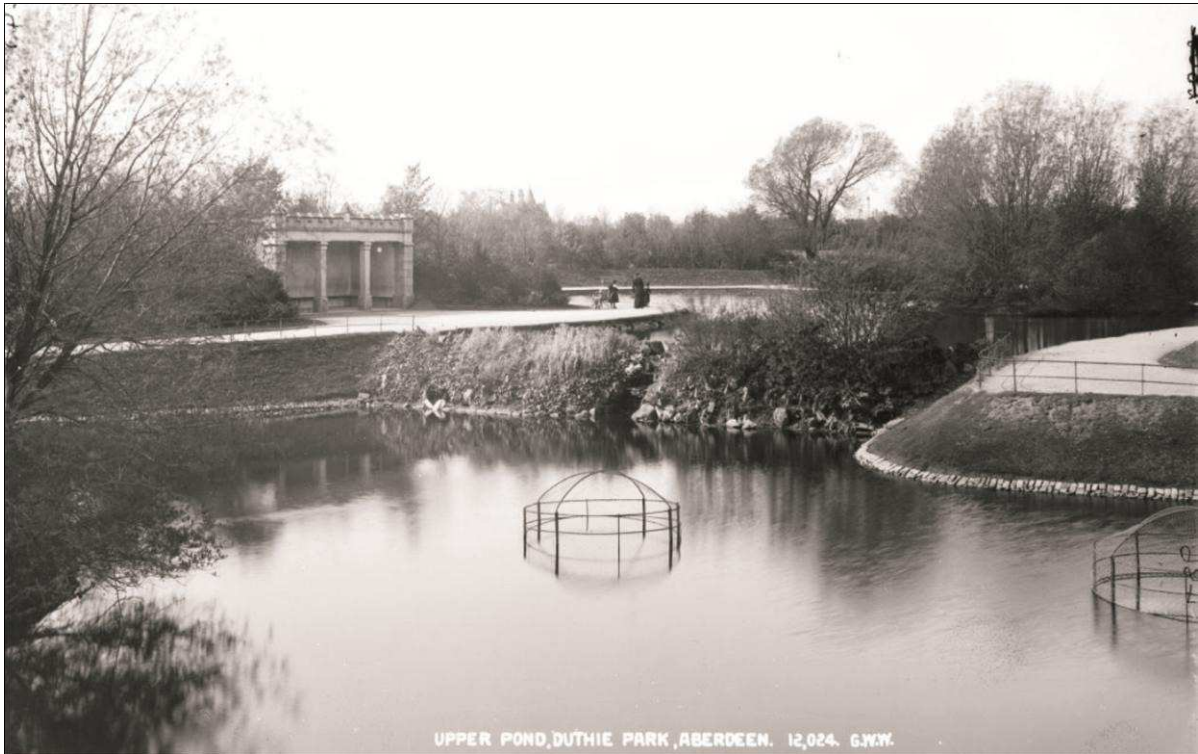
Illus 15 The stone shelter, Upper pond, probably late 19th century (copyright University of Aberdeen)

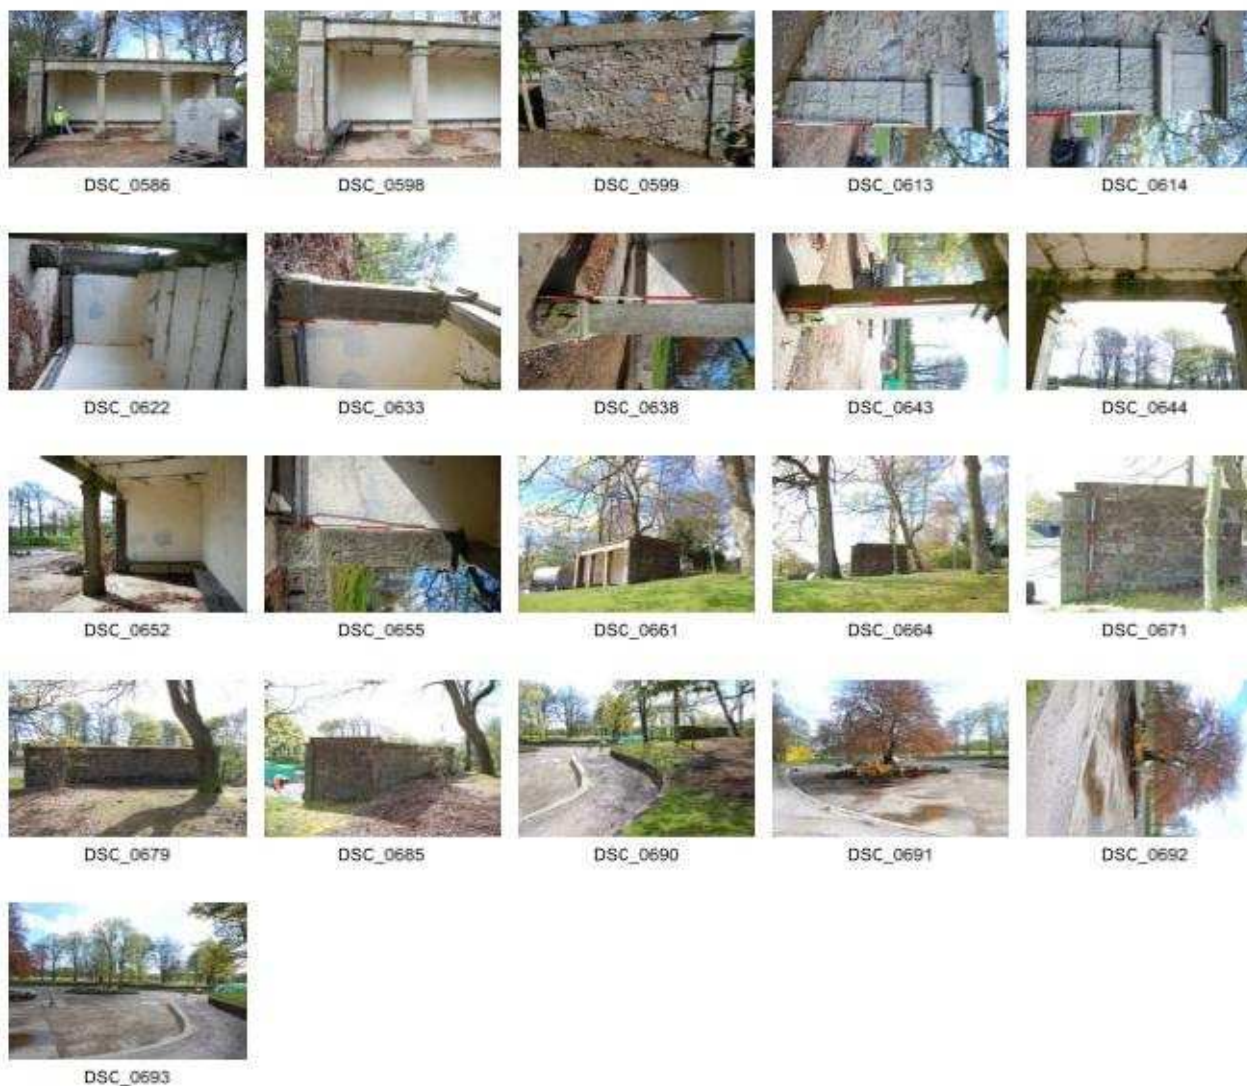
SHELTER

Shelter	
DSC_0585-0598	East front facade	W
DSC_0599-0618	south side wall	N
DSC_0619-633	Interior	S
DSC_0634-638	Stone pillar support	N
DSC_0639-643	Stone pillar support	NE
DSC_0644-648	Roof above supports	E
DSC_0649-653	Interior	SSE
DSC_0654-658	Pillar	N
DSC_0659-663	Shelter location	SSW
DSC_0664-674	North face	S
DSC_0675-680	west face	E
DSC_0681-685	NW corner	SE
DSC_0686-693	Drained pond east of shelter	S/N

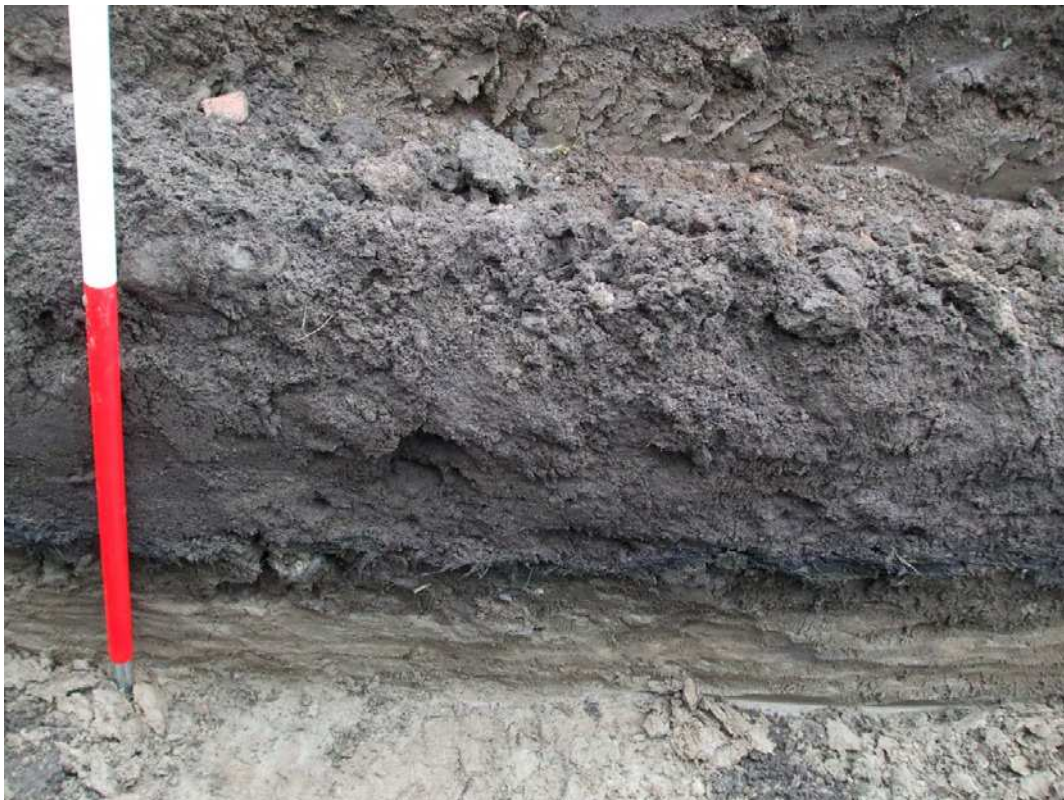
Trench 1 was positioned over the north-east extent of the pond to pick up its edge. No pond structure was uncovered but tip layers at each end of the trench (contexts 6, 7; Ill 11) were probably infill into the void after the pond structure had been removed. Natural subsoils consisted of organic remains and silty, sand and clay levels. No evidence of a waterproof lining (such as a puddled clay) for the pond was found, and it is assumed that the structure of the pond was more substantial, possibly granite or concrete. It appears that the waterproof structure that the pond would have required, was fully removed before the area was infilled with loams, clay, and redeposited natural subsoil; the sterile nature of these layers and the sparse finds recovered indicated that the infill was not brought into the site from a domestic or industrial area. It is possible that these soils came from the park itself, maybe from another area which was being landscaped at this time. The infill contained a small number of glass soft drink bottles, two cassies and a granite block shaped into a wedge. The bottles were probably discarded by workmen infilling the pond area, and the stonework may have been part of the pond structure or surrounding paving. The area of Trench 1 was covered with clinker surface (3).

Ill 4: Trench 1: detail of light grey silt (bottom), thin organic band above, and infill after removal of pond (top)

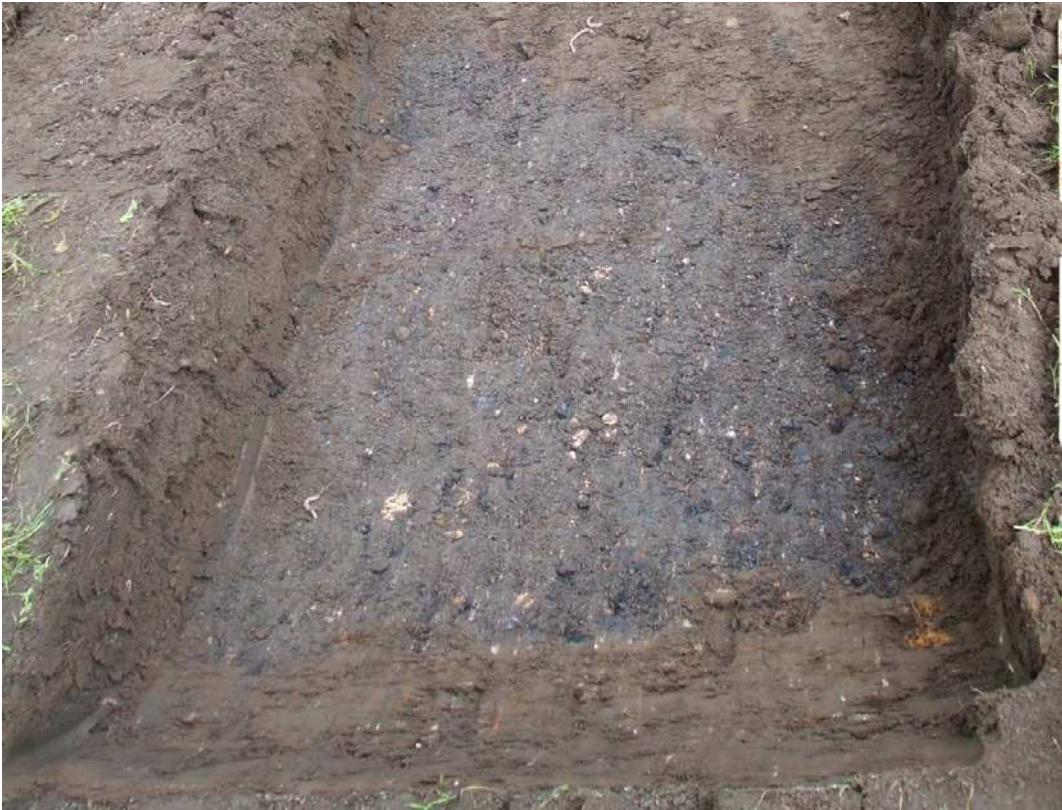
Ill 5: Trench 1: clinker surface (3)

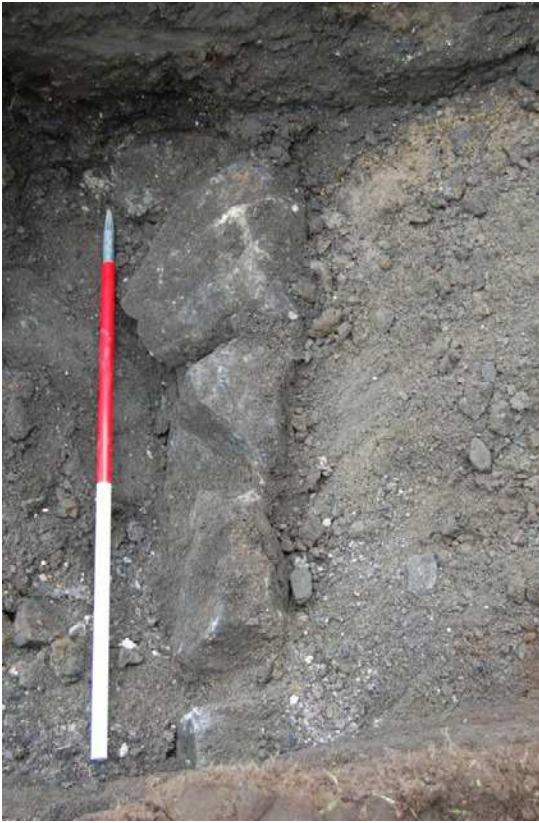
Trench 2 was located across the centre of the pond as seen on the 1901 Ordnance Survey map. Again tip layers into the pond structure were recorded, as well as the cut for the pond and stonework, which may be the edge of the pond or the surrounding path. Cut F14 (Ill 12) included a line of six granite boulders along its edge; no bonding material was present. Cut F14 was filled with loose stone and loam (2), and was the pit for the construction of the pond into which a lining would have been built. As in Trench 1 it is likely that this lining was made of concrete or granite which had been completely removed, possibly to improve drainage in the area. One wedge-shaped granite boulder in the edge of cut F14 (Ill 7, 12) may be the *in situ* remains of an edging for the pool or the surrounding paths. This stone was removed and stored in the Duthie Park sheds to allow inspection by an engineer.

Ill 6: Trench 2: stones in cut for pond (F14)

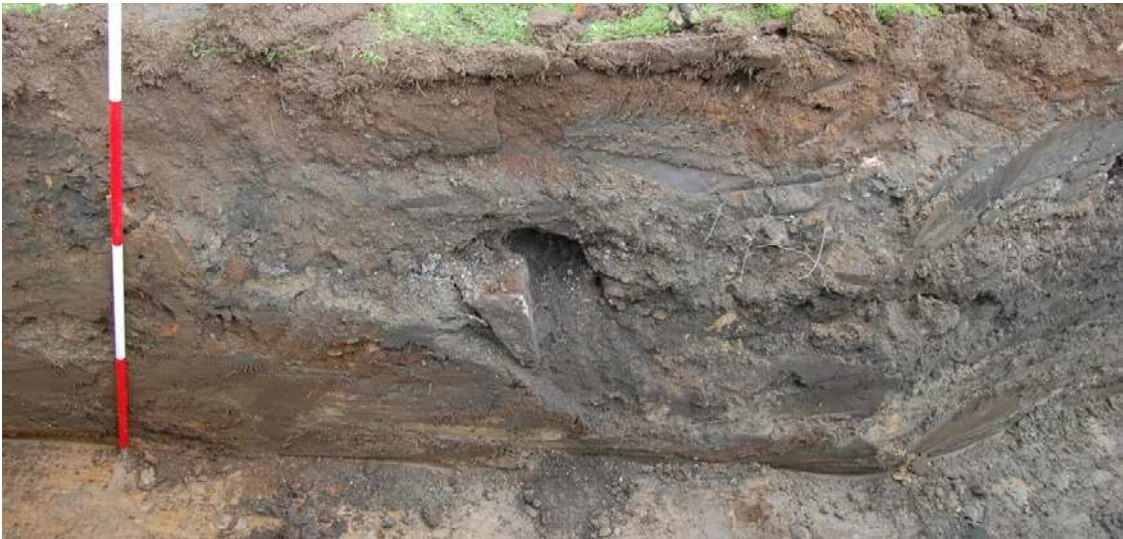
Ill 7: Trench 2: cut for pond (F14) and wedge-shaped stone *in situ*

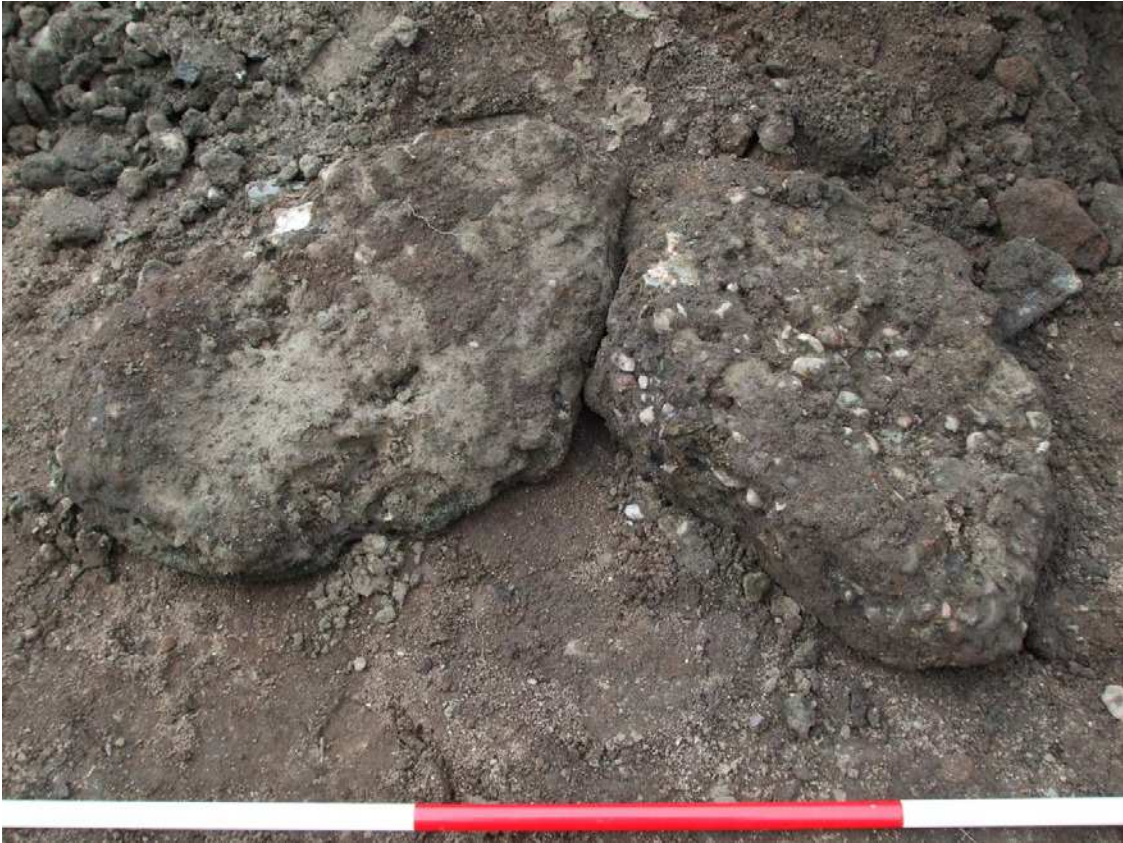
As in Trench 1 the pond had been infilled with fairly sterile material, including two sections of a concrete structure (Ill 8) c 1m diameter, which were photographed but not retained. These may have been part of the pond structure.

Ill 8: Trench 2: two fragments of concrete made with granite aggregate, in infill of pond, possibly originally part of the pond structure.

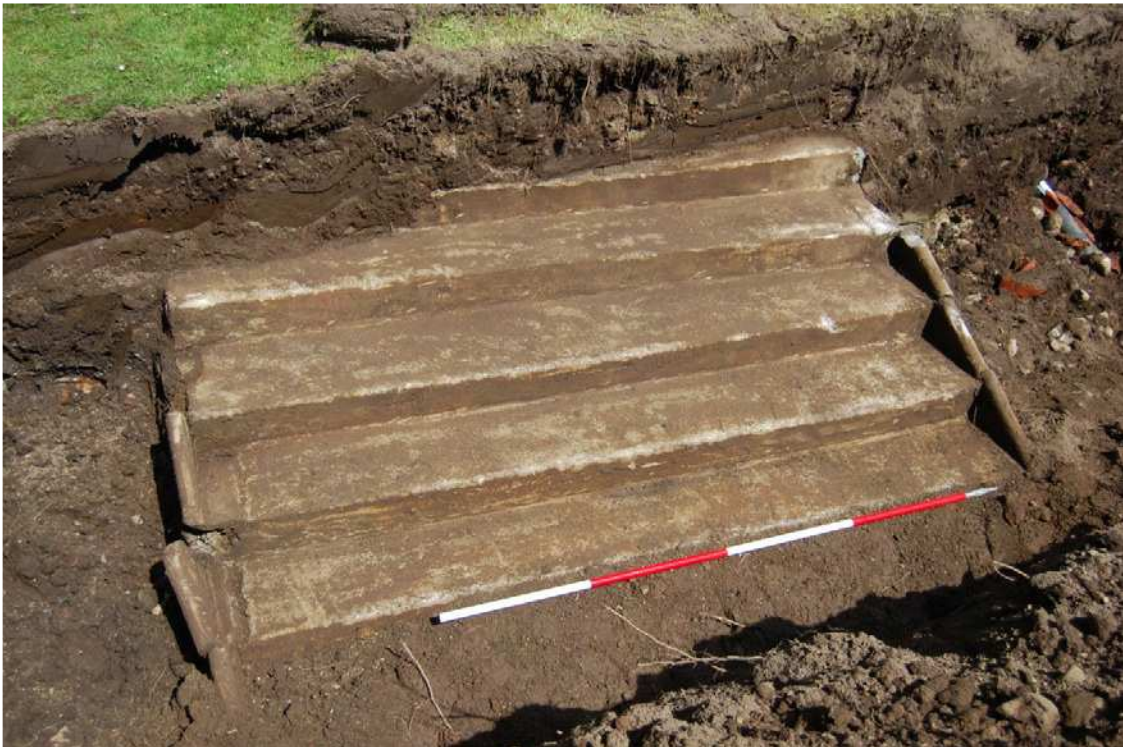
In Trench 3 a flight of six well-preserved concrete steps survived under 0.5-0.7m of well-drained topsoil (Ill 13). The treads of the steps were 3m long, each step was 0.40m wide and 0.14m deep and the steps were made from fine-grained concrete shuttered and poured *in situ*. The edging for the steps had been cast separately and attached onto the end of each step. The edgings were poorly preserved and some were missing, as these sections would have been weaker than the solid steps. A sample of this concrete was removed and stored in the Duthie Park sheds to allow inspection by an engineer. The foundation layer for the steps was a layer of stone, concrete and clay (18).

Ill 9: Steps F17 facing N
