Alterations and refurbishment, 50-52 College Bounds, Old Aberdeen, Aberdeen, AB24 3DS

**Alison Cameron
Cameron Archaeology Ltd
24 June 2012**

SUMMARY

A watching brief was carried out on 27th September 2011 - 20 June 2012 to observe the digging of holes for posts for a new fence, electric cables and water/sewage service trenches. A standing building survey was carried out on the interior of the building where a soft strip had taken place.

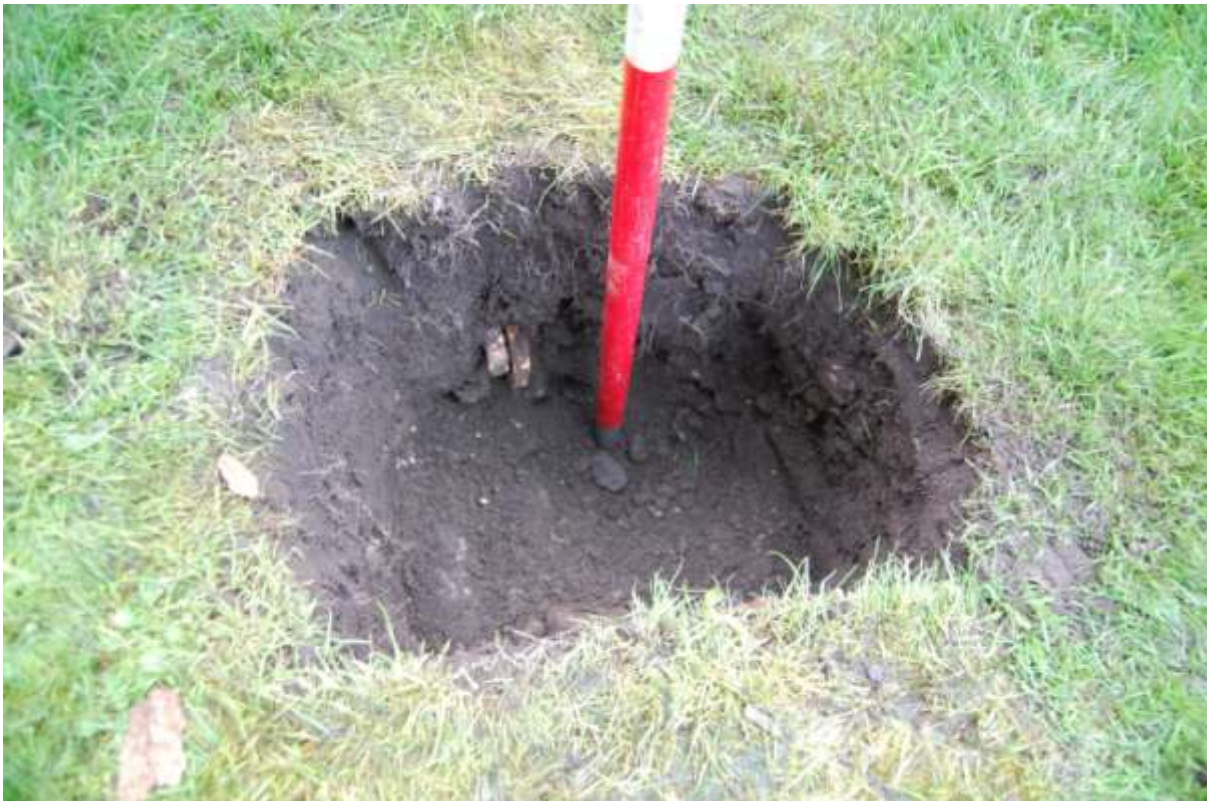
The watching brief was carried out from 27 September 2011 - 20 June 2012. Eight postholes were dug (in red on Illus 2) for fencing; the soil appeared to have been previously disturbed and there were mammal bones and late 19th-20th century pottery in the fills. Trenches for a new electricity supply (in blue on Illus 2) were excavated to the north of 52 College Bounds. Again much of this soil had been previously disturbed (especially by the King's College heating replacement, Cameron 2005b) and no in situ deposits were recorded. In Section 1 at the NE corner of the rear extension to No 52, the natural subsoil was recorded showing that the foundations of this building were built onto the natural subsoil (Illus 5).

Illus 4 detail of post-hole showing tile and bone finds; all 19th or 20th century and previously disturbed

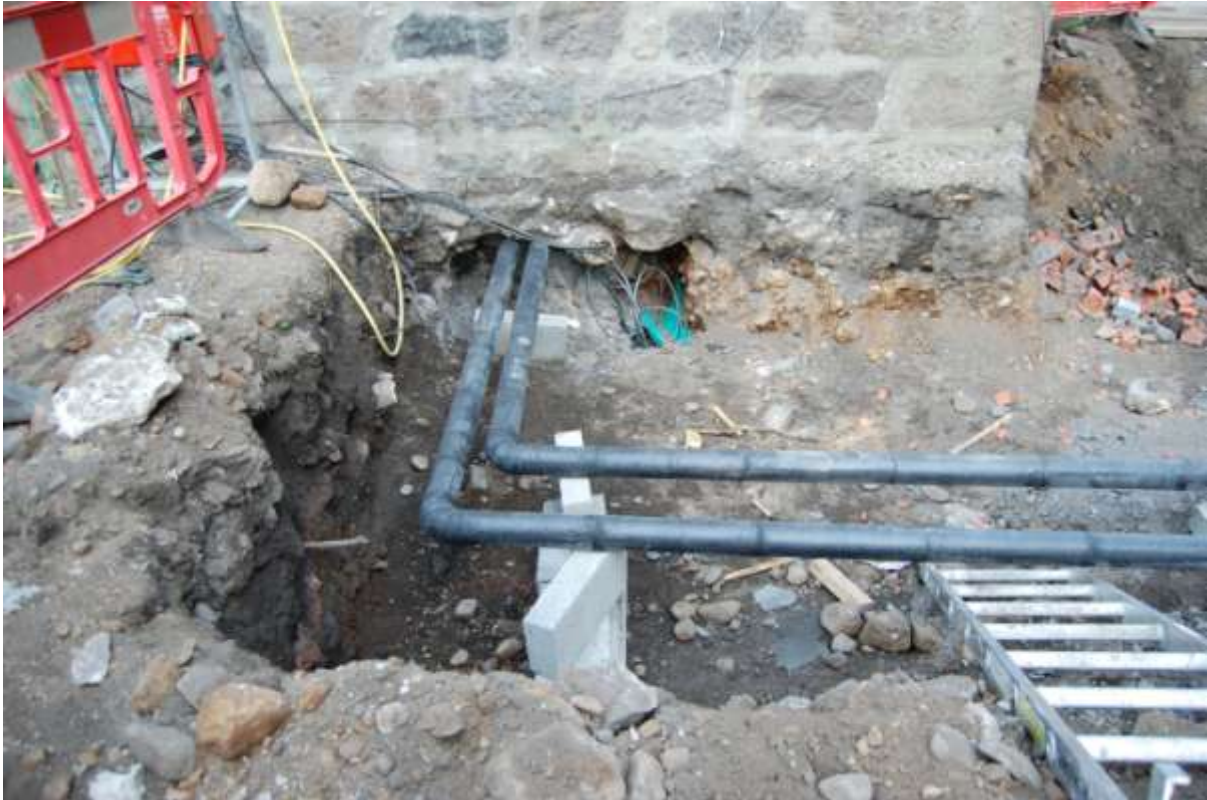
Illus 5 Trench for electricity cables; the level of the natural subsoil can be seen immediately below the foundation of the rear extension to 52 College Bounds (Section 1 Illus 2)

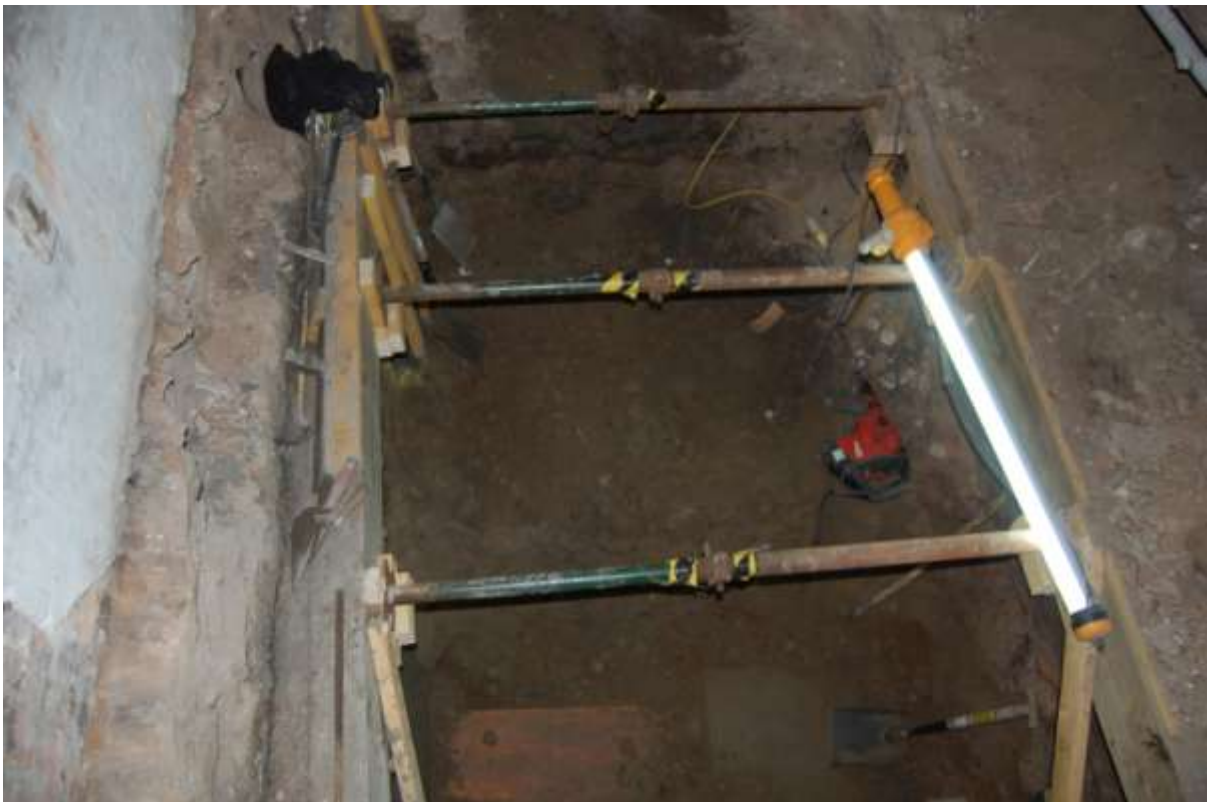
Illus 6 Trench for new lift shaft

A trench was excavated under the former stairwell of No 50 for a new lift (Illus 6, 7) and natural subsoil recorded at the basement level; several small trenches were excavated in the building for work on the foundations and for concreting; garden soil was removed but no archaeological contexts or features were recorded.

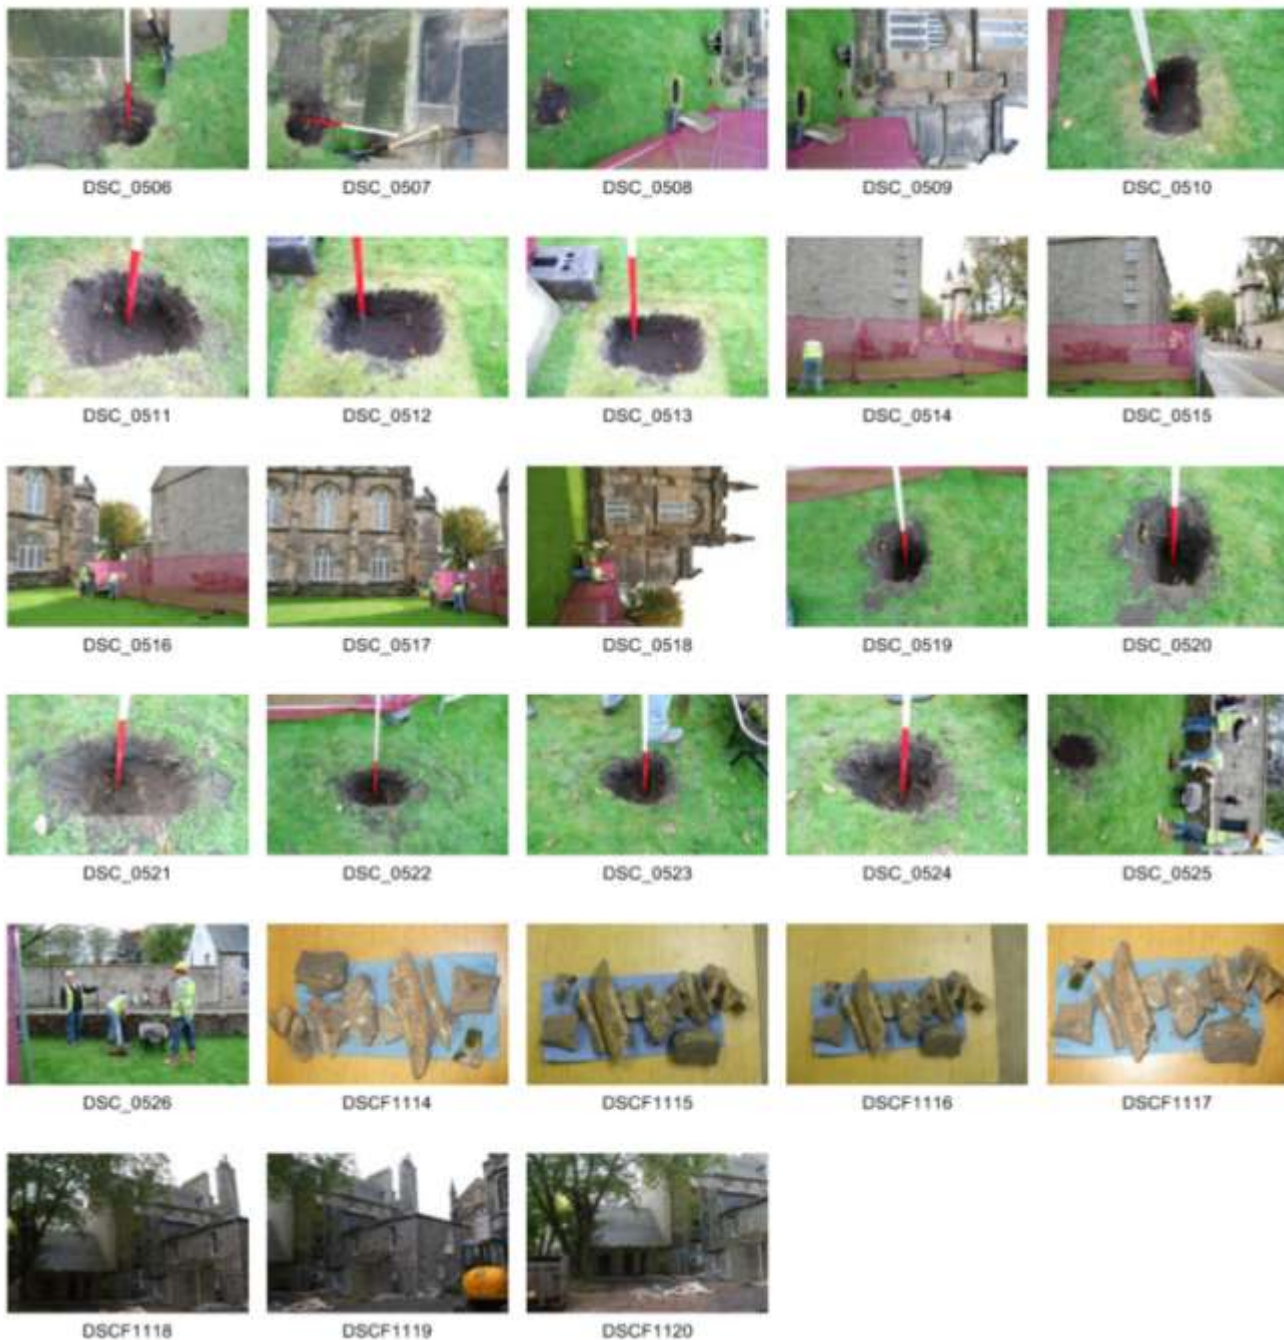
Postholes

Post-holes for fencing		
DSC_0506	Pit 1	E
DSC_0507	Pit 1	E
DSC_0508	Pit 3, 2, 1	E
DSC_0509	Pit 3, 2, 1	E
DSC_0510	Pit 2	W
DSC_0511	Pit 2	S
DSC_0512	Pit 3	W
DSC_0513	Pit 3	W

DSC_0514	Pits 4, 5, 6	S
DSC_0515	Pits 6, 7, 8	S
DSC_0516	Pits in relation to King's College Library (left) and 52 College Bounds (right)	SE
DSC_0517	Pits in relation to King's College Library (left) and 52 College Bounds (right)	SE
DSC_0518	Pits in relation to King's College Library	SE
DSC_0519	Pit 4	S
DSC_0520	Pit 4	W
DSC_0521	Pit 5	S
DSC_0522	Pit 6	S
DSC_0523	Pit 6	S
DSC_0524	Pit 6, 7, 8	W
DSC_0525	Pits 7, 8	W
DSC_0526	Pits 7, 8	W
DSCF1114	animal bones and medieval pottery sherd	
DSCF1115	animal bones and medieval pottery sherd	
DSCF1116	animal bones and medieval pottery sherd	
DSCF1117	animal bones and medieval pottery sherd	
DSCF1118	Rear of 50-52 College Bounds	NW
DSCF1119	Rear of 50-52 College Bounds	NW
DSCF1120	Rear of 50-52 College Bounds	NW

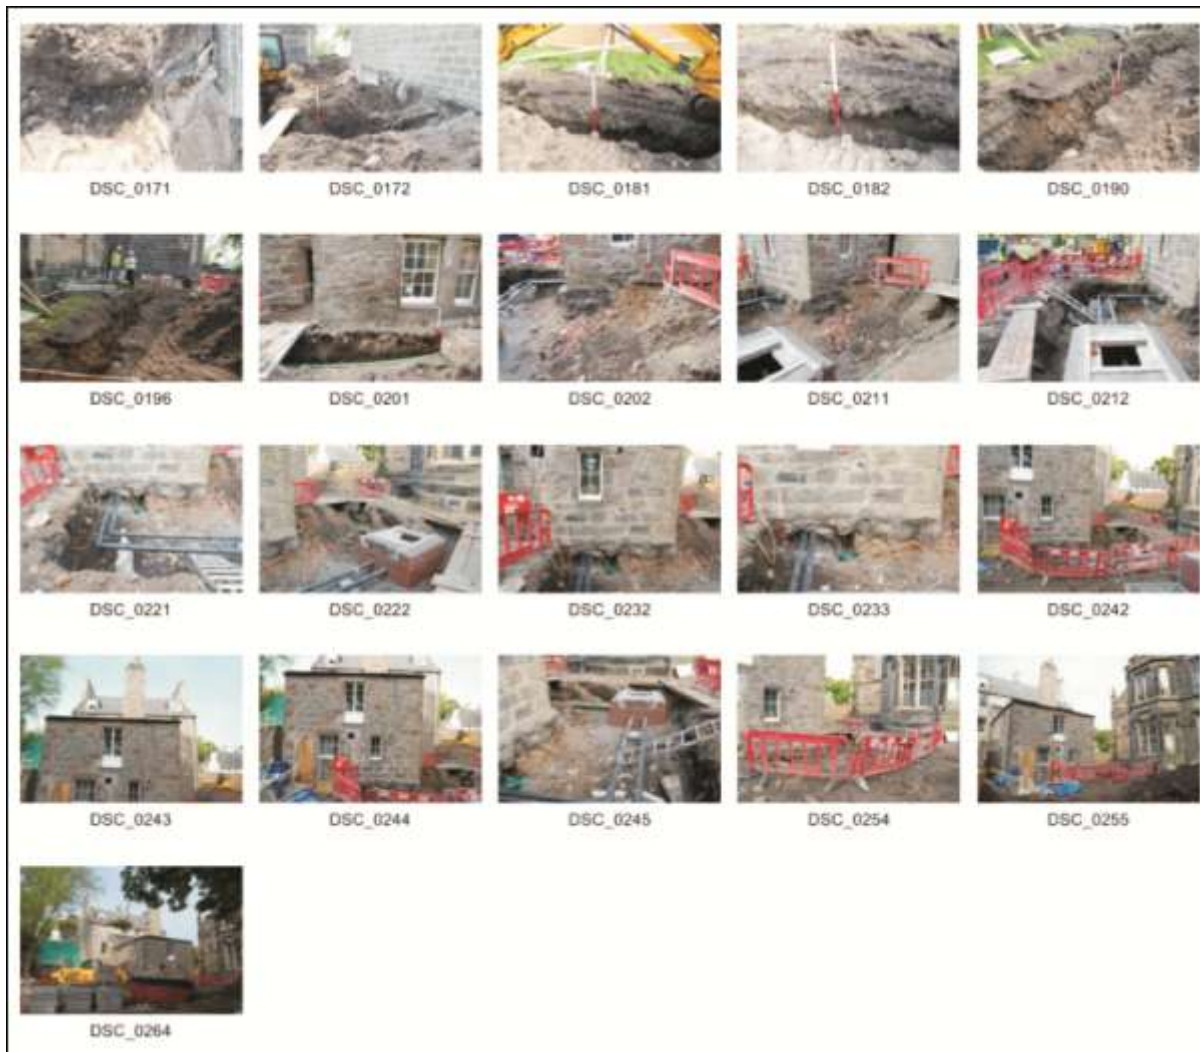
DSC_0168-171	West trench adjacent to north wall 52 College Bounds	SW/S
DSC_0172-176	West trench adjacent to north wall 52 College Bounds	E
DSC_0177-186	W-E trench	N
DSC_0187-191	W-E trench	NE
DSC_0192-196	W-E trench with King's College in background	ENE
DSC_0197-201	Trench adjacent to extension to rear of 52 College Bounds	S
DSC_0202-206	Rear extension 52 College Bounds - corner showing foundation built on natural subsoil	S
DSC_0207-211	Rear extension 52 College Bounds - corner showing foundation built on natural subsoil	SW
DSC_0212-216	Trench behind rear extension 52 College Bounds	S
DSC_0217-221	Trench behind rear extension 52 College Bounds showing foundation built on natural subsoil	W

DSC_0222-226	Trench behind rear extension 52 College Bounds showing foundation built on natural subsoil	NW
DSC_0227-242	Trench behind rear extension 52 College Bounds showing foundation built on natural subsoil	W
DSC_0243-244	52 College Bounds - rear facade	W
DSC_0245-249	Trench behind rear extension 52 College Bounds showing foundation built on natural subsoil	N
DSC_0250-259	Trench behind rear extension 52 College Bounds showing foundation built on natural subsoil	NW
DSC_0260-264	52 College Bounds - rear facade	WNW
