**WOODEND FARM, CULTER HOUSE ROAD,  
PETERCULTER, ABERDEEN, AB14 0NS  
STANDING BUILDING SURVEY**

**Alison Cameron  
Cameron Archaeology Ltd  
17 August 2012**

A Level 2 standing building survey was carried out at Woodend Farm prior to conversion of the steading buildings. It is recommended that no further work is required during this current development.

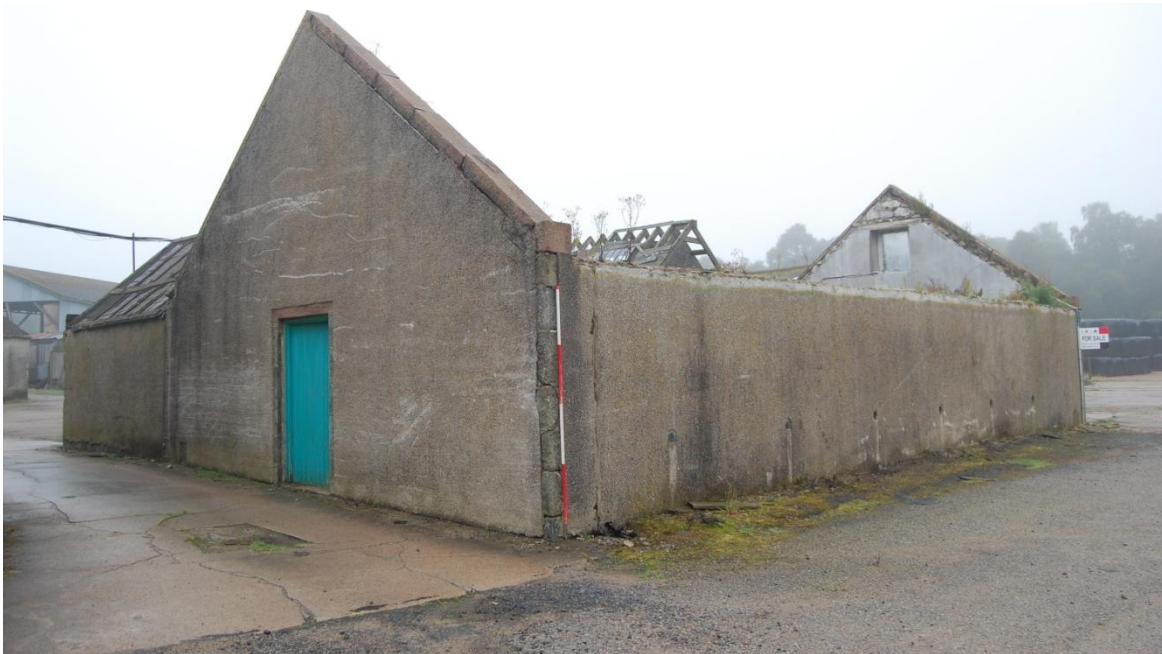
Illus 4 Room1 showing Door 2 (left) and ventilation pipes in east wall facing NW

Room 1 is 16.3m long and 8.5m wide (Illus 1) and is constructed of granite rubble with granite window and door lintels, sill and jambs. The whole room was converted in 1948 to a cattle byre with the installation of reinforced concrete partitions, troughs and floor with open runnels (Illus 2) which drained to the north where a muck heap was situated in the courtyard. Fireclay fittings are well preserved and these include pipes through the east wall towards the road and internal ventilation in the west partition wall (Illus 6). The north end of this room was stables in the mid 20th century and access through Door 4 led to a further barn area (Room 2) which was used as a milking parlour.

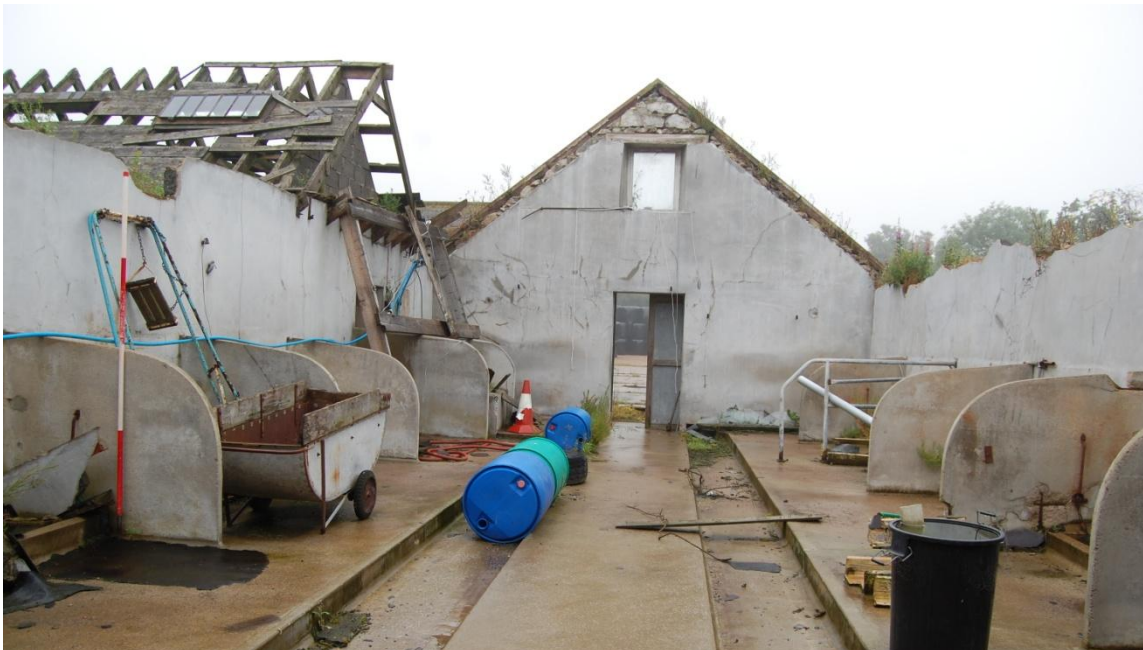
Illus 5 Room 1 showing reinforced concrete partitions, facing north

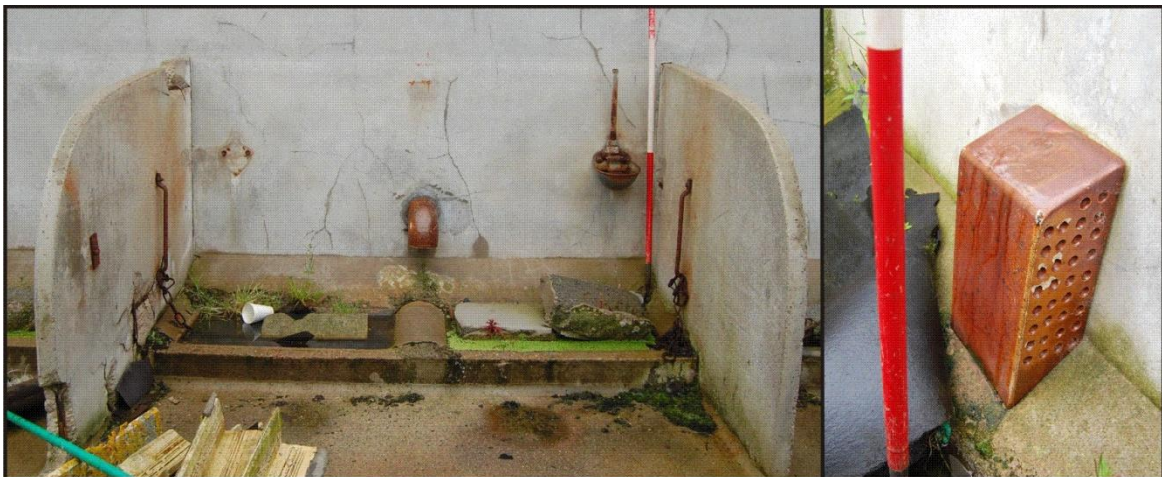
Illus 6 (left) reinforced concrete partitions, trough and fireclay pipes to external wall (right) fireclay ventilation through partition wall

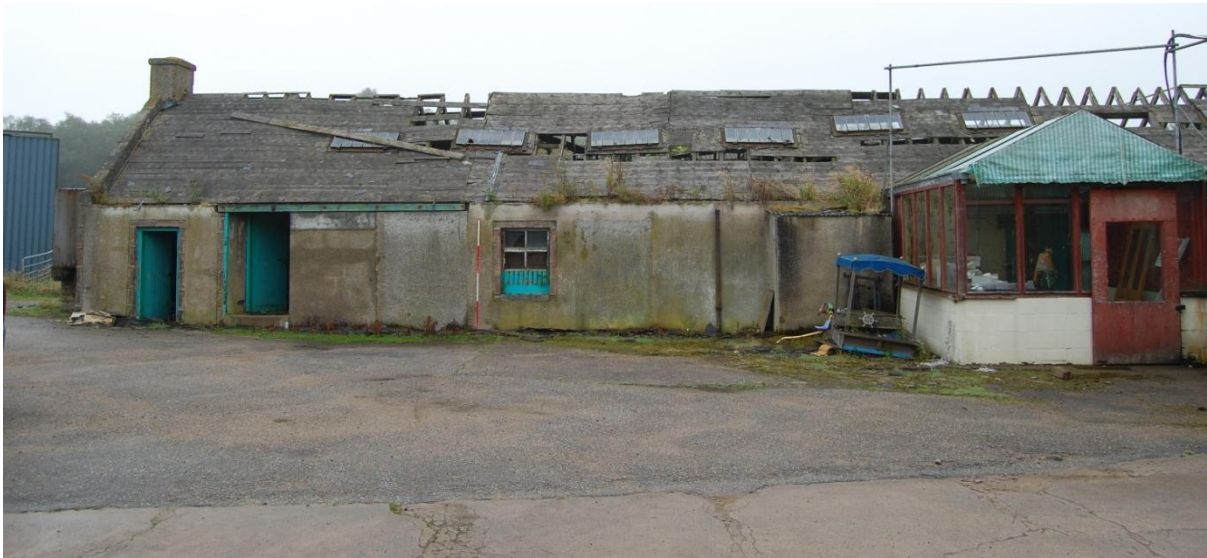
Illus 7 Rooms 4 (left) Room 3 (centre) and Room 2 (right) facing north

Rooms 2, 3 and 4 have all been heavily converted and there are no preserved internal fittings. Blocked Door 6 originally led to the loose box and blocked door 7 to the cart shed. Original doors D9 and D8 as well as Windows W2 and W4 have granite lintels, sill and jambs. Rooms 2-4 are 24m long and 5m wide; the walls stand 2m high and the roofs are in poor condition. All the walls are harled but they are of rubble construction.

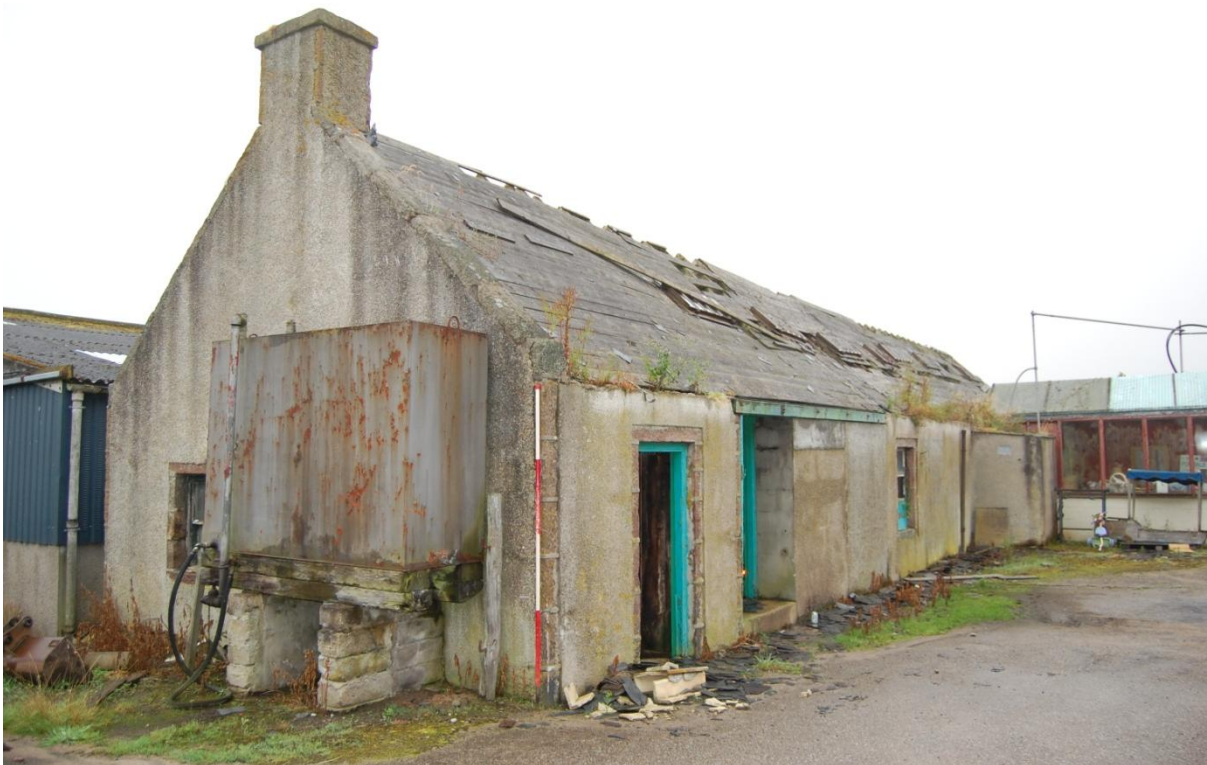
Illus 8 Room 4 (bothy; left) facing ENE
