Land to North East of Whiteknowes,
Craigievar, Alford, AB33 8LT
Standing building survey and watching brief

Alison Cameron
Cameron Archaeology
26.8.12

Land to North East of Whiteknowes (Piperwell), Craigievar, Alford, AB33 8LT Report on Standing Building Survey

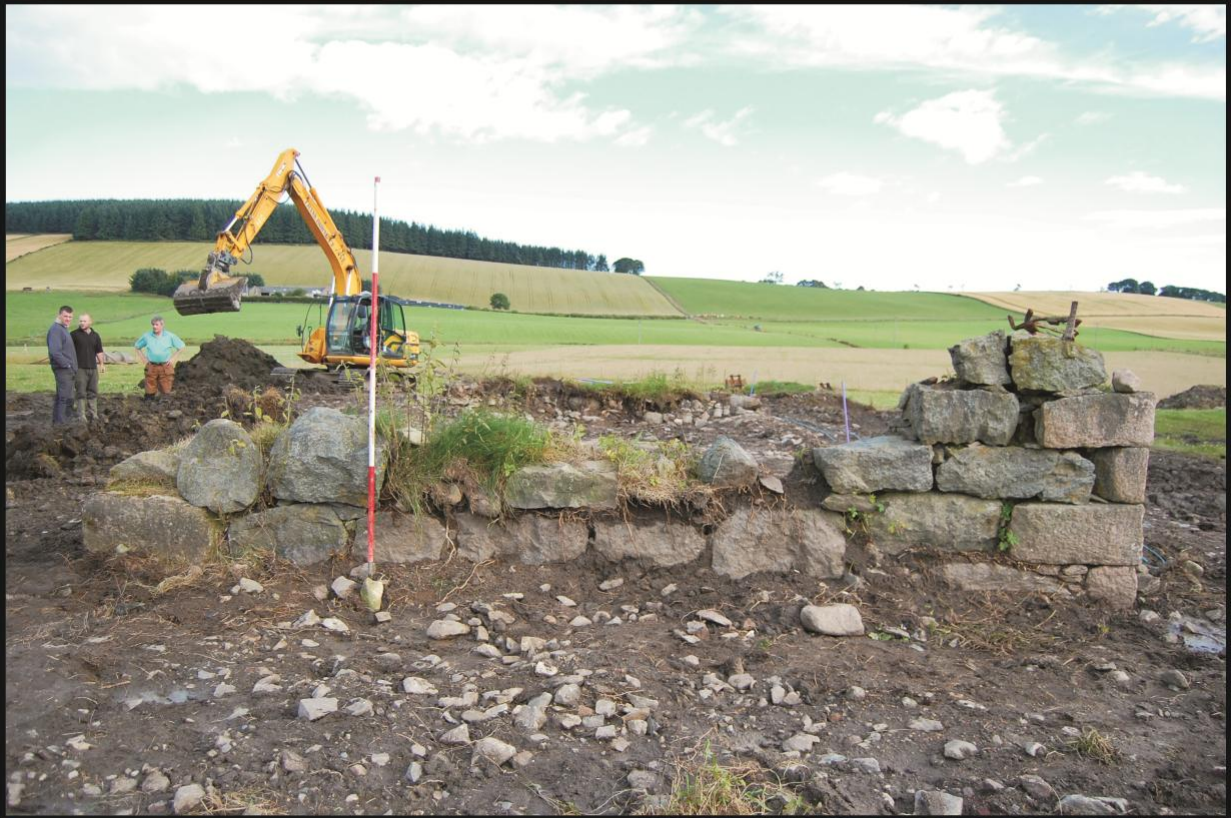
Cover (top) Wall 1 the south wall of the farmhouse facing north (bottom) greep F2 facing north

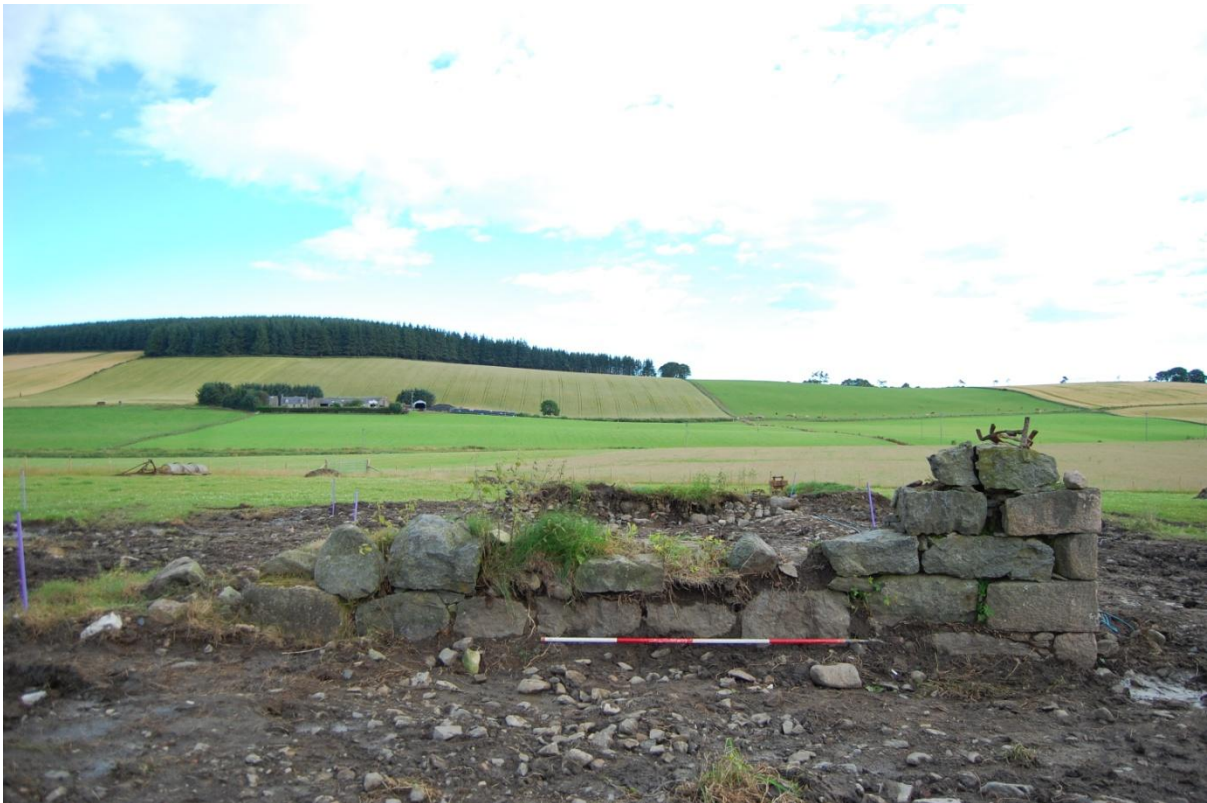
Illus 3 Wall 1 the south wall of Building 1; facing north

The remains of the house stood to 1.4m high and the building was 5.8m wide and 12.8m long. The walls were c 0.7m wide and the foundations c 1m wide. The walls were constructed of large grey granite quarried blocks and the quoins of pink granite blocks (Illus 5).

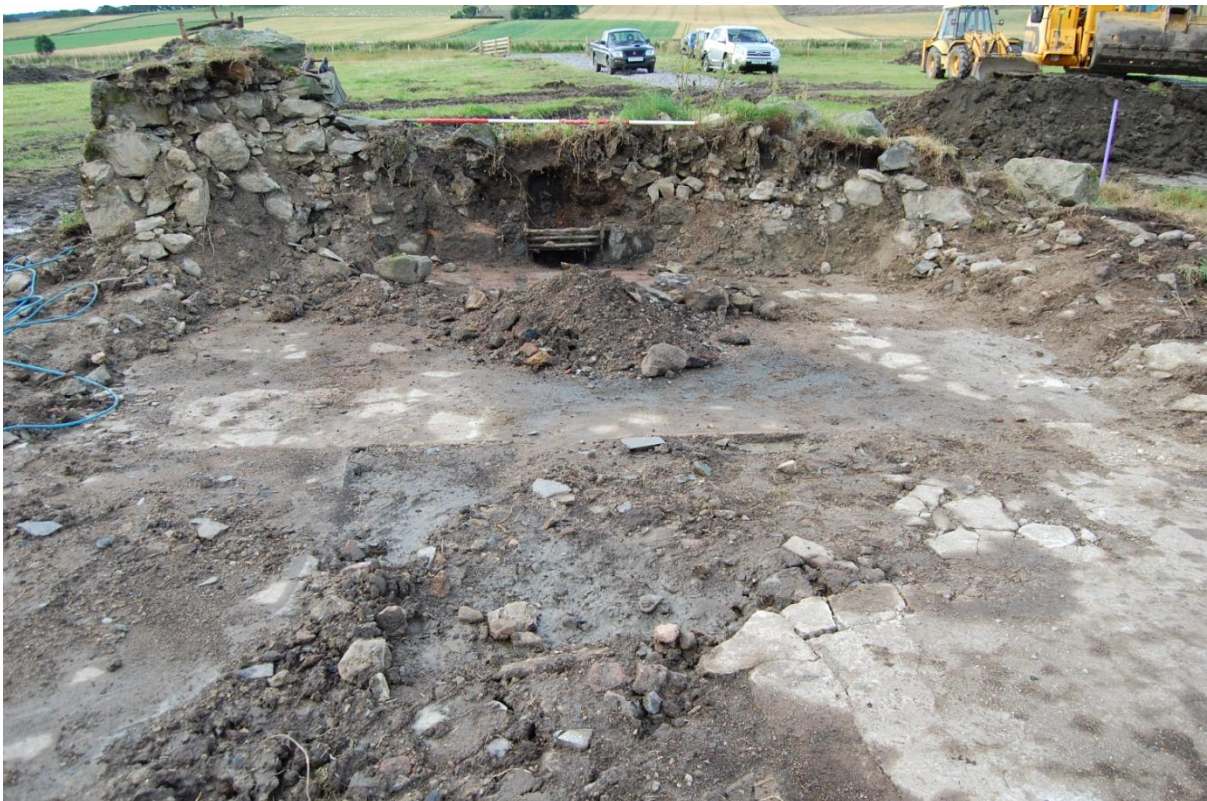
Illus 4 Building 1 floor F6 (foreground) and wall 1 with fireplace F4 (top); facing south

In the centre of the south wall is a fireplace (F4) with stone hearth (F5) and this room latterly had a concrete floor (Illus 5). All the walls of Building 1 were poorly preserved with no surviving mortar which had been replaced by soil from plant growth and the use of the ruin as a stone dump. The east and west walls survived as 1m wide large stone foundations only.

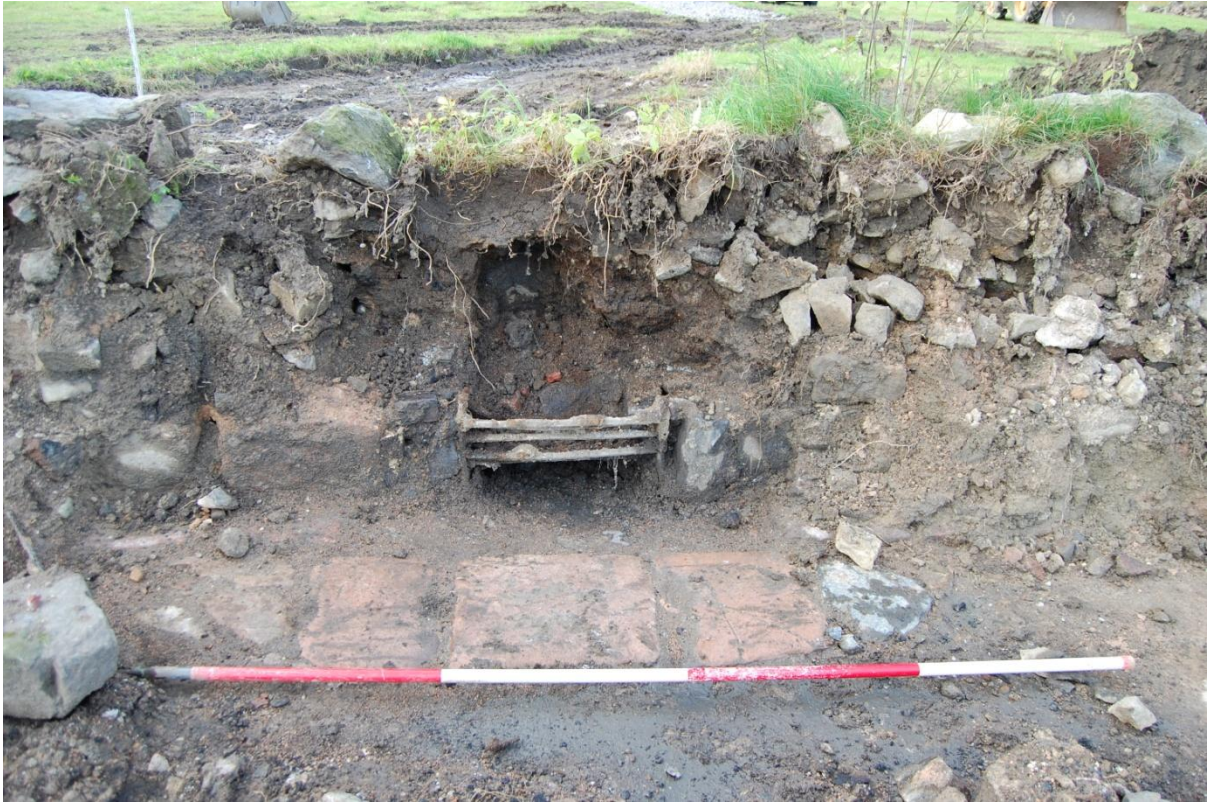
Illus 5 Fireplace (F4) in centre of Wall 1, the north wall of Building 1 with stone hearth (F5); facing south

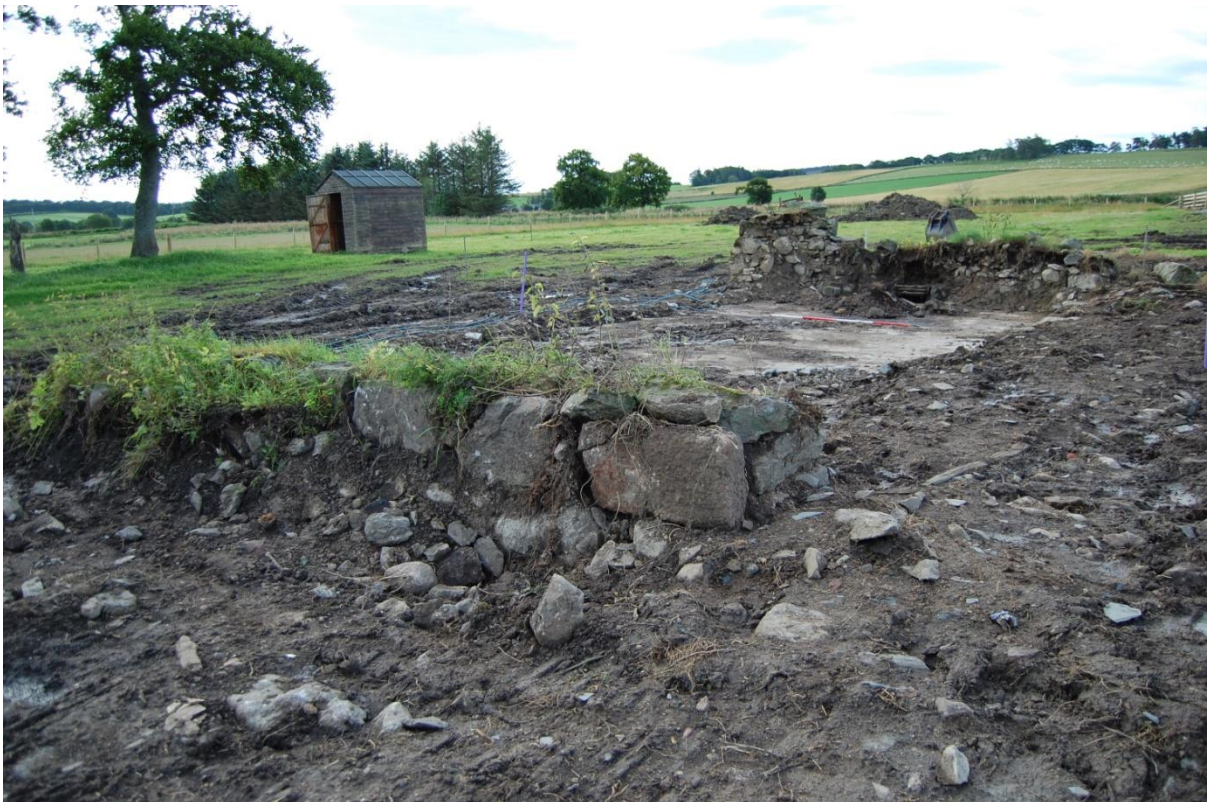
Illus 6 Wall 3 the north wall of Building 1; facing SE

The south wall of Building 1 (Wall 3; Illus 6) survived as one course of large grey granite blocks only and the large stone foundation was clearly visible. The building had been divided into at least 2 rooms with a smaller kitchen at the south end and a larger room at the north which may have been divided into two.

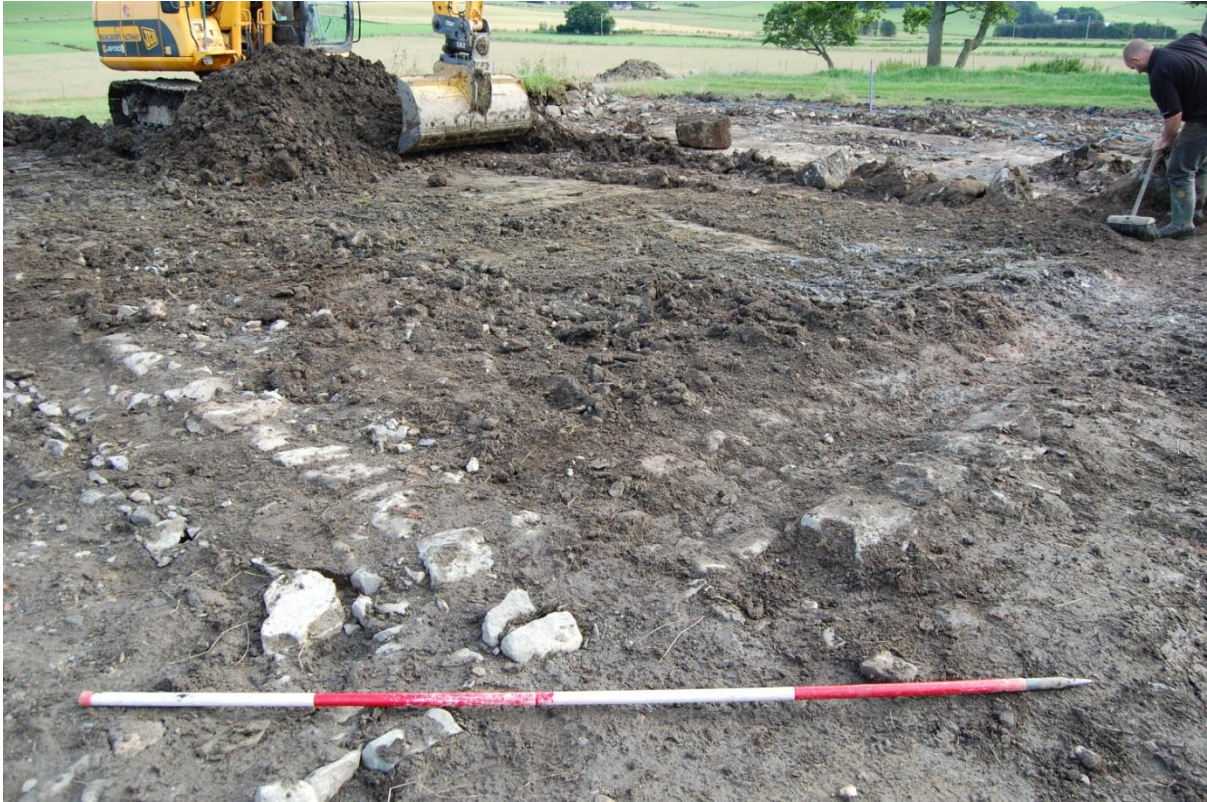
Illus 7 Byre floor showing runnels (greep) F1 (right) and F2 (left); facing NE

Building 2 had been the byre; the wall foundations survived as soil filled trenches c 1m wide with some stone surviving in the base of the trenches indicating that this building had been systematically demolished and the stone removed from the site prior to the 1940s (Mr McLaren, Whiteknowes, pers comm). The floor of the byre (greep; Illus 7) survived as a series of stone-lined runnels F1 along the interior face of the south wall and F2 along the

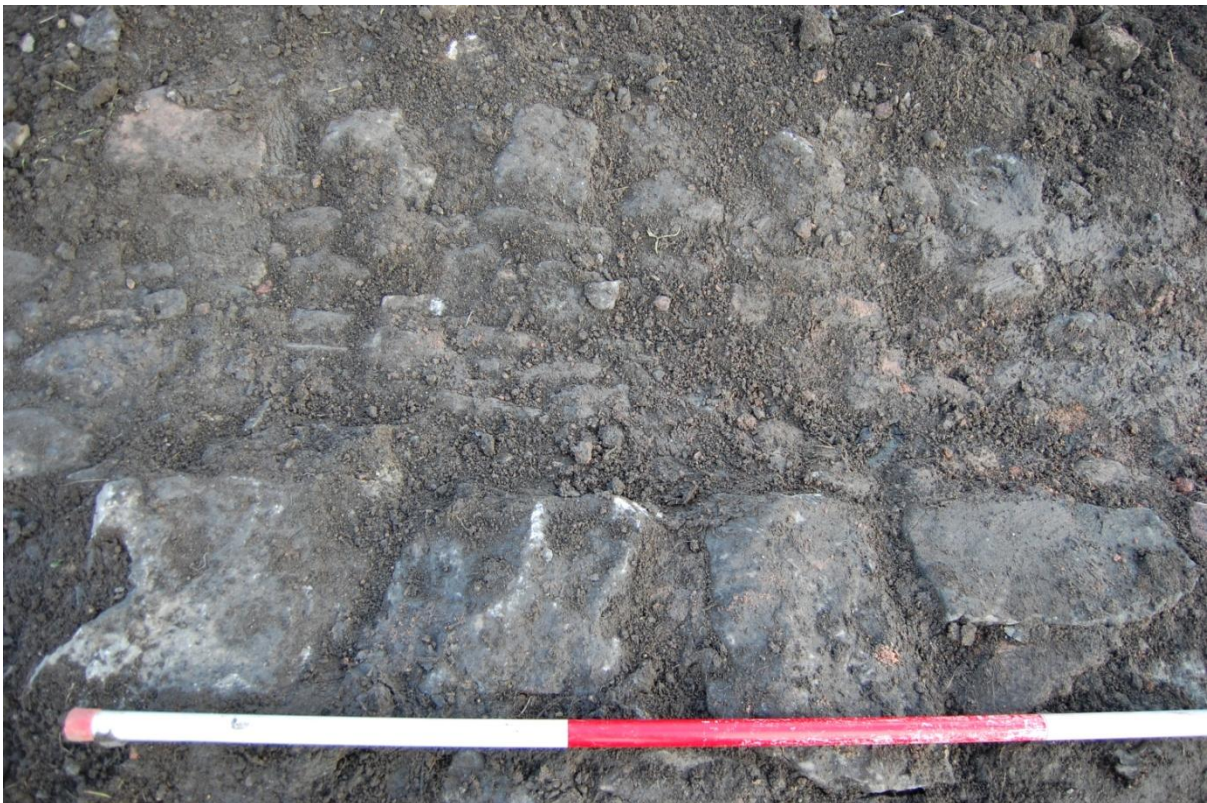
Illus 8 Greep F1 showing stones lining the edge of the runnel (bottom) and smaller stone base (top); facing north

interior of the west wall. These were 0.85m wide lined with larger flat granite field stones and the base lined with small pebbles (Illus 8). F2 sloped down to the north and presumably out through the north wall into the midden whilst F1 ran down to the east across the courtyard and into a stone drain F3 (not excavated). A layer of demolition material on top of this floor included grey slates and sherds of pottery of 19th or early 20th-century date.
