**Petersfield, Inch,  
Aberdeenshire, AB52 6LN  
Report on the Standing Building Survey**

**Alison Cameron  
Cameron Archaeology  
27 November 2012**

### 3 THE STANDING BUILDING PHOTOGRAPHIC SURVEY

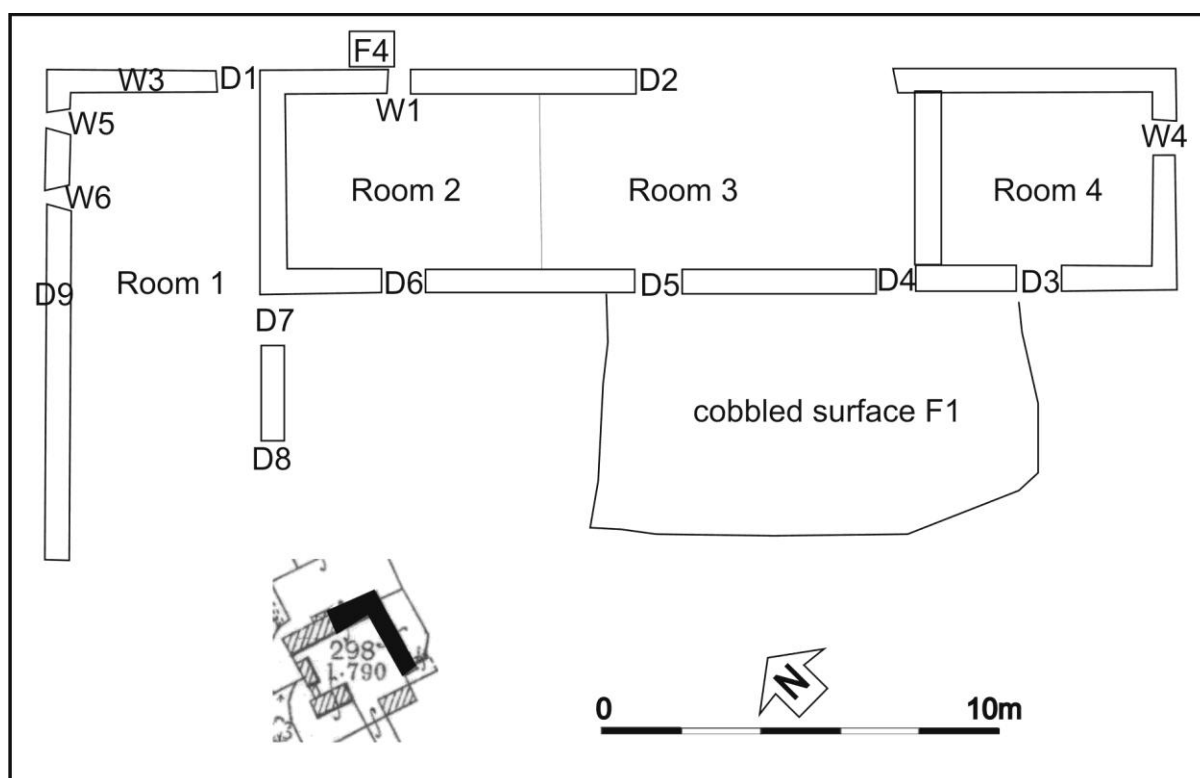
Illus 3 Plan showing main features recorded in this standing building survey with First Edition Ordnance survey inset showing surviving remains

Although some restoration work has already started on the building which has been damaged by years of inclement weather, the main structural elements surviving have been recorded. Four rooms survive (Illus 3) including Room 1 which is partly rebuilt in wood, Room 2 with a wooden door at the SE end and Rooms 3 and 4 which have been partially rebuilt. The buildings are all of black, grey and pink granite fieldstones which have been roughly dressed; there is cherry cocking throughout. All the doors are 1.1m wide and the lintels are all of pink granite except W4 which is of wood. These buildings appear to have been built in one phase and are probably mid 19th century in date.

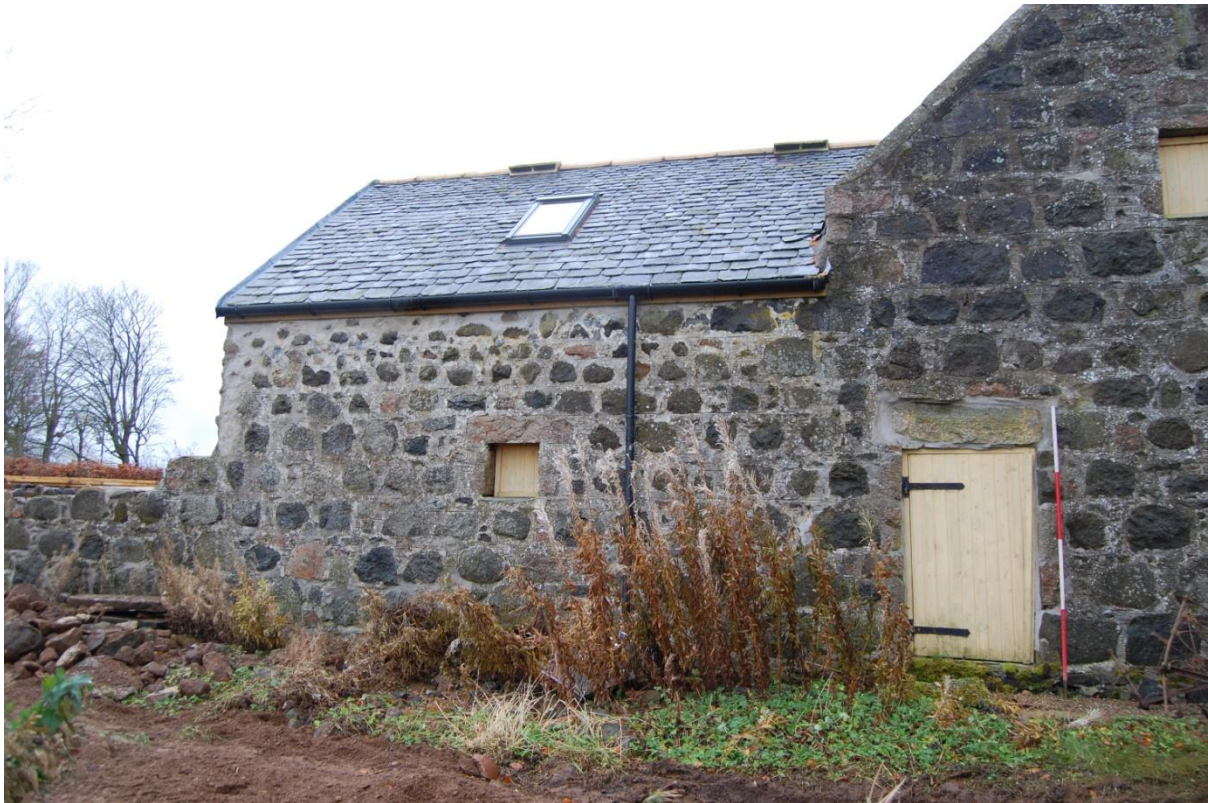
Illus 4 Room 2 (left) Room 1 gable (right) with W1, W2 (below) D1 and W3 (above)

Room 2 has operated as a mill with small apertures W1 and W2 allowing the drive shaft mechanism to enter the building. There is a stone platform adjacent to these apertures but no access is possible to the interior of this building to inspect the floor. Small windows (W5 and W6) were usually provided to allow a little ventilation into a room whilst keeping out the worst of the weather.

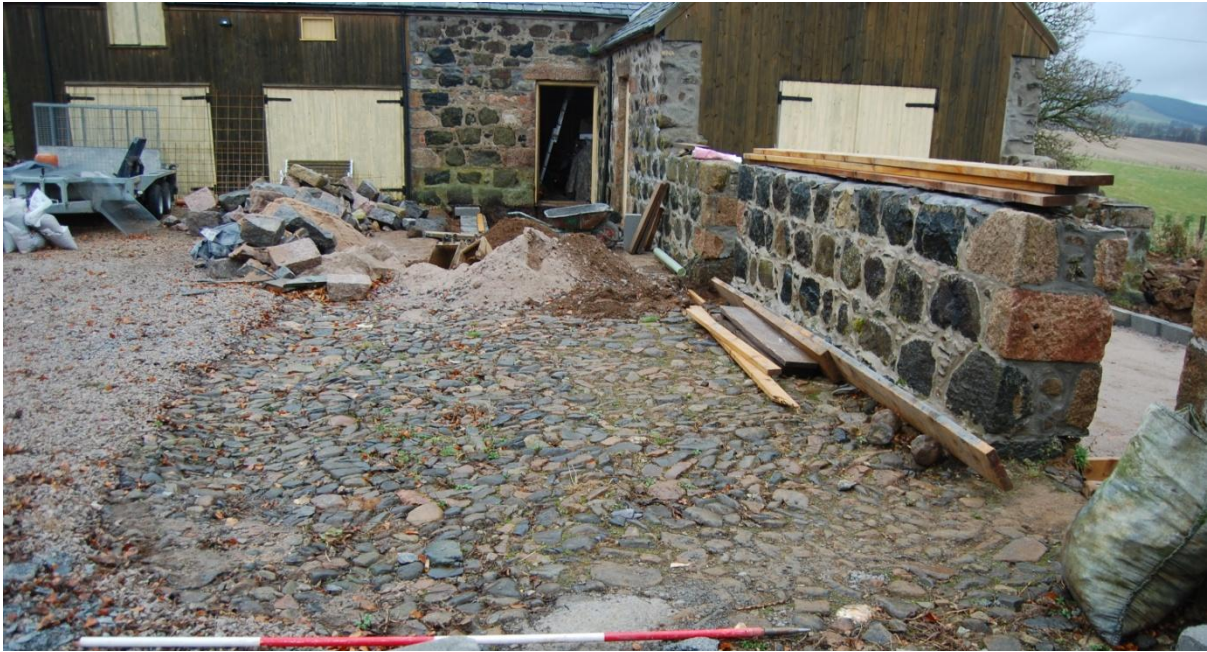
Illus 8 Cobbled surface F1; facing NW towards Door D7 (centre)
