**Den of Pitfodels, North Garthdee Farm, Garthdee Road, Aberdeen  
AB10 7EN  
Report on an archaeological evaluation  
and standing building survey**

**Cameron Archaeology  
18 January 2013**

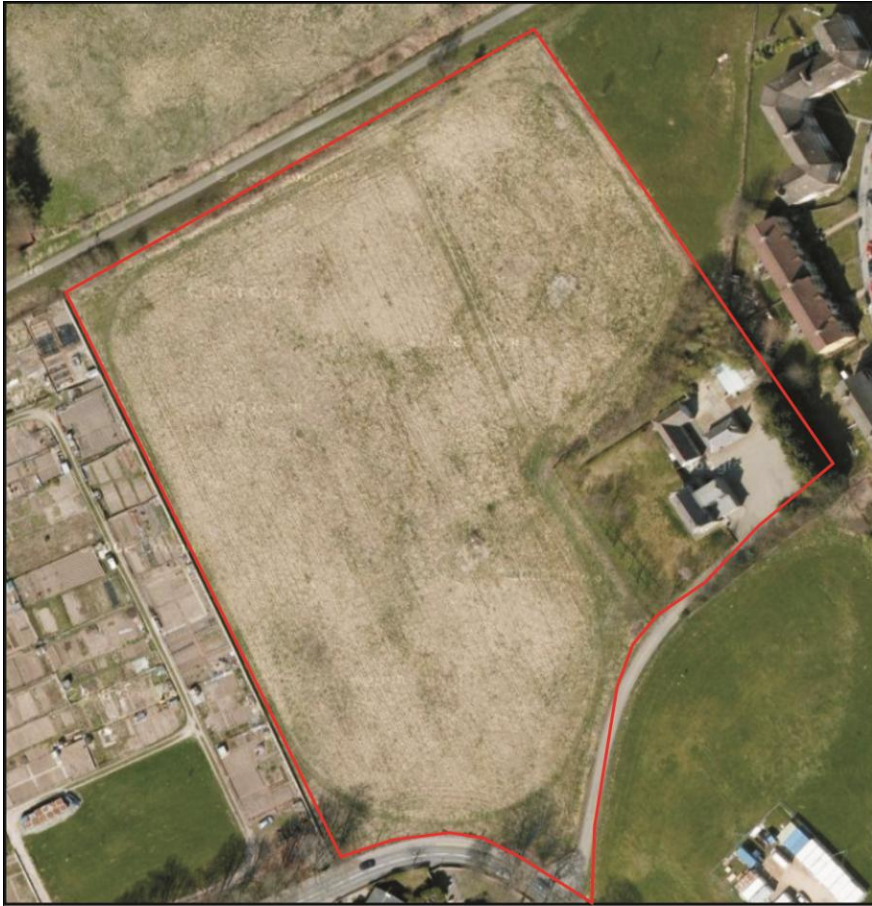
Illus 2 Aerial photograph with the current site outlined in red (*copyright Google*)

- 2.1 The current site is occupied by North Garthdee Farm to the extreme east of the site and cultivated fields to the north and west (Illus 2). North Garthdee Farm was built in the late 19th century after the demolition of East Middleton (NJ90SW.183; outwith the current development, to the south) after the First Edition Ordnance Survey (Illus 12).

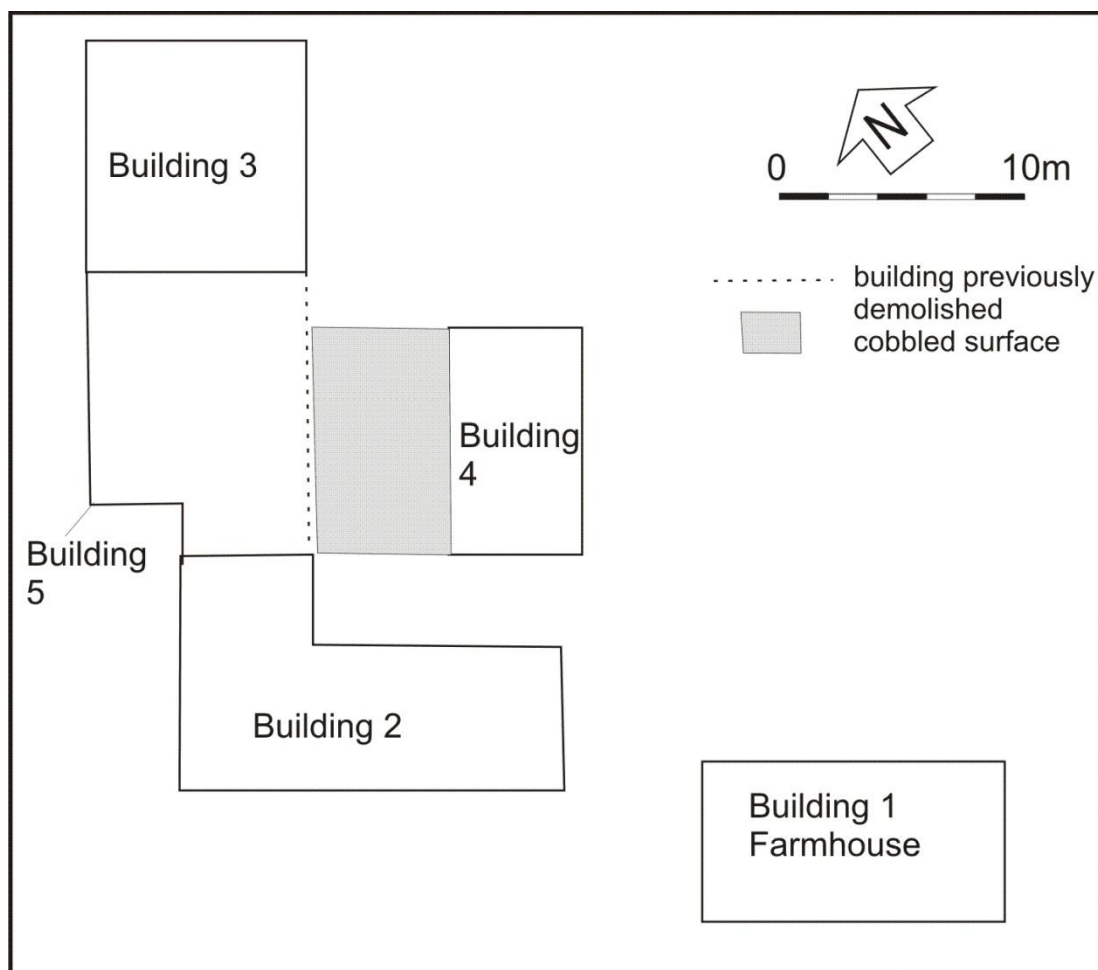
Illus 3 Plan of standing buildings

A standing building survey was carried out on 7-17 January 2013. There are the remains of five buildings which were constructed between the 1865 (First Edition OS; Illus 12) and 1901 (Second Edition OS; Illus 13). The current owner, Mr Gordon McWilliam, dates the construction to the 1860s and has title deeds indicating that this was Plot 3 sold by Banchory Devenick Estate in 1863; these documents were not available for viewing at the time of this work. Mr McWilliam knows of a fire which extensively damaged the property, particularly Building 5, in the 1960s after which much was rebuilt, Buildings 2 and 3 separated by a courtyard and concrete floors laid throughout. The cassettes were laid west of Building 4 at that time. The land itself has not been worked since the 1980s (G McWilliam pers com).

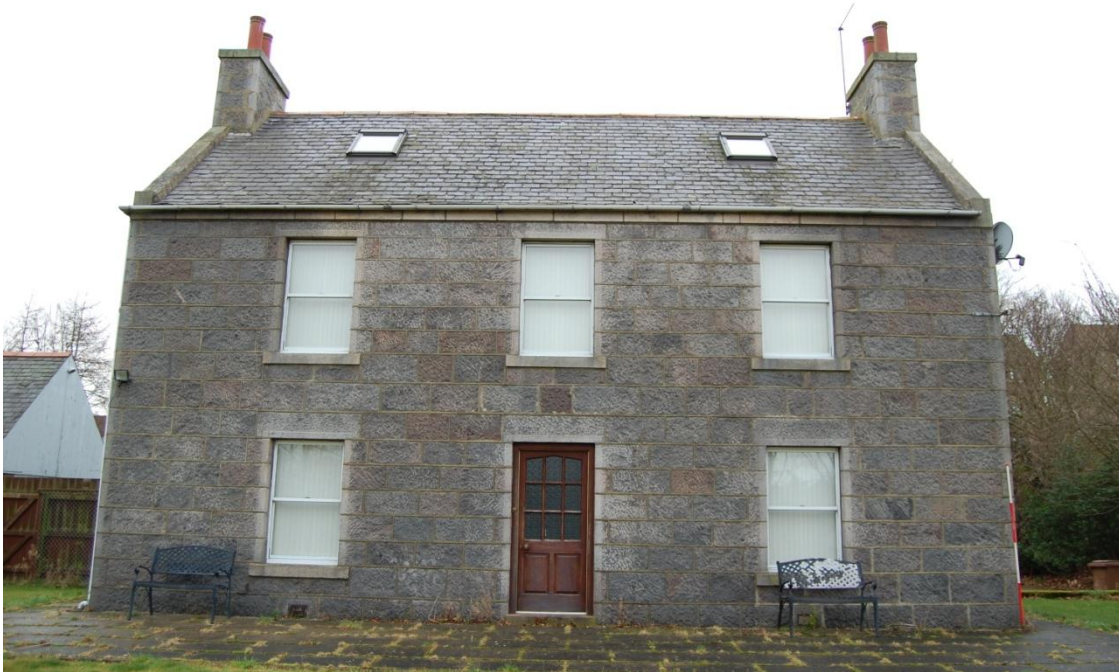
Building 1 is the farmhouse (Illus 3, 4). It is double fronted and two and a half storeys and fronts on to the SW facing Garthdee Road and Inchgarth. It is constructed of large, mostly grey, granite blocks and is 11.90m long and 5.80m wide. It has a modern extension on the NE side but this appears to have replaced an older extension which can be seen on the OS maps.

Illus 4 Building 1 the farmhouse; facing NE

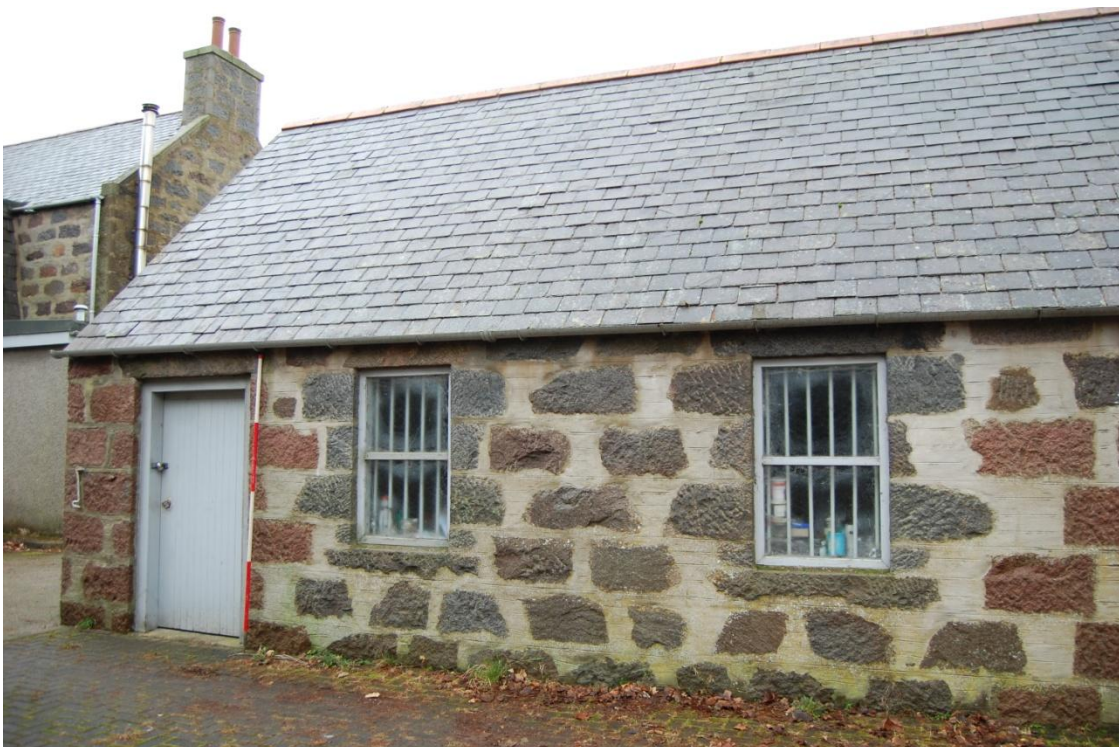
Building 2 is an L-shaped building at the west side of the farm courtyard. It is 5.6m wide and 14.9m long along the longest axis. It originally linked to Building 3 with the remains of Building 5. It is constructed of pink and grey granite blocks with heavily pointed cherry

cocking; the granite blocks are not random but the pink granite has been used for the wall ends and grey blocks for the mid walls (Illus 5).

Illus 5 Building 2; facing SW

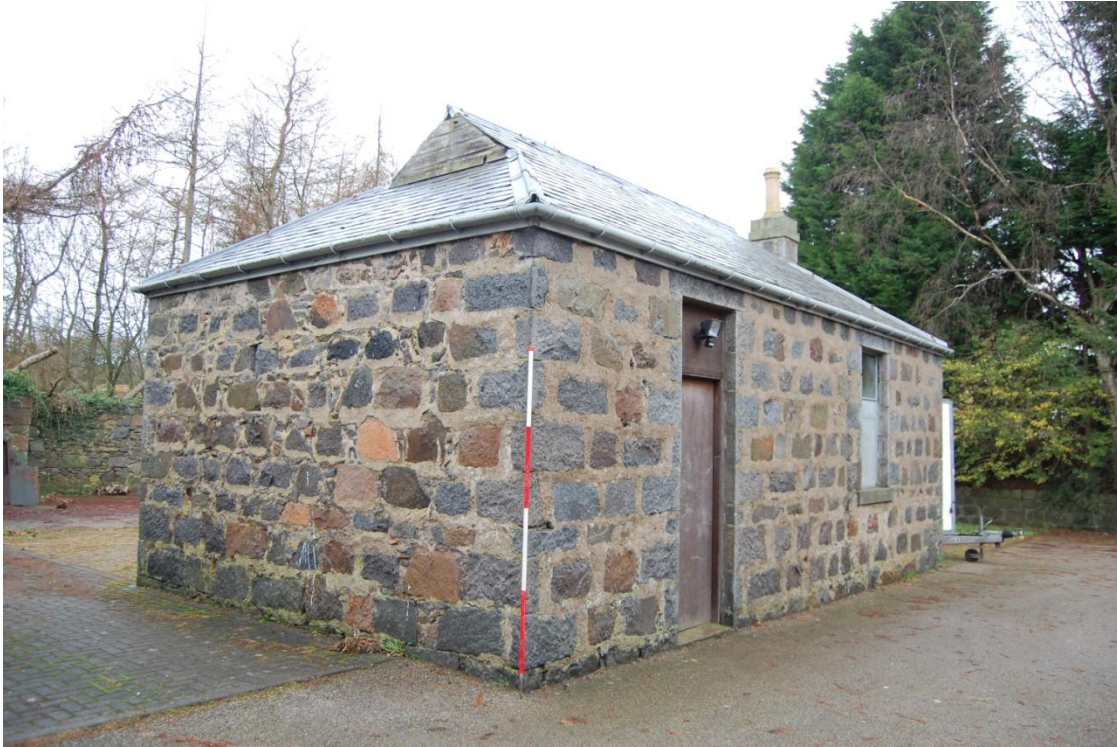
Building 4 is 8.4m long and 5.2m wide, sited at the centre of the farmyard and is not connected to other buildings (Illus 6). It is made from random grey and pink granite blocks with cherry cocking. It is thought to have been the bothy or accommodation for farm staff before being converted into the milk house (G McWilliam pers comm). There is an original fireplace on the NE internal wall (Illus 7).

Illus 6 Building 4; facing NNE

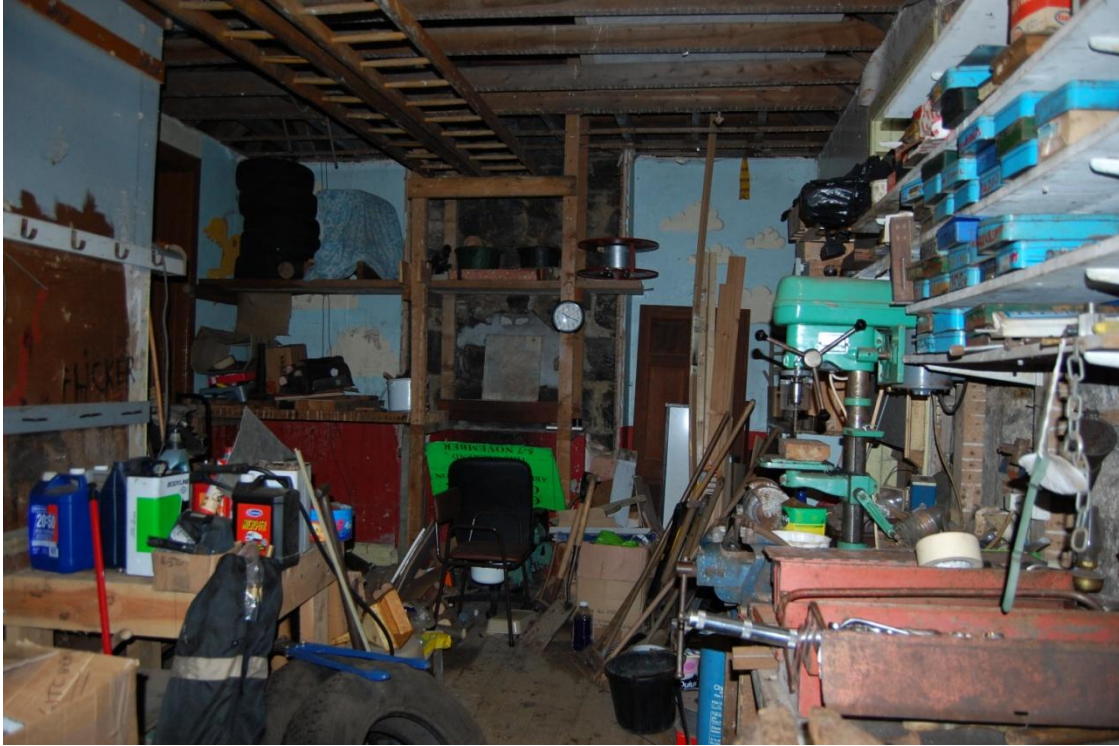
Illus 7 Building 4 facing NE showing original chimney breast and fireplace (centre)

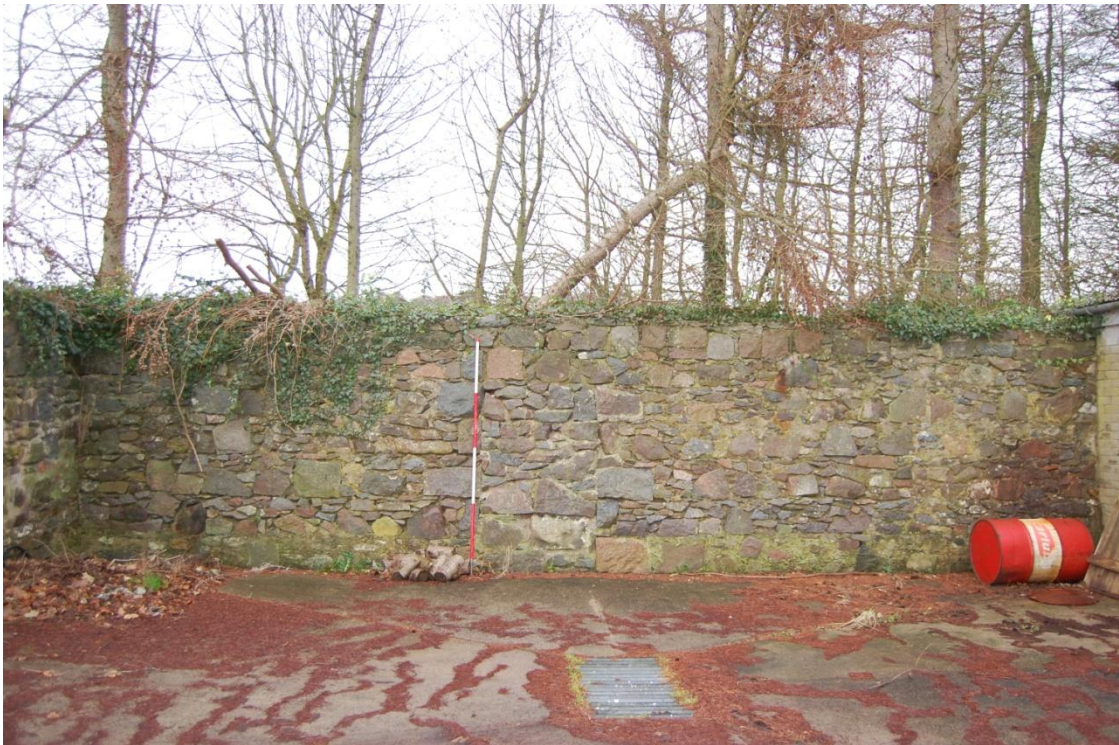
Illus 8 Building 5 NE wall remains; interior face of wall; facing NW

Building 5 has been mostly demolished leaving only the NW wall. It was originally sited between Buildings 2 and 3 (Illus 8). One door survives in the centre of the NW wall. This building was severely damaged by fire in the 1960s (G McWilliam pers comm) and much of the building was then taken down and some was rebuilt.

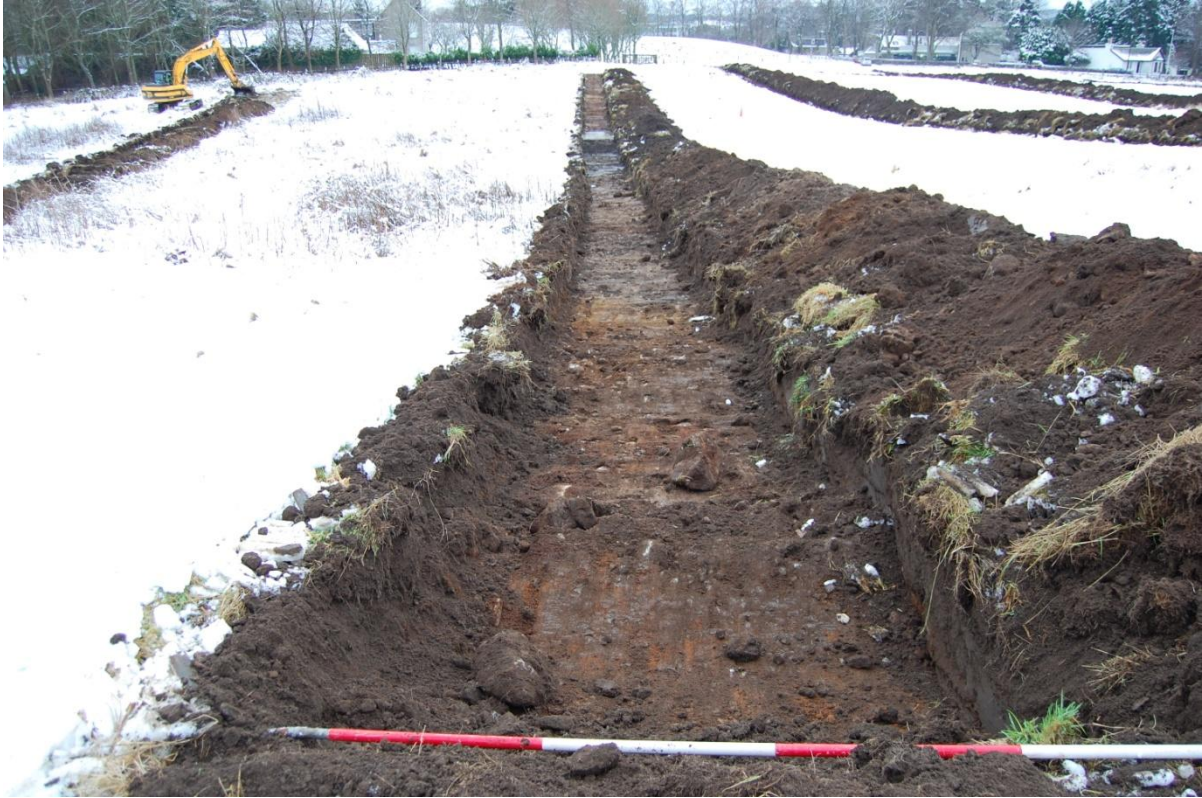
Illus 10 Trench 7 facing SE showing culvert F1 at the lowest point of the trench

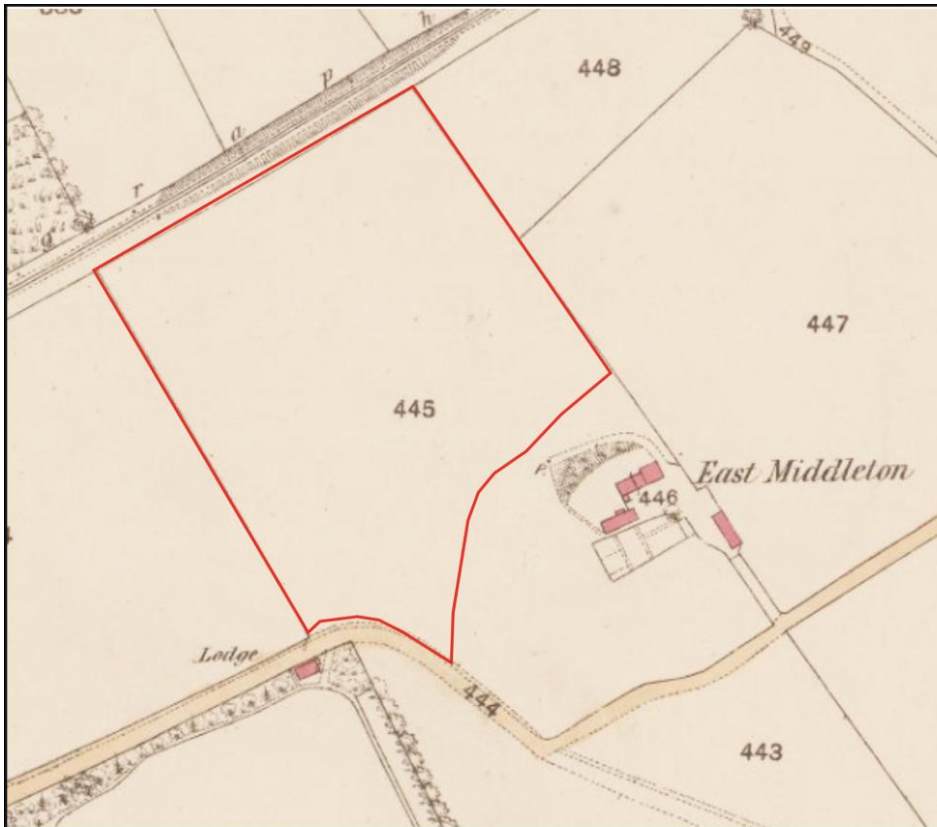
Illus 12 First Edition Ordnance Survey extract with site in red  
Kincardine Sheet IV.5 (Combined) Survey date: 1865 Publication date: 1868 (copyright National Library of Scotland)
