**Stoneywood Paper Mill, Aberdeen AB21 9AB
Archaeological evaluation and standing building survey**

**Cameron Archaeology
7 February 2013**

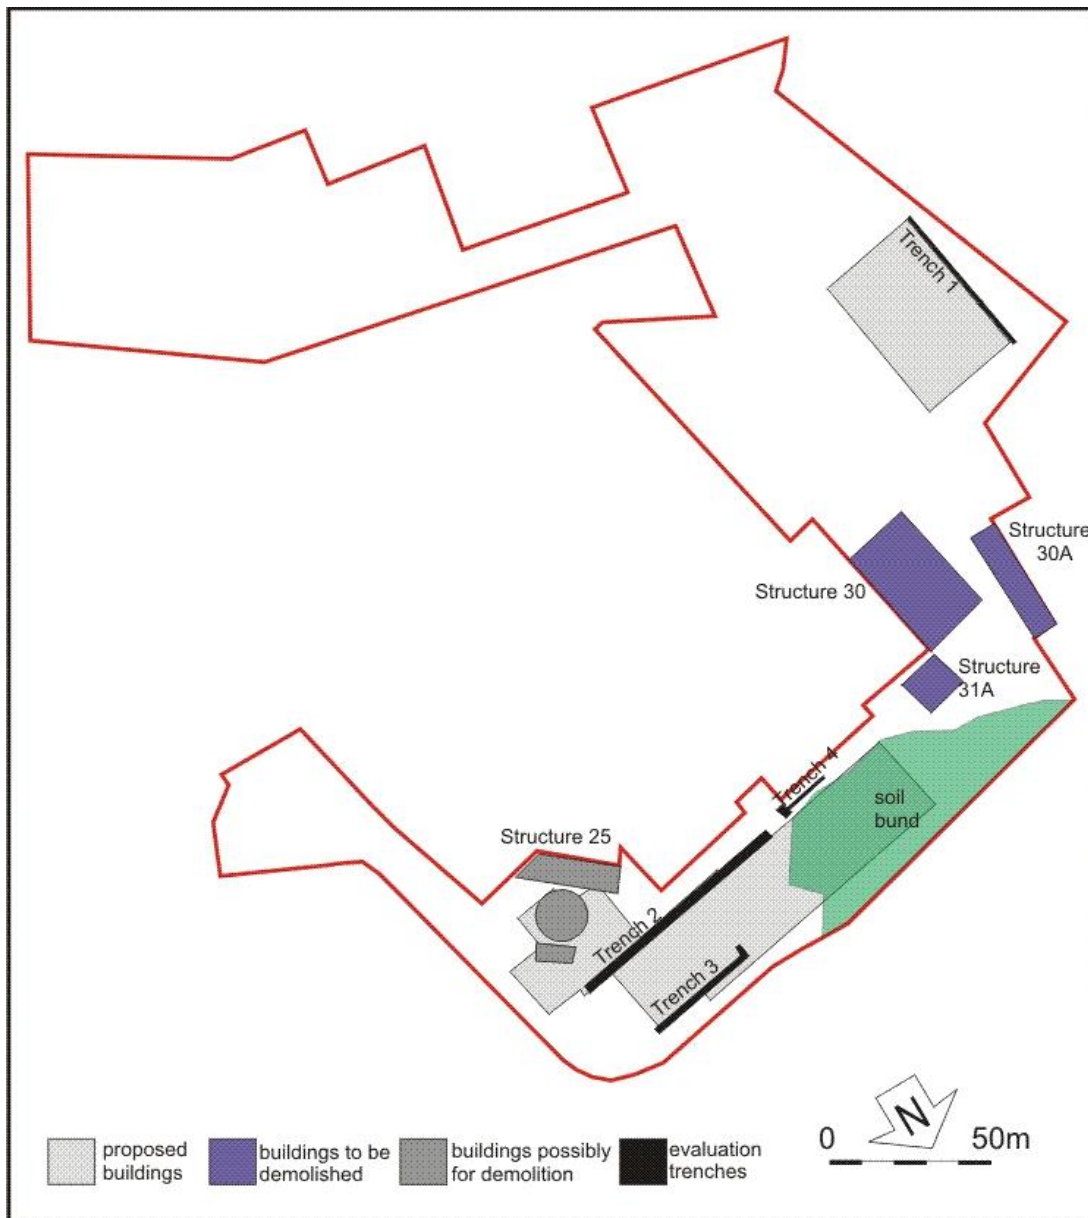
Illus 3 Plan showing Structures for demolition (30, 30A and 31A) and Trenches 1-4.

Following the archaeological evaluation and standing building survey it is recommended that a watching brief is carried out during the removal of a 5m high soil bund (Illus 3). Further archaeological work will be required when the foundations for the new buildings are constructed and the extent of this work will depend on the type of foundations to be utilised. If structure 25 (Illus 3) is to be partially demolished it should be recorded further after the removal of the adjacent water tank.

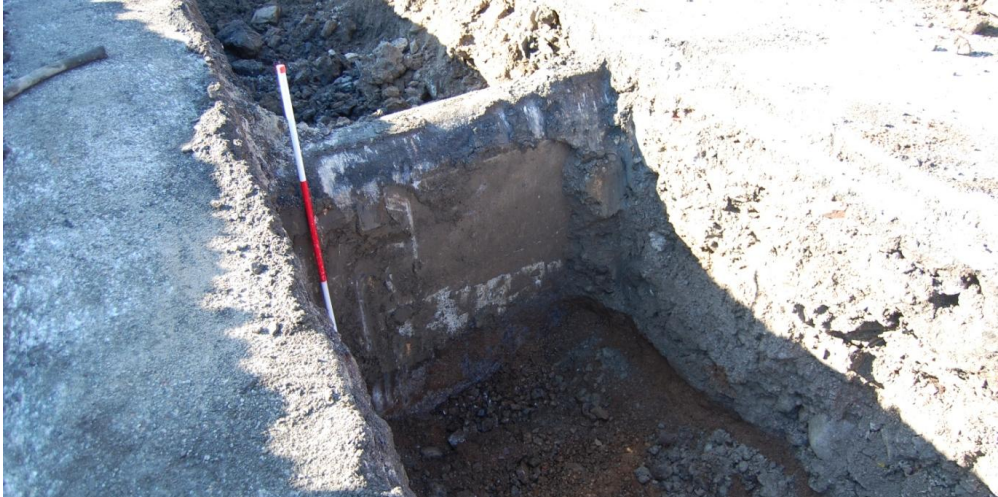
Illus 4 Shuttered poured concrete partition F1 within late 19th-century filter beds; facing WSW

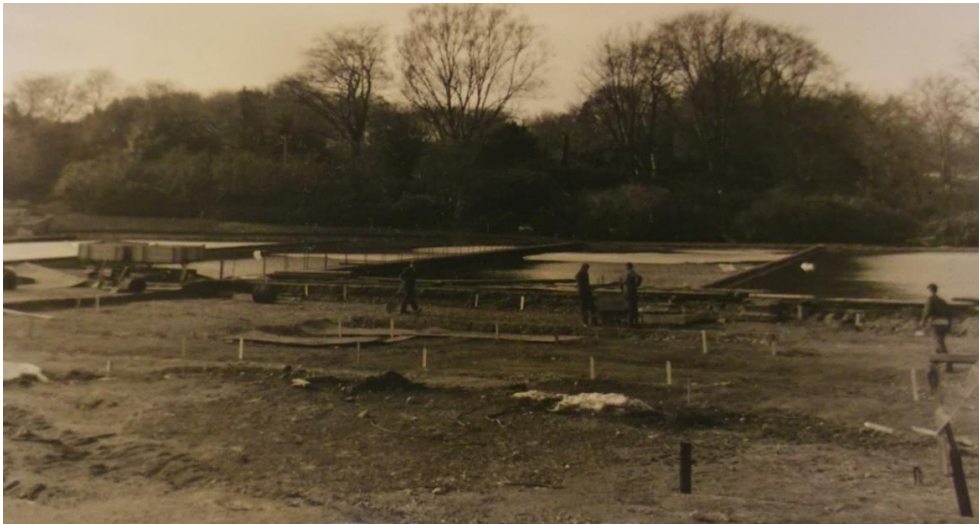
Illus 6 Chemical house and filters being constructed in 1947; the original late 19th-century filter beds can be seen in the background (copyright The Papeterie, Arjo Wiggins).

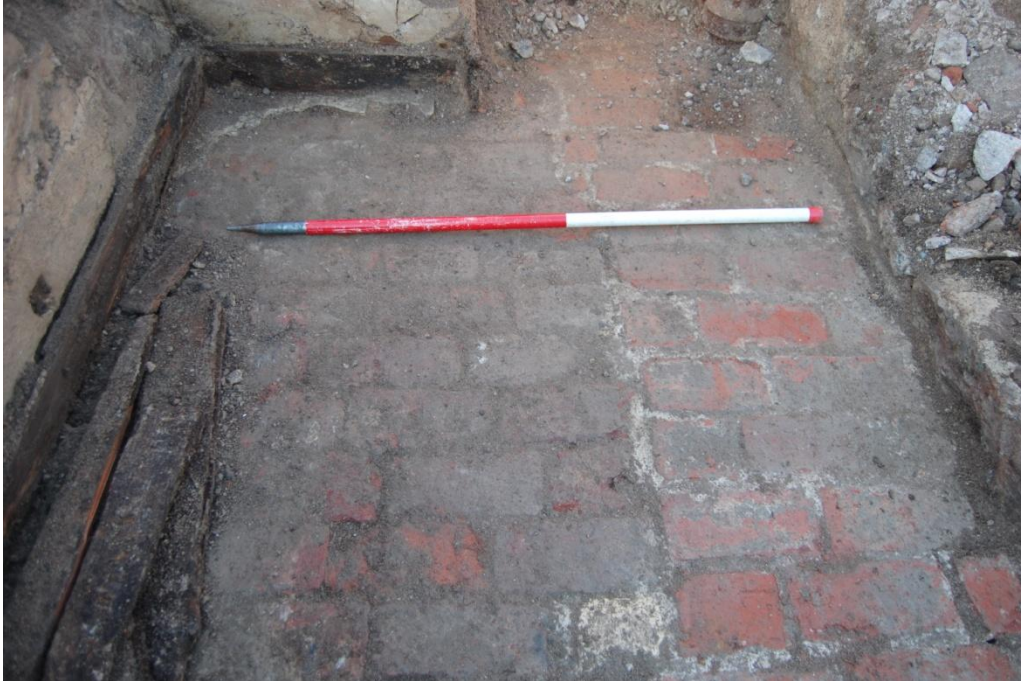
Illus 8 Duct or inspection pit F10 was originally constructed in stone and mortar with a brick floor; it was altered in the late 19th-century and a poured shuttered concrete wall added (left)

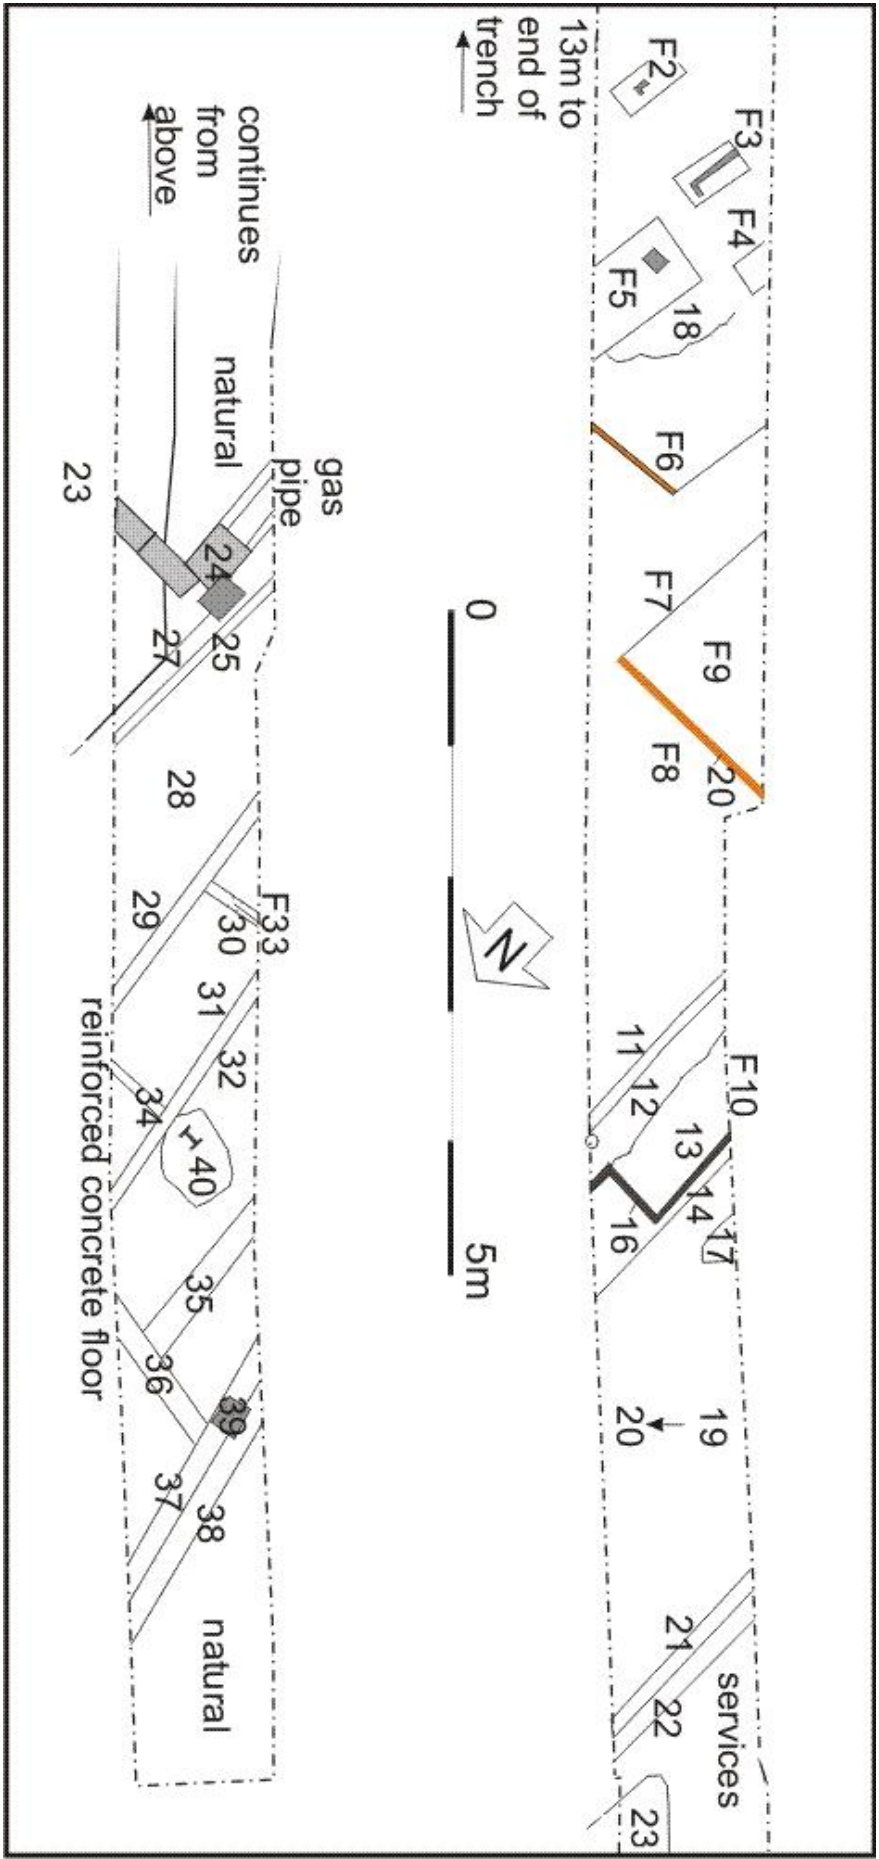
Illus 9 Trench 2 plan of features

Trench 2 (Illus 3, 9) was positioned along the south edge of the proposed biomass CHP Plant and was 61m long and 2m wide. The remains of several buildings were recorded and these have been identified as remains of the pasting machine and humidifier building (Illus 9; buildings 21) and the stock room (building 20). Most of the remains were late 19th or early 20th century but earlier structures might include F10 a duct or inspection pit for a machine (Illus 8) which was originally built in stone and mortar with a brick floor. A foundation for machinery and inspection pit F22 was also originally 19th century and had been sealed under an 20th-century concrete floor.

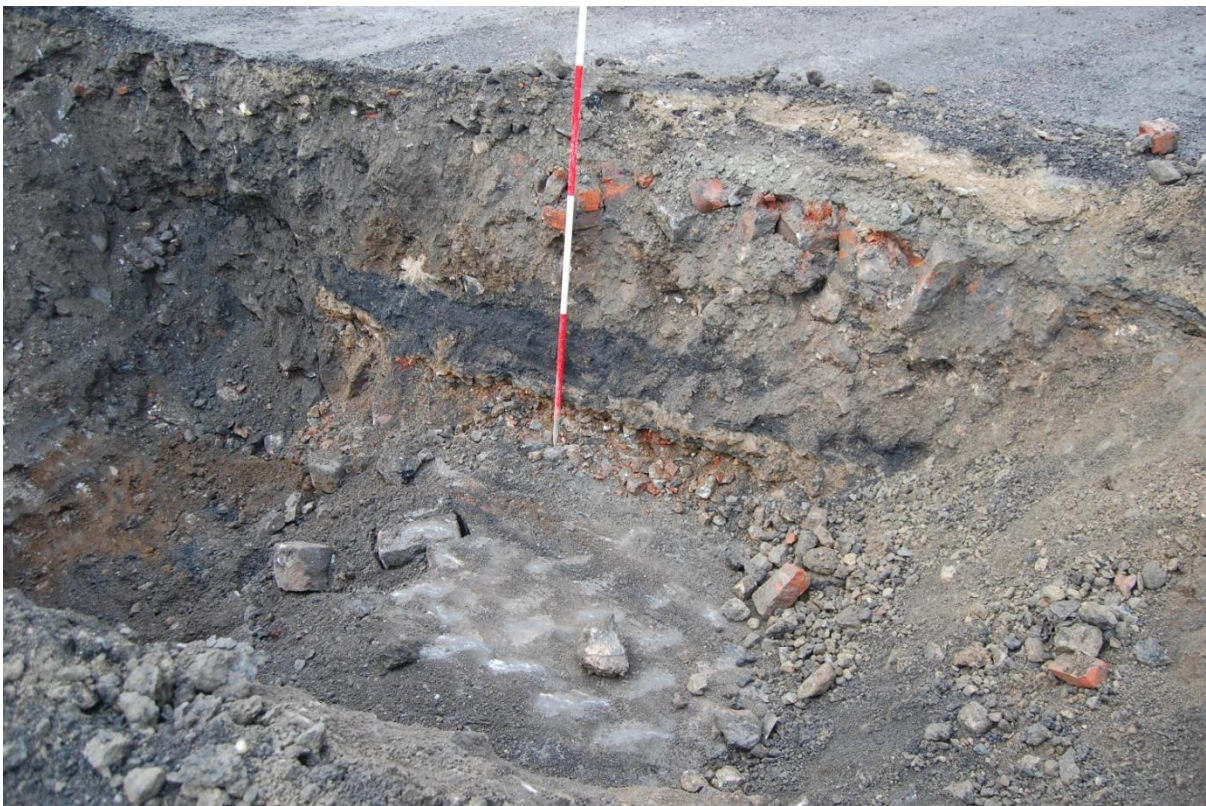
Illus 10 cobbled surface 40 (below) with yard layers above; the level of the area has been raised by 1.5m since the late 19th century; facing NNE

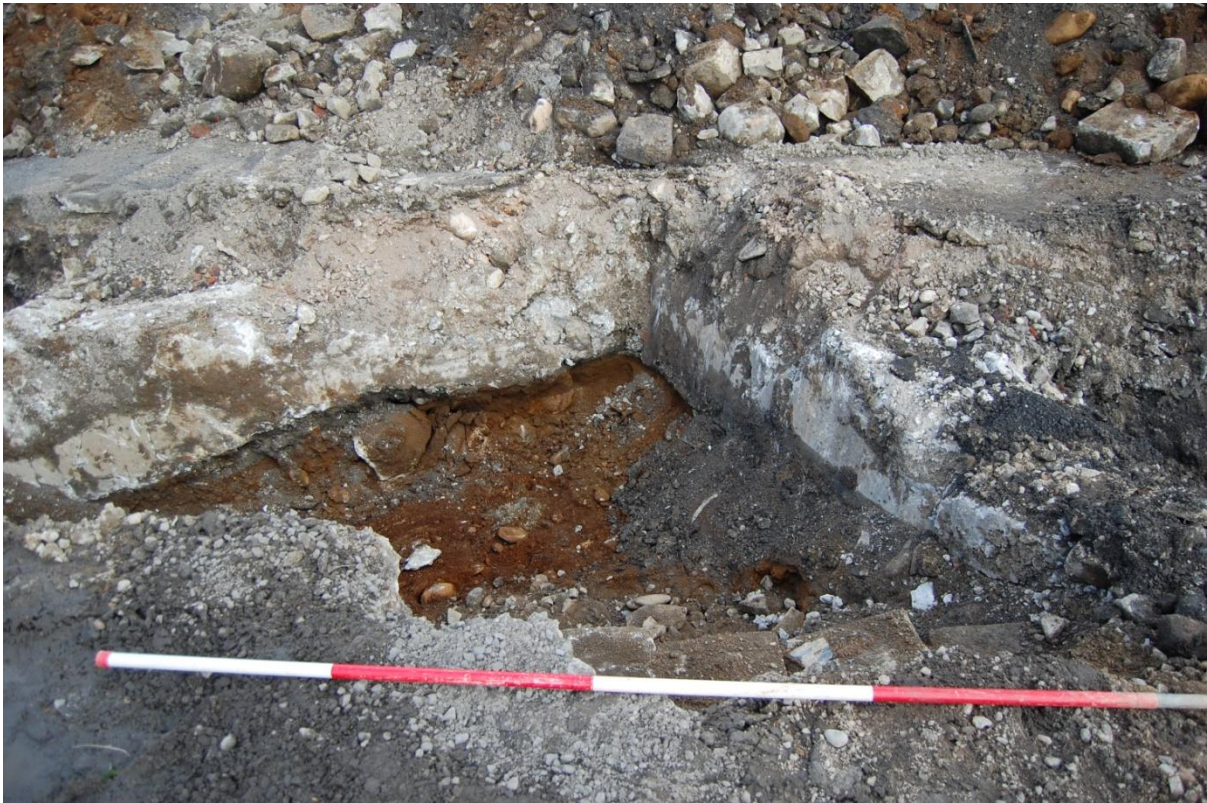
Illus 11 Walls F53 and F61 forming the NE corner of the reel store facing NE

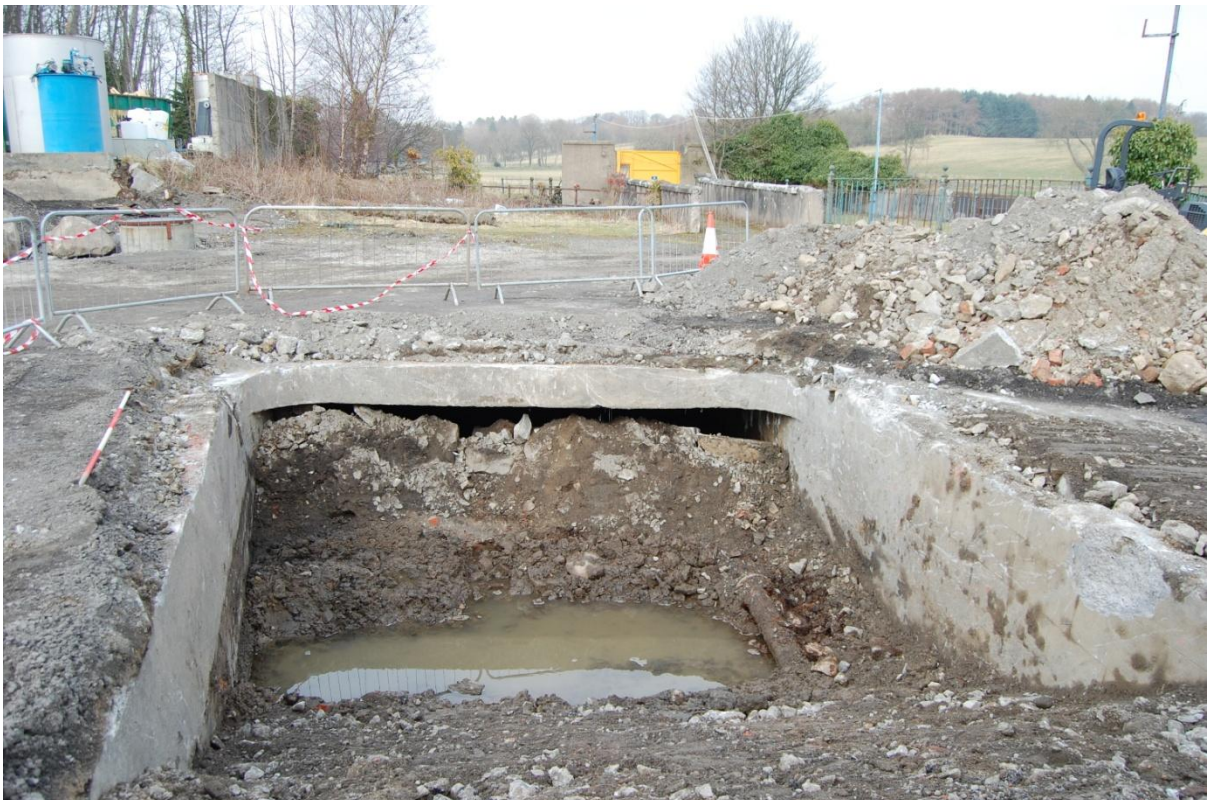
Illus 12 concrete lade intake F55 facing NE

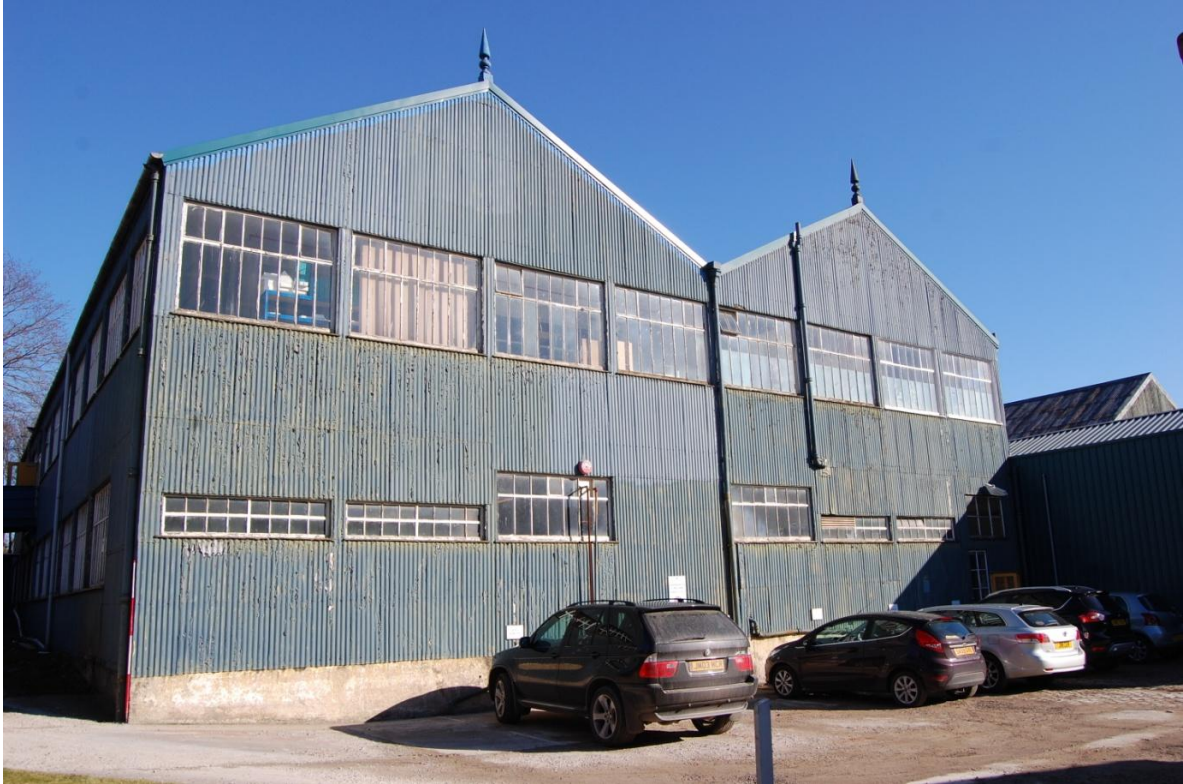
Building 30 was a stock room. It was probably constructed in the mid 20th century period. It was 22.5m wide and 48m long and is constructed of corrugated iron panels. It is a two-storey buildings with the ground floor being a large open space supported by cast iron pillars and the upper floor now divided for use as The Papeterie, a shop and classroom facility for schools and visitors. There is one main door in the ground floor and access to the upper floor is across a bridge from the upper car park to the first floor level.

Illus 17 Building 30 SW facade

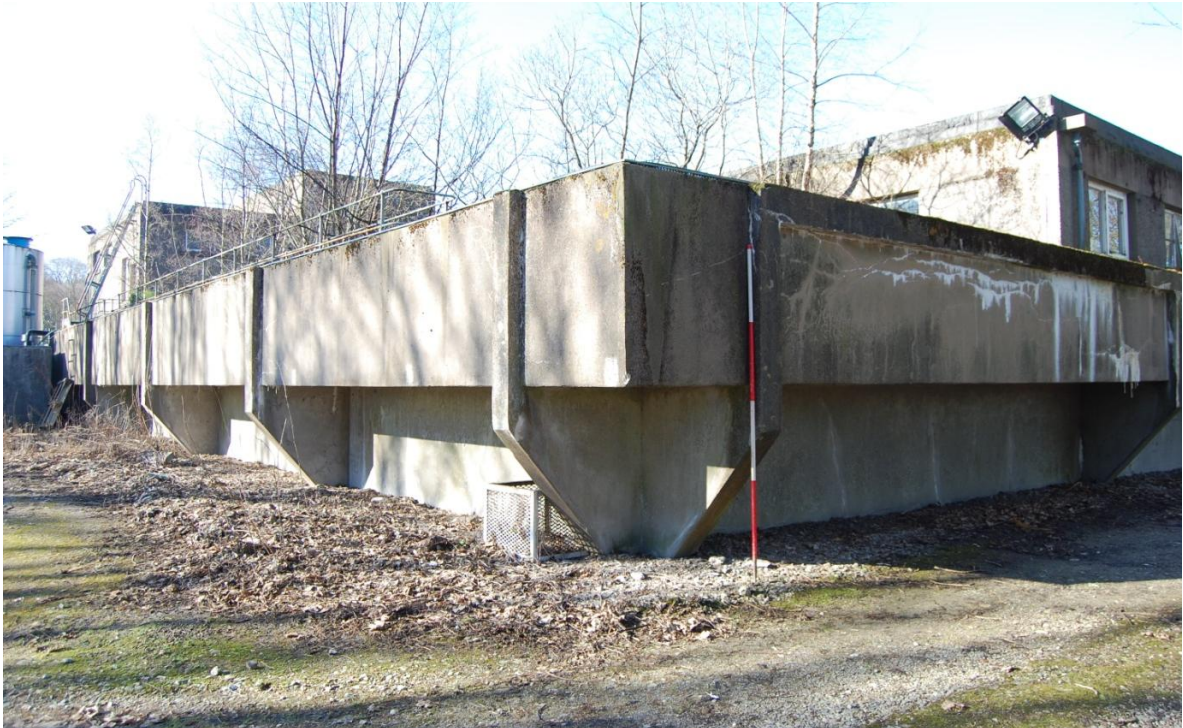
Building 30A was part of the filters and chemical plant built between 1947-49; it is dated 1949 on the SW wall and is featured in photographs being constructed in 1947 (Illus 5). The portion for demolition consists of one concrete filter tank and an air receiver tank. It is constructed of poured shuttered concrete and is a filter tank used for filtering water from the plant prior to returning it to the river.

Illus 18 Building 30A section to be demolished facing W

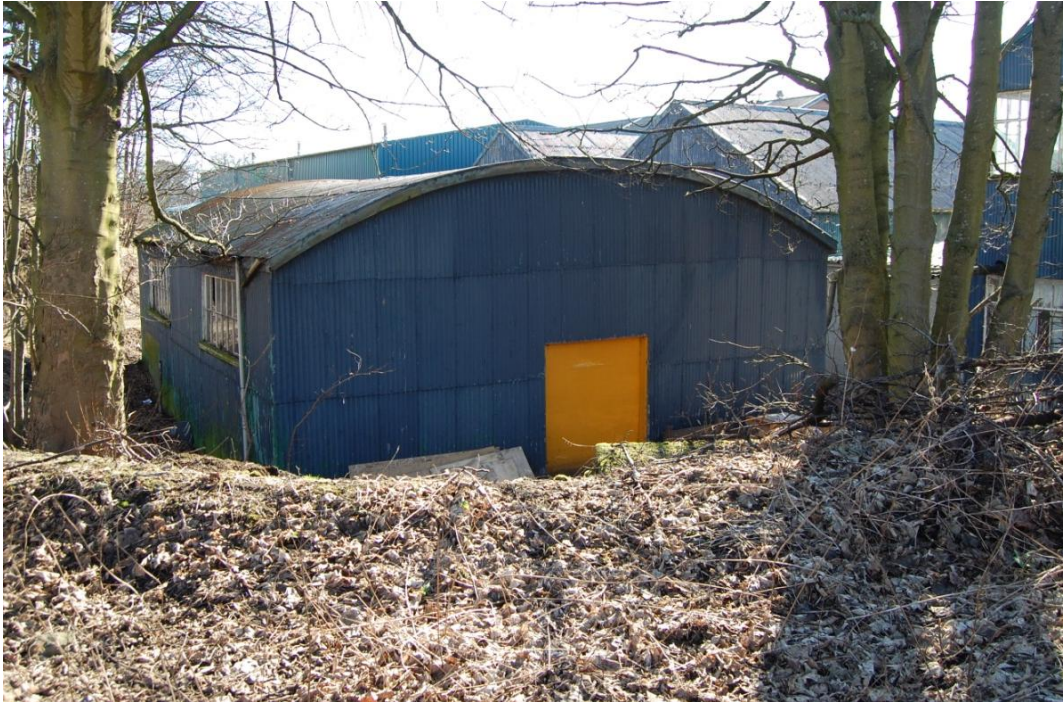
Building 31A was a store probably constructed in the mid 20th century period. It was 12.3 x 10.8m in size and is constructed of corrugated iron panel walls and roof. It is one storey and is a large open room built on a wooden frame and with a domed roof. There are windows in two walls and two doors.

Illus 19 Building 31A facing SE

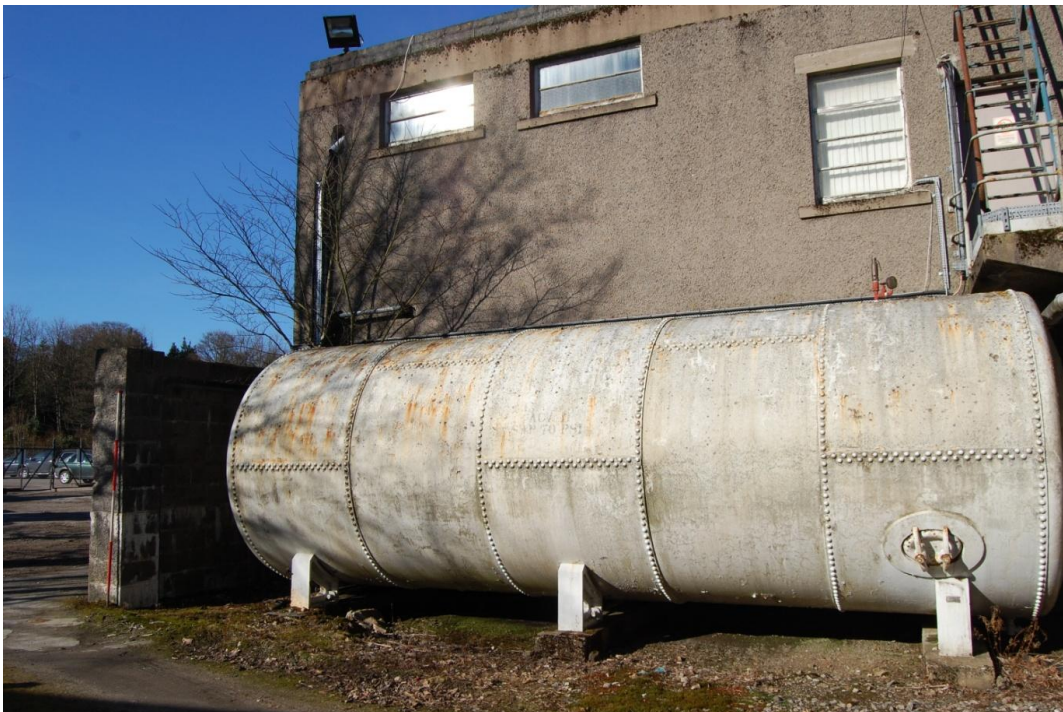
Illus 20 'Air receiver' to be demolished

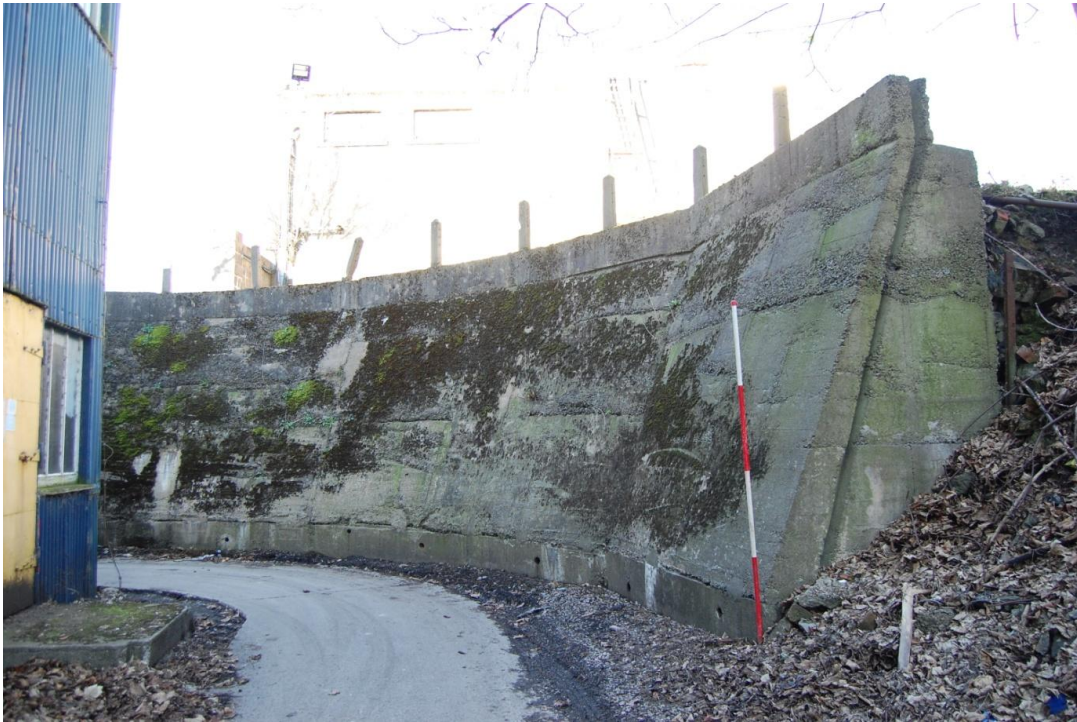
Illus 21

Poured shuttered concrete embankment between buildings 30 and 30A
