**Dubford, Aberdeen, AB23 8RL
Archaeological Evaluation and Standing Building Survey**

Alison Cameron and Cat Peters
Cameron Archaeology
15 February 2013

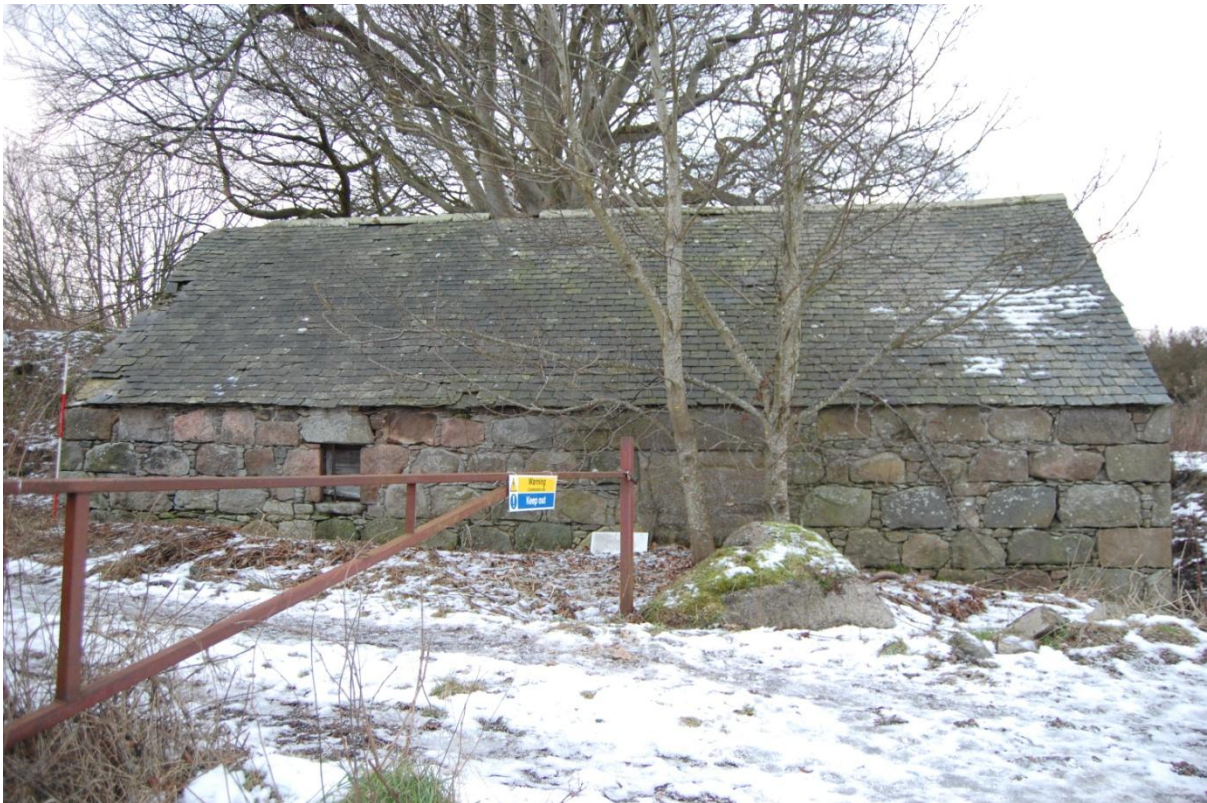
Illus 7 Building 1 east wall with Window 1 (left) and Door 1 (blocked; behind tree); facing W

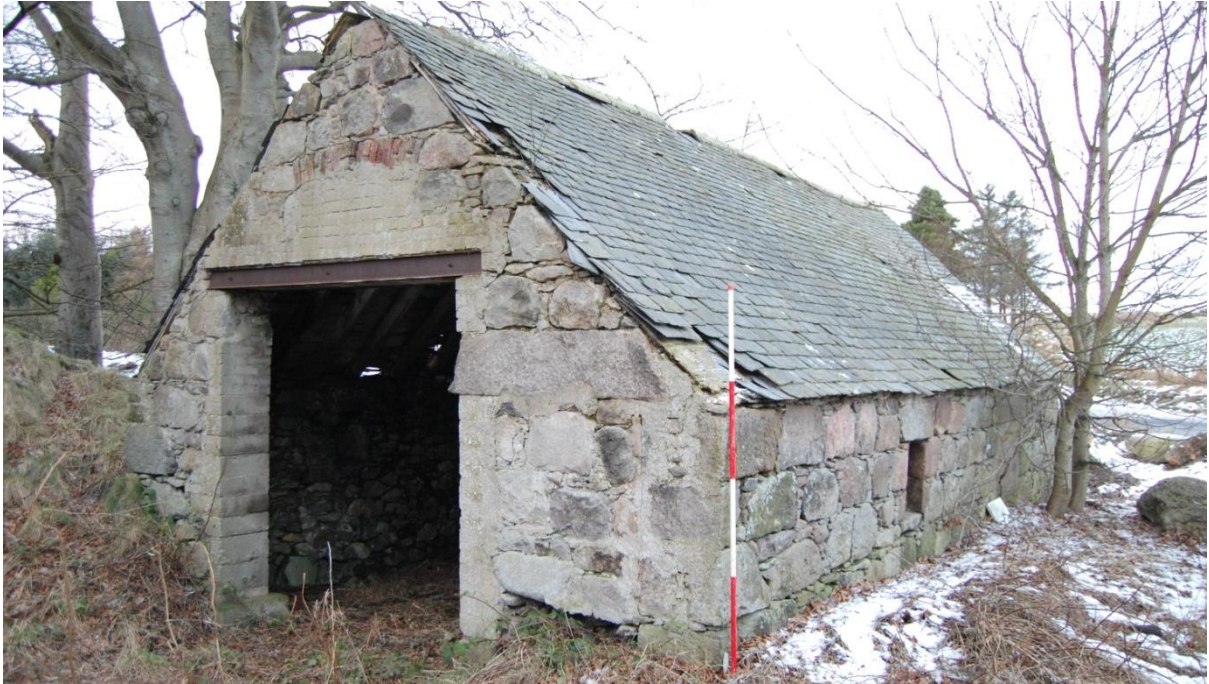
Illus 8 Building 1 south gable showing Door 2 a modern insertion; facing NNW

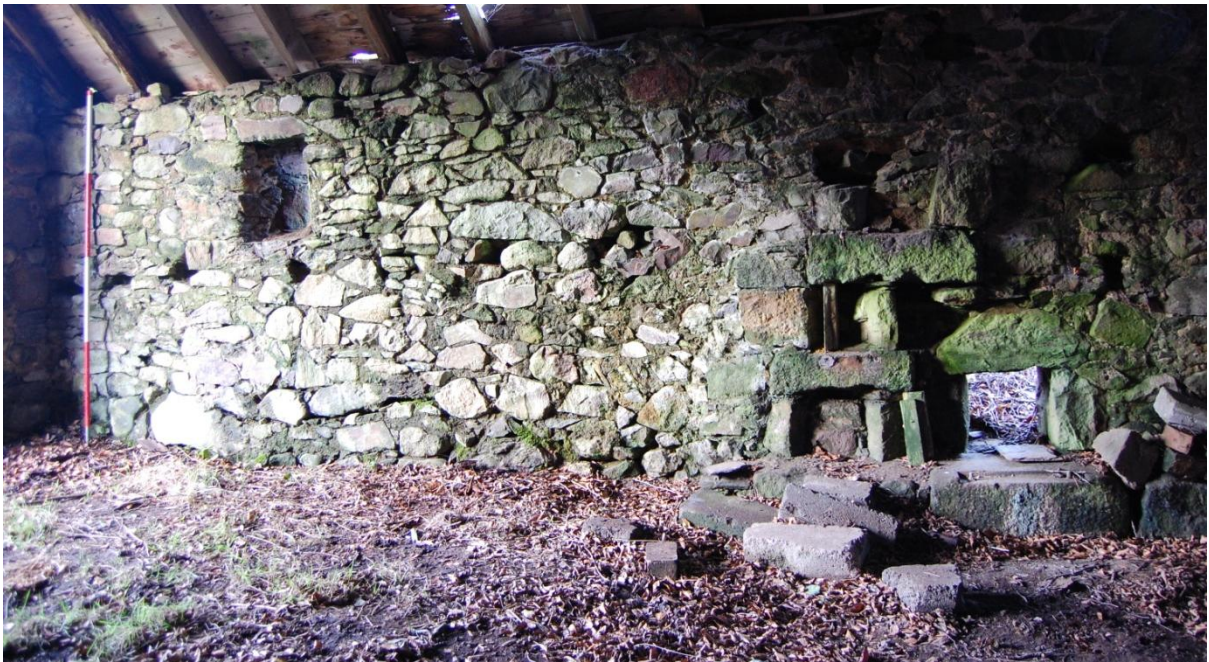
This west wall would have been the location of the mill wheel and this is confirmed by both the First Edition OS map and the apertures remaining in this wall (Illus 6, 9). The west wall contains several apertures which would have contained the mill mechanism including F102 and F103 which would have taken the drive shaft from the mill wheel to flywheels inside the mill attached to the grinding stones. F111 and F112 may have been associated with the attachment of the wheel. A sloping line of sockets (F113) had been for the attachment of an internal fitting, possibly a chute and beam slots F109 indicate that the north half of the building had an upper (mezzanine) floor.

Illus 9 Building 1 interior of west wall showing sockets F108 (left) and apertures for mill mechanisms (F102, F103, F111, F112 right); facing SW

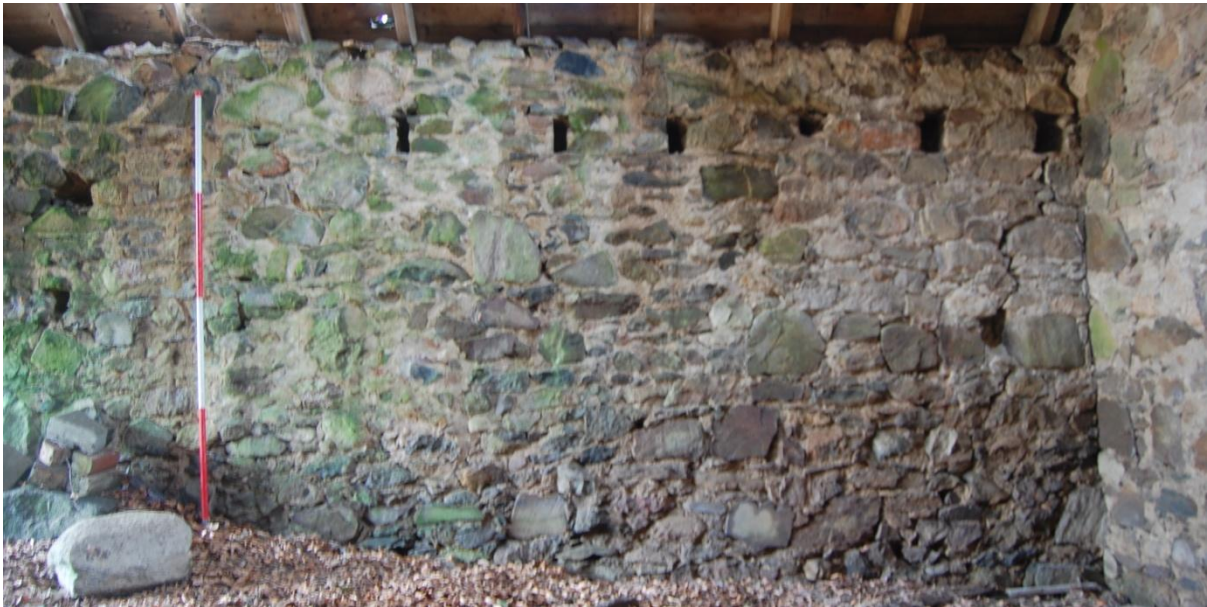
Illus 10 Building 1 interior of west wall showing beam slots F109 for mezzanine floor in north half of room; facing W

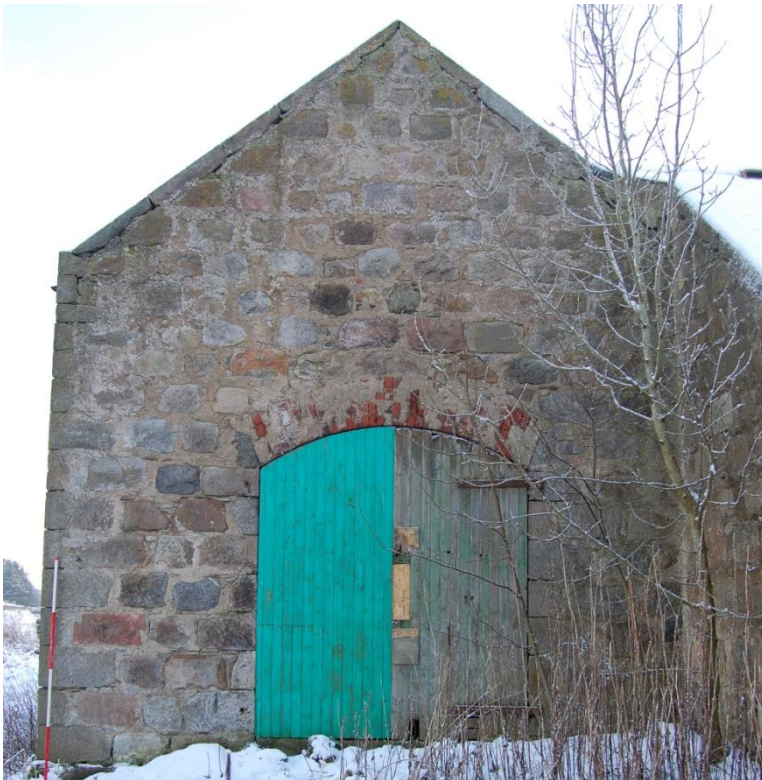
Illus 14 Building 2 Door 15 exterior; facing E

The cart door (Door 15) is 4.2m wide and 3m high with a brick arch constructed of 19th or early 20th-century local machine-made bricks. Access to this door for the carts would have been off the road, over the bridge over the Mundurno Burn up the access road to the farm. A brick wall forms the east end of the cartshed (Illus 15) and a first floor door in the wall and wooden balcony

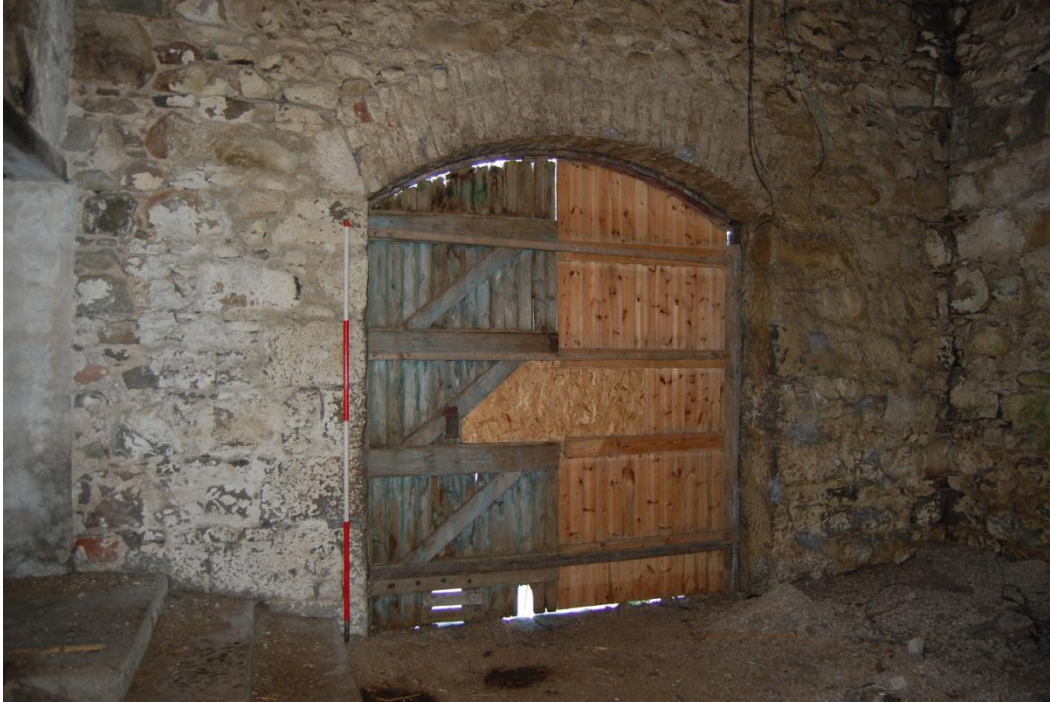
Illus 15 Building 2 Door 15 interior; facing W

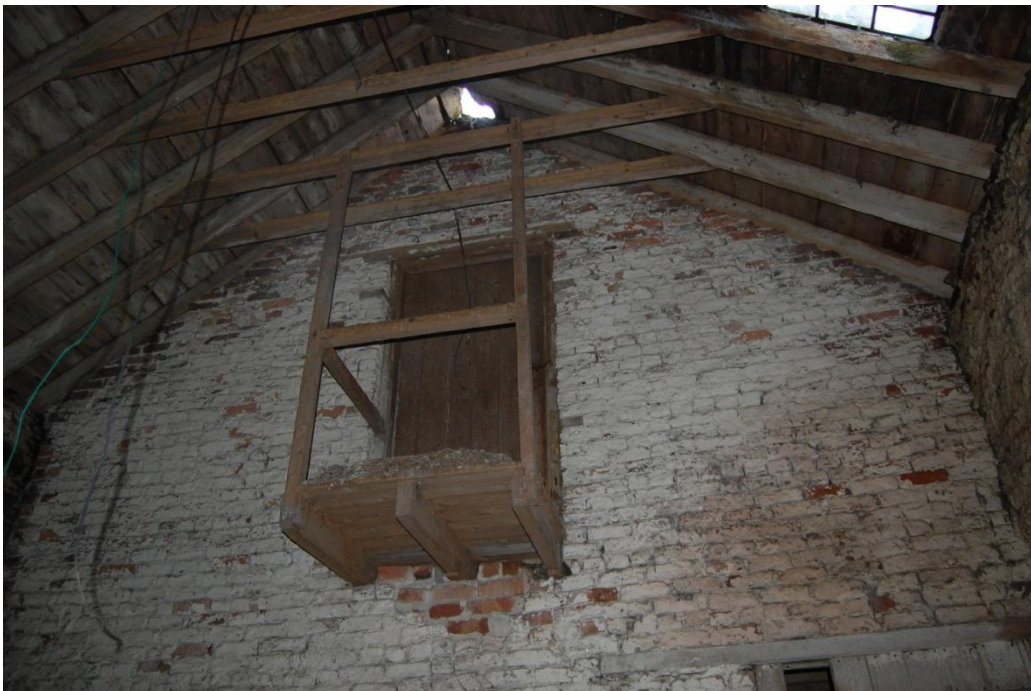
Illus 16 East wall of cartshed showing first floor door and wooden balcony facing E

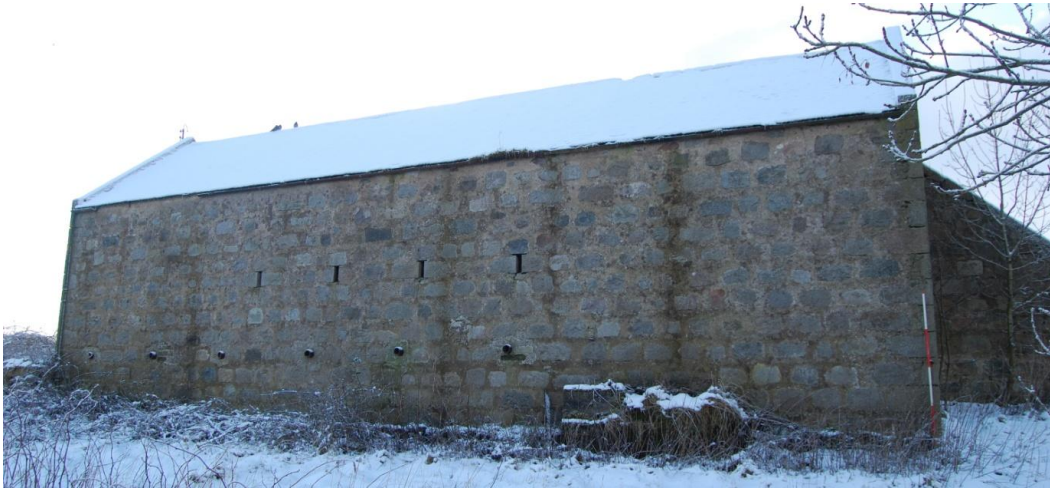
Illus 17 Building 2 north wall with ventilation holes; facing SSE

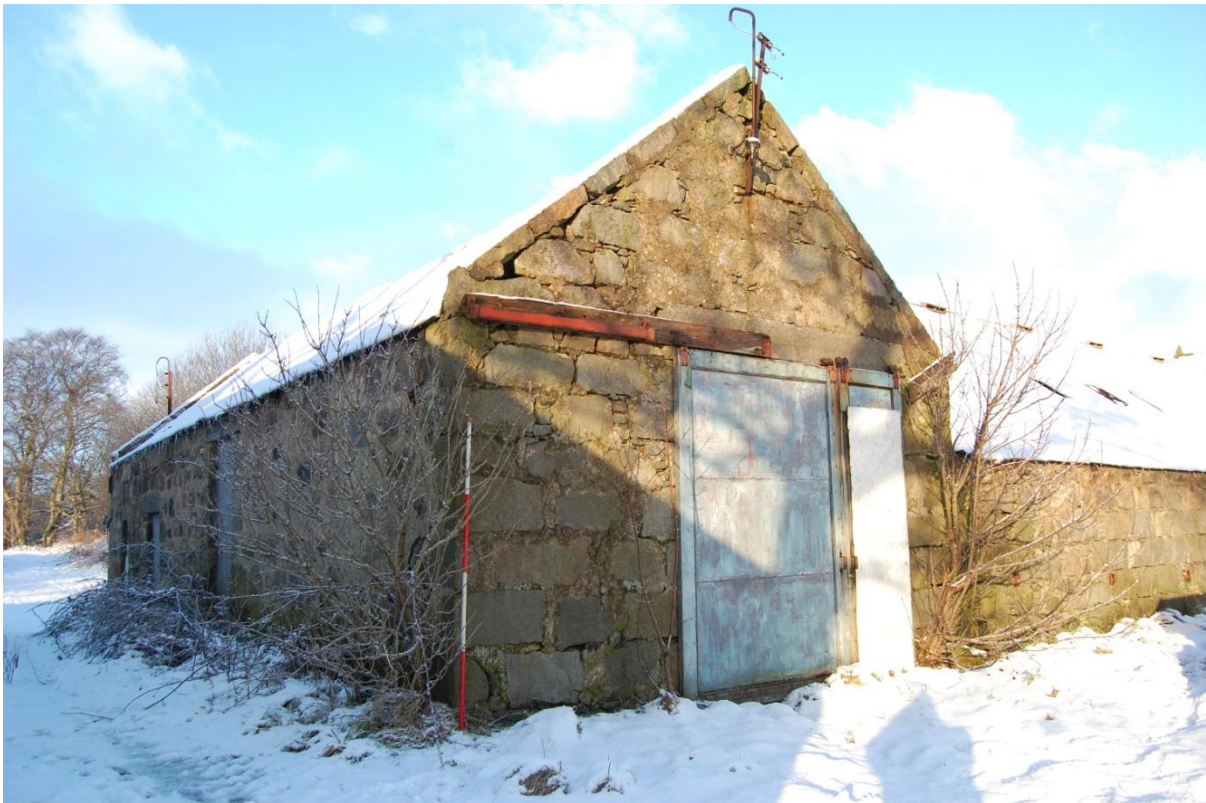
Building 3 is an L-shaped steading mainly converted to cattle byres with many internal fittings surviving. It is 15.5m wide and 21.30m long and construction of pink and grey granite fieldstones. The southern section of the building was probably farmworkers accommodation when it was constructed and was then subsumed into the accommodation for cattle and Buildings 4 and 5 used for accommodation.

Illus 18 Building 3 Door D10; facing NW

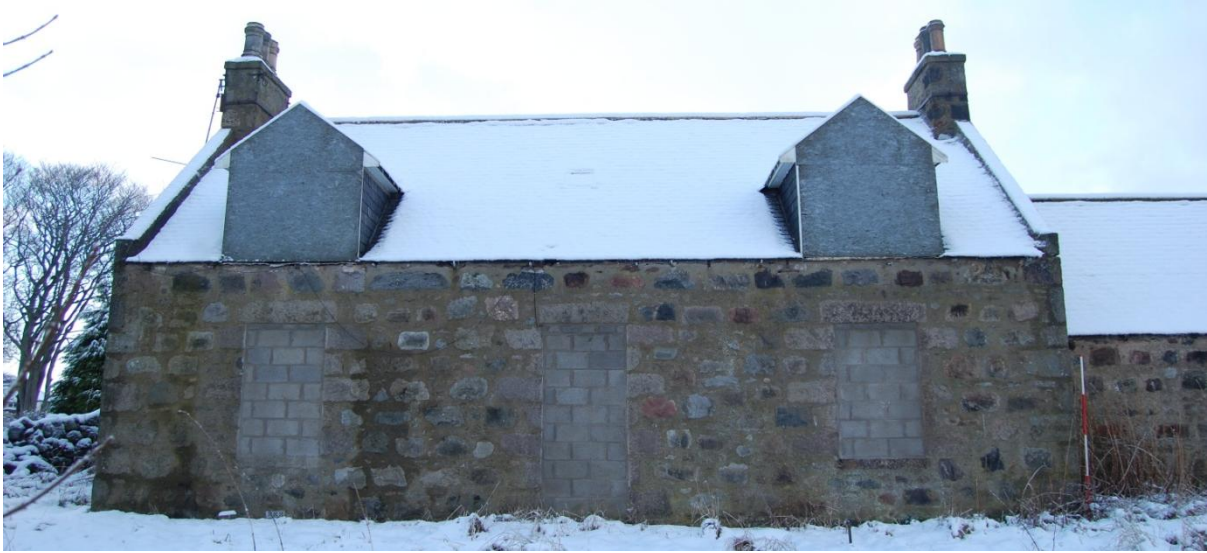
Building 4, the farmhouse, is 13.8m long and 7.2m wide. It is constructed of pink and grey granite rubble with cherry cocking. It fronts onto the south and is attached to Building 5 at the east end. The interior of the farmhouse was photographed but no interesting architectural features survived.

Illus 19 Building 4, the farmhouse; facing N

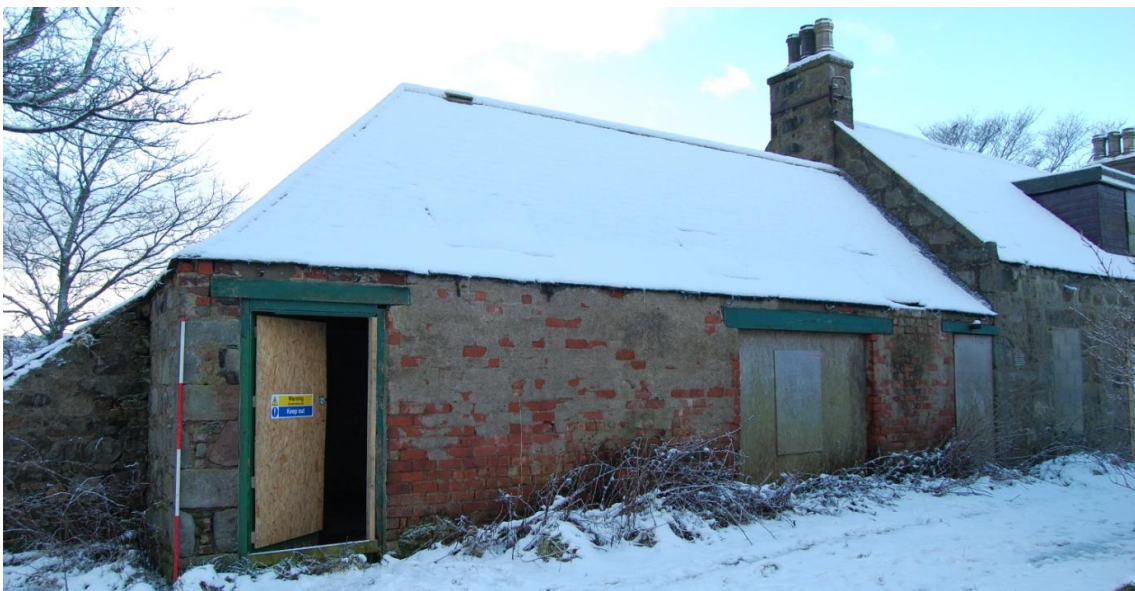
Building 5 is 10.95m long and 5.65m wide and is attached on to the east end of the farmhouse. It is constructed of 19th-early 20th-century machine-made local brick and probably represents a later addition onto the farm, possibly as accommodation for farm workers.

Illus 22 Building 5 with Building 6 (left) and Building 4 (right); facing SW

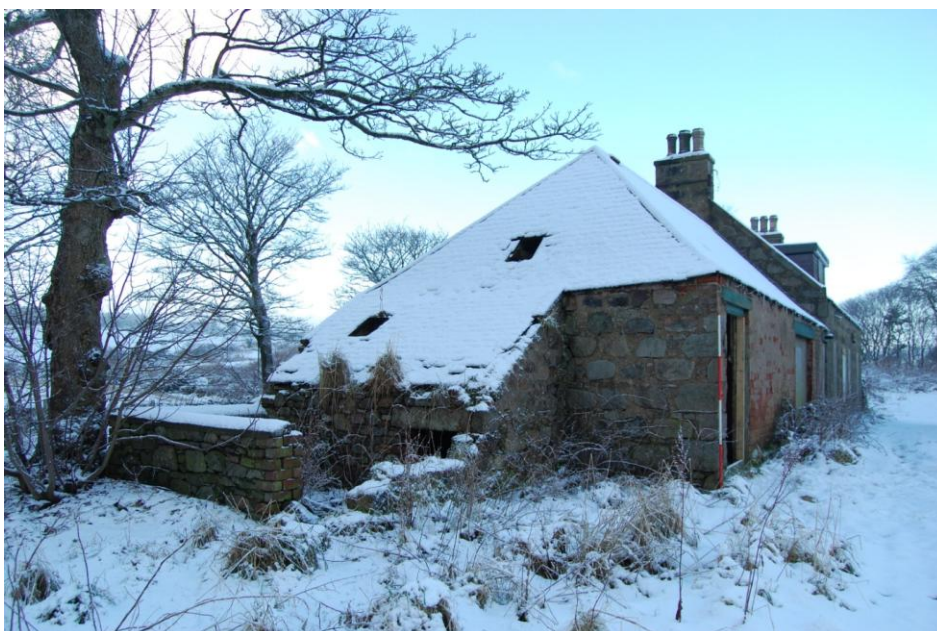
Attached on to the east end of Building 5 is a lean-to coal store 2m long and 3.7m wide. It is constructed from pink and grey granite field rubble and is in a poor condition.

Illus 23 Building 6 (left) attached top Building 5 (right); facing WSW
