**Proposed wind turbine and access track,  
South Lasts Farm, Contlaw Road,  
Milltimber, Aberdeen, AB13 0ES**

**Stuart Farrell  
for Cameron Archaeology  
Date: 14 June 2013**

*Cameron Archaeology was commissioned by Mr Brian Dow in June 2013 to undertake an archaeological watching brief for a development at South Lasts Farm, Aberdeen (NJ 84492, 03702) as part of a project for a wind turbine with associated access.*

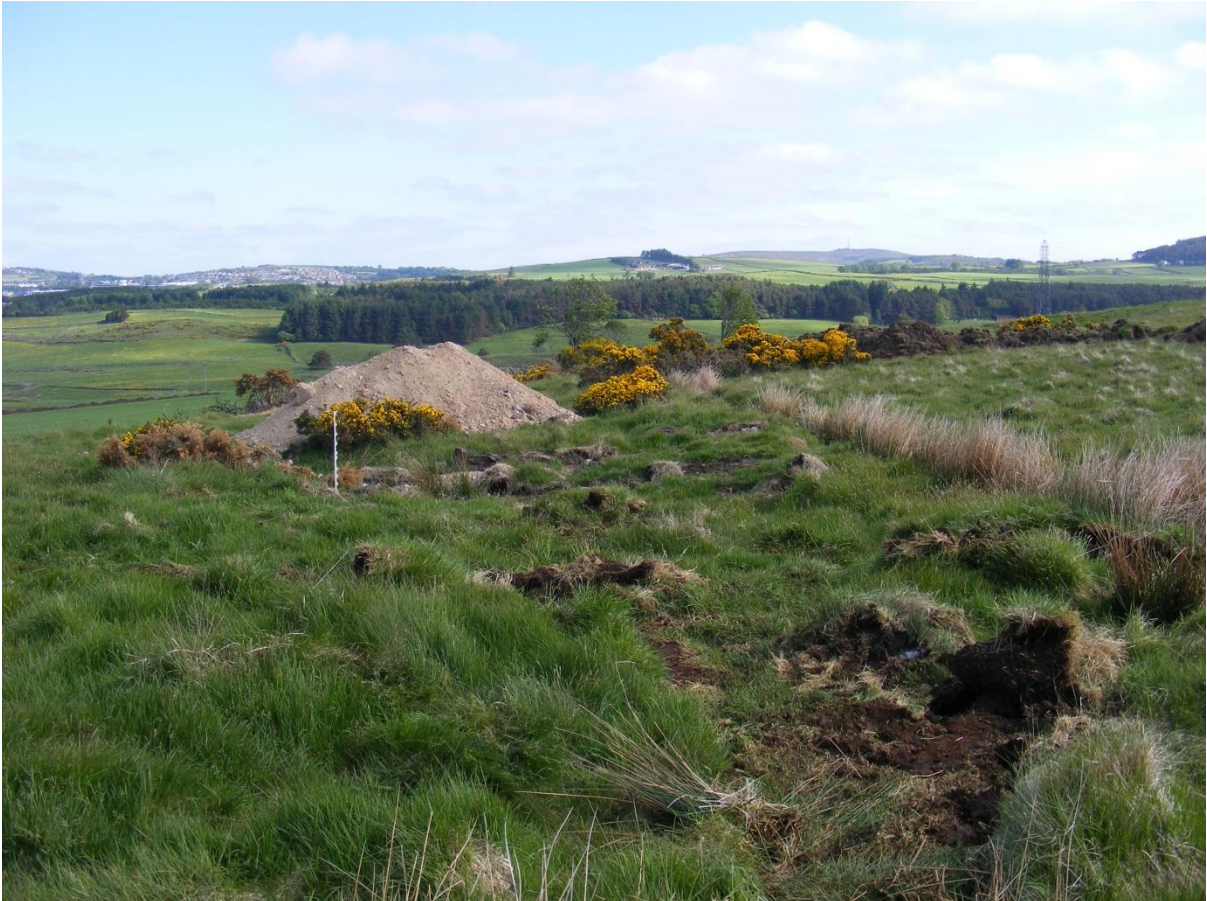
Cover: View of turbine location facing N.

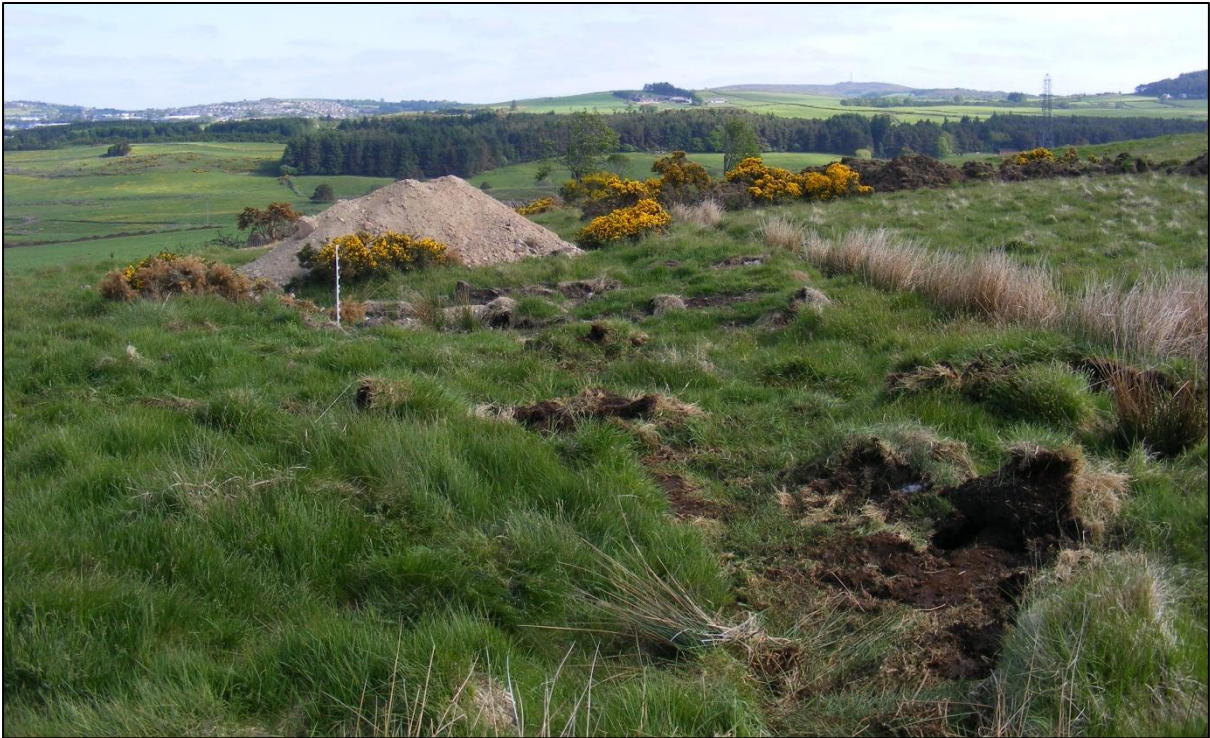
The turbine site lies on a slight southwest facing slope, of very rough pasture under grass with a natural ridge to the northeast of the site, bounded to the south by post & wire fencing with a stone wall and the boundary to the East was a post & wire fence separating the site from a woodland scheme. There are no upstanding features on the site.

Plate 1 – View of site of turbine before excavation facing N.

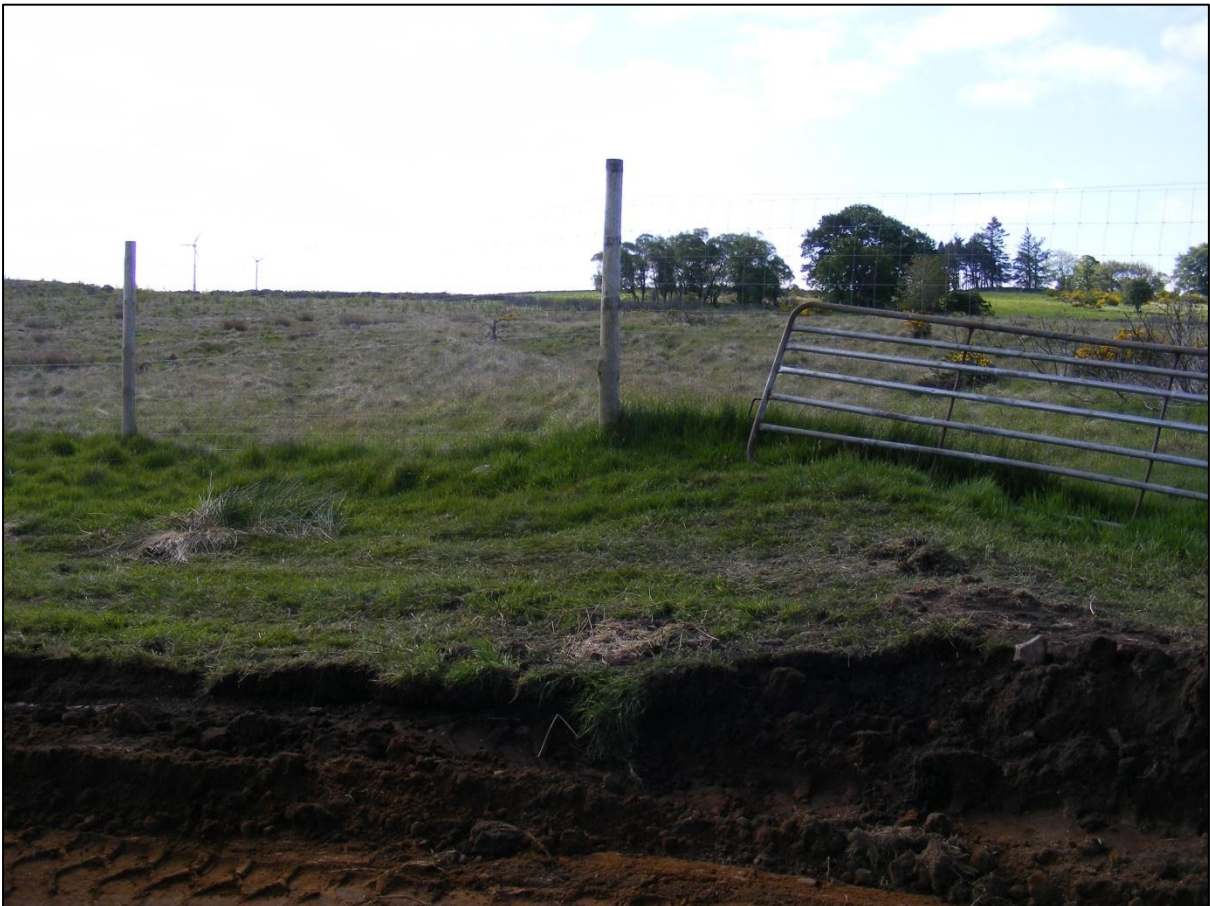
The topsoil and subsoil consisted of a loose light brown soil; it lay on top of loose soft yellow-orange-brown sandy silt natural with small to medium rounded stones, with patches of panning. A large number of boulders and smaller stones found to East side of excavation but none of these were structural. The edge of a small bank of small stones in the SE corner was 2m wide and 0.2m high and continued under fence to E for 30m. It is possibly post-medieval and remains of clearance.

Plate 2 – View of bank to SE corner facing E.

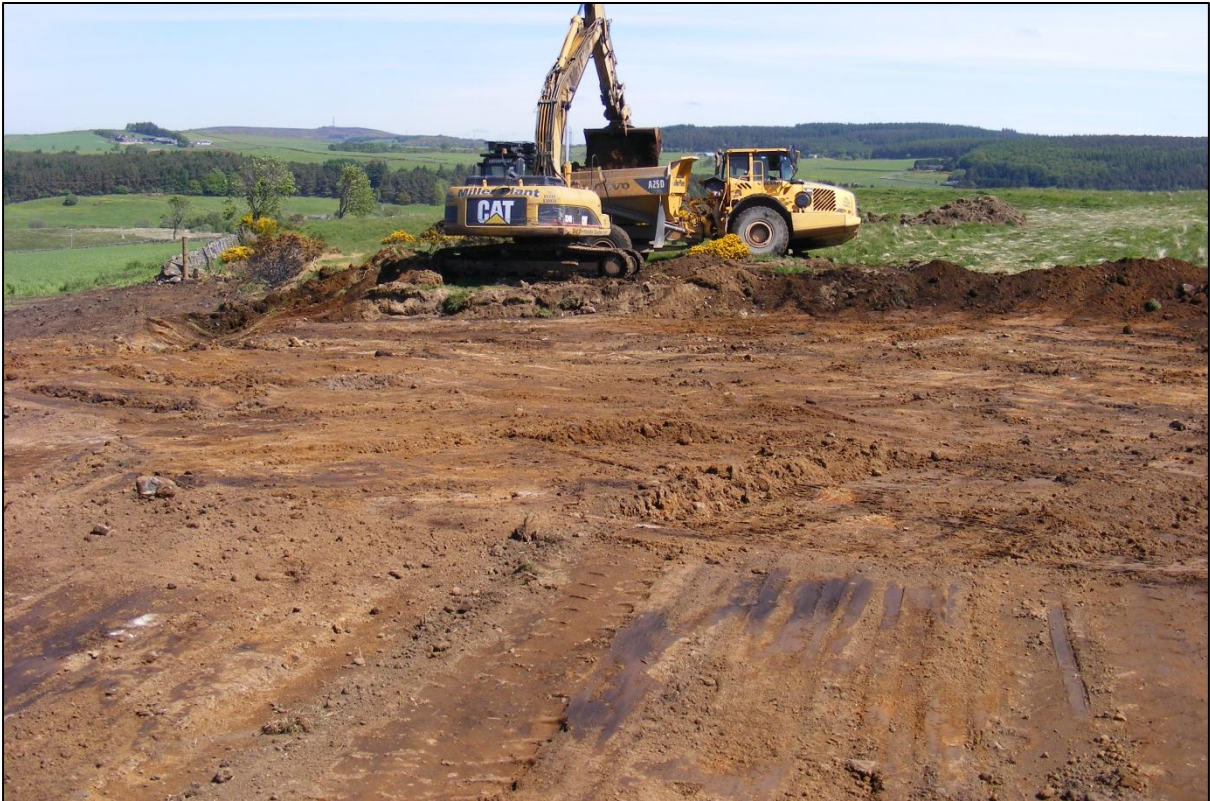
Plate 3 – View of turbine base during excavation facing N.

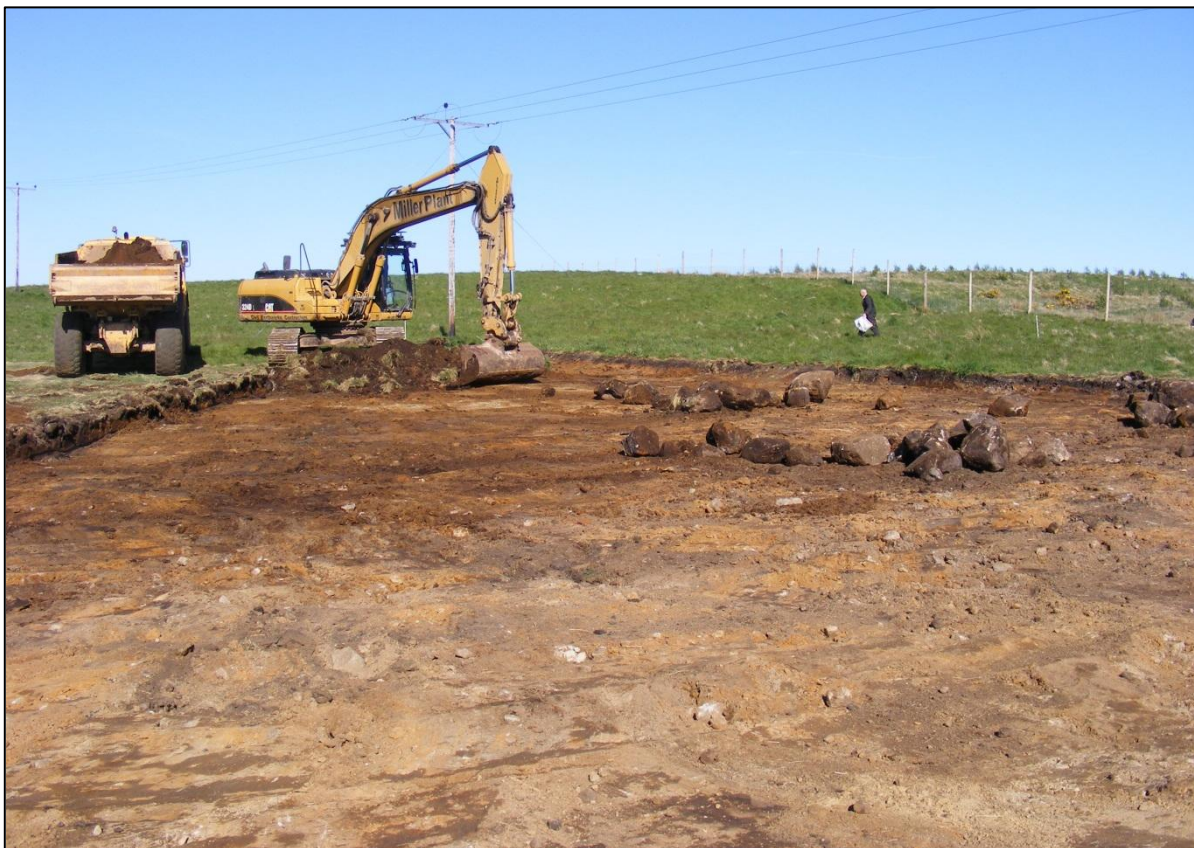
Plate 4 – View of crane pad during excavation facing NE.

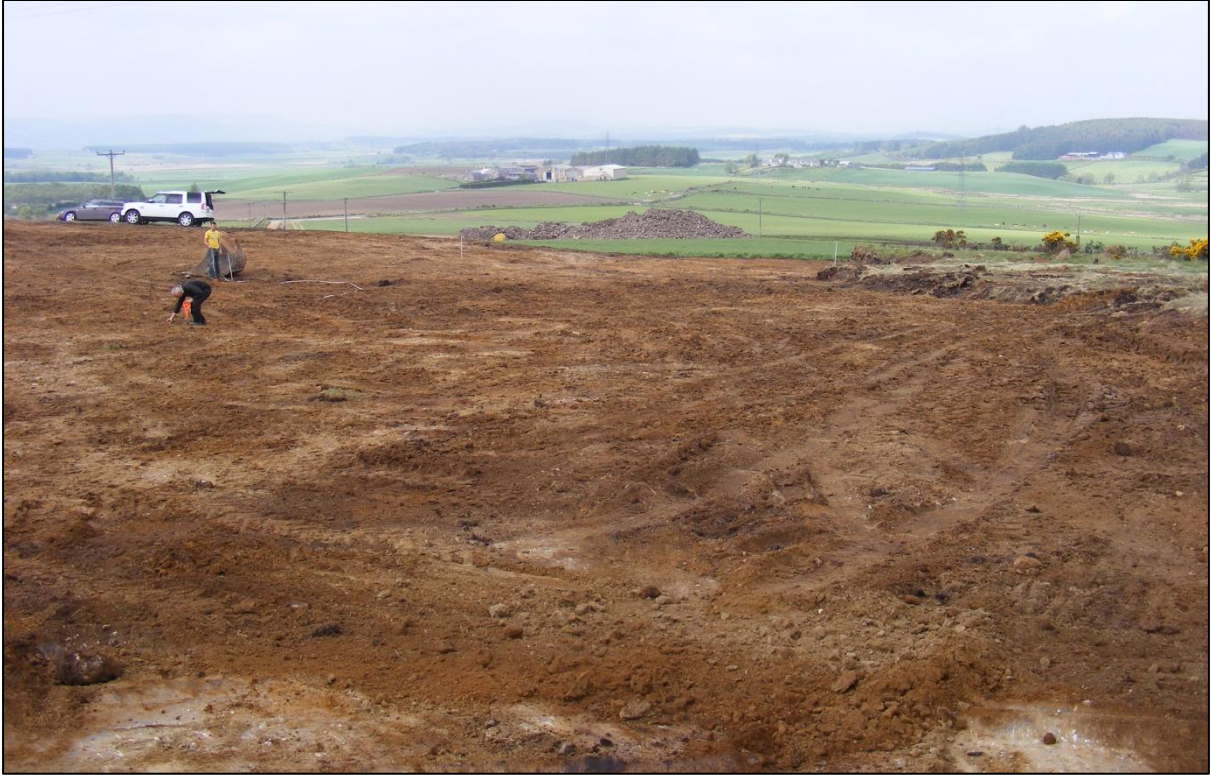
The archaeological watching brief conducted on this site revealed no archaeological features or deposits of interest. The map and documentary evidence available indicate that the development site has previously been an area of rough pasture. Although there are archaeological remains in the wider vicinity of the development site there was no indication of it being an area of archaeological activity.

Plate 5 – View of turbine base and crane pad upon excavation facing W.

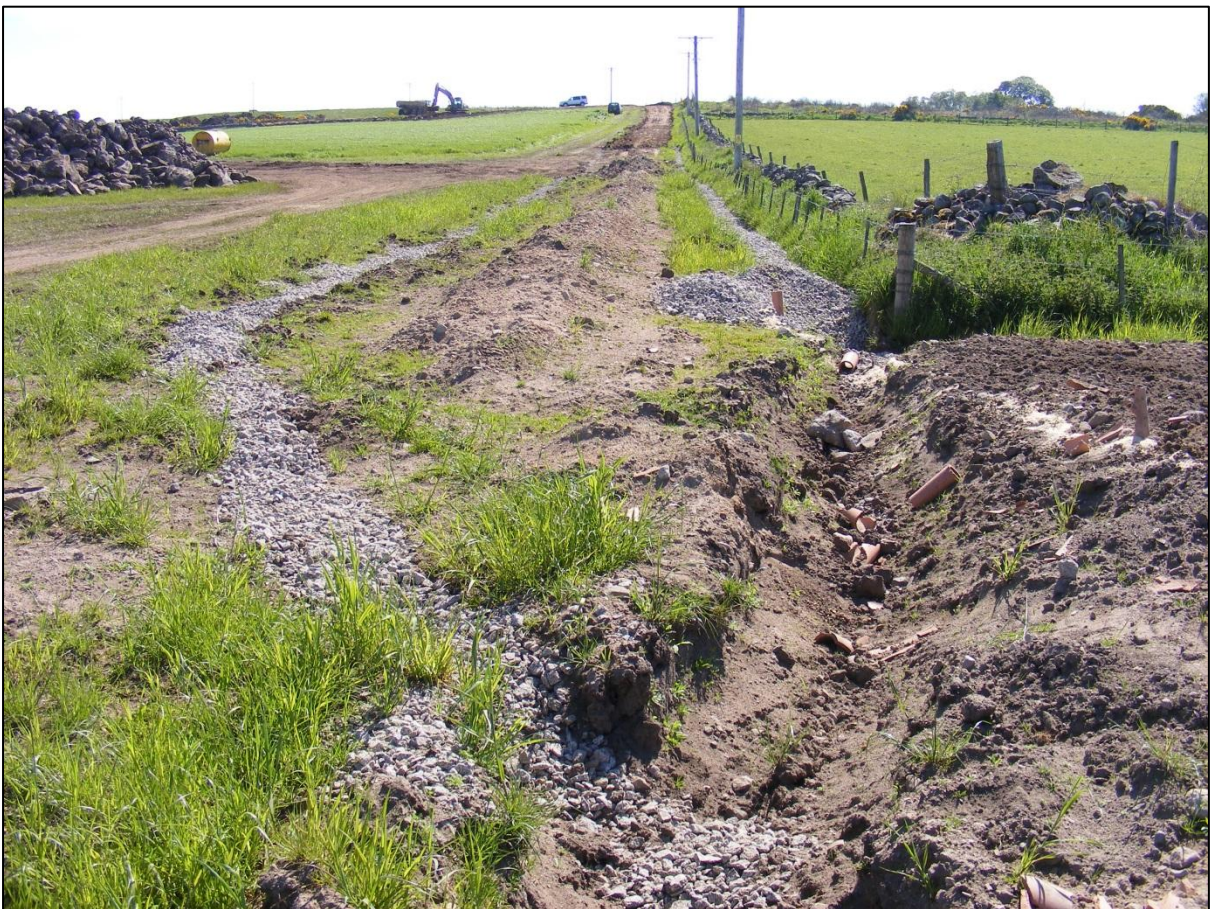
The excavation work conducted on the site was for the wind turbine base and the immediate area around for the crane base and road. The access road was also monitored, though an area to the centre had been previously excavated for the creation of drainage to the corner of the field in the form of 'french' drains with clay tiles. The trench for the construction of the road was excavated to a width of 3.8m along its total length, and in parts the topsoil was only 15cm deep in western field. The area of turbine base was excavated to an area c. 60m NS by 30m EW.

Plate 6 – View of drainage in road facing E.
