**Development of 750-1000 houses, commercial and community uses
Site at Maidencraig, North and South of the A944, AB15 6NB
Phase 1 archaeological evaluation report**

**Alison Cameron
Cameron Archaeology
12 May 2013**

**Development of 750-1000 houses, commercial and community uses
Site at Maidenraig, North and South of the A944, AB15 6NB
Phase 1 archaeological evaluation report**

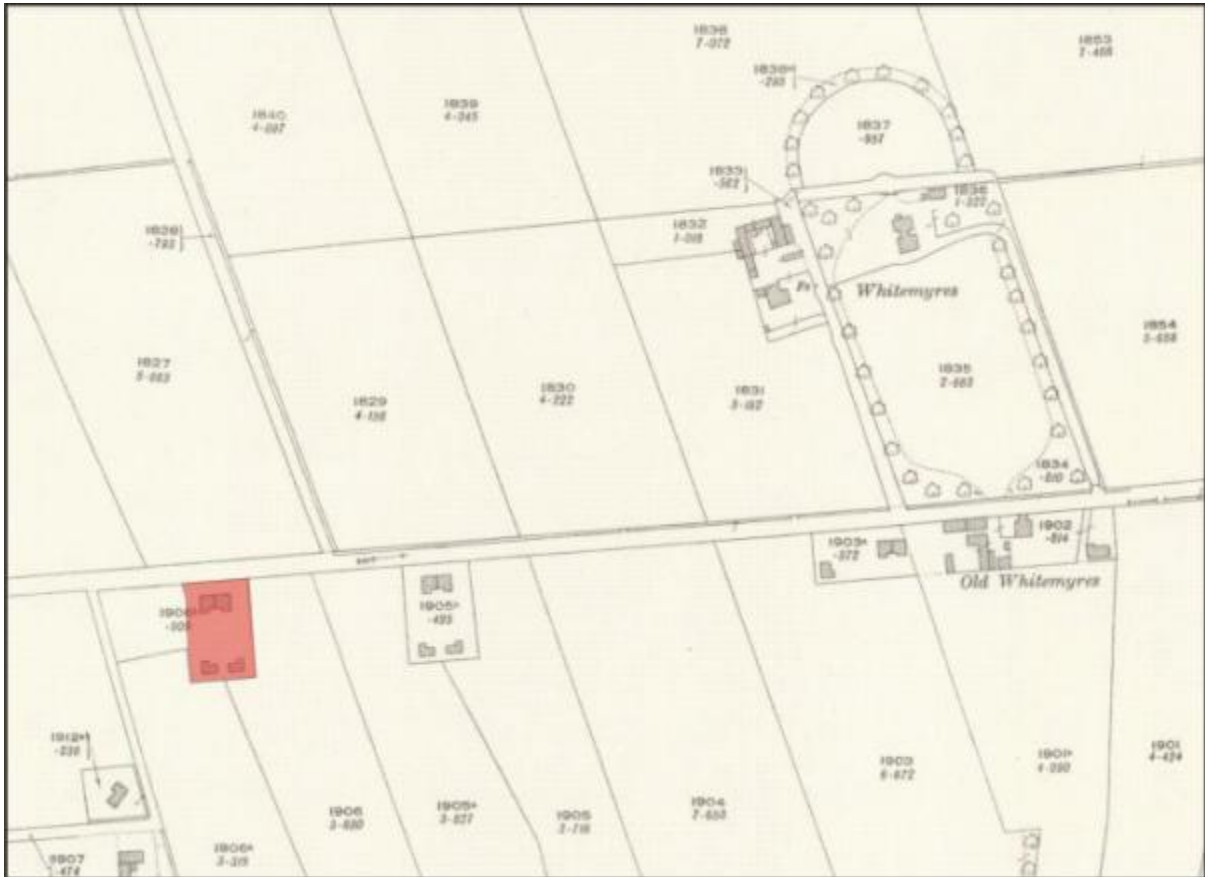
The standing building survey was carried out on 23 April 2013; the weather was bright and clear. Four buildings associated with No7 and No 8 Whitemyres Holdings were recorded prior to demolition prior to redevelopment of the land. The present owner, Mr Rattray was born in the house in 1935 and his father had moved to the property in the 1920s after returning injured from WWI. The Holdings were erected between 1900-1920s for these

returning soldiers who were each given a small plot of land. There appear to have been at least twelve 'Holdings' and most of the fields are 100m wide so have been systematically planned. Some of the residents were then allowed to rent or purchase further land. The Rattrays initially had pigs on the land and used Building 2 which had a boiler for boiling up pig feed. Most of the Holdings were used for the cultivation of potatoes and the extensive later barns were mainly used for storage of potatoes. Latterly No 8 was used as a livery stables and there is a horse training 'manege' at the south of the property.

Illus 5 Third Edition OS map showing No7 and 8 Whitemyres Holdings (in red)
 Aberdeenshire, Sheet 075.09 Publication date: 1925 Revised: ca. 1924 Levelled:
 1899/1900 (copyright National Library of Scotland)

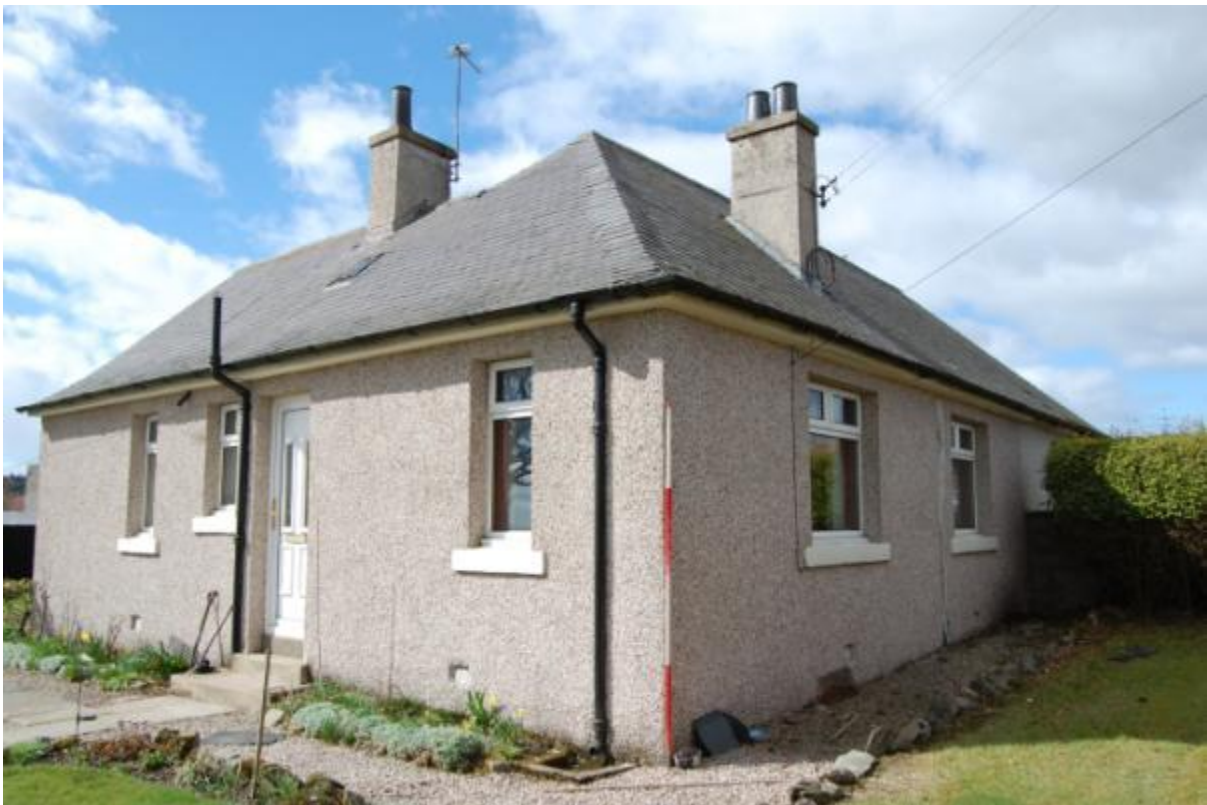
Building 1 is No 7 Whitemyres Holdings (Illus 4), a single storey cottage 9.4m N-S and 8.25m E-W. It is attached to No 8 Whitemyres Holdings and stands on the frontage of the original line of Lang Stracht (now a service road separate from the main road). It is harled and has a small garden with an attached field originally owned by the Dept of Agriculture for the use of the occupier. Latterly some of the occupiers purchased the associated land; an evaluation of this land is detailed in a separate report..

Illus 7 Building 1 No 7 Whitemyres Holdings facing NW

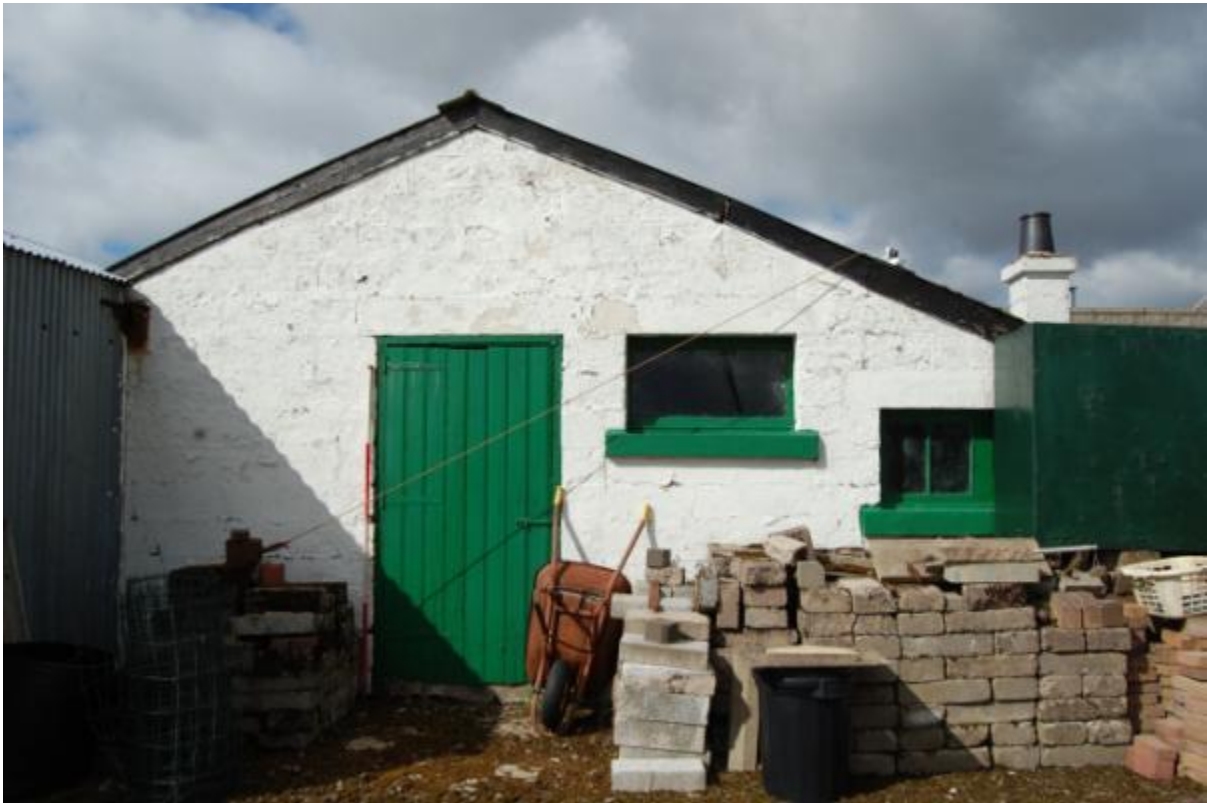
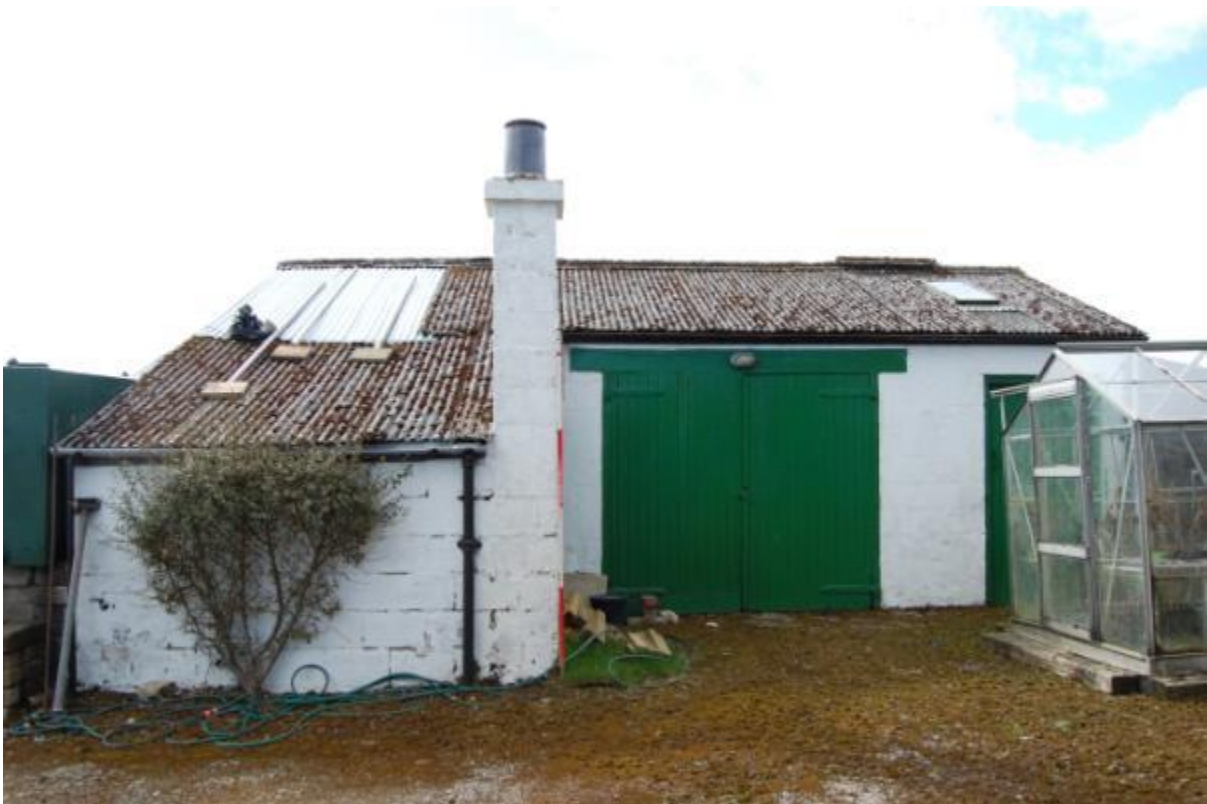
Illus 8 Building 2 shed of 7 Whitemyres Holdings, facing W

Illus 9 Building 2 shed of 7 Whitemyres Holdings, facing S

Building 2 is the shed of No 7 Whitemyres Holdings; it is 9.1m W-E and 7.3m N-S (Illus 5-6). The building is L-shaped and is constructed of pre-formed concrete blocks. There is a chimney in the centre of the north wall. The building was used by Mr Rattray for pigs.

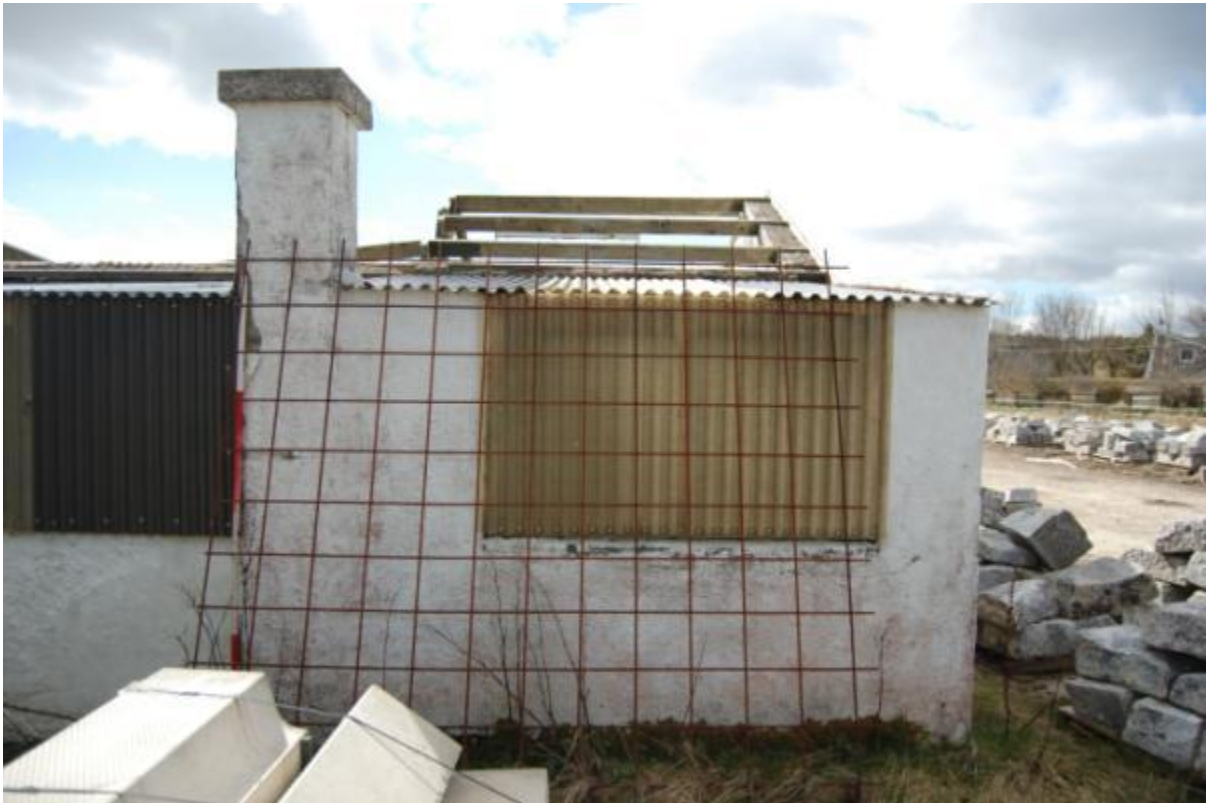
Illus 10 Building 3 shed of 8 Whitemyres Holdings facing S

Building 3 is the shed of No 8 Whitemyres Holdings; it is 9.1m W-E and 7.3m N-S (Illus 7). The building is L-shaped and is constructed of pre-formed concrete blocks. It is in poor condition and has been partially demolished when later sheds were attached to the south and east walls of this shed.

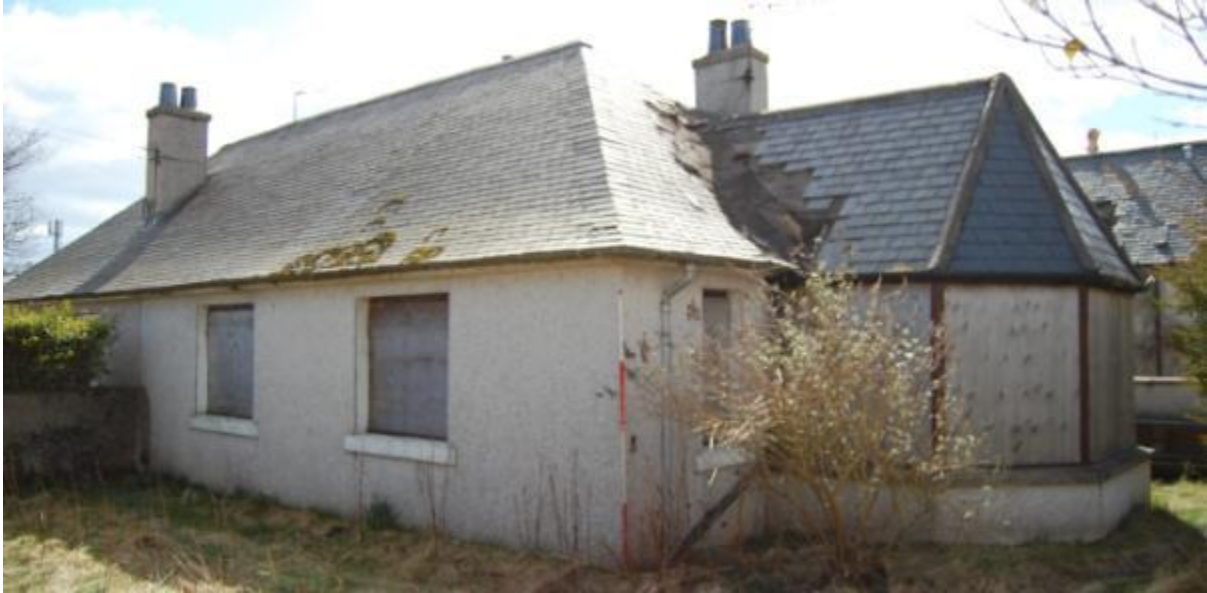
Building 1 is No 8 Whitemyres Holdings, a single storey cottage 9.4m N-S and 8.25m E-W (Illus 8). It is attached to No 7 Whitemyres Holdings and stands on the frontage of the original line of Lang Stracht (now a service road separate from the main road). It is harled and is unoccupied and boarded up; an extension on the west wall is a later addition.

Illus 11 Building 4, 8 Whitemyres Holdings facing SE
