**VIEWFIELD, CLINTERTY, ABERDEEN, AB21 0TL
REPORT ON WATCHING BRIEF AND
STANDING BUILDING SURVEY**

**Alison Cameron
Cameron Archaeology
1 October 2013**

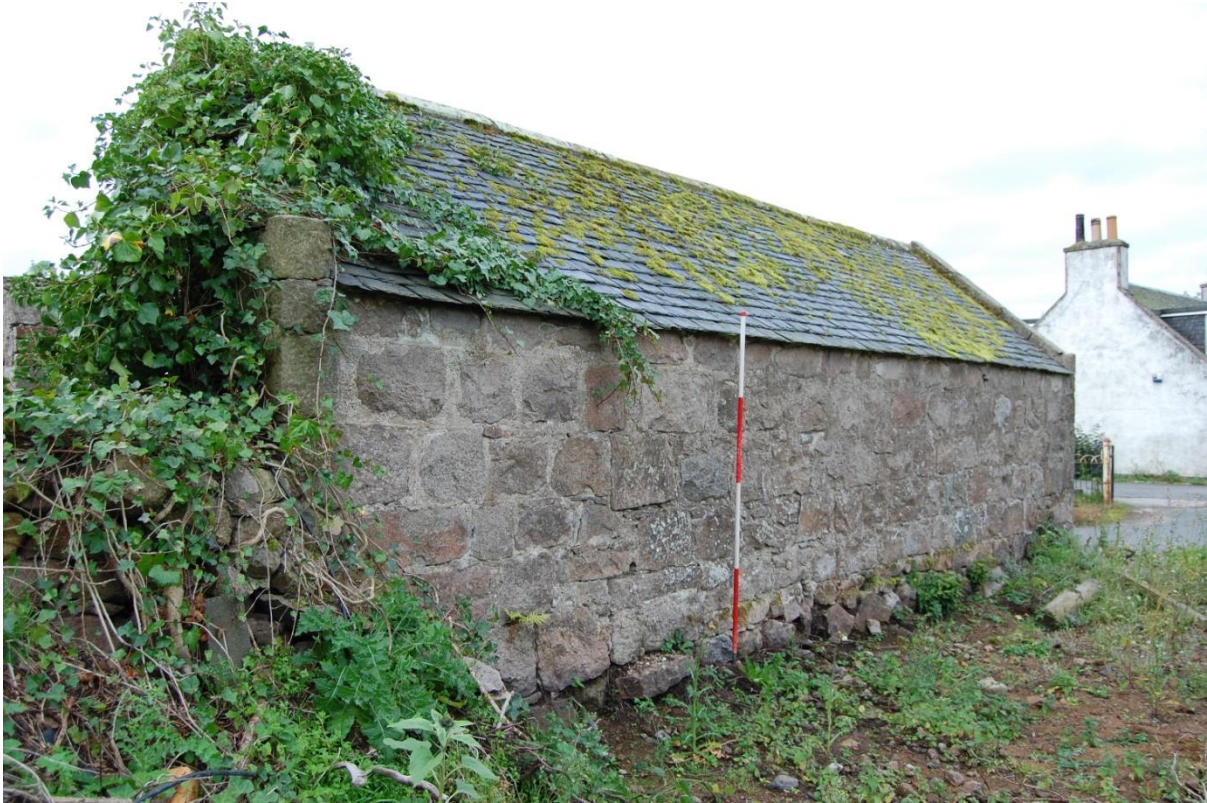
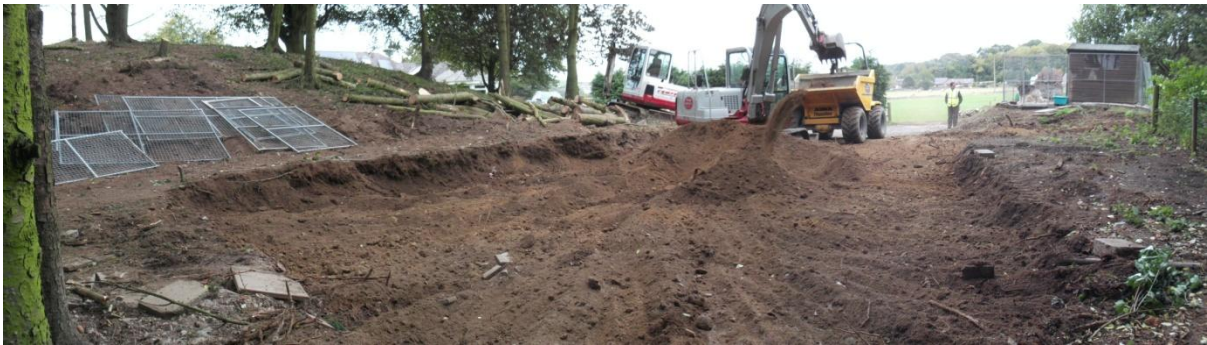
(top) north facing wall with blocked apertures for mill mechanism (bottom) soil strip showing modern dumped material and tree roots

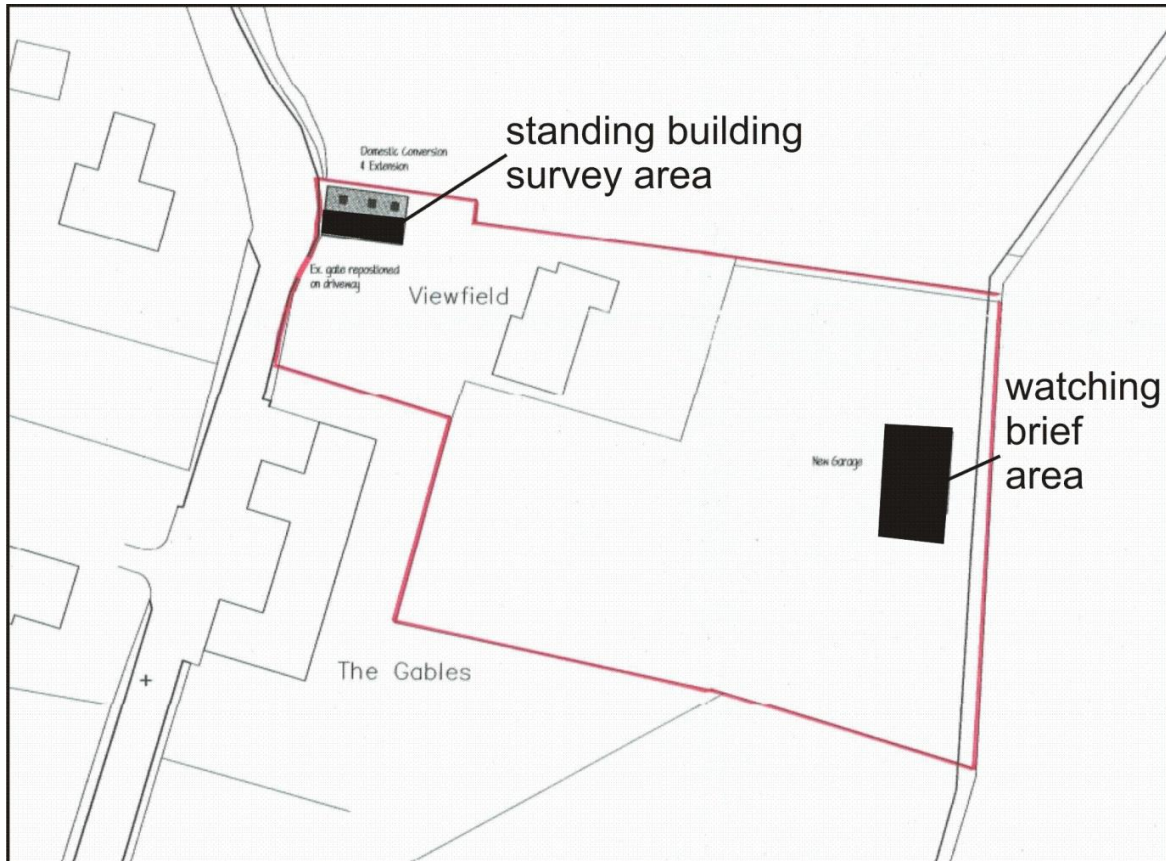
Illus 2 Plan showing watching brief area and building surveyed (based on copyright Squire Associates).

A watching brief on the soil strip for the new garage (Illus 2) was carried out on 30 September 2013. In the late 19th century a cist and burial (Shepherd, I A G 1986) had been found immediately south of the proposed garage (Illus 7, 8). The watching brief showed that the area had been previously disturbed, planted with trees and then used as an area for dumping and no archaeological contexts or finds were recorded.

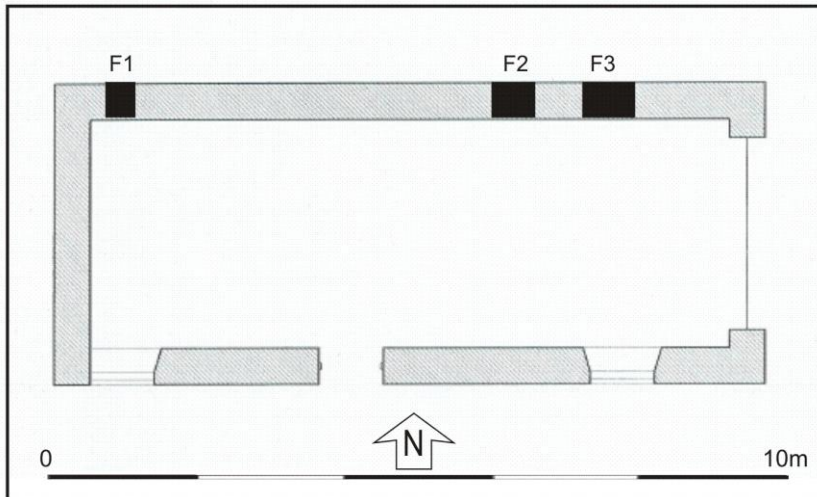
Illus 3 Plan of building showing apertures F1, F2 and F3 (based on copyright Squire Associates).

The north wall of the building originally had three apertures (F1, F2 and F3; Illus 3, 4) which had subsequently been blocked. The small size of the apertures (c 0.5 x 0.5m) and the fact that they are sited low on the walls suggests that they were probably for drive shafts and other mechanisms for a mill indicating that the building had been used as a mill, possibly a threshing mill for the farm. The First Edition OS map shows a mill pond to the east of the building (Illus 7) and issues bringing water from the NE to the farm; a lade presumably took

the water to the mill along the property boundary at the north side of this building but all traces have been lost on the ground and this is not indicated on the OS maps.

These apertures were then blocked and alterations carried out at the west end of the building including blocking a door at the west end of the south wall and also possibly shortening the building, possibly due to widening of the road. Subsequently the foundations have been revealed by reduction of the ground level at the west end causing large cracks in the north and south walls.

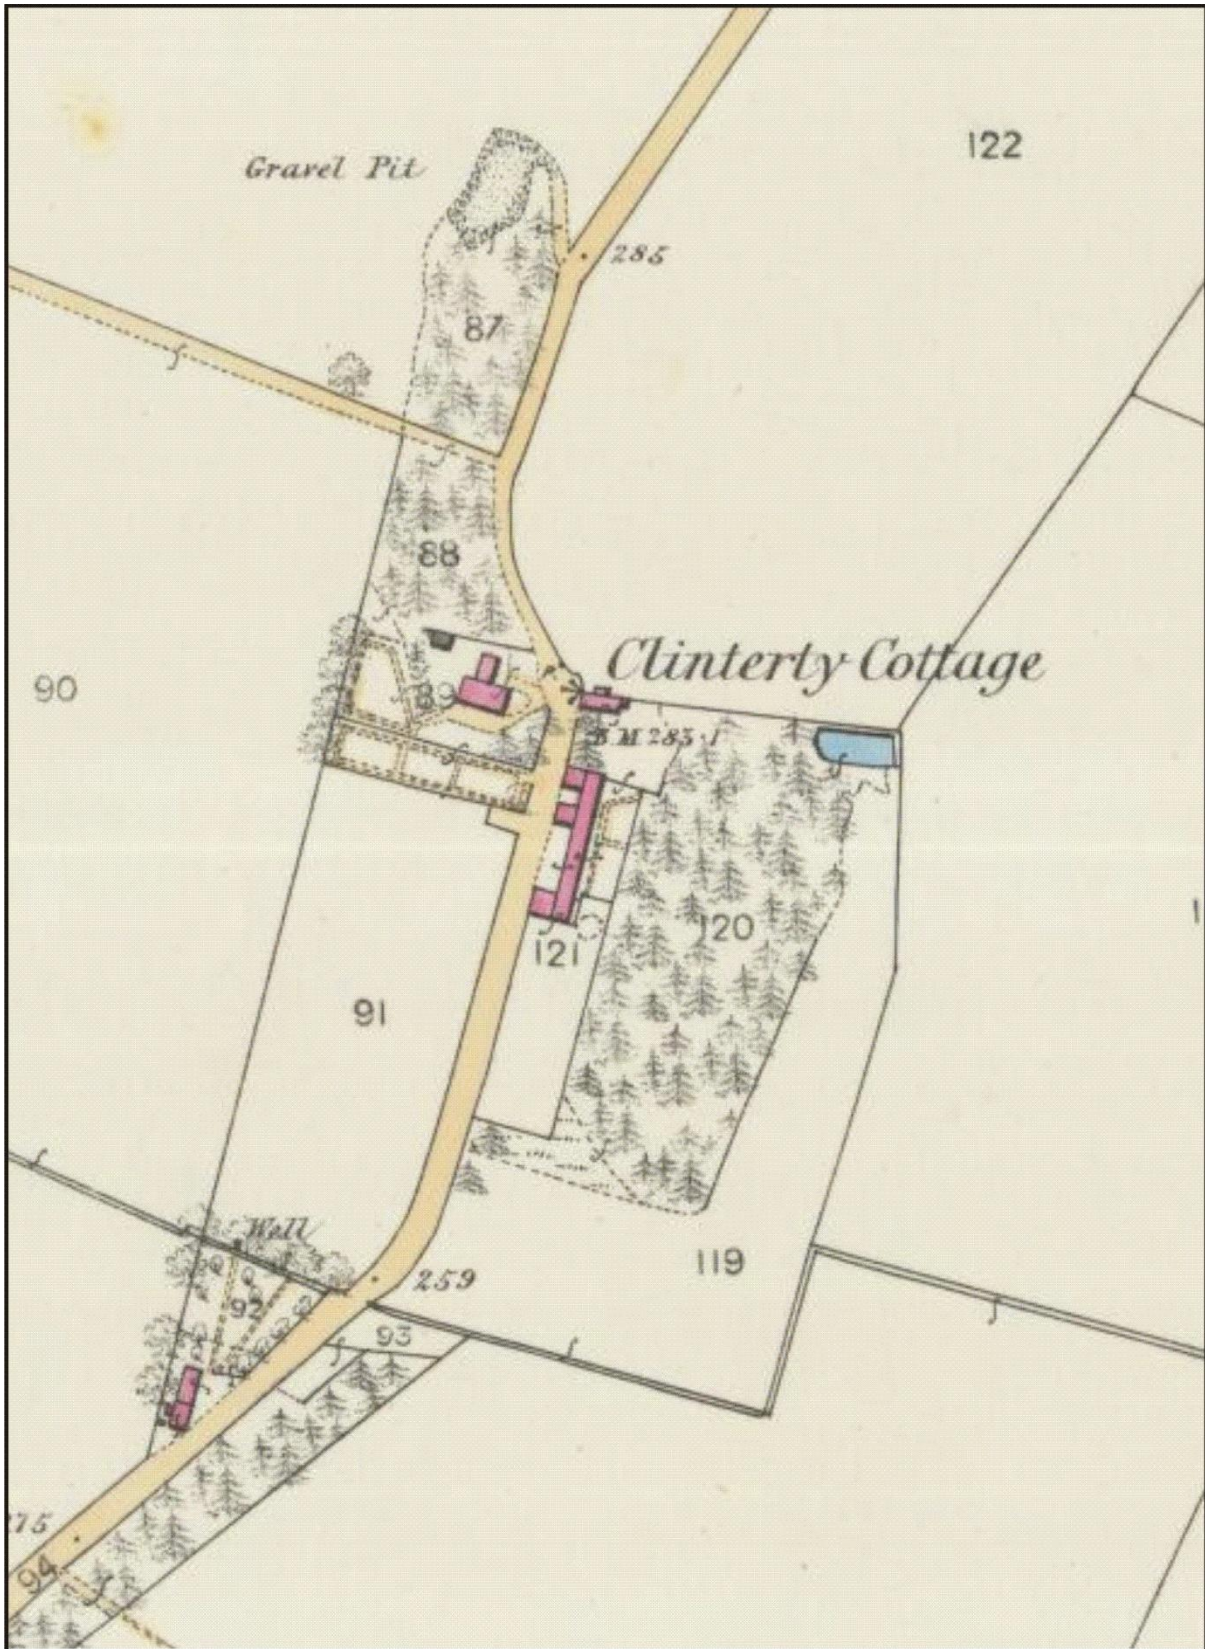
Illus 7 Ordnance survey First Edition (copyright National Library of Scotland)
Aberdeen Sheet LXV.15 (Newhills)
Survey date: 1865 Publication date: 1869

A Level 2 Standing Building Survey was carried out on 30 September 2013 as the structure is to be partially demolished to allow for redevelopment. The building is constructed of large pink granite blocks with cherry cocking. It is 9.7m long and 4.1m wide and the walls are c 0.75m wide and is oriented on an ESE-WNW alignment. The building can be seen on the First, Second and Third Edition OS maps as part of Clinterty Cottage and associated farm buildings (Illus 7, 8).

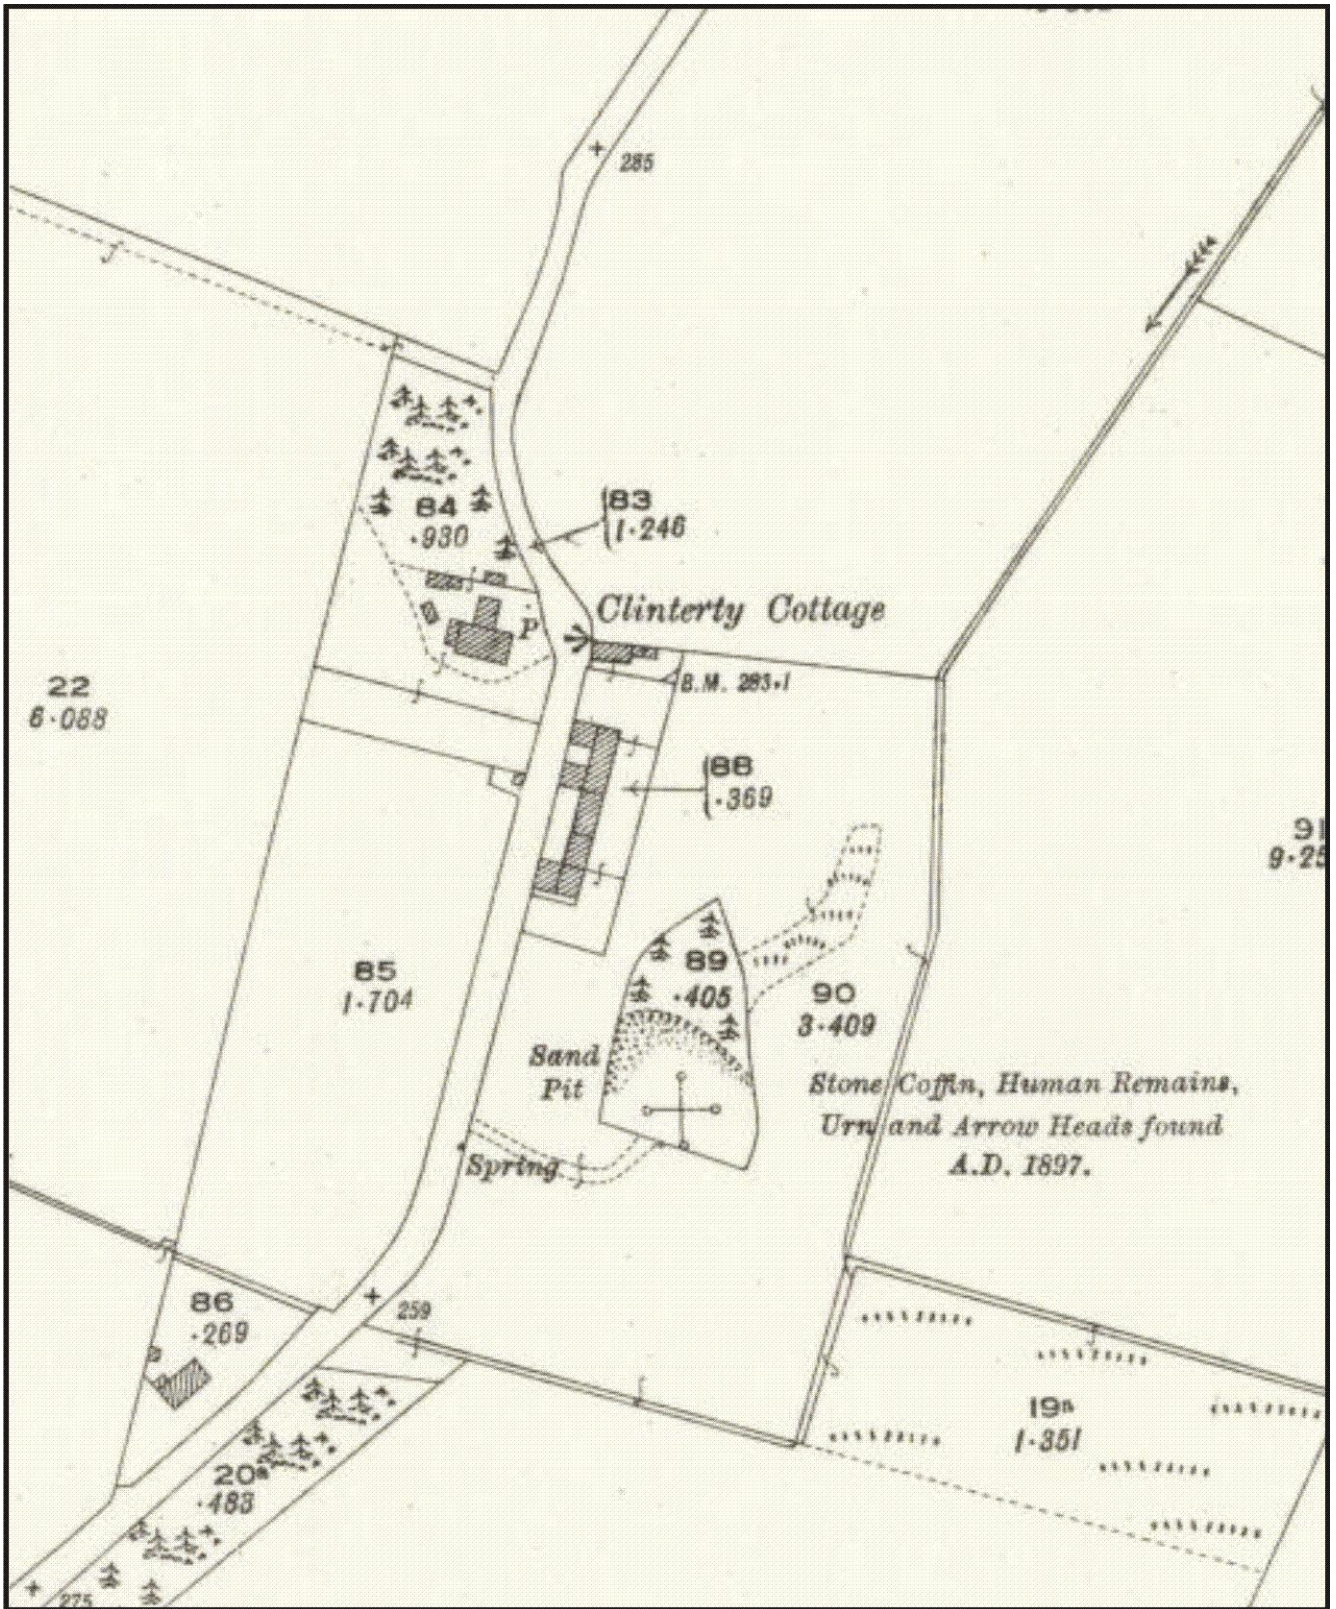
Illus 8 Ordnance survey Third Edition (copyright National Library of Scotland)
 Aberdeenshire, Sheet 065.15
 Publication date: 1925 Revised: ca. 1923 Levelled: 1899
