**Pittrichie Mansion House, Oldmeldrum,  
Inverurie, AB51 0QT**

**Alison Cameron  
Cameron Archaeology  
5 December 2013**

A level 1 survey was carried out on this 19th-century house. It is recommended that no further archaeological work is required during the current development subject to agreement by Aberdeenshire Archaeology Service.

Aberdeenshire Council planning reference APP/2012/1895 for full planning permission for the reinstatement of the mansion house and erection of ancillary building was passed on 1.10.12 with an archaeology condition (condition 6) for a standing building survey of the upstanding remains. The site is at NJ85515 25470 in the parish of Udney and at 110-115m OD.

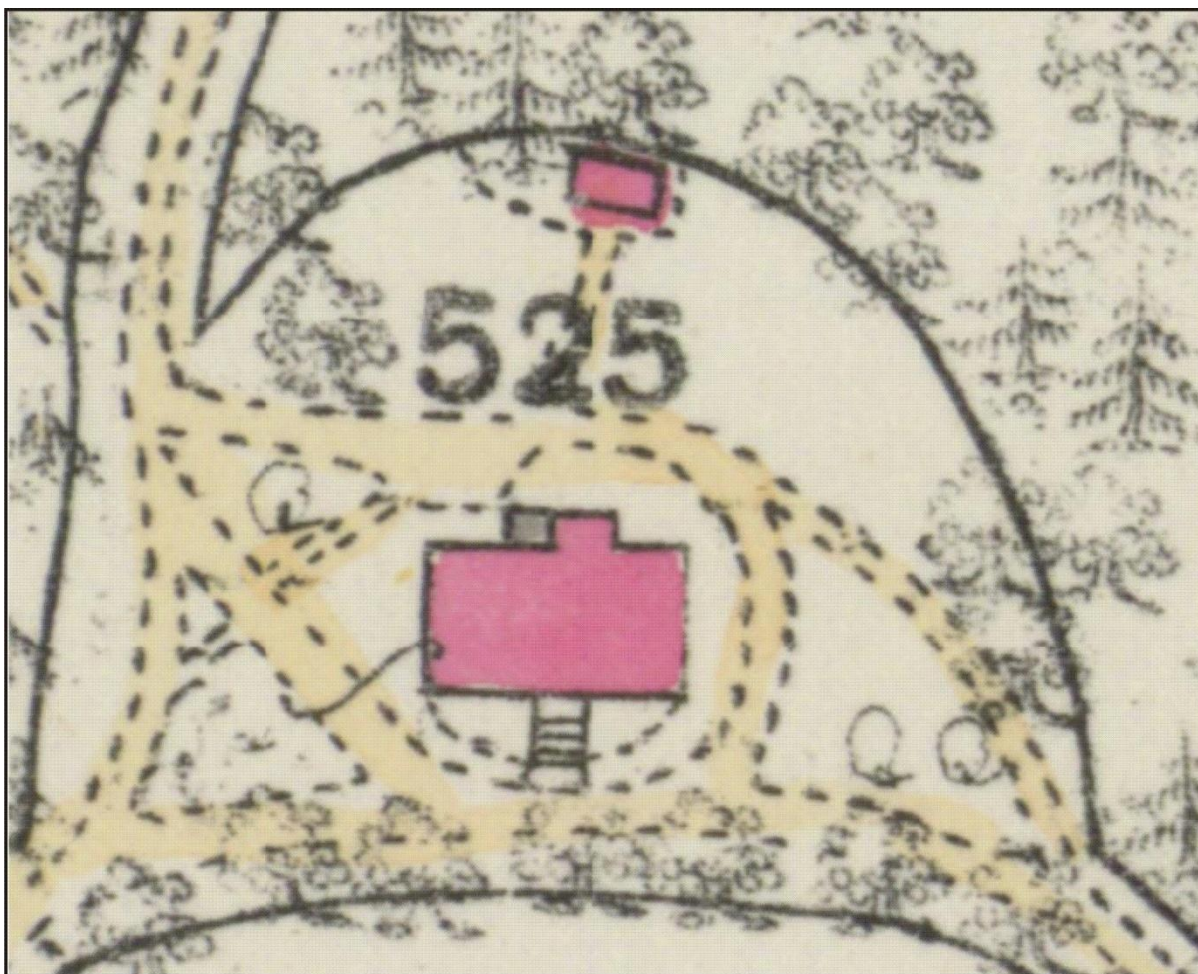
Illus 2 First Edition Ordnance Survey map (surveyed 1867) showing House (in pink) showing stairs on south wall and extension adjacent to main north door and Building 2 (top) (copyright National Library of Scotland) Aberdeen Sheet XLVI.11 (with inset XLVI.7) (Udny) Survey date: 1867 Publication date: 1870.

The house is 17m long (E-W) and 9.m wide. The house was built in one phase from large pink and grey trimmed granite blocks with cherry cocking; the interiors are constructed of small and medium granite fieldstones. There are patches of grey harling surviving on the exterior of the walls, particularly the gable walls (Illus 7). The windows and doors are mostly original and feature granite surrounds, lintels and sills. A central mullion is present in the front basement window under the original front door (Illus 11); this window is now obscured by undergrowth. The front door (Illus 6) is now inaccessible but there was originally a set of wide steps up to the front door which are detailed on the OS maps (Illus 2 and Appendix 2); there is now no trace of these stairs.

There is a small (5.8 x 1.5m) extension just off centre on the exterior of the north wall in which the original stair would have been located. The stair to the basement lower ground floor level survives but is heavily shored up by steel and concrete blocks (Illus 8, 9, 12). The stairs are 1m wide and are constructed of granite tread and risers and at the top of these stairs is a threshold inside the back door which contains a socket (Illus 10) for a pillar to support the stairs to the upper floor (which have since been removed). There are scars on the walls adjacent to the back (north door where a lean-to extension has been sited (Illus 4); this can be seen on the First Edition OS map (Illus 2) coloured grey indicating that it was of wood or iron.

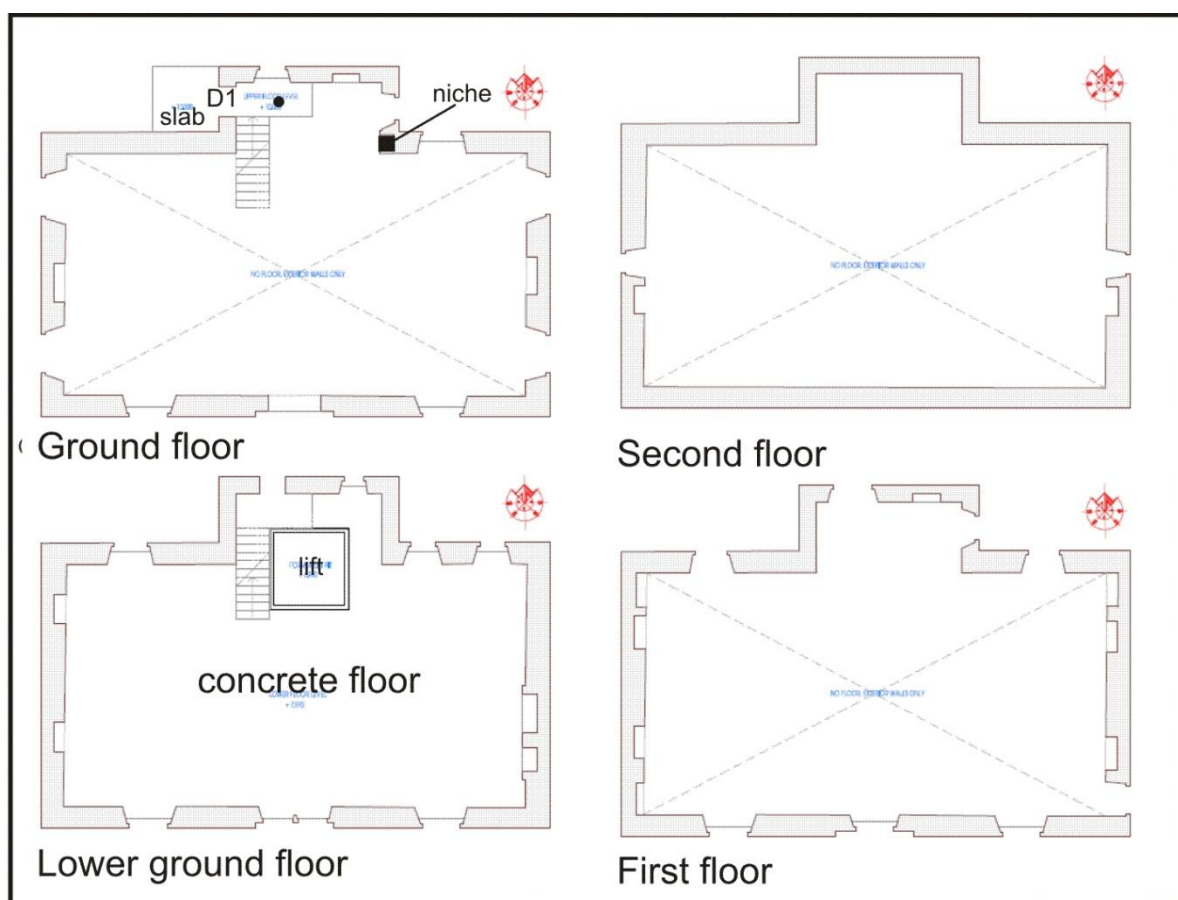
Illus 3 Plan of four floors of house (copyright William Lippe Architects)

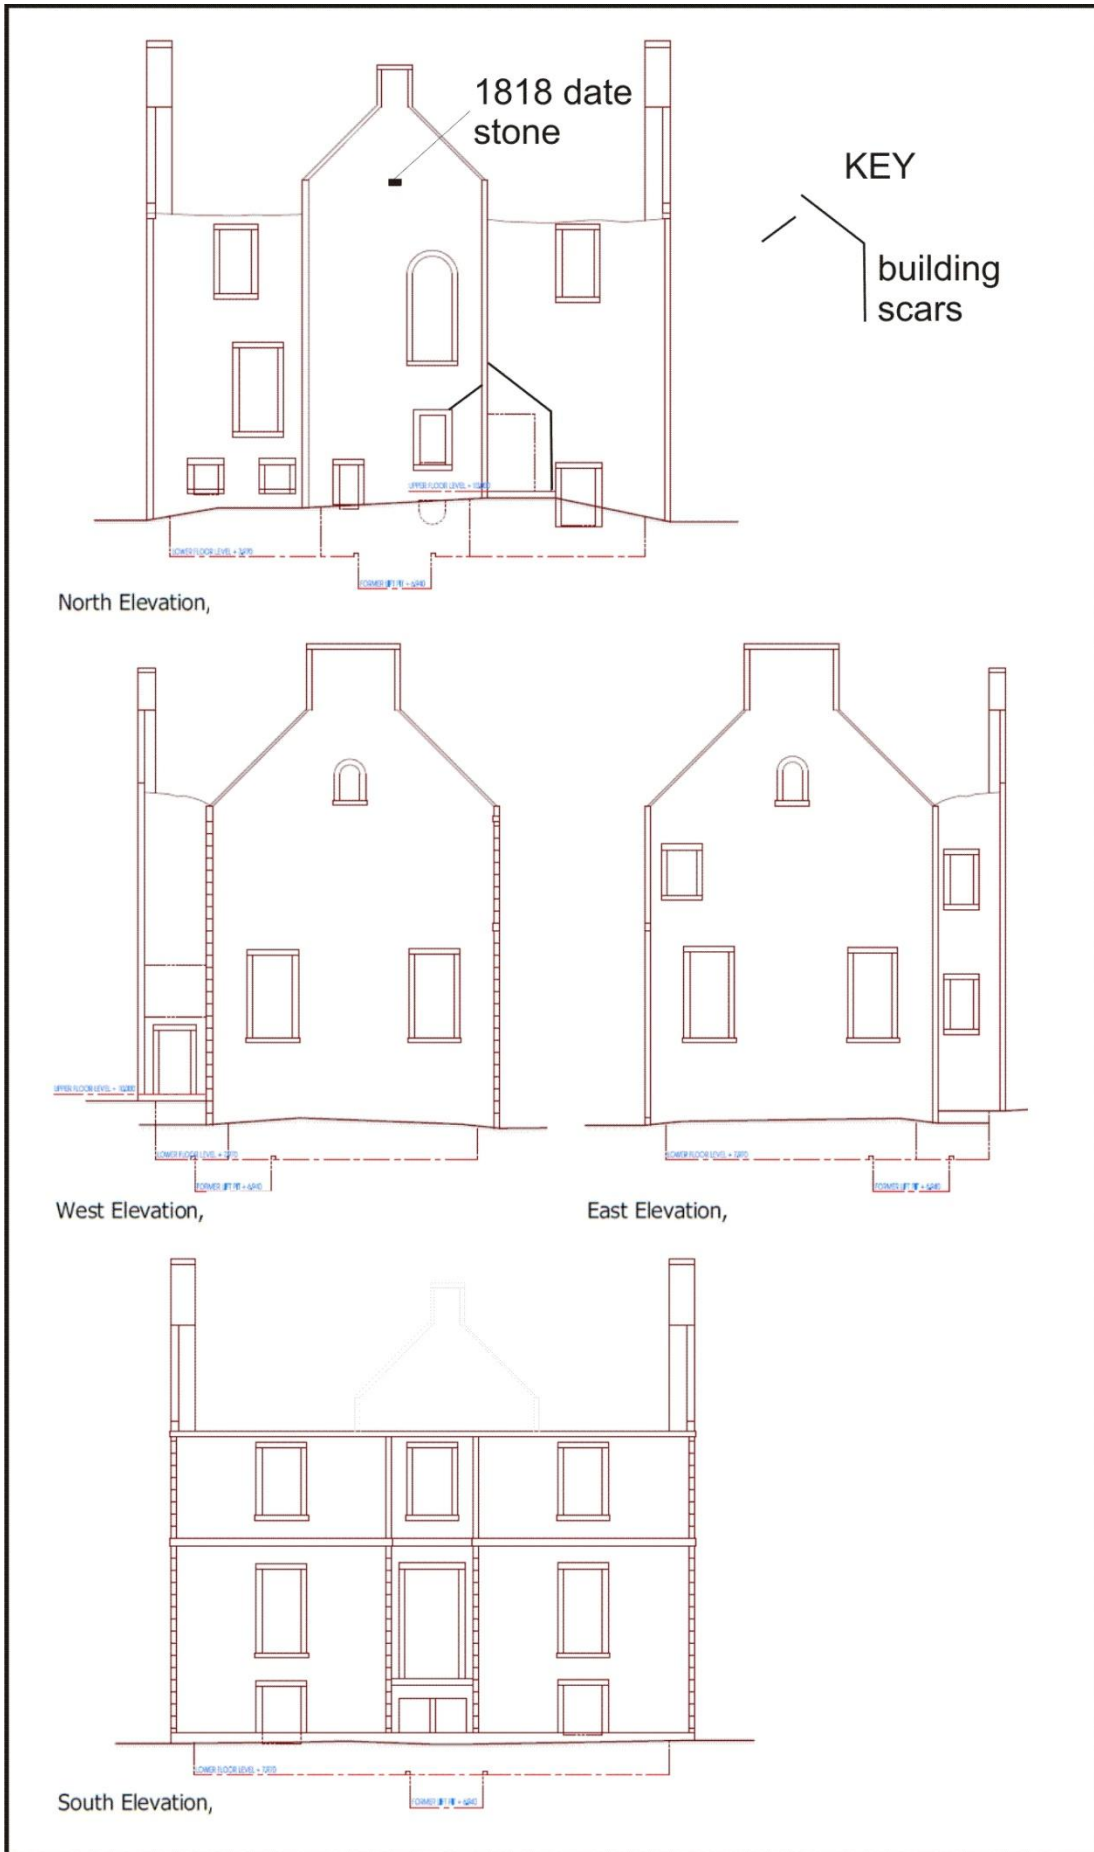
Illus 4 Elevations of House (Building 1) (copyright William Lippe Architects)

There is a small projecting date stone (1818) at the centre of the north wall (cover and Illus 4).

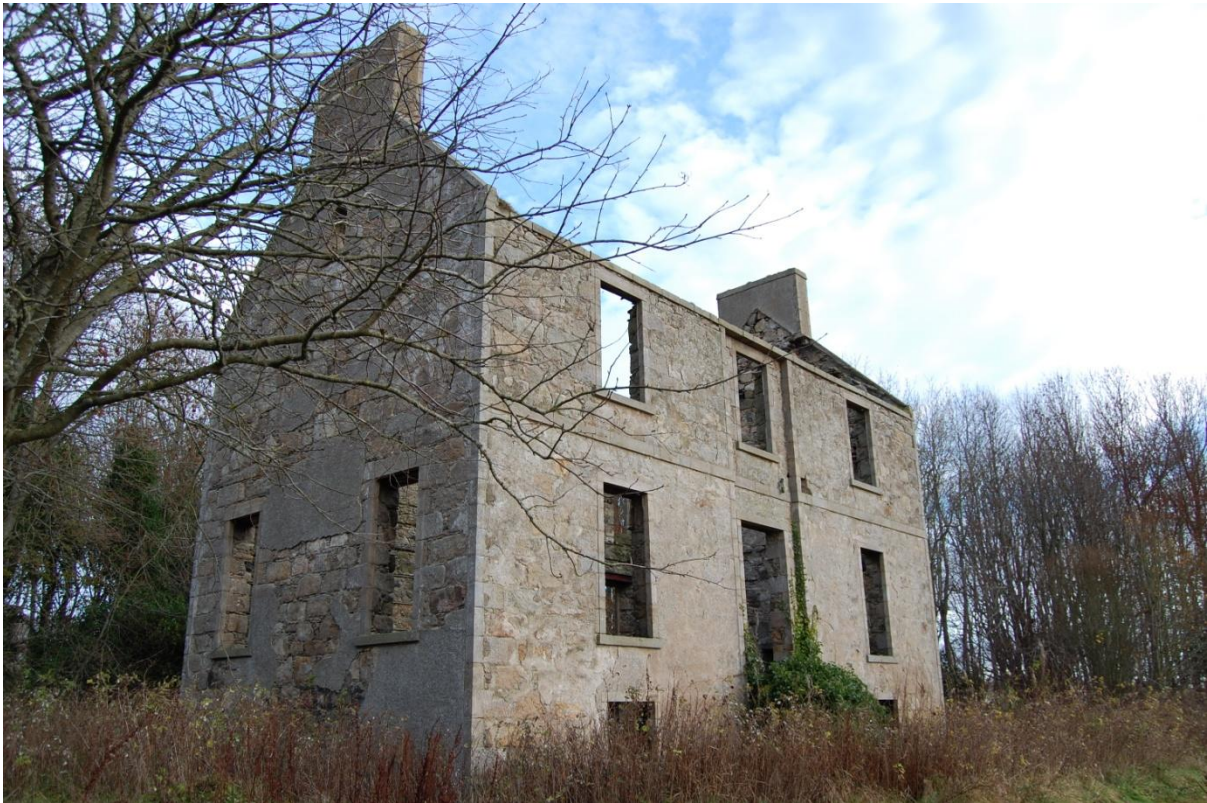
Illus 5 Frontage of house from NW showing recessed central bay with front door and upper window; lower window overgrown and visible from interior only; facing SW.

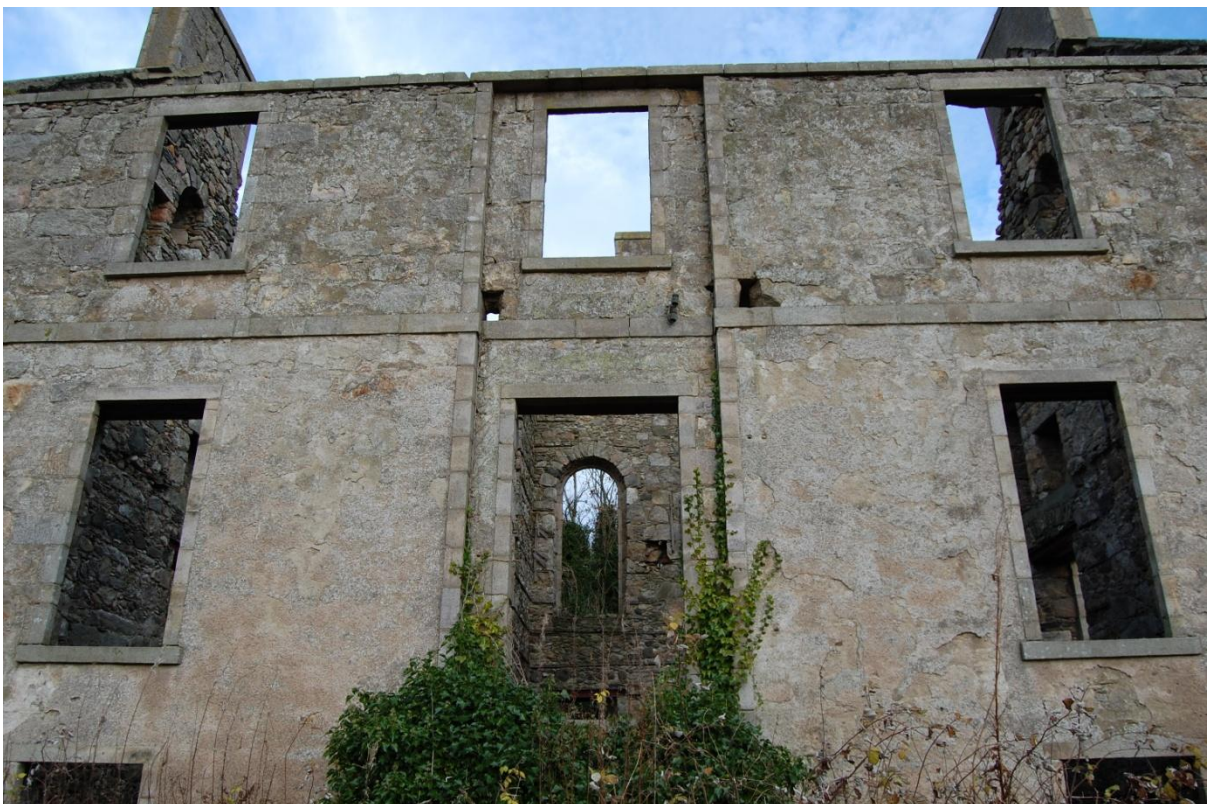
Illus 6 Front south facing facade with front door (bottom centre); the arched window in the north wall can be seen through the door aperture; facing north.

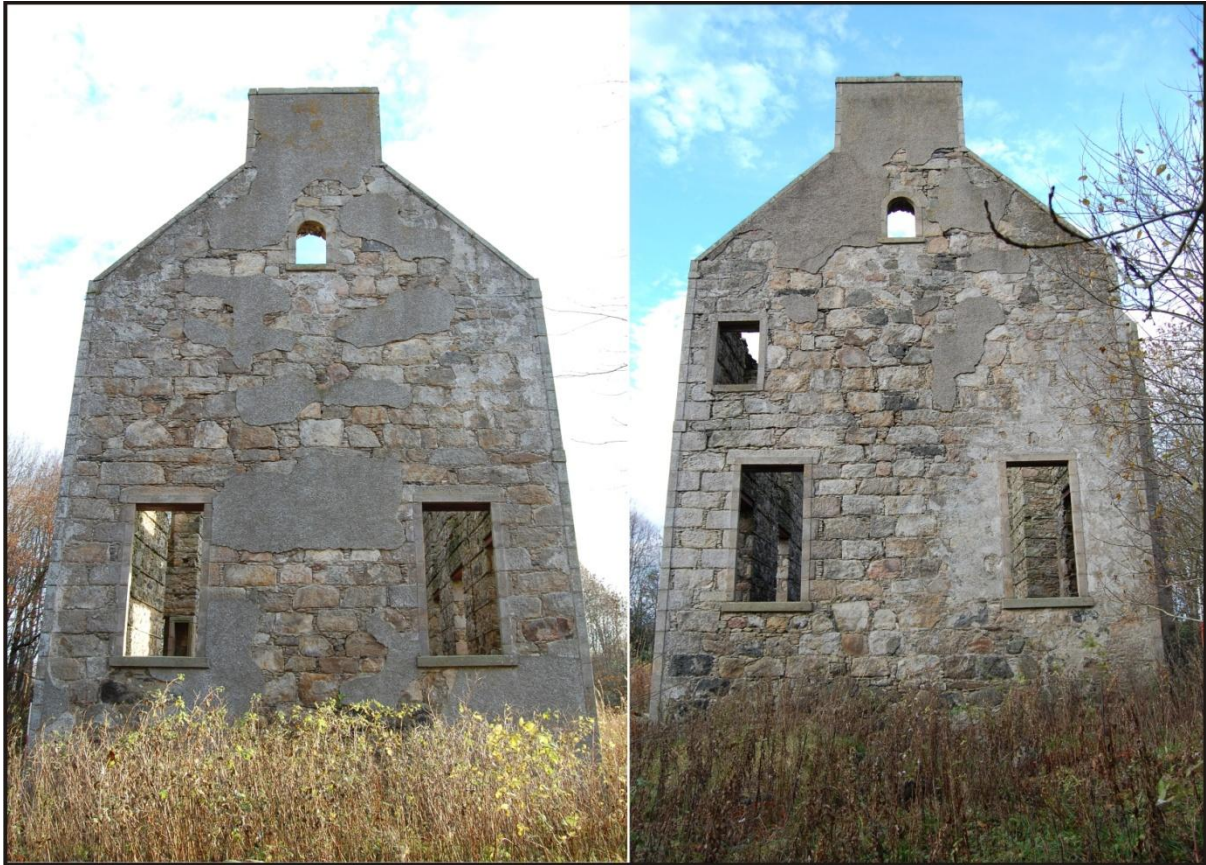
Illus 7 House (Building 1) west gable (left); east gable (right)

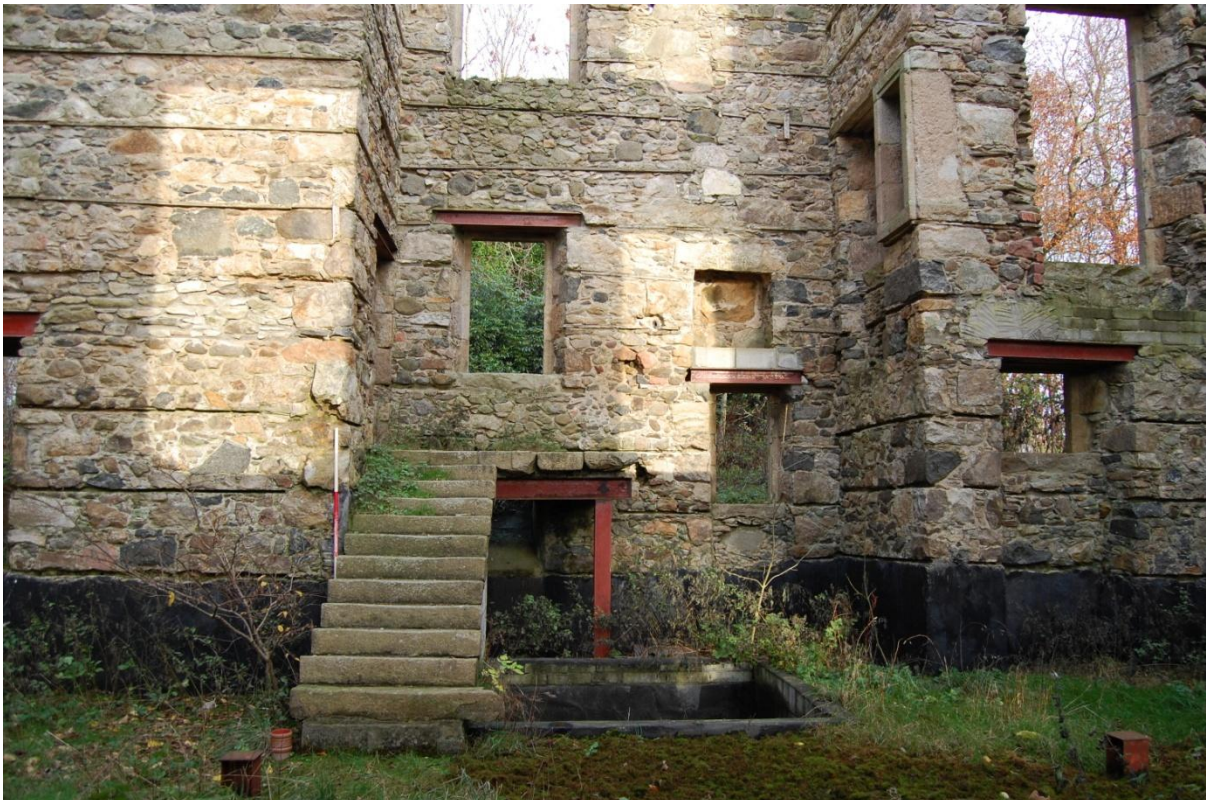
Illus 8 House (Building 1) interior of north wall showing stairs and interior of extension which would have housed the original stairs to the upper floors; facing north.

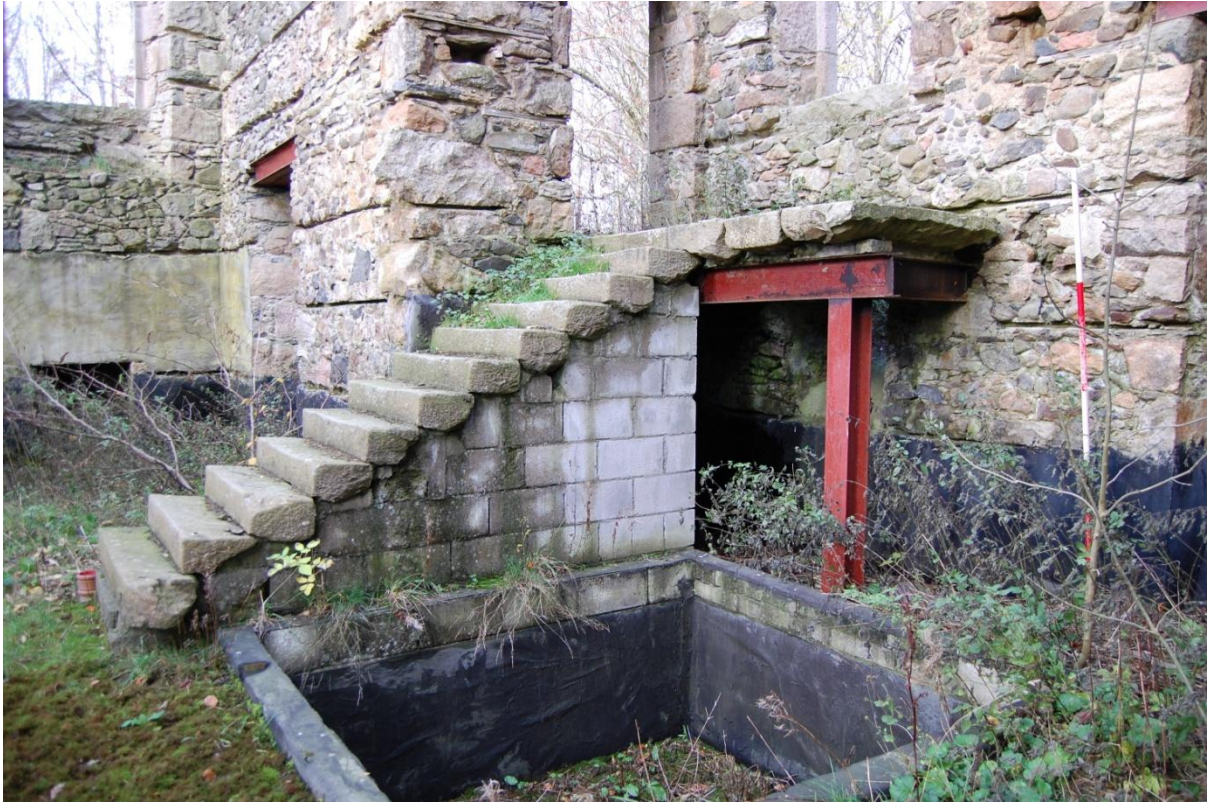
Illus 9 Stairs to lower ground floor basement; facing NW.

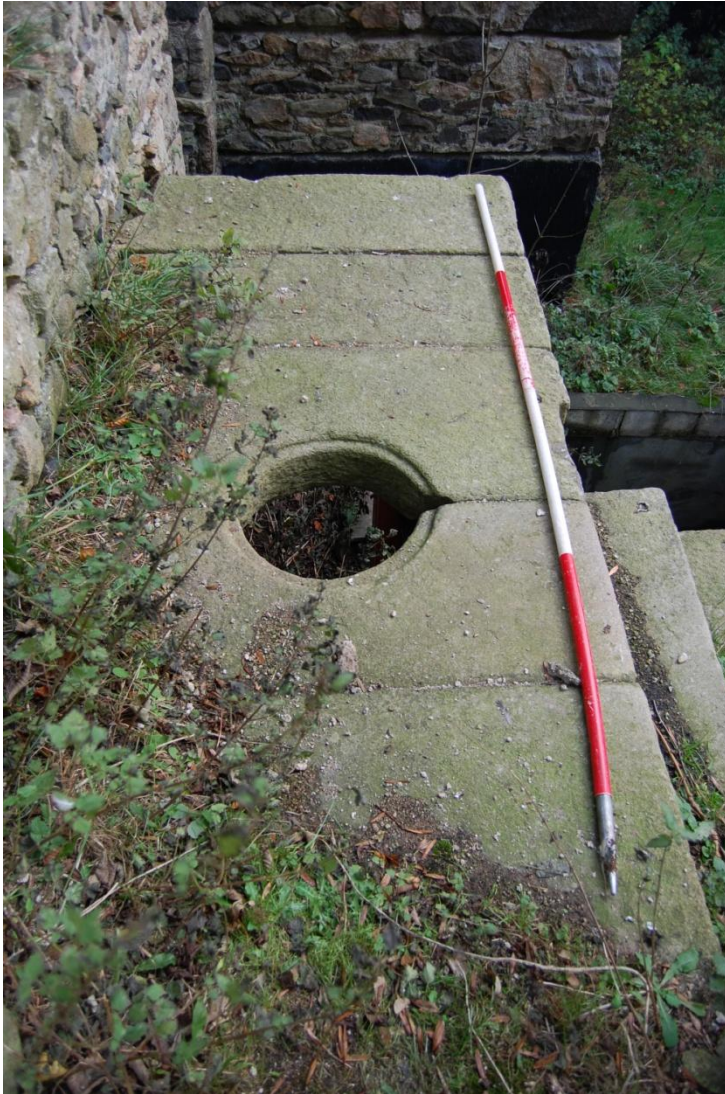
Illus 10 Granite threshold inside the back door which led into the stairwell to the basement; the original stairs would also have been set in this extension; facing east

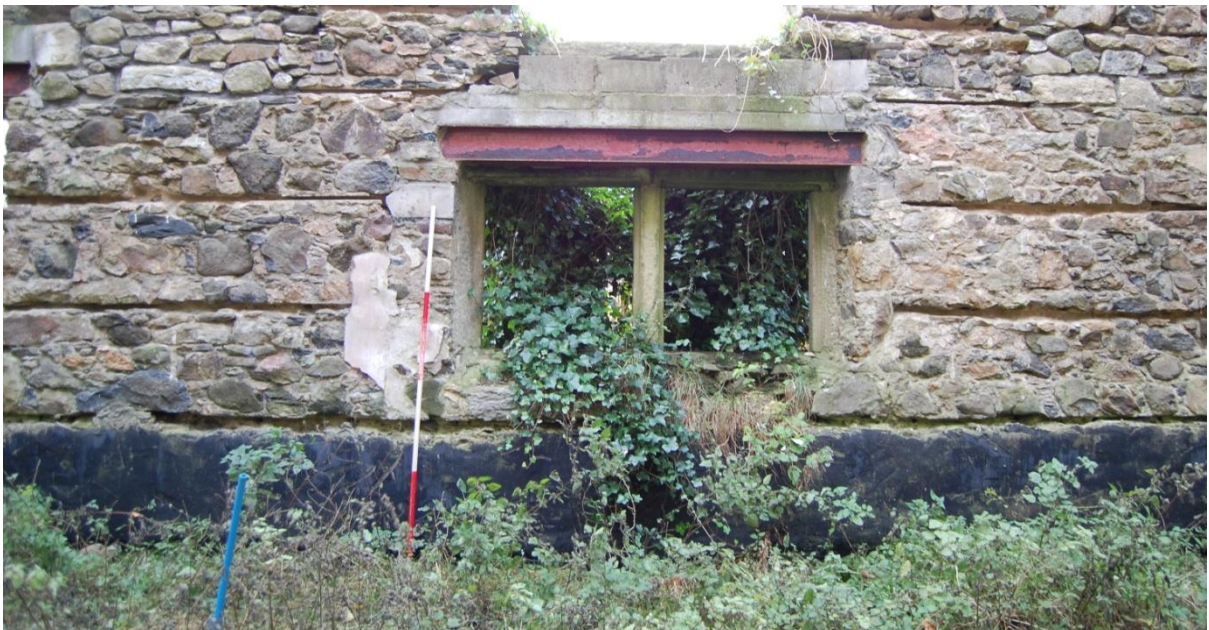
Illus 11 Lower ground floor window in centre of south wall under main front door with central mullion surviving; facing south.

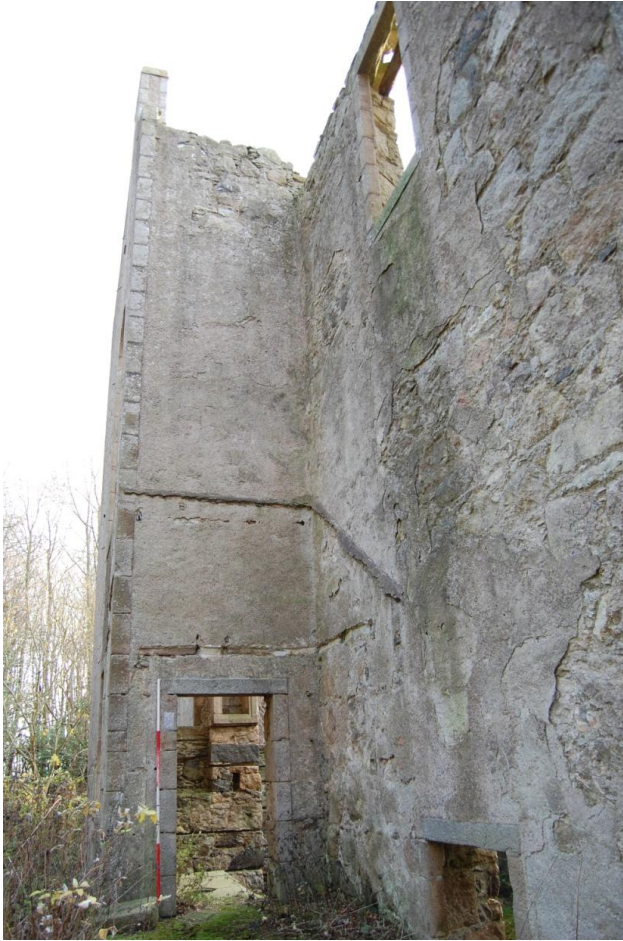
Illus 12 Extension to exterior of north wall with rear back door and scars showing lean-to extension above'; facing east

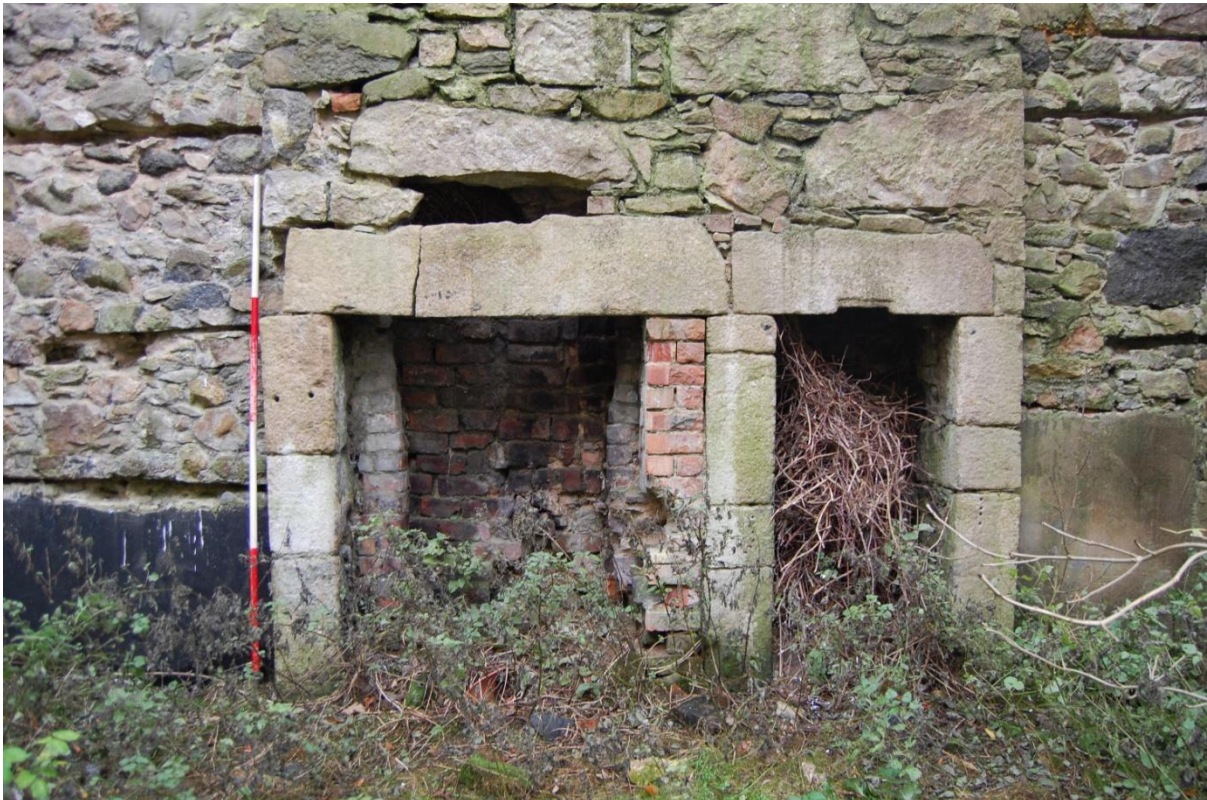
The basement/lower ground floor was lit with several lightwell windows (Illus 14); a concrete floor is still *in situ*. No internal fittings survive but there are two fireplaces in the south end of the east wall, presumably the old kitchen area. The fireplaces (Illus 13) are 1.5m high and the larger (northerly) one is 1.4m wide and the smaller adjacent fireplace is 0.75m wide. Two smaller fireplaces are visible in the wall above these features and the larger fireplace has also been relined with a brick surround and flue.

Illus 13 Fireplace in basement lower ground level on interior of east wall; facing east

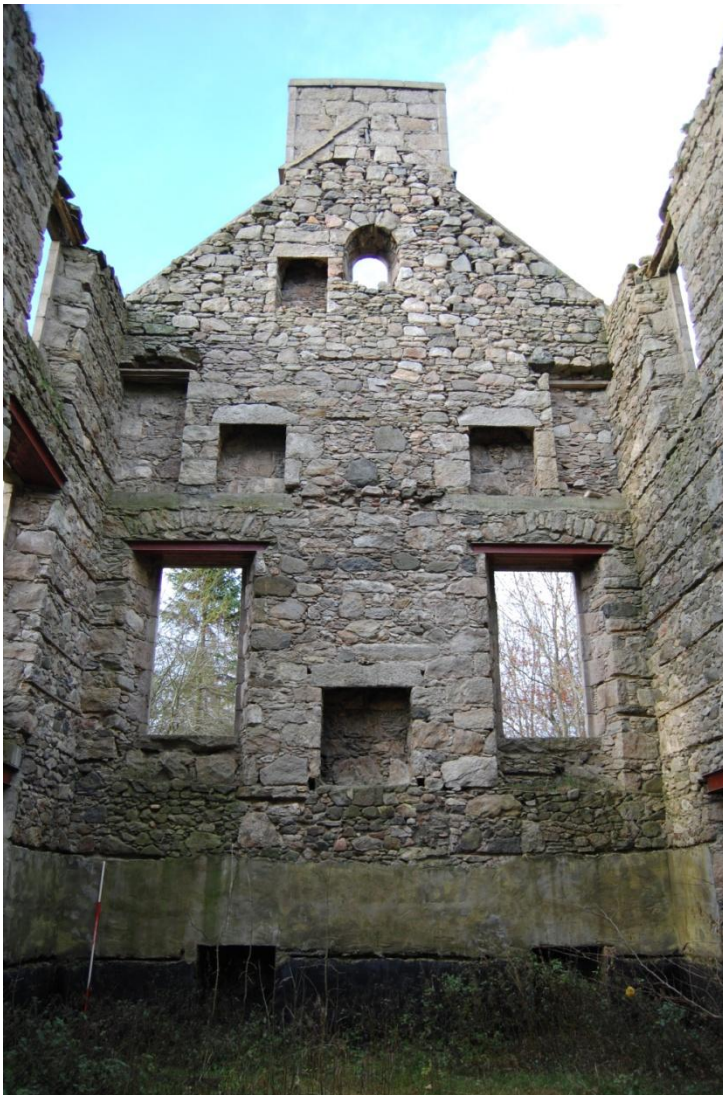
There is a central fireplace on the interior of the west and east gable walls on the ground floor indicating that there were two main reception rooms on that floor of the house; there are two fireplaces on the first floor, presumably indicating two bedrooms above each reception room and a small fireplace in the second floor attic room (Illus 15) as well as small arched windows in the upper floor gables.

Illus 15 Interior of west gable showing one fireplace on ground floor, two on first floor and a small fireplace in the second floor attic room; lightwell windows can be seen at the bottom of the photo and also the tar waterproofing; facing west.

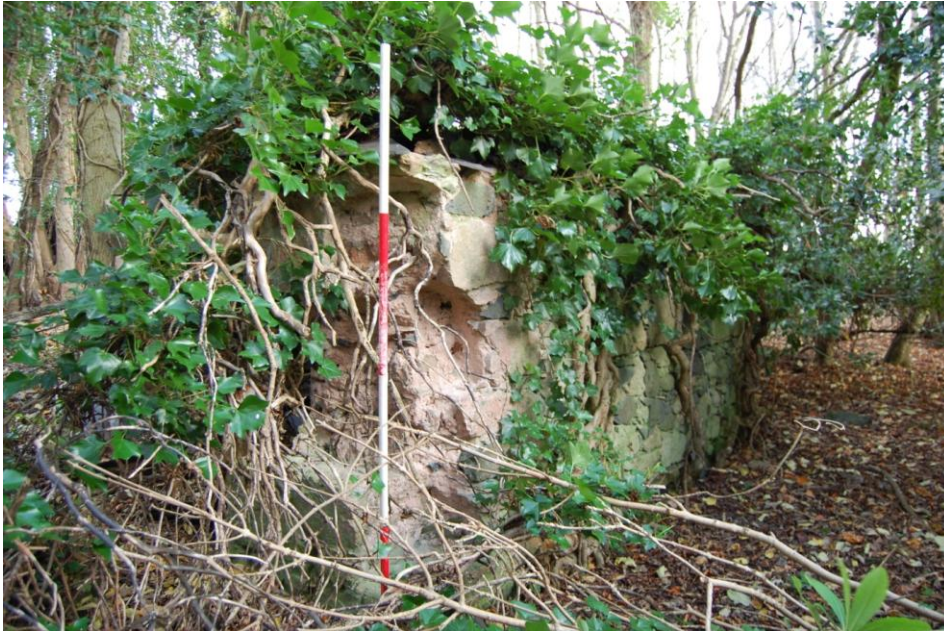
Illus 16 Building 2 facing E

Building 2 is c 6m long, 3.2m wide and surviving to 1.8m high. It is constructed of granite fieldstones bonded with pink mortar. The building is very poorly preserved and overgrown with no access to the interior.

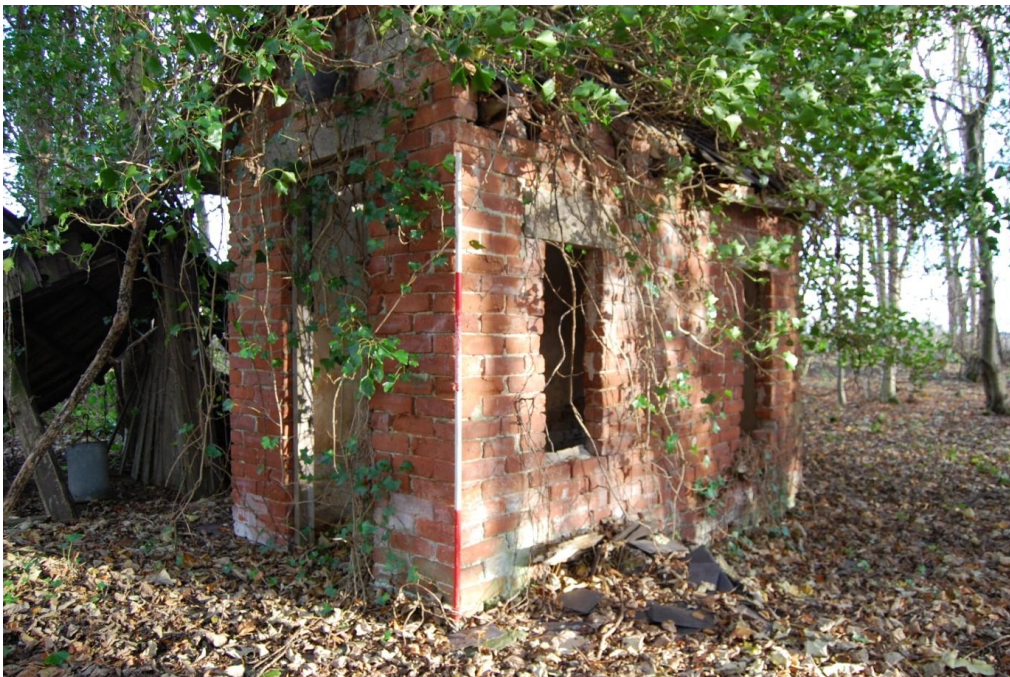
Building 3 is a small brick shelter and was recorded photographically (Illus 17).

Illus 17 Building 3 facing NE.
