**Proposed biomass boiler,  
Glen Moray Distillery, Elgin, IV30 1TS  
Report on archaeological evaluation and standing building  
survey; Data Structure Report**

**Alison Cameron  
Cameron Archaeology  
18 March 2014**

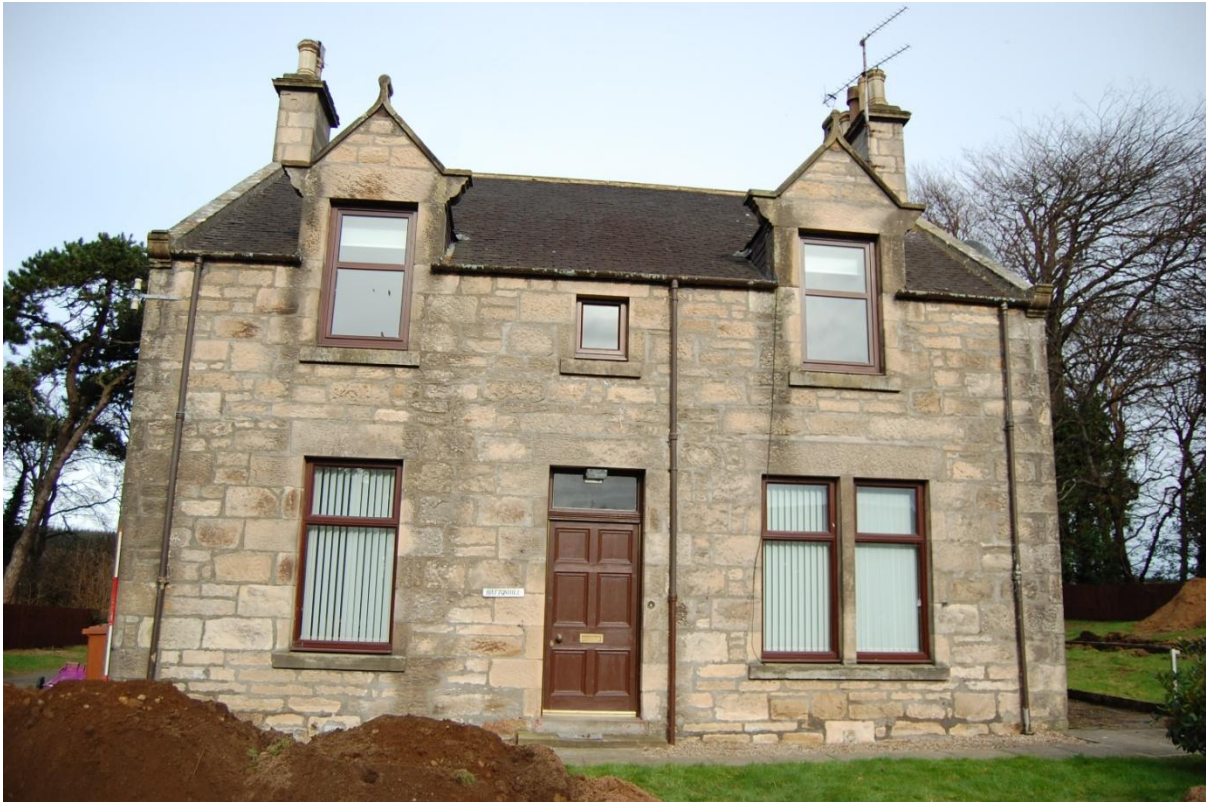
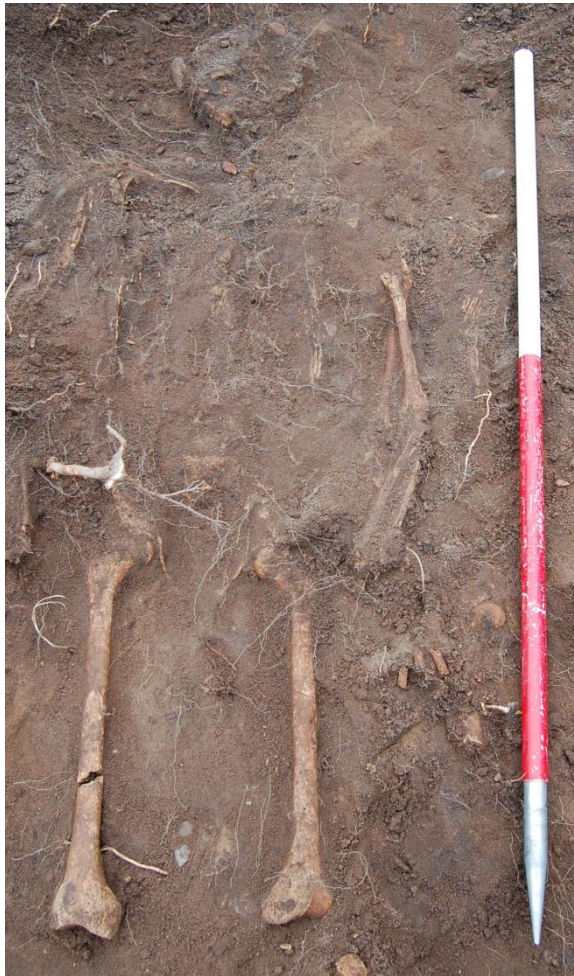
(top) south facade Hattonhill House, facing N  
(bottom) SK 1 with SK 2 (right and underneath)

SK 1 was complete although the lower legs and feet were recovered from the JCB bucket. The burial was buried 5cm below the turf and had a path of random paving slabs constructed over the top. There is no evidence of the burial being in a shroud or coffin and there were no finds to date the burial. The bones were in a very poor condition as roots from the

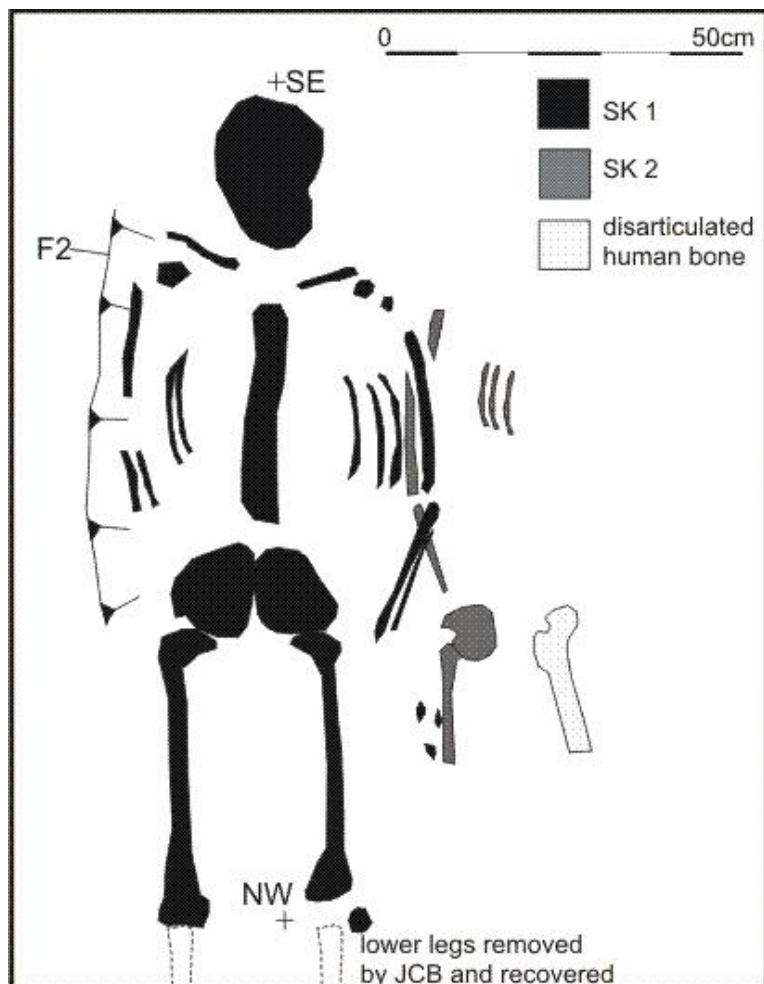
Illus 4 Plan of SK 1 and SK 2

SK 2 lay under SK 1 (Illus 4). It was also extended and supine but most of the skeleton had been disturbed, probably by past gardening activities. The right arm was position under the left arm of SK 1 and the right pelvis, proximal end of the right femur and right ribs were present.

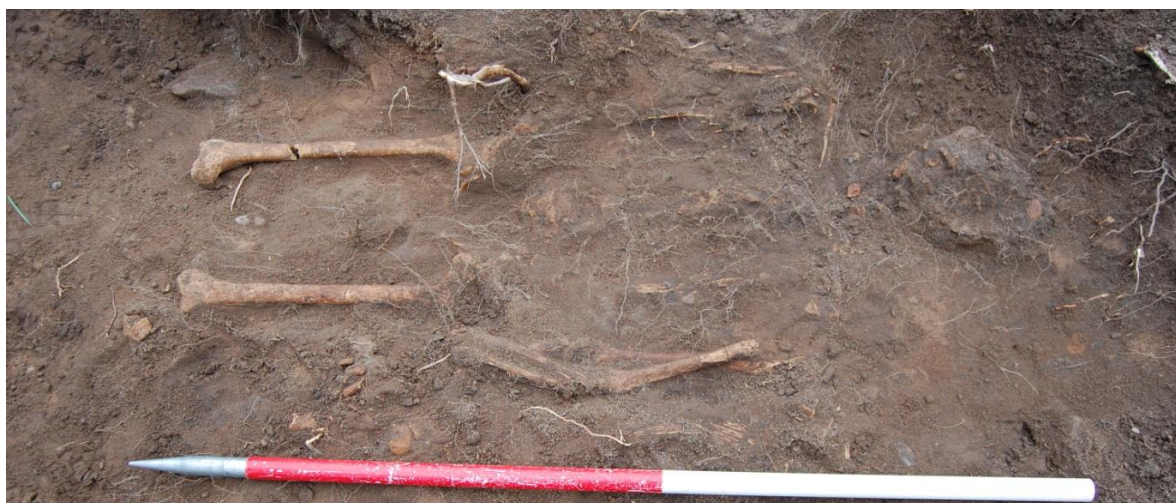
Illus 5 SK 1 (top) and SK 2 (below); facing NE. The right arm of SK 2 can be seen under the left arm of SK 1.

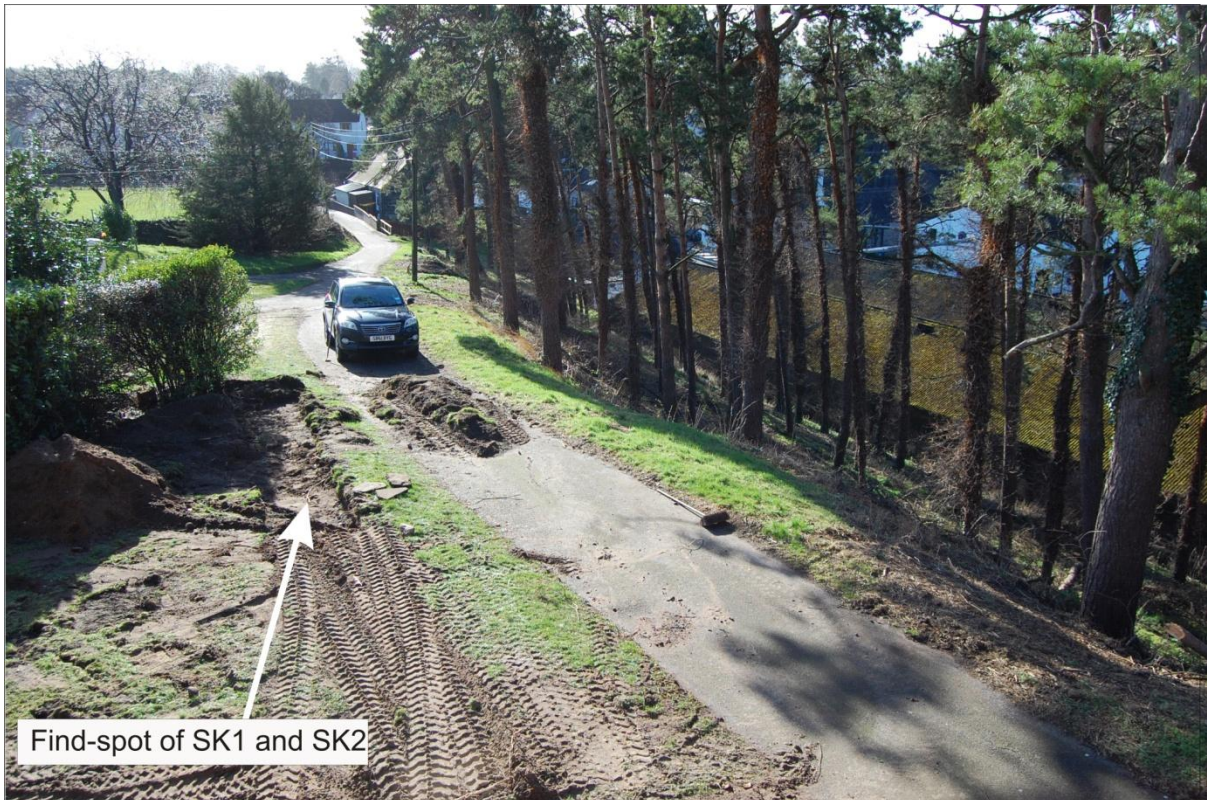
Illus 6 Find spot of SK 1 and SK 2 from window of Hattonhill House.

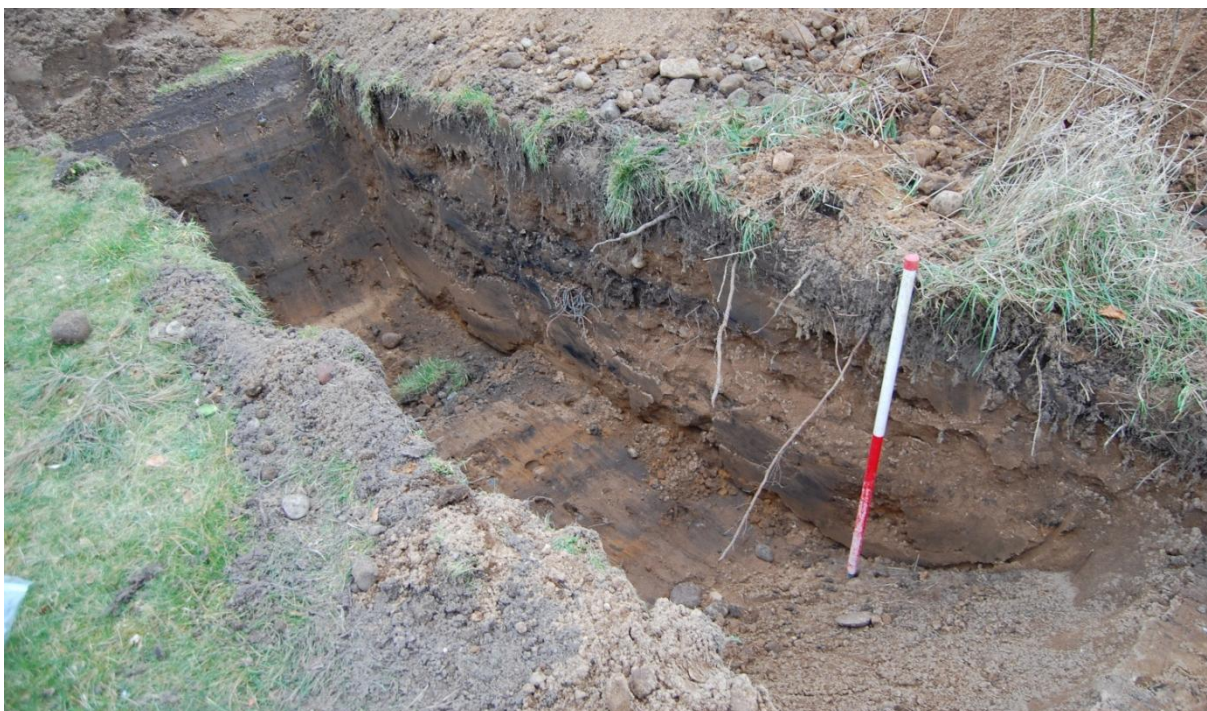
Trench 3 was up to 1m deep and contained 0.4m modern rubbish on top of laminated sands.

Illus 7 Trench 3 showing modern upfill and sand dunes below; facing NW

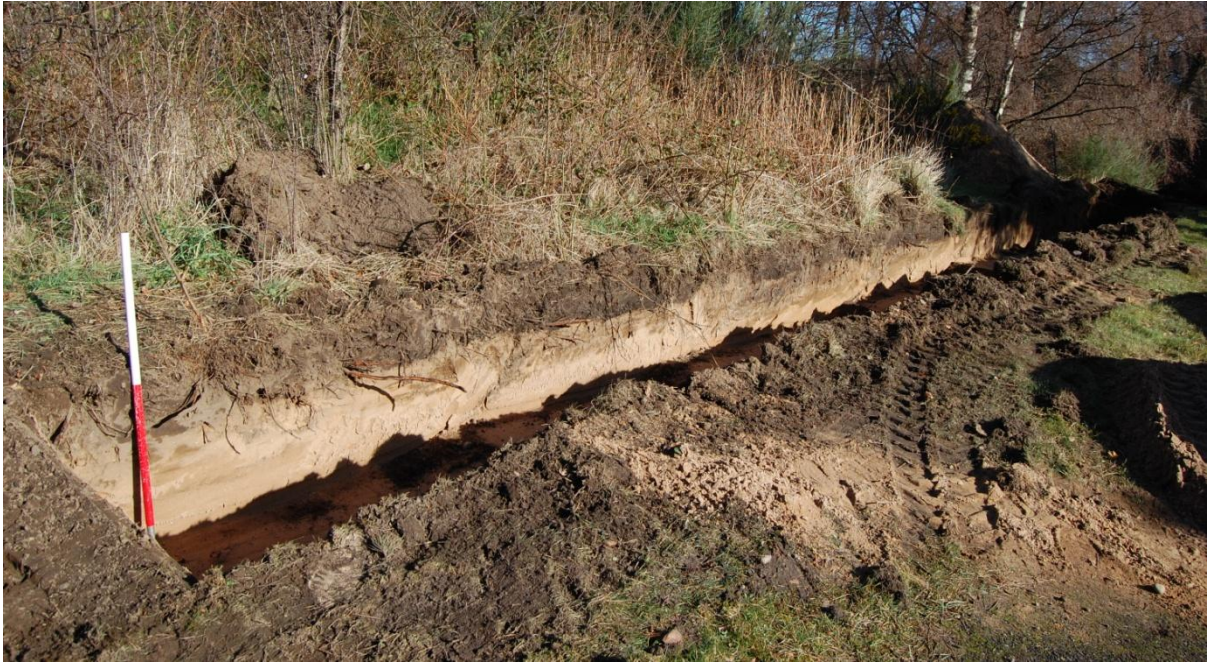
Trench 4 was excavated WSW-ENE between the undergrowth to the north and the driveway to the south. There was a layer of modern loam and plant roots 0.1-0.2m deep and under this were clean sands. The loam contained numerous fragments of china, glass and metal.

Illus 8 Trench 4 showing sand dunes facing NE

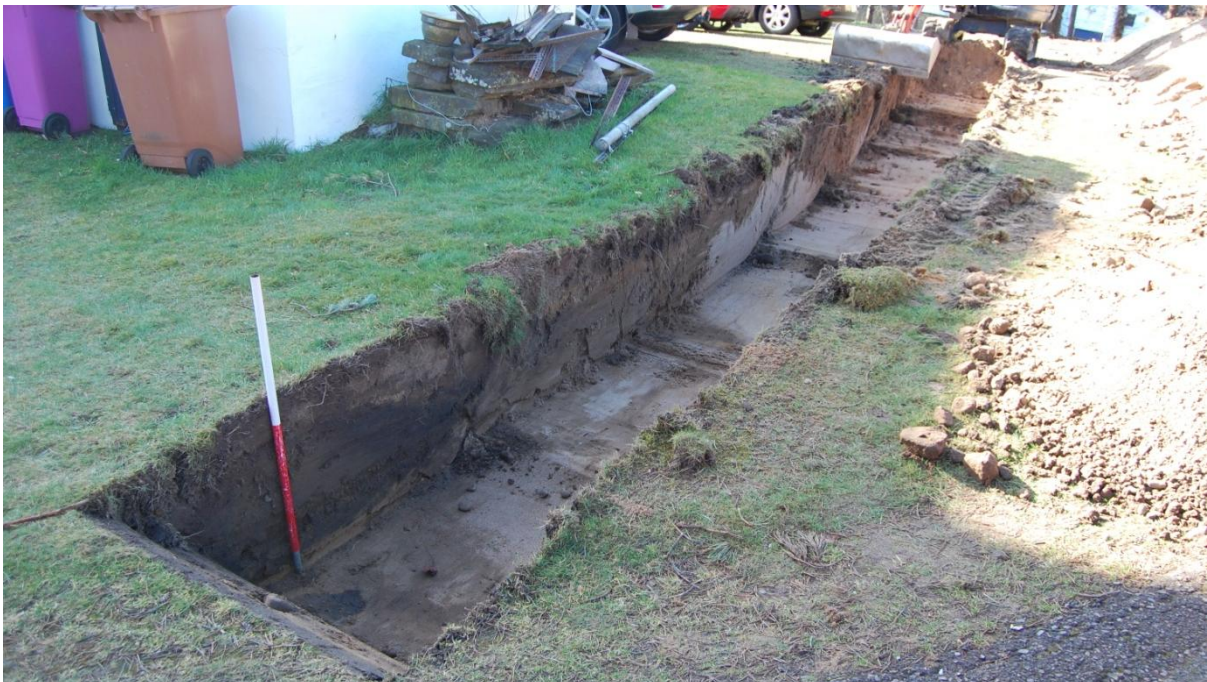
Trench 5 was excavated in the grass island between the access roads adjacent to a shed. The trench contained the remains of undulating sand dunes from 0.1-0.6m below the current ground surface. There were many sherds of modern china, glass and metal and one broken distal fibula fragment.

Illus 9 Trench 5 showing sand dunes; facing SW

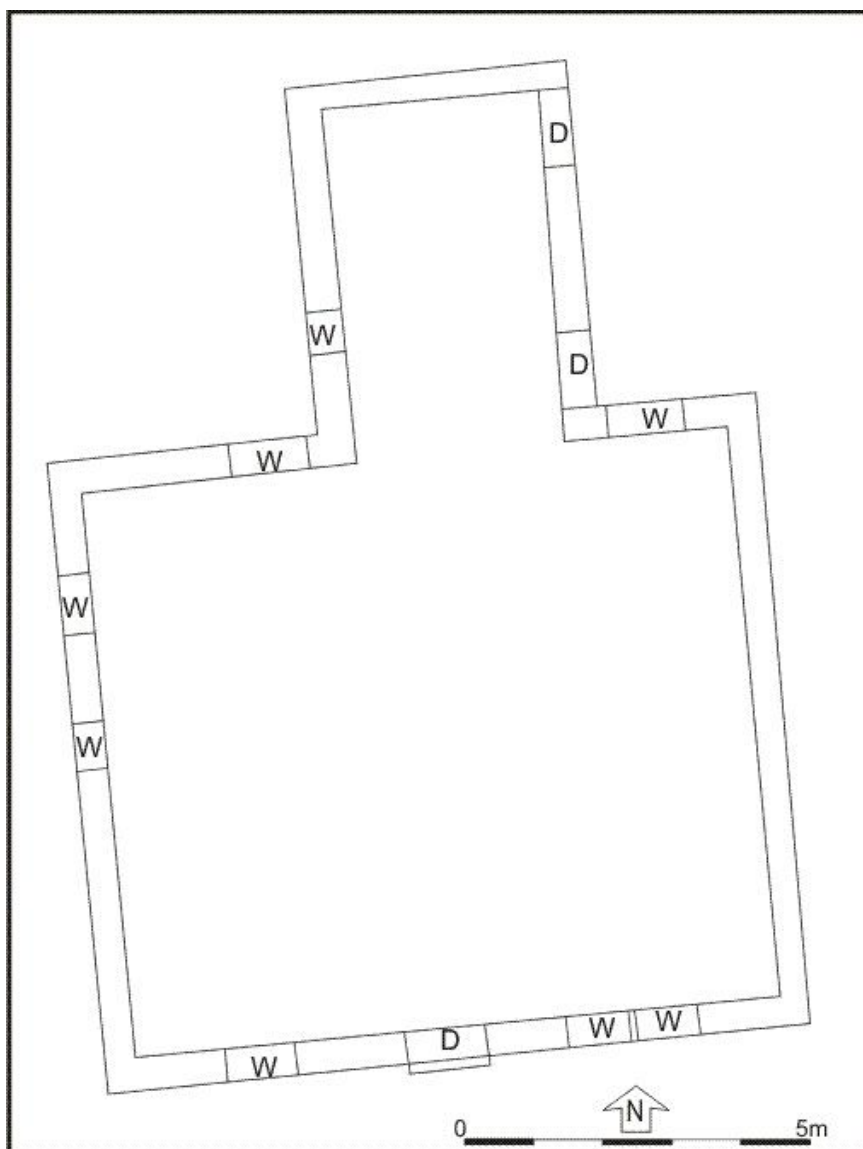
Illus 10 Plan of ground floor Building 1 Hattonhill House

The interior of the building has been recently renovated and there are few original features present. There is a central hallway with two reception rooms at the south side of the house. A rear reception room in the Ne corner and bathroom at the NW leads into the extension which is now a kitchen and laundry. There is a central stair leading to the first floor central window on the west gable, leading to upstairs bedrooms and bathroom.

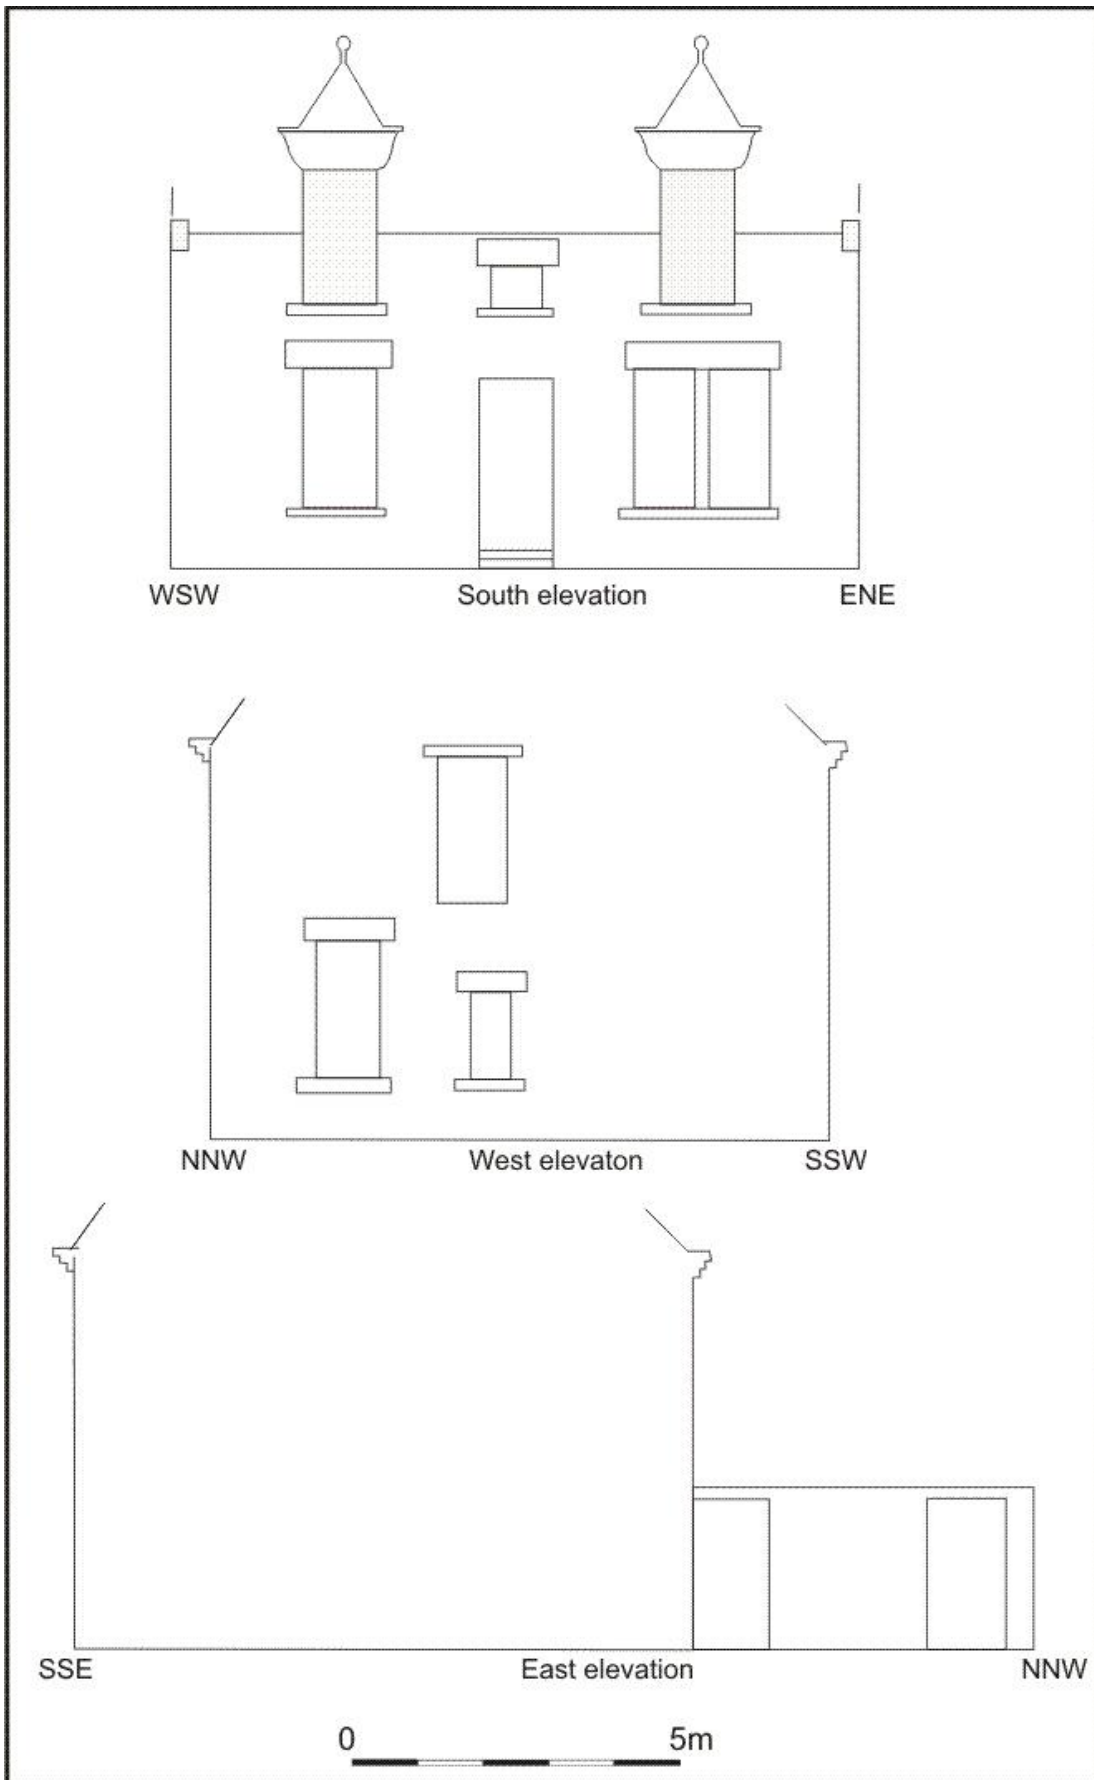
Illus 11 Elevations of Building 1 Hattonhill House

The house is 10.5m W-E and oriented with the frontage to the SSE. It is 9.4m N-S and has an extension 5.2 x 4m wide on the north (rear) side. The house is constructed of large and medium sized light brown sandstone blocks which have been hand-tooled (Illus 13). The first floor windows on the front facade have decorated finials (Illus 12).

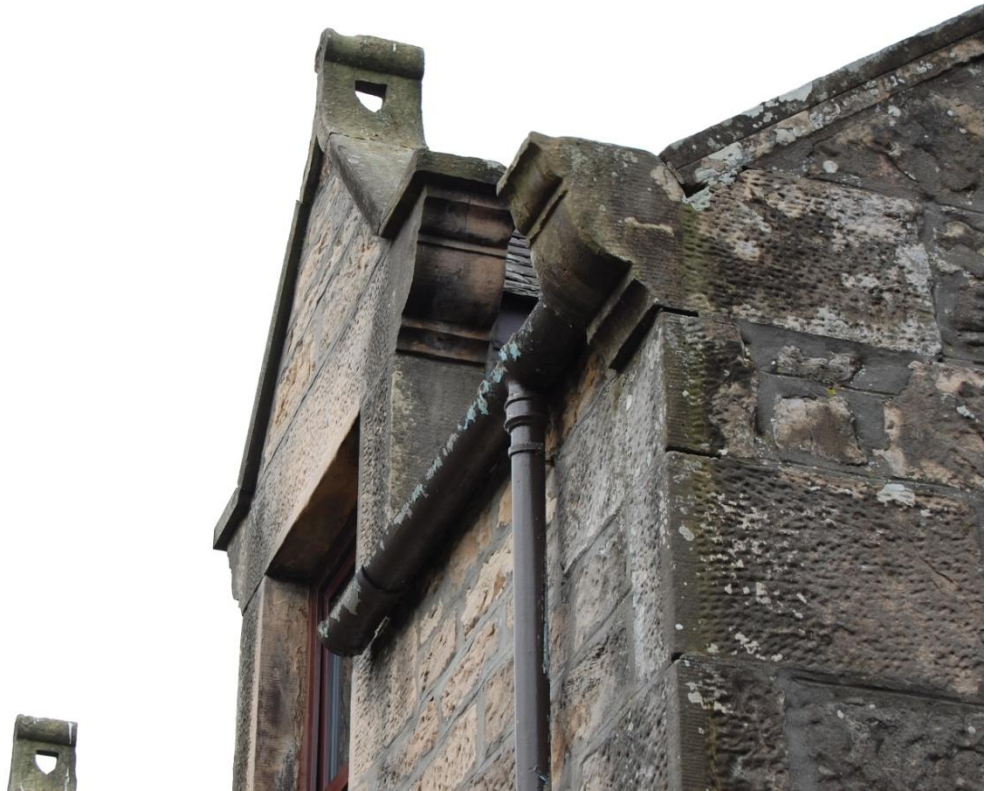
Illus 12 South facade Hattonhill House showing finials and roof detail

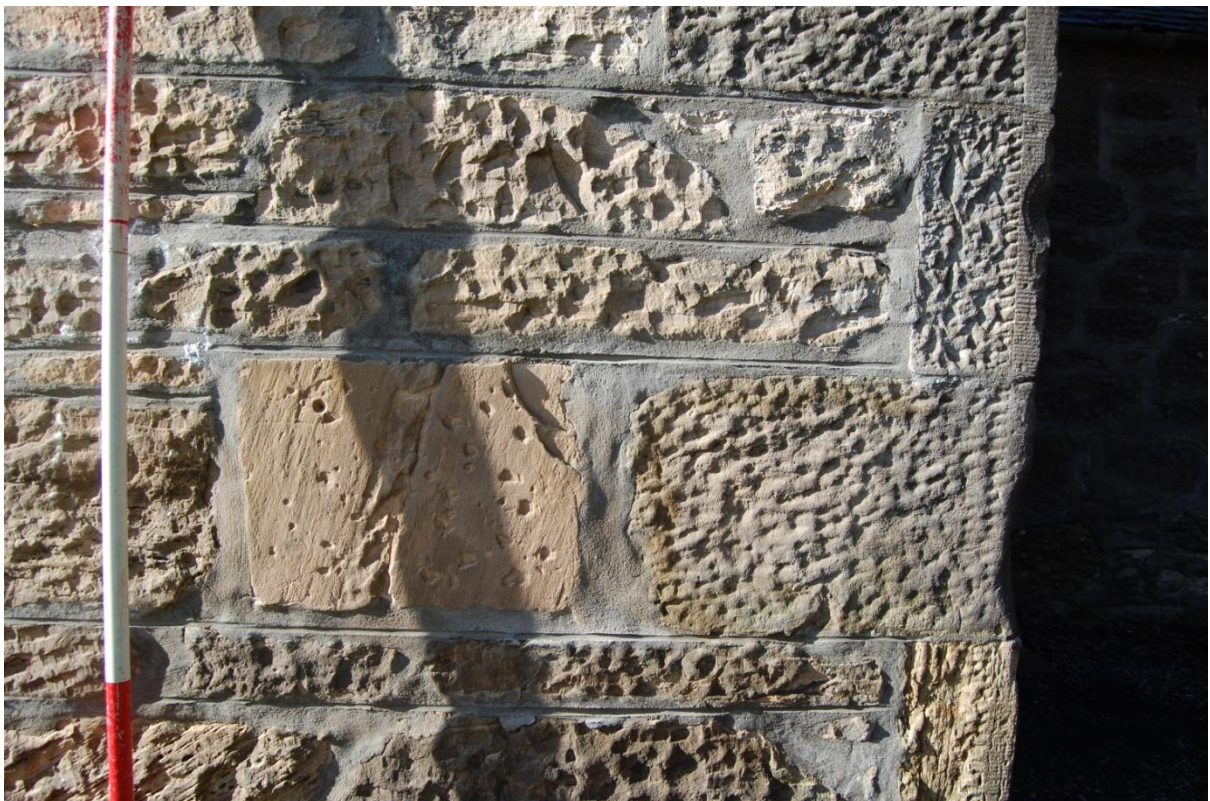
Illus 13 East gable showing tooling marks

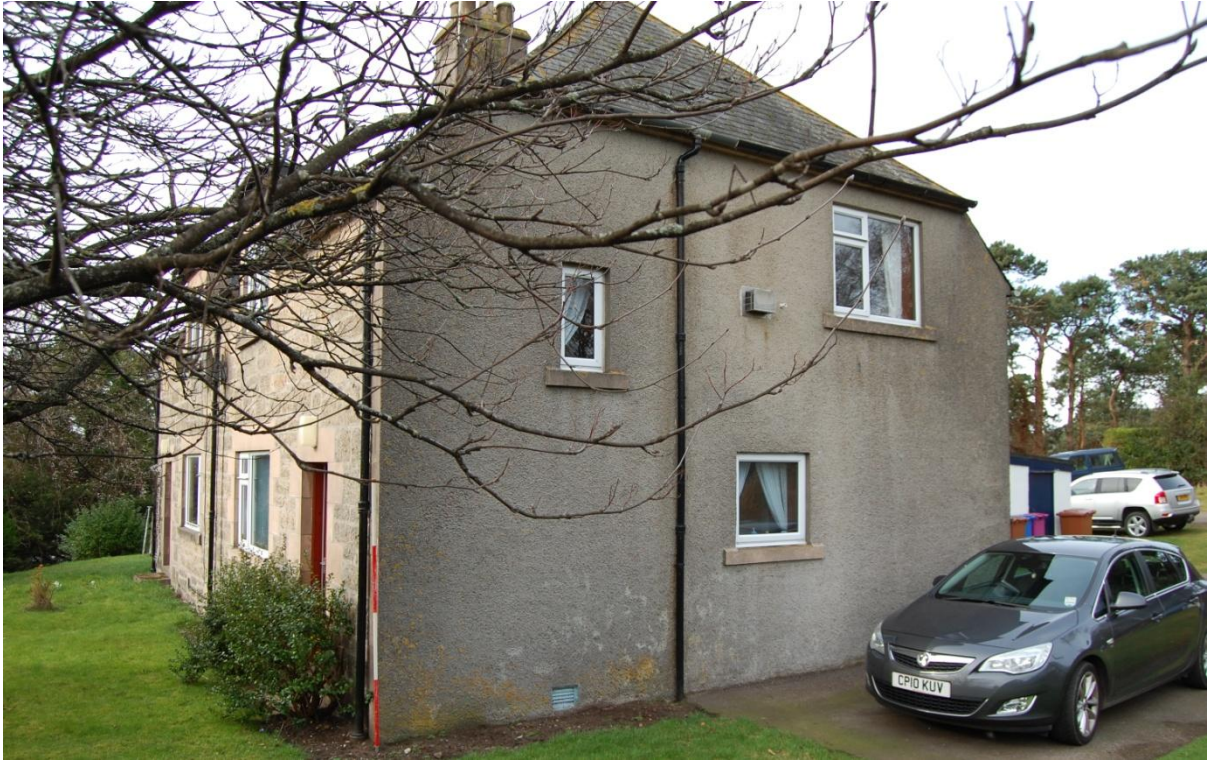
A photographic survey of Glen Moray Distillery Cottages was carried out. There were four cottages on the First Edition (1868) and they have now been rebuilt into two larger cottages probably reusing stone with new window surrounds.

Illus 14 Glen Moray Distillery Cottages showing older stone reused in south facade with newer addition; facing WSW

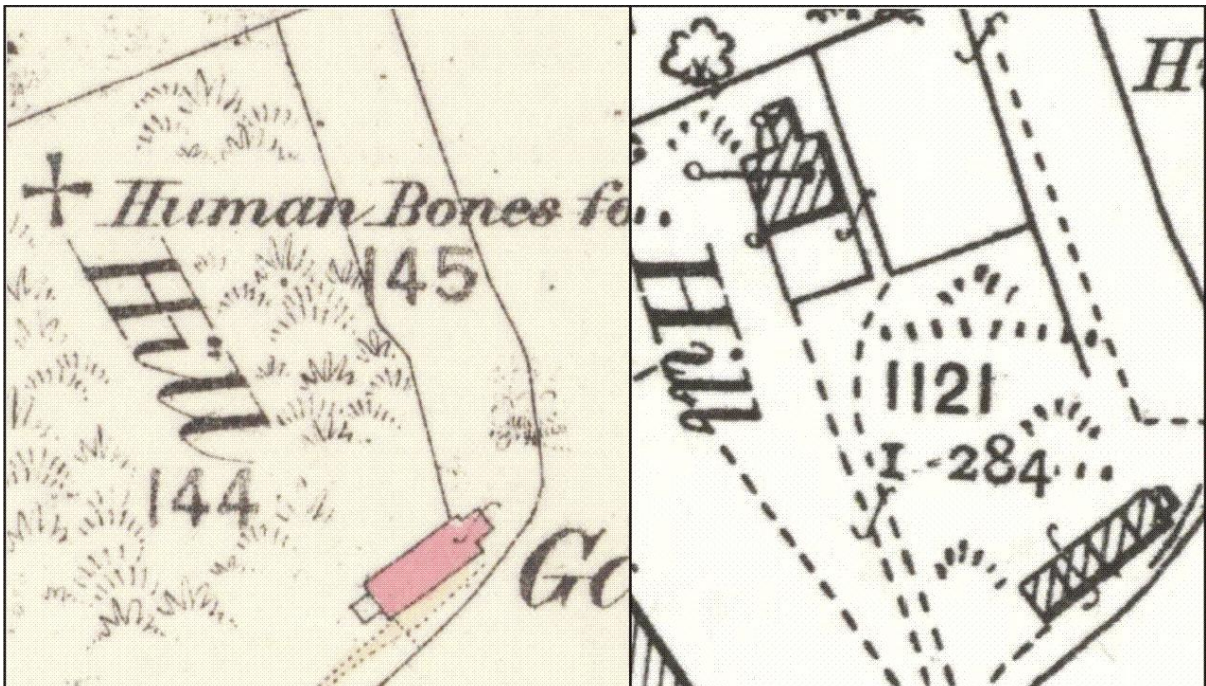
Illus 15 Detail of First Edition (left) and Second Edition (right) OS map showing Hattonhill House (not present in 1868 (left) and Glen Moray Distillery Cottages (bottom right) (copyright National Library of Scotland).

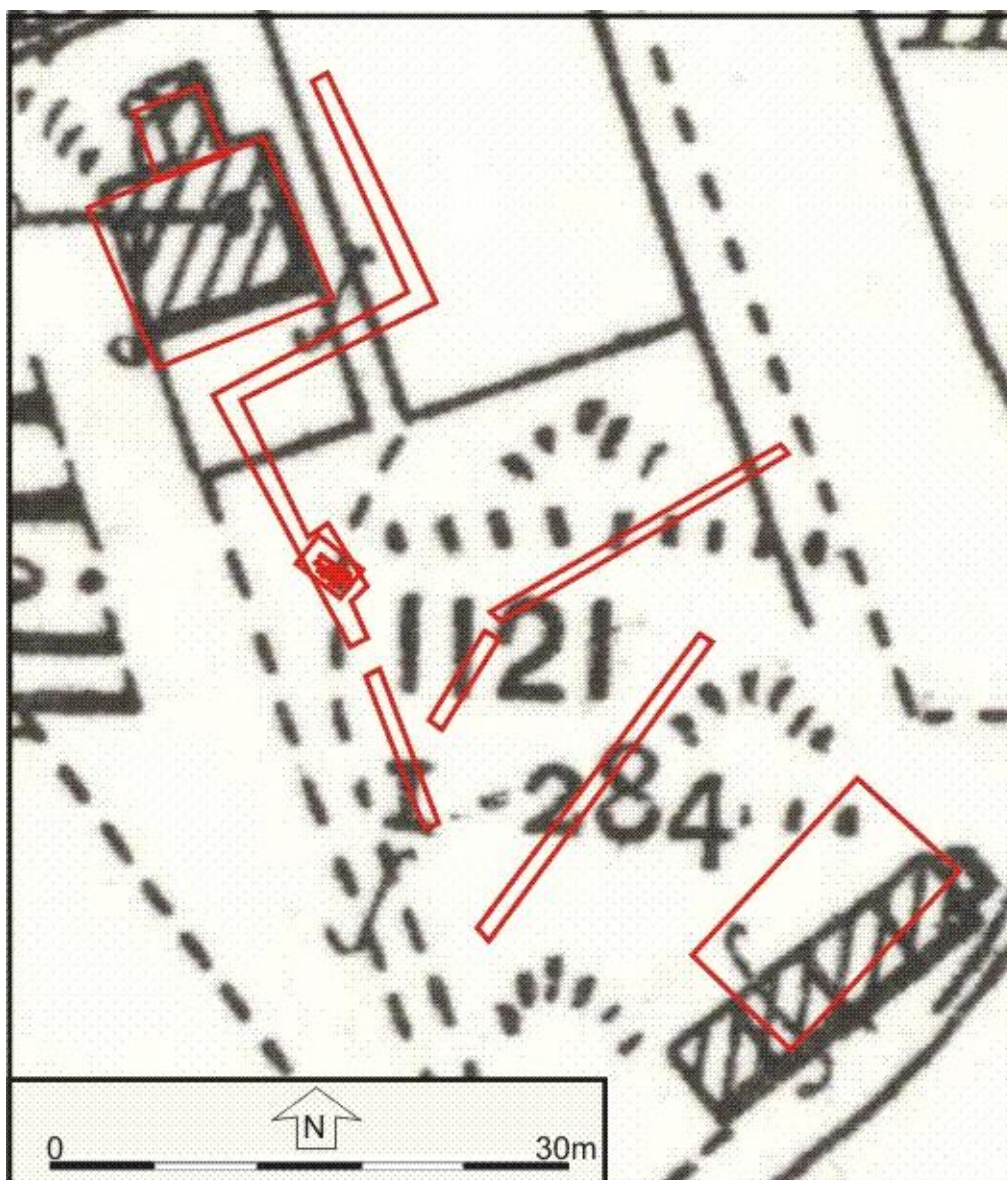
Illus 16 Second Edition OS map 1905 with overlay of current buildings and archaeological trenches in red

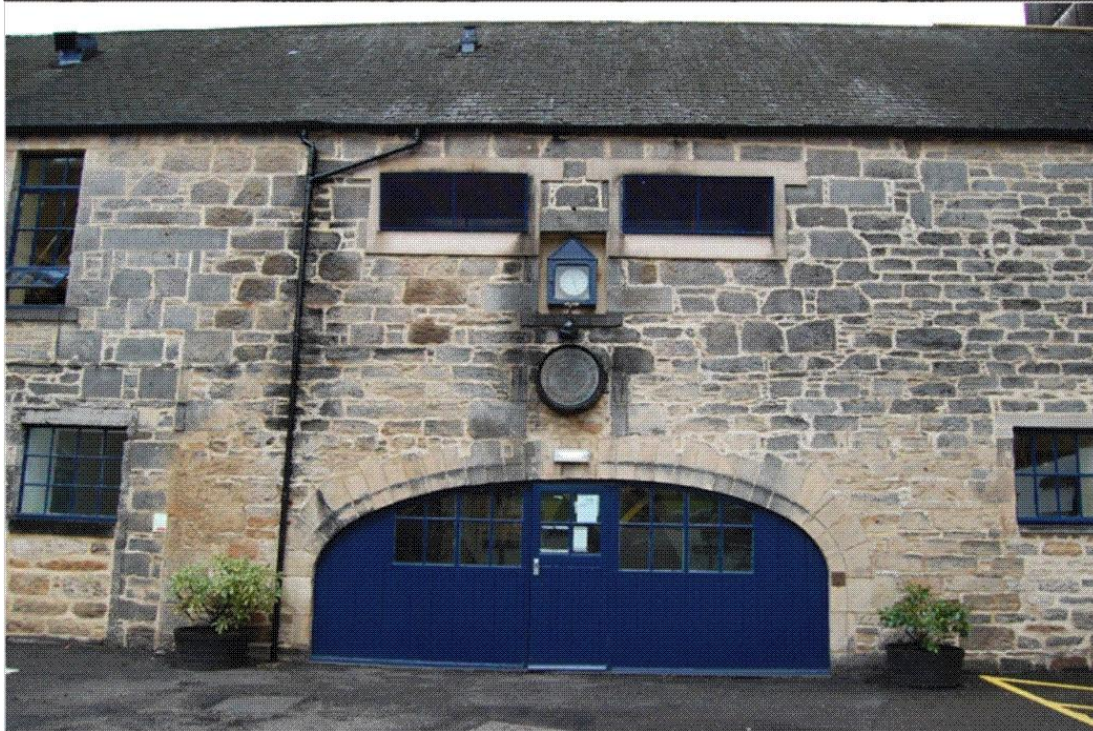
Illus 19 Second Edition (top). Elginshire, Sheet 007.15 Publication date: 1905 Revised: ca. 1904 (copyright National Library of Scotland) with brewery buildings (bottom). Photo location arrowed in map.

- 5.2 The standing building recording revealed that Hattonhill House is a late 19th or early 20th-century country house built in the same stone and style as the brewery (Illus 19) which occupied the site prior to the distillery taking over the site in 1897 (<http://www.glenmoray.com>). The house was built as the Manager's house. The Glen Moray Distillery Cottages are earlier than the house and are on the First Edition OS map (Illus 18); however they have been rebuilt in the mid-late 20th century possibly using some of the stone from the four cottages.

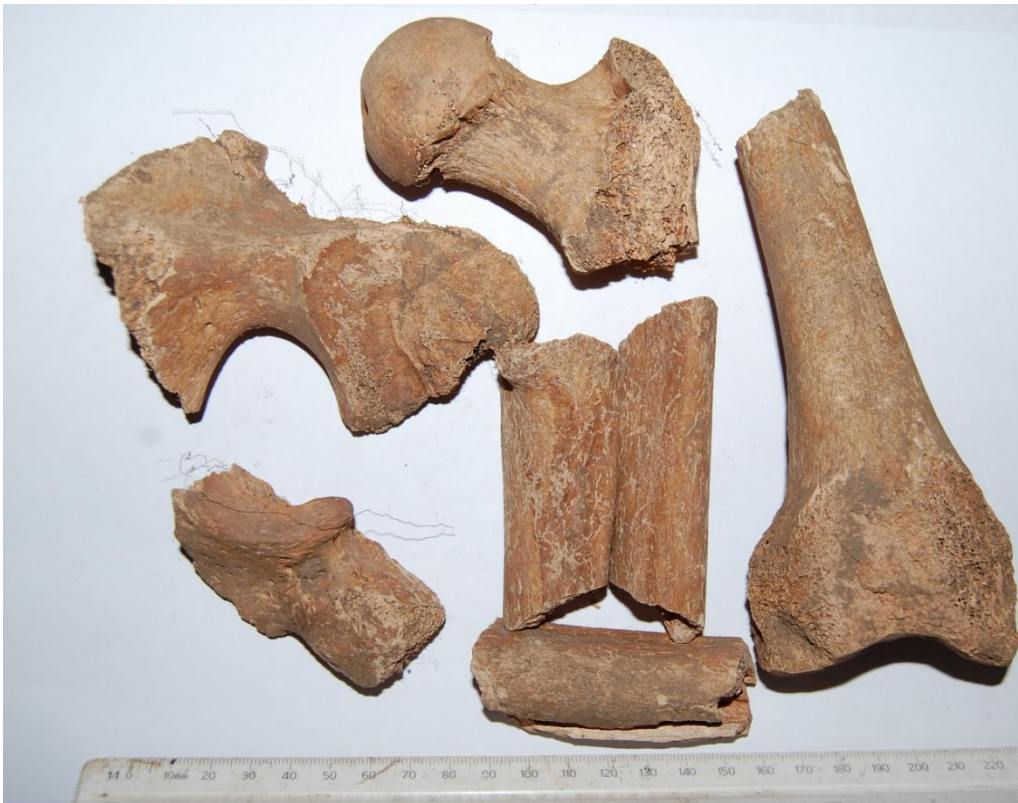
surrounding vegetation has grown through the bones as well as damage from gardening works.

Illus 20 SK 1 right leg and pelvis

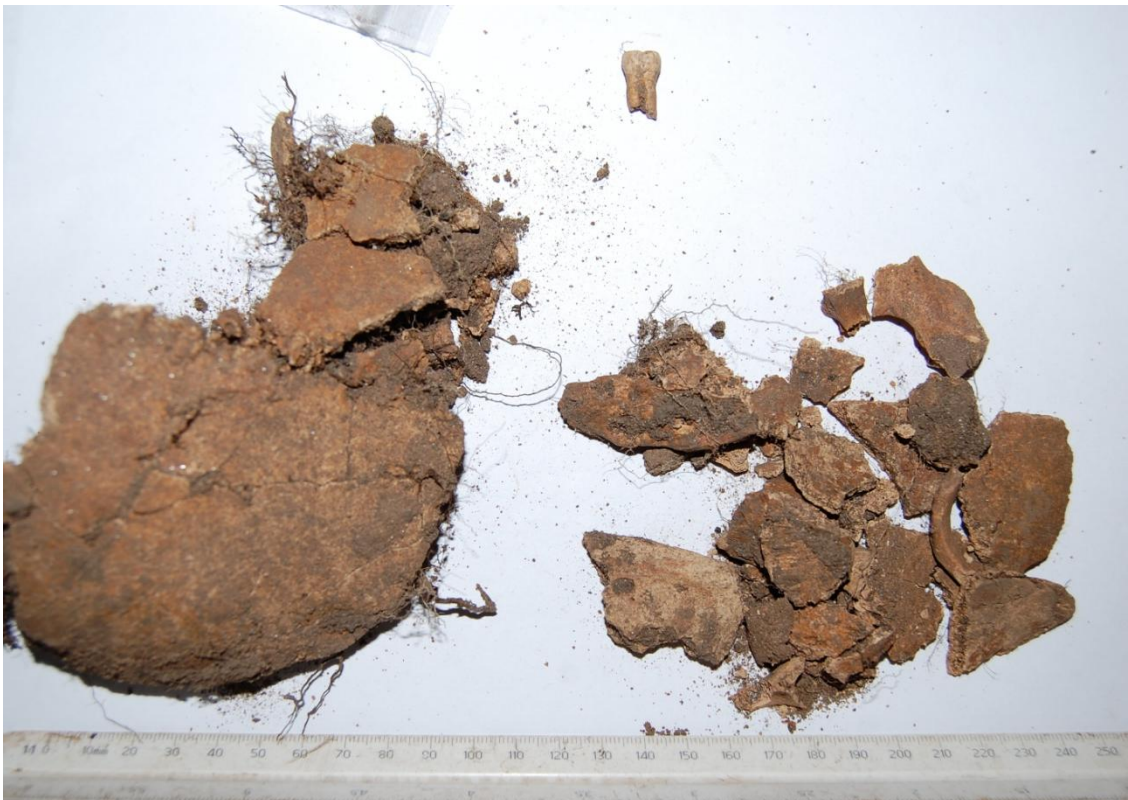
Illus 21 SK 1 skull

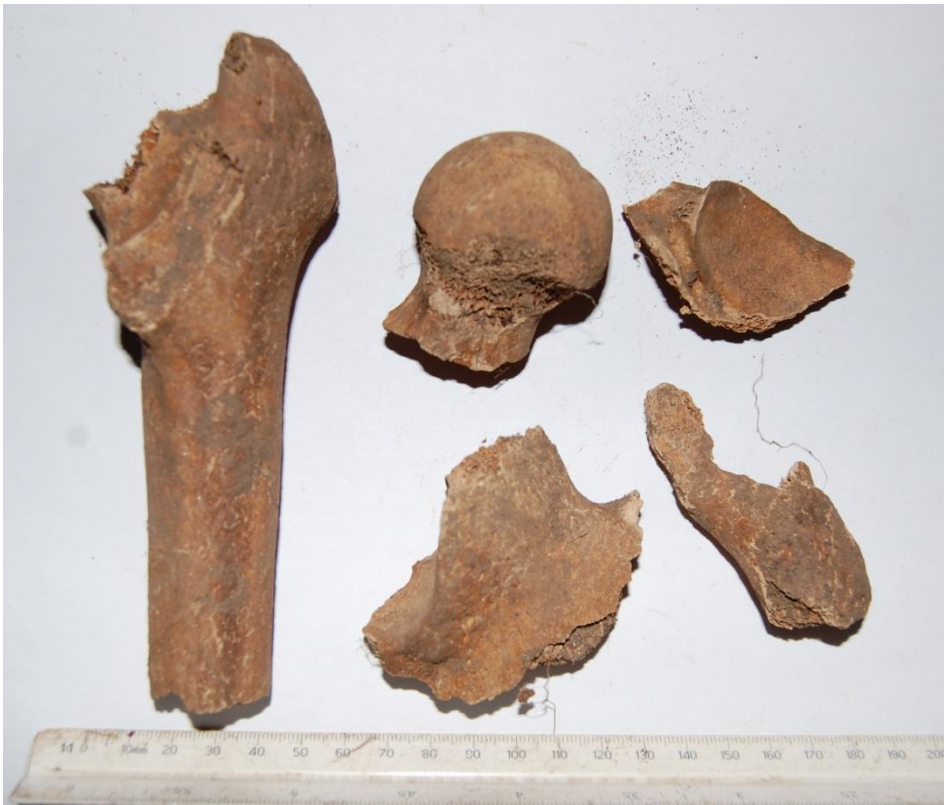
Illus 22 SK 2 right femur and pelvis

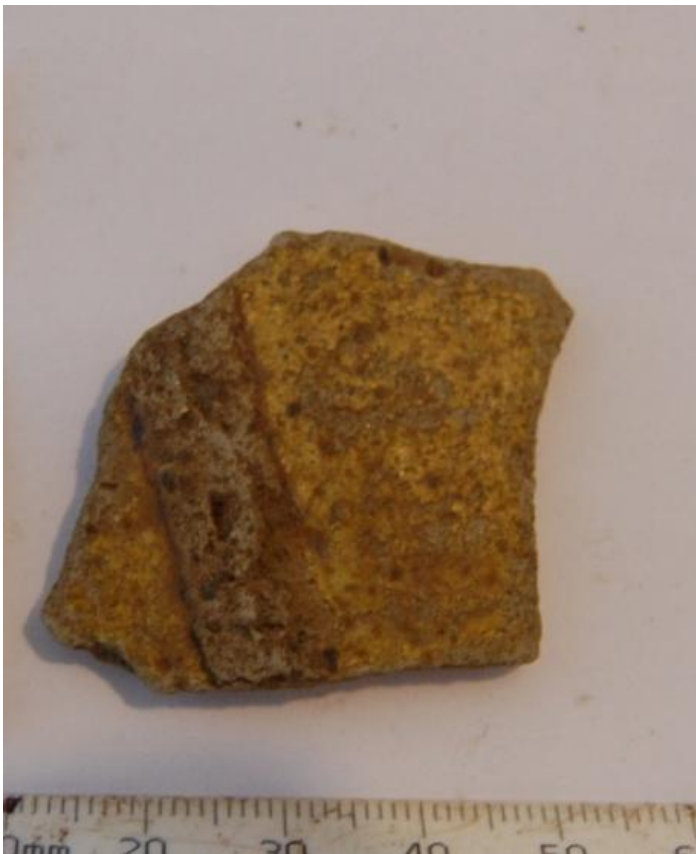
Trench 1 was dug around the east and south side of Hattonhill House. A path leading from the front door of the house (F1; Illus 3) was constructed of cinders on a bedding of sand which contained three fragments of human tibia and femur, probably reburied in the path foundation. In the south arm of the trench (1c) two extended supine burials were excavated. They were buried with their heads to the SE and trace of a cut (F2) survived on the east side of SK1. On sherd of local redware pottery with applied decoration (Illus 23) was found in the loose soil above the graves.

Illus 23 Trench 1c sherd of 13th-early 14th century local redware
