The Blair, Fintray, Aberdeenshire AB21 0JL

Report on Level 1 Standing Building Survey

Alison Cameron
Cameron Archaeology
4 September 2014

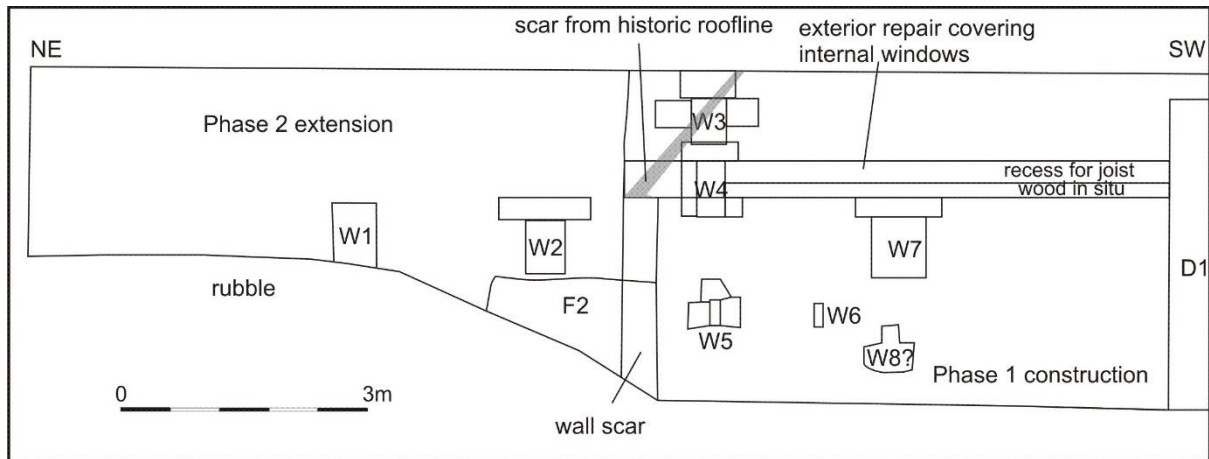
In this phase the horse mill was demolished and a water wheel constructed. An associated lade and mill dam can be seen on the Second Edition of 1899 (Illus 16) but these structures have been infilled. A wall line surviving on the track west of the buildings, F1 (Illus 3, 7) is probably the remains of the east side of the mill lade. Rubble at the NW corner of the buildings is obscuring remains of the wheel and associated building but the scar of this building can be seen on the wall (Illus 4) and apertures W7 and W8 are probably from this phase. Possibly at the time the water wheel was installed, the NE range was moved north and as a result the courtyard was extended (Illus 16). The extension of the NW range can be seen in different stonework construction (Illus 4 and 5).

Illus 4 Exterior wall of the NW range, north end showing Phase 2 extension (left) and scars where Phase 2 wall and roof attached to the exterior of the Phase 1 wall (centre, right)

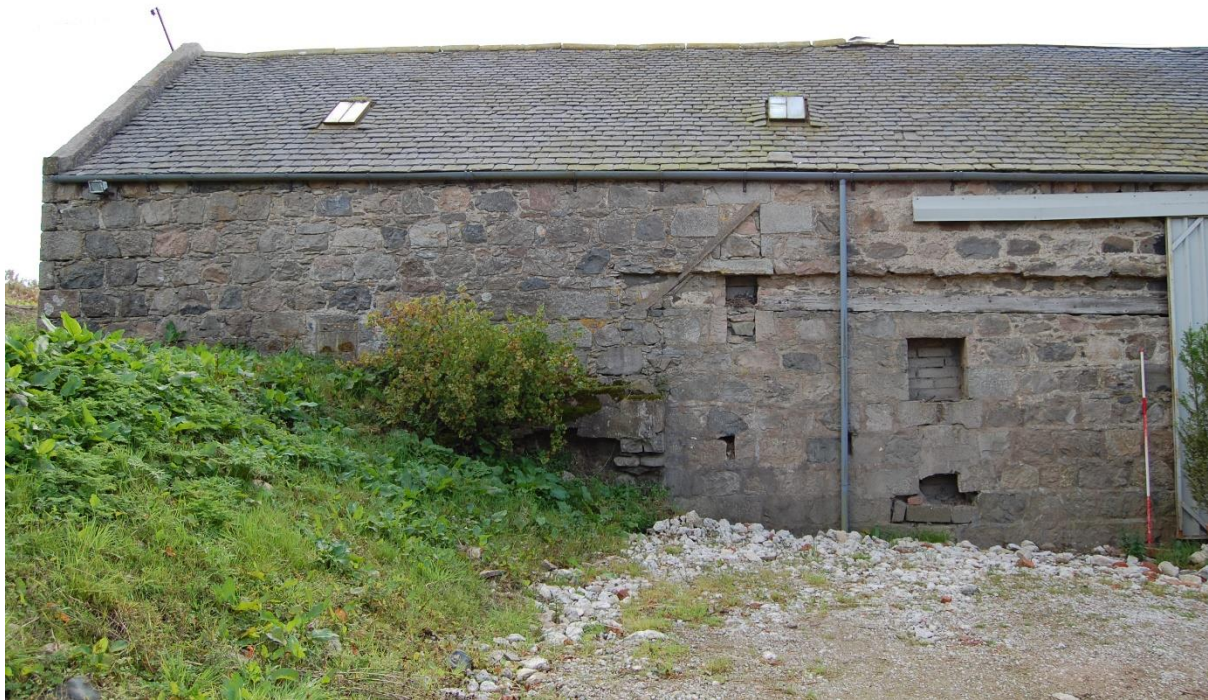
In Phase 1 the buildings around a central courtyard with a horse mill adjacent to the NW range. Windows W2, W3 and W4 (Illus 3-5) probably date to this period as well as other windows in that range. These apertures would probably have been associated with the horse mill seen on the First edition OS map dating to 1866 (Illus 16). The SW façade constructed of squared granite blocks (Illus 9 and cover) with cherry cocking with central cart door (Illus 11) was probably constructed in this phase.

Illus 5 Exterior wall of the NW range, north end showing north extension of the building in Phase 2 (left of centre) and the apertures for the Phase 1 horse mill and Phase 2 water mill. The rubble from the recently demolished grain store can be seen bottom right; facing SE

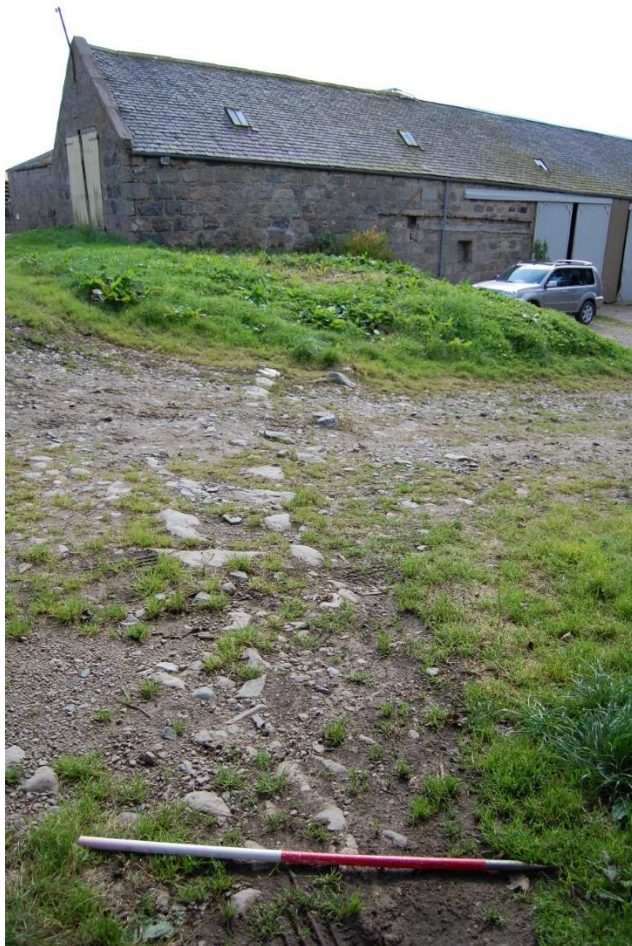
Illus 7 Wall F1 (foreground) with north end NW range in background and rubble mound (centre); facing SSE

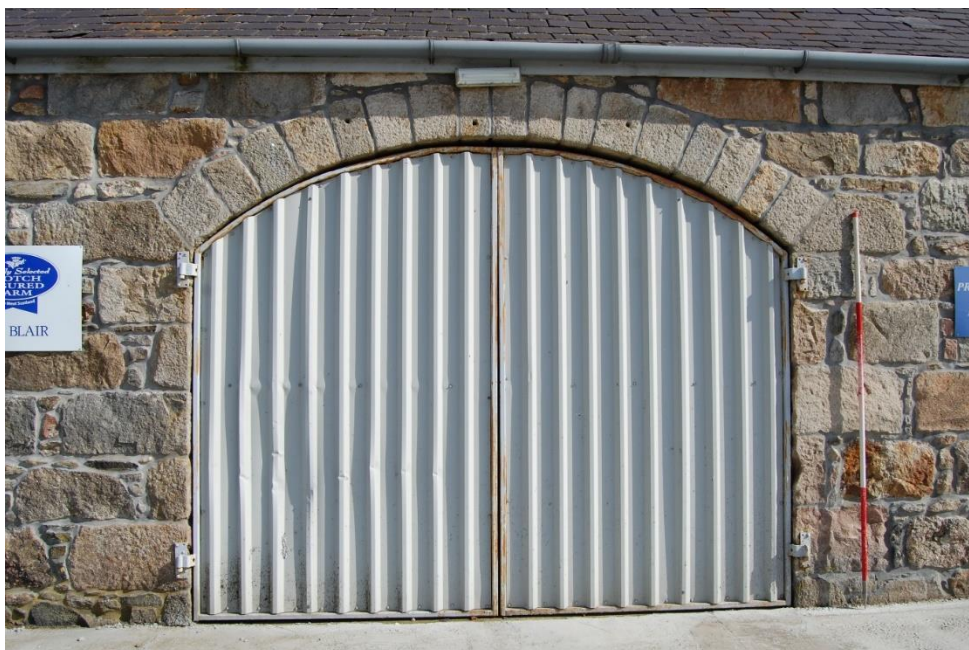
Illus 11 Exterior cart door D5; facing NE

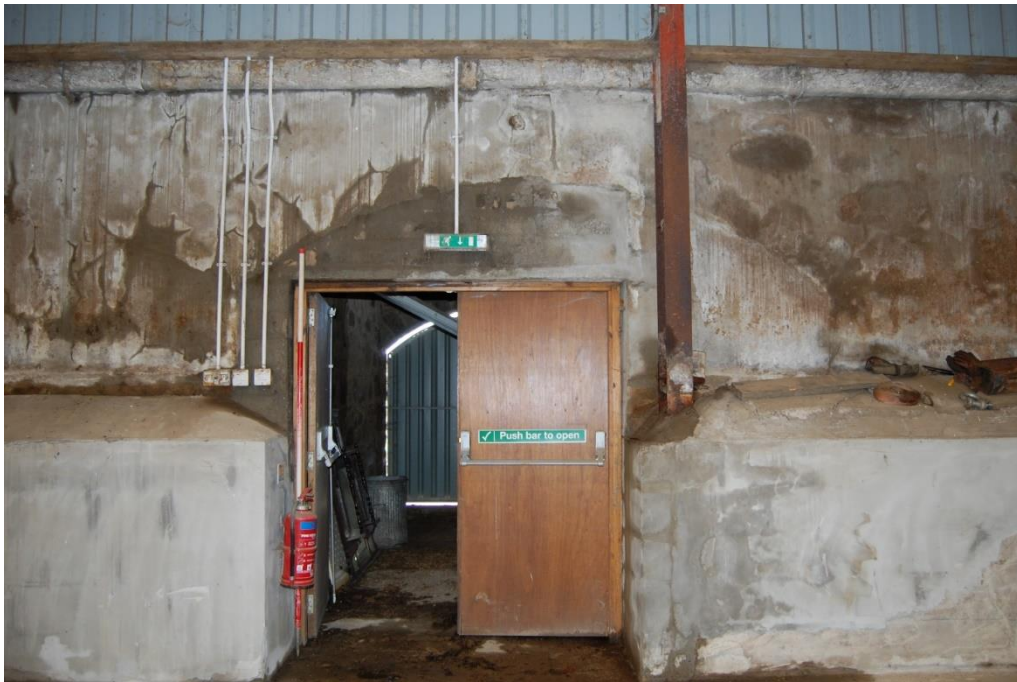
Illus 14 NE internal face Door D6 showing as a scar in the concrete infill created when the sheds were converted for cattle in the 1960s; the modern door (D7) dates to this phase

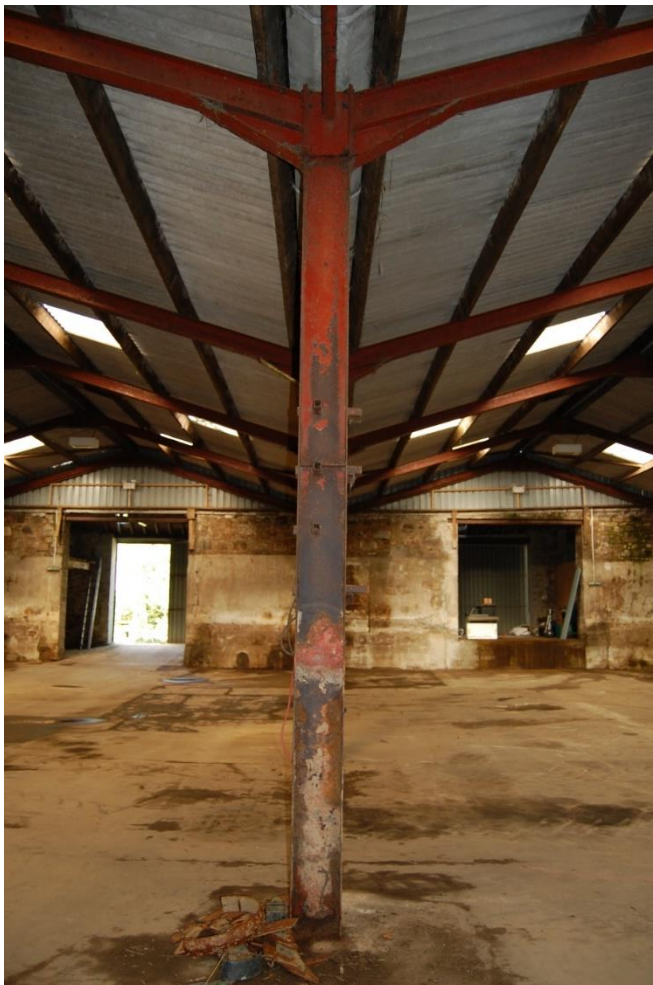
In Phase 3 the SE range was harled on the exterior and much of the interior covered with concrete when the buildings were upgraded in the 1960s. The courtyard was roofed in the 20th century and the cast iron pillars and roof supports are in situ (Illus 15). New apertures were created including large doors in the NW, SW and SW facades and older apertures blocked. The circular grain silo was constructed adjacent to Door 1 on the rubble from the waterwheel building and infilled lade and this was demolished just prior to this survey.

Illus 15 SE internal wall of courtyard showing cast iron beams supporting roof

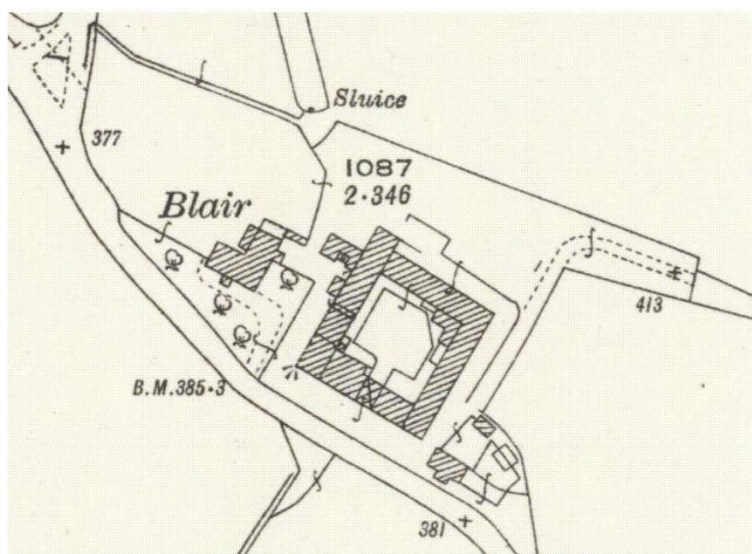
Illus 17 First Edition OS 1866 (top) Aberdeen Sheet LV.7 (Fintray), Second Edition 1899 (middle) Aberdeenshire, Sheet 055.07) and Third Edition c 1924 (bottom; Aberdeenshire, Sheet 055.07) (copyright National Library of Scotland)
