**Slampton Park Steading, Auchnagatt, AB41 8UH
Aberdeenshire
Report on Level 1 Standing Building Survey**

**Alison Cameron
Cameron Archaeology
18 September 2014**

A Level 1 standing building survey was carried out on 16 September 2014 at Slampton Park Steading (NMRS no NJ94SE 59). Several phases of building were recorded including fittings associated with the former horse mill. It is recommended that no further work is required during the current development.

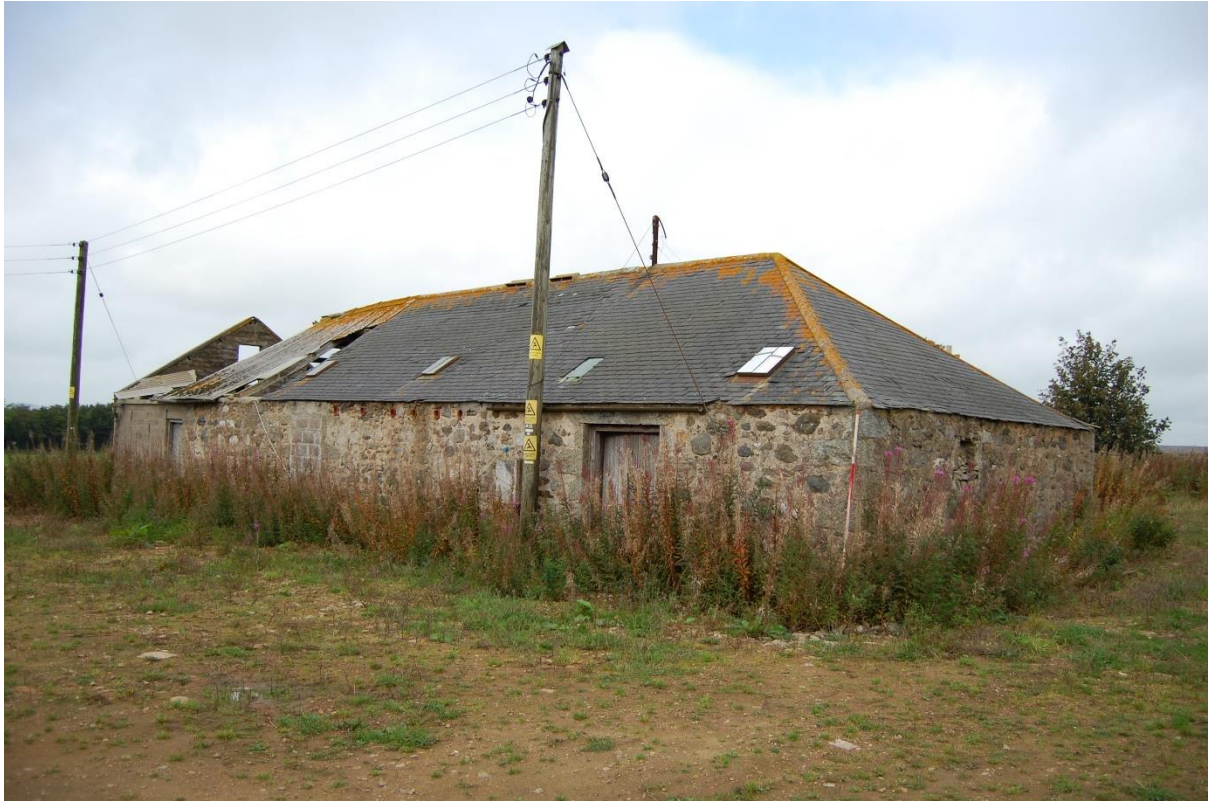
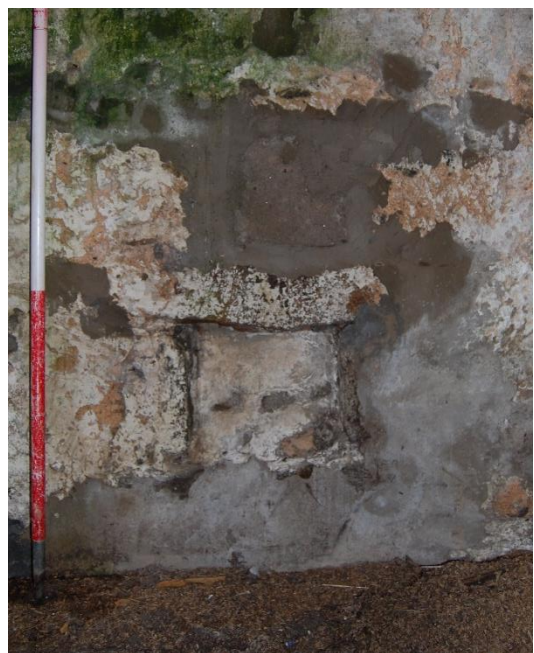
Cover: top steading building facing NW; bottom F4 and F5 apertures for driveshaft of horse mill

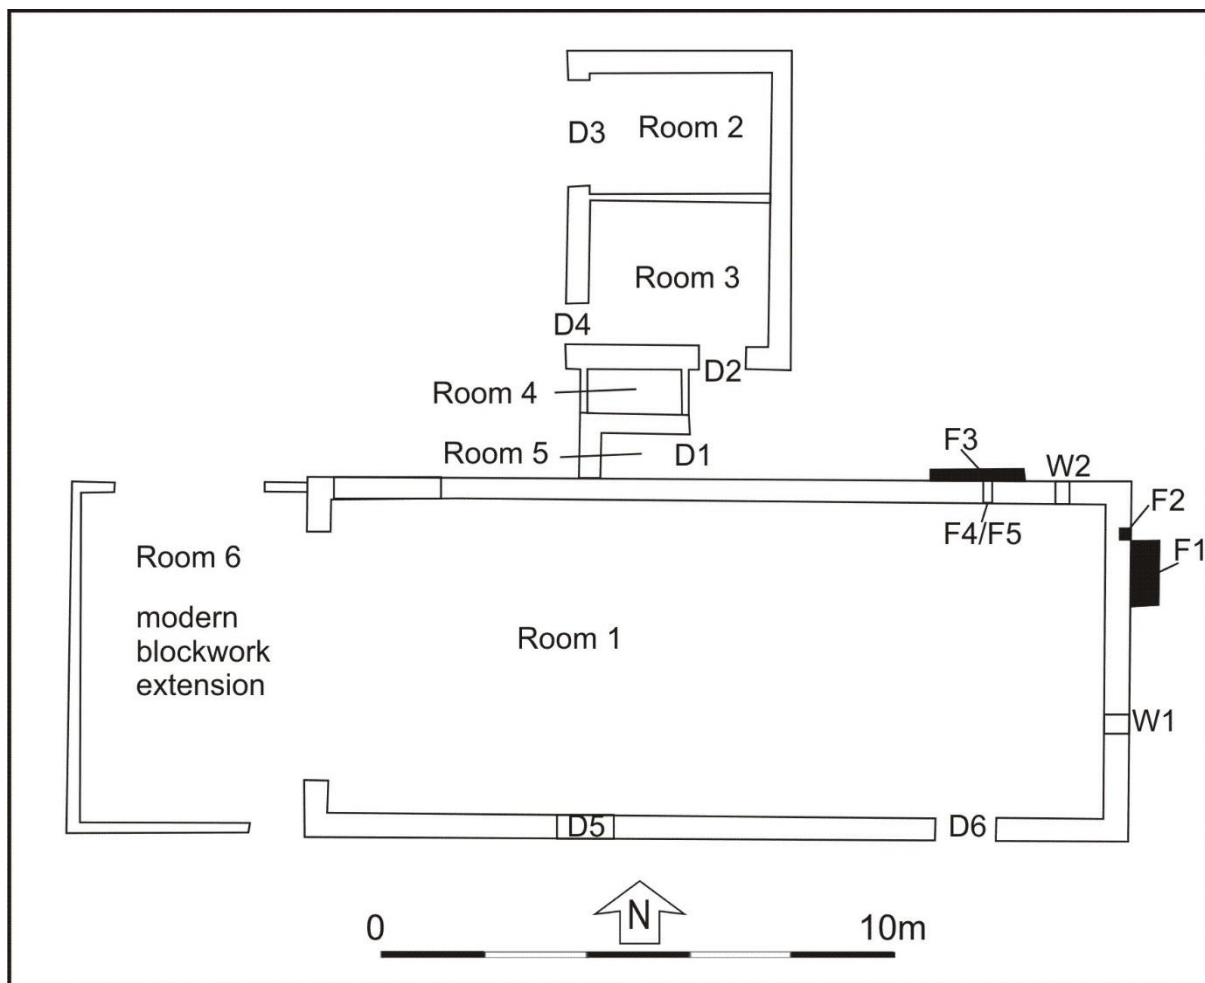
Illus 2 Plan showing buildings recorded and features identified (redrawn from *copyright Robert J Brand*)

North of this building are three small buildings; Rooms 2/3 the cart shed and Room 5 the lean-to shed were constructed between the First and Second Ordnance Survey maps. Room 2 is the former cart shed and is 6.4m wide and 4.6m long with the cart doors on the west façade (Illus 7). Room 4 is a modern corrugated iron shed and Room 5 a stone lean-to shed 1.3m wide with the door in the east gable.

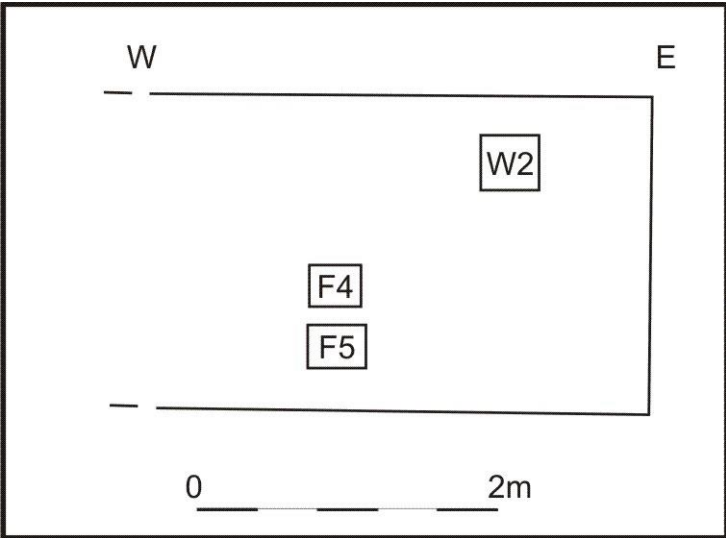
Illus 4 East end of north wall (interior) of Steading Room 1 showing apertures F4 and F5 for horse mill driveshaft

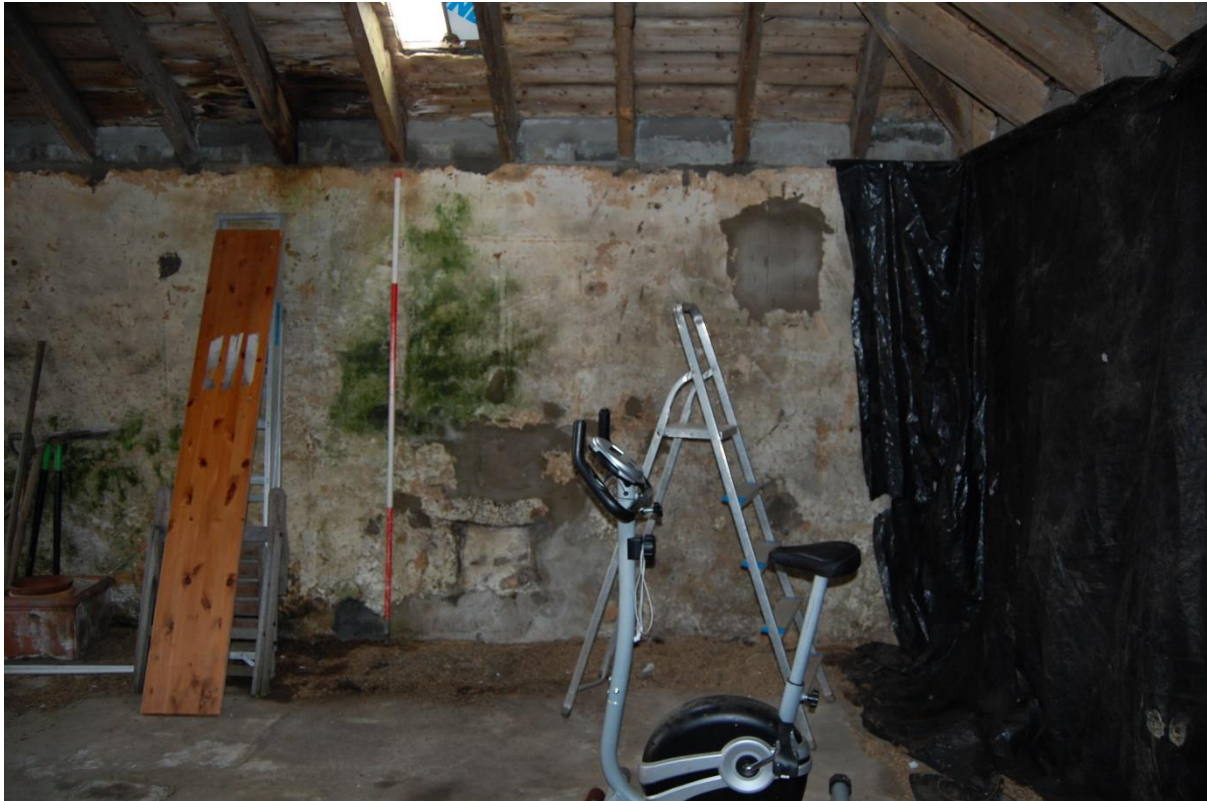
Illus 5 East end of north wall of steading showing Window W2 (top right blocked) and F4 and F5 (centre) the apertures for the horse mill driveshaft.

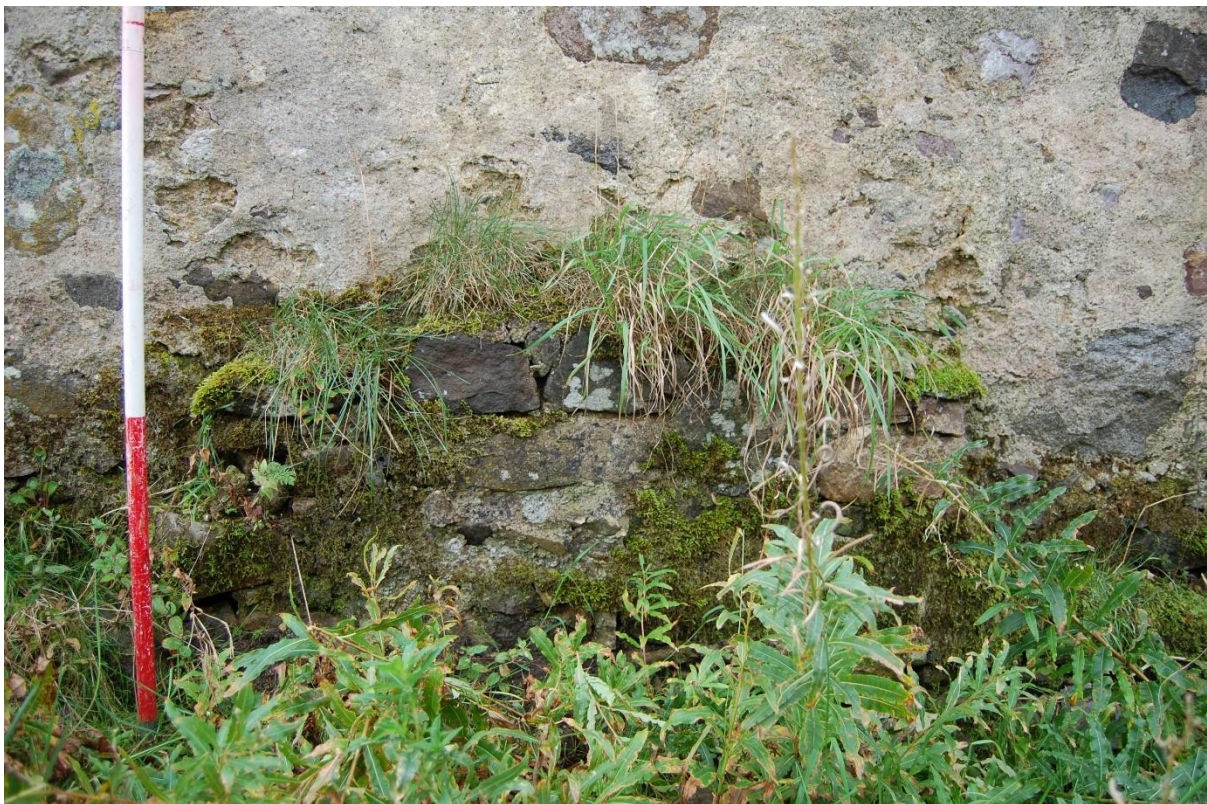
Illus 6 Mortared stone extension on north wall of steading where horse mill attached to the main building; F4 and F5 are heavily mortared on the exterior and not visible

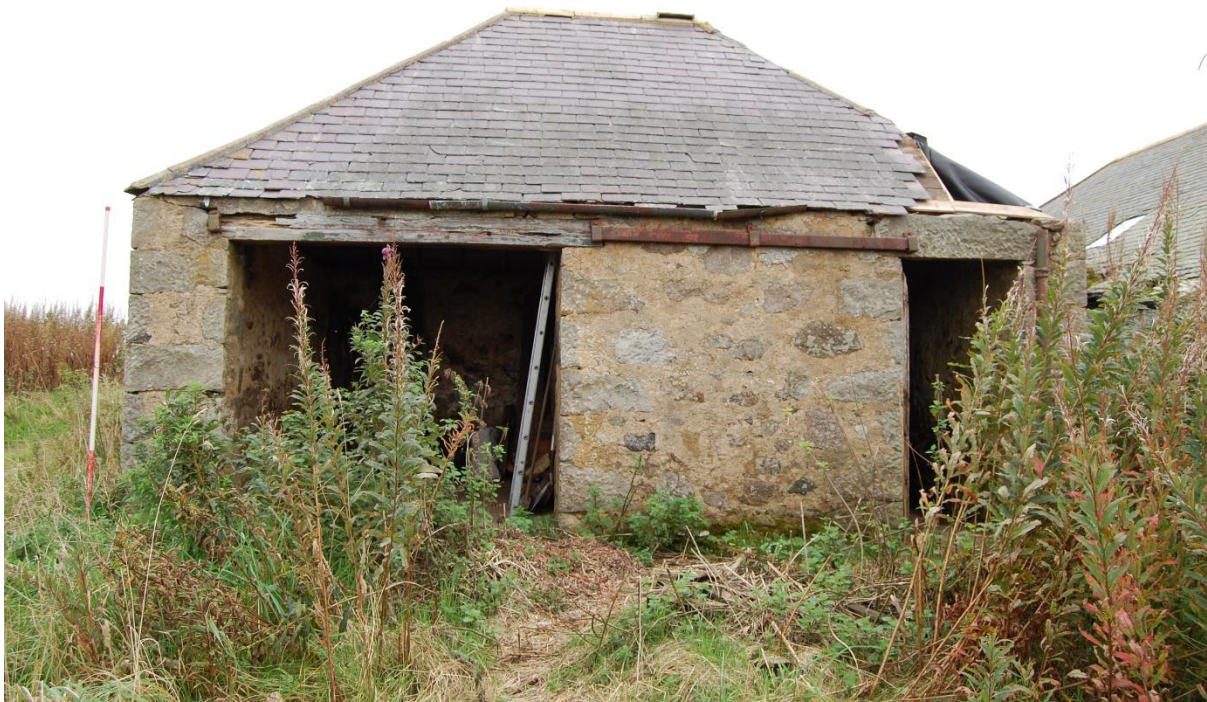
Illus 7 Cart shed west wall with Door D3 (left) and D4 (right)

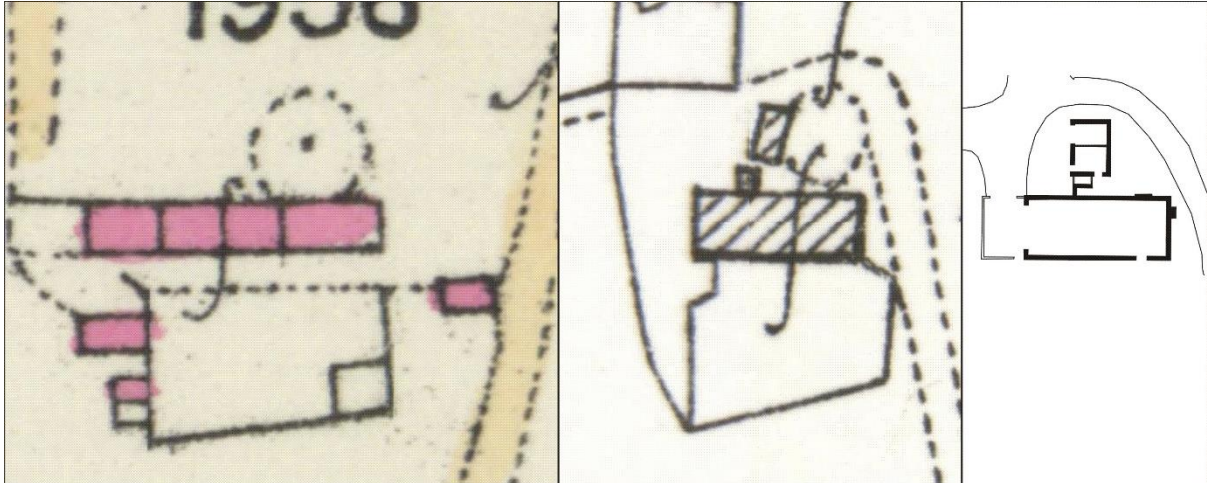
The Level 1 standing building survey was carried out on 17 September 2014 and the buildings were recorded. The building seen on the First Edition OS map is substantially longer than the current building and at least one third of the length was removed prior to the Second Edition. The horse mill is present on both maps and a small building (the cart shed) was added in the late 19th century prior to the Second Edition. Several structures to the SE and SW of the steading were present on the First Edition and they appear to have been completely removed by the Second Edition.

Illus 8 Phase plan showing First and Second Edition OS maps (*copyright National Library of Scotland*) and 2014 plan (right). First Edition Aberdeen Sheet XXI.15 (Old Deer) Survey date: 1870 Publication date: 1873. Second Edition Aberdeenshire, Sheet 021.15 Publication date: 1901 Revised: ca. 1899 (*copyright National Library of Scotland*).

A full record of the structure has been recorded and it is therefore recommended that no further archaeological work is carried out during the current planning application.
