**Hillhead of Tarves, Tarves, AB41 7LB  
Report on Level 1 Standing Building Survey**

**Alison Cameron  
Cameron Archaeology  
3 October 2014**

A Level 1 standing building survey was carried out on 29 September 2014. Building 2, the cottage had been heavily modernised but Building 1 the steading showed evidence of conversion for use with a horse mill and then removal of the mill. It is recommended that no further archaeological work is required during this development.

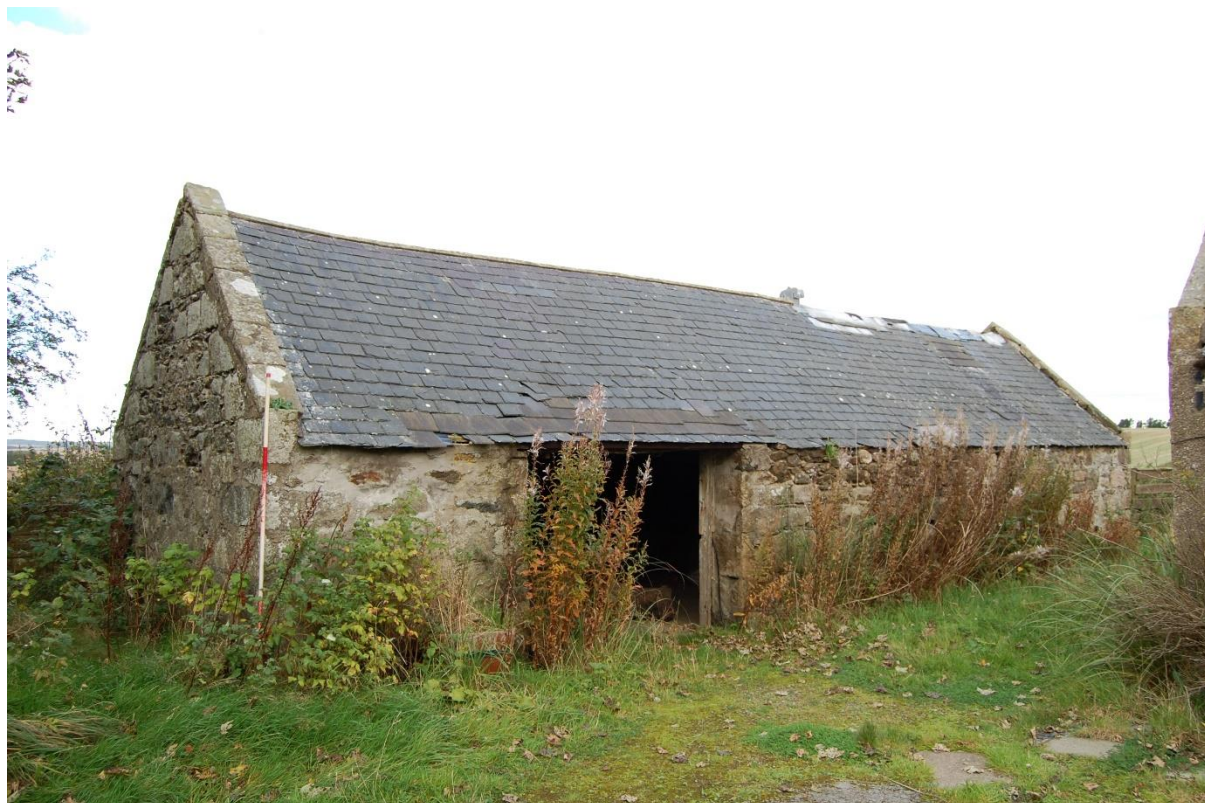
Cover: Building 1 east wall; facing WNW

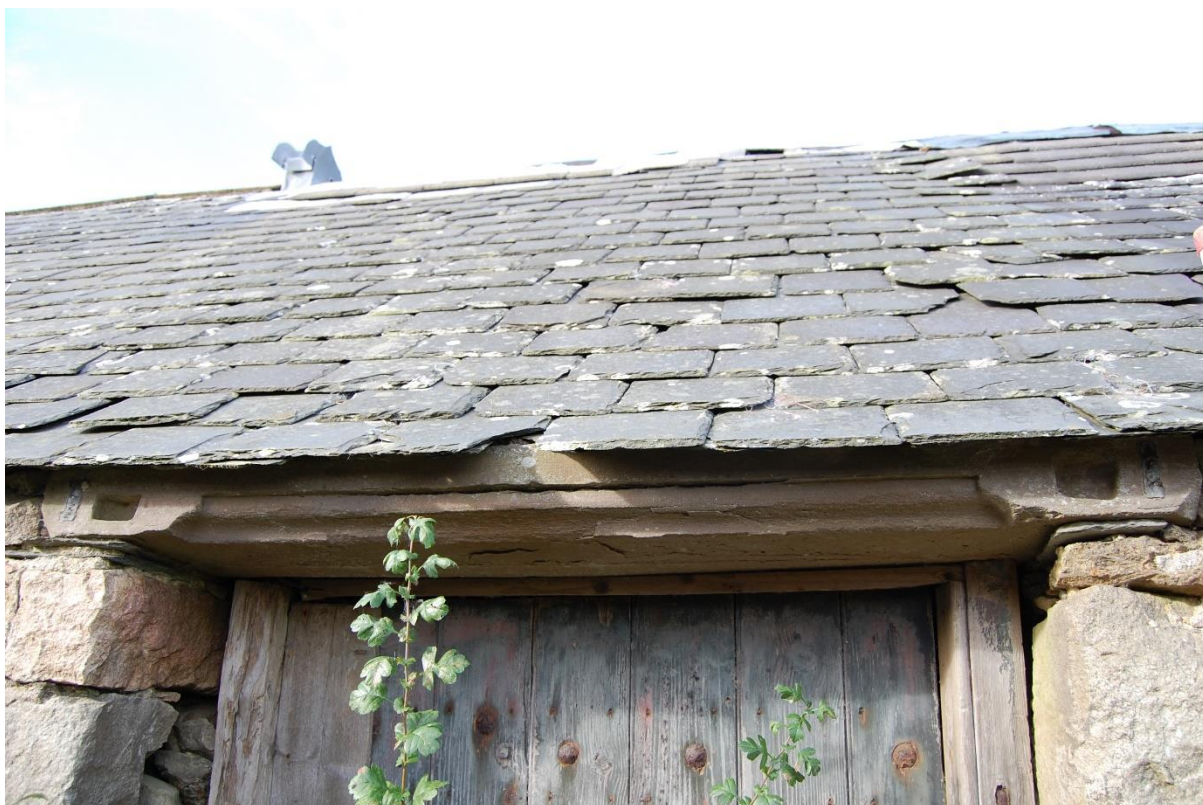
Building 1 is rectangular in plan and 14.5m long and 4.7m wide. It is constructed of granite rubble with granite quoins and jambs and wood and cast iron lintels with the exception of Door 3 which has a sandstone lintel with sockets and lead fitting (Illus 5). This is probably reused from another building.

Illus 5 Building 1 sandstone lintel above Door 3

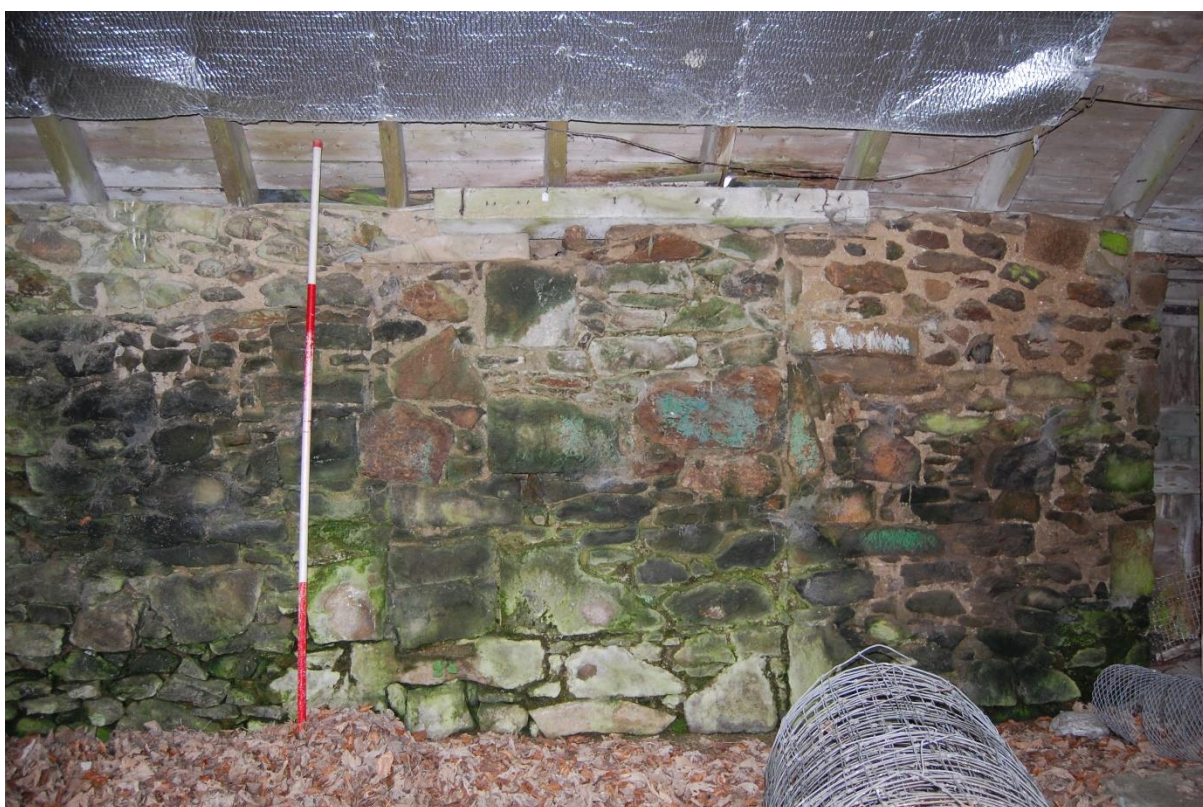
Between the First and Second OS maps a horse mill was added to the south side of the west wall. Door 4 was blocked and apertures added adjacent to that door (F1 and F2; Illus 6) to allow the driveshaft through the wall. This mill then went out of use and these apertures were all blocked.

Illus 6 Building 1 interior west wall showing blocked door D4 (centre) and F1 (left) and F2 (right) apertures for driveshaft of horse mill

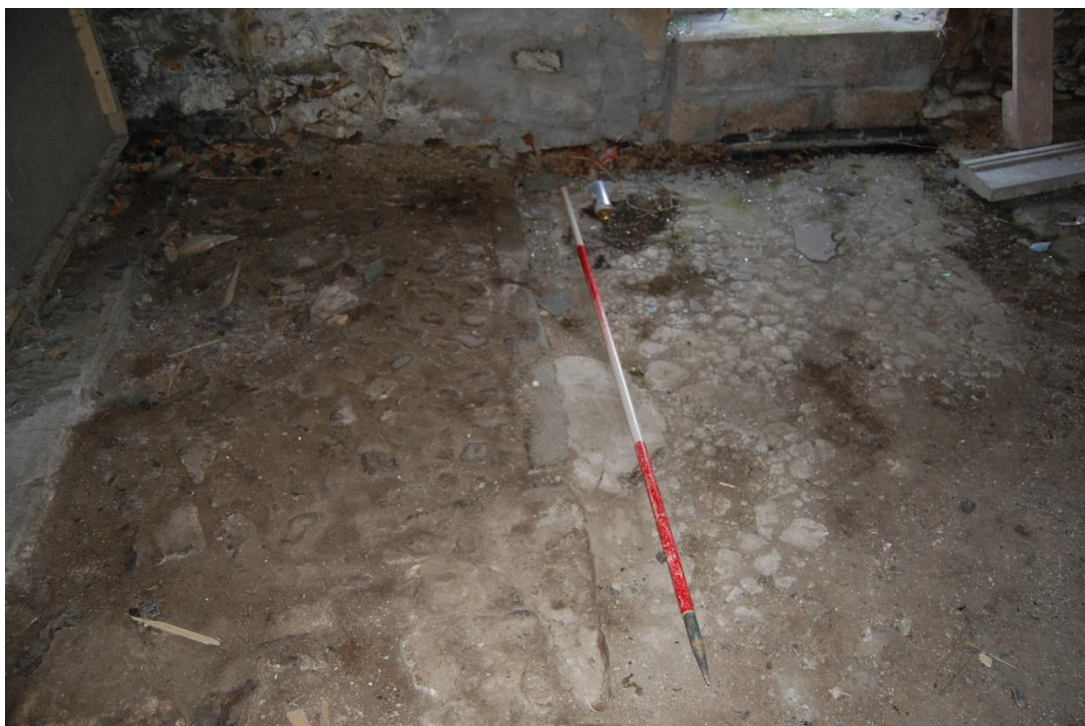
The northern room has a cobbled floor constructed from medium and small waterwashed pebbles with runnels. A stone plinth or foundation along the north wall (F5) is associated with the use of the steading for housing animals.

Illus 7 Building 1 cobbled floor in north room

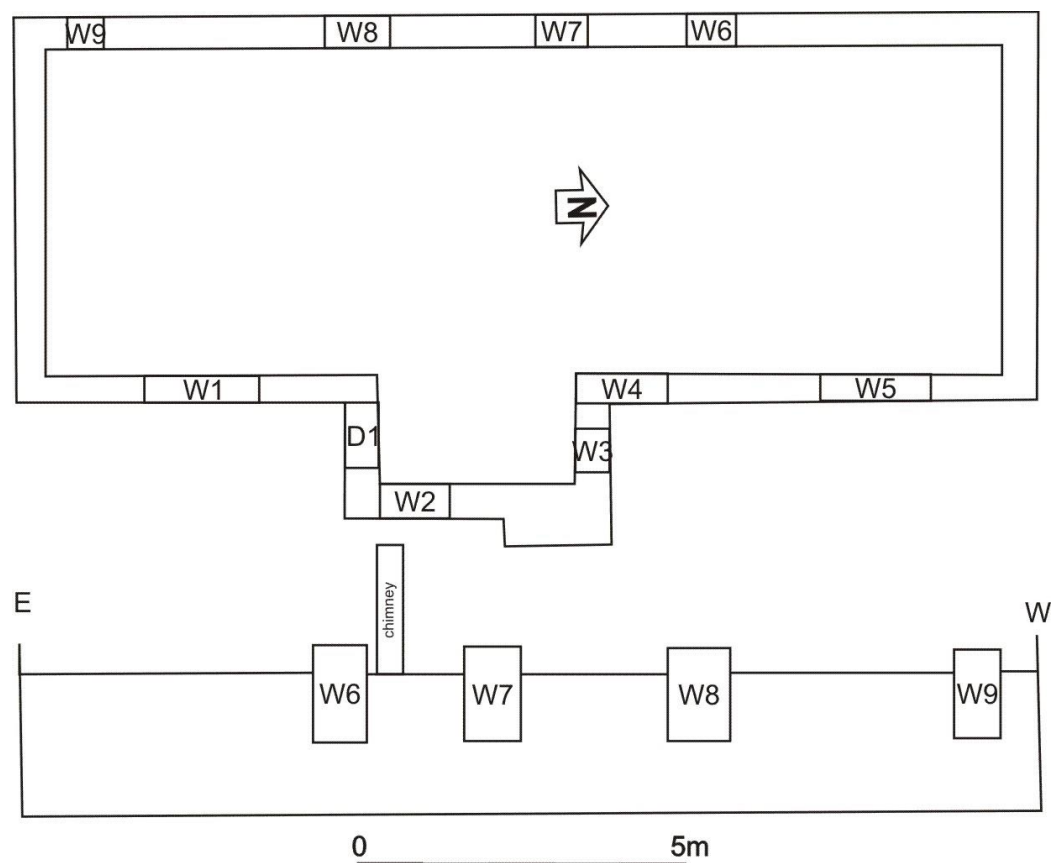
Illus 8 Building 2 plan (top) and elevation of north wall (bottom)

The cottage is 15.5m long and 5.8m wide with a porch added to the south façade. The exterior is harled with concrete lintels and the interior is completely modernized. This may have been completely rebuilt in the 20<sup>th</sup> century or heavily modernized throughout.

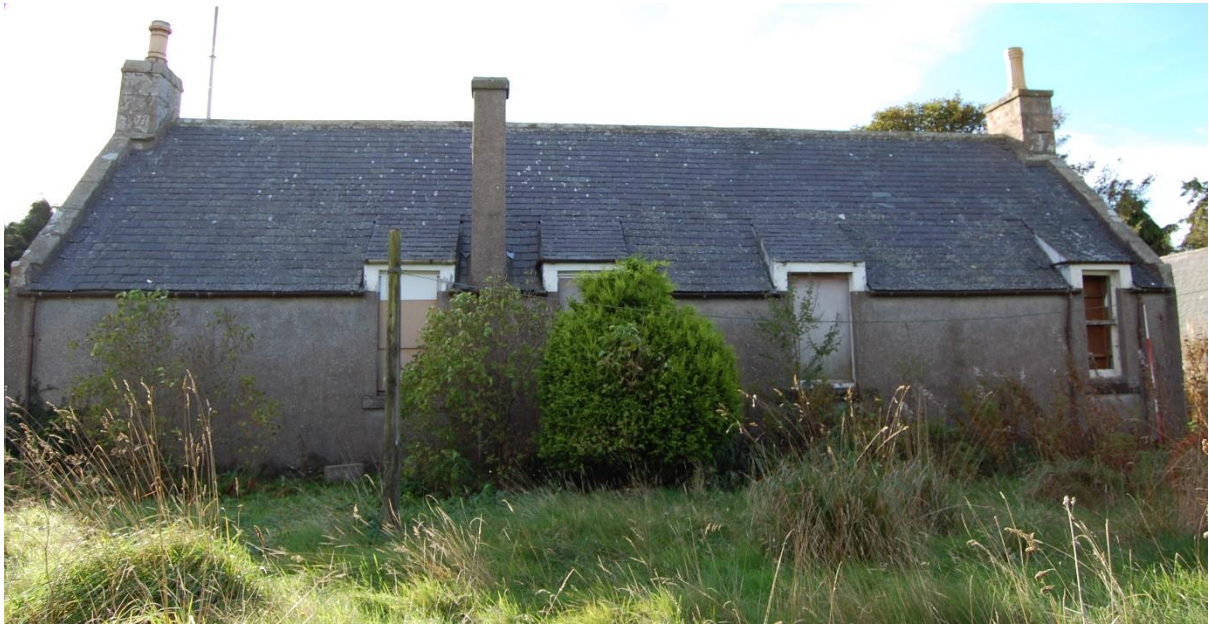
Illus 9 Building 2 north façade

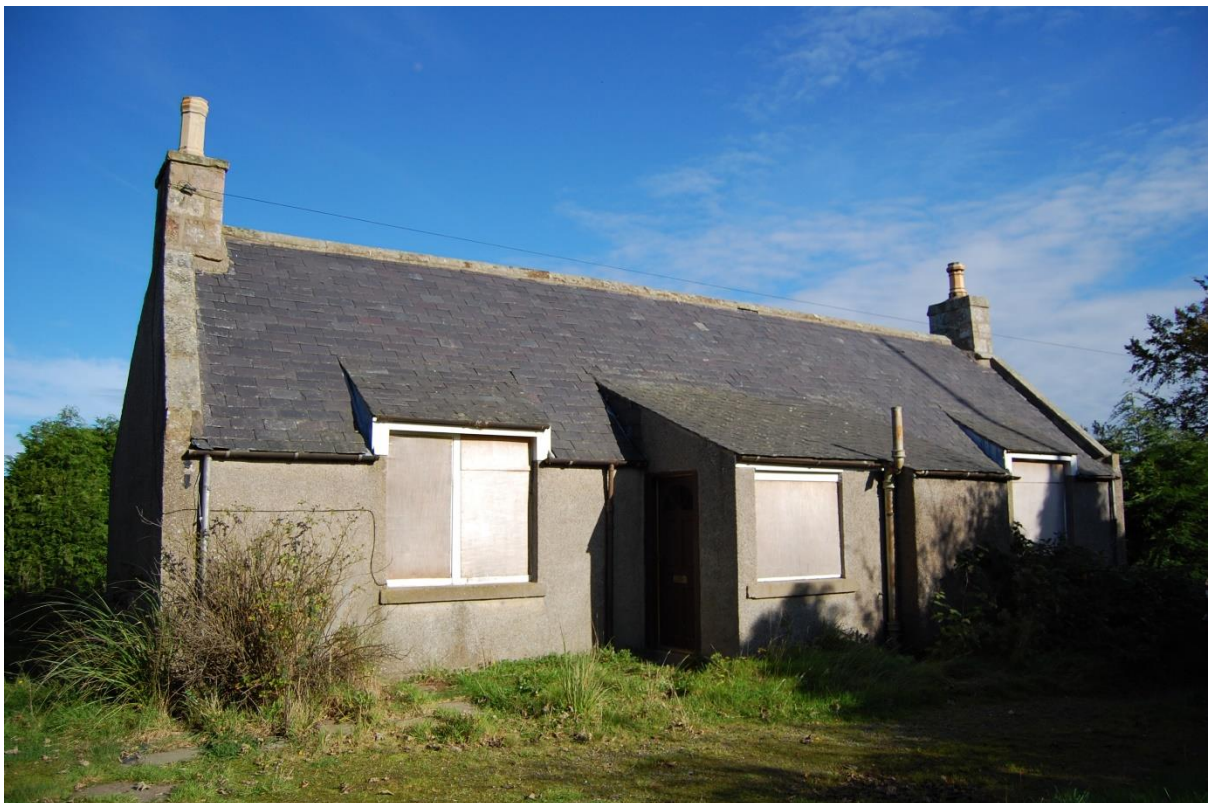
Illus 10 Building 2 south facade

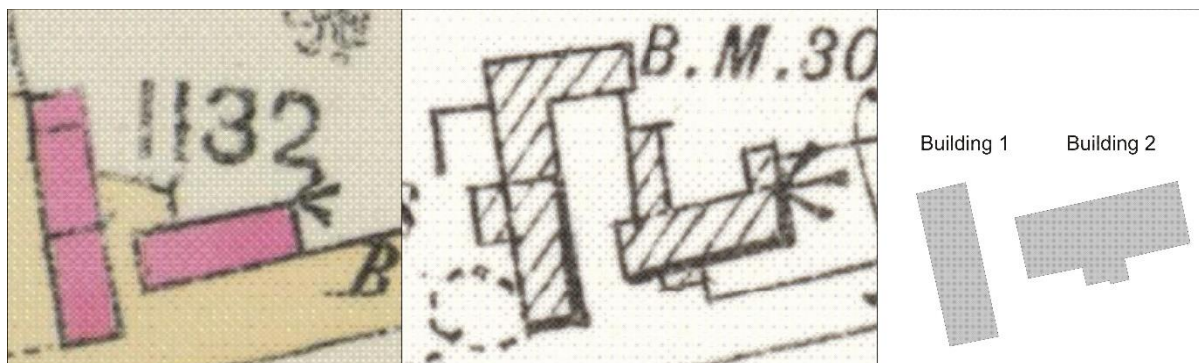
Building 1 the steading showed evidence of conversion for use with a horse mill and then removal of the mill. The north half of Building 1 has been demolished since the Second Edition OS map (Illus 11).

Building 2, the cottage was heavily modernised and may have been completely rebuilt in the 20<sup>th</sup> century. Previous additions seen on the Second Edition OS map (Illus 11) are no longer visible.

Illus 11 Phase plan showing First Edition OS (left) Second Edition (middle; copyright National Library of Scotland) and modern plan (copyright David Murray Associates) showing conversion to use with horse mill

It is recommended that no further archaeological work is required during this development.

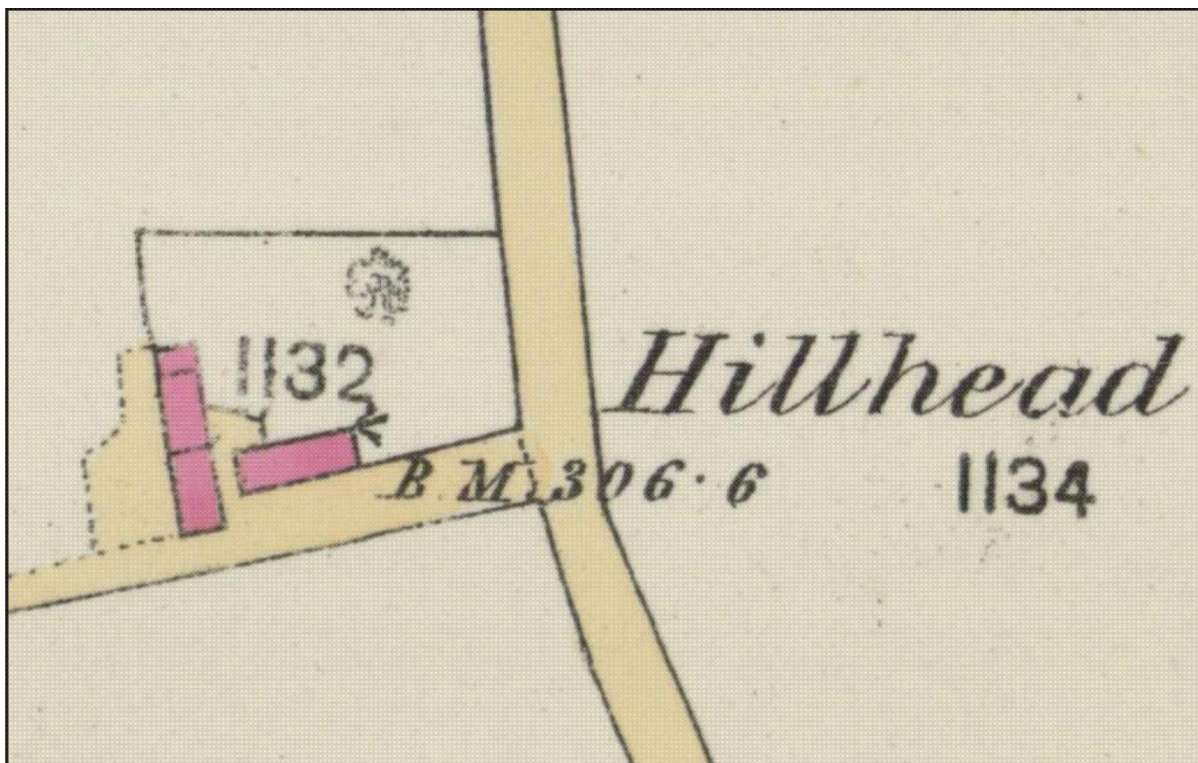
Illus 13 First Edition OS map Aberdeen Sheet XXXVII.12 (Tarves) Survey date: 1868 Publication date: 1871 (copyright national Library of Scotland)
