SCOTSTOWN MOOR, ABERDEEN
SITES AND MONUMENTS RECORD ENHANCEMENT
RADIO DETECTION FINDING STATION, CHILDREN'S CAMP, WWII PRACTICE
TRENCHES

Alison Cameron
Cameron Archaeology
20 October 2014

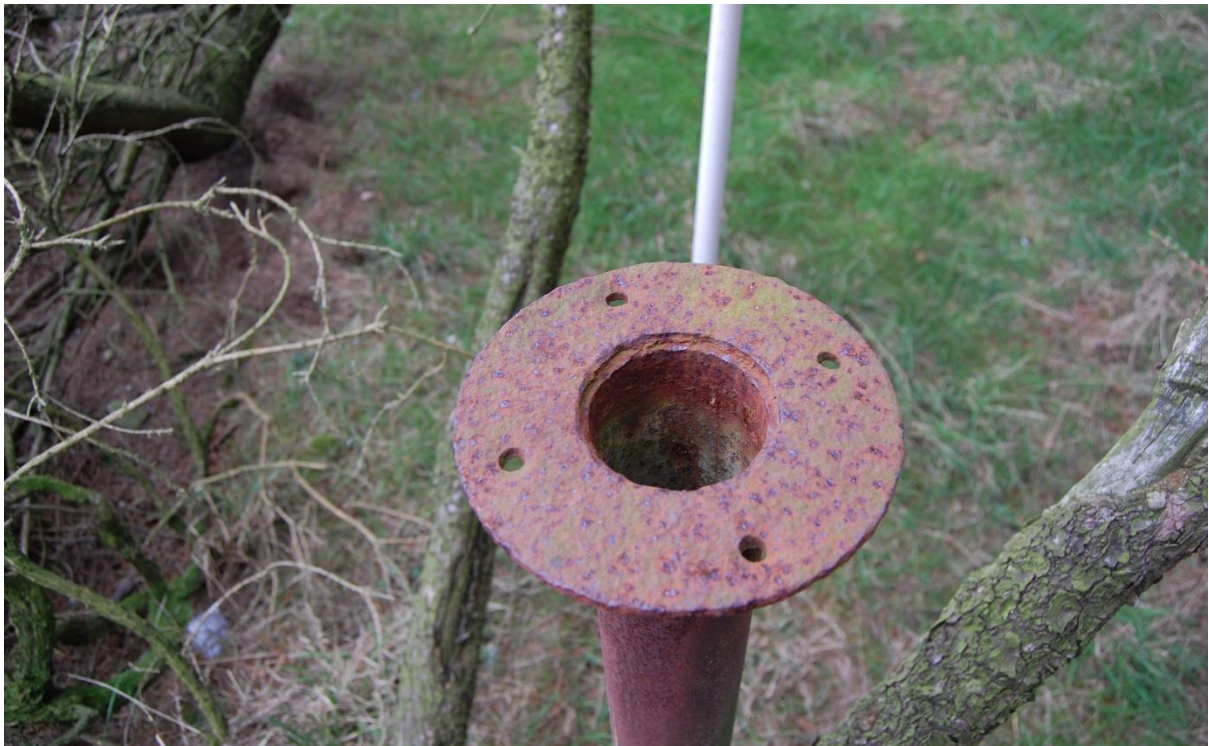
F1 is an iron cylinder 117cm high, diameter 6.5cm with a slightly domed square base plate 66cm wide; the fitting has a circular plate on the top 16.5cm diameter and 7mm thick and has four 1cm diameter holes spaced evenly around the edge. There is a lead covered cable protruding from the base with four rubber sheathed wires. A bracket 13cm long half way down the cylinder is welded on to the west side. This may be the base for an aerial.

Illus 4 F1 circular plate with holes on top of fitting

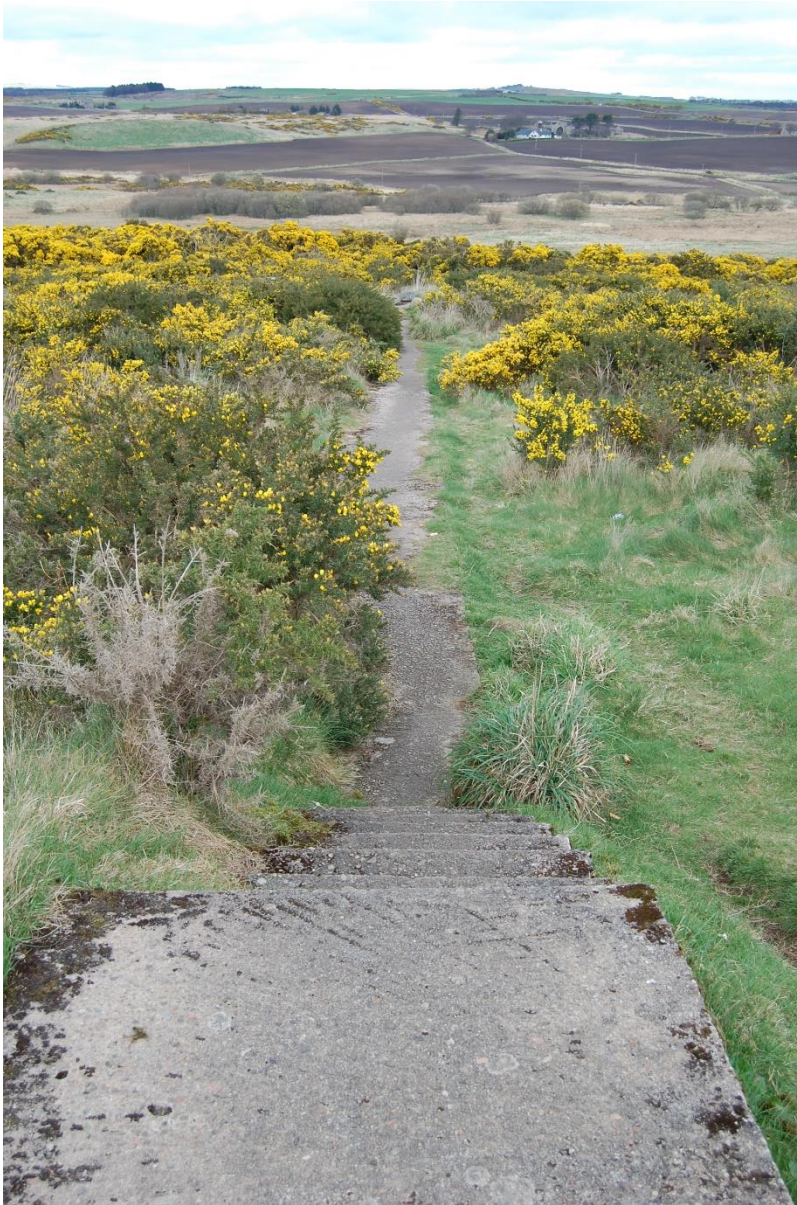
F4 is a N-S concrete path running from rest Hut No 1 in the north to structure F26 in the south.

Illus 8 Path F4 with steps F22 (foreground); facing north

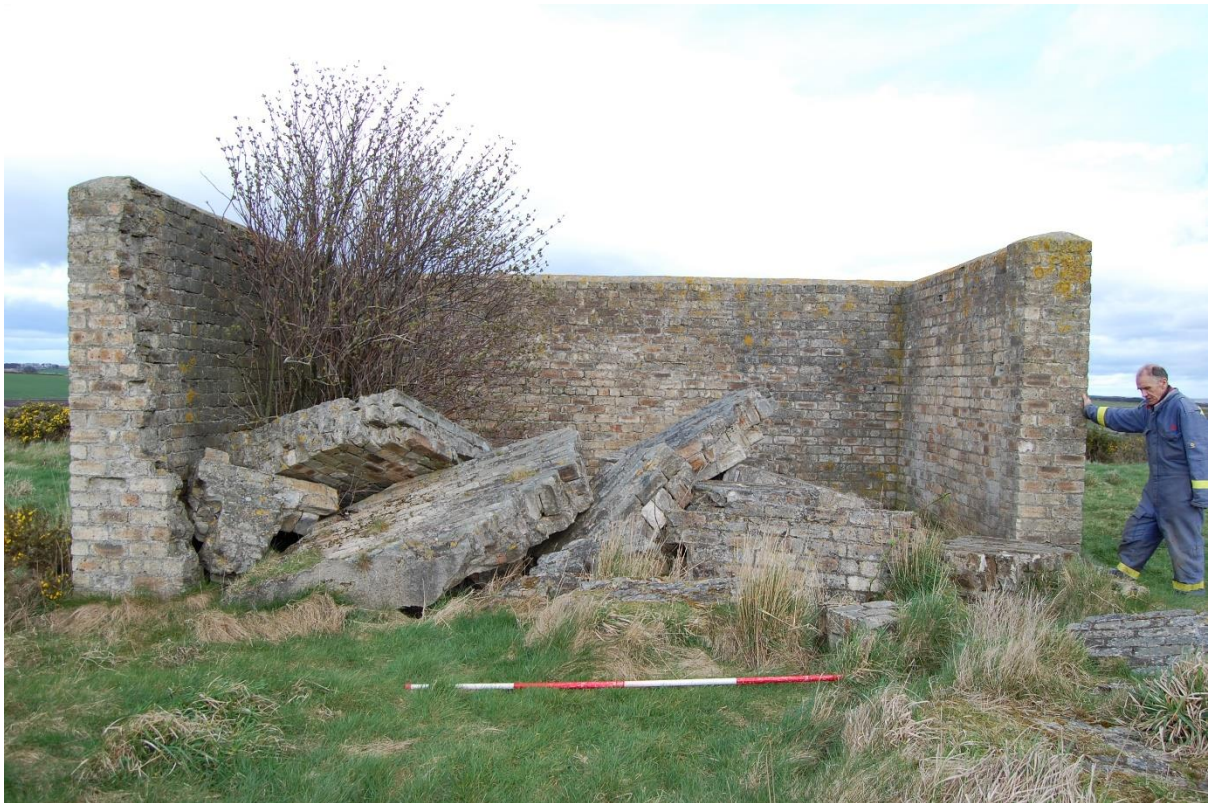
Illus 11 F6; facing N

Rectangular brick building on the line of path F4 between F3 at the north and F26 at the south; it is 6.6m W-E and 5.24m N-S with walls 0.37m wide (Illus 11). The south wall is partially demolished with debris fallen on the interior. Concrete pads survive on the interior (Illus 12). This is labelled 'No 1' on the plan of 11/1/1945 (Illus 7).

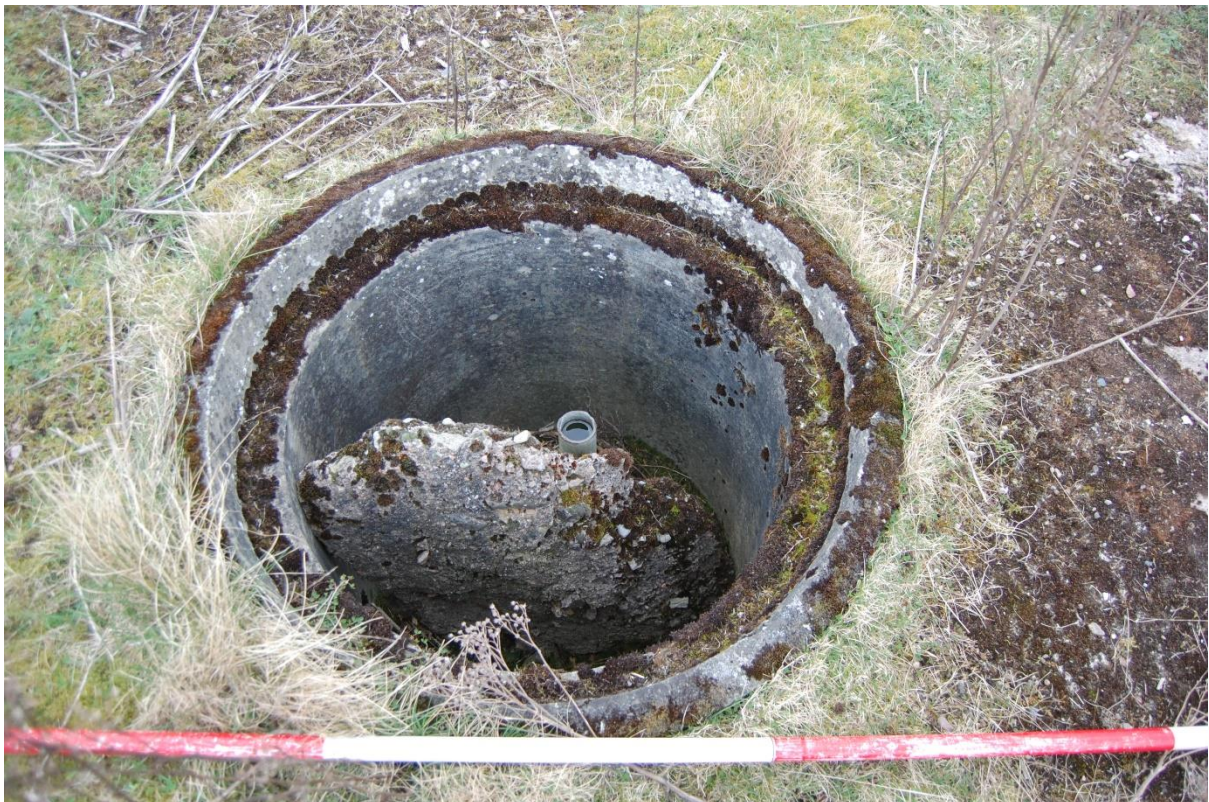
F8 is a concrete octagonal foundation 4m diameter with walls 1.64m long (Illus 16). Around the periphery a channel 0.35m wide which may represent the robber trench where the original wall has been removed. This was mainly overgrown in 1998 and had been partially dug away during this survey in May 2014 (Illus 17). There is a circular concrete pipe in the centre of the building 1.02m diameter with a central pipe 6cm diameter probably a housing for cables (Illus 18). This is labelled 'New Site' on the plan of 11/1/1945 (Illus 7). This is probably the foundation for a direction finding tower and may have been an octagonal brick base with a tower, possibly in wood. There is no rubble in the area but this may be buried nearby. An artists's impression (below) for a similar tower at Ibsley features a wooden tower above a brick base (Illus 19).

Illus 18 F7 central concrete pipe showing central cable fitting; facing E

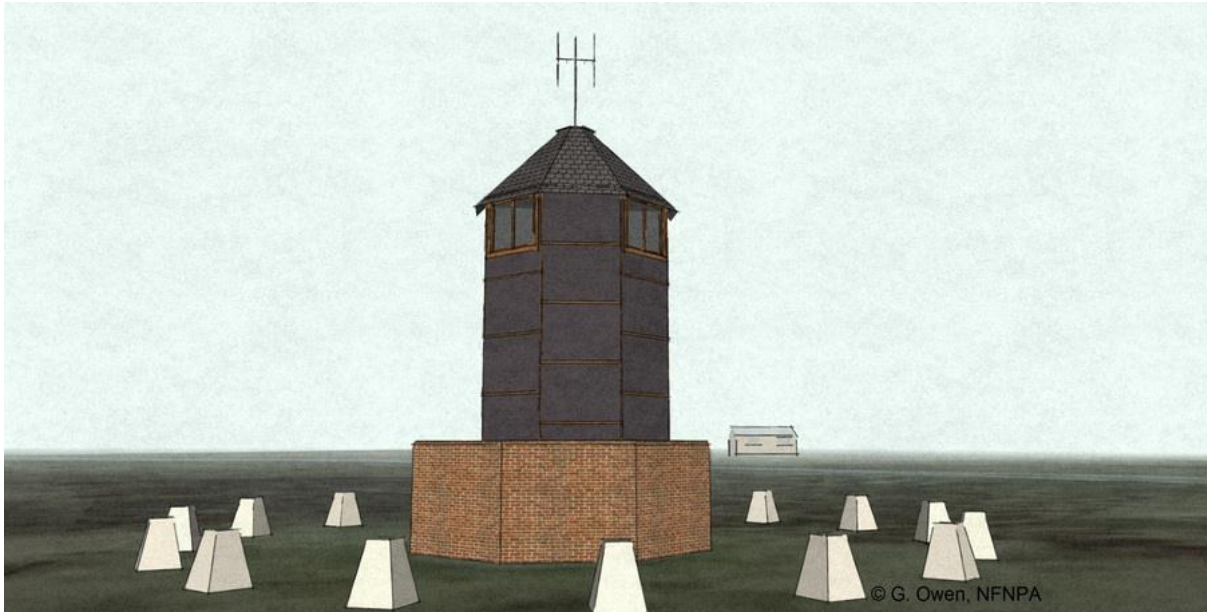
Illus 19 Artists's impression of Ibsley Direction Finding Station (<http://www.newforestww2.org/ibsley-hf-df/>)

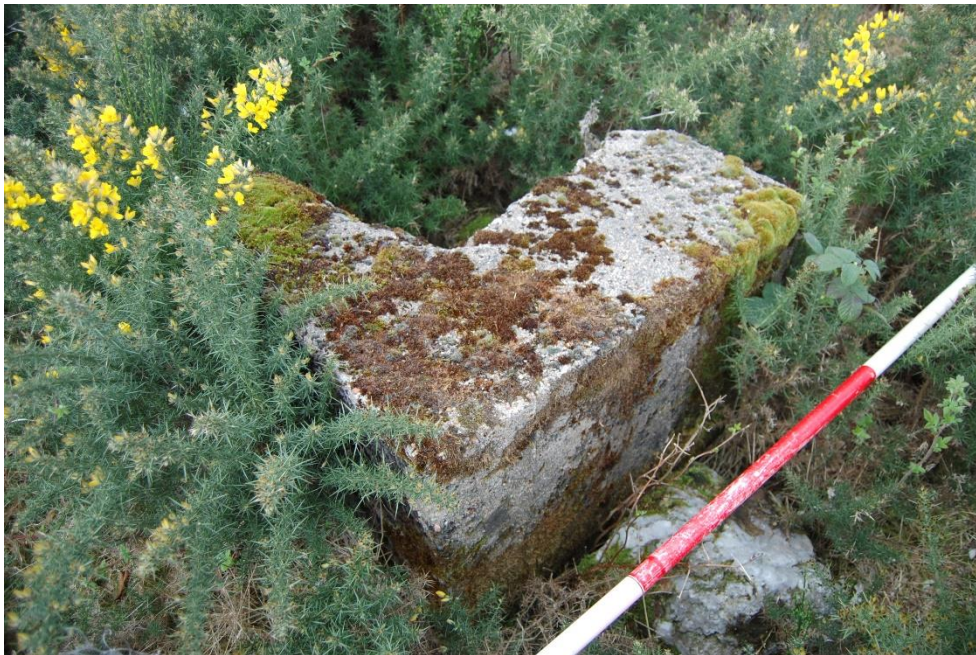
Illus 20 Concrete pedestal

F17 is a concrete pedestal with a central ceramic pipe (Illus 20) on the NE side of octagonal structure F8.

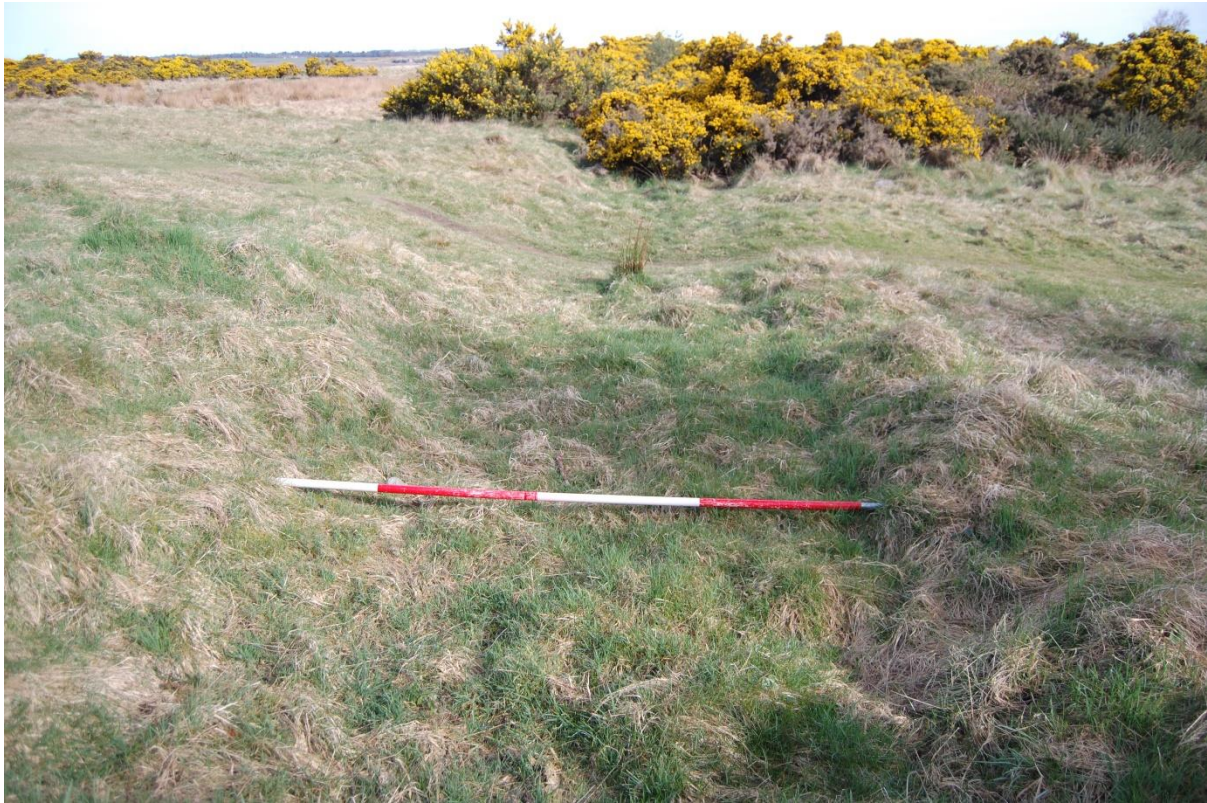
Illus 21 hollow way; facing N

F18 is a hollow way c 2m wide (Illus 21) running N-S. It aligns with a path through the woodland.

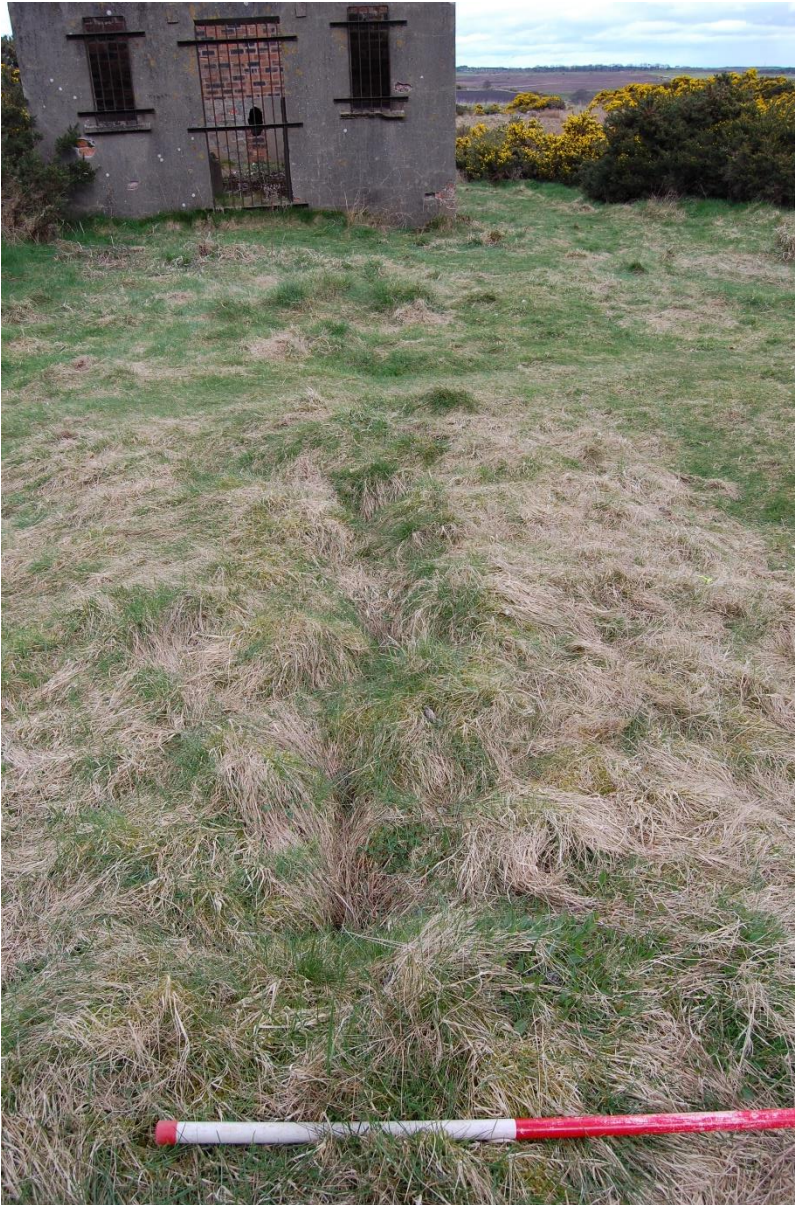
Illus 22 Trench F19 with rest hut 2 F7 (top); facing N

F19 is a sunken trench between rest hut F7 and pillbox F5 which probably contained cabling (Illus 22).

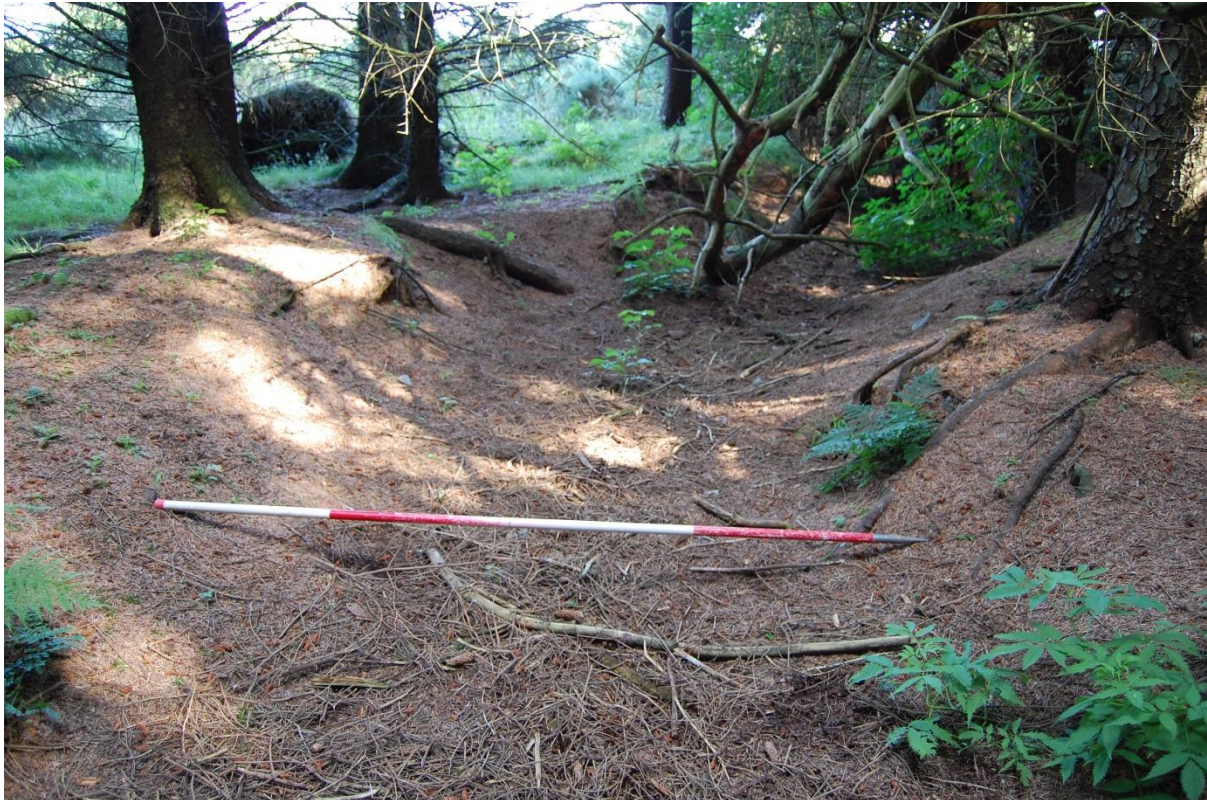
Illus 23 Section of trenches F20

F20 is a series of hand-dug zig-zagging u-shaped trenches forming two conjoined squares 48 x 49m in size (Illus 23). The area is now moderately heavily tree covered and some of the trenches have become infilled with fallen trees. The trenches vary in width but are typically 3.2-3.6m wide and up to 0.75m deep although they have been infilled. There is a natural subsoil and soil bank on the interior aspect formed from the upcast from the trench.

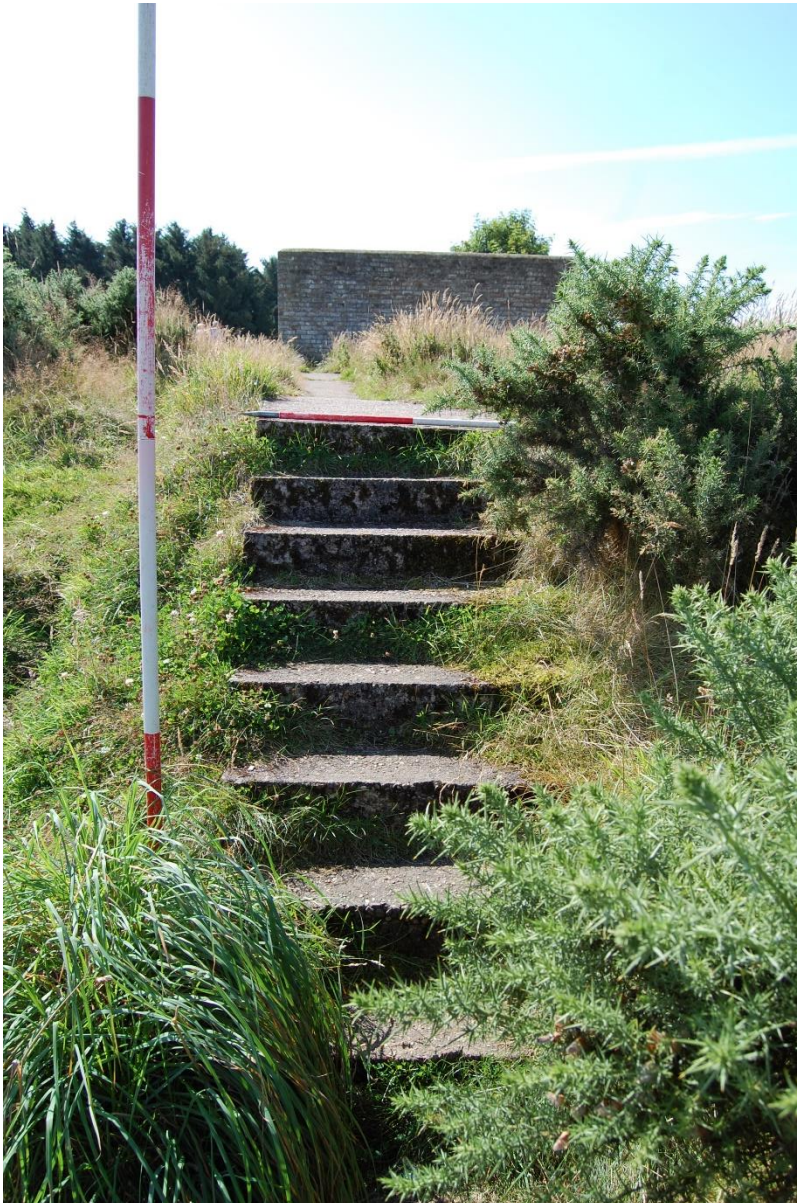
Illus 25 Concrete steps F22 with building F6 (top); facing S

F22 is a set of seven concrete steps in path F4 (Illus 24).

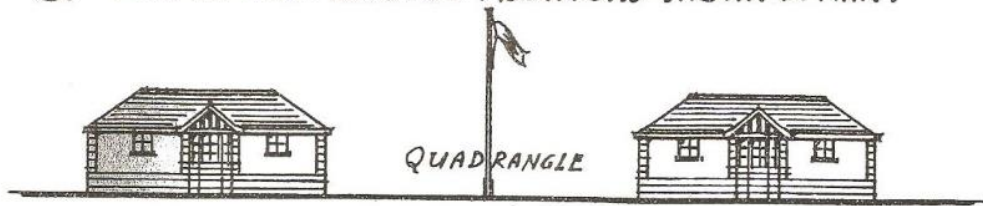
THE · SCOTSTOWN · MOOR · CHILDREN'S · CAMP
 3. PLAN OF MISS HENDRY'S ADDITIONS · SHOWN IN PINK .

SOUTH · ELEVATION · OF · NEW · WINGS

Illus 30 Plan showing the camp with 'Miss Hendry's additions'

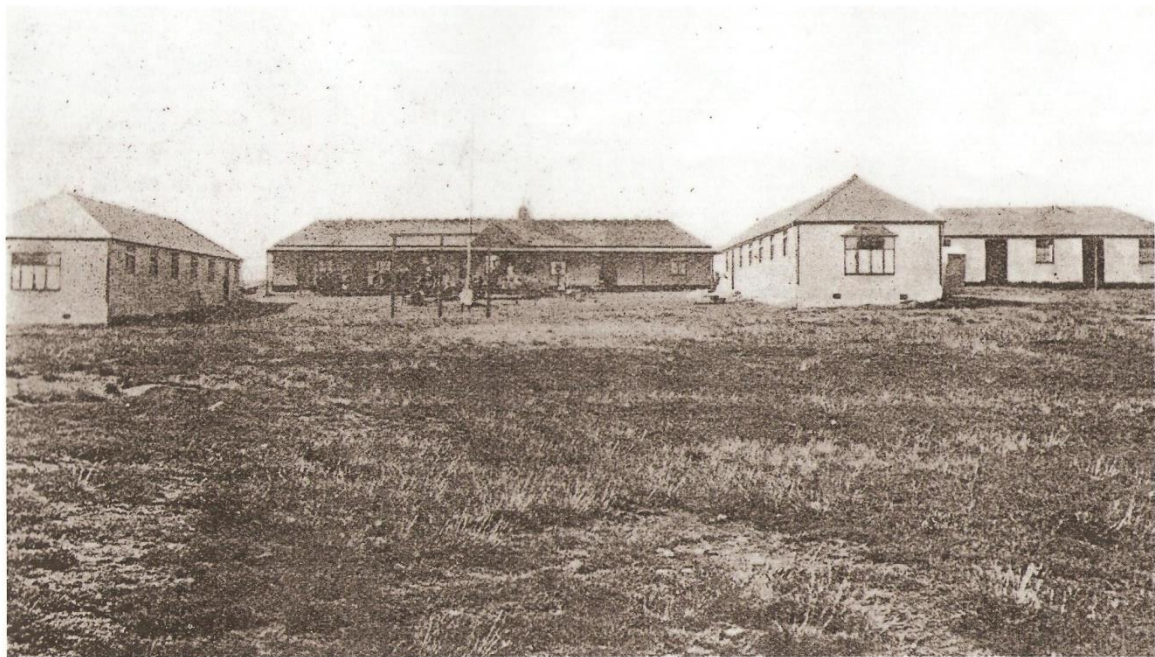
Children's Camp, Scotstown Moor, 1932

Illus 31 Photographs of the camp 1932 with F15 (left) F10 (centre) F14 (centre right) F12 (right); facing NW

F12 is a building 15.3m long and 6.2m wide with a concrete slope at the SW end and a concrete plinth at the NE end. It is now constructed of wooden slats but the foundation and base is probably part of the Childrens' Camp building and it is labelled 'recreation hall' on the 'plan of Miss Hendry's additions to the camp' (Illus 29). There was no access into the interior of the building during this survey.

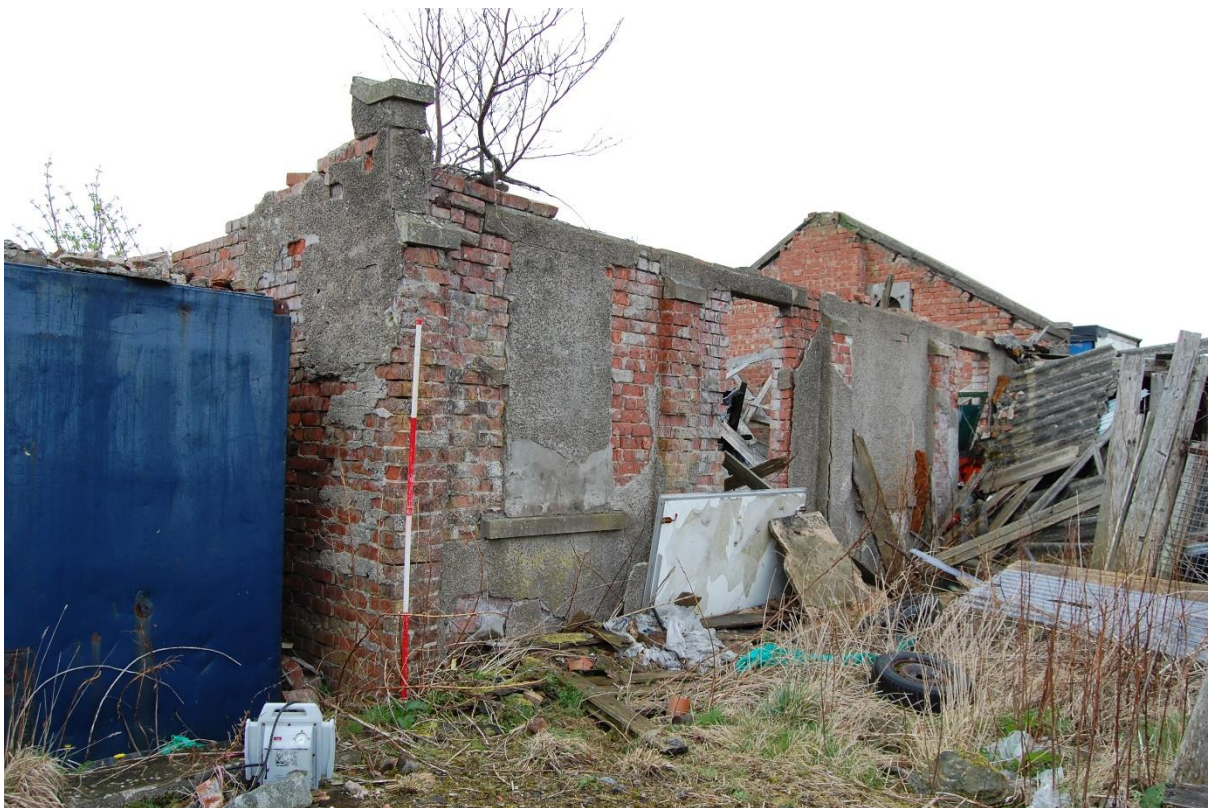
Illus 35 F9 NE wall; facing W

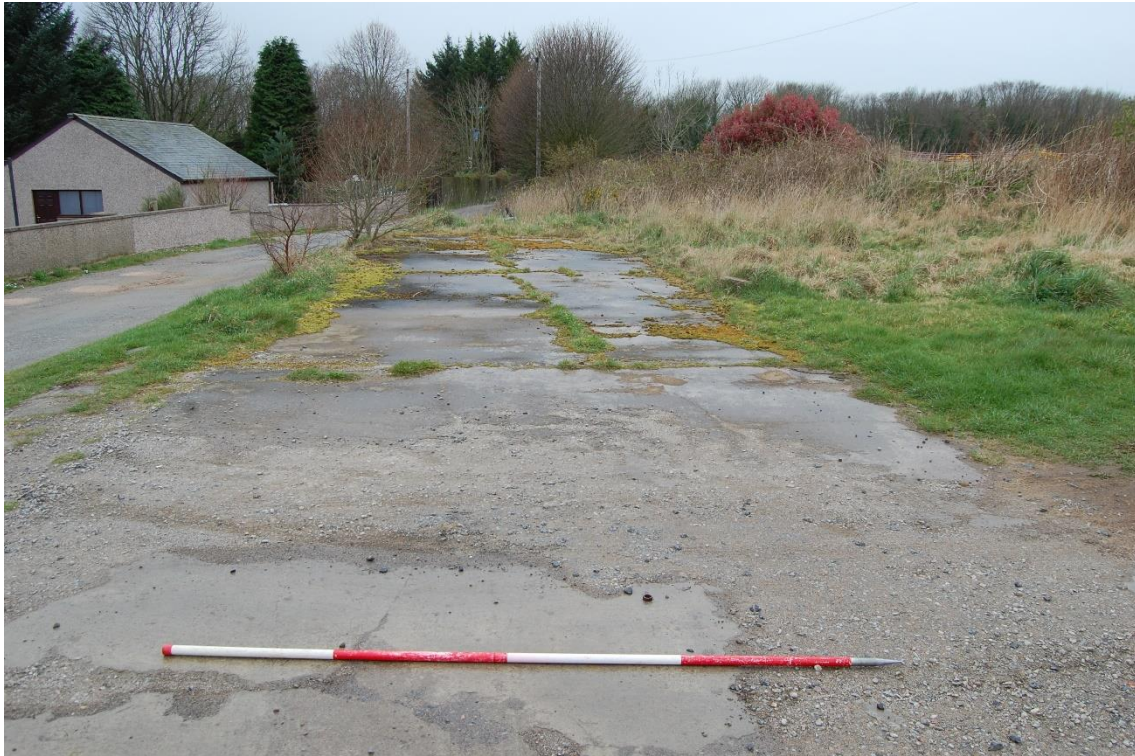
F10 is 30.4m long and 4.55m wide and survives as a concrete base. It is divided from F11 by a step and there is stone along the SE edge of the building, the remains of 'the verandah'. The building is labelled part of 'kitchen and offices' on the 'plan of Miss Hendry's additions to the camp' (Illus 29).

Illus 36 concrete base F10; facing SW

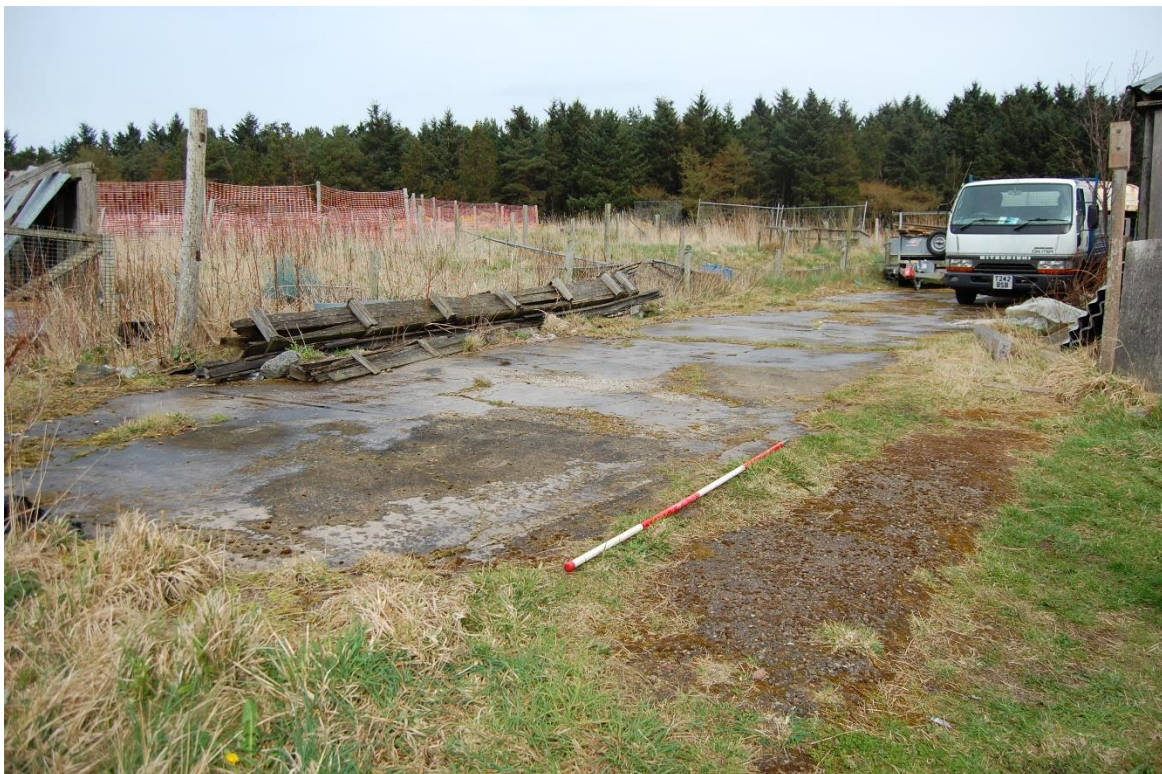
F11 is 23.3m long and 5.9m wide and survives as a concrete base. It is labelled part of 'kitchen and offices' on the 'plan of Miss Hendry's additions to the camp' (Illus 29).

Illus 37 Concrete base F11; facing N

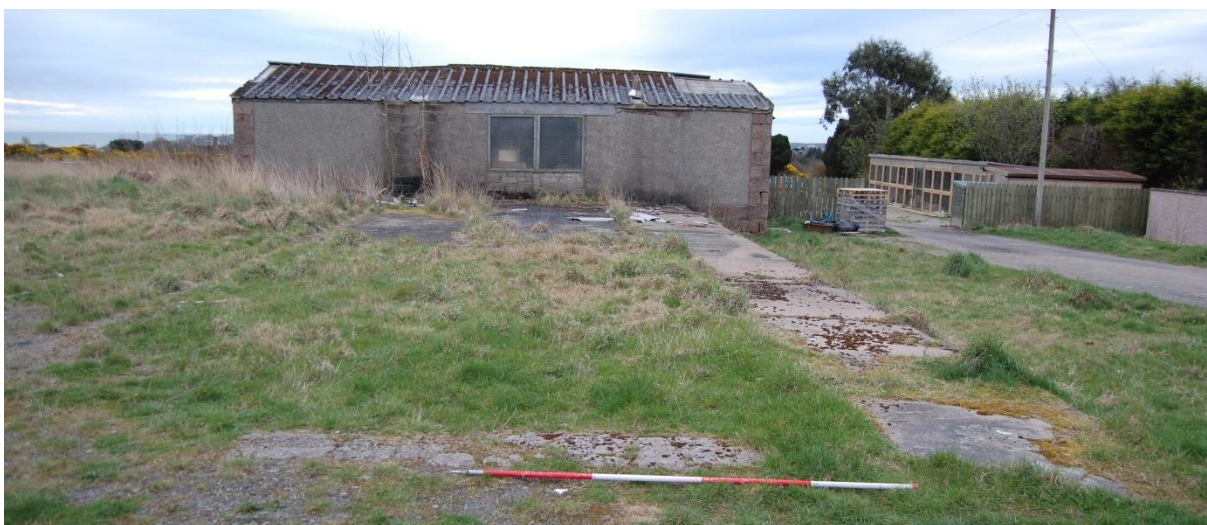
F13 is a concrete base 19.2m long and 7.3m wide at the NW side of F14 (Illus 38). It is labelled part of 'girls' dormitory' on the 'plan of Miss Hendry's additions to the camp' (Illus 29).

Illus 39 concrete base F13 with F14 (background); facing SE

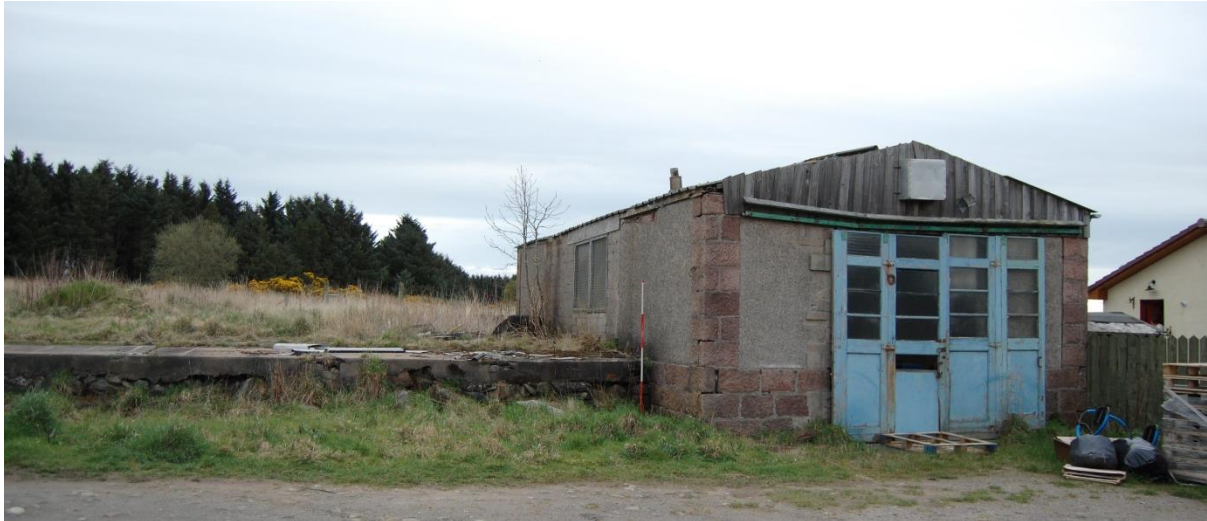
F14 is a standing building 13.2m long and 6.45m wide (Illus 38, 39). It has stone base and quoins and is harled. It is labelled 'girls' dormitory' on the 'plan of Miss Hendry's additions to the camp' (Illus 29). There was no access into the interior of the building during this survey.

Illus 40 concrete base F13 (left) with F14 (right); facing ENE

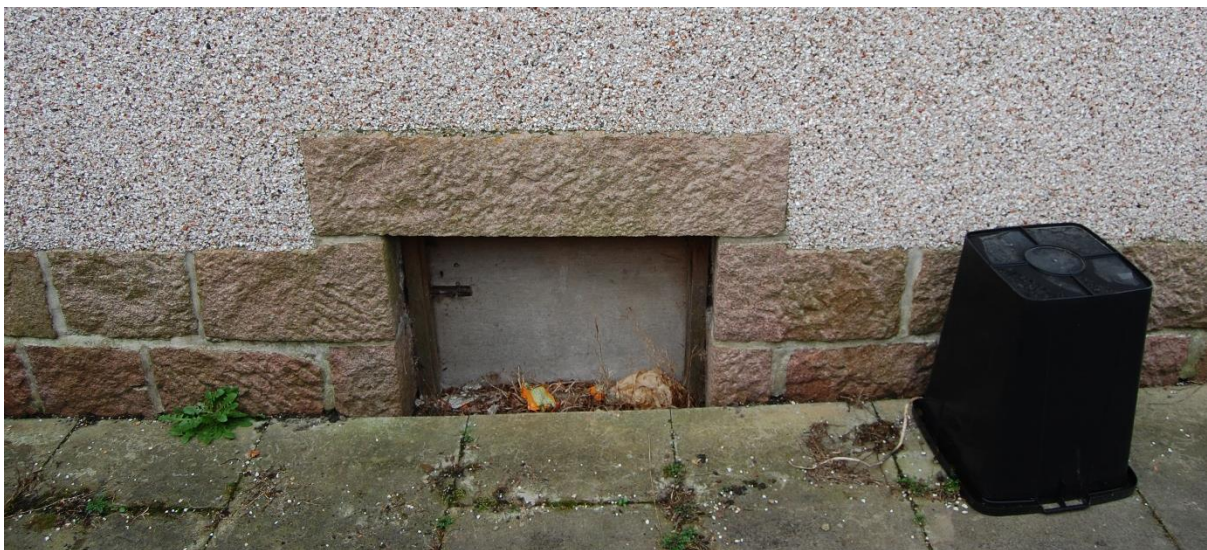
Illus 41 Detail of F15; facing SW

F15 is a modern house with harled walls but there are features visible which indicate that it was formerly part of the Children's Camp on the 1940 photograph (Illus 31). It is labelled 'boys' dormitory' on the 'plan of Miss Hendry's additions to the camp' (Illus 29).
