**Report on archaeological watching brief  
Proposed new amenity housing  
Haugh Road, Elgin, Moray, IV30 1AS**

**Alison Cameron  
Cameron Archaeology  
16th December 2014**

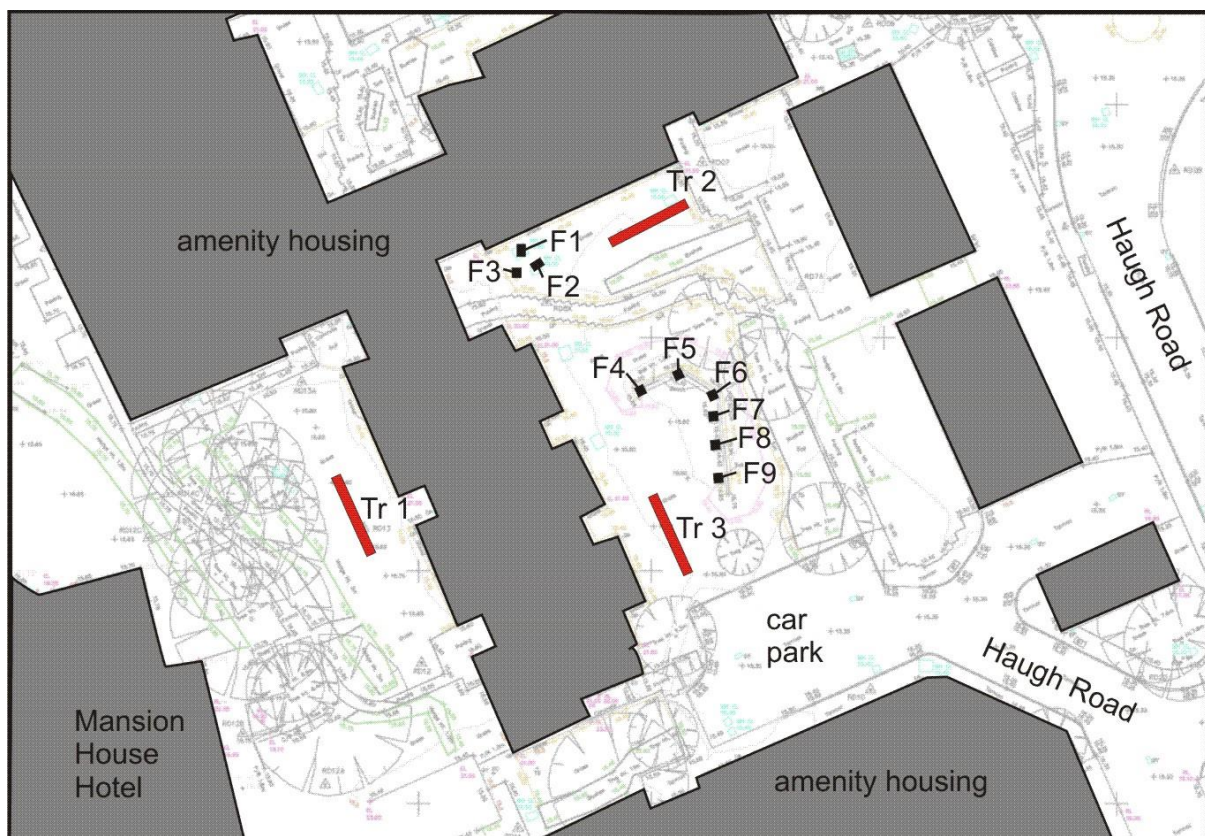
Illus 1 Site plan showing Trenches and stonework (copyright ICOSIS)

A watching brief was maintained on 10 December 2014 during the excavation of three trenches for archaeological assessment and soil sampling. The trenches were 5m long and 1.5m wide dug with a wheeled JCB with a toothless ditching bucket.

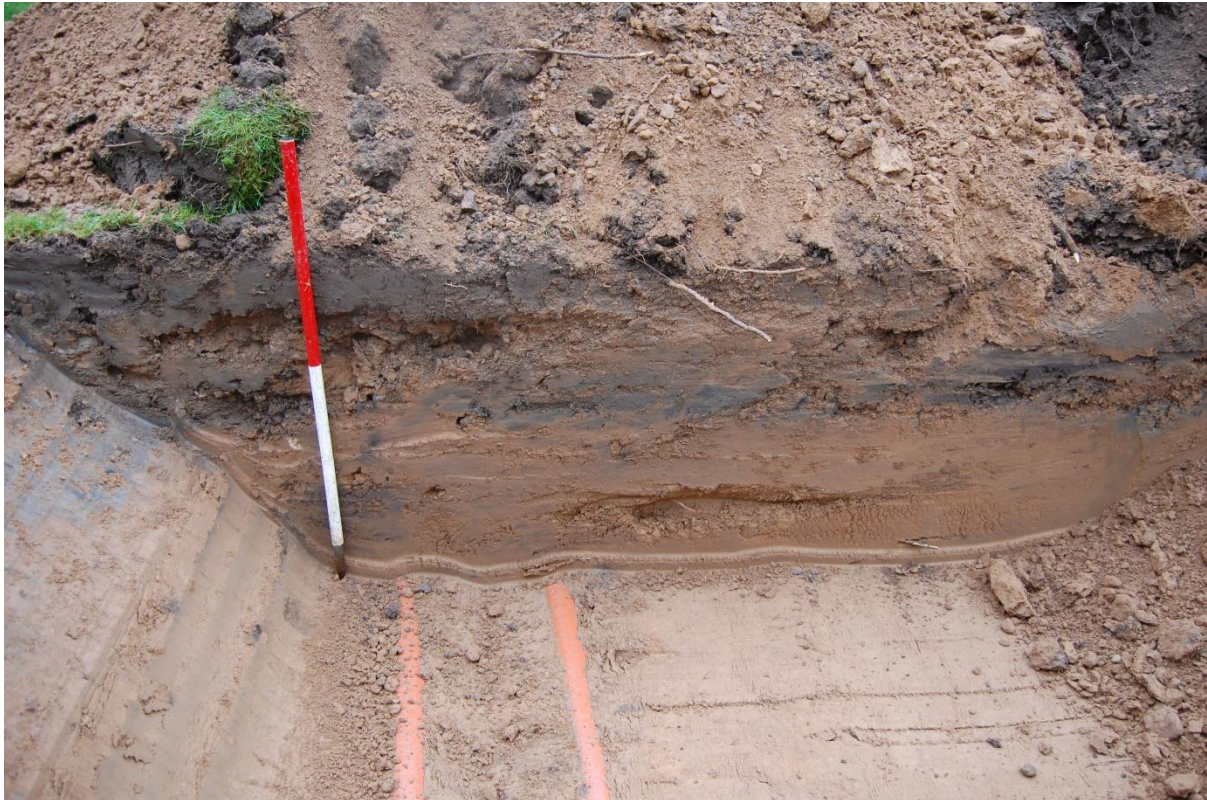
Trench 1 was located in Area B on the west of the amenity housing. The upper 0.5m of the trench was mixed sand, soil and modern rubble on top of wet clean light brown beach sand. At the north end of the trench a cut was located for two plastic drainage pipes (Illus 3).

Illus 2 Trench 1 section with plastic drainage pipes; facing NE

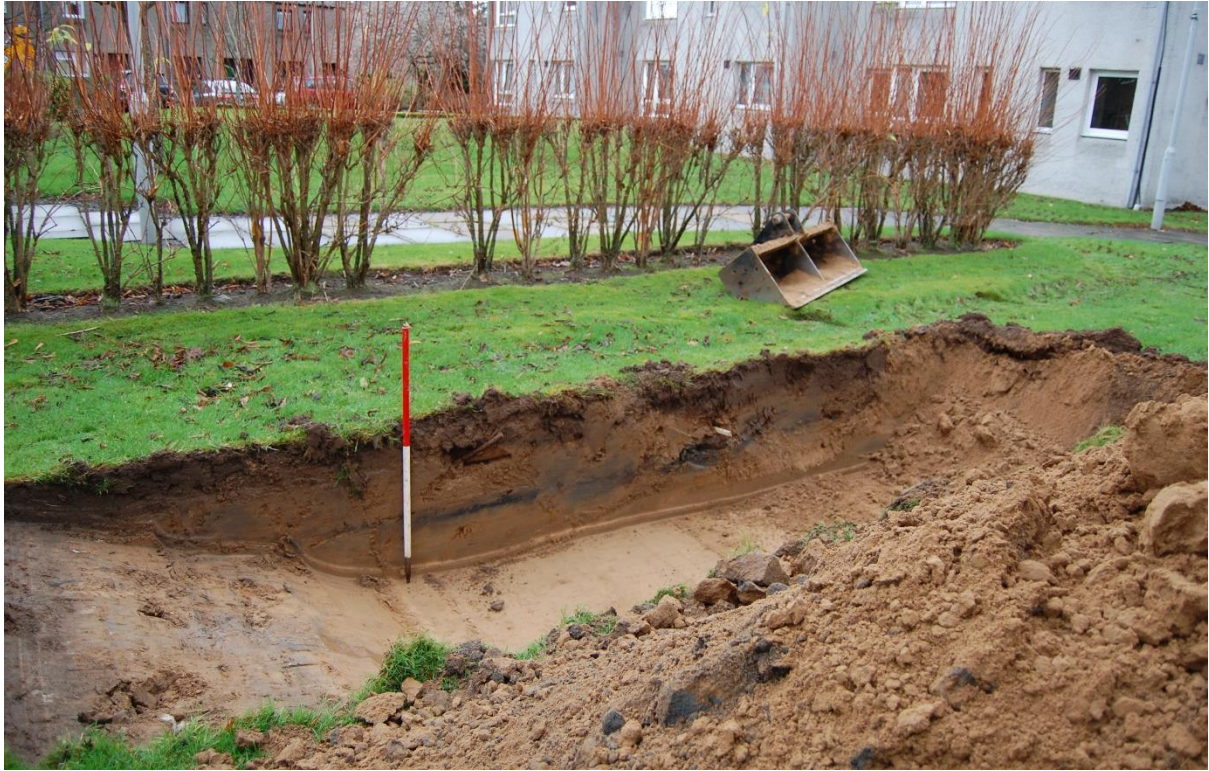
Trench 2 was located at the north end of the internal courtyard within the current amenity housing. The upper 0.5m of the trench was mixed sand, soil and modern rubble on top of wet clean light brown beach sand. At the north end of the trench a cut was located for two plastic drainage pipes (Illus 4).

Illus 3 Trench 2; facing SW

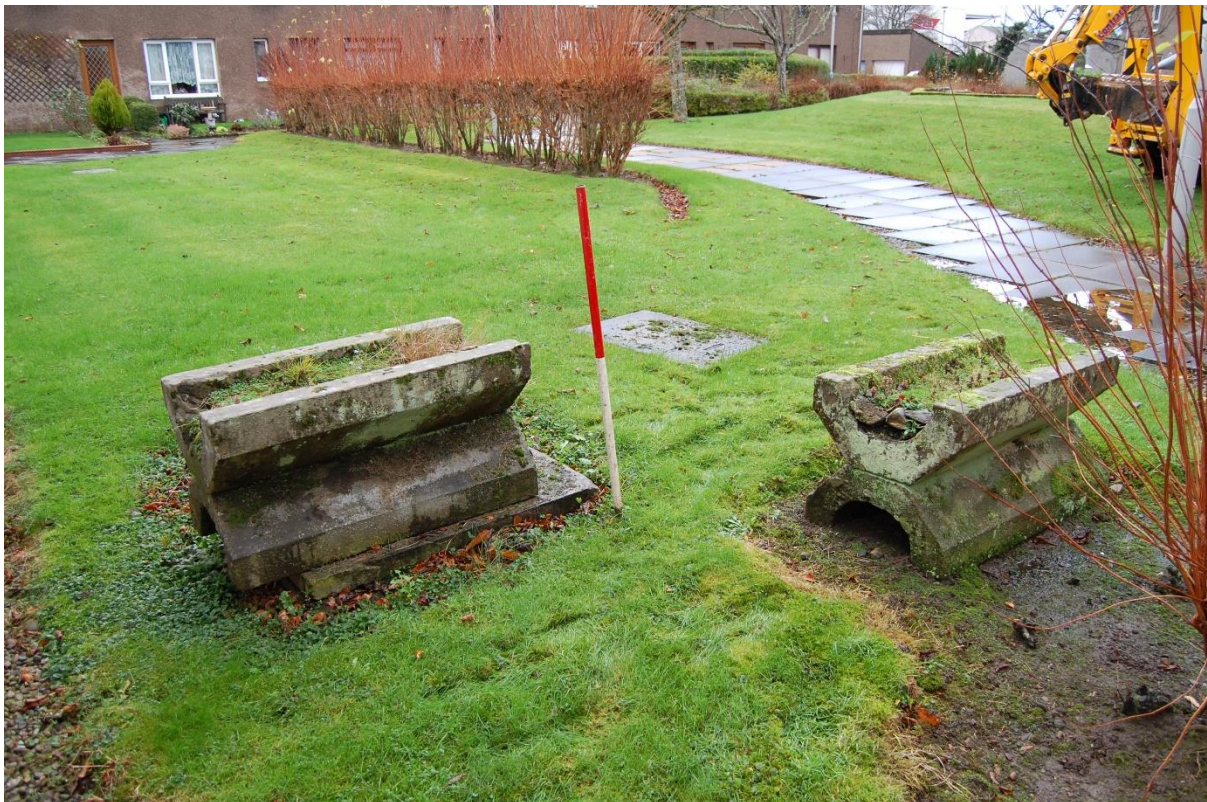
Nine items of stone had been reused within the garden of the amenity housing. F1 and F2 are sections of sandstone drain/gutter paired to form flower containers (Illus 6). F3 is a stack of three sandstone pillar bases stacked to form a flower container (Illus 7). F4 and F5 are sections of shaft with a capital from one of the 17th-century arcades which can still be seen in 7 High Street, Elgin (Illus 13) and F7-9 are sandstone pillar bases reused as flower containers.

Illus 5 F1 (left) F2 (right); facing ENE

- It is recommended that no further archaeological work is required during the redevelopment of amenity housing.
- It is recommended that the stonework should be reused within the new amenity housing development.

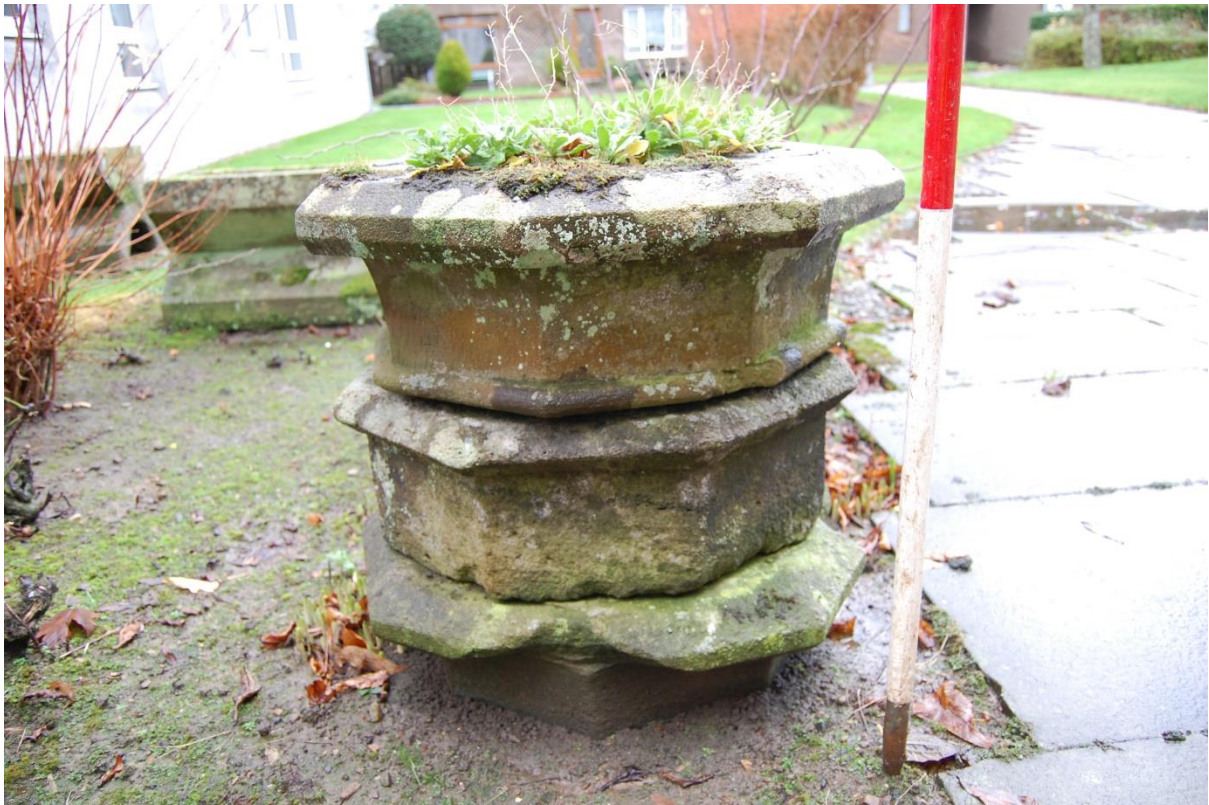
Illus 6 F3; facing ENE

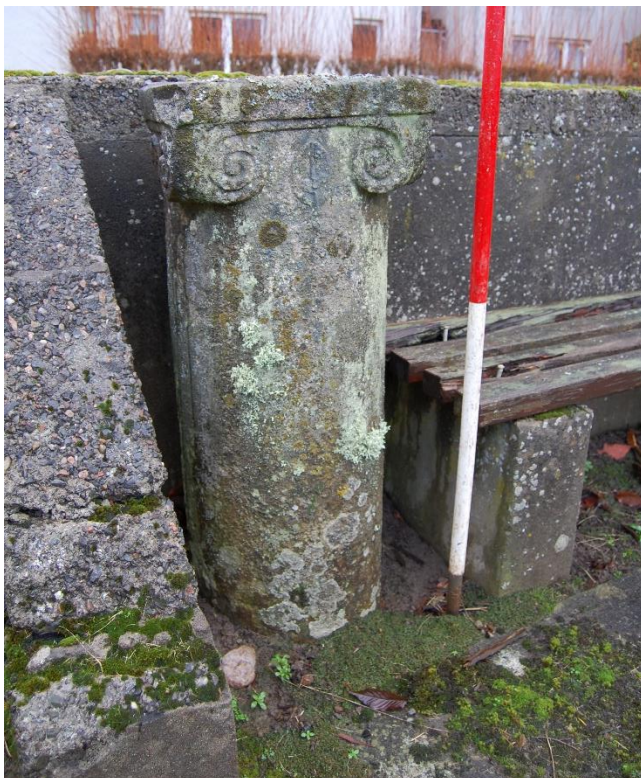
Illus 7 F4; facing N

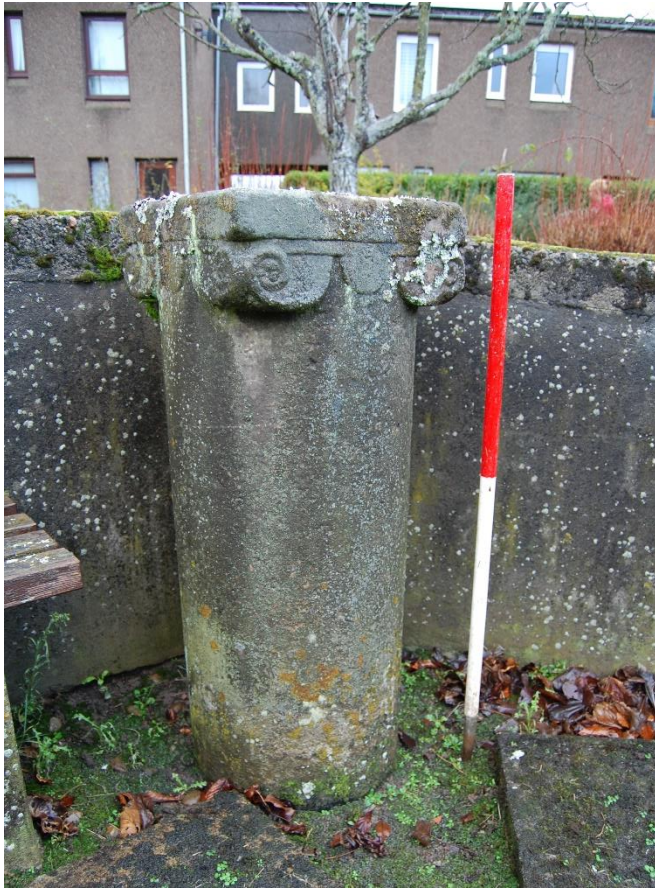
Illus 8 F5; facing NE

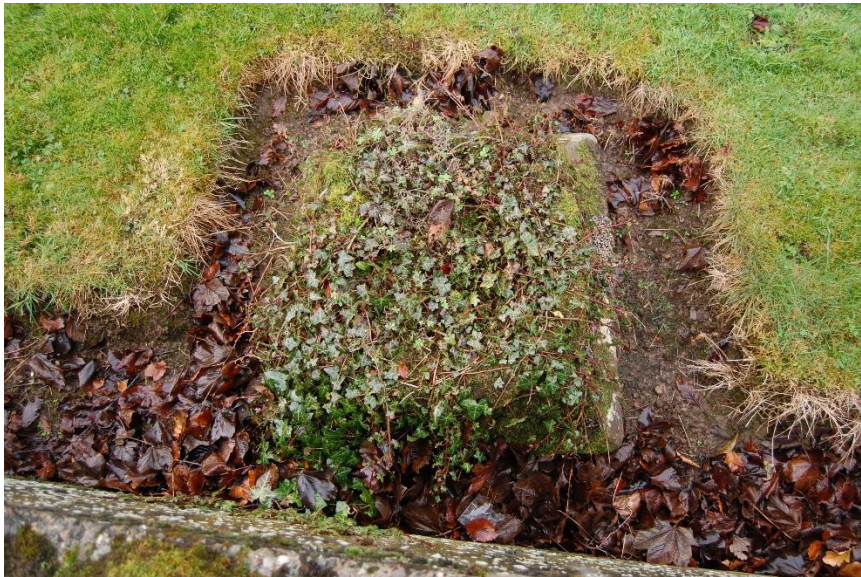
Illus 9 F7; facing W

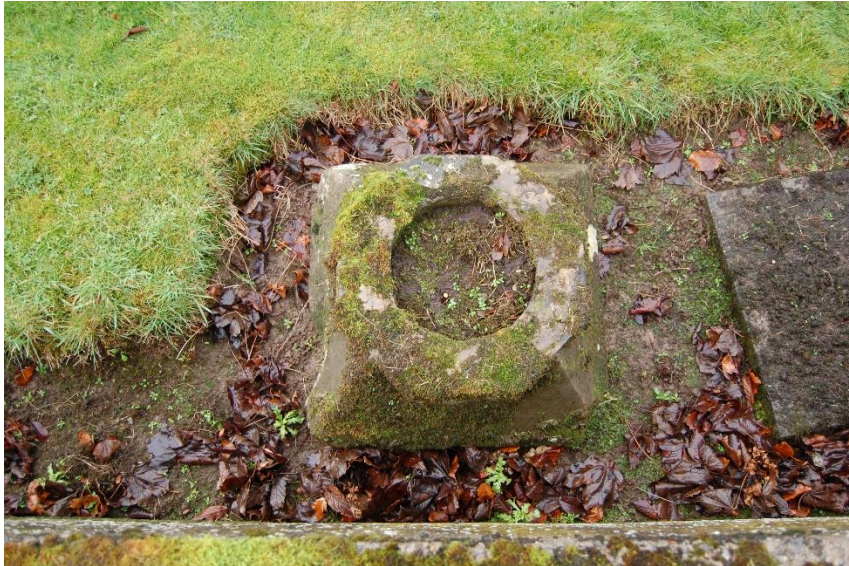
Illus 10 F8; facing W

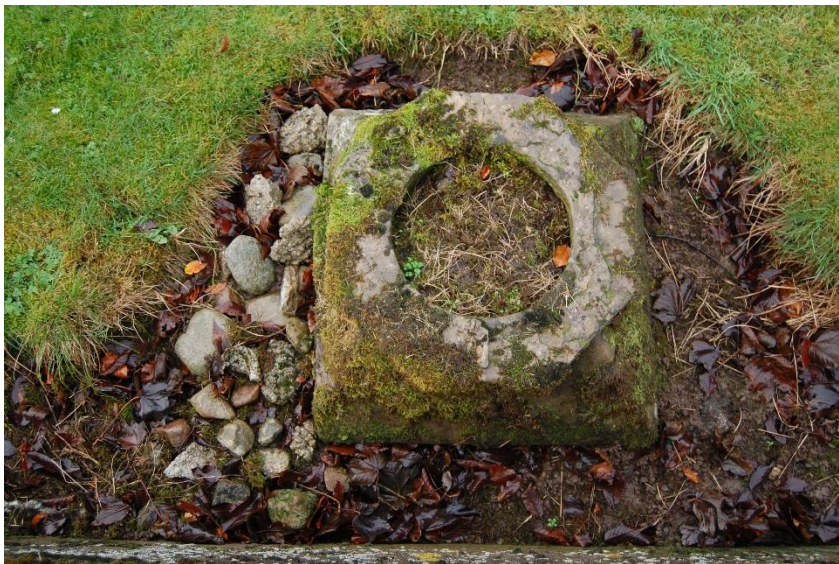
Illus 11 F9; facing W

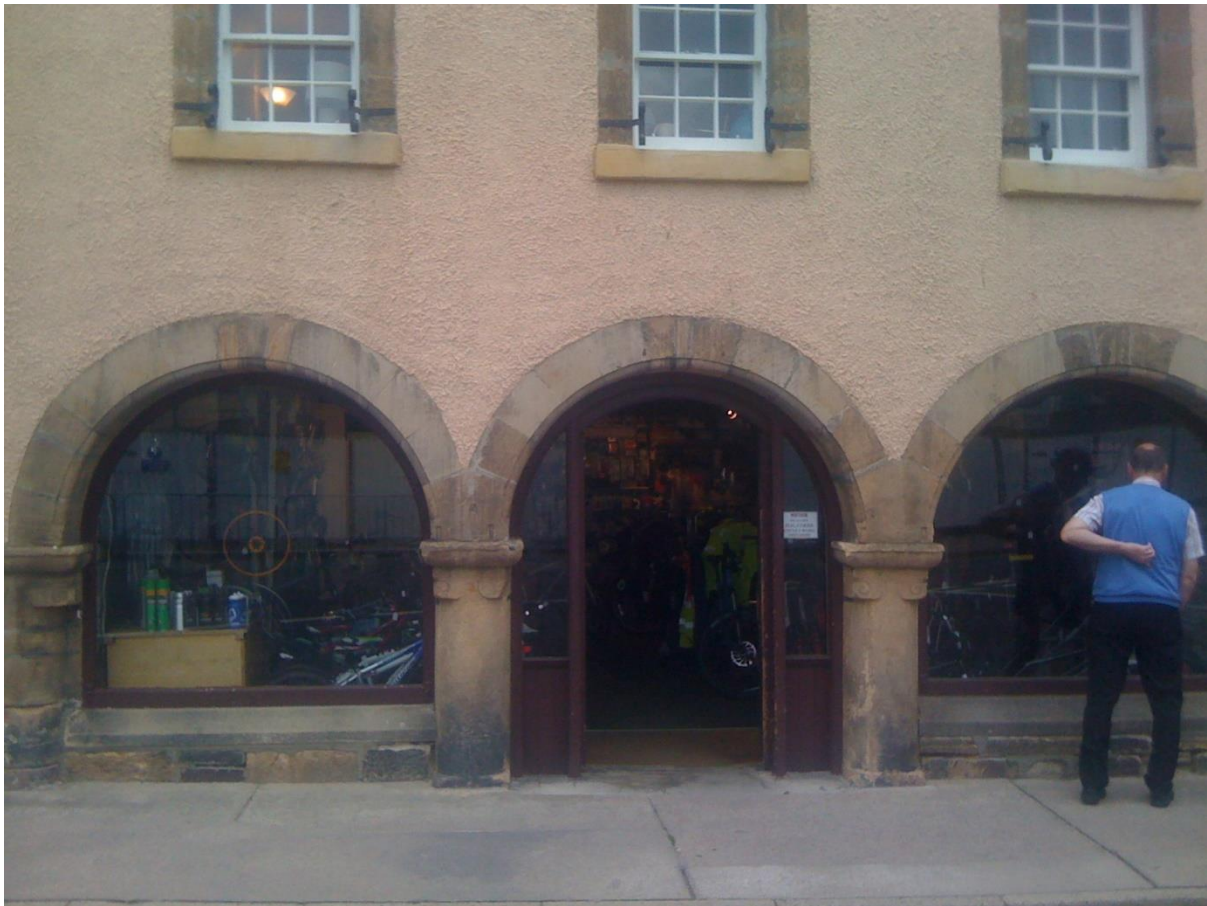
The three trenches excavated indicate that the area was scarped during the construction of the amenity housing in the 1970s. The stonework recorded probably comes from a nearby site where 17<sup>th</sup>-century arcades (Illus 13) were being demolished and the stone was used in the garden of the amenity housing.

Illus 12 7 High Street, Elgin showing 17<sup>th</sup>-century arcade

The architects (ICOSIS) are intending to resite the stonework within the new amenity housing development.
