**Report on Archaeological Evaluation
Proposed housing development, East Lodge,
Ury Estate, Stonehaven, AB39 3QA**

**Alison Cameron
Cameron Archaeology
14 August 2015**

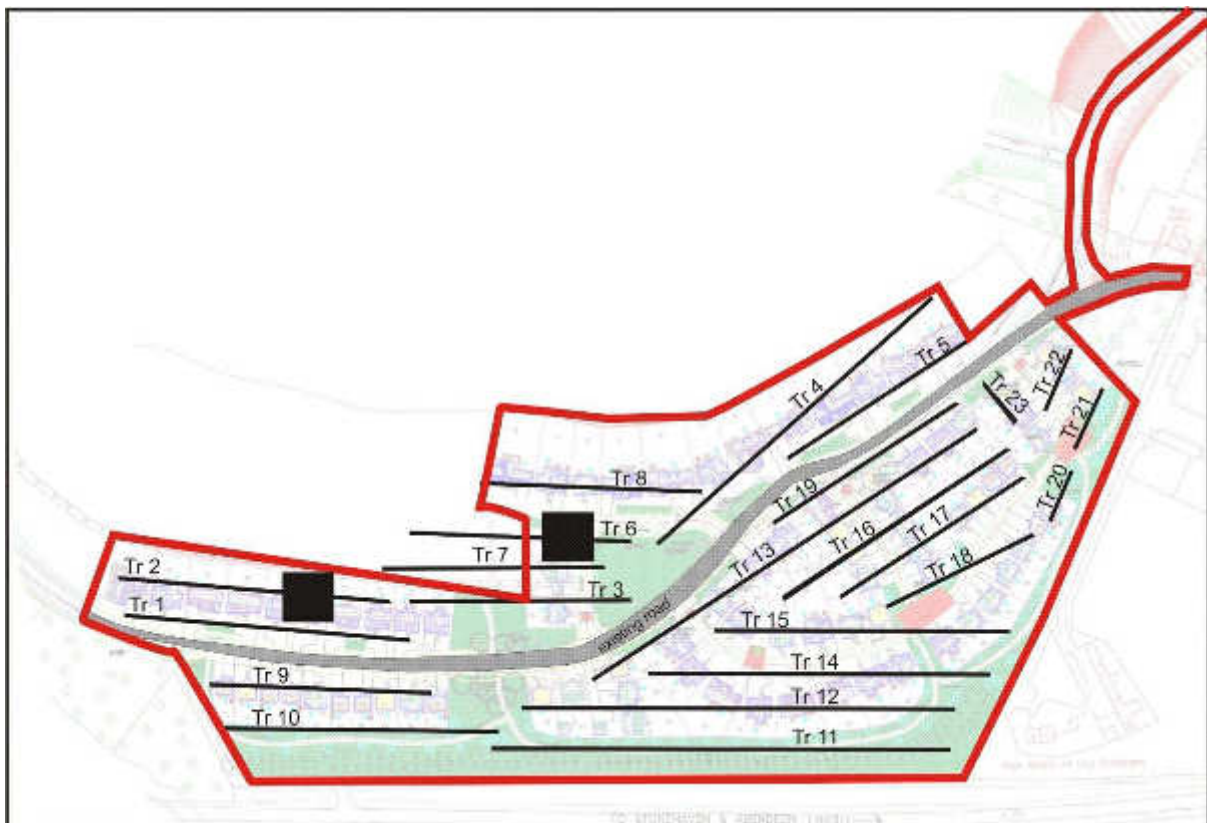
Illus 4 Plan showing evaluation trenches and two 20x20m box trenches (*copyright Kirkwood Homes*)

A 7% archaeological evaluation was carried out from 11-19th September 2014 by Stuart Farrell. 23 trenches were excavated with a 14 ton tracked machine with a 1.8m ditching bucket and two areas opened with 20 x 20m box trenches. The topsoil was shallow (c25cm) in most trenches and deep modern plough scars were seen in Trenches 9-23.

An irregular charcoal spread was uncovered in Trench 6 but a box trench 20 x 20m in size revealed that this was the remains of a burnt tree bole and no further features were identified in the trench.
