**An Archaeological Watching Brief on Trial Pits (CA215)
Station Hotel, 78-80 Guild Street, Aberdeen, AB11 6GN**

**Robert Lenfert
Cameron Archaeology
January 26th, 2015**

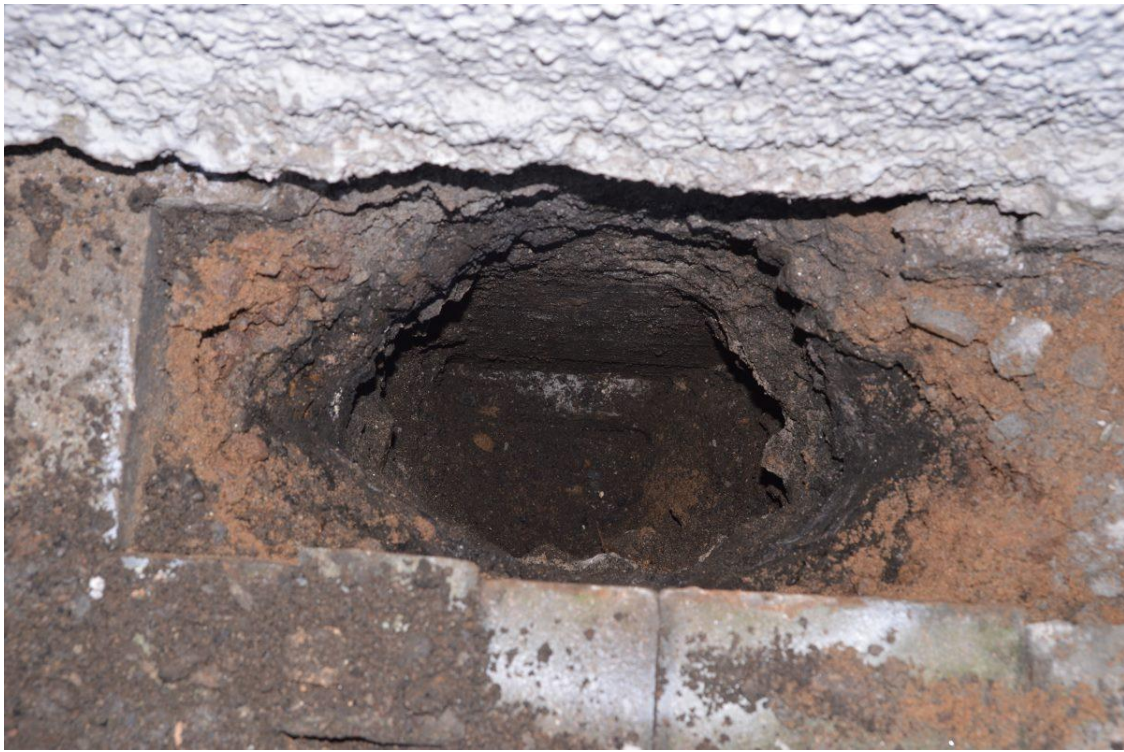
Illus 4 Hand-dug Test Pit 2 (HD2)

HD2 – (Illus 4) An orange-brown fine sand overlies a dark, sooty layer of gritty soil with a slight organic component which extends to the bottom of the test-pit. No archaeological remains were encountered. It is reasonable to suggest this darker, lower context represents infill associated with civil works, or alluvial deposits washed in from the nearby coast or former watercourse of the River Dee itself.

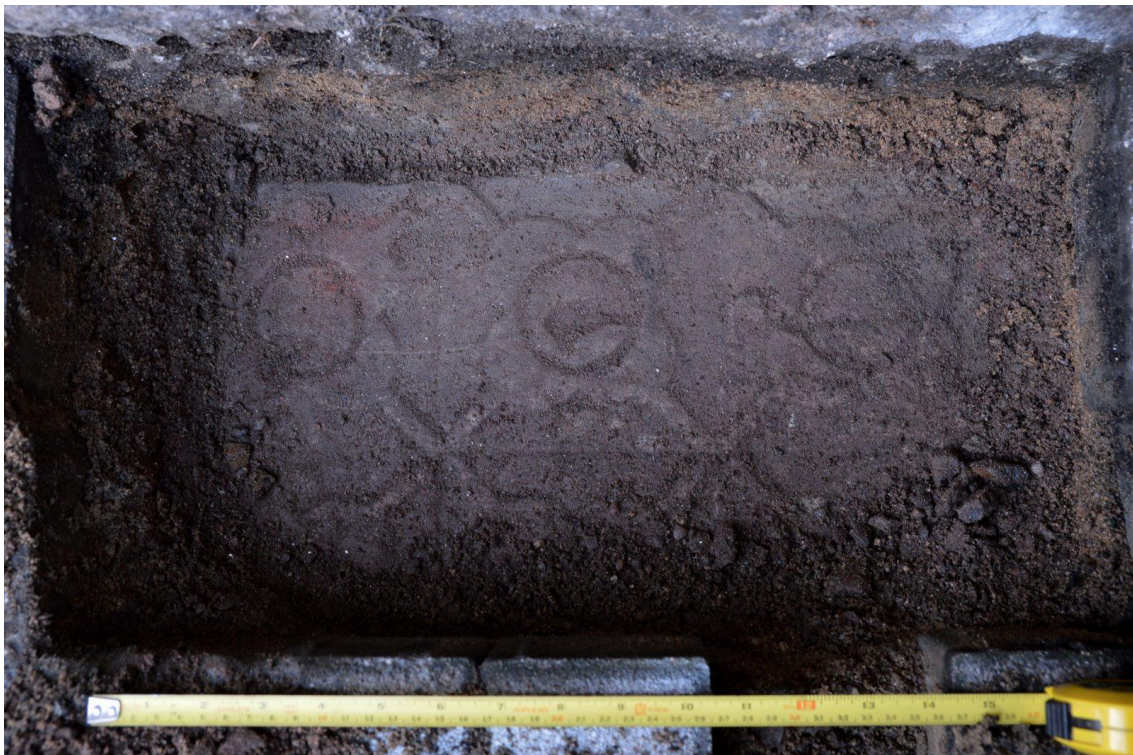
Illus 5 Hand-dug Test Pit 1 (HD1). South-west-facing view of flooring tiles unearthed in HD2 (photo: author). Note layer of clean sand on top imported to site for modern paving slabs and shallow buried depth (>20cm) of tiles.

HD1 – Soon after excavation began adjacent to the NE facing wall of the hotel, dark red clay flooring tiles with a distinct raised motif moulded on top were revealed at a depth of c.20cm (Illus 5). The tiles are 6x6 inches each, with a simple symmetrical four-petal flower motif and straight lines radiating from each corner to produce an x-shaped join between flowers. It is thought that the tiles would have been revealed during re-surfacing (c.1990), as a clean layer of sand lies directly on top. The tiles may be tentatively dated to the late-19th or early 20th C, or perhaps more specifically to the construction of the hotel, completed in 1894 (Brogden 1998). An attempt to remove one intact was unsuccessful due to the grout used underneath and the small dimensions of the test pit. No other archaeological remains were present, but one may safely assume that tiles remain intact at least in the immediate surrounding area.

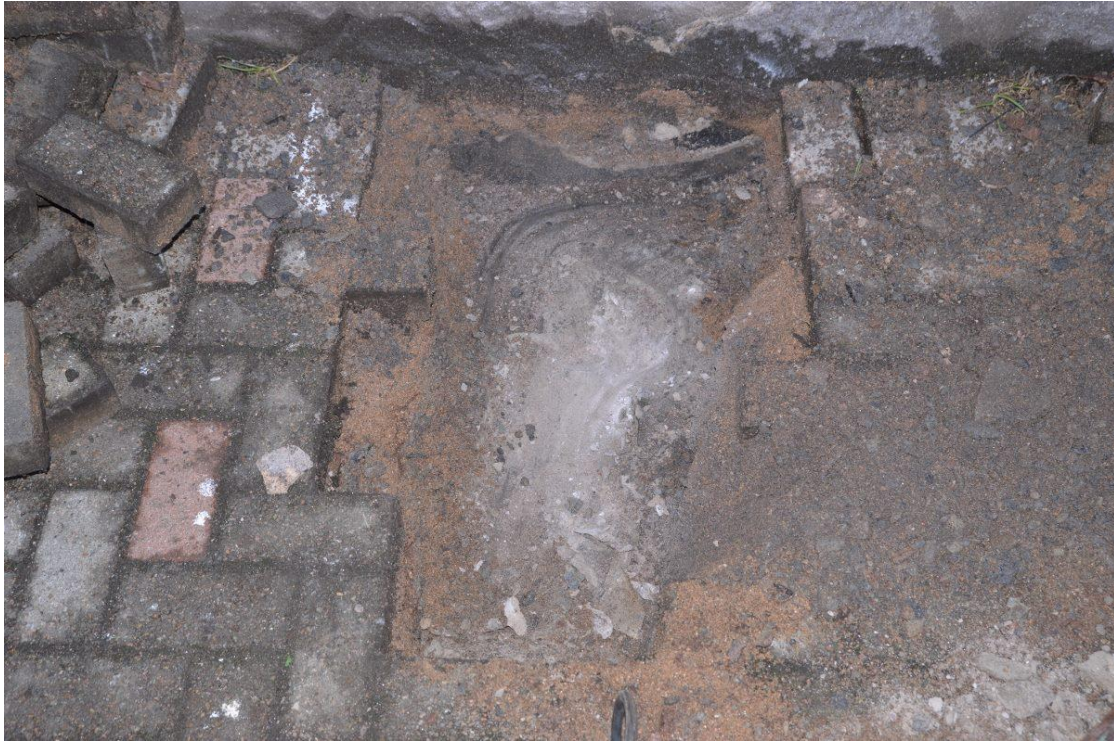
Illus 6 Hand-dug Test Pit 3 (HD3)

HD3 – (Illus 6) Excavation immediately revealed a concrete foundational layer associated with the walling which surrounds the car park. The engineer and drillers made a decision to halt at this point as the roto-hammer could not break through. No archaeological remains were found.

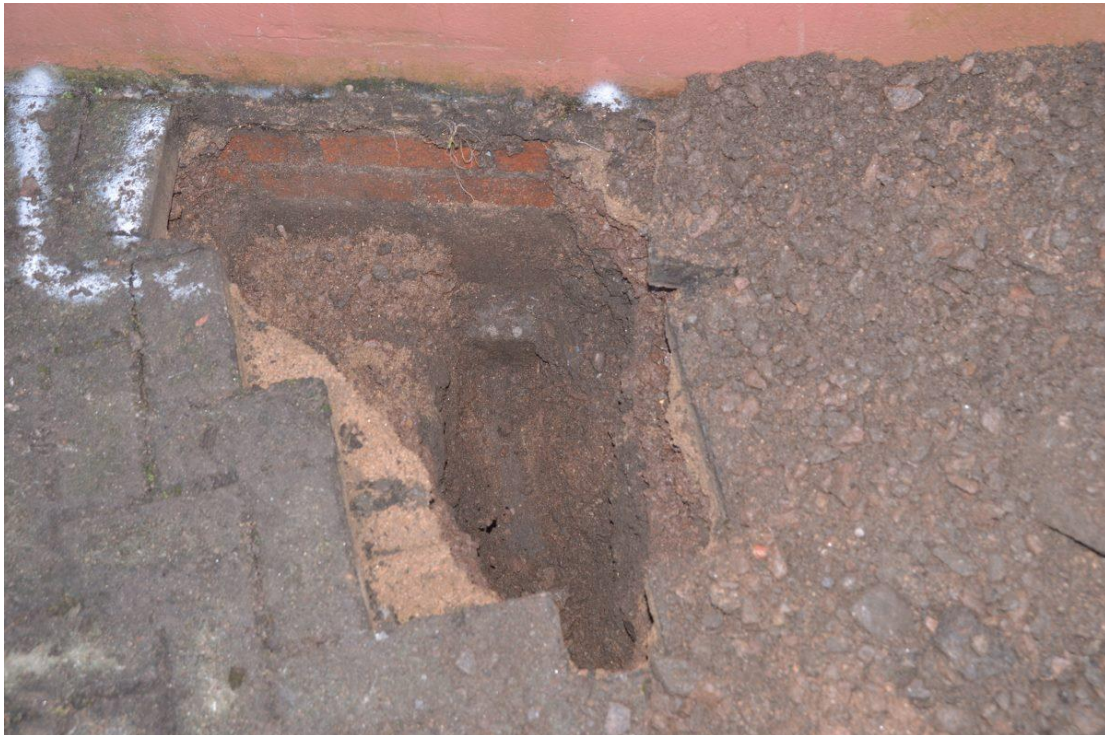
Illus 7 Hand-dug Test Pit 4 (HD4)

HD4 – (Illus 7) Similar to HD2, though slightly lighter in colour, perhaps a reflection of relative soil dampness No archaeological remains were encountered.

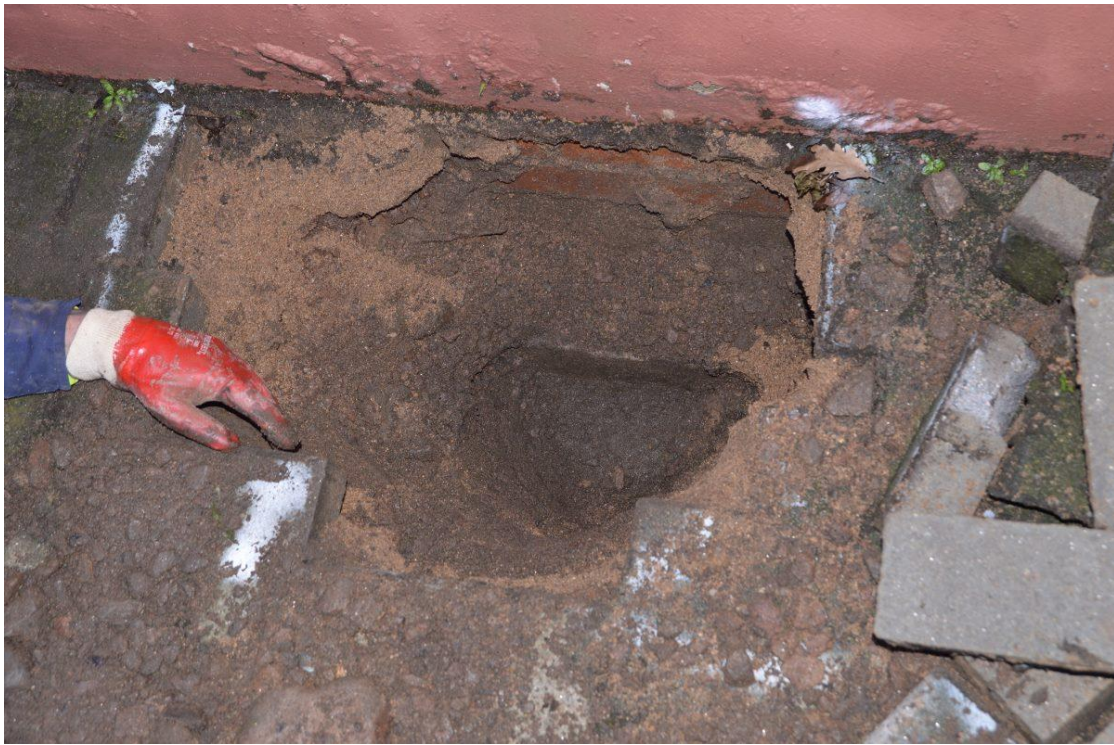
Illus 8 Hand-dug Test Pit 5 (HD5)

HD5 – (Illus 8) Similar to HD2 and 4, this pit did not reveal any archaeological material, though the brickwork for the car park walling was seen to extend for several courses.

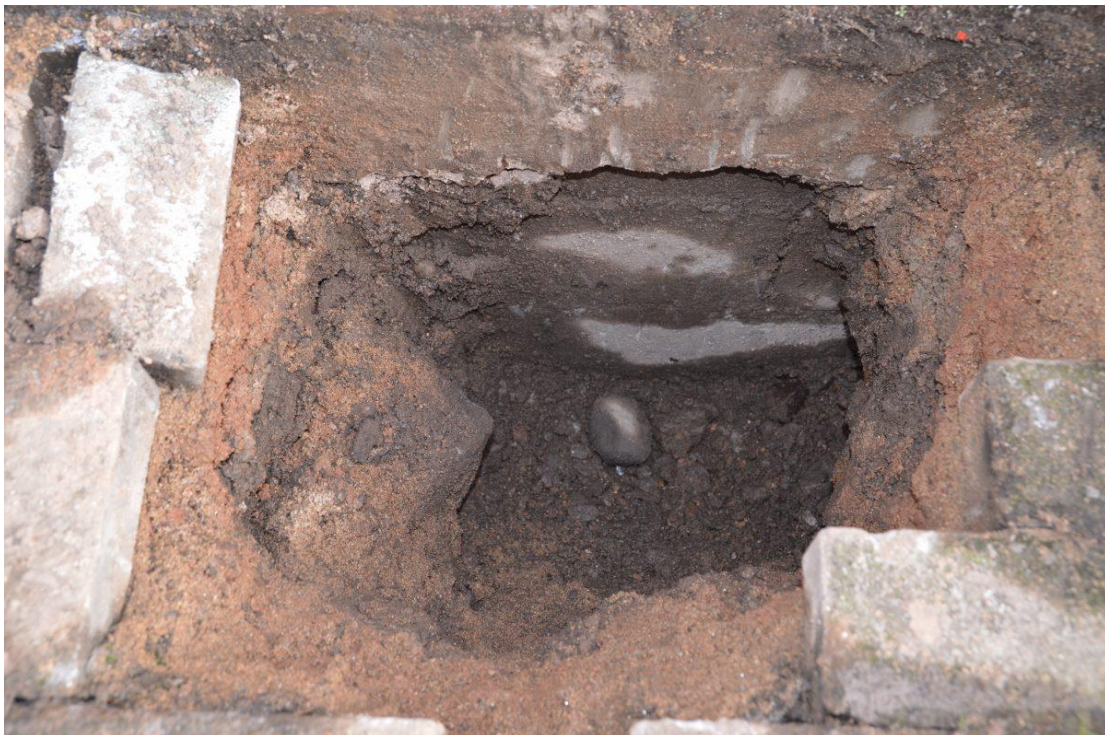
Illus 9 Hand-dug Test Pit 6 (HD6)

HD6 – (Illus 9) Again, a sandy-layer overlies a dark, gritty layer of soil with a slight organic component. The edges of the footer for the car park wall were also exposed. No archaeological material was noted.

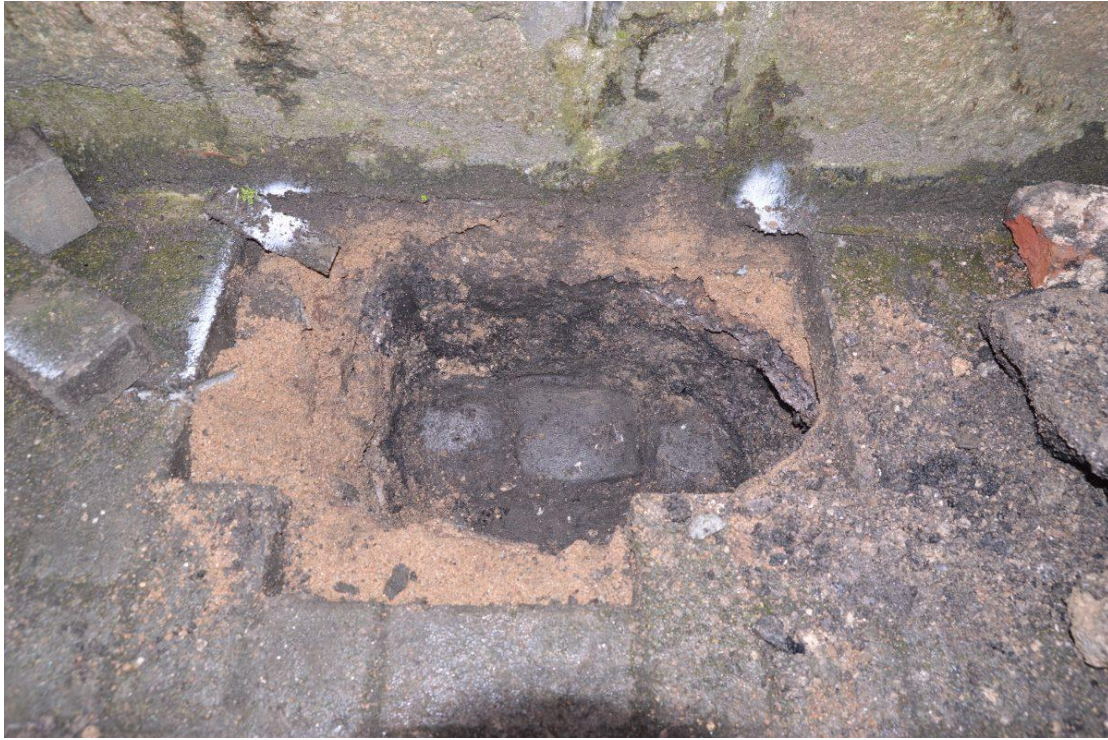
Illus 10 Hand-dug Test Pit 7 (HD7)

HD7 – As this pit was immediately adjacent to a granite buttress along the car park wall (as opposed to brick for the remainder), robust granite footers were encountered which brought excavation to a halt. No archaeological material was noted.

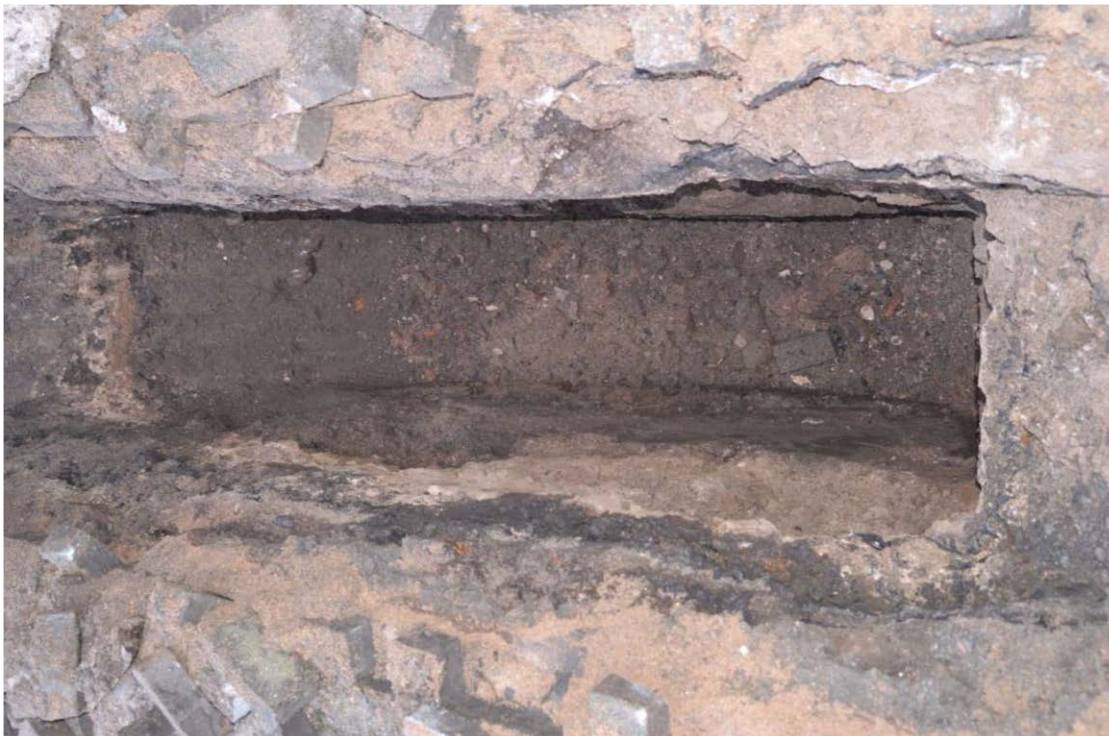
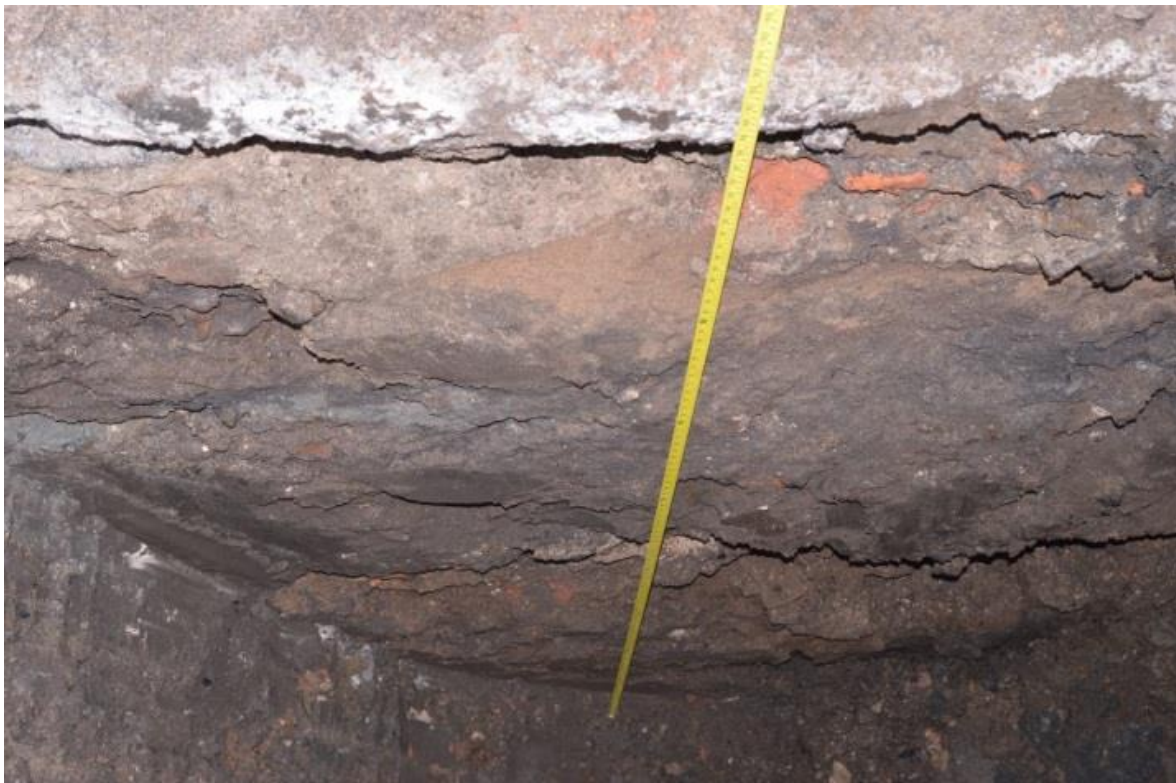
Illus 11 Machine Test Pit 1 (MP1)

An 8-ton excavator with a c.60cm bucket was used to reach a maximum depth of c3.5m below the current surface, creating a relatively narrow, yet deep inspection window. As the sides were prone to collapse and small slumps occurred several times, photos were taken at arm's length from a safe distance, while close visual inspection of the deeper strata was impossible for safety reasons (Illus 14). However, photos captured general detail in the lower reaches, albeit at sharp oblique angles.

MP1 – (Illus 11,14,17, 18) The first machine trench produced the most artefacts, including a number of animal bones, later identified as sheep, in addition to a number of locally-produced Seaton ceramic sherds (production 1868-1964) including bases, in addition to white porcelain sherds found from 2m onwards. The bone and Seaton ceramic artefacts appeared from the mid- to lower reaches of the pit, 2.0m to 3.0m/deep, but it was difficult to ascertain if these artefacts represented infill from civil engineering works, or indeed intact archaeological deposits. A banded layer of what appeared to be reddish sandstone rubble was also visible in the lowest reaches of MP1 and MP2, suggesting the possible presence of earlier post-Medieval building materials. One rare surviving example is

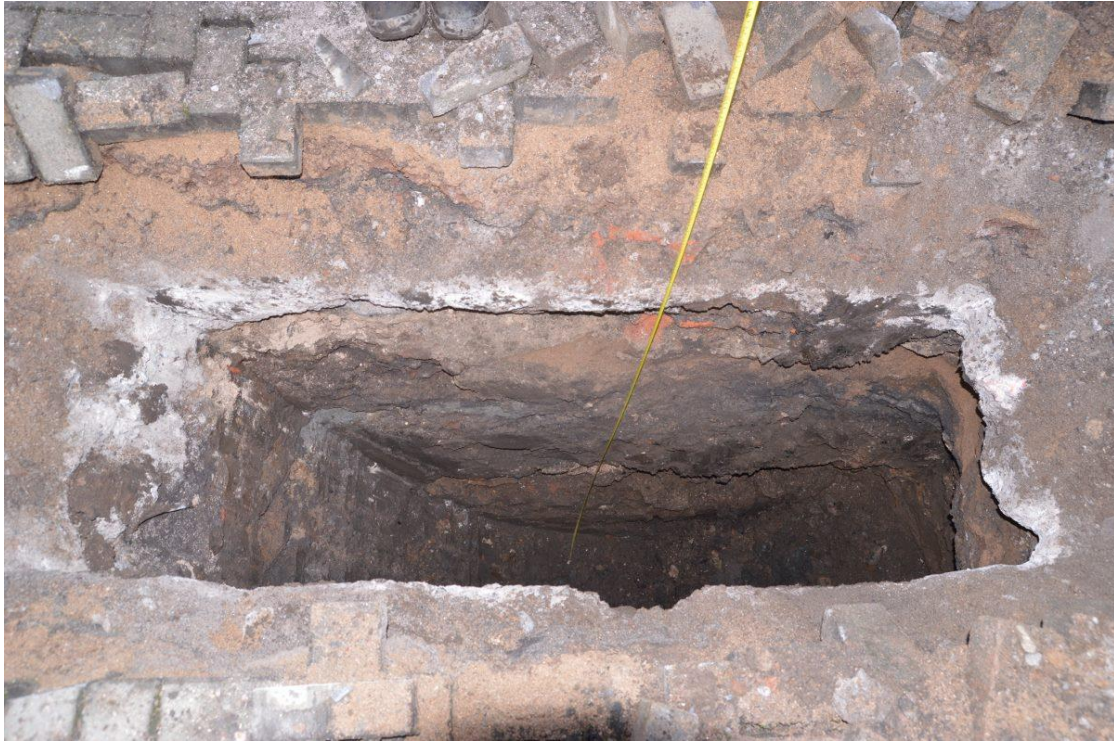
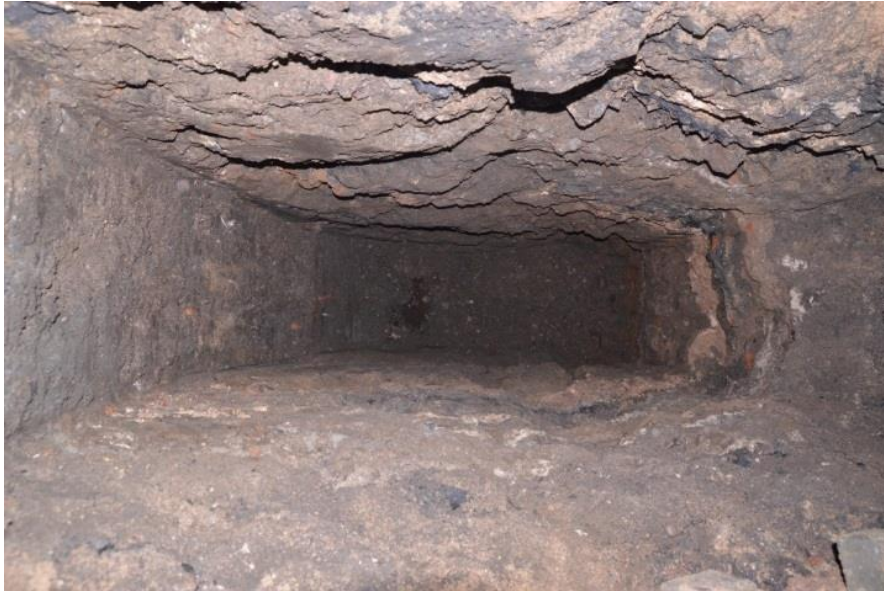
Illus 12 Machine Test Pit 2 (MP2)

MP2 – This pit (Illus 15, 19, 20) was capped under the modern paving by a robust concrete pad (though lacking metal rebar) which soon tore one of the teeth off of the excavator bucket. The concrete was then broken up by a hydraulic jackhammer attachment before progress could resume. Below the concrete, the strata was more homogenous than MP1, revealing a dark, organic layer interspersed with grit and small water-rounded pebbles. Indications of brick or red sandstone rubble were visible below the sandy layer immediately underneath the concrete, but due to trench instability, close visual inspection or sampling was not possible. Towards the lower reaches, c.2.5m, a discreet deposit of building material - either red sandstone or brick - appears. It was not possible to visually determine if this reached the absolute bottom of MP2.

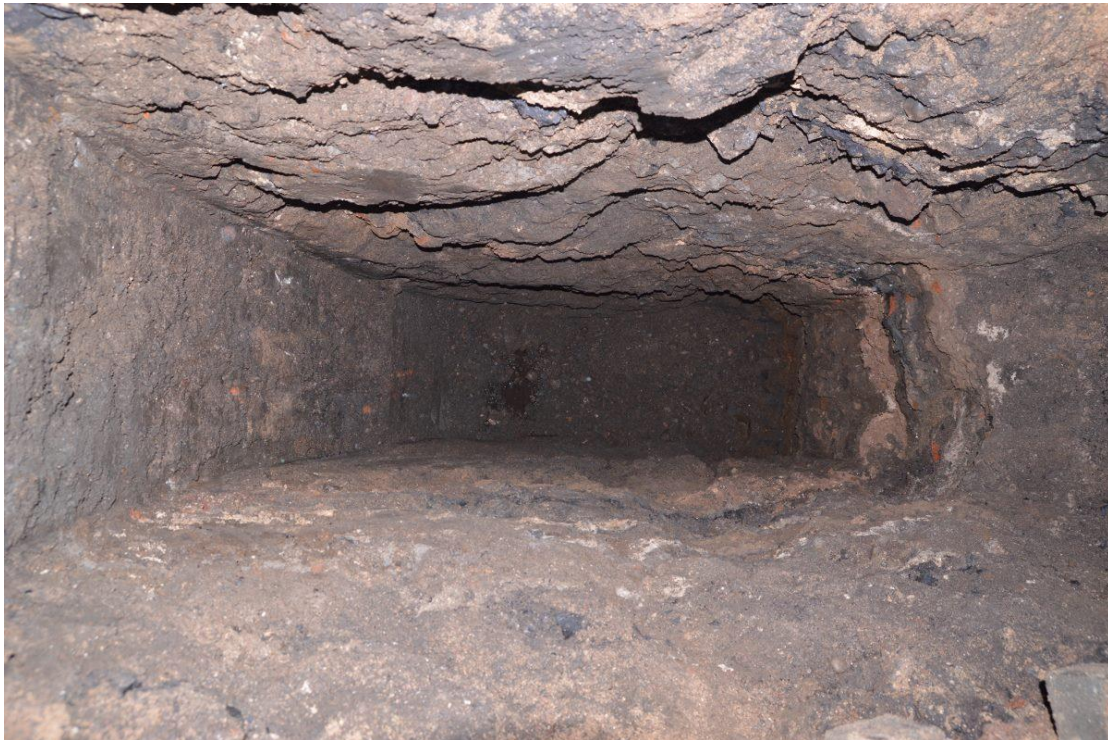
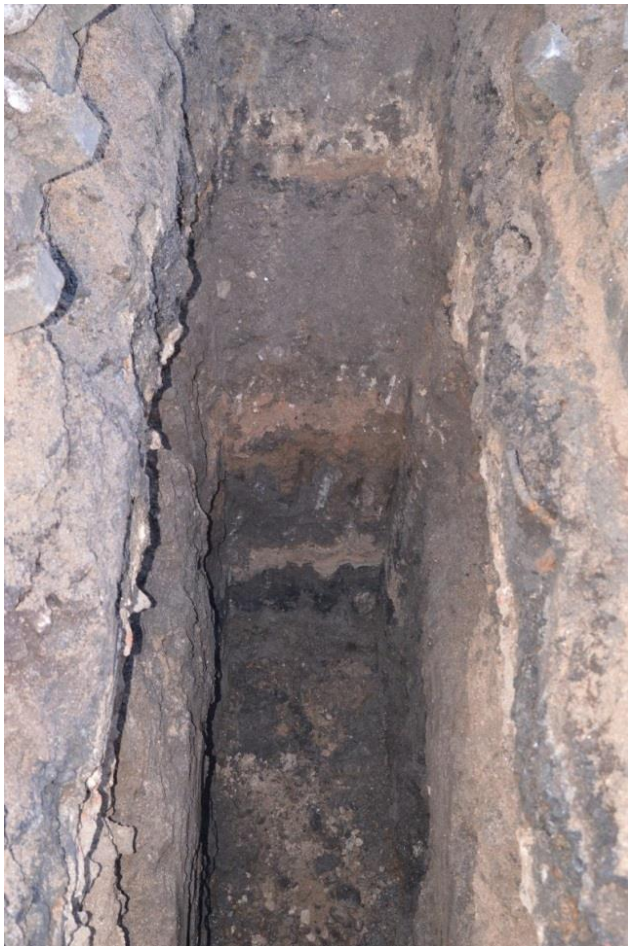
Illus 13 Machine Test Pit 3 (MP3)

MP3 – The final machine pit produced the fewest artefacts (Illus 16, 21), but still yielded one bone fragment and coarse clay ceramics which are possibly fragments of building material or drainage pipes, and finally small timber offcuts which remain preserved in waterlogged conditions near the bottom (c.3.5m). The stratigraphy reveals (from the surface) a mottled gritty deposit of brown silts with dark coal-like inclusions, below which a discreet rubble layer c.1.5m deep with brick fragments.

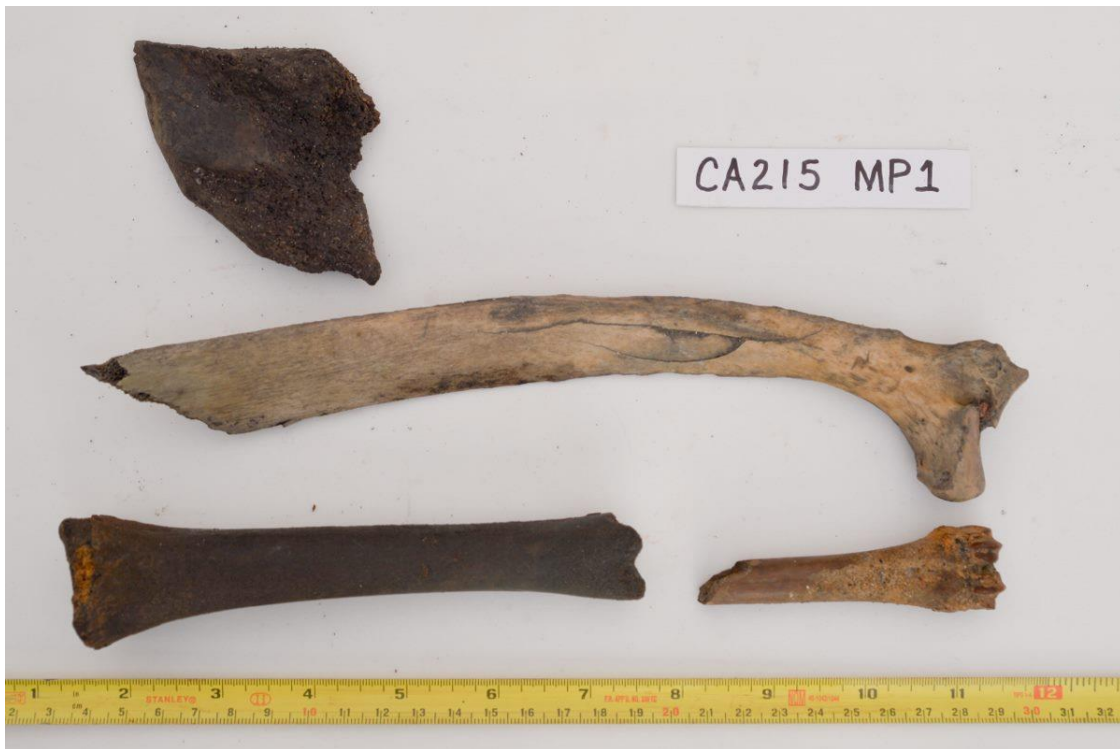
Illus 17 Sheep bone from MP1

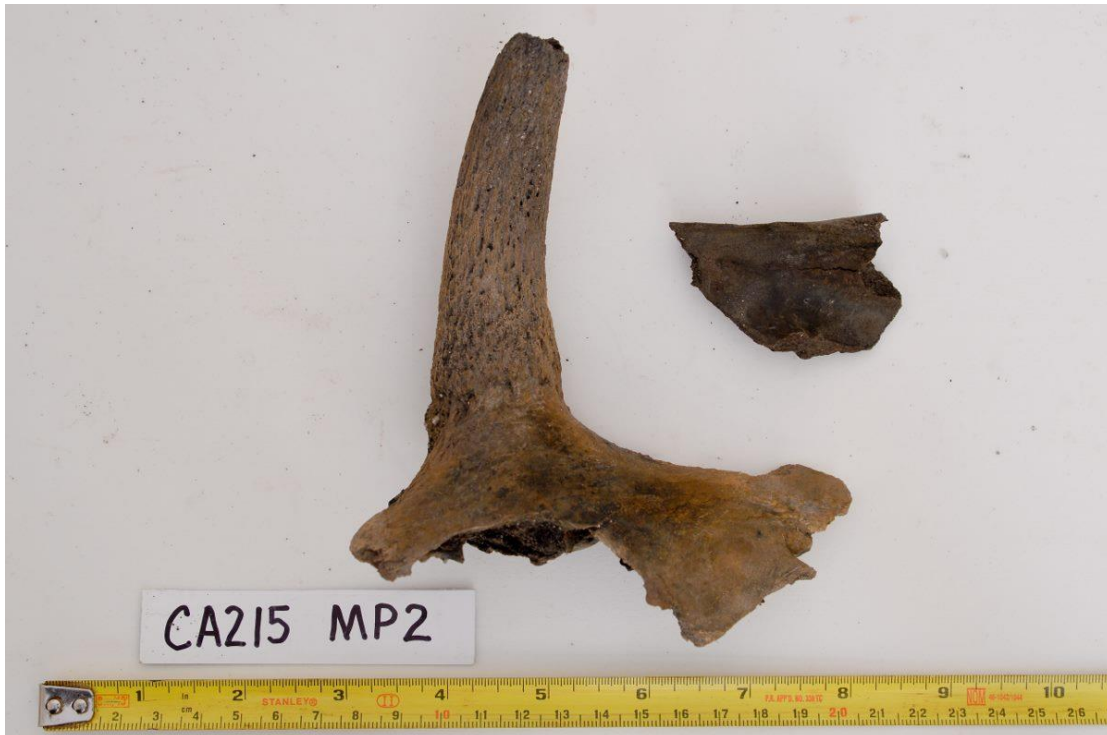
Illus 19 Sheep horn and bone fragment from MP2

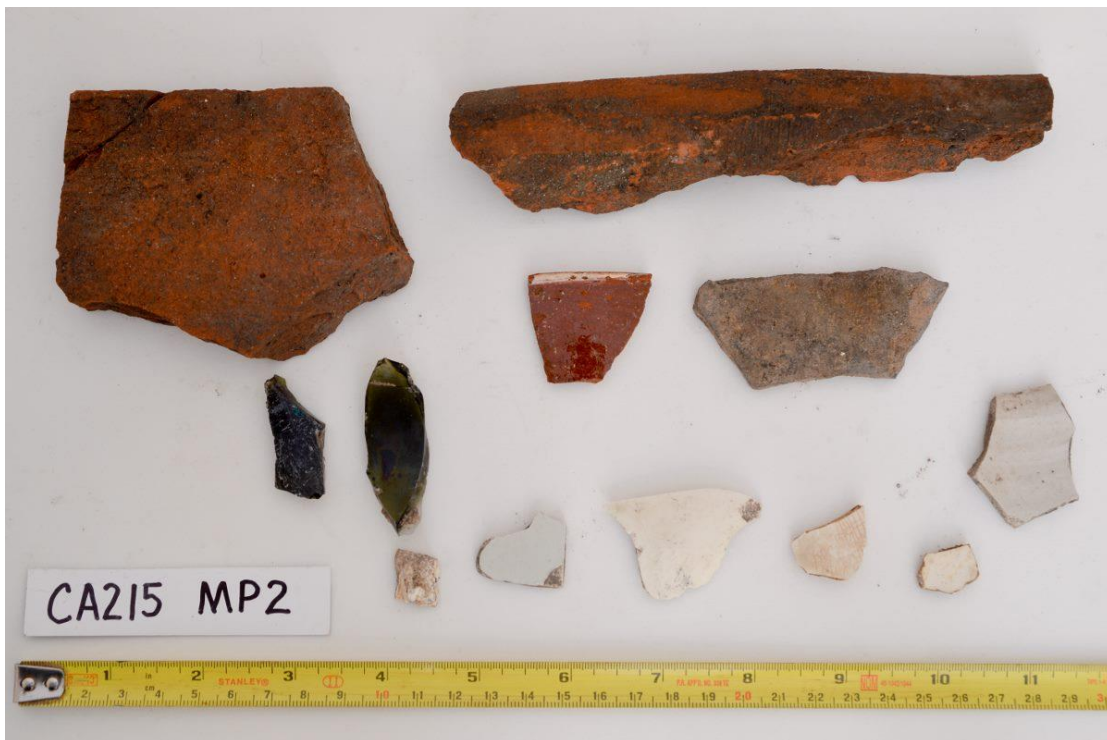
Illus 20 Ceramic and glass (dark green, lower left) recovered from MP2

The question is how much of the deposits remain *in-situ*, and how much were imported as in-fill for the expansion of New Aberdeen over the ensuing centuries, or brought in by periodic flood episodes. Another aspect to consider is the former expanse of foreshore, which would have certainly been a frequent focus for human activity from the prehistoric to the early modern period, ranging from subsistence to recreational activities. Given the rather unstable nature of the machine test pits, it was difficult to closely examine and conclusively determine the intactness of the deeper deposits, but photos and finds, along with artefacts in the excavator bucket from the deeper reaches, revealed a complex stratigraphy of human activity down to 3.5m, largely of a Victorian nature, though the hand-blown green glass (Illus 18) with bubbled inclusions from MP2, along with the devitrified nature of the glass itself, suggests an earlier date.

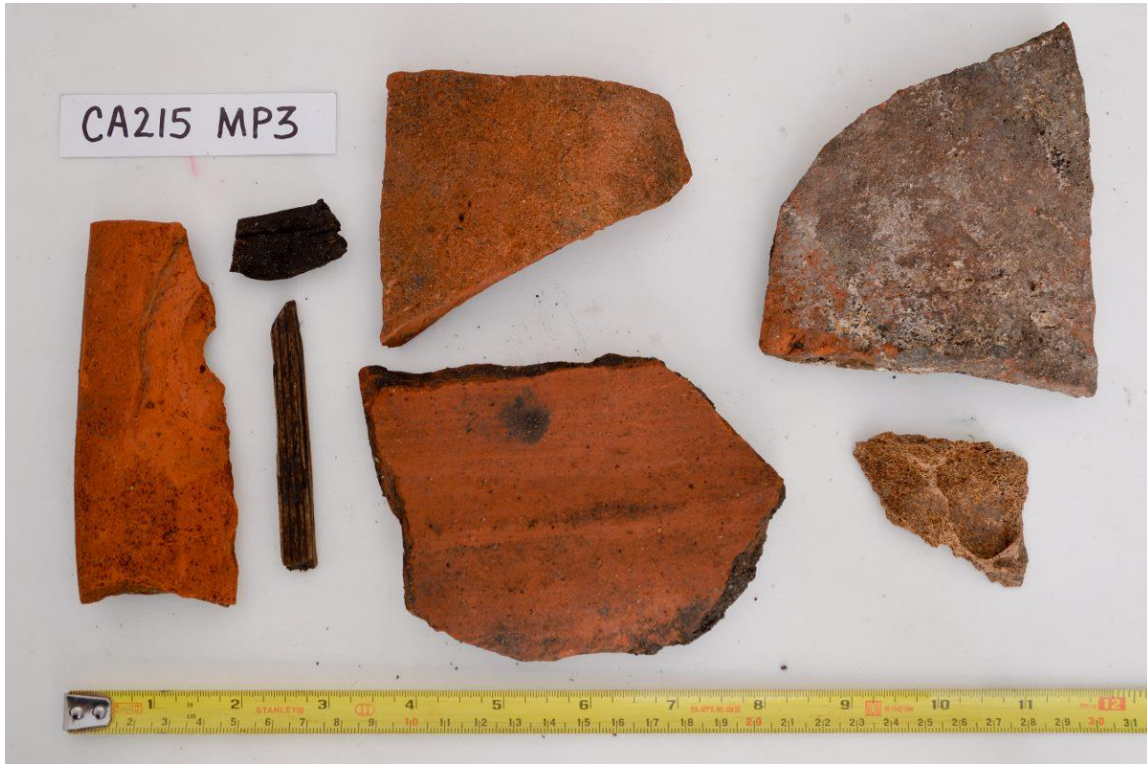
Illus 21 Course ceramic finds, small timber offcuts (below label, L) and small bone fragment (lower right) from MP3.
