**ABERDEEN ART GALLERY, SCHOOLHILL
ABERDEEN, AB10 1FQ
Watching brief on trial pits**

Alison Cameron
Cameron Archaeology
28 January 2015

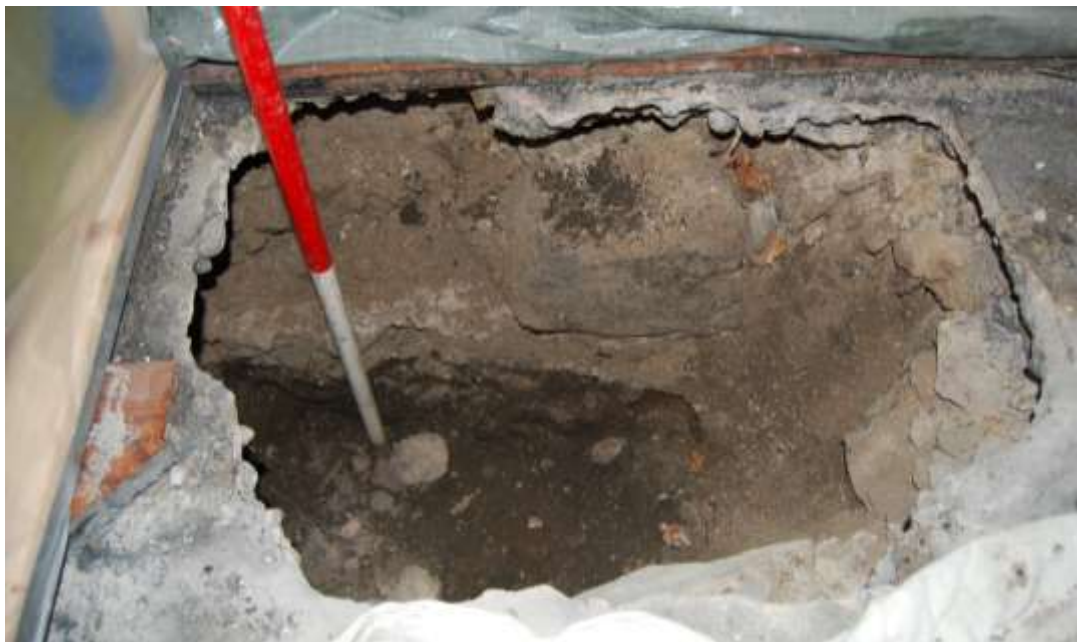
Located on the inside of the north wall of the rear court this trial pit was dug down adjacent to a pillar and revealed the stone pillar base. The test pit contained 40cm of granite rubble, above 50cm of mixed loam, sand, construction debris on top of natural subsoil consisting of reddish brown sand and rounded boulders.

Illus 3 TP4 showing foundation for pillar and loam with construction rubble (2); facing N

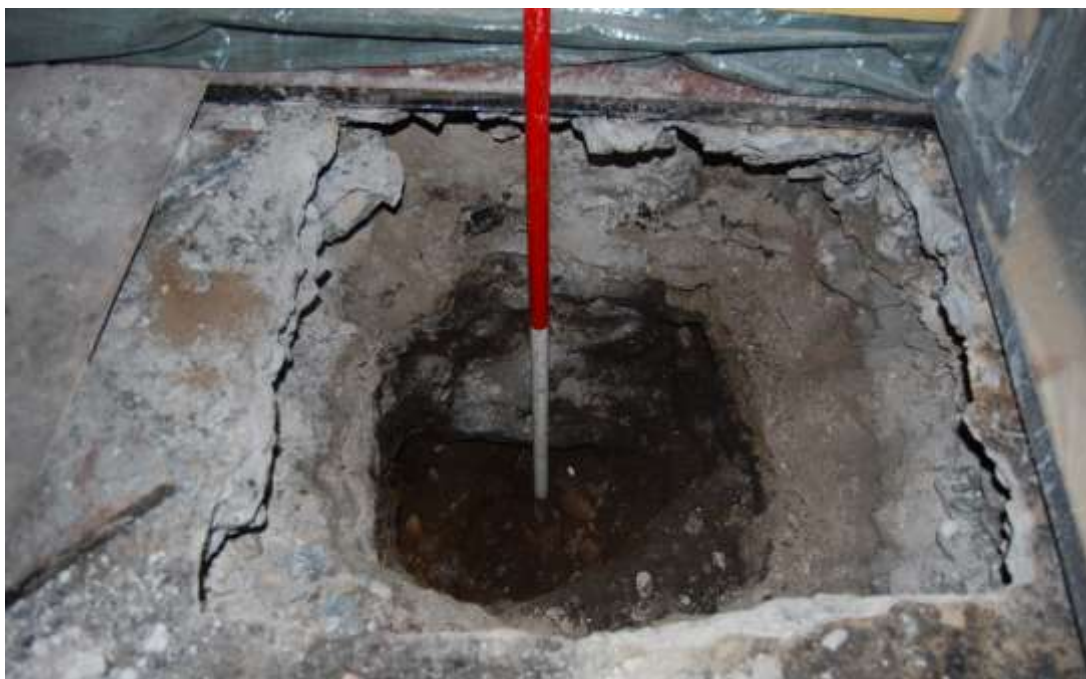
Located on the inside of the north wall of the rear court this TP was dug down adjacent to a pillar and revealed the stone pillar base. The test pit contained 40cm of granite rubble, above 50cm of mixed loam, sand, construction debris on top of natural subsoil consisting of reddish brown sand and rounded boulders.

Illus 4 TP5 showing foundation for pillar and loam with construction rubble (2); facing N

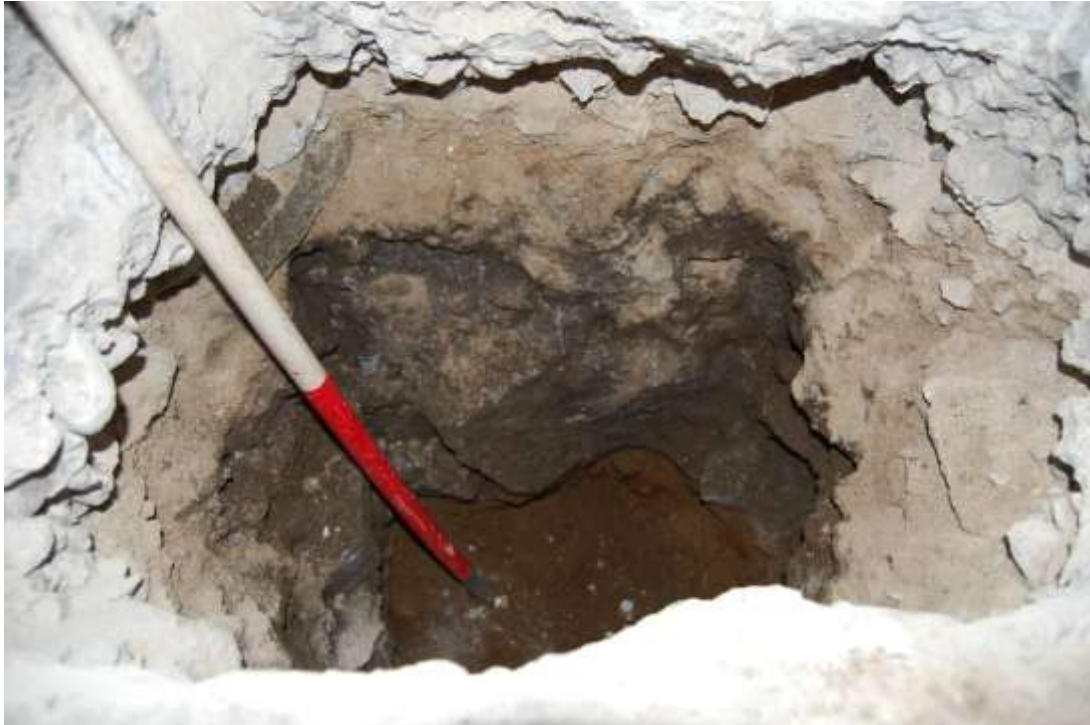
Located on the inside of the NE corner of the rear court this TP was dug down adjacent to a pillar and revealed the stone pillar base. The test pit contained 30cm of granite rubble (1), above 45cm of mixed loam, sand, construction debris (2) on top of natural subsoil consisting of reddish brown sand and rounded boulders.

Illus 5 TP6 showing granite rubble fill, loam and stone (1) on top of natural subsoil; facing N

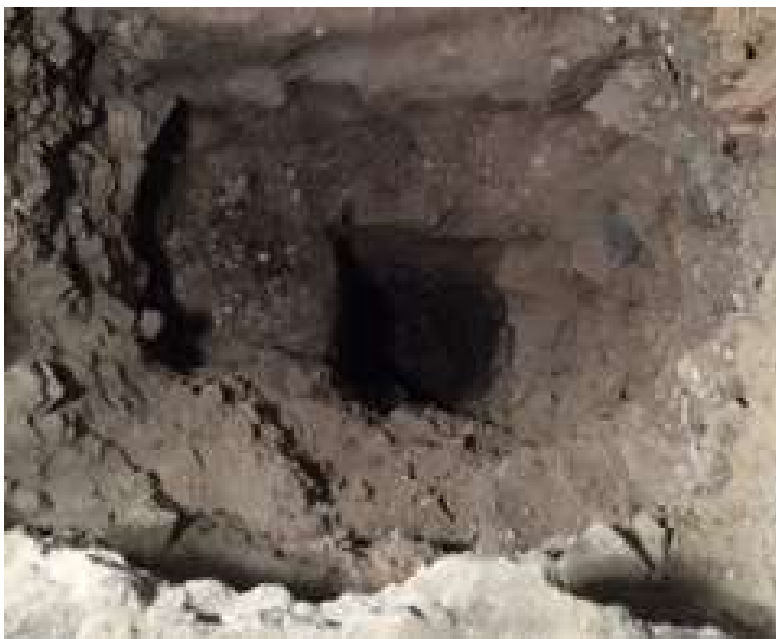
Located on the inside of the east wall of the rear court. It contained rubble fill (1) to 50cm on natural subsoil.

Illus 6 TP7 showing rubble fill (1) above natural subsoil

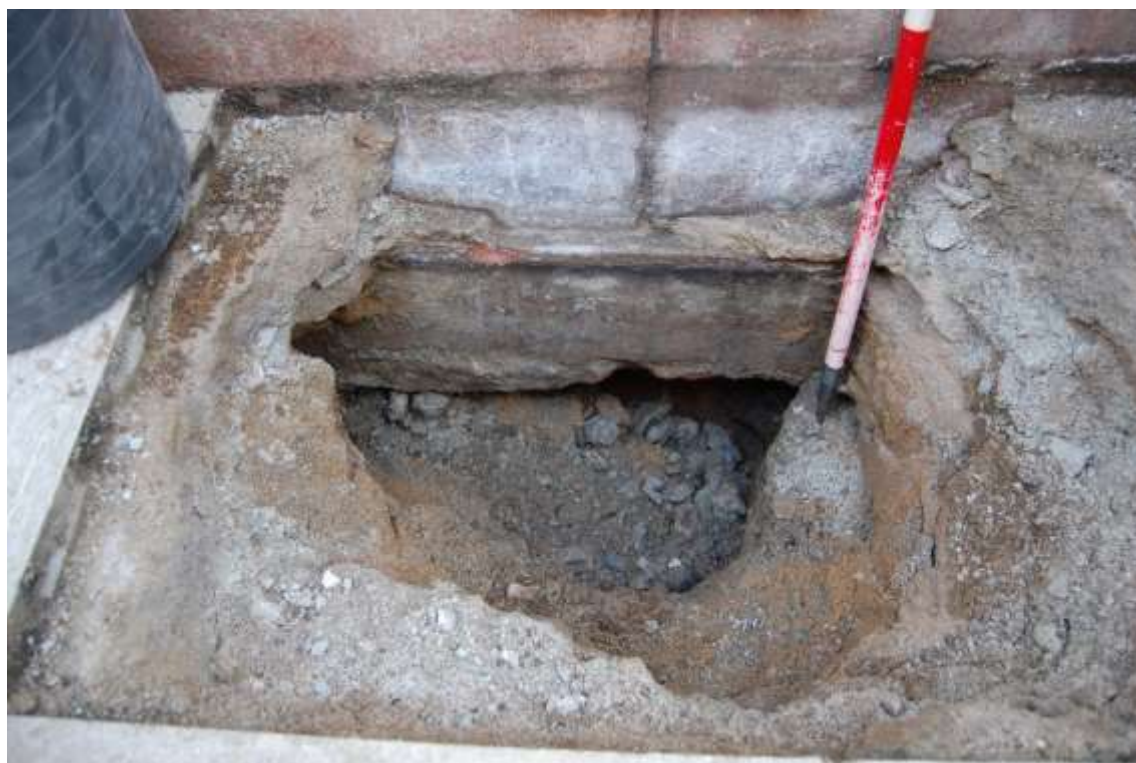
TP10 was located on the exterior of the south wall of the Art Gallery on the pavement on Schoolhill, just to the west of the main entrance. The foundation of the Art Gallery south wall consisted of large sandstone block (4) 45cm below the current street level; Hall 2012 reported a similar sandstone stepped foundation on the north wall (Hall 2012, 10). The fill of the trial pit revealed lead water pipe and ceramic drain pipe (3).

Illus 7 TP10 showing stone stepped foundation (4) of south wall of Art Gallery; facing N

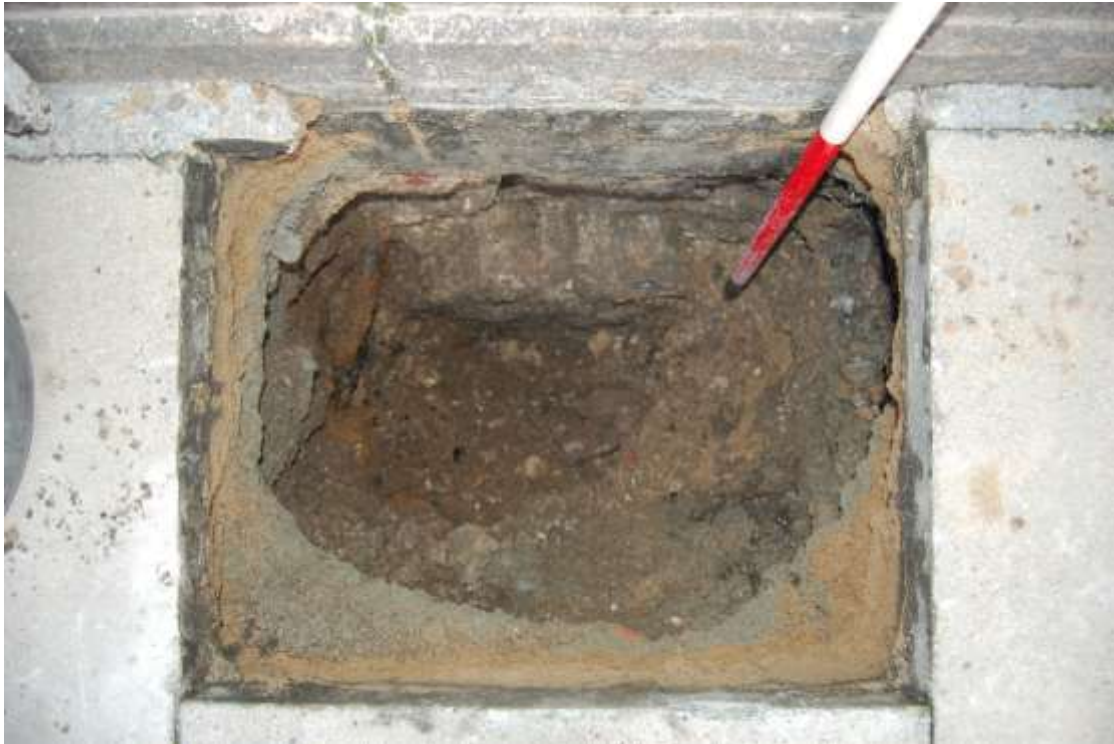
TP11 was located on the exterior of the south wall of the Art Gallery on the pavement on Schoolhill. The foundation (4) of the Art Gallery south wall was revealed (as TP10) and under this a large granite block (5) forming a stepped foundation. A cast iron gas pipe was contained in context 3 ran N-S into the wall foundation.

Illus 8 TP 11 showing stone foundation (4 above 5) and cast iron gas pipe (left)
