**Steading at Mains of Carnousie, Turriff, AB53 4LA
Report on Level 1 Standing Building Survey**

**Alison Cameron
Cameron Archaeology
7 September 2015**

SUMMARY

A Level 1 standing building survey was carried out on 27 August 2015. The main buildings (1 and 2) were built on one phase for office and residential use with a mill and later converted for more general agricultural use. It is recommended that no further archaeological work is required during the current planning application.

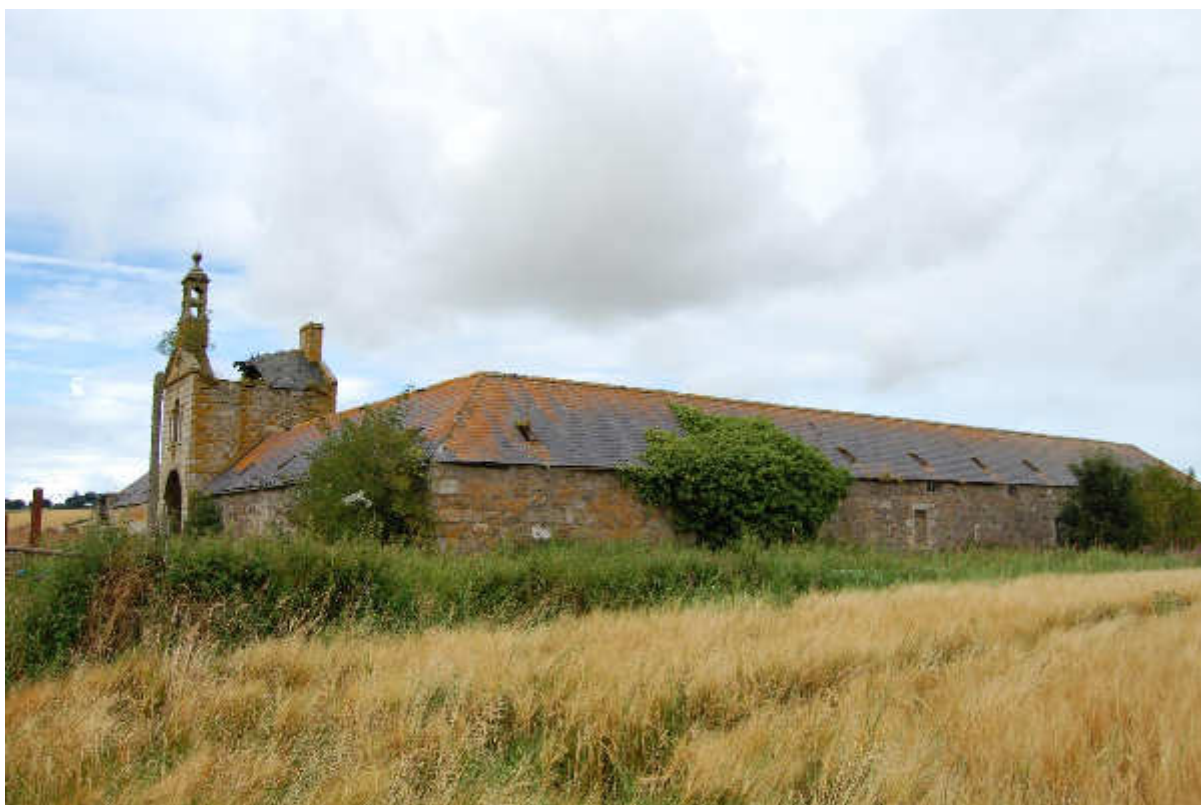
Building 1 (Illus 3) is a square steading with a central courtyard and towers at the centre of the N and S wings with cart doors under each tower. The buildings are constructed of granite quoins and window and door facings with granite and quartz rubble with granite, slate and red sandstone cherry cocking.

Illus 3 Building 1; facing WNW

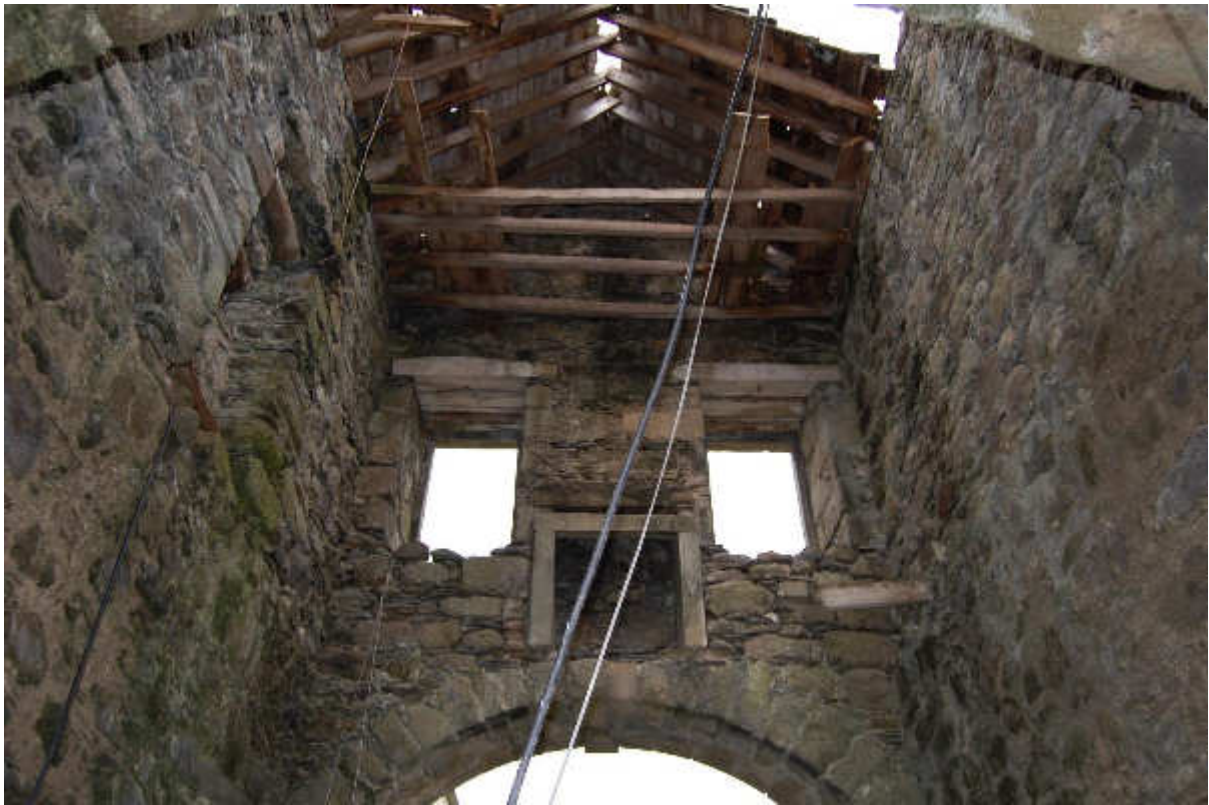
Room 1 forms the main cart door (Illus 6) from the south into the courtyard and has a first floor room above with windows and fireplace (Illus 5) and bell-cote above.

Illus 5 Room 1 first floor with W3 (left) fireplace 1, W2 (right); facing N

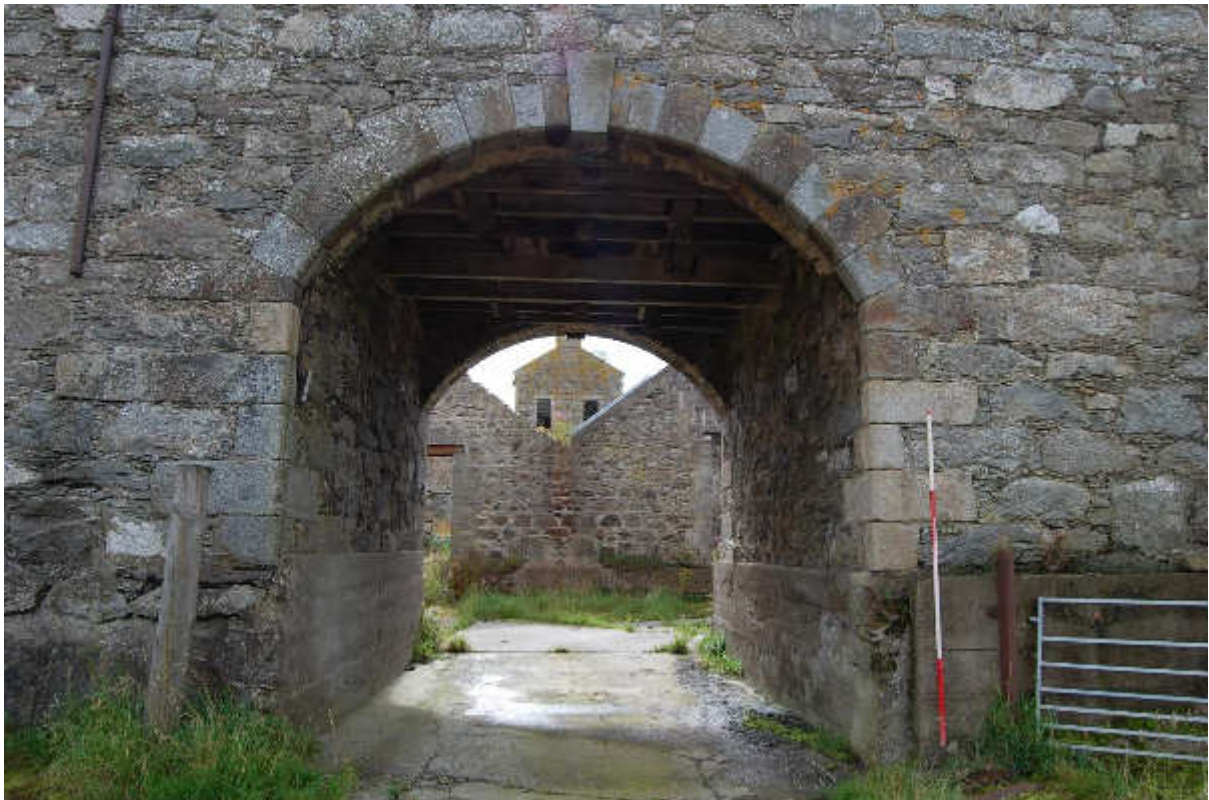
Illus 6 North façade entrance D2; facing S

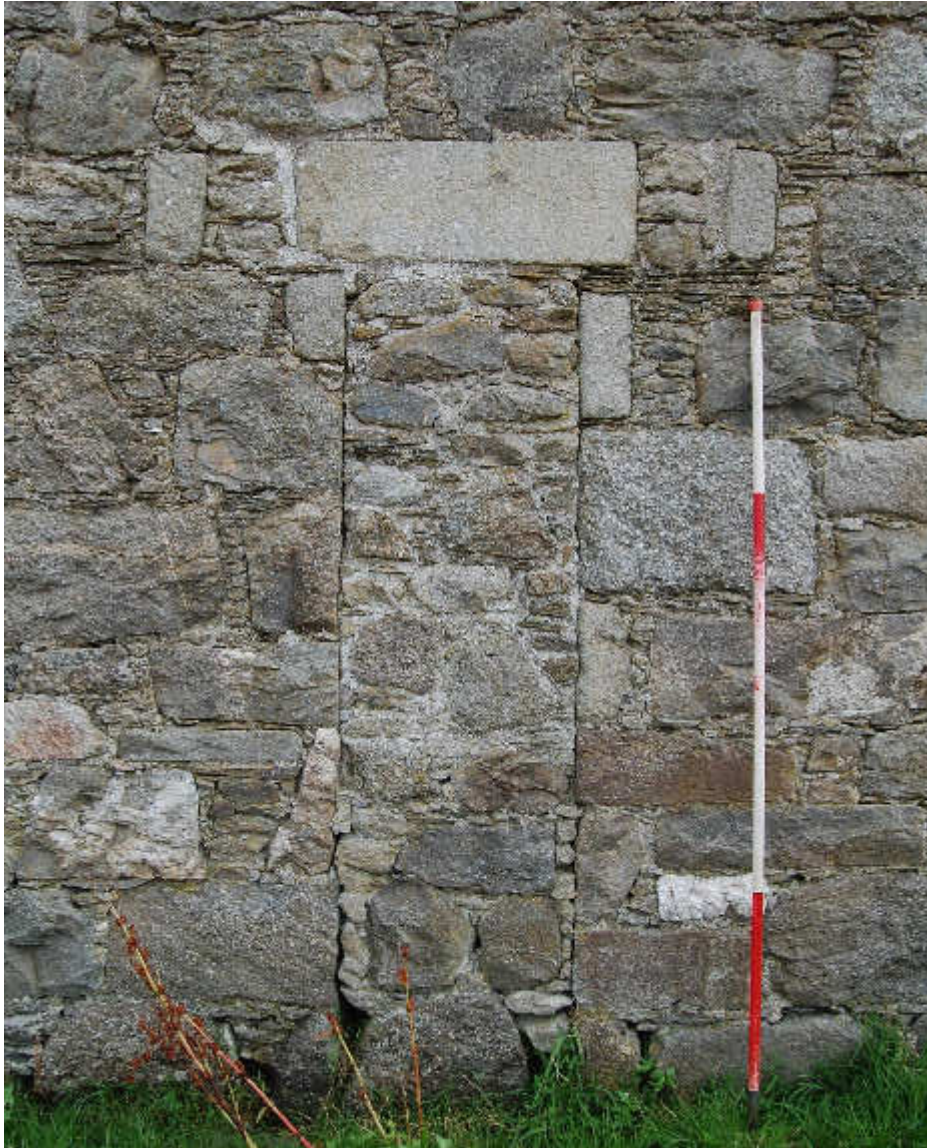
Many of the apertures have been blocked (eg D27; Illus 7) and this probably represents the change from a domestic and office use in the first phase (late 18th-19th century) and conversion of the rooms for milling and general agricultural use (late 19th and 20th centuries).

Illus 7 West façade blocked door D27 showing mixed building materials including granite, quartz and slate; facing E

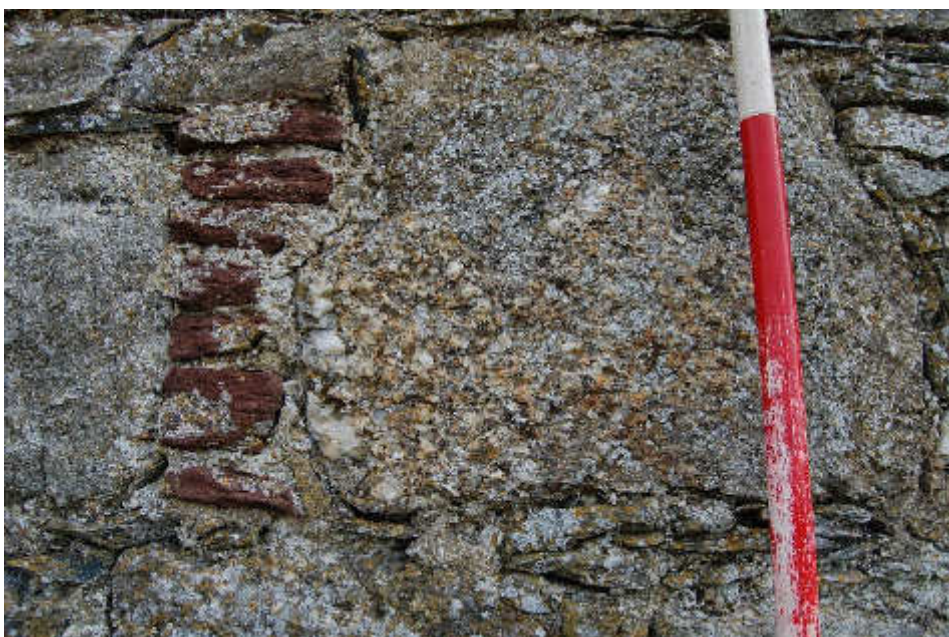
Illus 8 W façade showing red sandstone used in cherry cocking; facing E

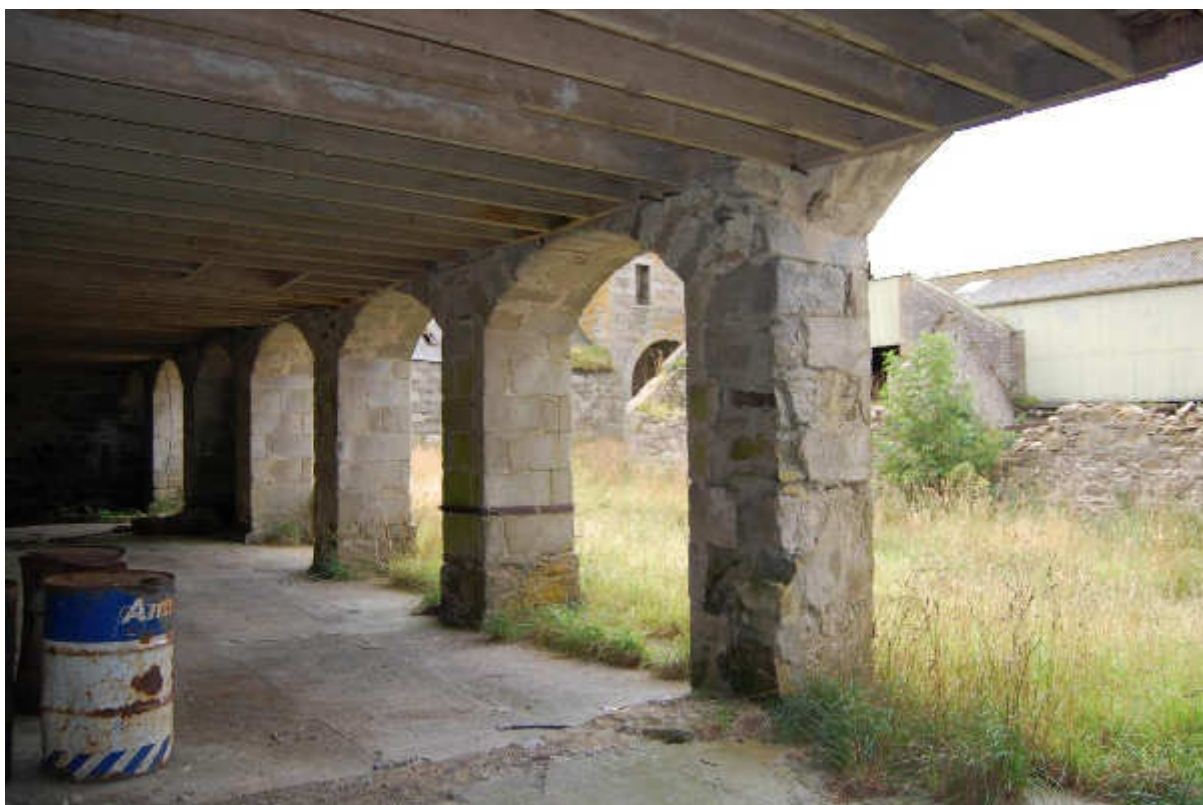
Rooms 3 and 4 were domestic dwellings or offices (see First edition OS Illus 17) and Rooms 5a and 5b were cartsheds with 7 large cart doors for access from the courtyard (Illus 9, 10). Rooms 6 and 7 in the SE corner of the steading were for agricultural use.

Illus 9 Room 5a with interior of cart doors; facing SSW

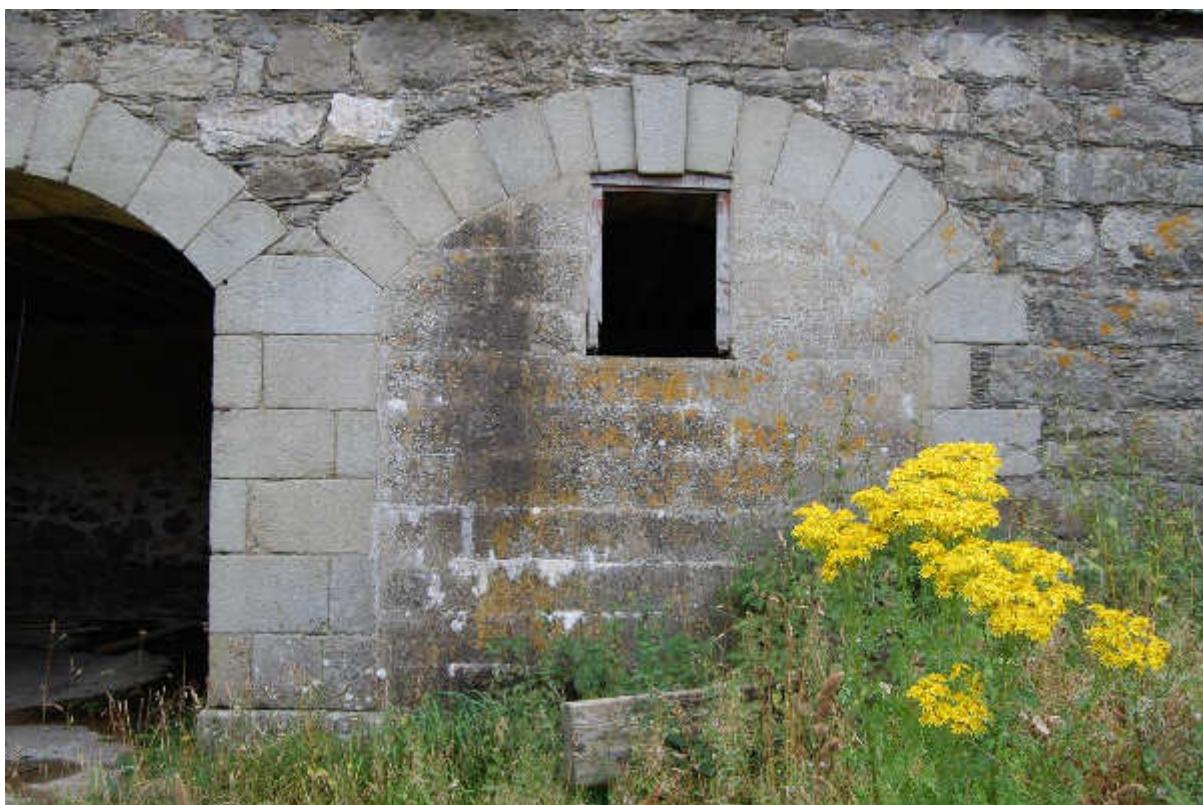
Illus 10 Cart door D22; facing E

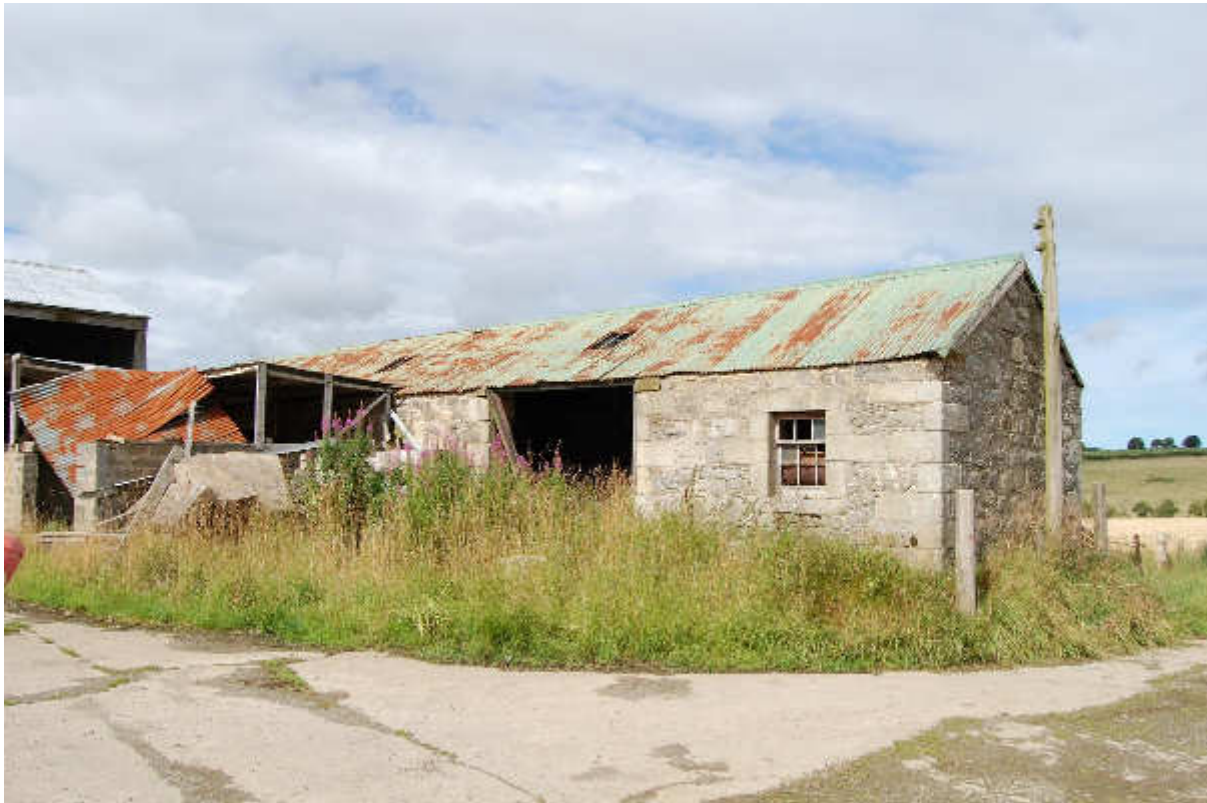
Building 2, the smiddy, is located on the N side of Building 1 (Illus 11). It is constructed of the same building materials as Building 1 and probably at the same time. There is a modern shed attached to the W and S walls and the exterior of the building was not fully accessible.

Illus 11 Building 2; facing SE

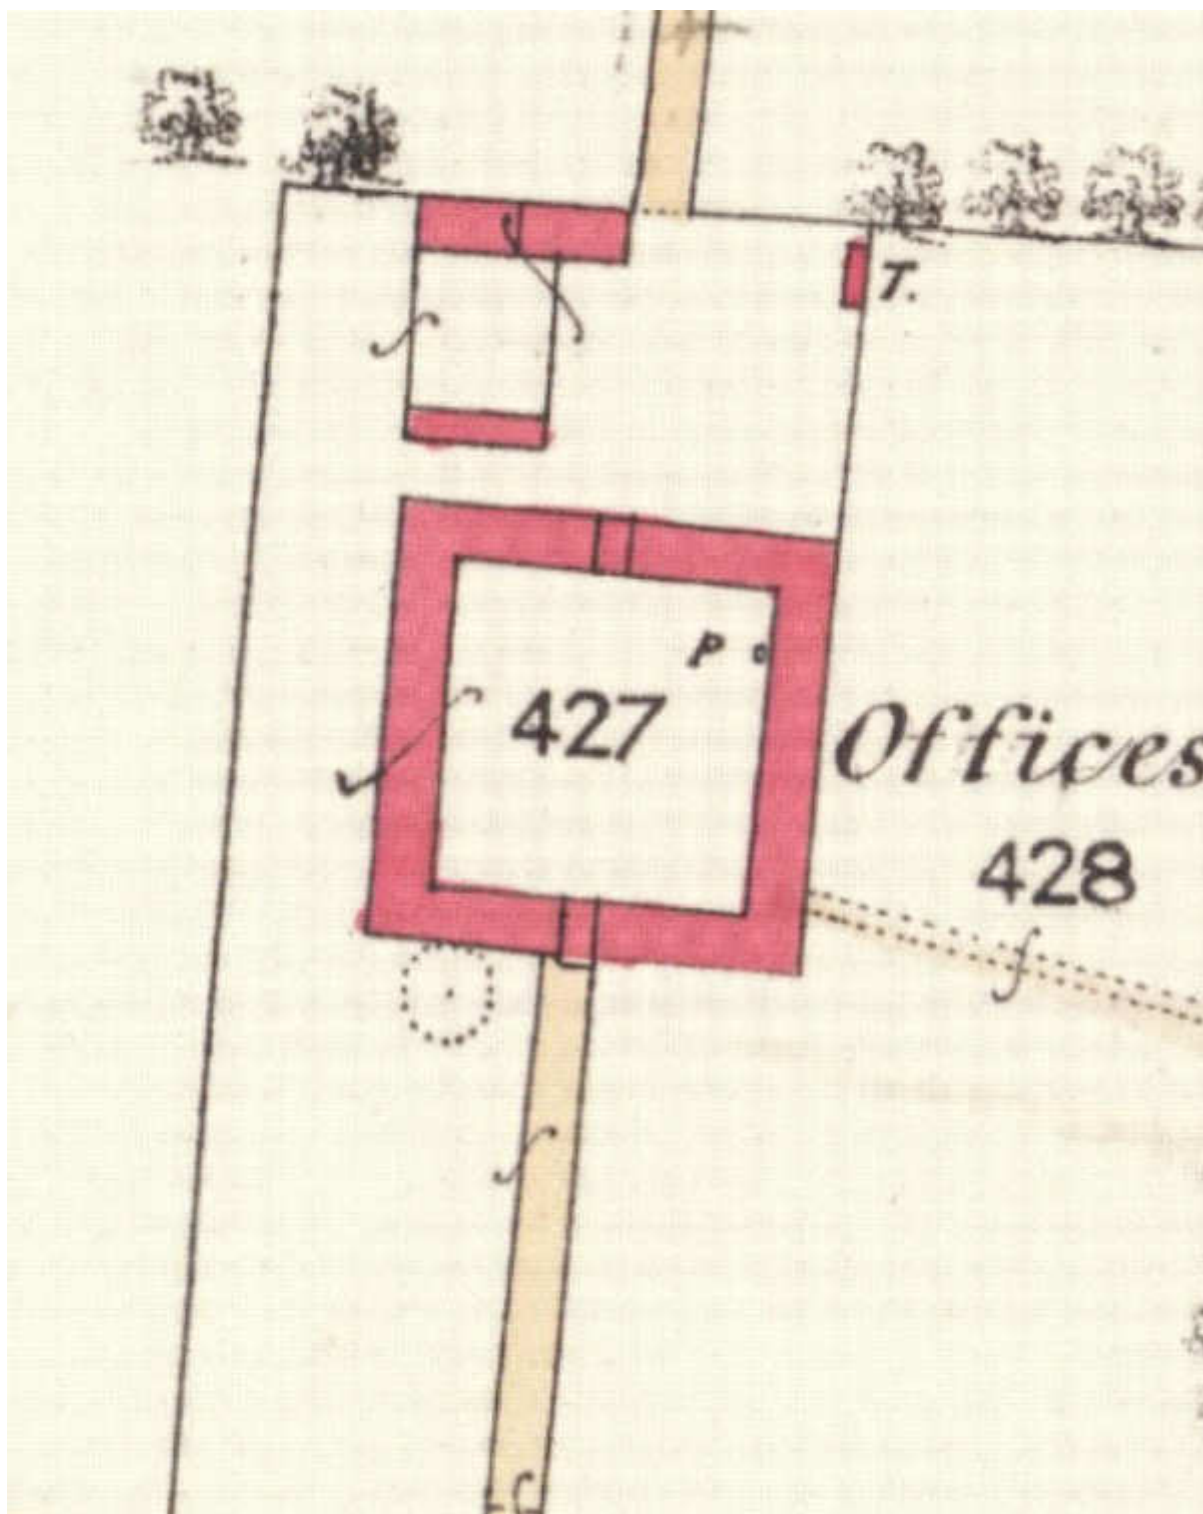
Illus 17 1st Edition Ordnance map showing steading. Banff Sheet XVI.16 (Forglen)
 Survey date: 1868 Publication date: 1871 (copyright National Library of Scotland)
