Mar Lodge Estate

Crathie and Braemar, Aberdeenshire
Post-Hurricane Bertha Condition Survey
2015 MAR/15/2

Dr Robert Lenfert
on behalf of
Cameron Archaeology
August 2015

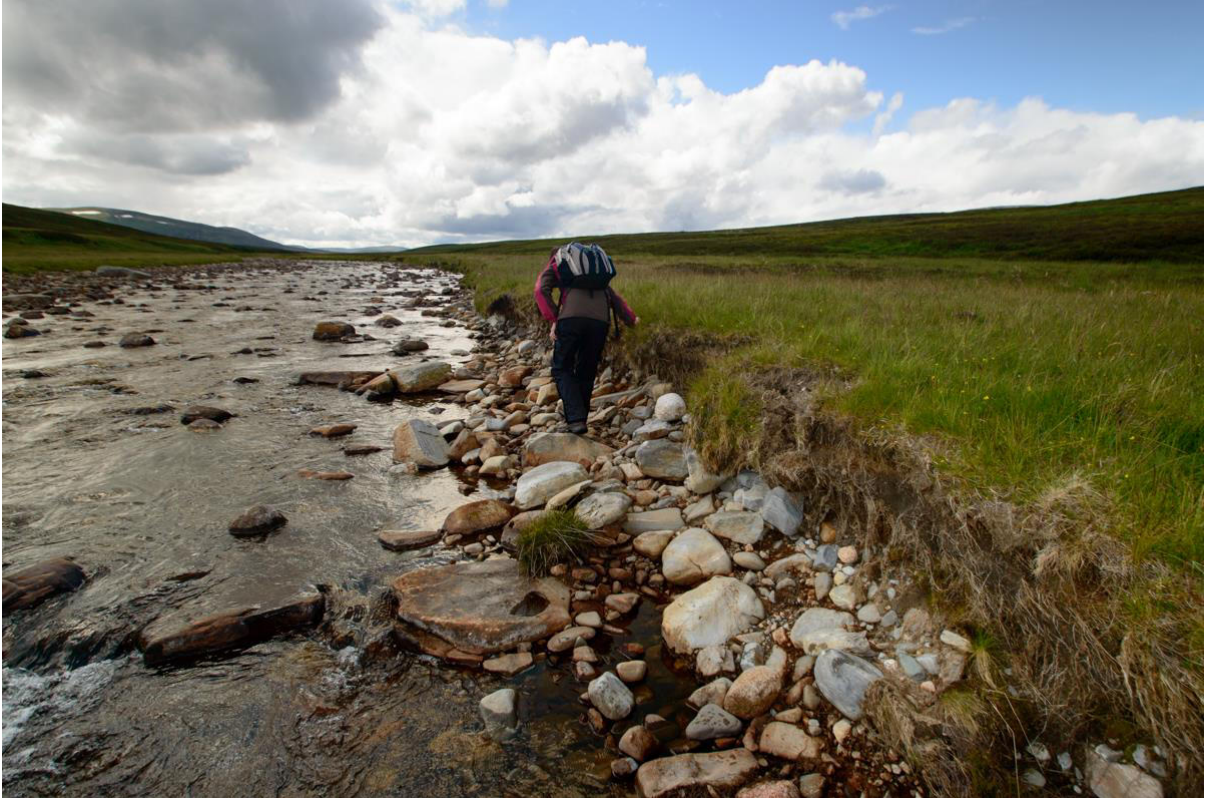
Illustration 3: Inspection of undercut peat banks containing remnant conifers along the River Dee.

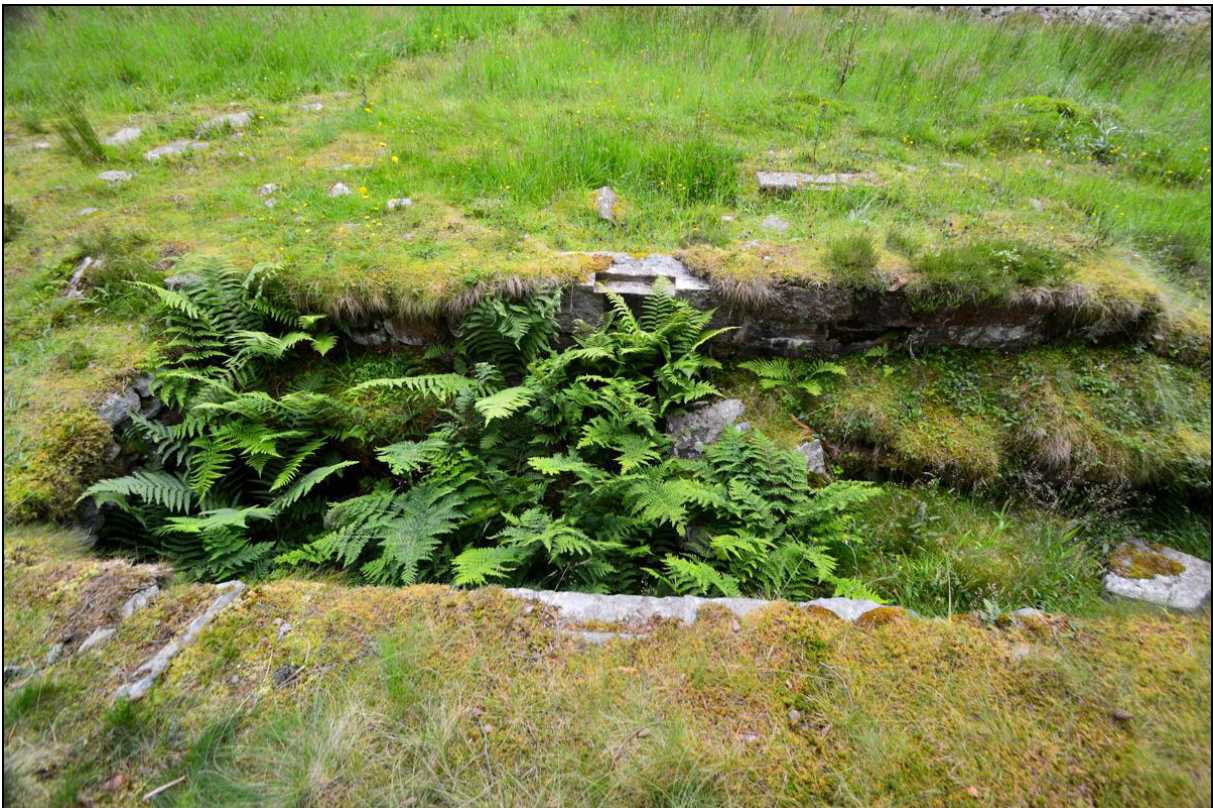
This particular site appears to have sustained the most damage in the wake of Hurricane Bertha, yet drystone walling which lines the water channel remains intact along with several chiselled stone footers (Illus. 4) and at least one robust metal fitting from the later stages of the mill's working life in the early 20th Century. Not having personally inspected the site prior to Hurricane Bertha it is therefore difficult to make a precise estimation of the damage sustained. However, existing images such as RCAHMS SC 438588 indicate that some of the foundations consisting of loose stones have been dispersed from their former location. In this regard, some 70 digital images were taken of the remaining visible sections of the mill and surrounding areas in Glen Quoich up to the 'Punchbowl' and nearby footbridge to aid in measuring future change within the area.

Illustration 4: A small section of surviving water channel for the sawmill at Linn of Quoich

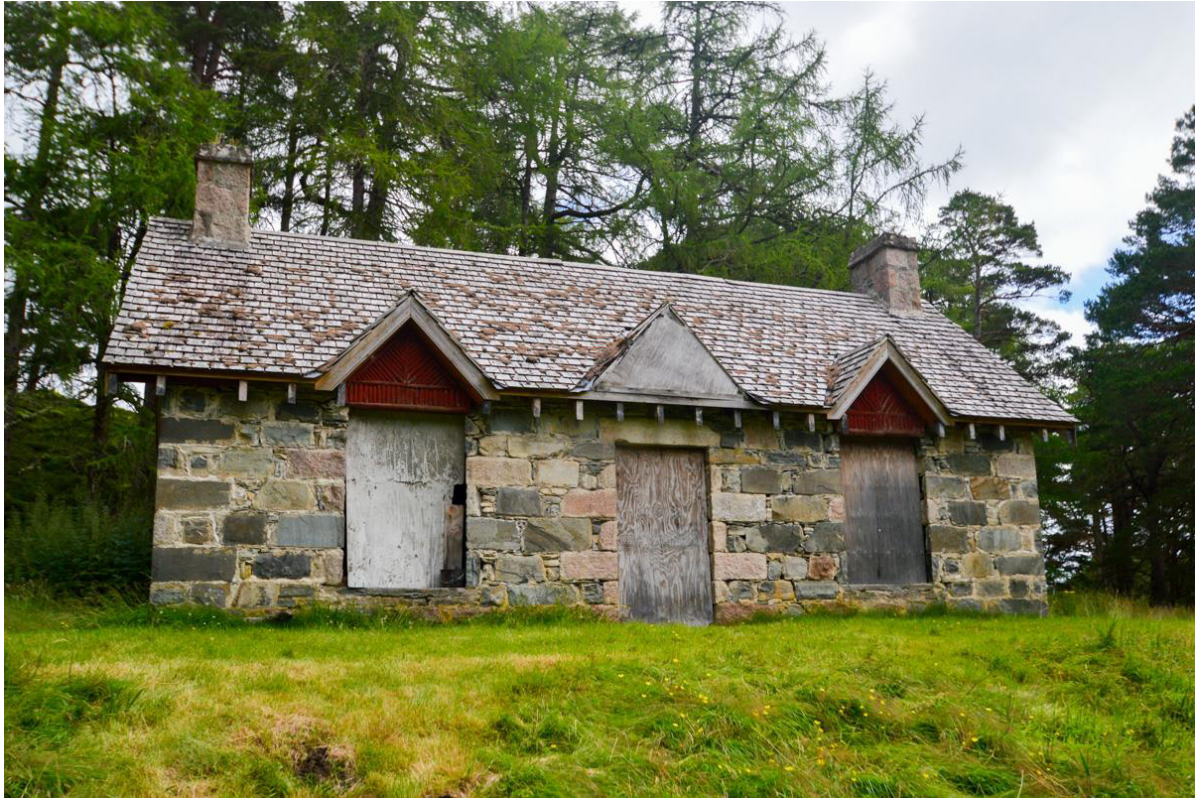
Although in close proximity to the Quoich Water, the lodge is located a safe elevation and does not appear to have sustained any flood damage. However, it is adjacent to a popular footpath a short distance from the nearest carpark, and despite being boarded up, clear attempts to access the derelict interior (Illus. 5 & 6) have been successful as evidenced by modern rubbish including disposable barbeques. Structurally, the building appears stable overall and is largely dry inside.

Illustration 5: Queen Victoria's Picnic Lodge with left window used for access.

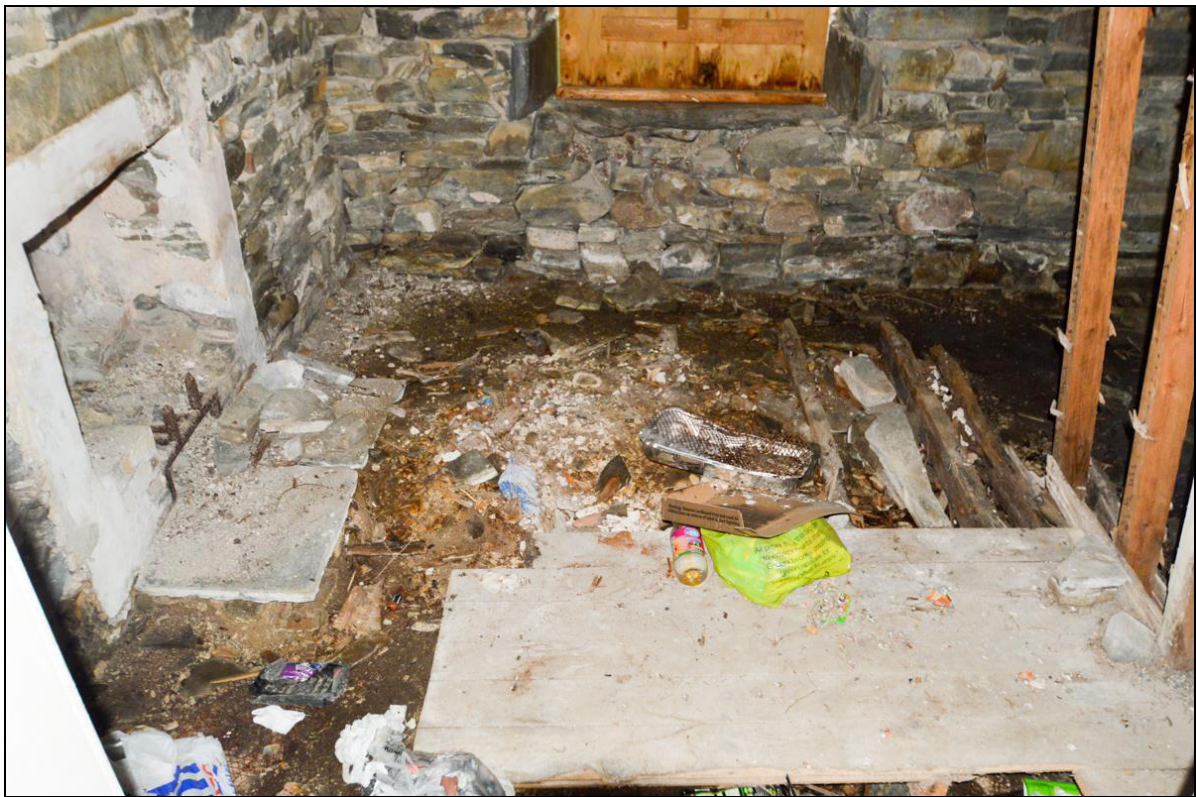
Illustration 6: Discarded rubbish inside Queen Victoria's Picnic Lodge.

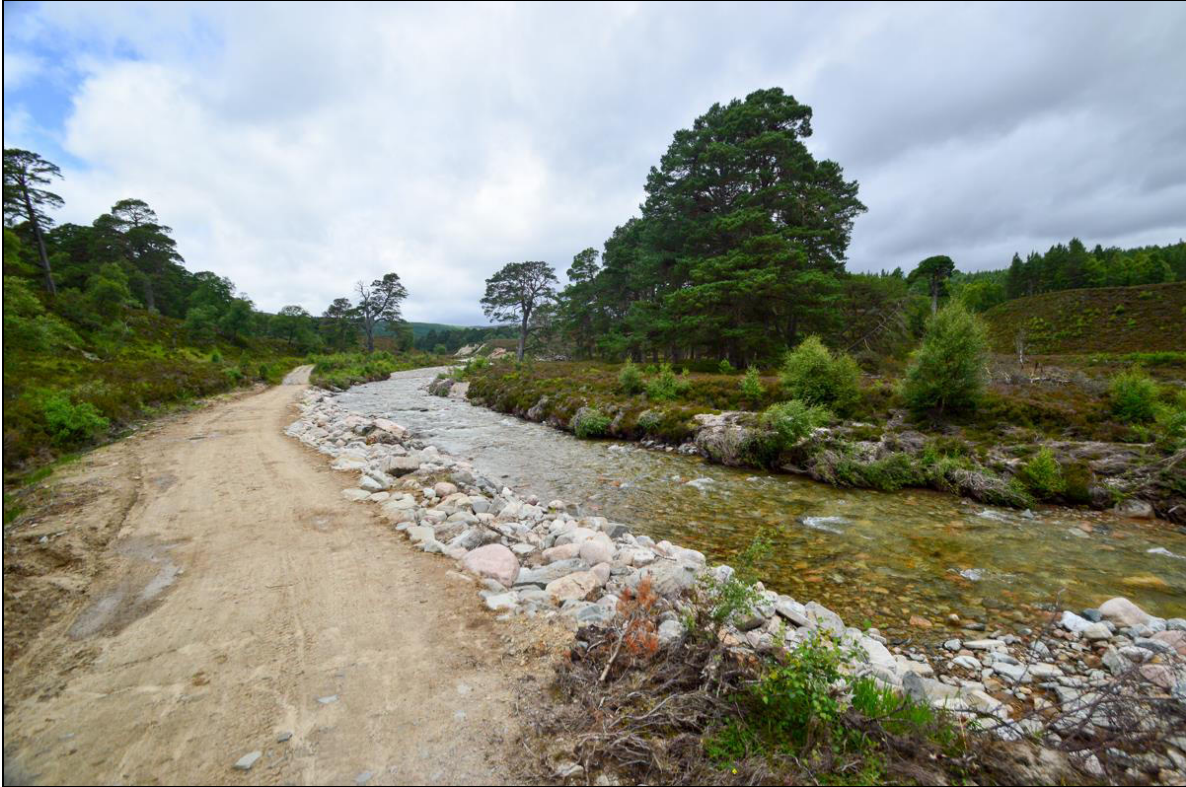
Illustration 7: The newly created section of track along Glen Quoich which replaced the former section which was completely washed away during Hurricane Bertha.

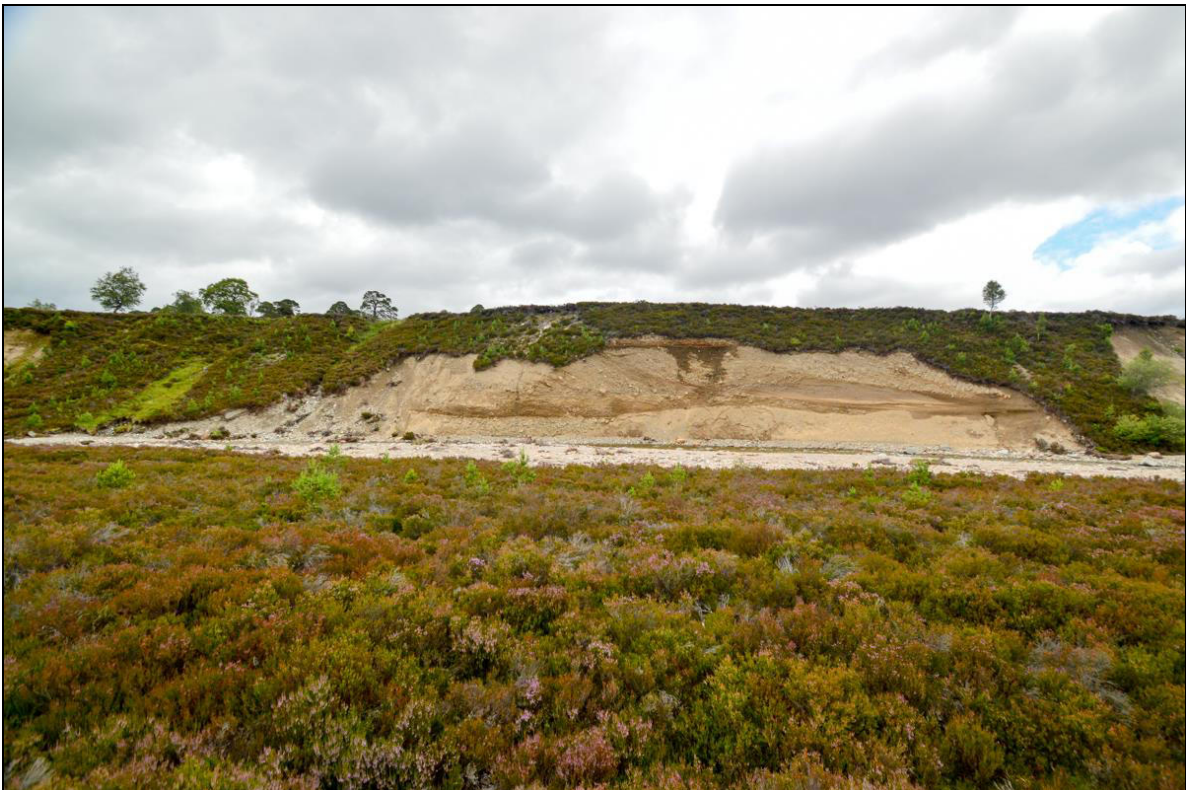
Illustration 8: Large collapsed section of bank along Quoich Water, some 15-20m in height.

The middle sections and lower reaches of Glen Quoich indeed appear to have borne the brunt of the flooding in August 2014. This is due to the large catchment area upstream, a steep and relatively narrow gorge-like situation along much of its middle and lower length, and lastly, the narrow outlet at the bottom of the glen which would have created a Venturi effect, especially around the mill area, with a correspondingly high hydraulic head and velocity. As a result, the most visible signs of flooding and erosion within the estate are located here, even several kilometres upstream from the confluence with the River Dee (Illus 7-9). It is this narrow valley situation which appears to have limited archaeological settlement within Glen Quoich, at least in historic periods, as would-be occupants were likely aware of the dangers of building permanent structures in these flood-prone areas.

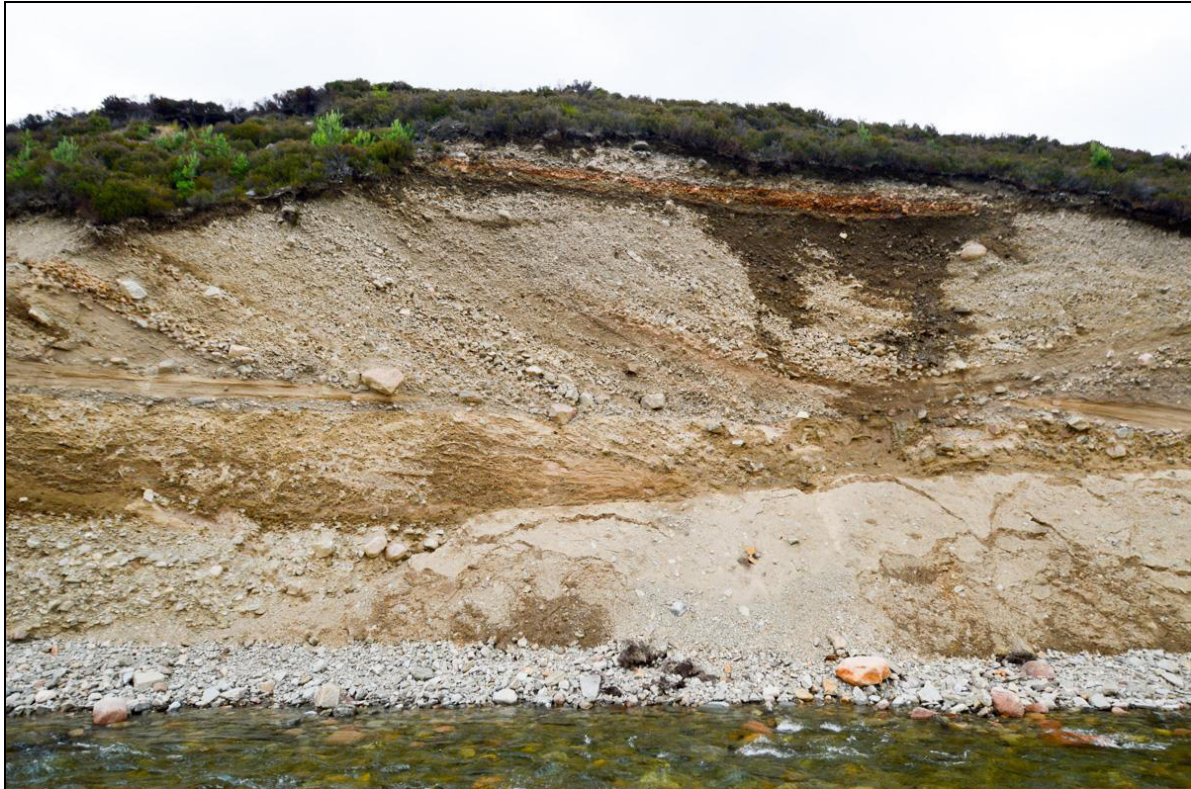
Illustration 9: Detail of central area of eroded bank in Illustration 8.

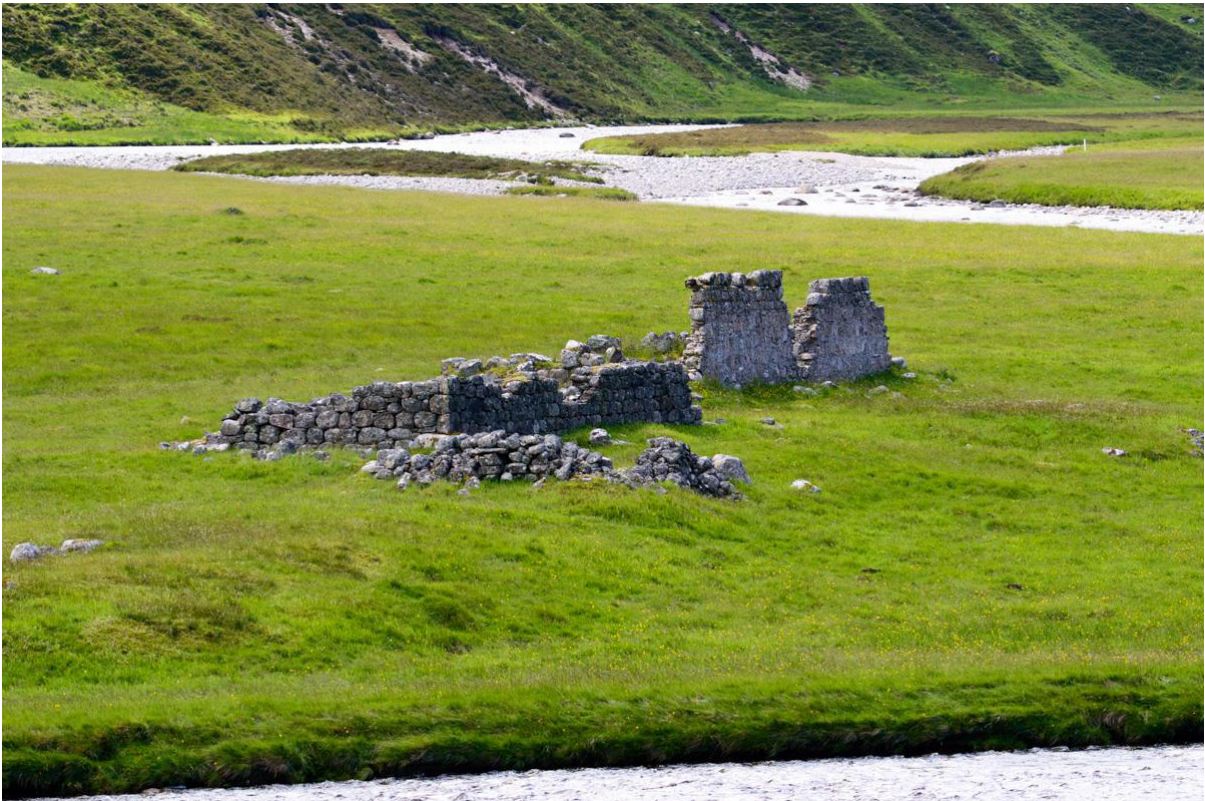
Illustration 11: Upstanding remains of buildings within Dalvorar Township, taken from the north bank of the River Dee.

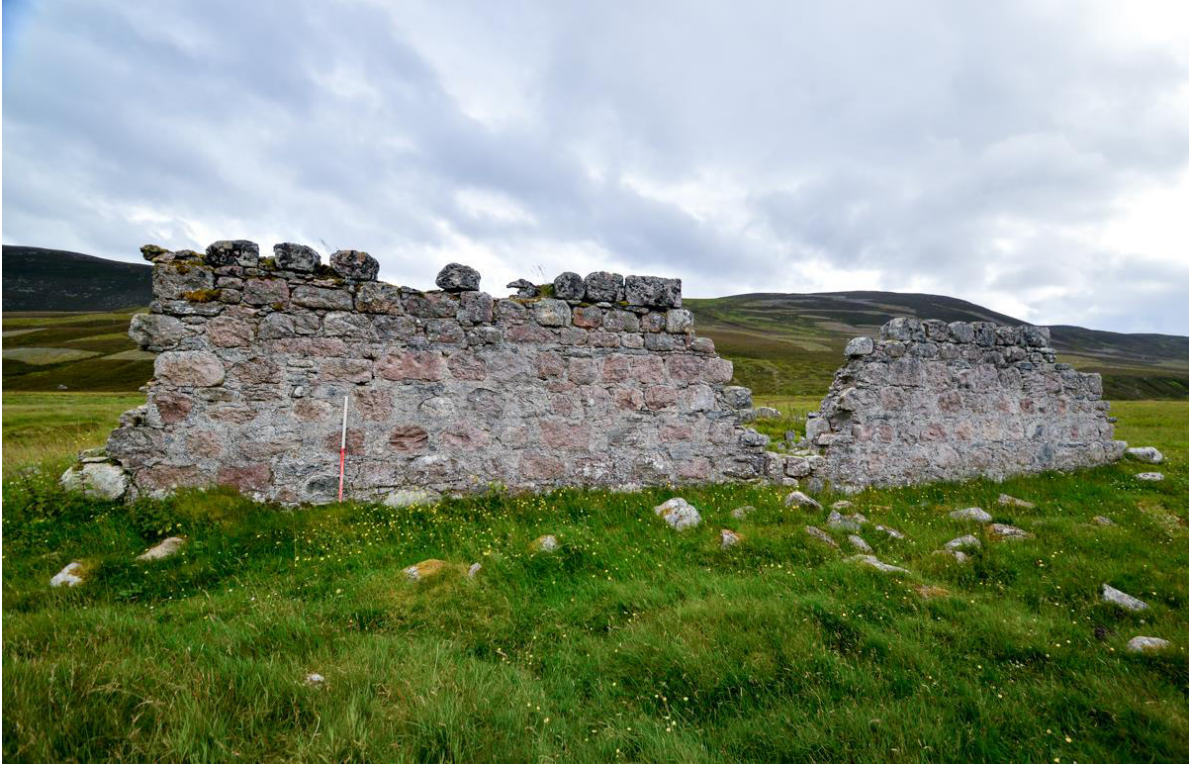
Illustration 12: Detail of buildings in Dalvorar Township. These are the best-preserved remnants of township structures within the estate.

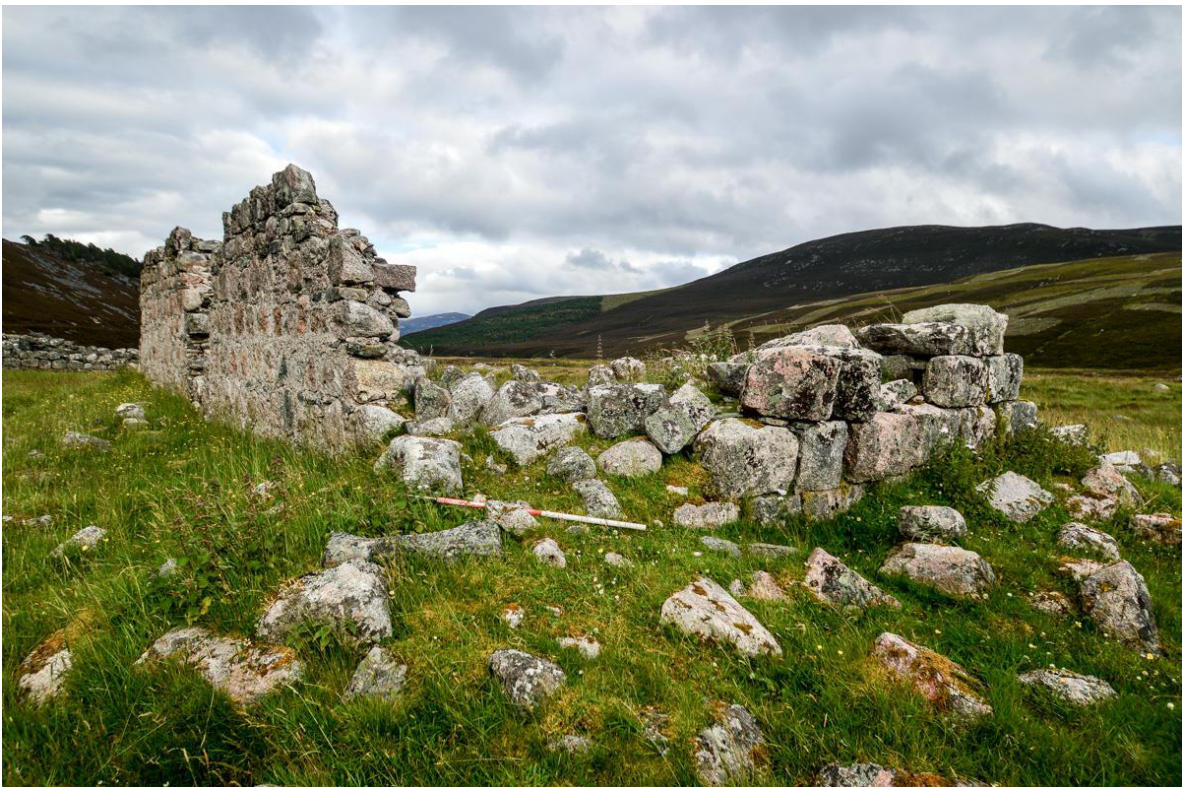
Illustration 13: Scattered stone tumble surrounding the main structure within Dalvorar Township.

Given that the majority of remains do not stand beyond .5m to 1m in height, tumble is relatively contained and only poses a threat to the largest structures and walling, particularly as Dalvorar, where walling can stand over 2m with clear indications of fairly recent stone collapse or tumble are visible (Illus. 11 & 12). One makeshift hearth for a campfire (Illus. 14) may have been created by robbing stone from a nearby section of walling on the north side of the north track along the River Dee near Creag Phadruig (NGR NO 046 893).

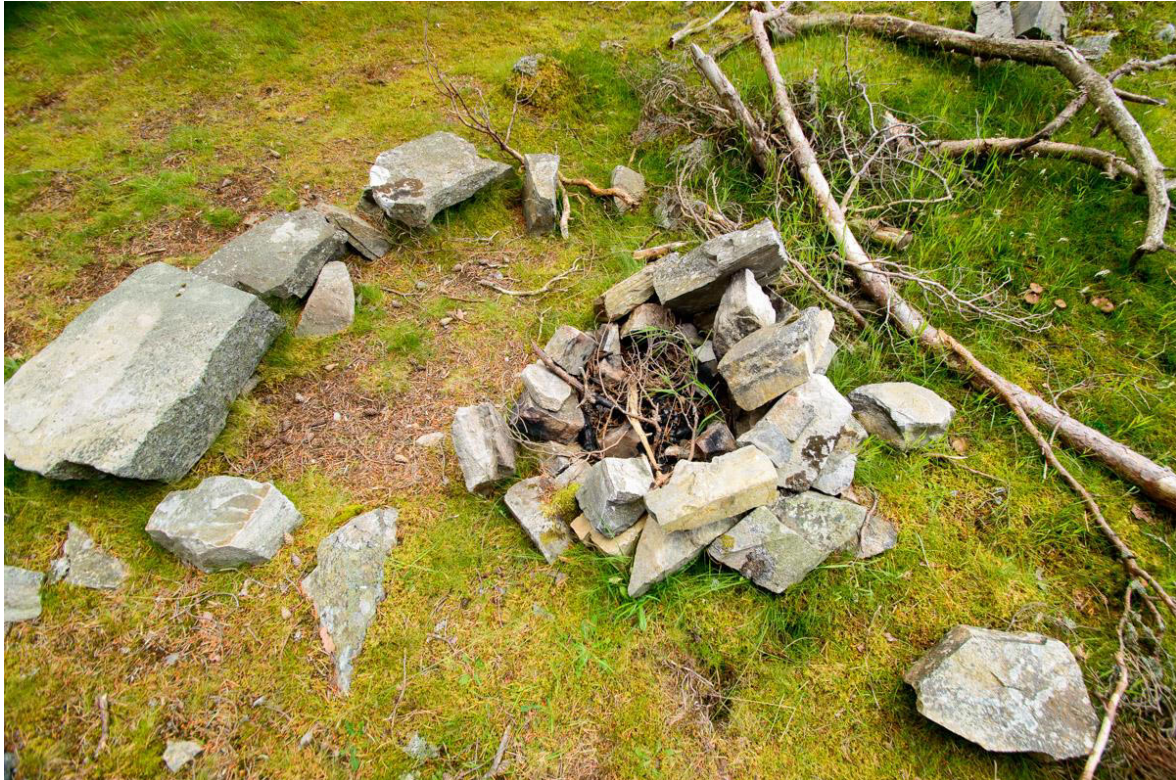
Illustration 14: Stone possibly removed from a nearby section of drystone walling for use as a makeshift hearth. Brush fires pose a threat to the estate, especially during the summer near conifer stands and plantations.

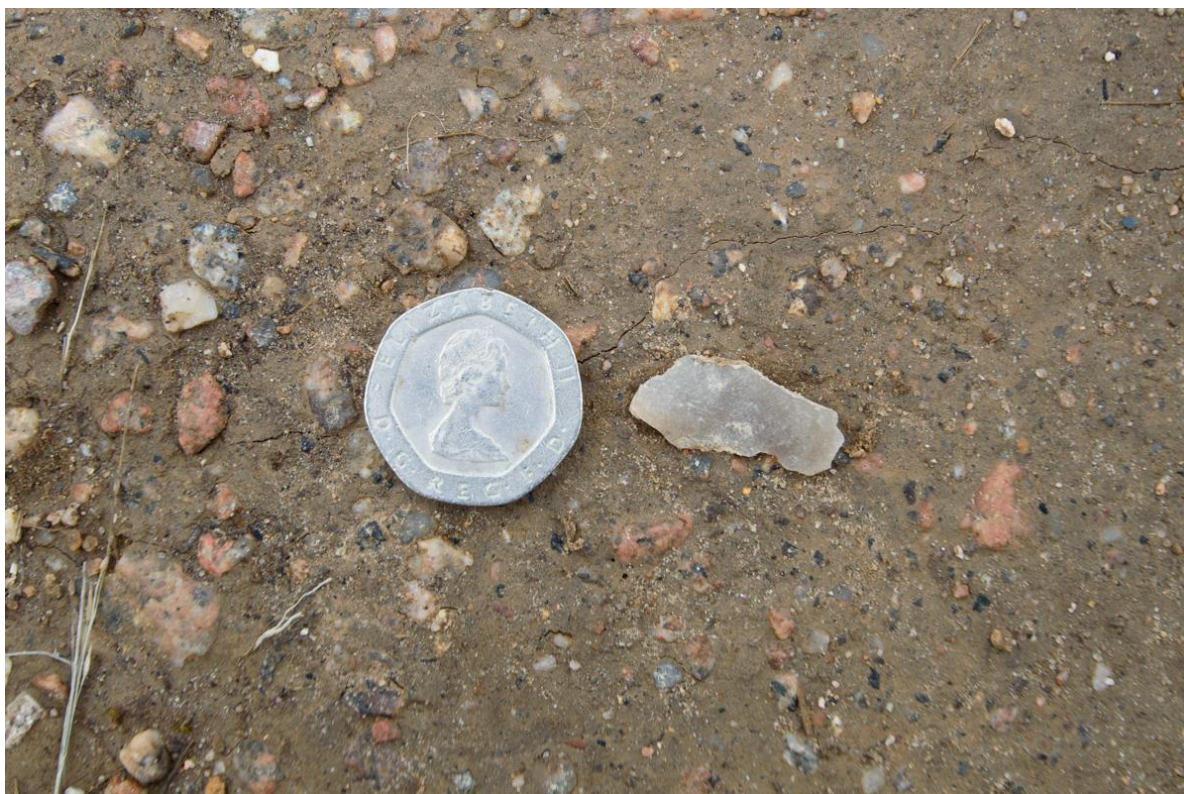
Illustration 15: Exposed flint along the footpath leading to the Chest of Dee.

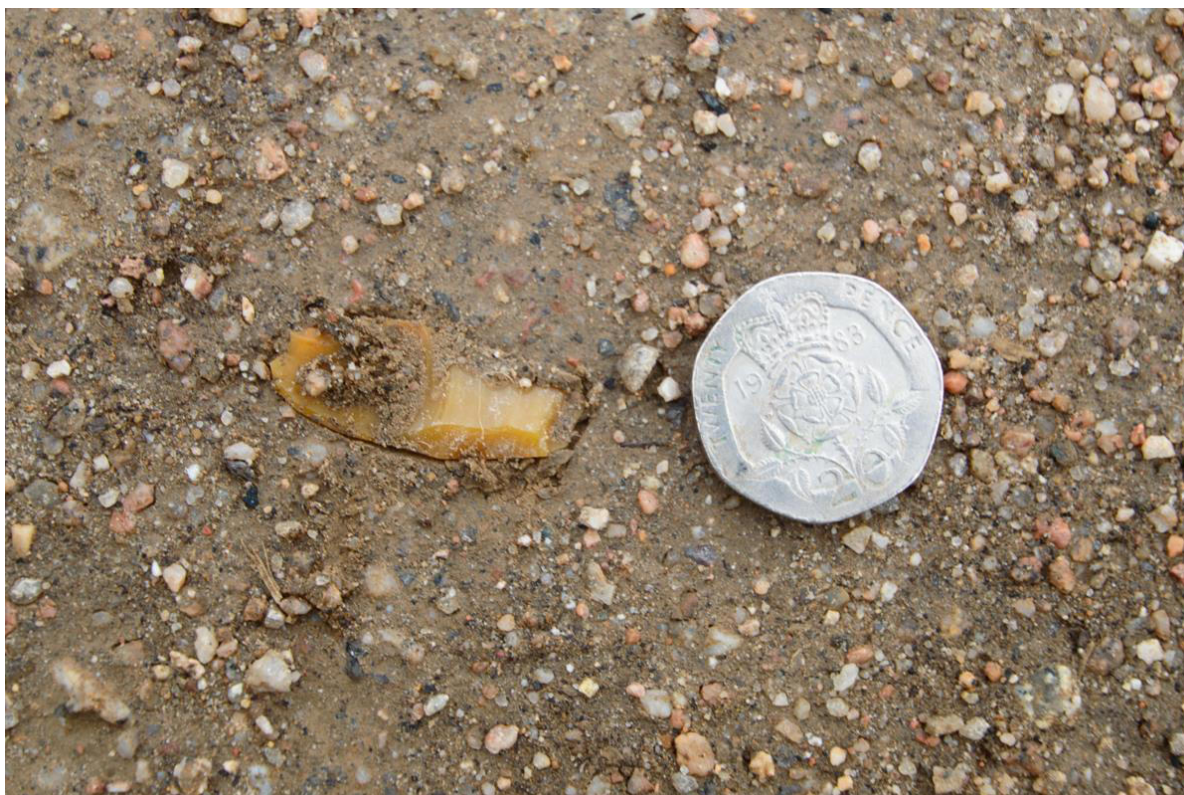
Illustration 16: Additional exposed flint identified along the Chest of Dee footpath.

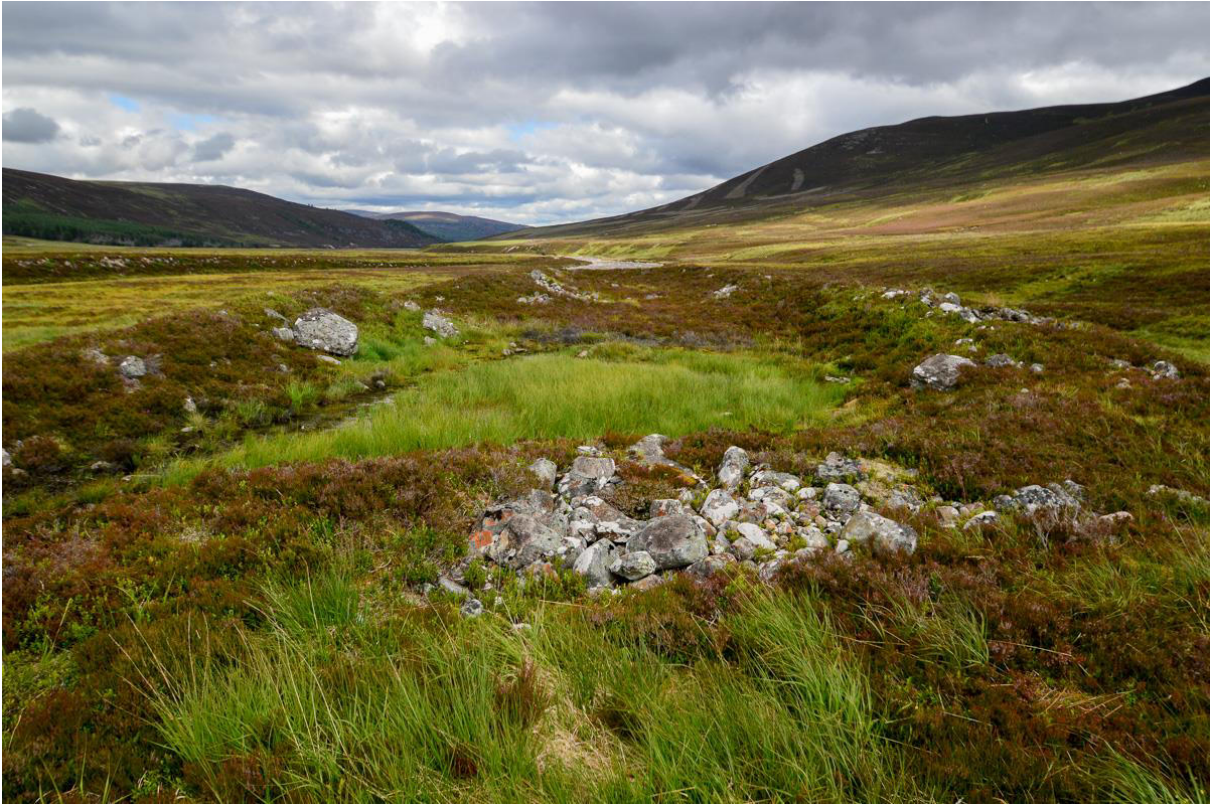
Towards the end of the walkover survey, a short inspection over a raised stoney bank between the confluence of the River Dee and Geldie Burn revealed the presence of what appears to be a large sub-rectangular enclosure (centred upon 56°58'34.15"N 003°36'52.59"E, NGR NO 01946 88411) approximately 12x45m in size, and some 1.5m in height, with walling approximately 2-3m in width at the base (Illus 17 & 18). It does not appear in any archives such as Pastmap or Canmore, or the local Aberdeenshire SMR. There is the possibility that it is a natural feature (a view also shared by S Fraser – *pers comm*), perhaps formed by the accumulation of glacial debris (e.g. a moraine-type deposit) or relic floods where the two watercourses meet, though the author is of the opinion it may be at least partially man-made or modified. Equally, it may represent modern quarrying activity for the nearby track along White Bridge, as there is a faintly visible vehicle track immediately on the north side of the feature which joins up with the current track.

Illustration 17: East facing view of the possible enclosure from atop the western end.

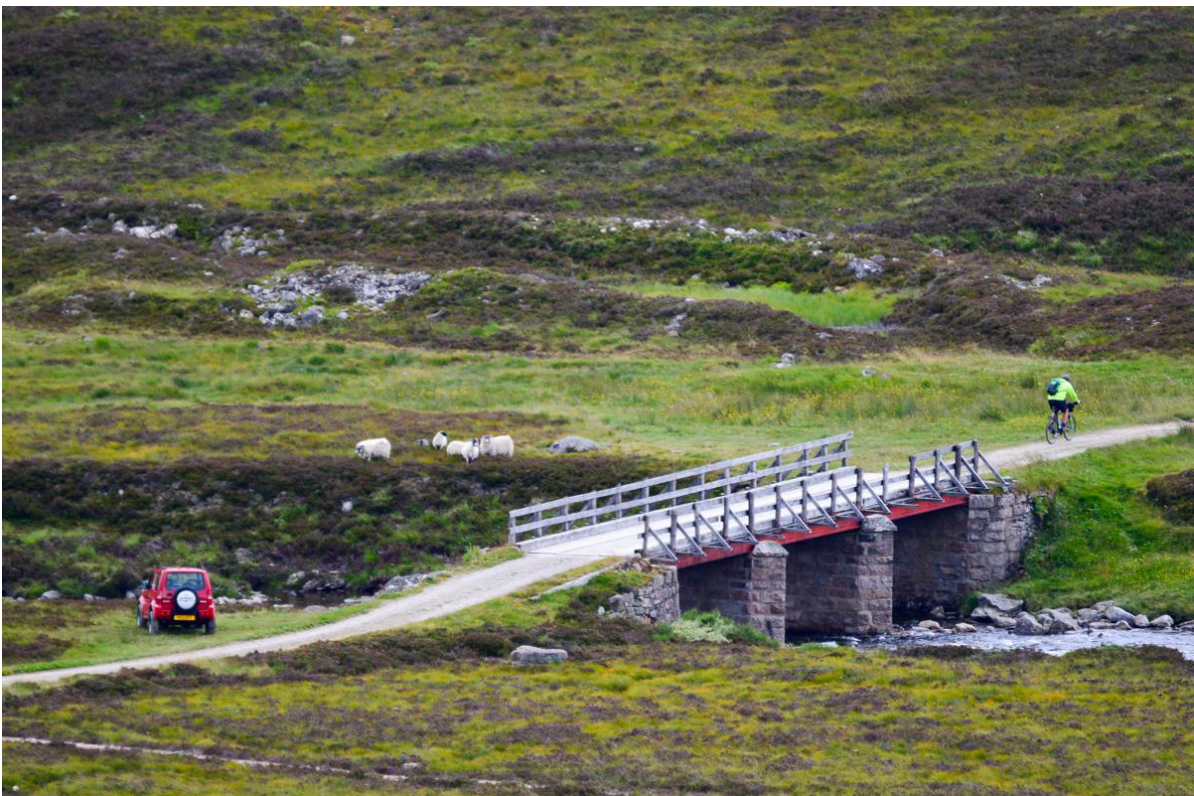
Illustration 18: South facing telephoto shot of White Bridge with possible enclosure in background.

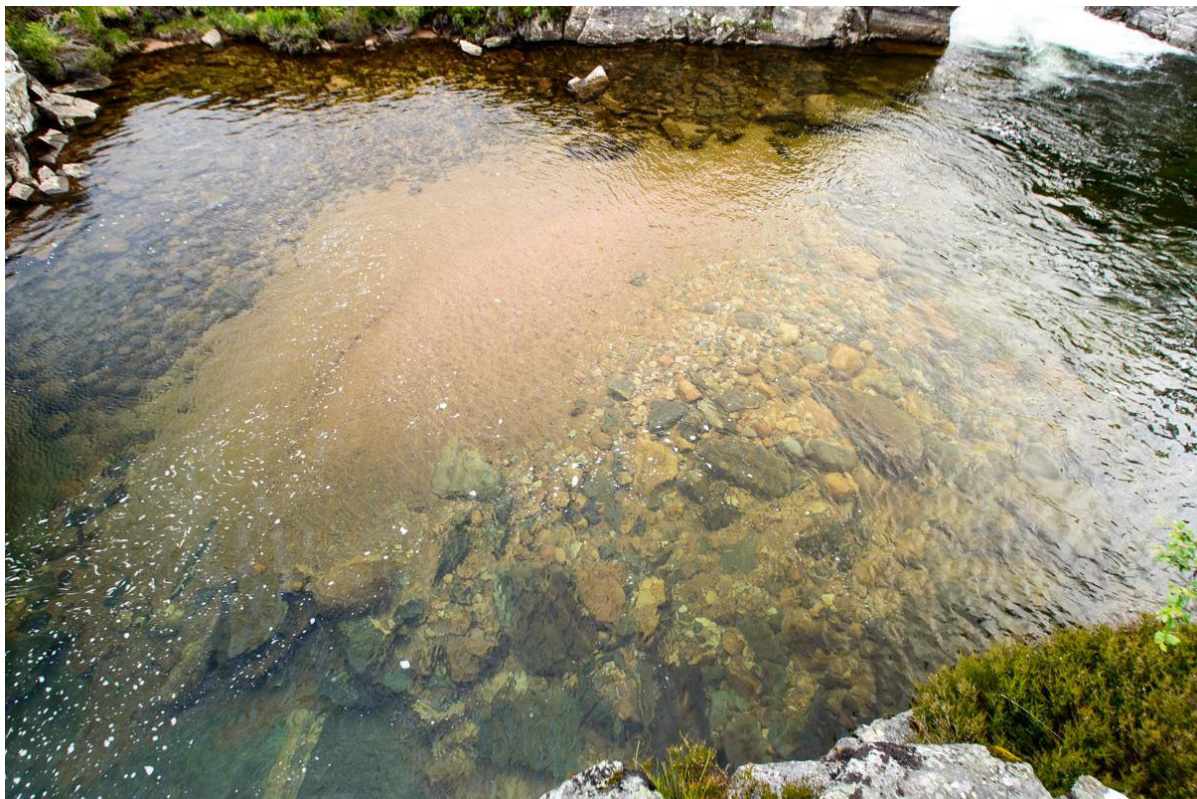
Illustration 19: The lower reaches of the Chest of Dee. Exceptional water clarity throughout the estate highlights the potential for the identification of submerged flints *ex situ*, which in turn would help locate *in situ* deposits.
