Report on Level 1 Standing Building Survey

Site Adjacent To Drumshalloch, Hillhead, Kintore,
Inverurie, AB51 0QQ

Alison Cameron
Cameron Archaeology
23 October 2015

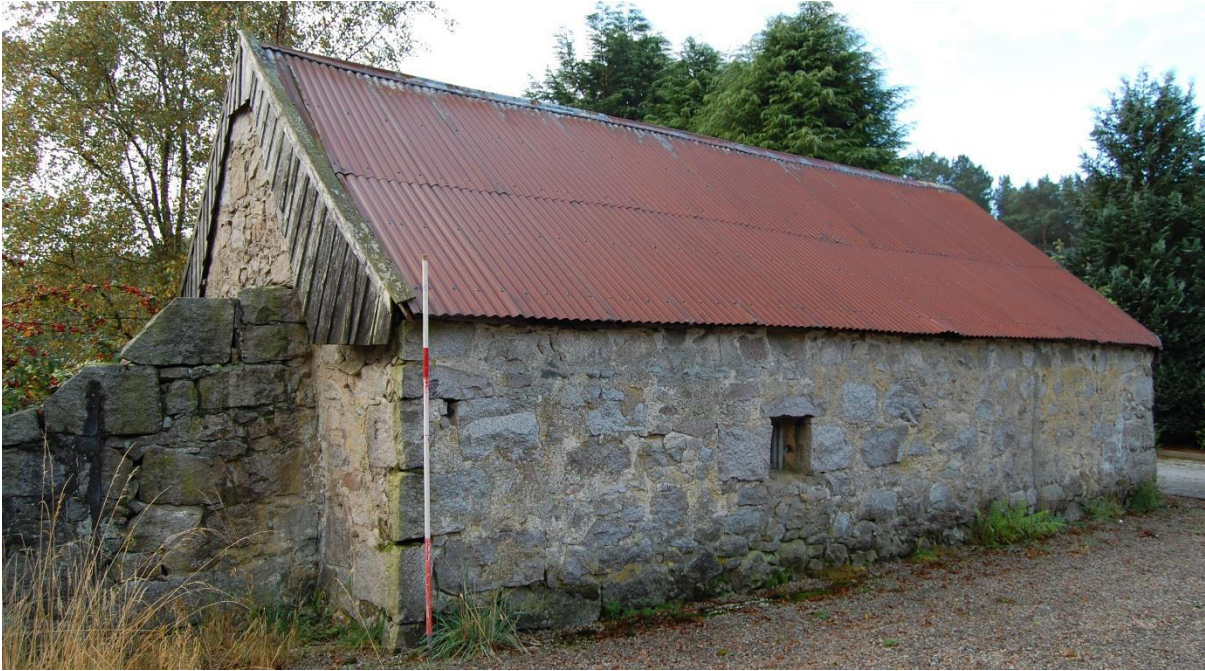
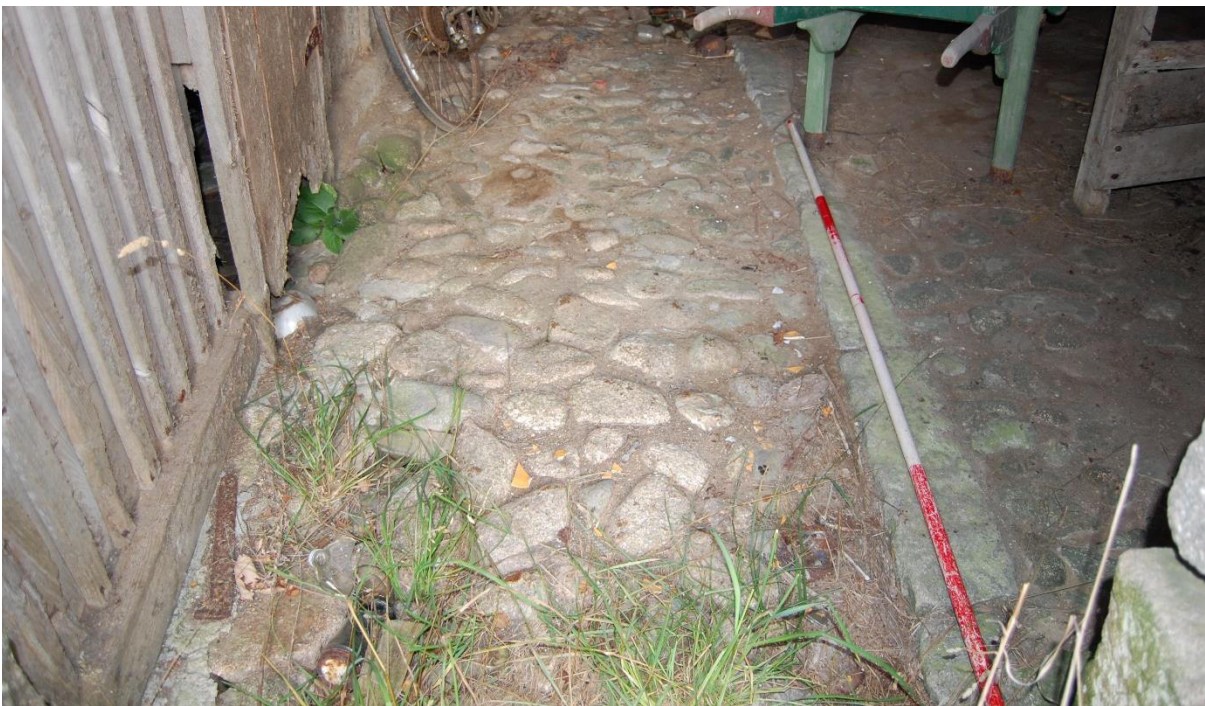
Cover: (top) N façade of building; facing SSW (bottom) Room 2 cobbled floor F3; facing N

Room 2 has a door in the S wall (D2) and a small window in the N wall (W1; Illus 7, 8). There is a granite cobble floor covering the whole of the room with a granite block edging (F4) between the two different levels of cobbles (F3 and F5; cover illus). There are wooden stalls surviving in this room which was used for housing animals.

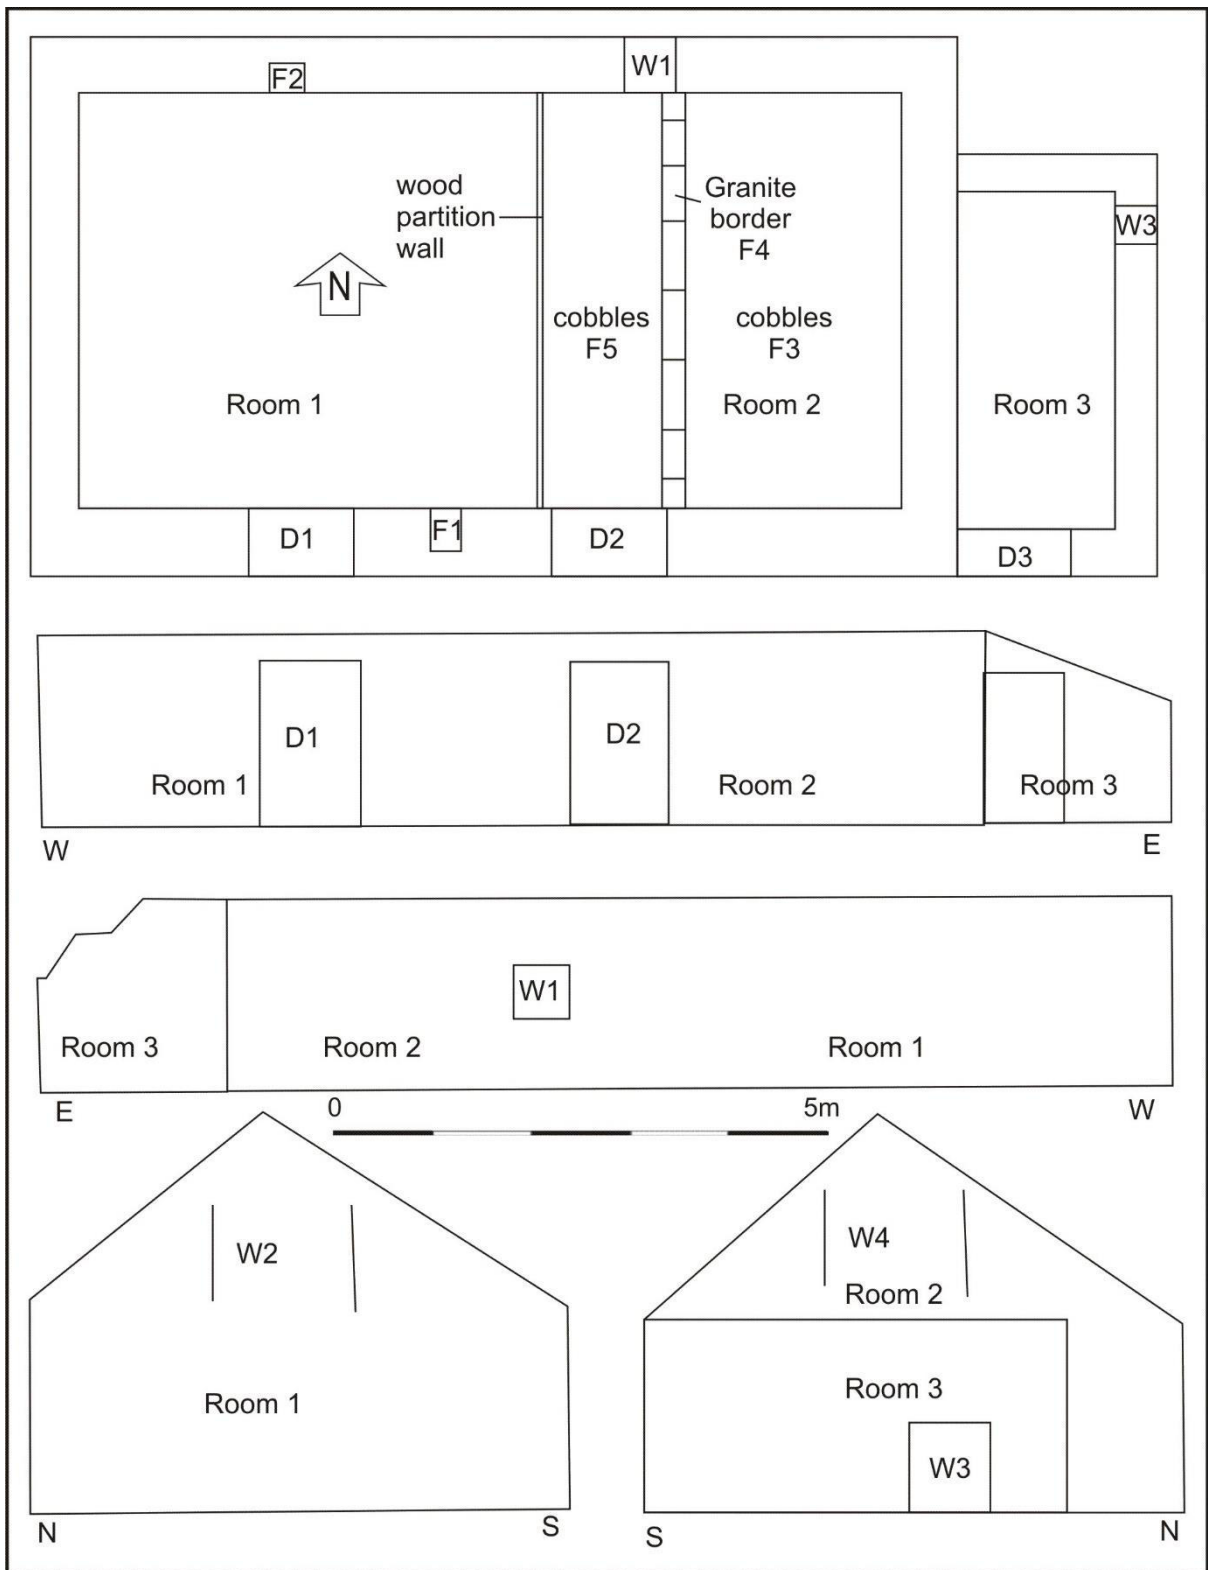
Illus 2 Plan (top) and elevations

There is evidence of windows in the upper half of the W and E gables (W2 and W4; Illus 2) but these have been infilled with granite and lintels and sills removed. There was no access to these apertures and they were both covered internally, with daub in Room 1 and whitewash in Room 2.

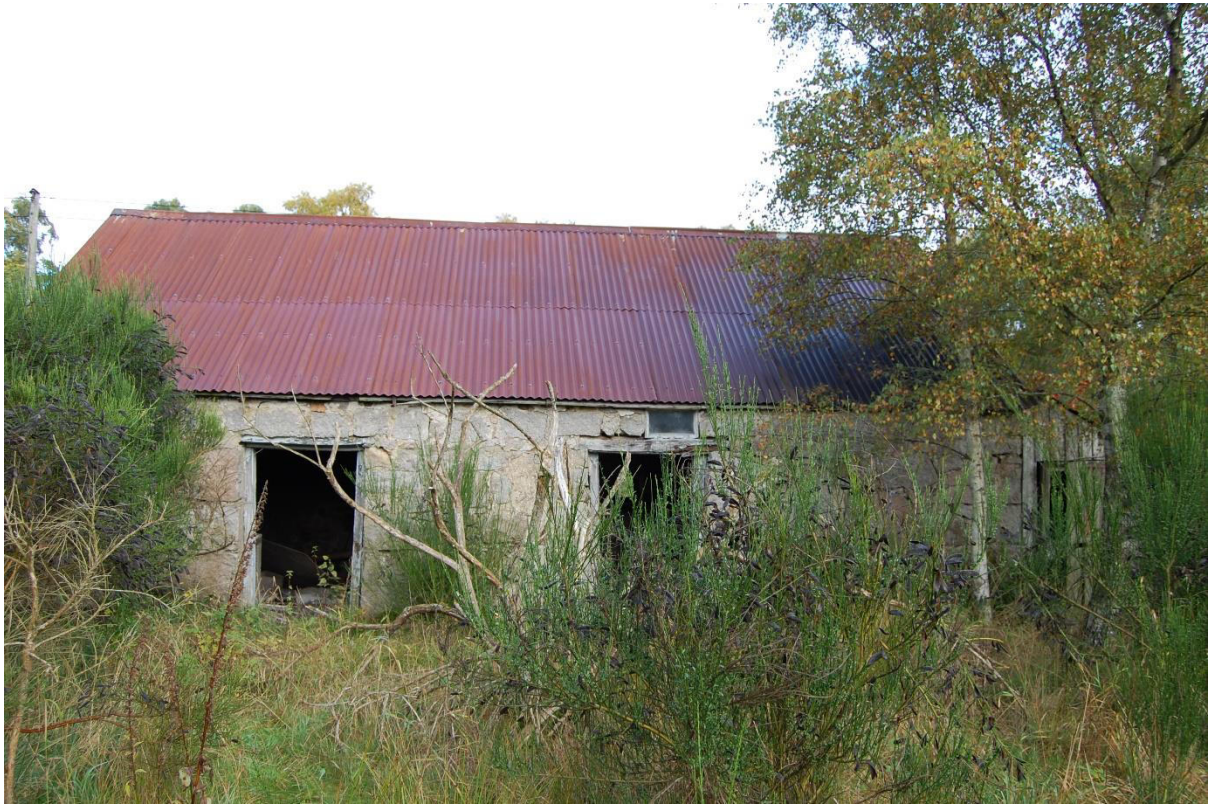
Illus 3 S façade of Rooms 1 and 2; facing N

A level 1 standing building survey was carried out on 15 October 2015. A full photographic survey was completed and plan and elevations drawn. Rooms 1 and 2 form a rectangular farm building 9.3m W-E and 5.4m N-S (cover and Illus 5) with a small lean-to shed attached to the E end 1.9 x 4.2m in size (Illus 3, 4). The buildings are constructed of granite rubble with granite window facings (W1, W3) and wood lintels on the doors in the S façade (Illus 3). There is a wooden partition between the rooms with a wooden door. Room 1 has a concrete floor and a door in the S wall (D1) and two alcoves, one on the S wall (F1) and one on the N wall (F2). F1 is 0.5 x 0.3m in size and 0.3m deep and F2 is 0.3 x 0.25m in size and 0.27m deep. The interior of the walls of Room 1 are covered with a thick layer of daub (Illus 6).

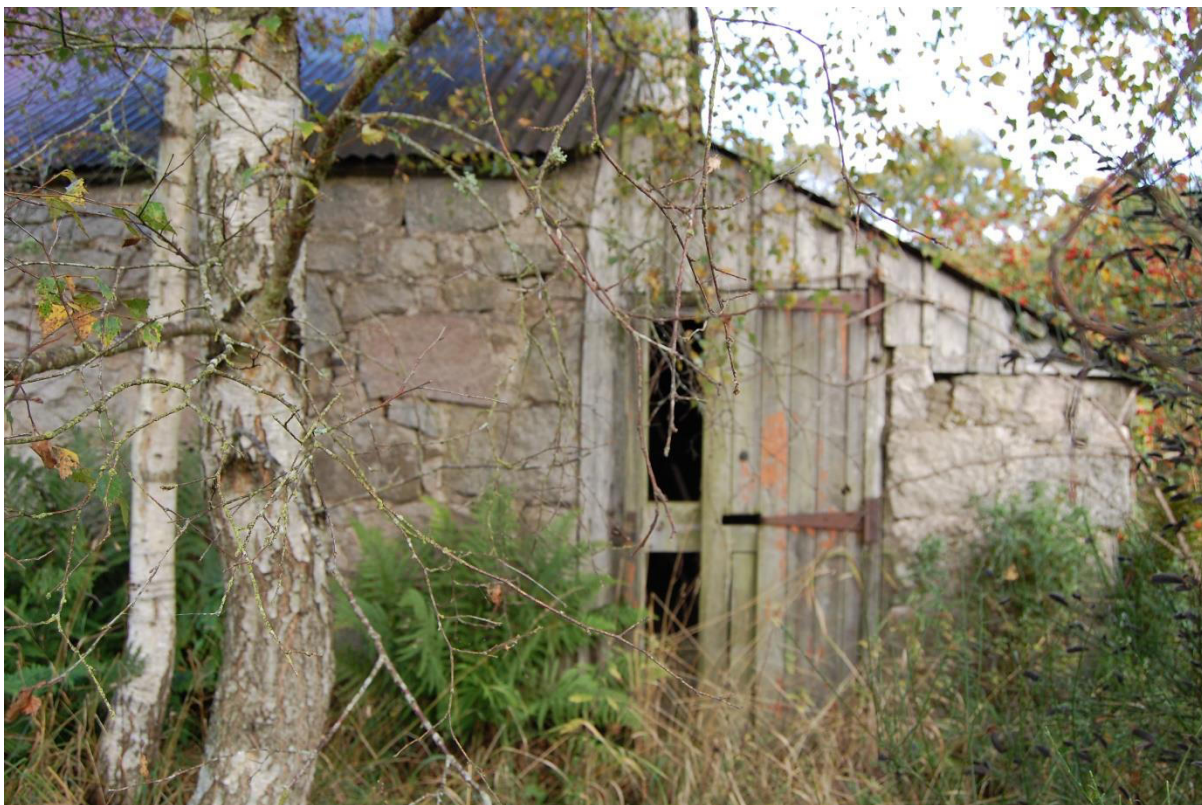
Illus 5 S façade with Room 3 lean-to (right); facing N

Room 3 is a lean-to with little access to the interior and overgrown exterior during this survey. There is a door on the S façade (D3; Illus 5) and a small window in the E wall (W3).

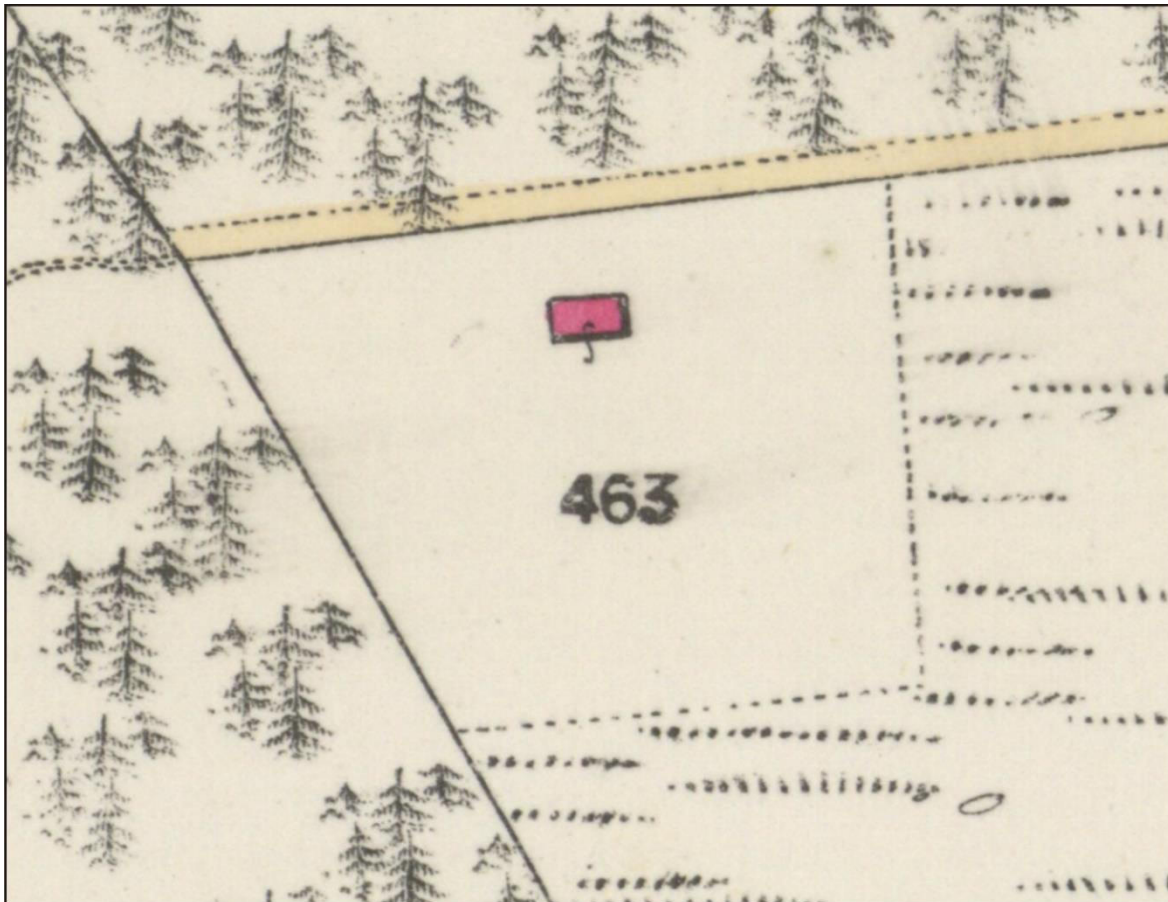
Illus 9 First Edition OS map Aberdeen Sheet LXIV.4 (Kintore) Survey date: 1864 Publication date: 1869 (copyright National Library of Scotland)

This building is not on CANMORE or Aberdeenshire Council Sites and Monuments Record and is not Listed. On the First Edition map (Illus 9) the main building (Rooms 1 and 2) can be seen in a trapezoid shaped field with no neighbouring buildings. There is woodland on the N and W sides and a track along the N side of the building. By the Second Edition (Illus 10) two other small buildings have been constructed on the NE side of this building. The nearer one to the surveyed building had a horse mill on the N side. These buildings have since been demolished. The buildings are not named on these maps.

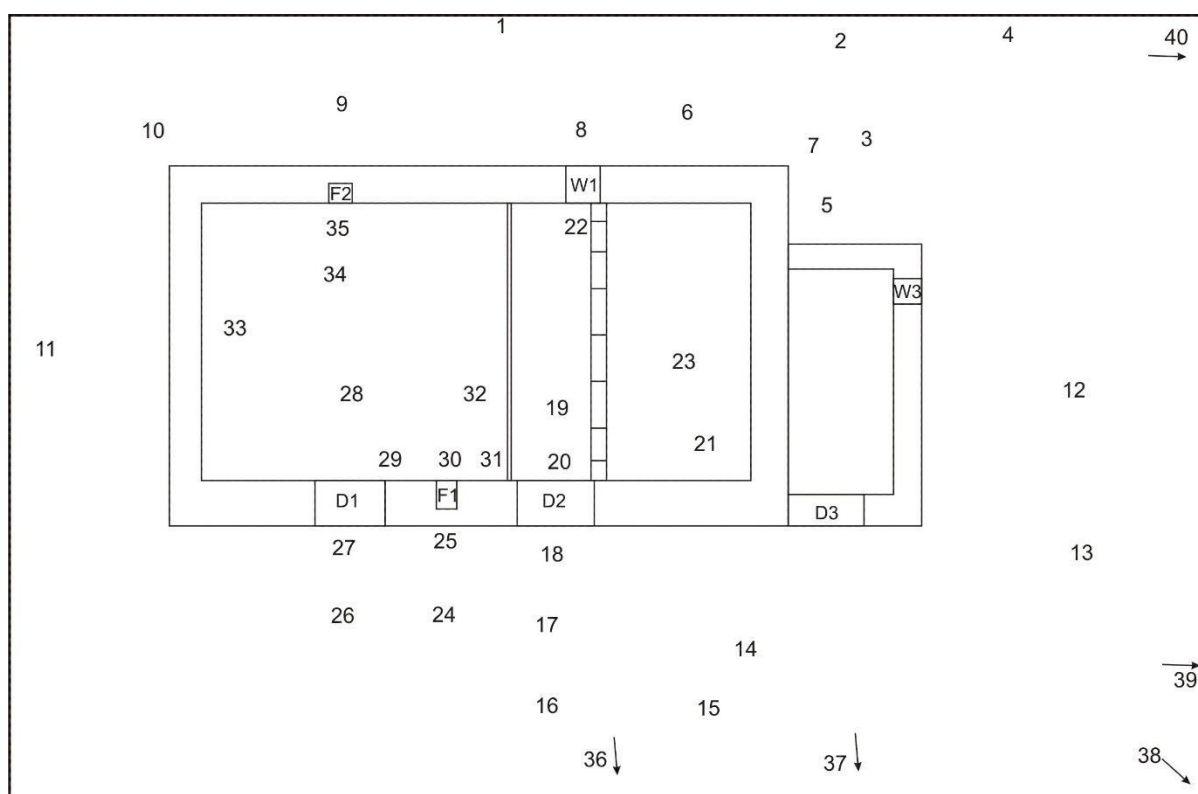
Illus 11 Camera points used in this survey

Photo no	Description	Facing	Camera point
DSC_1183-90	South façade with W1	S	1
DSC_1191	South façade with W1	SSW	2
DSC_1192	Room 2 E gable with Room 3 (foreground)	SW	3
DSC_1193	N wall Room 3	S	5
DSC_1194	Room 2 E gable with Room 3 (left)	W	5
DSC_1195	Room 2 upper E gable	W	5
DSC_1196	Room 2 N wall with W1	S	6
DSC_1197	NE quoin	SW	7
DSC_1198	W1	S	8
DSC_1199	Room 1 N wall	S	9
DSC_1200	NW quoins	SE	10
DSC_1205	Room 1 W gable showing foliage covering wall; traces of an upper window W2	E	11
DSC_1206-7	E gable with Room 3 (bottom)	W	12
DSC_1208-9	E gable with Room 3 (bottom)	WNW	13
DSC_1210-1	S wall Room 3 (right) with door D3	N	14
DSC_1212	S wall Room 3 (right) with door D3 and D2 (left)	N	15
DSC_1213	D2	N	16
DSC_1214	D2 (right) D1 (left)	NW	16
DSC_1215	Room 3 S wall with D3	NE	17
DSC_1216-7	D2	N	17
DSC_1218	D2 (left) D3 (right)	NE	17
