**Land 220m North Of Easter Marcus Cottages, Finavon,
Forfar, Angus, DD8 3QH**

Report on watching brief

**Alison Cameron
Cameron Archaeology
8 January 2016**

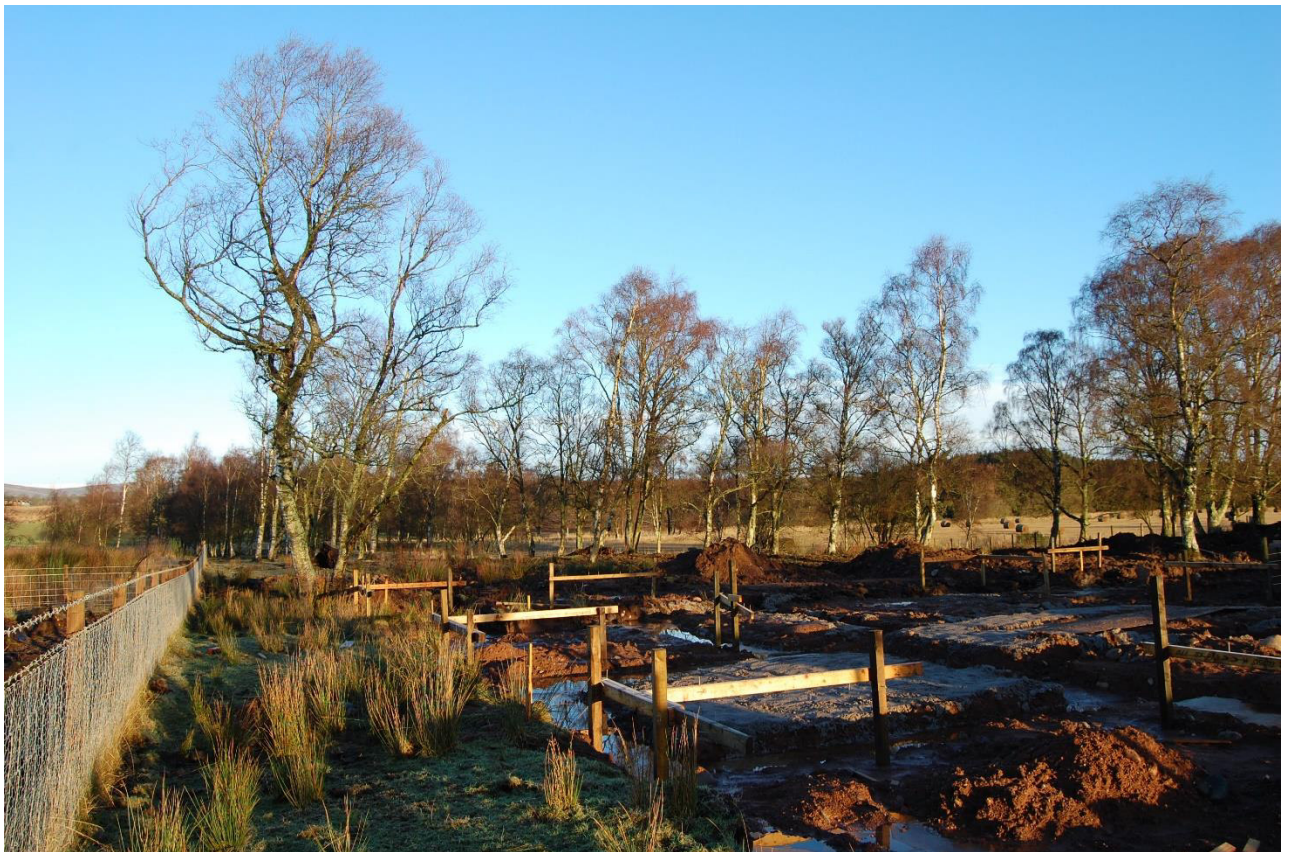
Cover: the house site showing shallow topsoil and trees; facing N

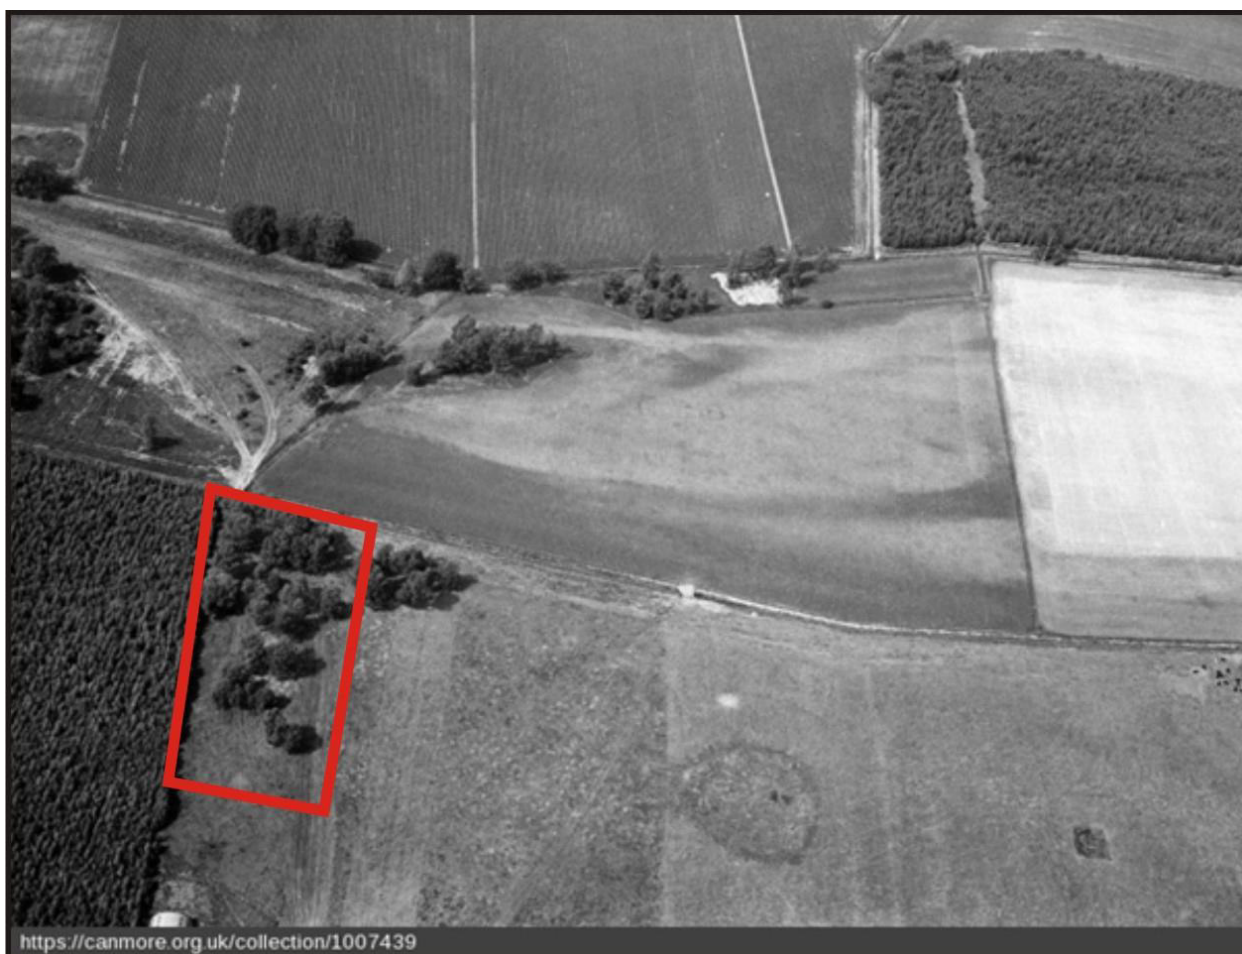
Illus 2 Oblique aerial view centred on the cropmarks of the timber hall at Noranbank (NO55NW 40) with Haer Cairn (bottom centre) looking N with site outline in red (copyright Ian Ralston and RCAHMS)

- 2.2 130m N of the site is Noranbank (NO55NW 40; Illus 2). Cropmarks 740m SE of Noranbank farmsteading (Maxwell 1978, 44) reveal what may be the wall-trench of a rectangular timber building measuring about 27m by 8m internally. Although this building may belong to the Neolithic period, its dimensions differ significantly from those at Balbridie (NO79NW 16; Ralston 1982, 238-49), and it could be of much later date.

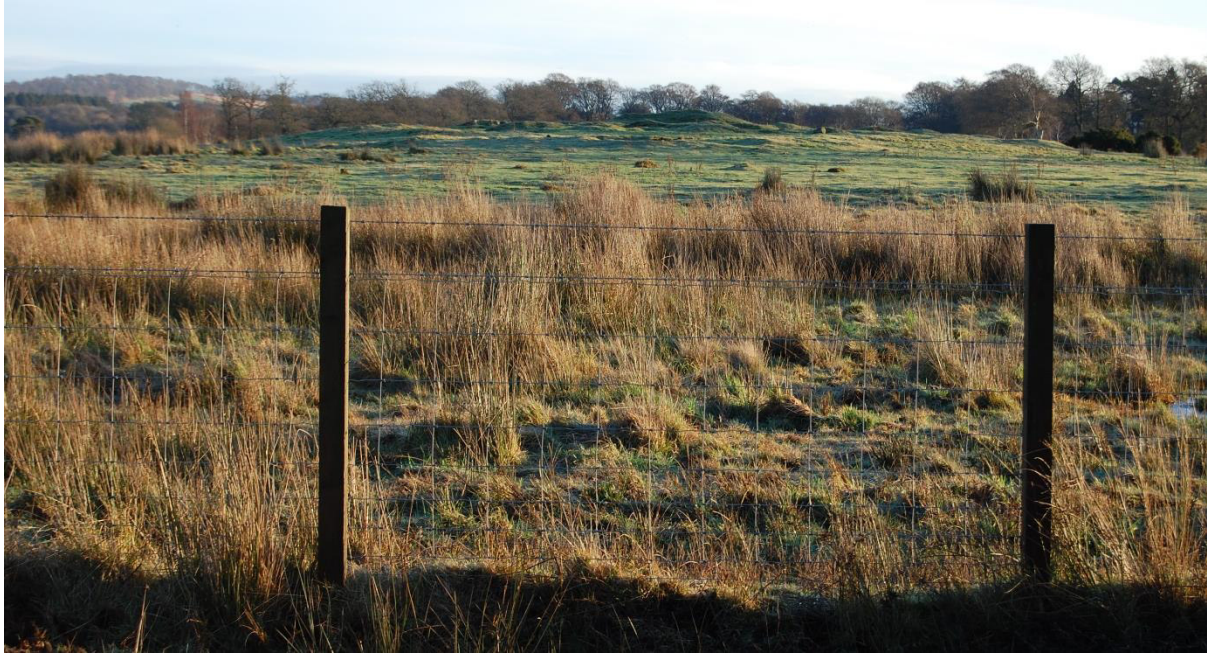
Illus 3 Remains of Haer Cairn from current site; facing E

- 2.1 100m to the E of the site is Haer Cairn (NO55NW 9; Illus 2, 3) 'Several rude stone coffins...containing human bones... were found c.1833 at a place called the Haercain in Howmuir Wood...there were no urns, and the remains were confined to the coffins' (Jervise 1853). Haer Cairn was a hillock or tumulus which was removed about 1830 and the site is marked by a hollow place in the wood' (Name Book 1861). It measures 38m N-S x 39.5m E-W and is generally c.1.0m high except on the west where it is only 0.2m high. Some spoil heaps give it an added height of 1.2m. The perimeter is clearly defined as a stony bank; but within is just a mass of spoil heaps. One large boulder lies on the west side of the cairn (RCAHMS 1983).

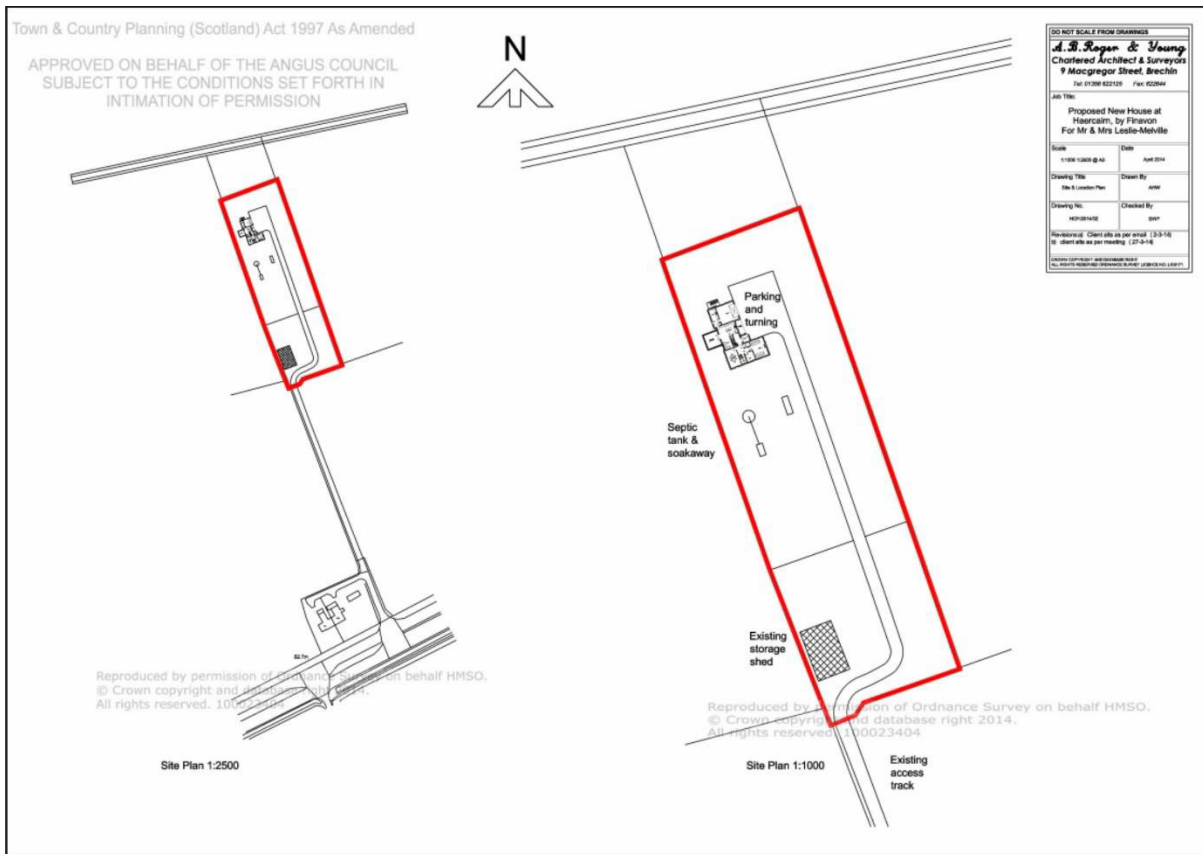
Illus 4 Plan of new house (copyright AB Roger and Young Ltd)

A watching brief was carried out on 8 January 2016. The site had previously been stripped of topsoil and strip foundations concreted (Illus 4, 5). A walkover was carried out of the area of the foundations, surrounding field and spoil heaps (Illus 6). The topsoil which had been removed was c10-15cm thick and the area had been heavily planted with trees on the First edition OS map (Illus 7). Approximately 12 trees were removed by the current owner prior to the soil strip at this site.

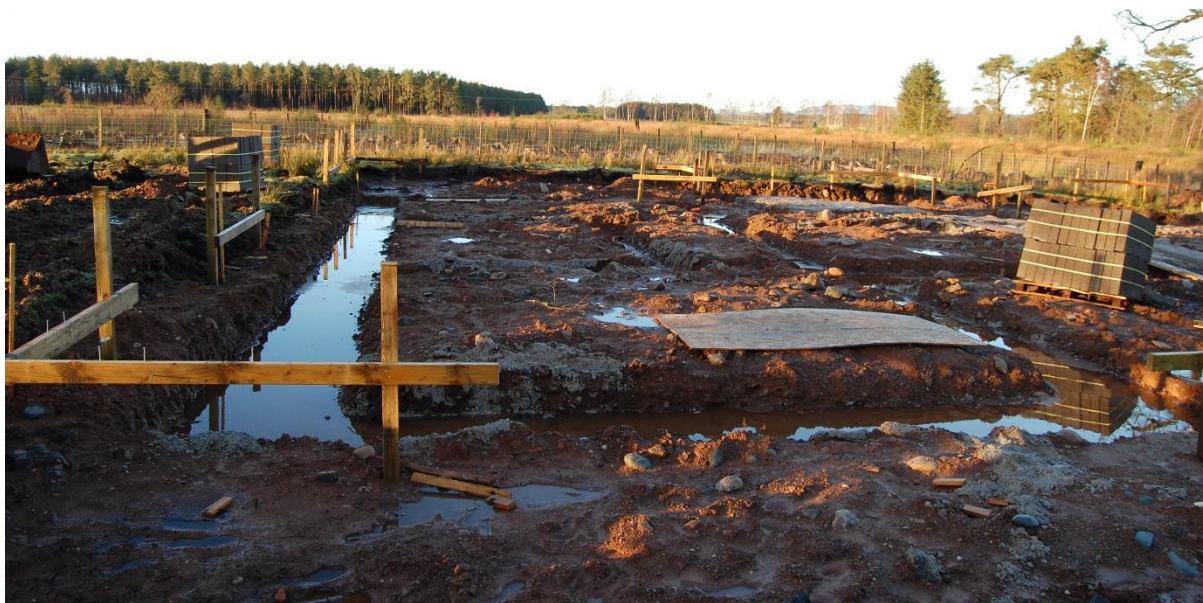
Illus 5 Site of house with topsoil removed and foundation trenches dug and cemented; facing W

No archaeological features or finds were identified during the walkover/watching brief and as a result it is recommended that no further archaeological work is required during the current planning application.

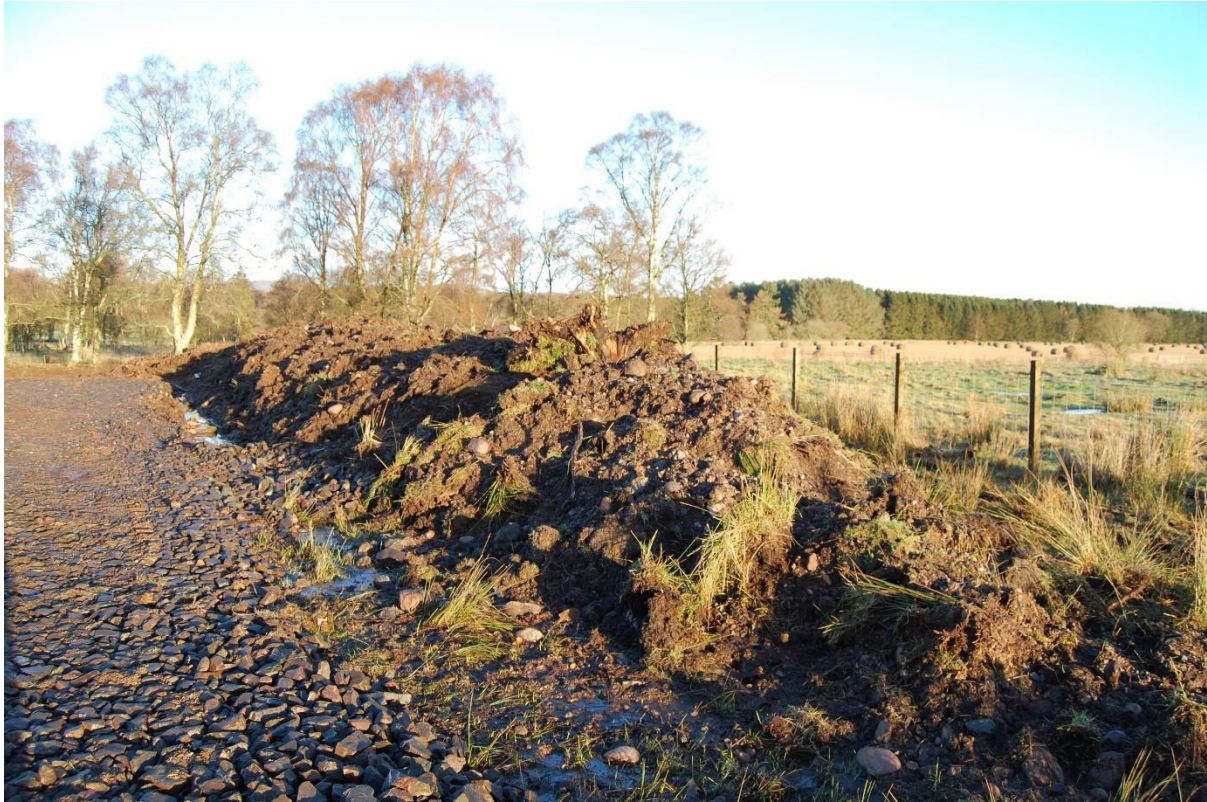
Illus 6 Spoil heap showing tree roots; facing N
