**Mains of Melrose, Gamrie, Aberdeenshire, AB45 3EN**  
**Report on watching brief**

**Alison Cameron**  
**Cameron Archaeology**  
**23 February 2016**

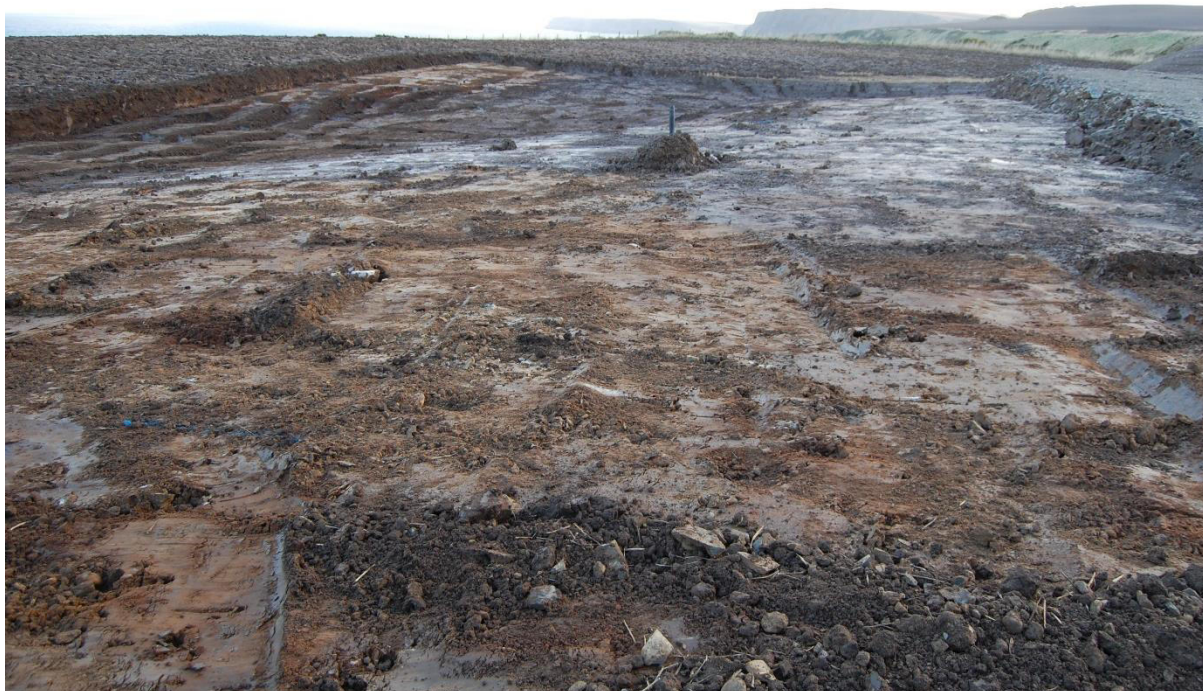
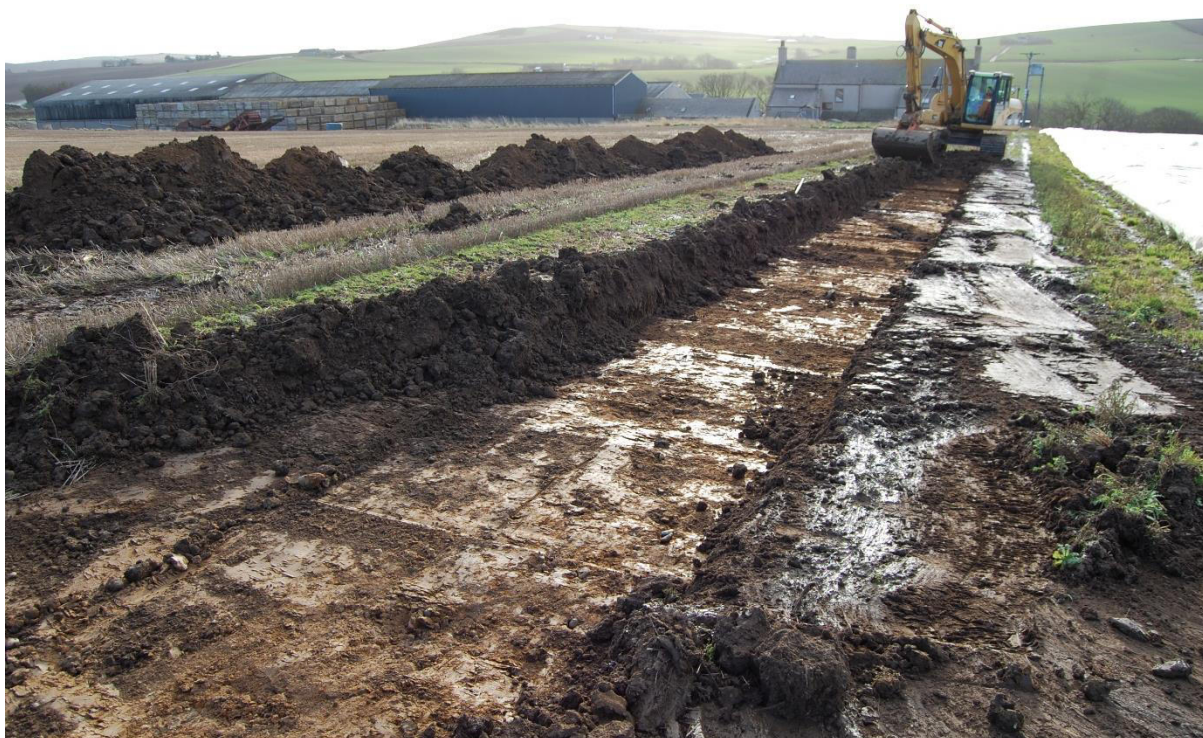
Cover soil strip for turbine base (foreground) and associated agricultural works revealing palaeochannel (top left); facing E; Bottom soil strip for cable trench; facing S

A watching brief on the cable trench was maintained on 1 February 2016. The trench was 1.5m wide and ran from the sub station diagonally to the field boundary to the W and then S along the field boundary to near the existing pylon. The N-S trench along the former field boundary revealed several field drains, concrete and an iron pipe (cover illus, bottom). A road had been previously located along this boundary.

A watching brief for the turbine base and associated agricultural works took place on 22-23 February 2016. This trench was 15m wide and 60m long to allow for a lower area of the field to be backfilled the extra material from the turbine base trench. This hollow was the remains of a palaeochannel which was partially uncovered (cover illus, top).

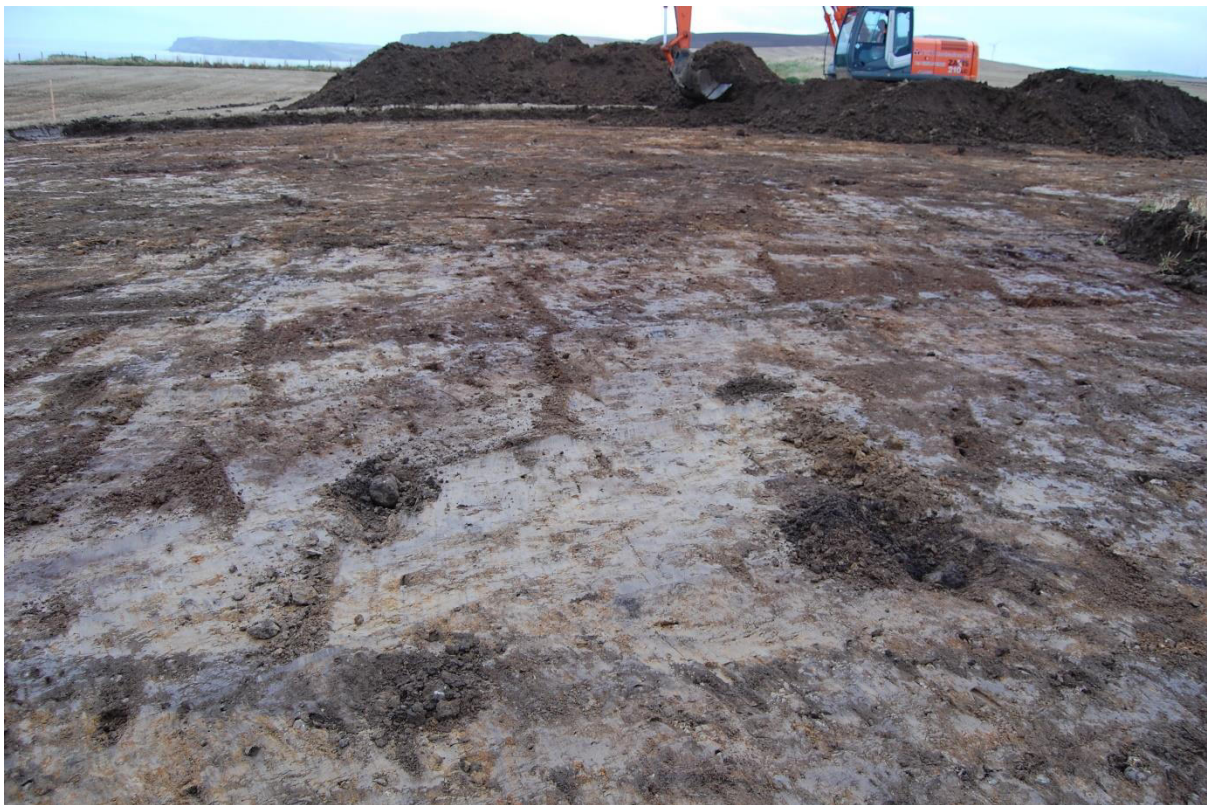
Illus 3 Soil strip for crane base and associated works showing shallow topsoil and field drains; facing S

A watching brief for the crane base (Illus 3), turning area and access road (Illus 4) was carried out on 15-16 December 2015. The area of the crane base was gravel subsoil with 0.2m clayey topsoil. There were numerous medium and large stones in the subsoil with associated stones holes which were investigated. The access road trench had 0.12-0.2m of heavy clay topsoil on a pink clay subsoil.

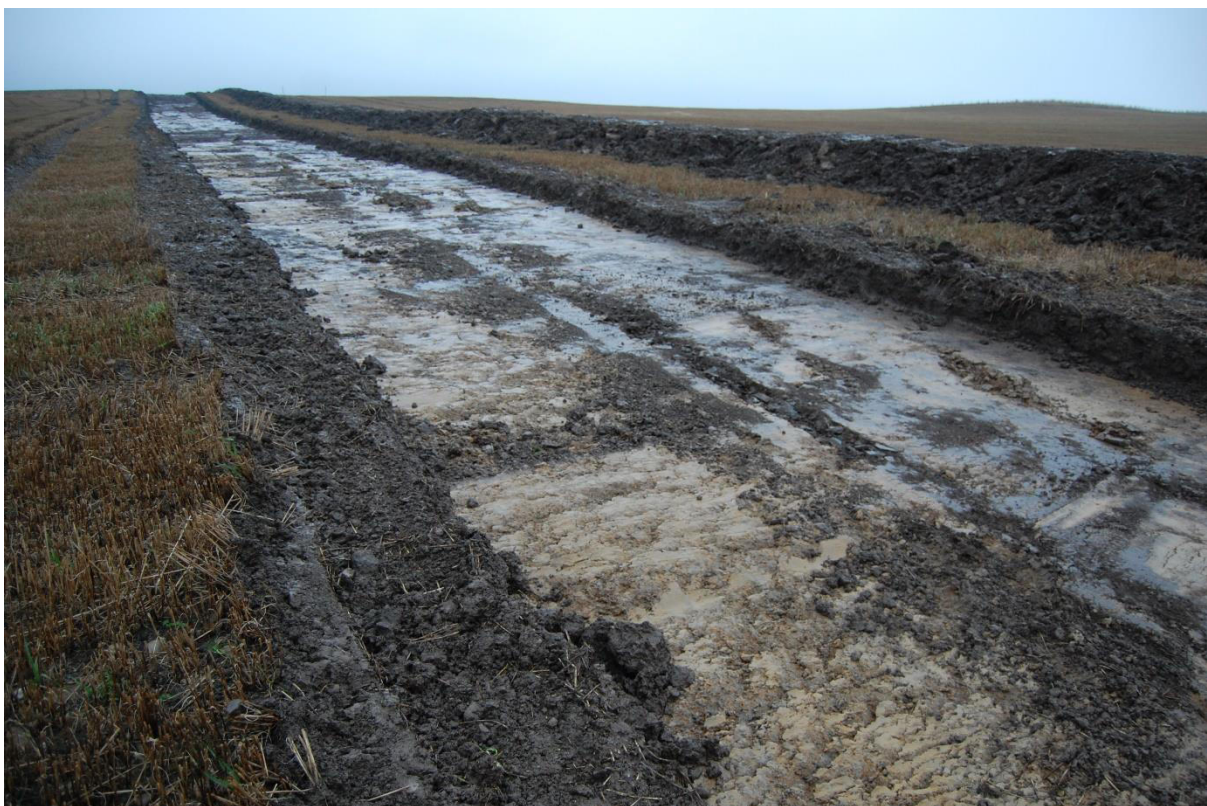
Illus 4 Soil strip for road; facing NNE
