**Kintrockat House, Kintrockat, Brechin, DD9 6RP  
Report on Level 2 Standing Building Survey**

**Alison Cameron  
Cameron Archaeology  
10 February 2016**

## SUMMARY

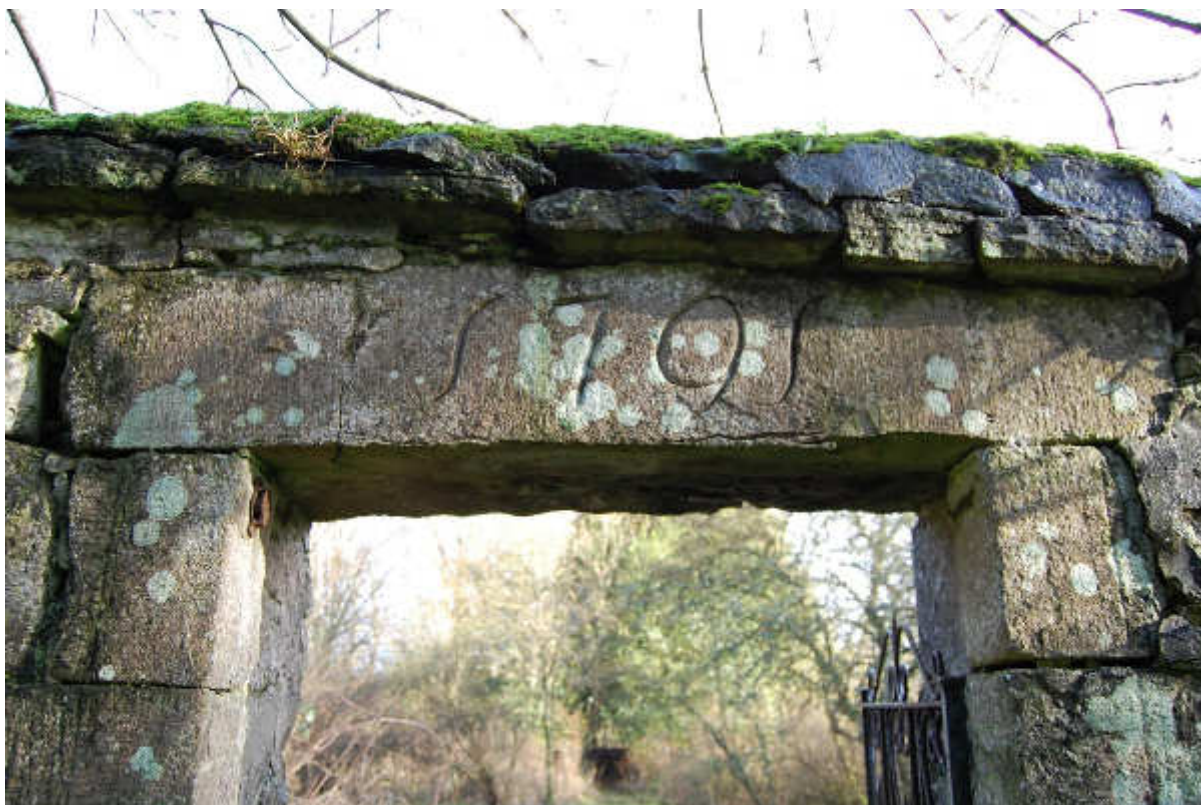
Illus 2 Lintel of gate to walled garden inscribed '1791' (not included in this planning application); this may date the house or more likely the Phase 2 or 3 wings; facing W

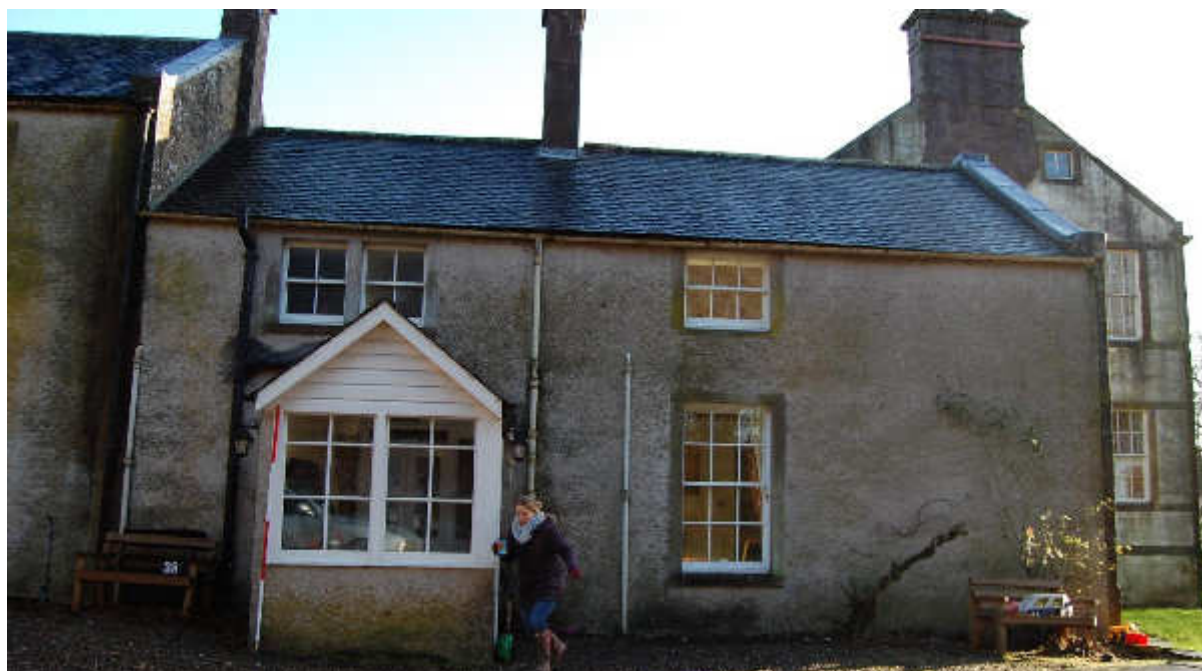
Illus 3 Phase 2 W wing not included in this application, W wall; facing E

The N end of the W (Illus 3) and E wings were added in Phase 3 and the N wing is probably contemporary. The N wing is 38.1m long and 6.2m wide and the extensions to the W and E wings are 8m long. The Phase 3 wings have been built onto the N ends of the Phase 2 wings (Illus 4, 5). There is no evidence that the N ends of the E and W wings and the N wing was built in more than one phase, possibly in the early 19<sup>th</sup> century. There are tooled sandstone mouldings throughout (although some of the mouldings have been replaced with sympathetic concrete mouldings).

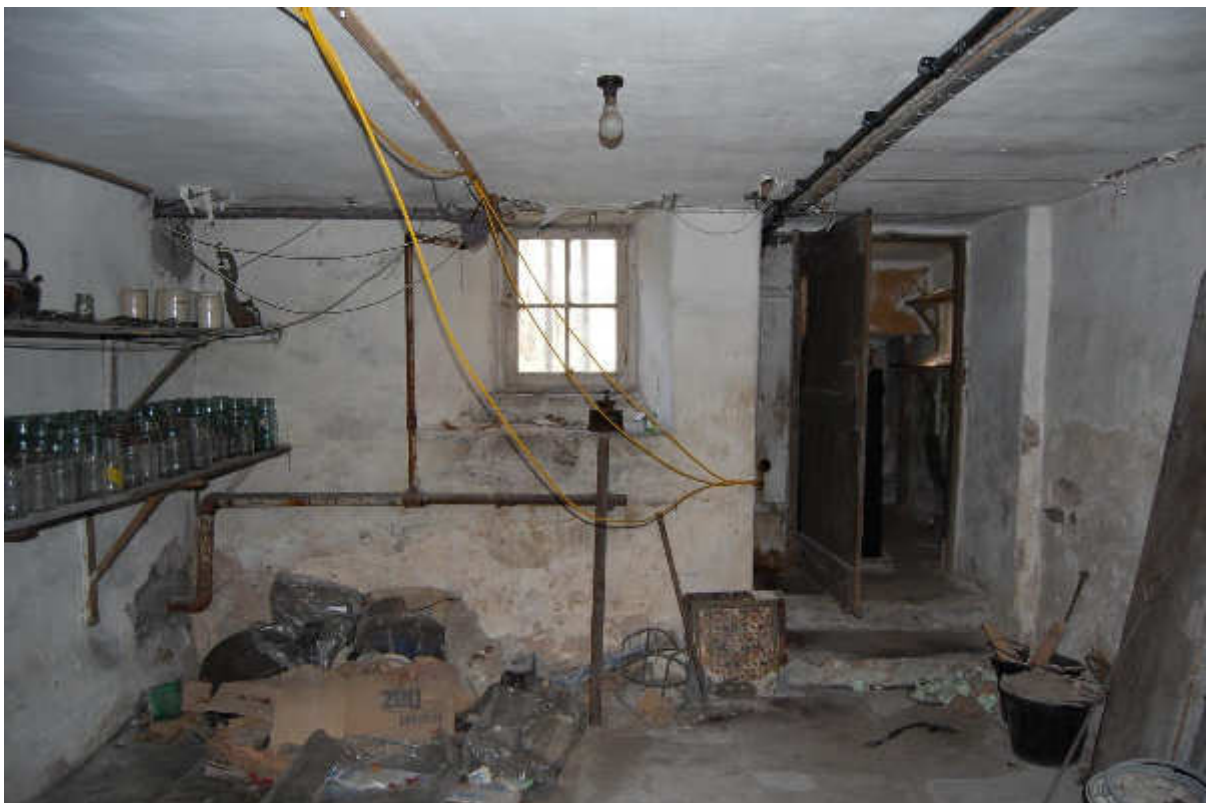
Illus 7 Room 2 W wall with W3 (left) and D52 (right); facing W

NW basement room with steps to ground floor (F34; Illus 8) and window in the W wall (W3; Illus 7).

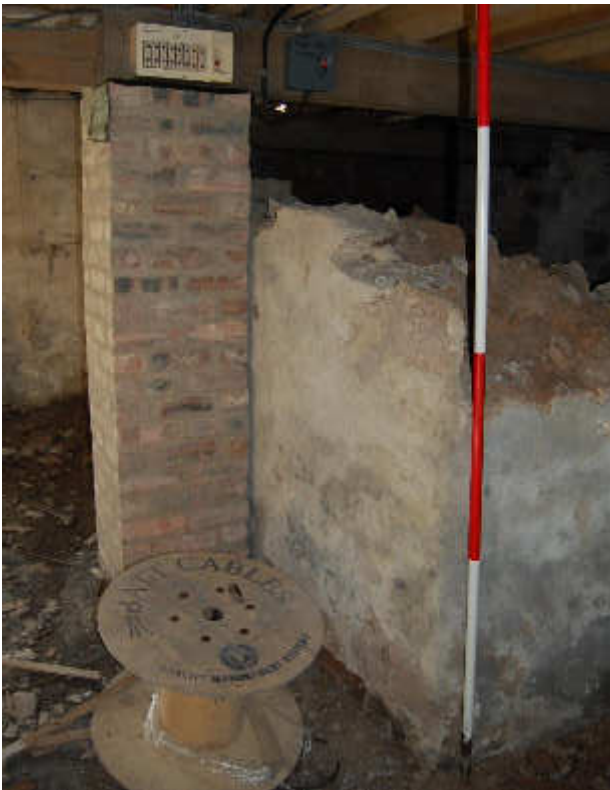
Illus 9 Room 4 NE corner of wall showing partially demolished wall (right), new wooden ceiling beams (top) and brick support for new ceiling (left); facing SSW

Small room in centre of S basement which has been partially demolished and infilled with rubble. It is 3.3 x 3.5m in size and the walls stand to 1.5m in height (Illus 9). These walls are butted on to the S wall of the house adjacent to the exterior steps F3.

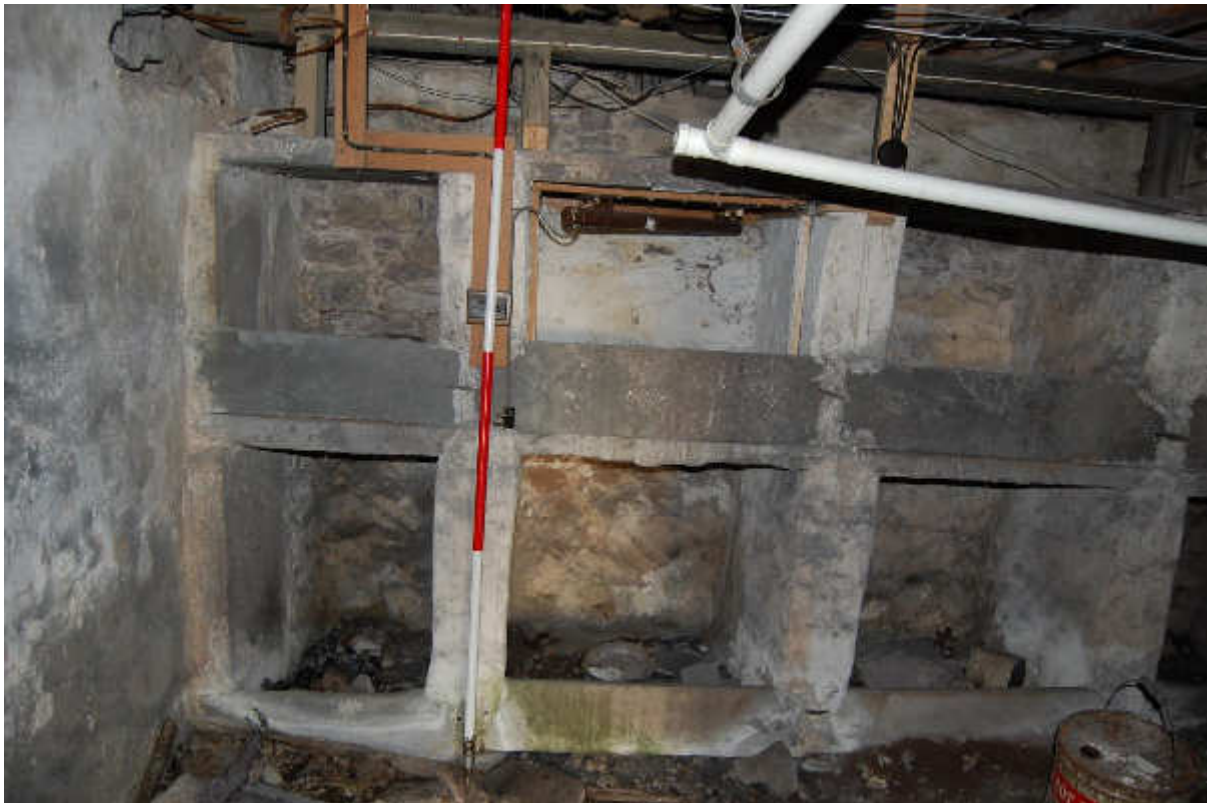
Illus 10 Stone shelves F27; facing N

This is the NE basement room which was a cold store or pantry. The room is 5.1m long and 3m wide with plastered stonework walls. On the E wall is window W4 and on the S wall W66. On the N wall is a series of 10 plastered masonry and sandstone alcoves (Illus 10) used for keeping foodstuffs cool. There are two rows of five shelves but it is possible there was another row above which were removed when the new wooden roof was built.

The shelf structure is plastered masonry creating apertures on the top row 68 x 42cm and 85cm deep and on the lower shelf 68 x 70cm and the same depth. At the front of the aperture are sandstone blocks 73 x 22cm in size forming a lip (Illus 11); the sandstone blocks have been pinned with iron staples (Illus 11). The shelves are also constructed of sandstone blocks. This room was latterly used to store coal and there is a pile of coal at the E end of the room.

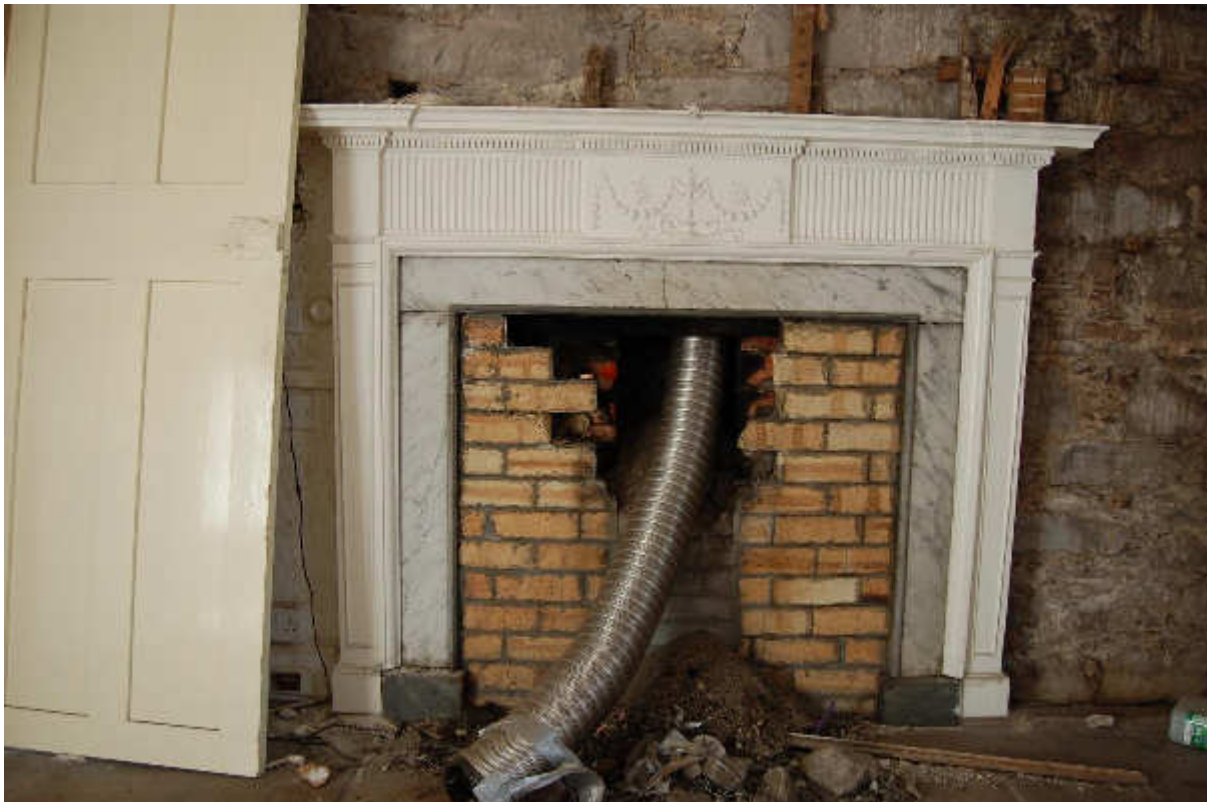
Illus 12 F10; facing E

This room is in the SE corner of the Phase 1 house and was a dining room. It has marble fireplace with wood surround on the E wall (F10; Illus 12) and a window on the S wall. There is cornicing which is probably part of the Victorian adaptations which have taken place in the house including removing fireplaces, skirting boards and coving (verbal report by Mr Graham Grant, a lecturer at Robert Gordons University to current owner). The lath and plaster has been taken off some of the walls of this room (due to water ingress) and this reveals sandstone blocks and rubble construction (Illus 13).

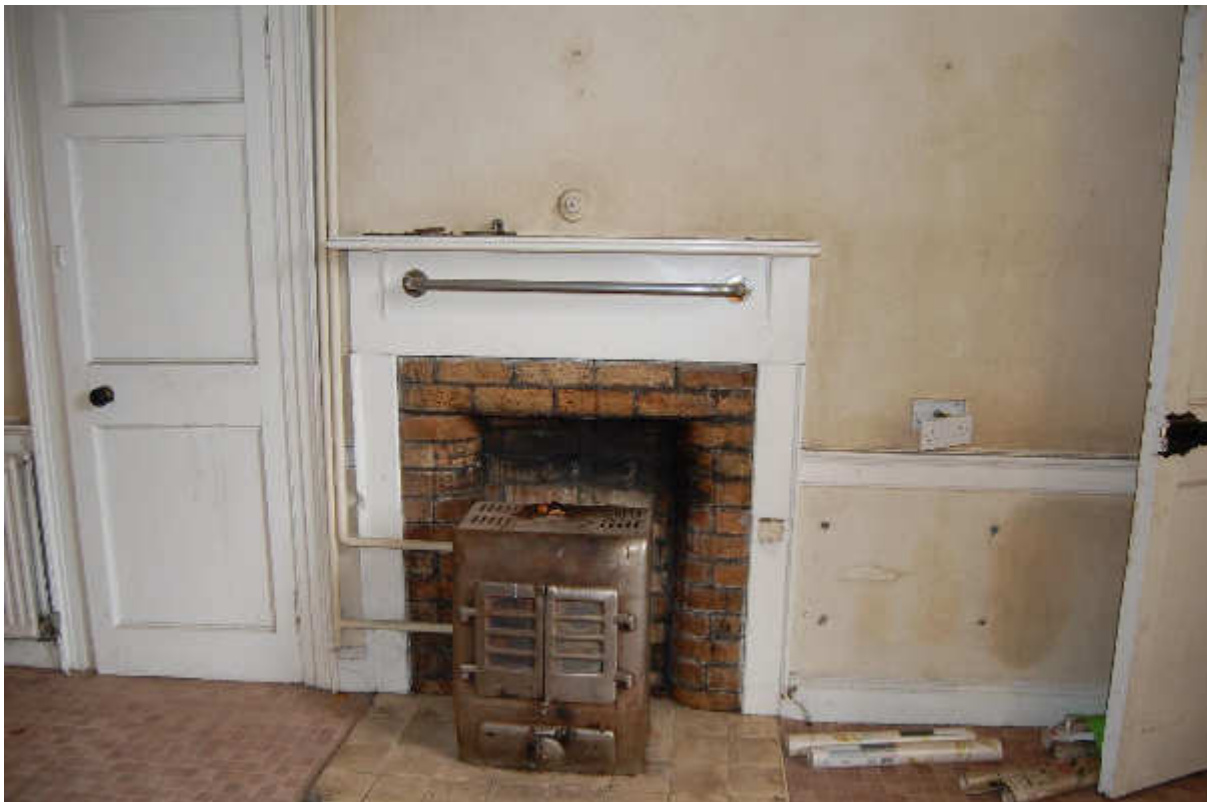
Illus 14 F12; facing N

This is the NE room of the Phase 1 house and was latterly the kitchen. It has window on the E wall W5 and fireplace/hearth F12 (Illus 14) on the N wall formed using 20<sup>th</sup>-century bullnose bricks with (possibly original) wood surround.

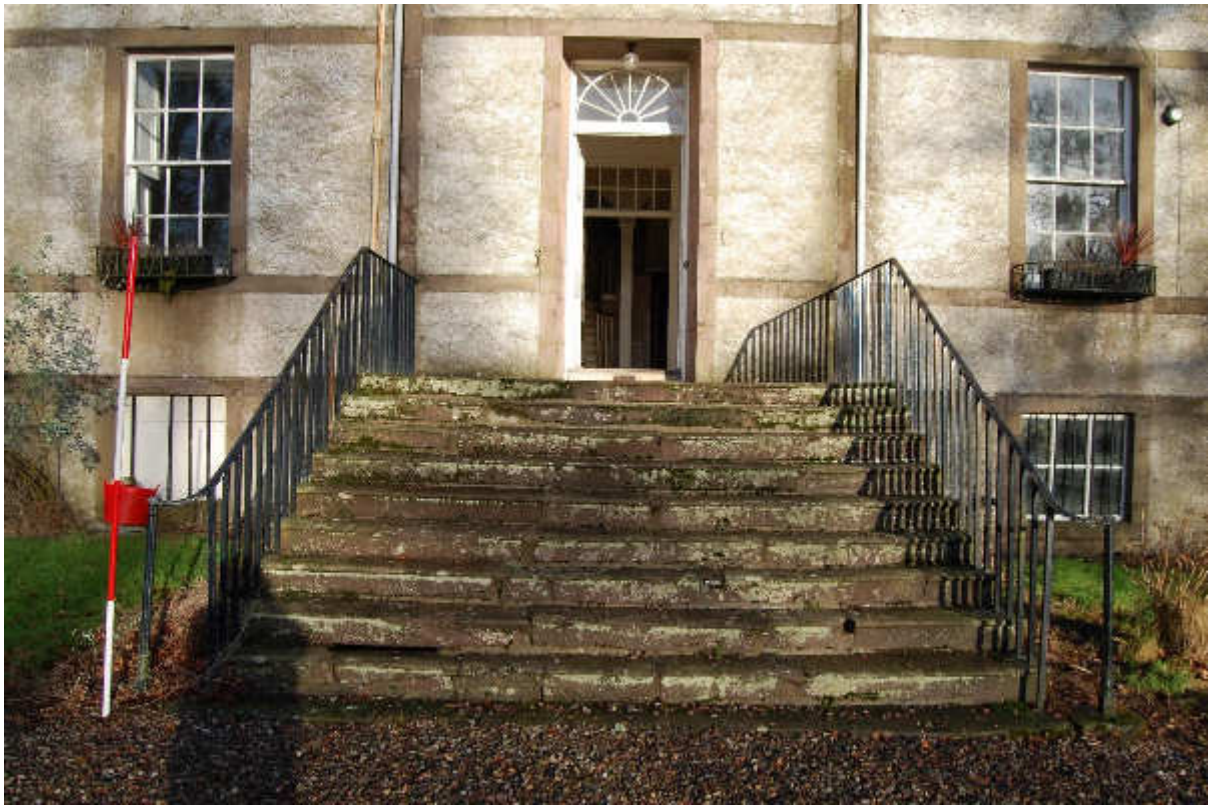
Illus 15 Steps F3 to D1 and Room 9 vestibule; facing N

Room 9 is the vestibule inside main door D2 (Illus 15). D2 is 1.25m wide and 3.1m high and is accessed by a set of sandstone steps (F3; Illus 15) with cast iron balustrade. The door has an upper fanlight window and the walls on either side of the door are curved creating a circular threshold (Illus 16). The vestibule has a glass and wood partition and doo leading to the hallway, Room 10.

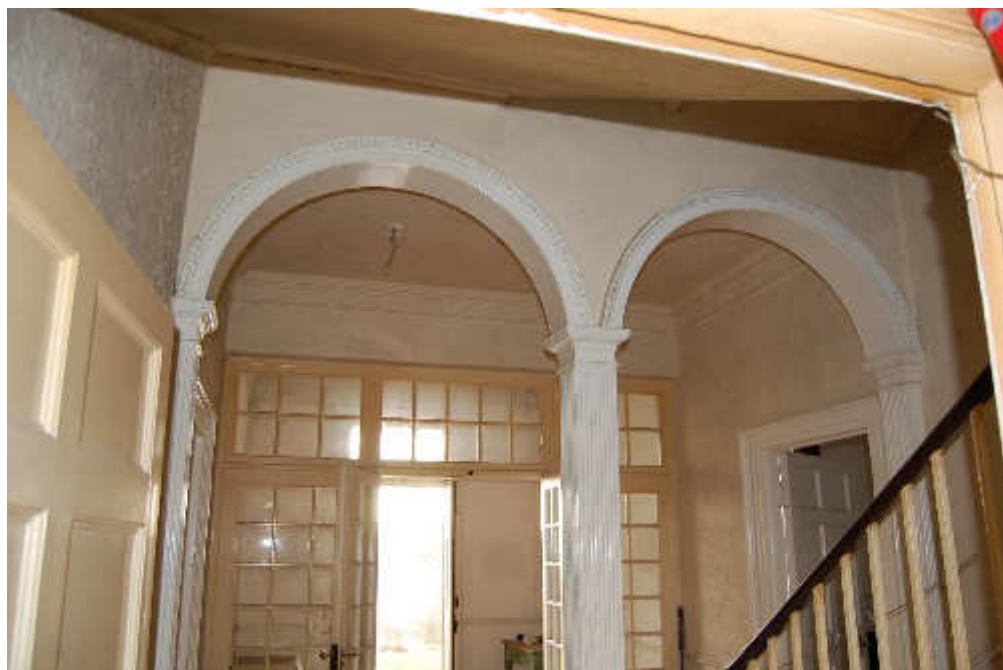
Illus 17 Arches on N side Room 10 between hallway and stairs; facing SSW

Room 10 is the stairwell leading to the main stair F23 and to the door to the basement (D51, on the E side of the stairs). There are wooden arches dividing the hallway from the stairs (Illus 17). The stairs from the ground to first floor are sandstone. There are doors in the W and E walls to the two main reception rooms (Rooms 7 and 11).

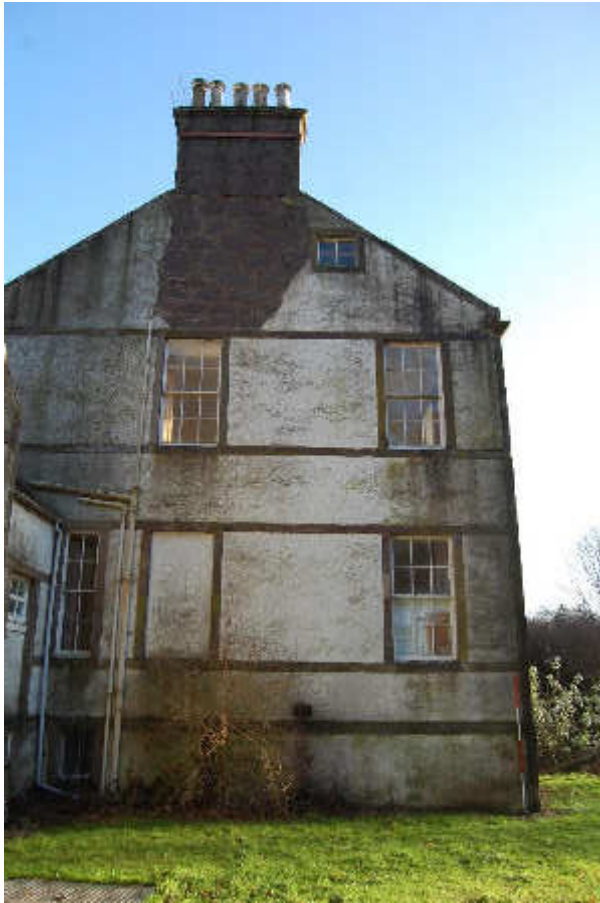
Illus 18 Phase 1 house W gable with Room 11 windows (W8, W9 blocked, W10 centre); facing E

This is the SW room was the sitting room. It is accessed from hallway Room 10 through door D31 and has two windows on the w wall (W8, W10) and would have had another in between (W9) but this has been blocked and harled over (Illus 18). There is a fireplace (F11) on the W wall and a window on the S wall W7. The room is now partitioned with an arched wood partition into an office and a door (D32) on the N wall to a cupboard adjacent to the main stair.

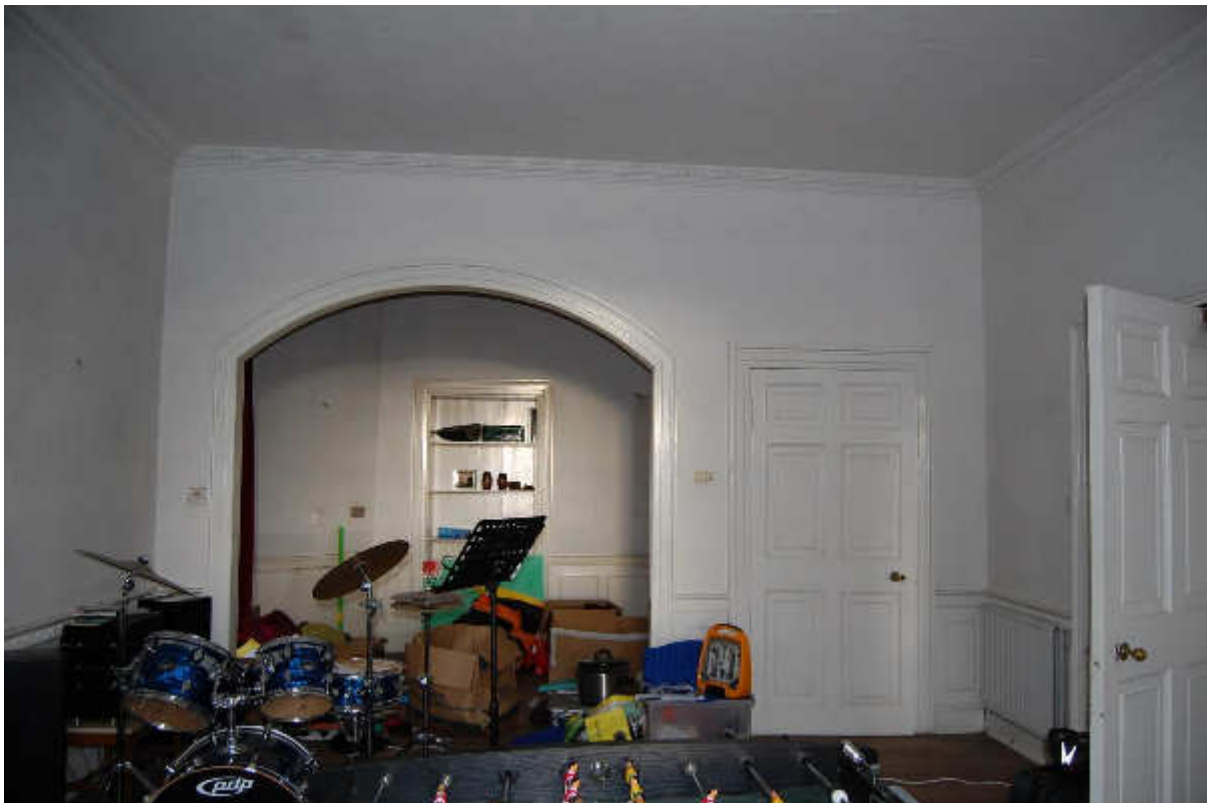
Illus 19 Room 11 with arched wooden partition to office, Room 12 and door to cupboard (D32, centre with D31, right); facing N

Small office at the N end of Room 12 with an alcove on the N wall (Illus 19).

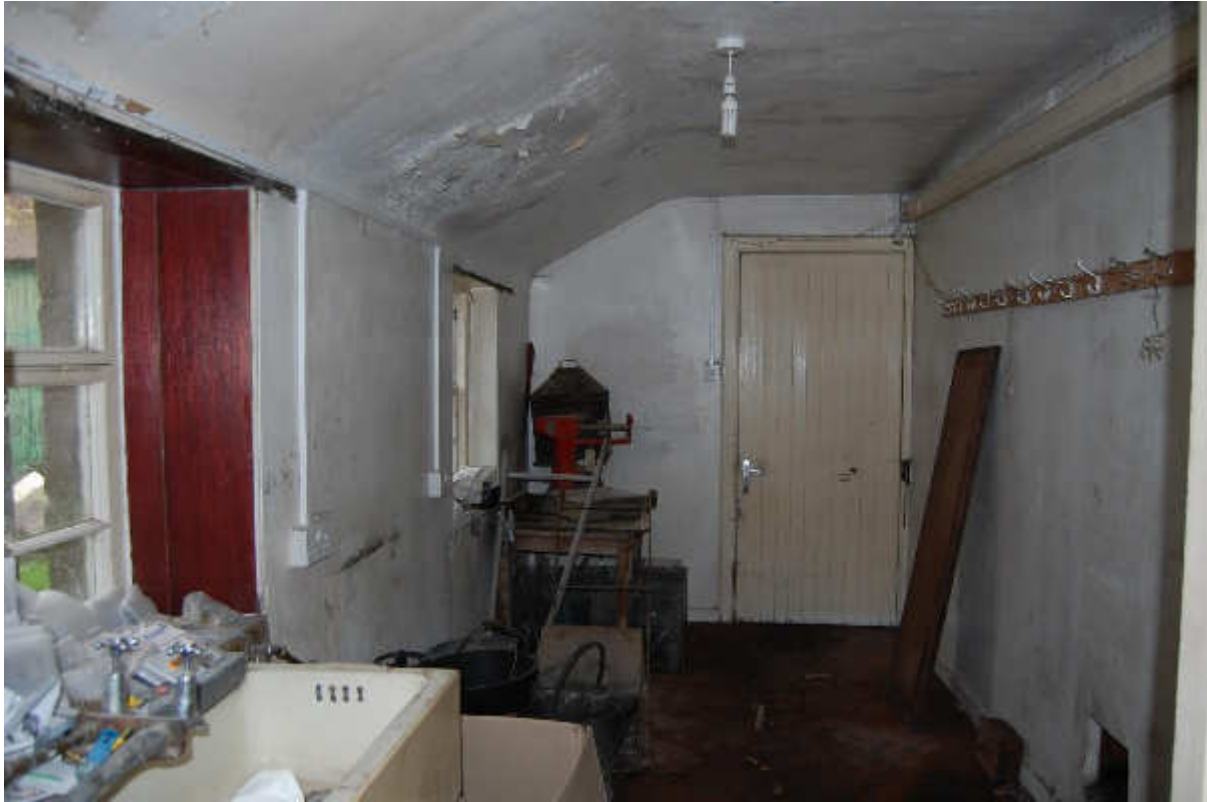
Illus 20 Room 14 corridor along the n wall of the Phase 2 house with D37 (right); facing E

Rooms 14 and 15 form a corridor (Illus 20) on the N wall of the Phase 1 house which may be Phase 2 or 3. It was constructed either when the Phase 2 wings were built or more likely at the same times as the Phase 3 wings. There is a window facing the courtyard (27) and a door (D4) has now been converted to a window (Illus 21). This corridor can be seen on the 1<sup>st</sup> Edition OS map. It formed a corridor for staff to access areas of the house and wings without entering the main house. The door at the E end of the corridor (D37) was originally an exterior door until D3 was built enclosing this area. Room 14 is single storey and has been used as a laundry.

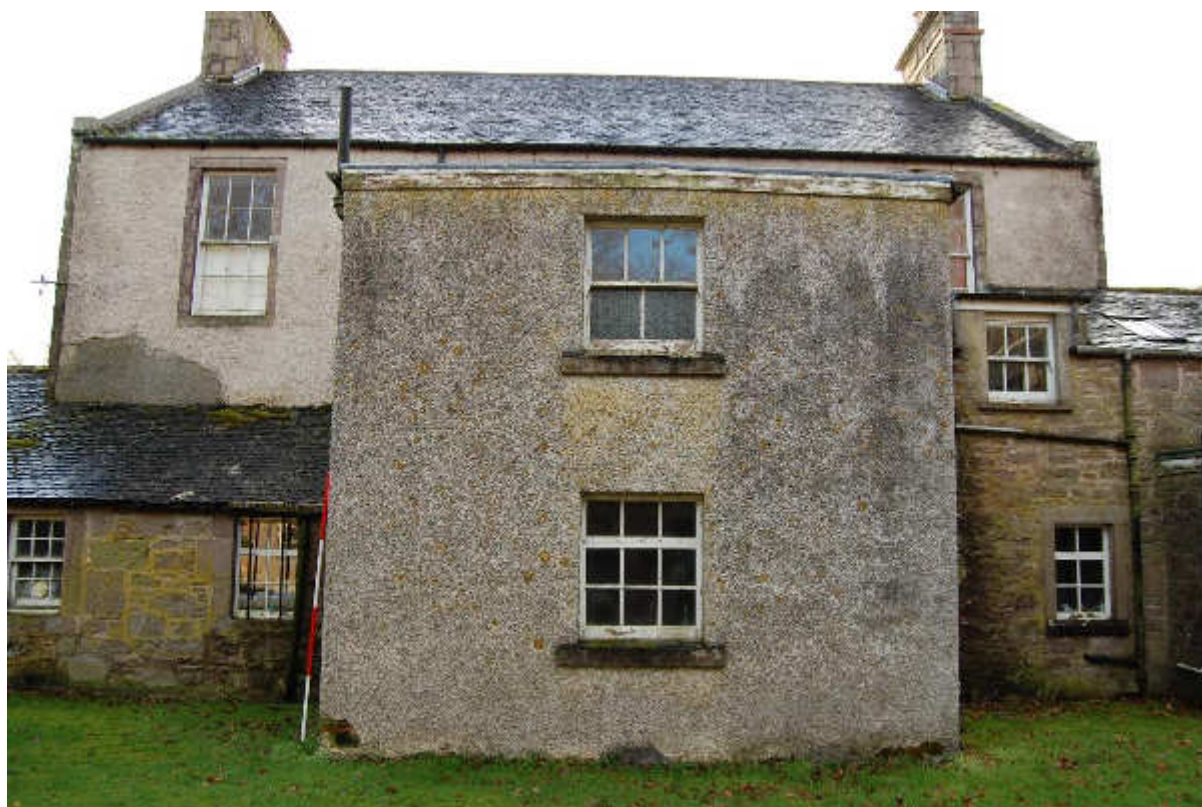
Illus 22 Room 16 N wall W28 (below) W25 (top) with Phase 1 house N wall at rear; facing S

Extension on the S side of the courtyard now used as a bathroom (Illus 22). Constructed of brick with concrete window sills and harled. There is a building in this location on the 1<sup>st</sup> Edition OS map (Illus 44) but this has presumably been rebuilt on the 20<sup>th</sup> century.

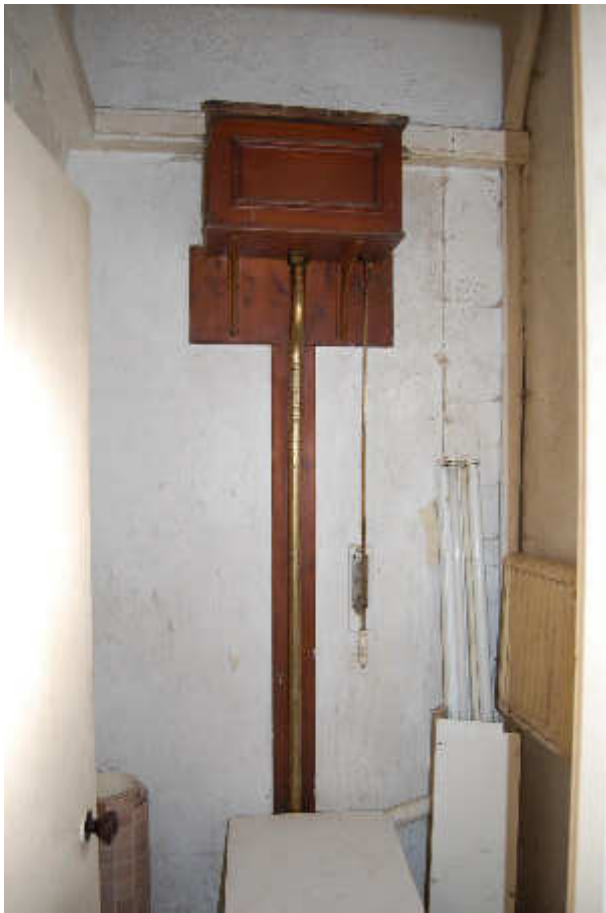
Illus 23 Room 17 fittings; facing E

Victorian style bathroom with fittings (Illus 23). This room is in the link between the NE corner of the Phase 1 house and the Phase 2 E wing with door to the Phase 1 house on the W wall and to the courtyard on the N wall. The room had a large window on the S wall which has been blocked and harled leaving a small upper window when the room was converted to a bathroom.

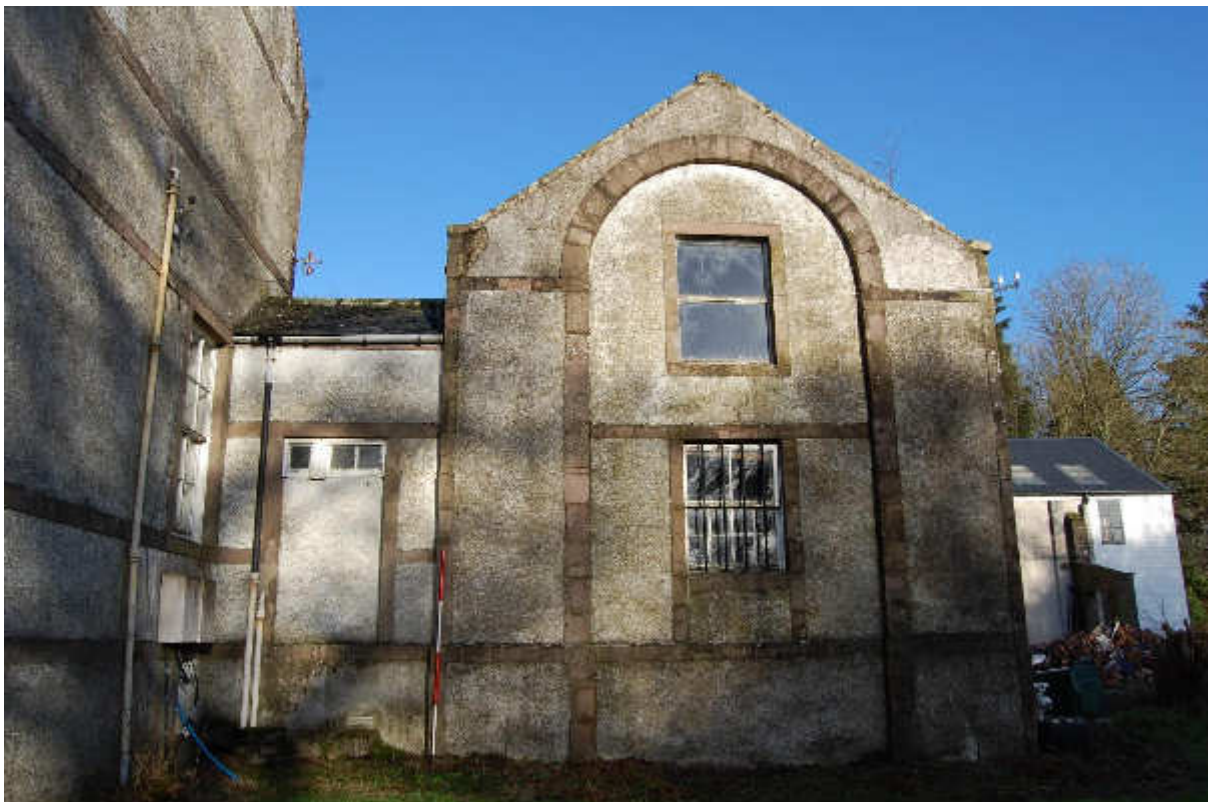
Illus 24 Phase 2 E wing (right) ground floor Room 19 window W52 and Room 34 W51 (above) with link to Phase 1 house Room 17 W50 (left); facing N

Workshop at the S end of the Phase 2 E wing. This room has a large window on the S wall (W52; Illus 24) and a door on the E wall (D7) which has been inserted or altered with brick infill around the jambs (Illus 25). There is a flue on the N wall (F13) below chimney F30.

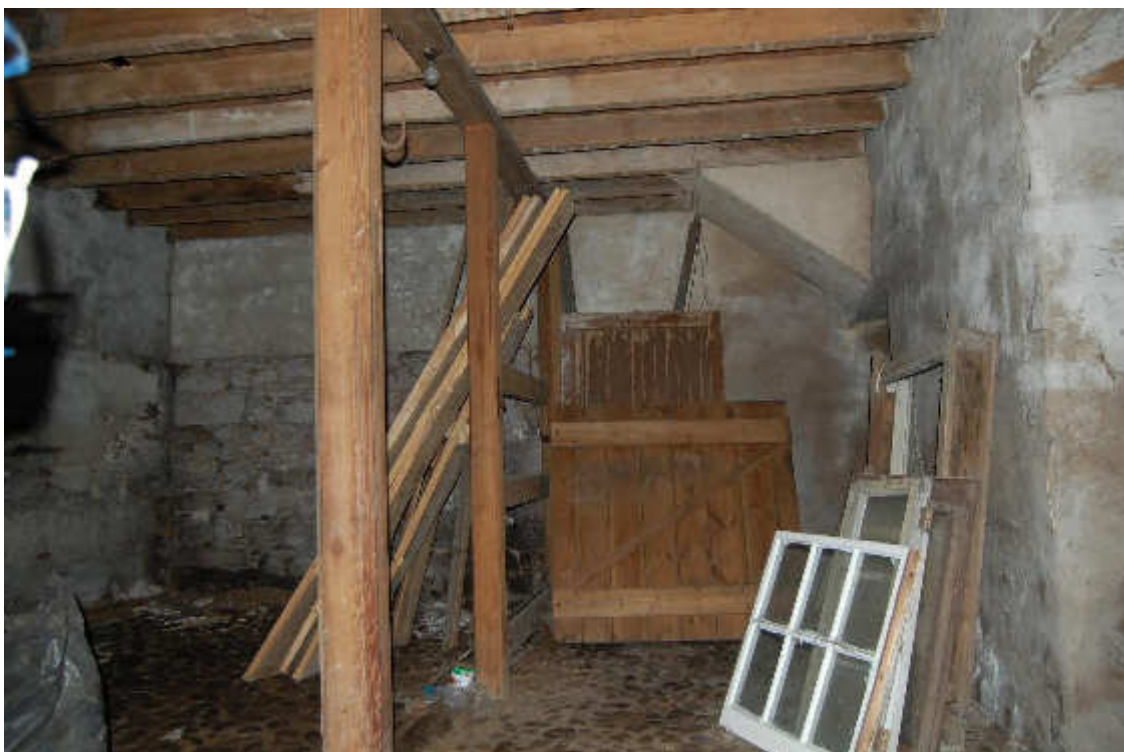
Illus 26 Room 20 with cobbled floor, D22 (right) and wooden partition for animals; facing S

Former stables room at the N end of the Phase 2 E wing. There is a door to the courtyard (D22) and a door to the Phase 3 extension to the N (D26). The room has a cobbled floor and uprights for wooden stalls survive and much of the interior of the room have been plastered (Illus 26). There is a triangular inset between the floor and roof in the SW corner of the room which is probably associated with stairs F4 which are on the exterior of this wall. It is possible that this is the remains of an earlier internal staircase.

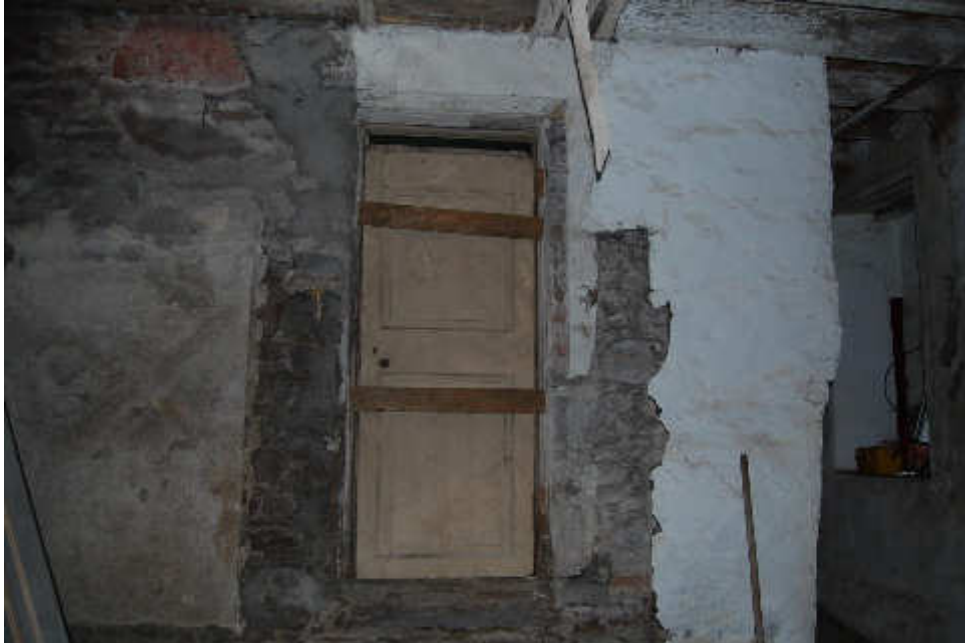
Illus 27 Room 21 N wall with gap/door D54 (right) and D27 (centre); facing N

Room on ground floor at S end of Phase 3 E wing on used as a store. There is a gap/door (D54; Illus 27) in the N wall through to Room 22 at the E end where the wall has been removed and another smaller door in the centre of the N wall (D27). There is a door to the courtyard on the W wall (D21) and D8 on the E walls. D28 was blocked when the squash court was built (Illus 28).

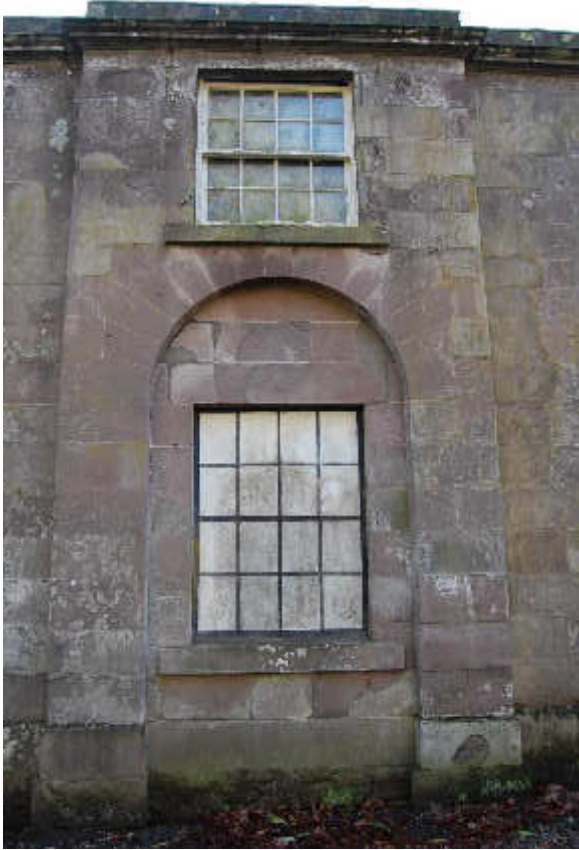
Illus 29 Room 22 N wall window W54 (bottom) and Room 37 window W53 (above); facing S

Room on ground floor at N end of Phase 3 E wing on used as a store. There is a stone staircase (D49; Illus 30) on the S wall of this room, a window on the N wall (W54; Illus 29) and door on the E wall (D9). Access to these rooms from the courtyard is through a stone door (or corridor) D20 (Illus 31).

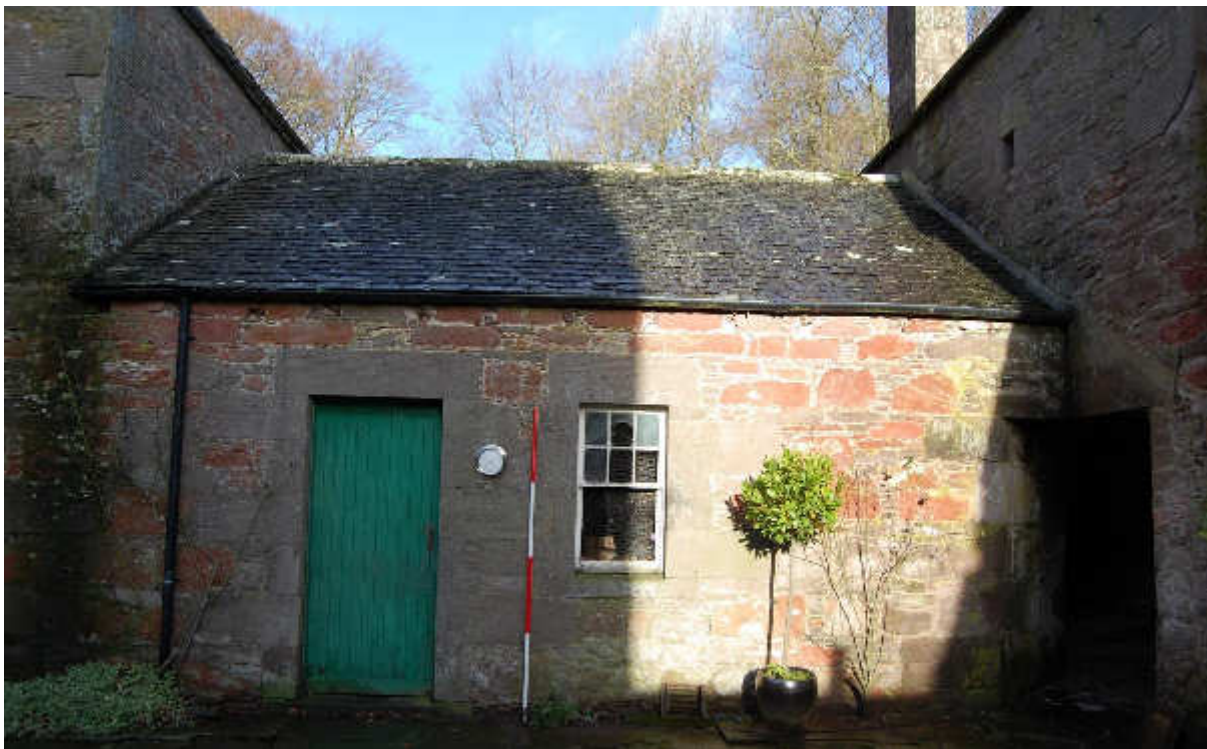
Illus 32 S wall of Room 23 the wood store with D19 and W63; facing N

Room 23 is the wood store. It is a single storey link building between the two storey E wing and the two storey bothy (Illus 32). Here is a door (D19) and window (W63) on the S wall onto the courtyard and a door D11 and window W55 on the N wall. There is a small recess 40 x 30cm Room 23 interior S wall W of D19 (Illus 33). The rooms of the N wing have no chimneys associated and no fireplaces evident so were probably associated with the farm and nearby stables.

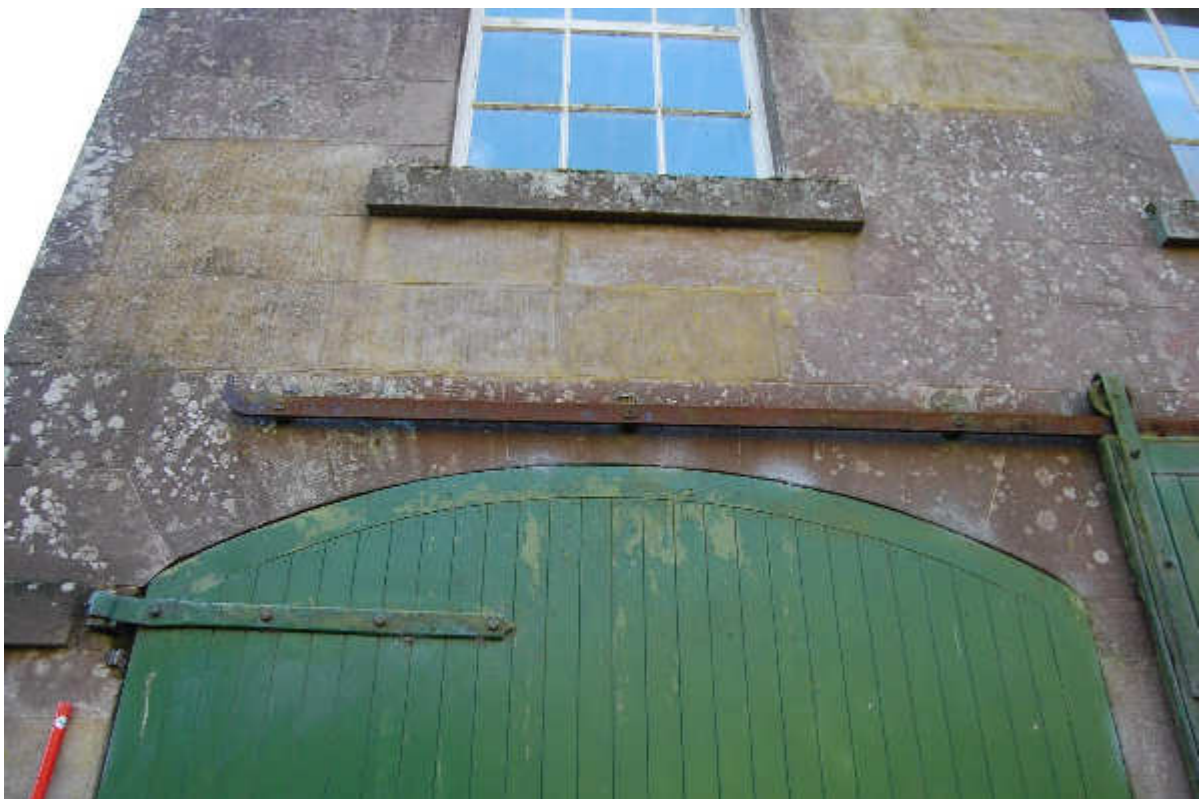
Illus 34 Detail of ashlar sandstone forming lintel of cart door D12; facing S

Ground floor room in centre of N wing used as cart shed/garage. There are two large cart doors on the N façade (D12 and D13) 2.25m wide and 2.4-2.75m high. The N façade is all of sandstone ashlar and the arched lintels of these door was fashioned from radiating blocks of sandstone (Illus 34). There are two lintels above each door on the S wall (D17 and D18; Illus 35) indicating that the height of the doors has been reduced and new lintels inserted. These may originally have been cart doors.

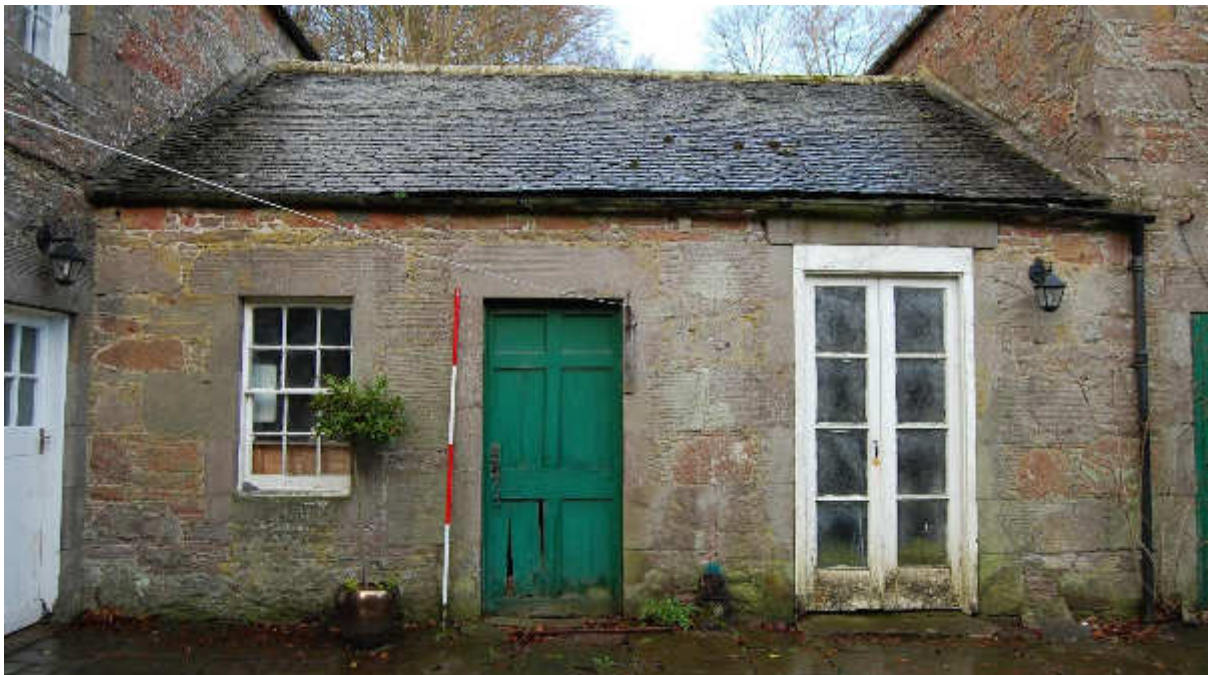
Illus 36 Room 27 S wall W61, D15 showing tooled sandstone lintels and mouldings with D16 (right) with newer sandstone lintel inserted when door inserted; facing N

Room at the W end of the N wing used as a store which was originally probably one room. The rooms were in use as larder and stores. There are two doors in the S wall (D15 and D16) and a window (W61) and a door (D14) and window (W58) in the n wall. Door D16 in S wall may have been a smaller door or a window which was opened out and a new sandstone lintel inserted (Illus 36).

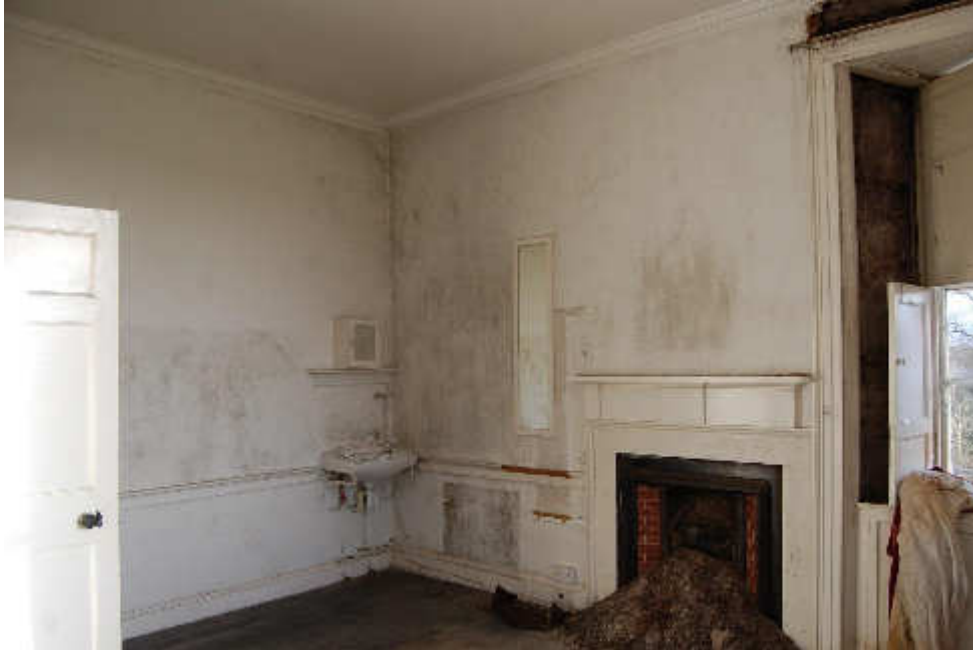
Illus 37 Room 28 NE corner showing coving and later fireplace (F8) set into earlier fireplace surround with W15 (right); facing NE.

Phase 1 house 1<sup>st</sup> floor SE bedroom. There is a large window on the S wall (W16) and on the E wall (W15) and a fireplace on the W wall (Illus 37). The rooms on this floor all have very dep skirting boards and there are wooden window seats and shutters *in situ* on many windows (Illus 38).

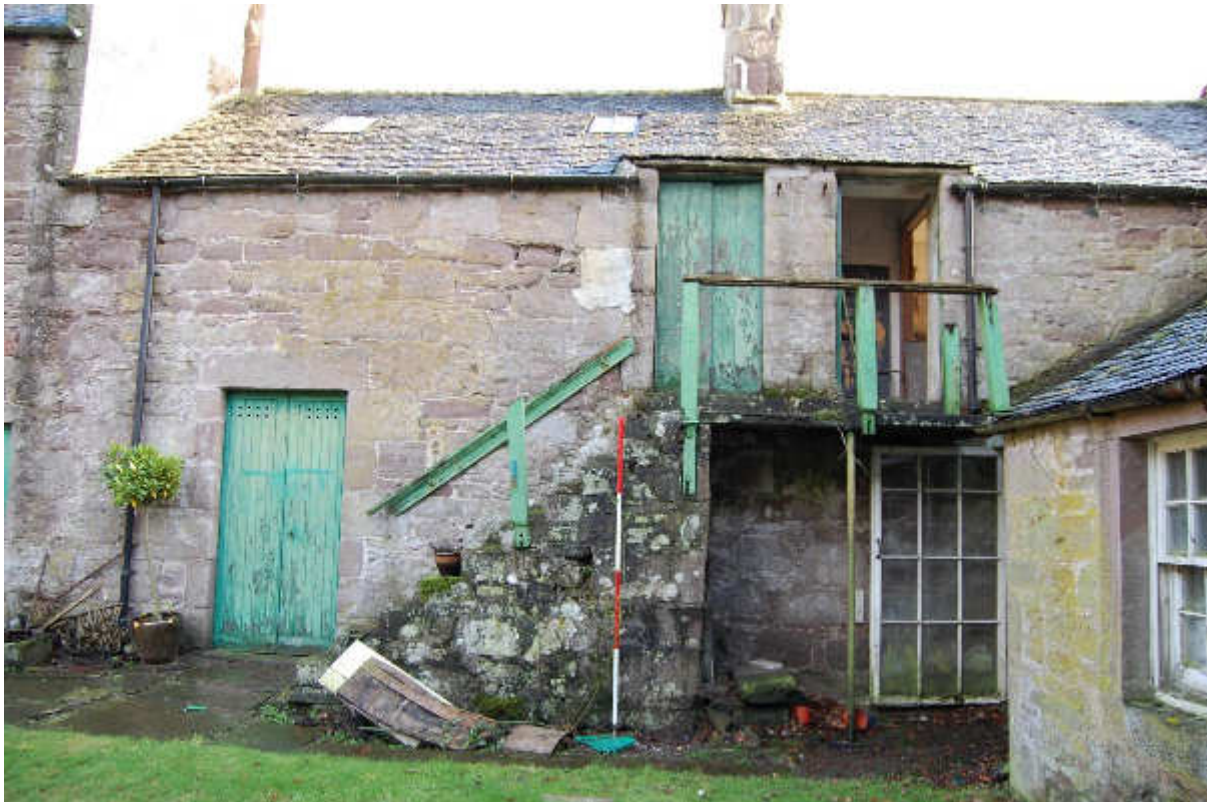
Illus 39 Sandstone stairs F4 leading to Room 35 D23 (left) and Room 34 D24 (right); facing E

Room not accessible due to poor condition of access stairs. Loft in Phase 2 E wing accessed by stone stairs F4 (Illus 39).

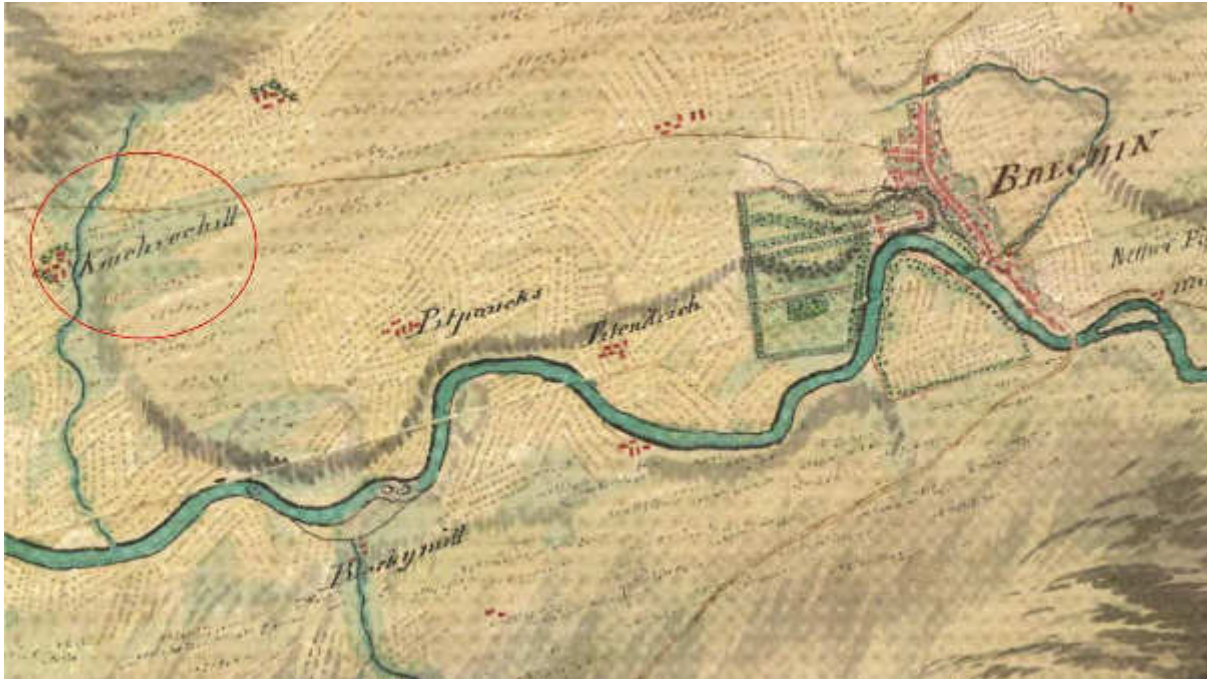
Illus 45 Roy's map showing 'Kinchrachill' (copyright National Library of Scotland)
