**Kintrockat House, Kintrockat, Brechin, DD9 6RP  
Report on Level 2 Standing Building Survey**

**Alison Cameron  
Cameron Archaeology  
10 February 2016**

## SUMMARY

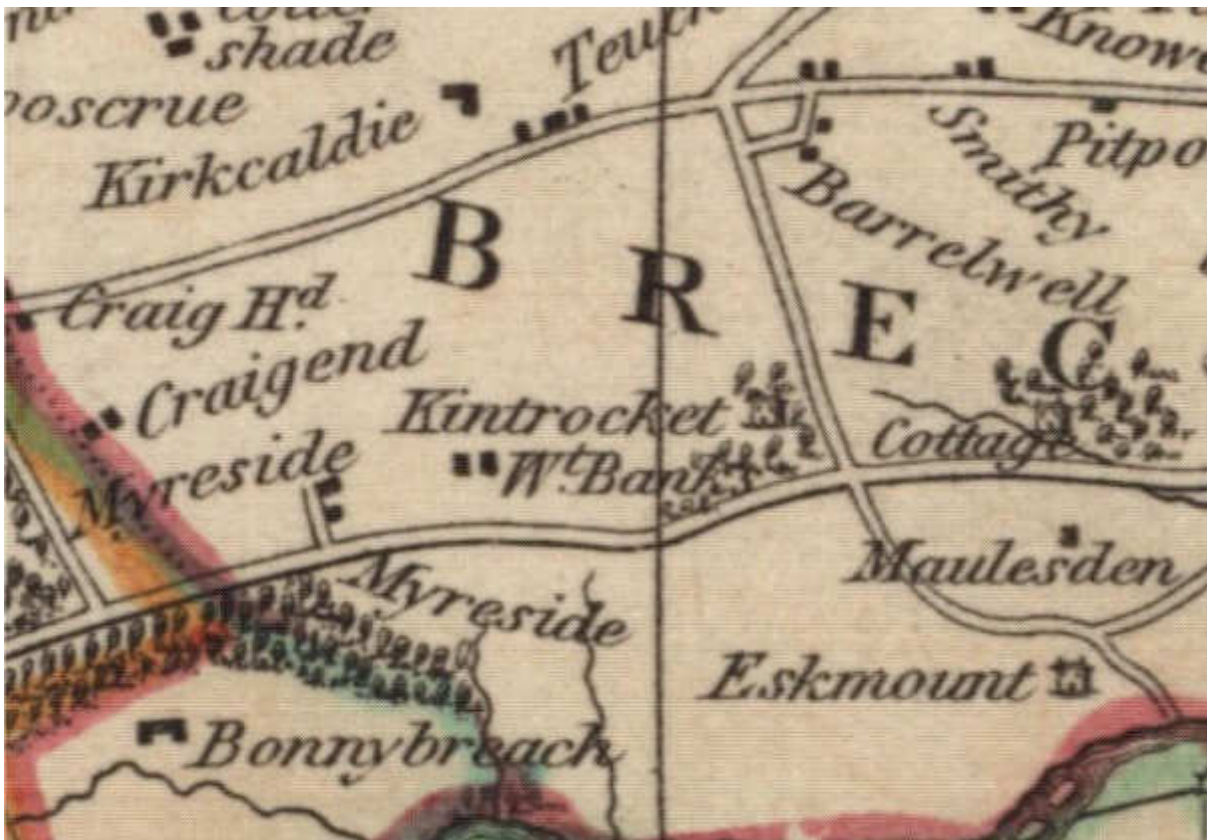
Illus 46 Thomson map (copyright National Library of Scotland)

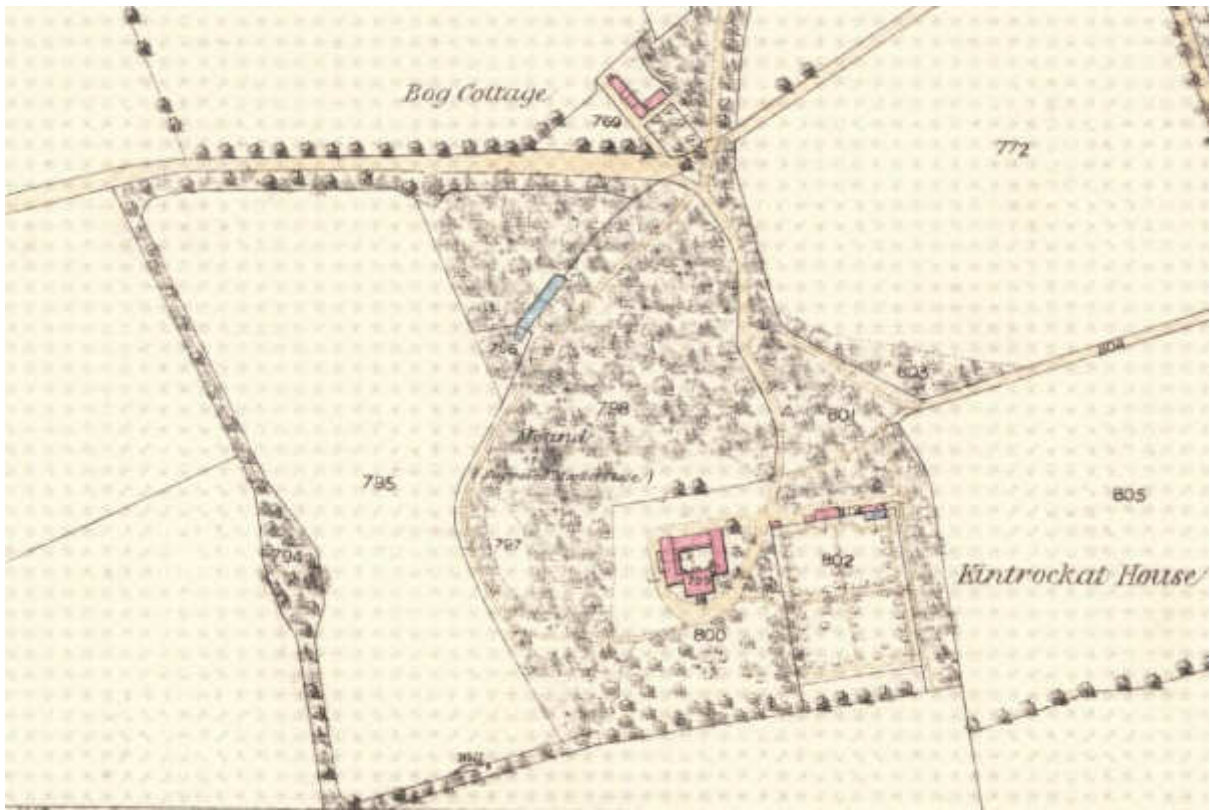
Illus 47 First Edition Ordnance Survey map Forfar Sheet XXVI.16 (Brechin) Survey date: 1862 Publication date: 1865 (copyright National Library of Scotland)
