**Upper Park, Drumoak, AB31 5HD
Report on Level 1 Standing Building Survey
(site code CA279)**

**Alison Cameron
Cameron Archaeology
3 February 2016**

A Level 1 standing building survey was carried out on 2 February 2016. The structures are early 19th-century in date and are typical Aberdeenshire farmhouse (Building 1) and bothy (Building 2). Four phases of development of Building 1 were recorded and it is recommended that no further archaeological work is required during the current planning application.

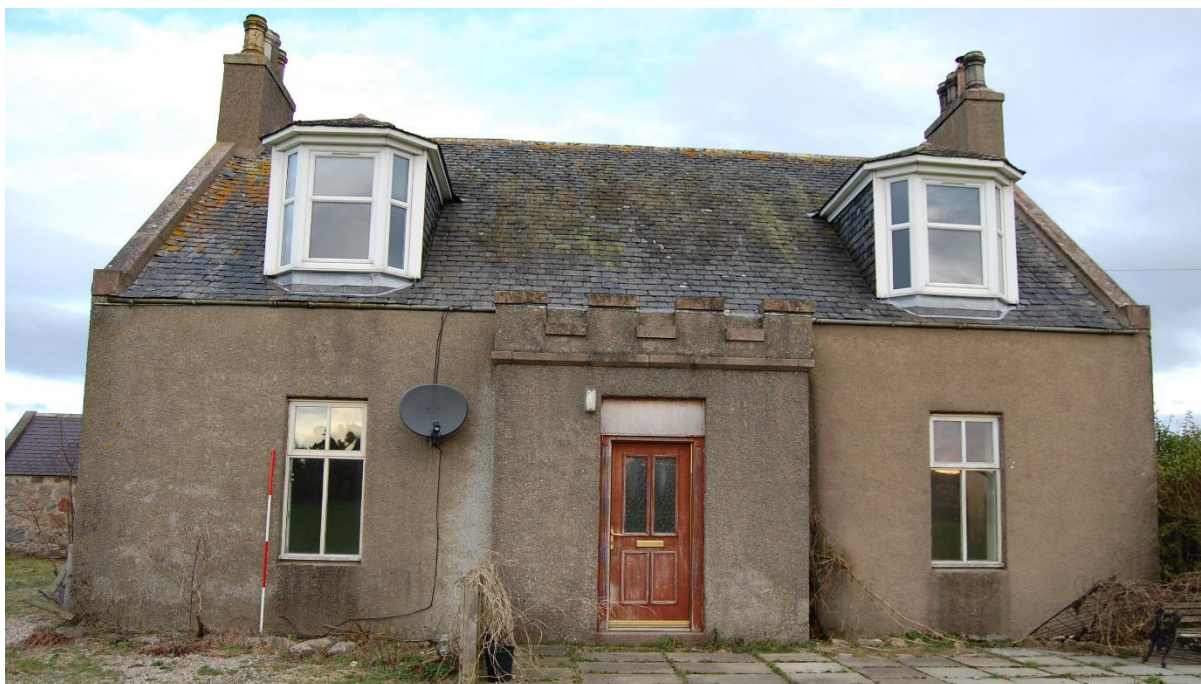
Cover: top Building 1 S elevation; bottom Building 2 from SW

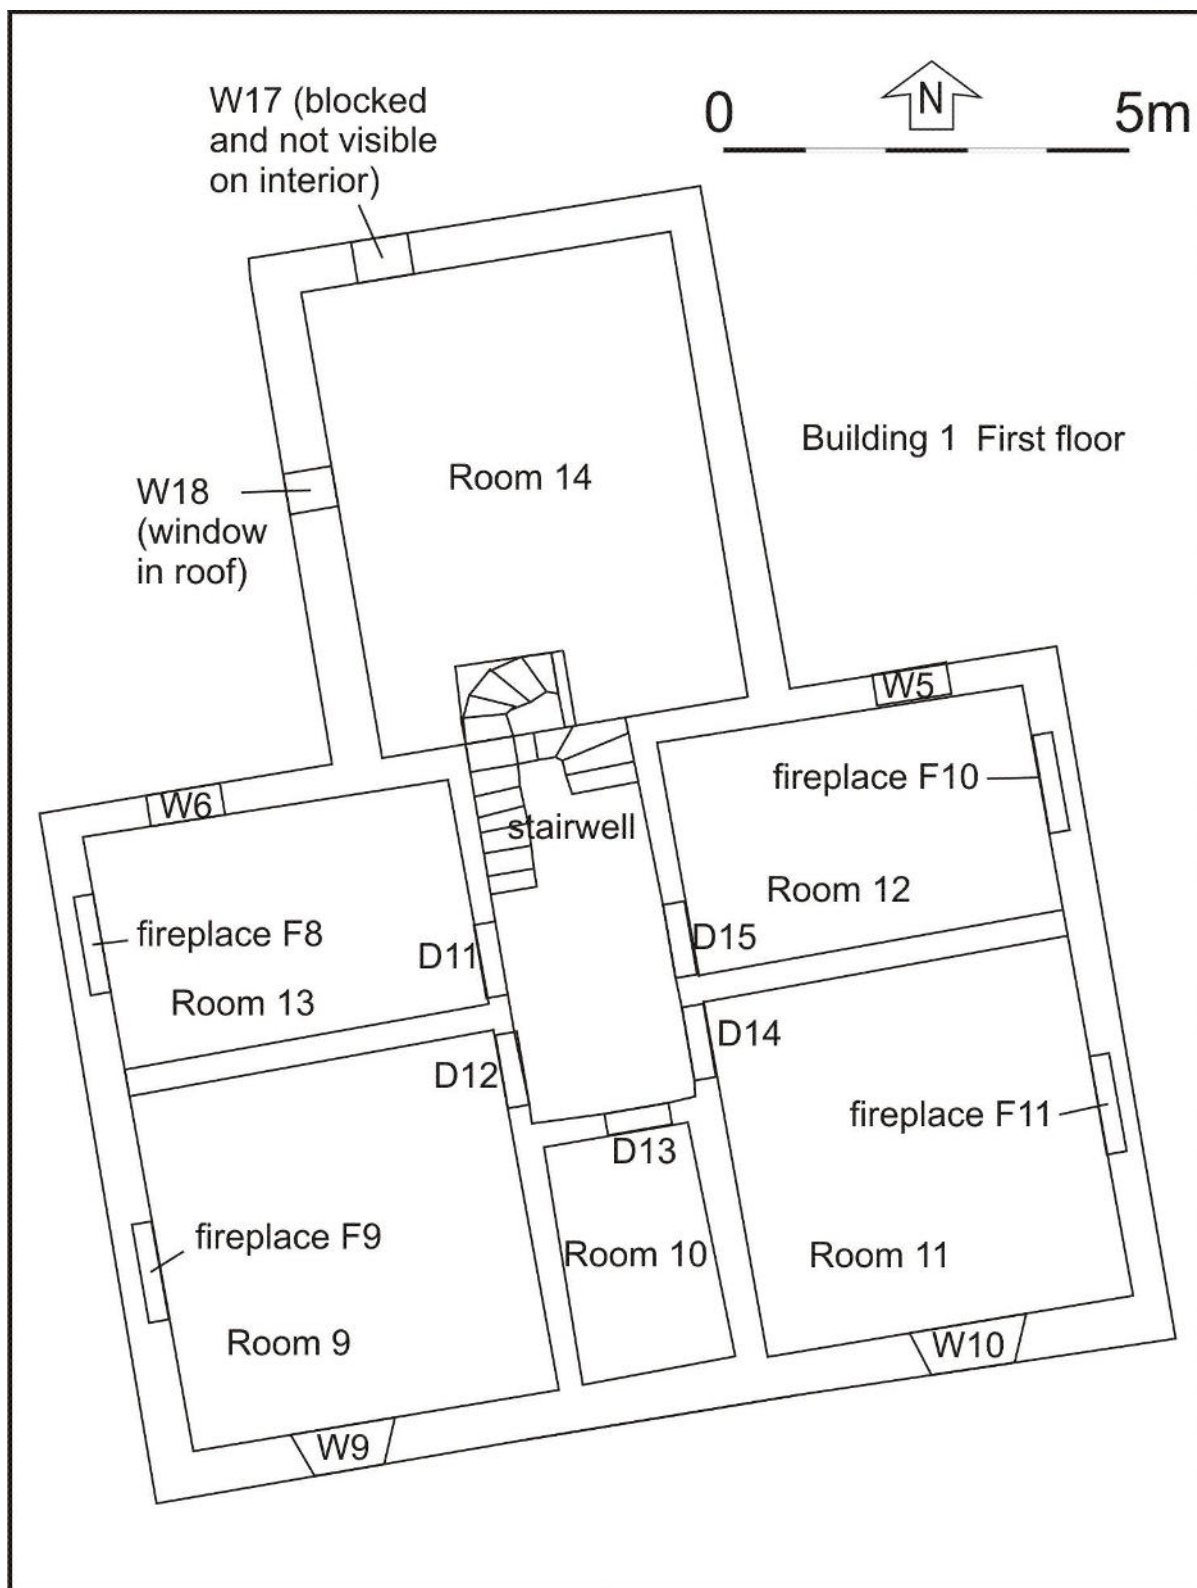
Illus 3 Building 1 first floor plan annotated with numbers used in this survey (from copyright Ian Duncan Architects)

On the first floor (Illus 3) there are 4 main bedrooms and a small windowless box room on the S wall within the roof space (Room 10). There are fireplace settings in each of the four main bedrooms, all painted over and blocked (F8-11).

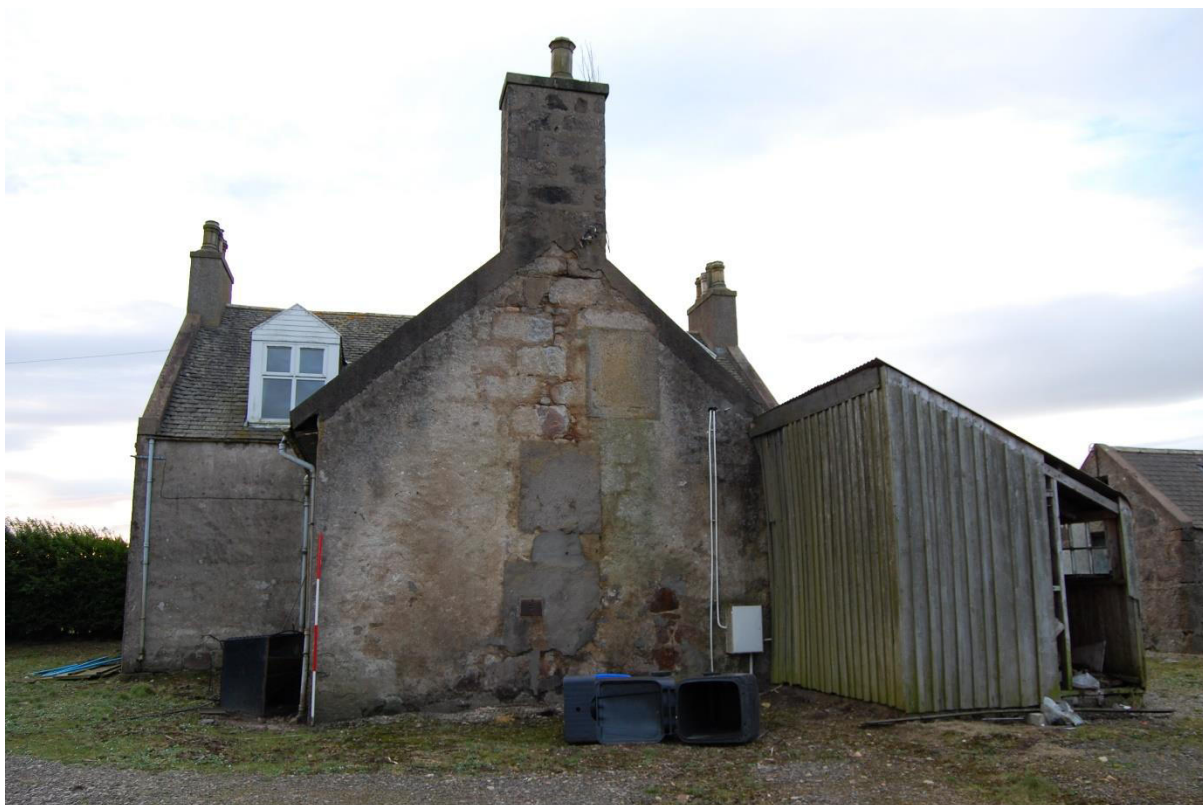
Illus 7 Building 1 N elevation, Facing S

In Phase 2 an extension is built onto the N side 6.2m N-S and 5.5m E-W. There are 2 windows on the E aspect and possible window (W16, W17) and fireplace/flue (F12) on the exterior of the N wall (Illus 7). Door D10 had been the Phase 2 back door. In Phase 2 an extra room was added on the first floor (Room 14) in the roof space above. A corridor between Rooms 5 and 6 leads to the Phase 2 and 3 rooms and Window 10 may have been added in this phase to allow a little natural light into this corridor (Illus 13). The crenelated rusticated granite detail harled porch (F13; see cover illus) may have been added in this phase.

A small extension was added on the W side of Room 8 (including Window W7); it is harled over 20th century red brick. A wooden shed has been added to the N of the building (Illus 7).

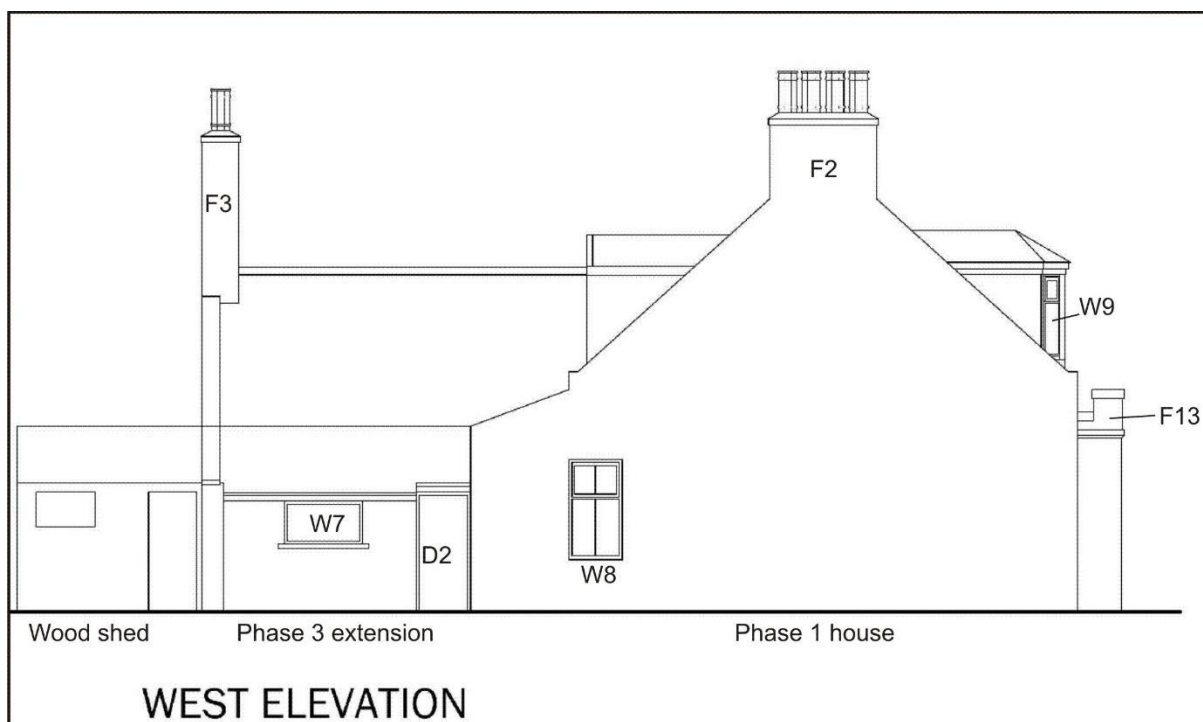
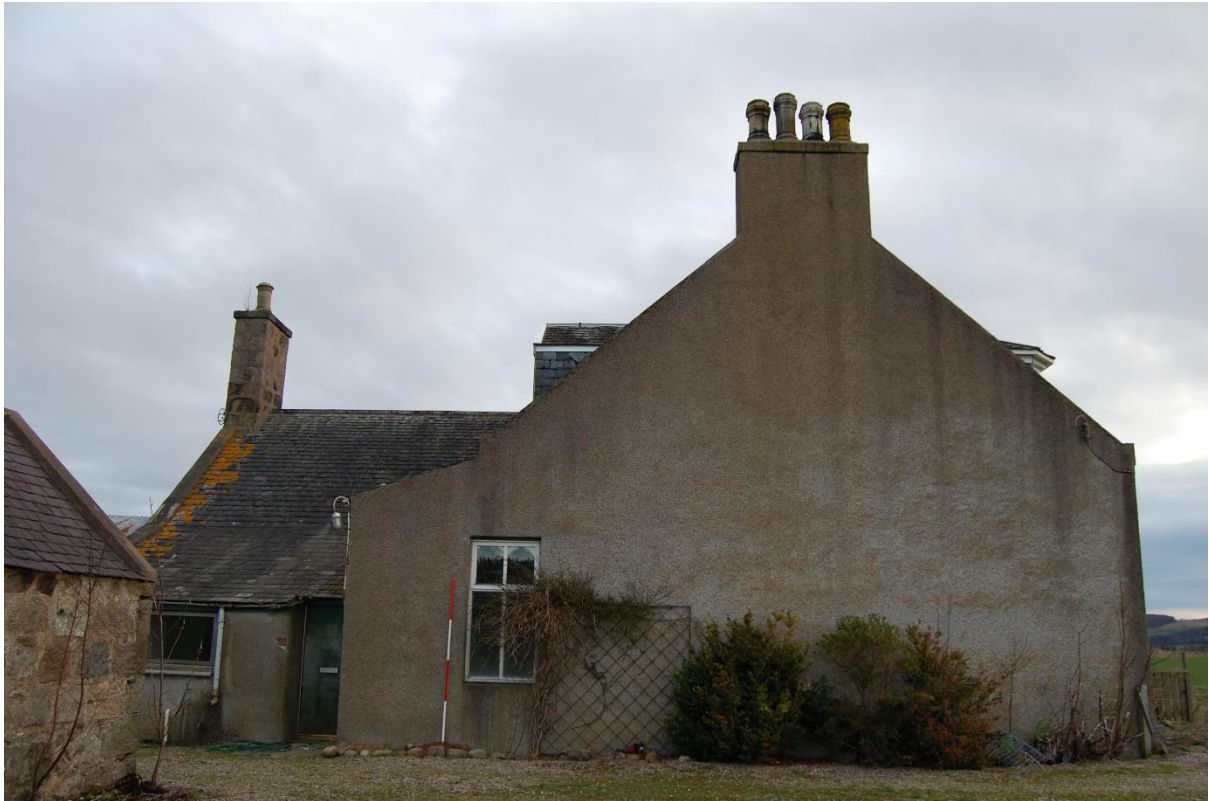
Illus 9 Building 1 W elevation annotated with numbers used in this survey (from copyright Ian Duncan Architects)

In Phase 3 an extension is built in the NW corner of the building between the N wall of the Phase 1 farmhouse and the W wall of the Phase 2 extension (Illus 9-10). It is 4.8 x 3.2m in size and is of granite construction. In this phase D2 became the main back door of the building.

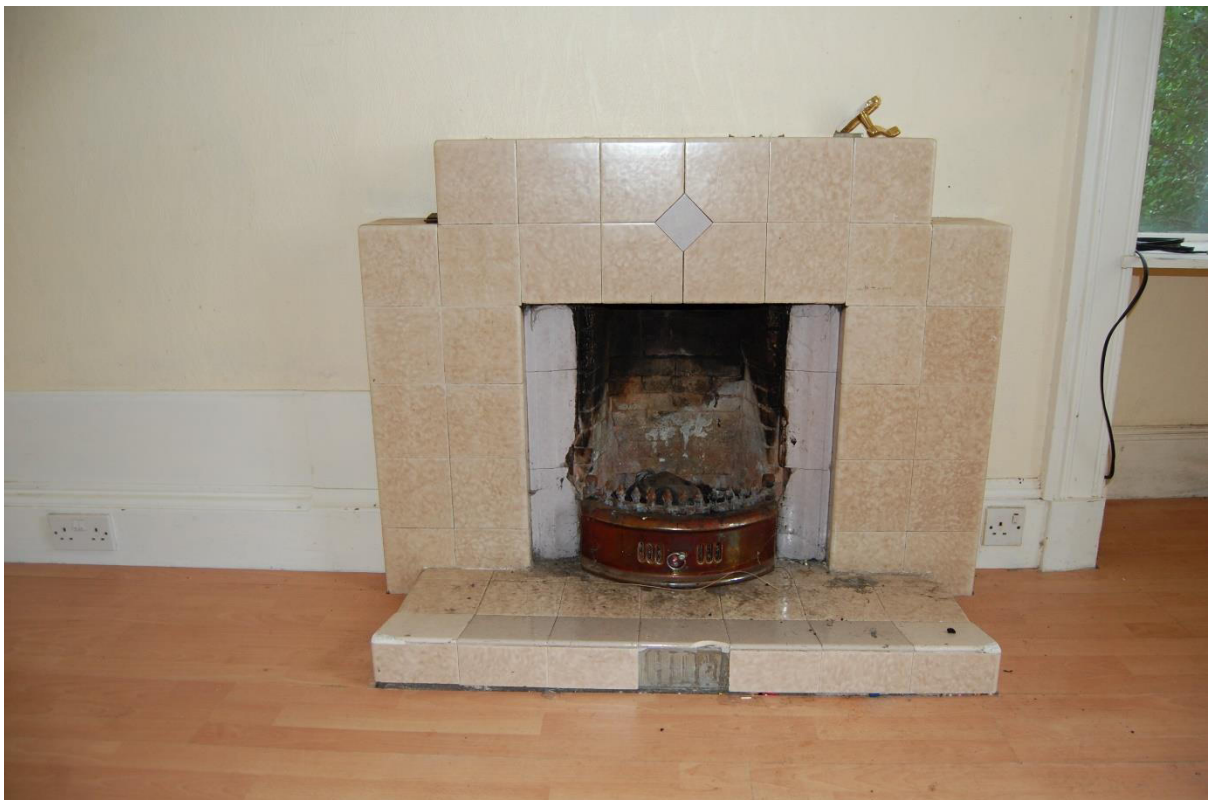
Illus 11 Building 1 Room 3 fireplace F7; facing E

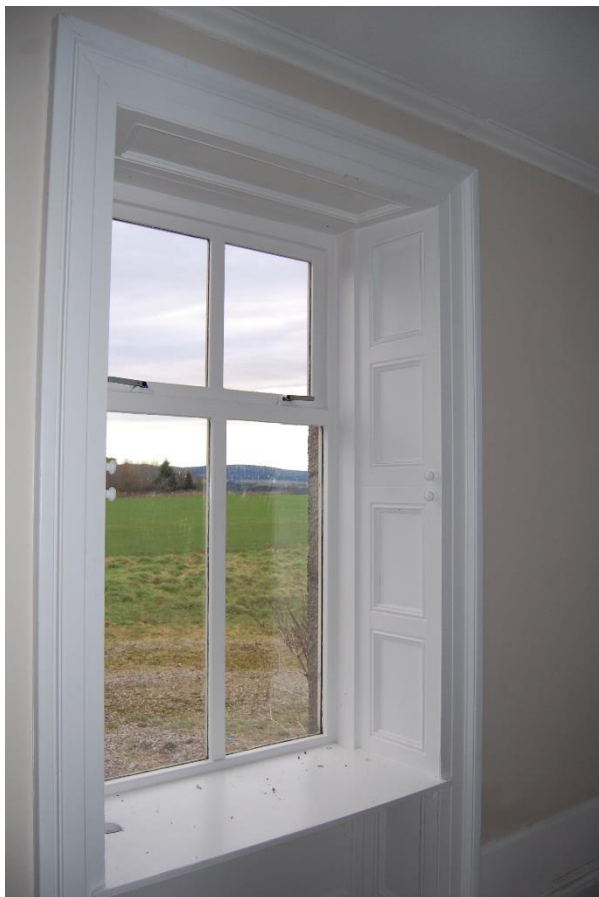
Building 1 was built in at least four phases. The Phase 1 farmhouse is 12.5m W-E and 8.5m N-S. The walls are 0.55m thick and are constructed of granite blocks with cherry cocking. The roof is slate and the windows have all been replaced in the recent past. The building has two storeys high with a central door on the S façade (D1). There are four main rooms on the ground floor and stairs to a second floor (Illus 2). There is an alcove in the SW corner of Room 1 and a fireplace on the W wall of Room 3 (Illus 11); all the other fireplaces have been removed or covered. There are original door surrounds throughout, cornicing and exterior shutters (Illus 12) on the ground floor windows.

Illus 12 Building 1 Room 3 W12 wooden shutters *in situ*; facing SW

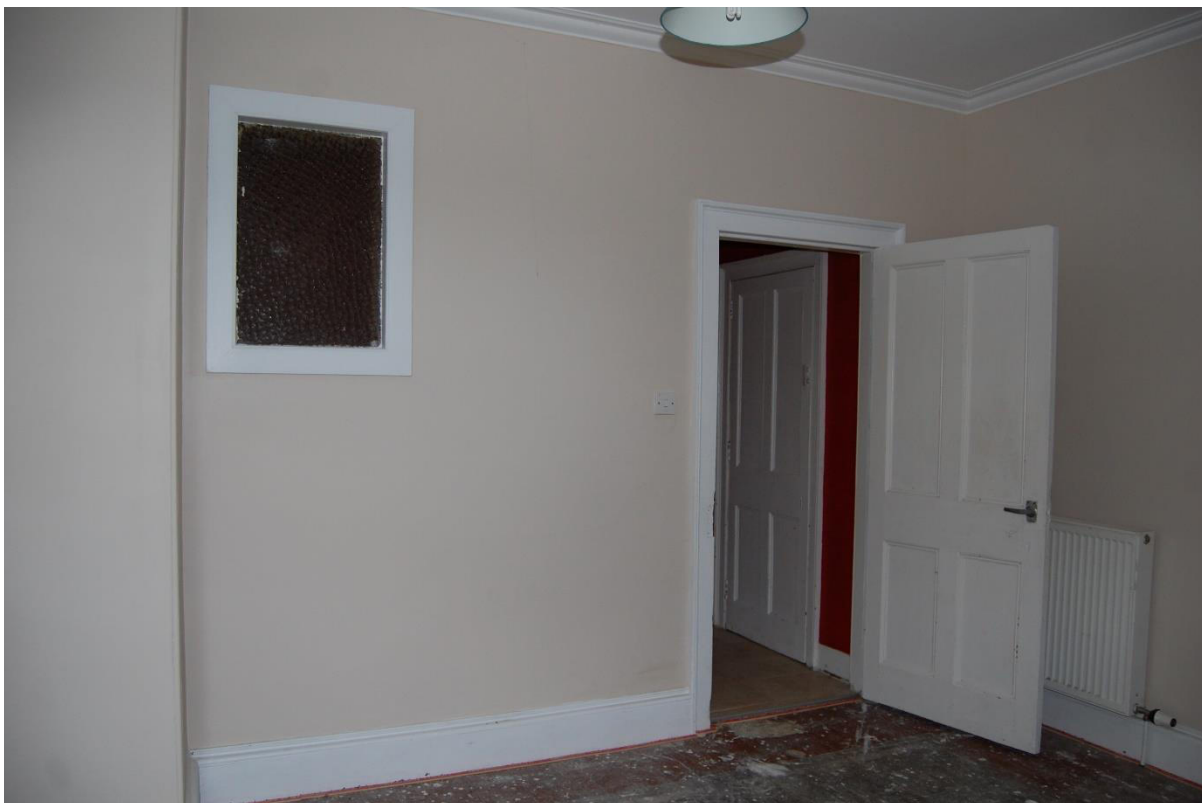
Illus 13 Building 1 Room 6 E wall with W10 and D9 (right); facing SE

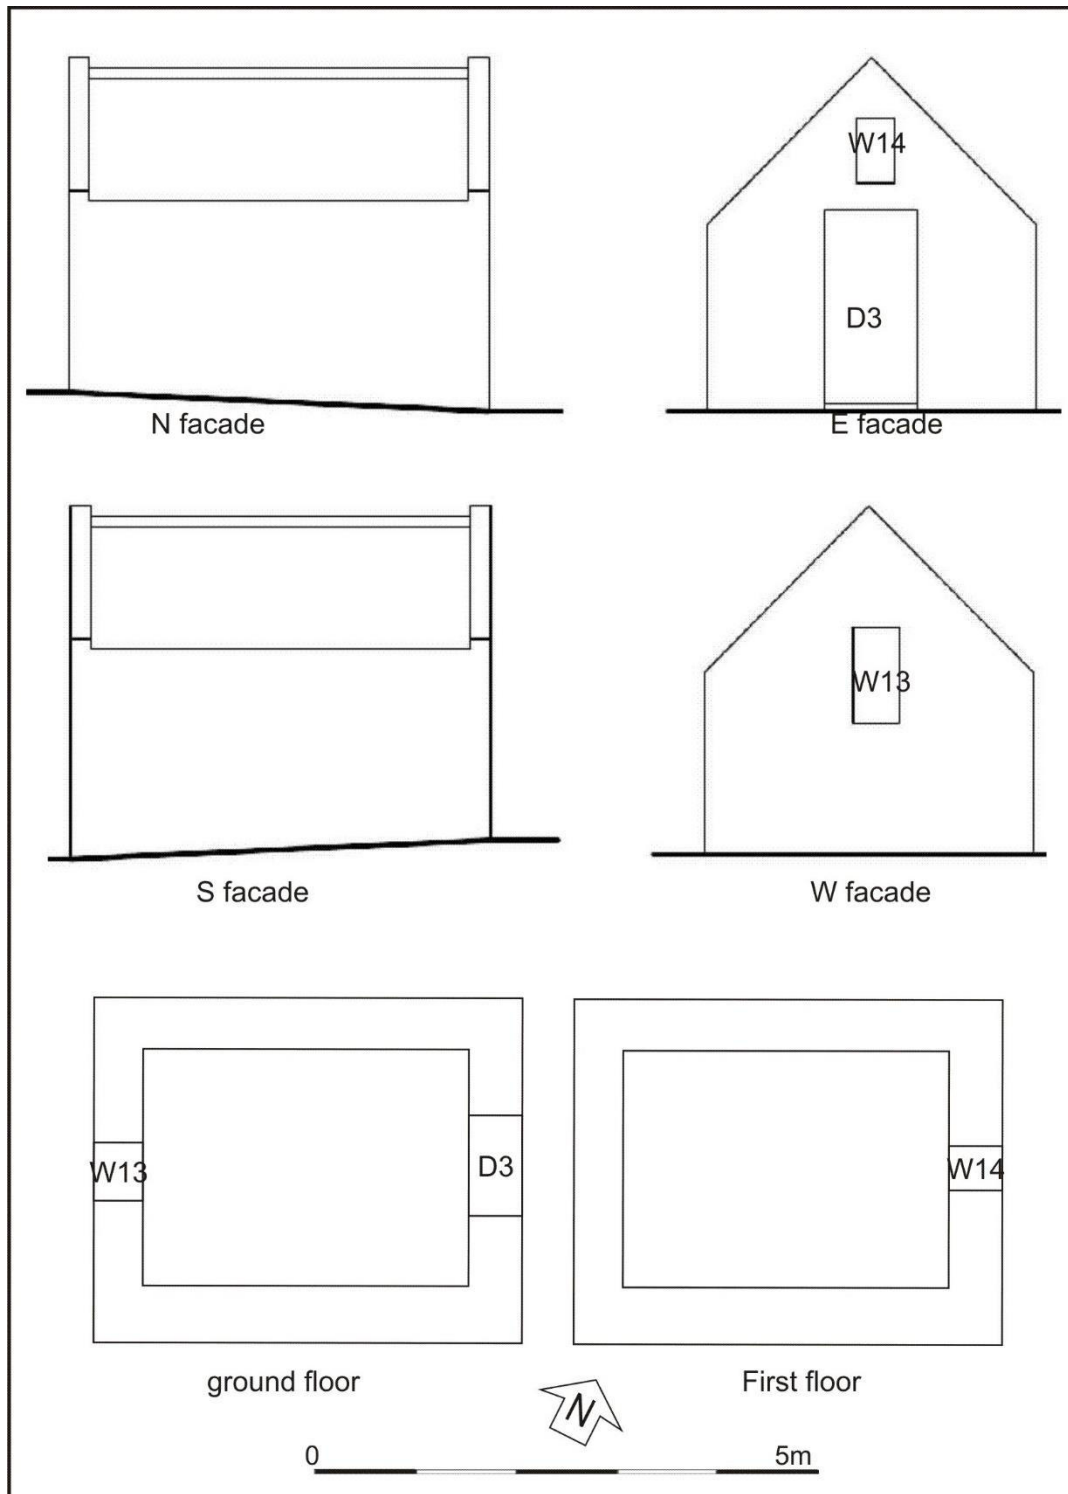
Illus 14 Building 2 plan and elevations annotated with numbers used in this survey (from copyright Ian Duncan Architects)

Building 2 is a small bothy to the W of Building 1 and is 4.2m W-E and 3.3m N-S (Illus 14). The walls are 1.9m high and 0.5m wide and are constructed of pink and grey granite blocks with cherry cocking (Illus 15). The E gable has a door (D3) and small window above (W14) and the W gable has a small upper window (W13). The interior is whitewashed with concrete floor and wooden shelves (Illus 16).

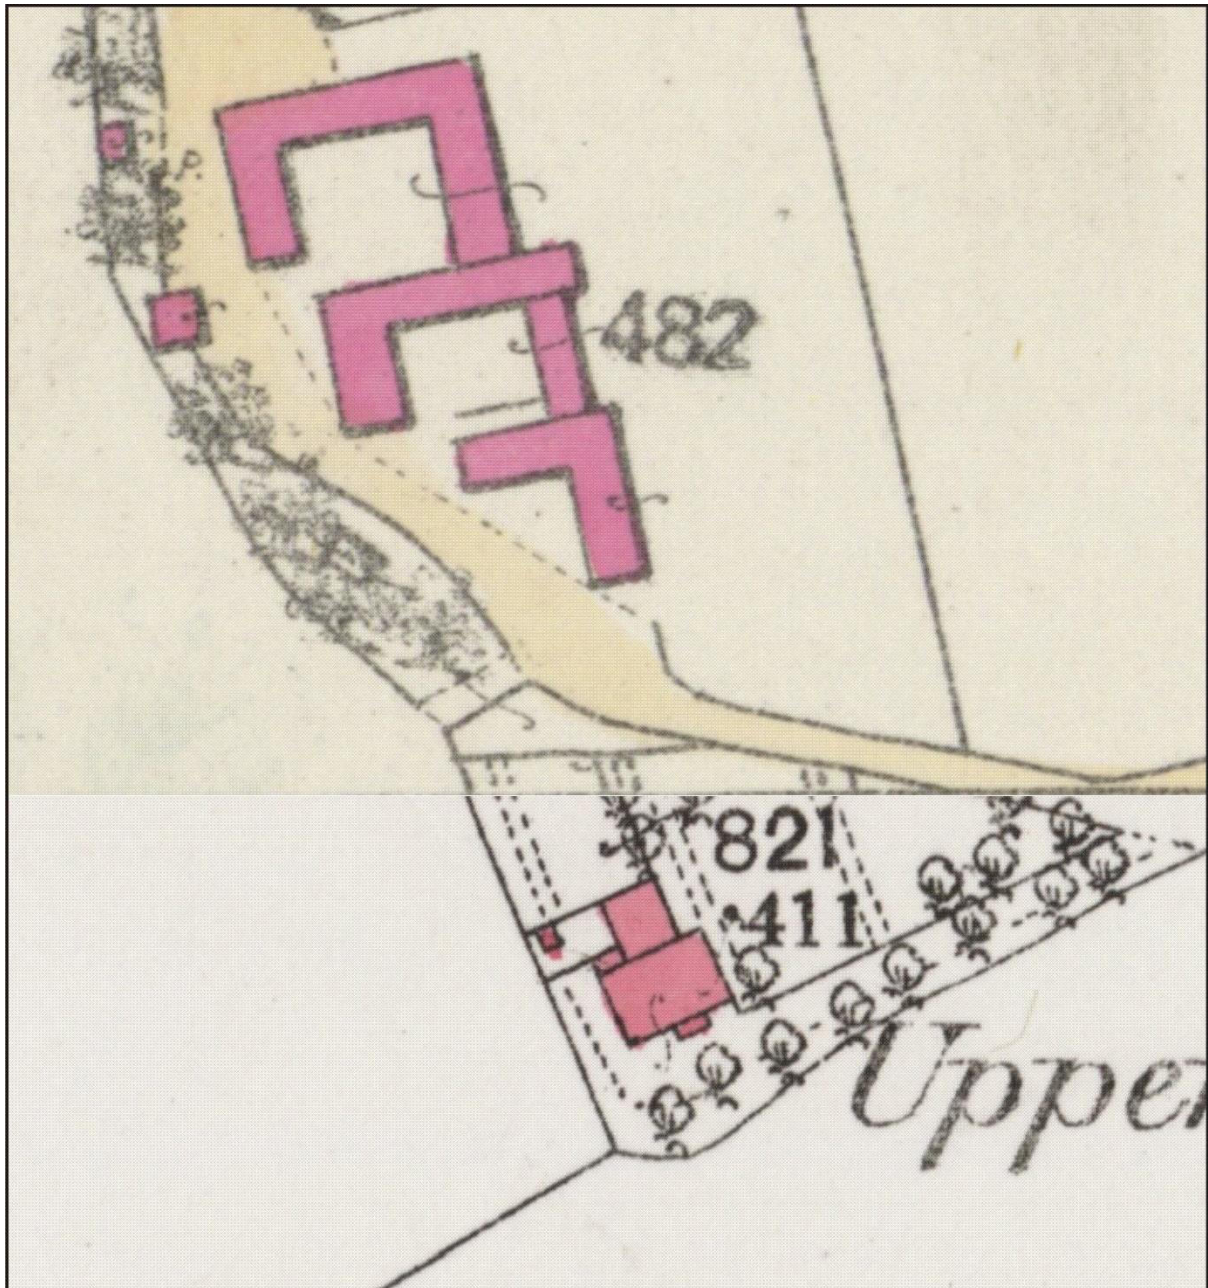
The buildings are not Listed and are not on CANMORE database. On the 1st Edition OS map the house has an extension added to the N and there is a small separate bothy to the W. The plan of buildings is retained on the 2nd and 3rd Edition OS maps but the small bothy does not appear on either map. It is a small stone building which appears to have been constructed in the 19th century and may therefore have just been omitted from the later maps. It may have been unroofed by the 2nd Edition OS map.

Illus 17 shows Phase 3a and 3b; there is no evidence visible on the building of this smaller addition in Phase 3a and an extension in Phase 3b but the First Edition OS map (Illus 18) shows a small addition with the 3b addition by the Second Edition OS map (Illus 19).

Illus 18 First Edition Ordnance Survey map. Aberdeen Sheet XCIVa.4 (Combined) & LXXXIV.16 (Drumoak) Survey date: 1865 Publication date: 1869 (copyright National Library of Scotland)

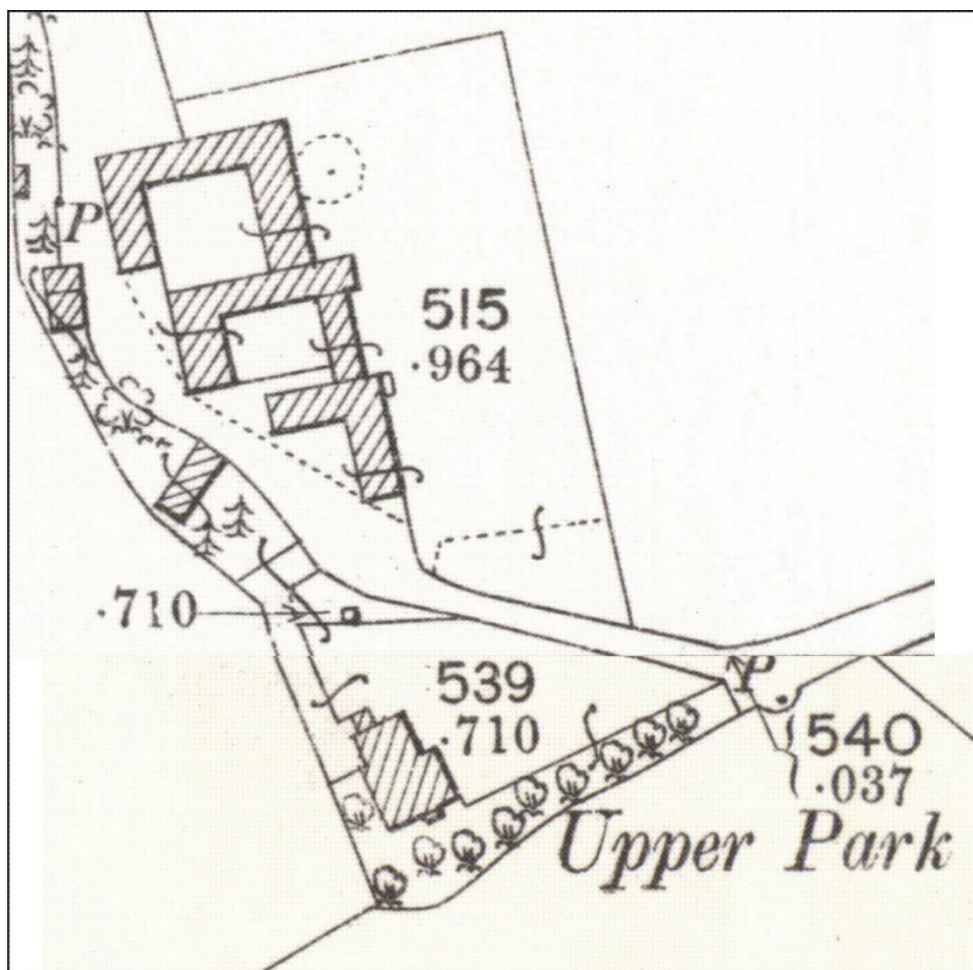
Illus 19 Second Edition Ordnance Survey map Aberdeenshire 084.16 (includes: Drumoak) & 094a.04 (includes: Banchory-Ternan; Drumoak; Durris) Publication date: 1900 Revised: 1899 (copyright National Library of Scotland)
