A Report on Trial-pits at Balnagask Motte, Torry, Aberdeen

**Robert Lenfert
Cameron Archaeology
29 March 2016**

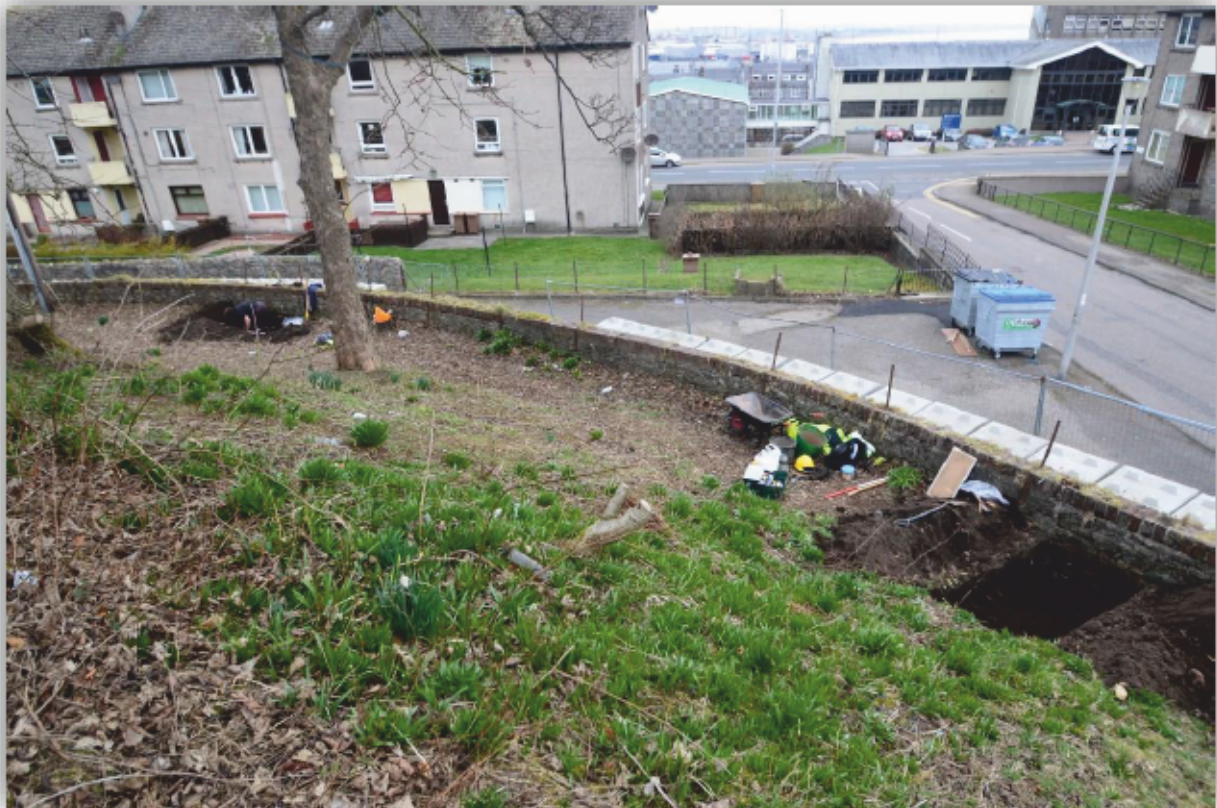
Illus 4 General view of trial-pit locations along the retaining wall for Balnagask Motte with TP1 (left) and TP2 (right); facing N

Balnagask Motte currently exists as a relatively steep mound encircled by a stone retaining wall over 2m tall in areas. The trial pits were located at the base of this mound alongside the retaining wall which is collapsing and has been supported by concrete blocks. Initial clearing of the topsoil revealed a fairly substantial amount of modern rubbish, including a bicycle wheel, beyond the regular assortment of bottles and cans, etc. This is perhaps due to two factors – one, the settling of any discarded or windswept packaging along the base of the mound, and two, casual rubbish disposal over the top of the retaining wall by passers-by from the pavement below.

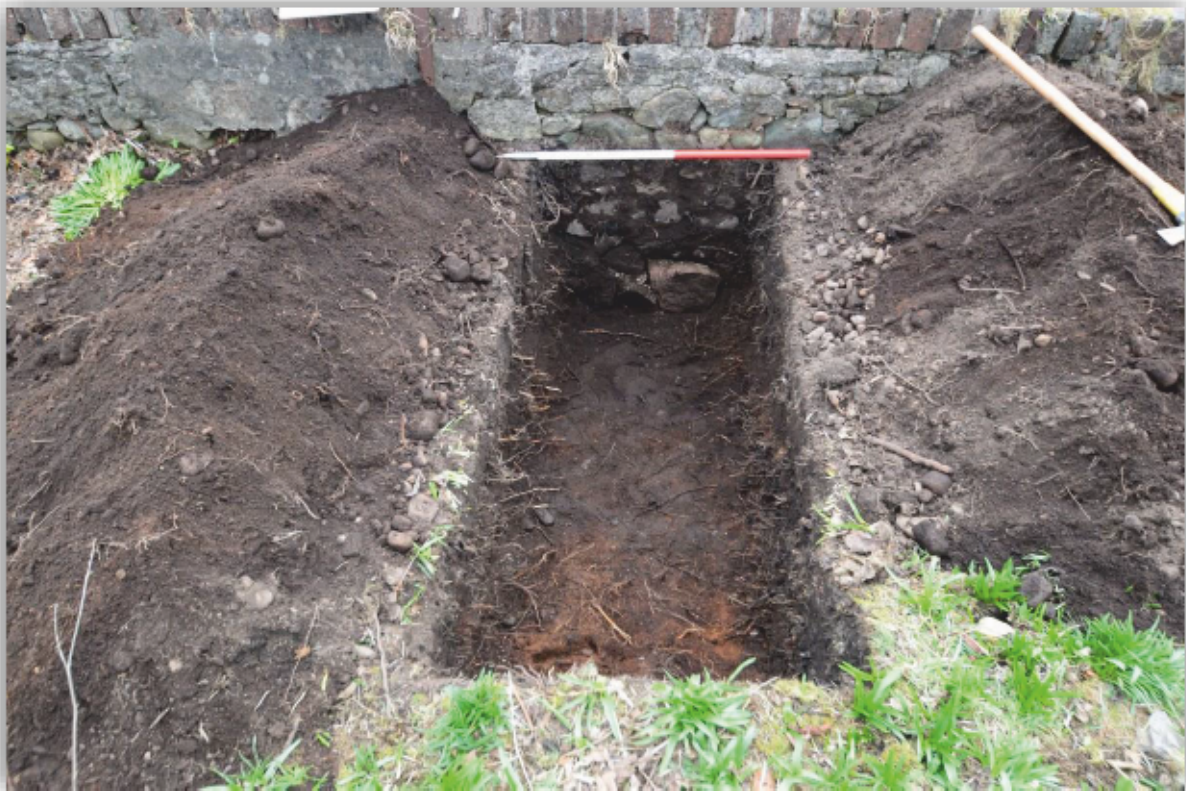
Illus 5 View of completed Trial-pit 2 prior to backfilling. Note gradual change from reddish-brown natural at top to darker more organic natural along wall.

Trial-pit 2 was excavated down to a maximum depth of c.0.80m before consistently encountering the natural sub-soil (Illus 3, 5). It sloped down from SW to NE following the slope of the mound. One layer (2) was recorded which contained 19th-20th-century glass, ceramics and mammal bones. This upper layer 2 was similar in composition to that of Trench 1, with a compact grey clayey loam also containing roots, albeit to a lesser size and extent than Trench 1. Trench 2 ran into the hillside perpendicular to Trench 1, revealing a dark orange-brown friable sandy-loam natural with c.50% consisting of moderately-sorted rounded gritty-gravel inclusions. This layer appeared in three areas: 3, 4 and 5. No artefacts were located within these layers. Layer 2 was located at the SW end of the SE section (i.e. upslope) while a redeposited layer 3 was encountered in the downslope area running from c.0.40m below the present surface to the base of Trench 2. It was not a continuous layer across the trench, and appears to have been redeposited after the construction phase of the adjacent wall. In the NW section of Trench 2 (opposite), layer 5 was the same consistency as 3 and 4, though appearing less substantial in section.

Archaeologically, this trend appears to have been somewhat of an ongoing process, with dispersed sherds of 19th and 20th century ceramics recovered from both pits. TP1 contained one layer with 19th and 20th-century finds dispersed throughout and a tree bole at the base of the trench cut into the natural subsoil adjacent to the wall F13. In addition, a clay pipe stem and horse bones were recovered from TP2, alongside discarded hearth material including burnt coal. Also, fragments of clay roofing tile and metal pipe which appears to be 19th or early 20th century in date with mixed within the topsoil layer. It should be noted that the interior of the retaining wall was most likely backfilled after construction, later silting up to reach the present ground level. This would result in a natural topsoil layer accumulating upon the earlier redeposited backfill, but no distinct stratigraphy was visible in the excavated layer. The distribution of ceramic sherds from the same vessel at different levels within the topsoil in TP2 reinforces this observation. A reddish-brown gritty gravel subsoil lens (3, 4, 5) was first encountered in TP2 at a depth of some 0.40m below the present ground surface within the upslope portion of the trial pit (Illus 3, 4). This changed into a darker, more organic sub-soil with coarse stony inclusion towards the retaining wall (F13). The change was not visible as a cut, but rather as a subtle but continual shift along the trial pit.

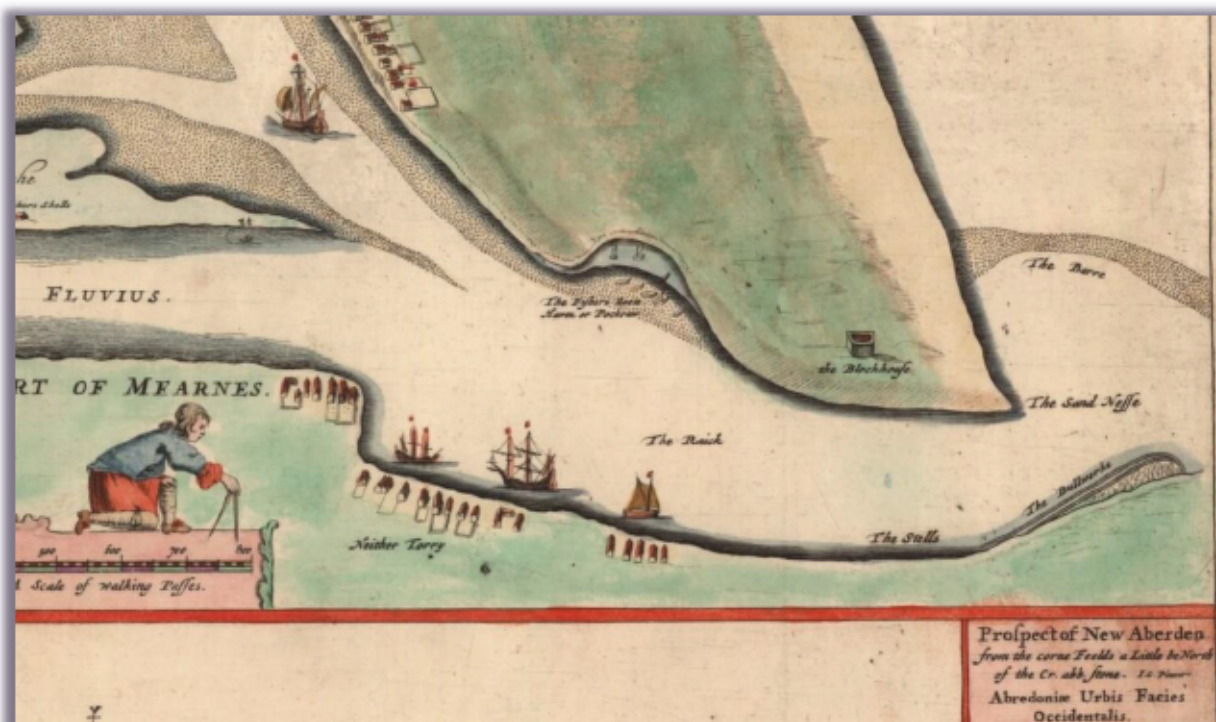
Illus 6 Detail of 'Neither Torry' along the south bank of the River Dee from the early Gordon map of 1661 (copyright National Library of Scotland)

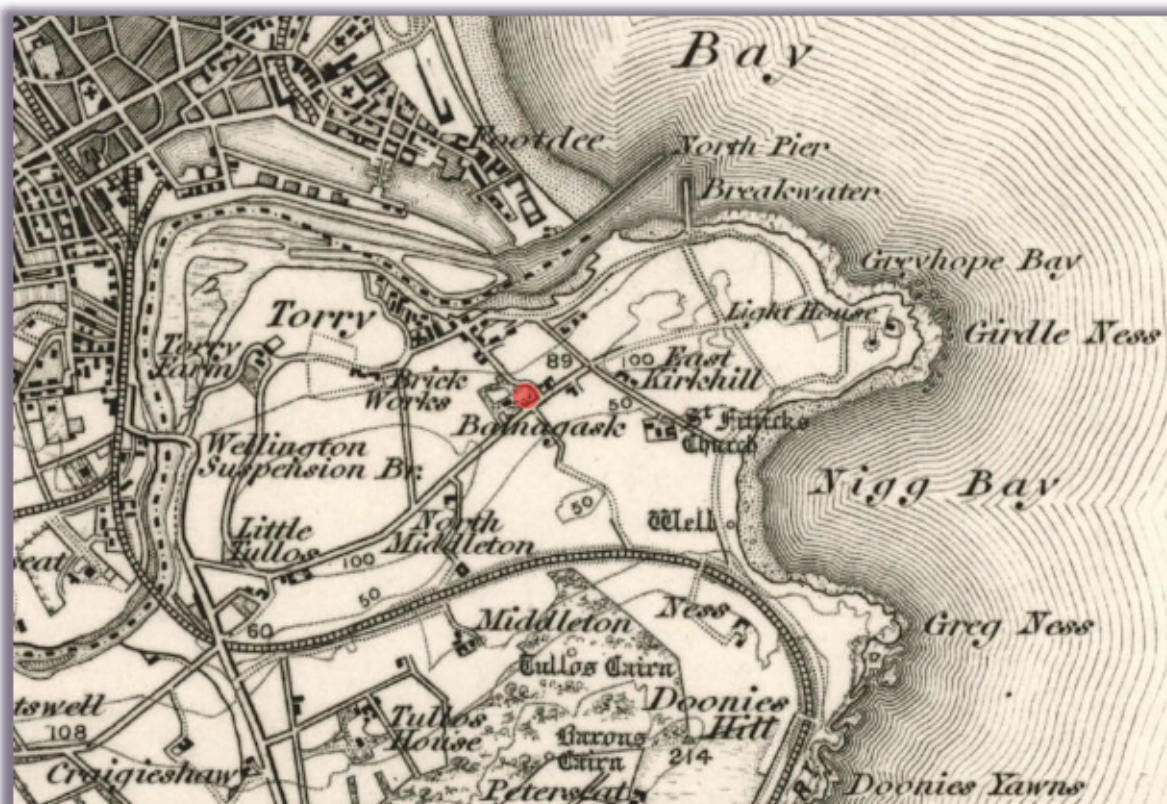
Illus 7 First Edition OS map showing site location in red (copyright National Library of Scotland)
 Sheet 77: Aberdeen, Survey date: 1864-1868 Publication date: 1886

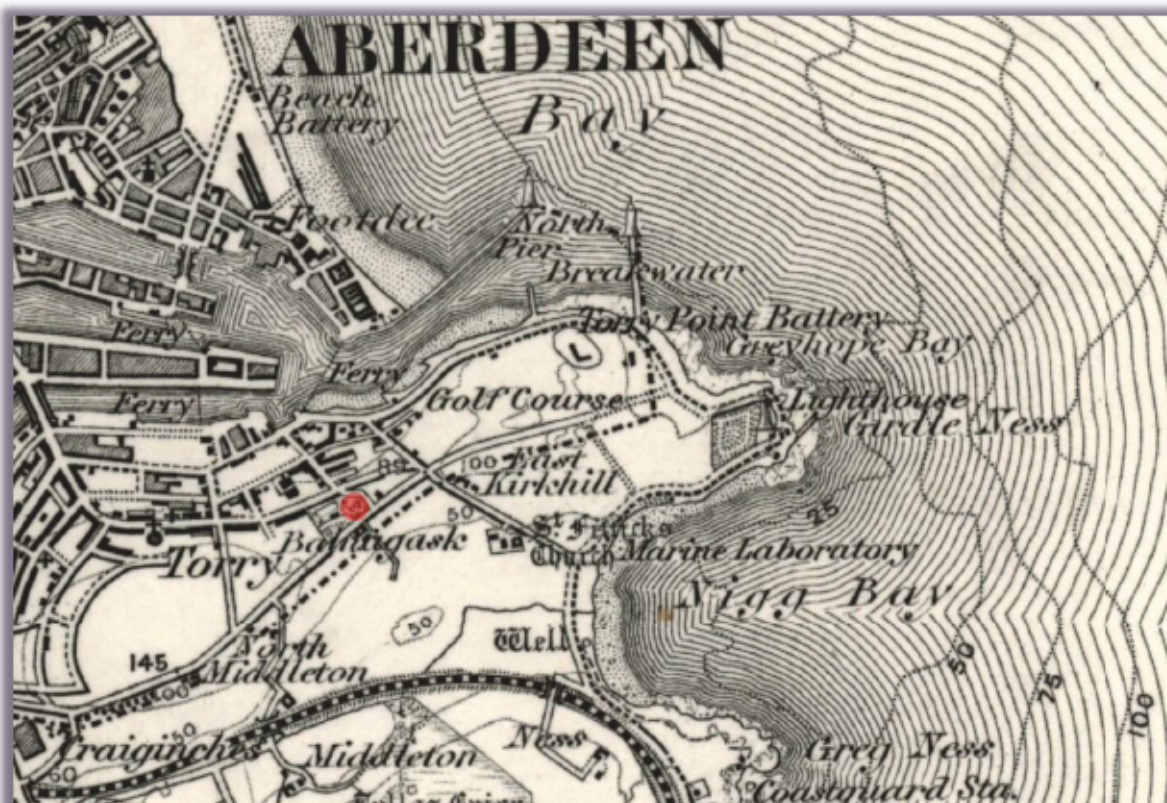
Illus 8 Third Edition OS map showing site location in red (copyright National Library of Scotland)
 Sheet 77: Aberdeen, Revised 1905-1906, Publication date: 1909

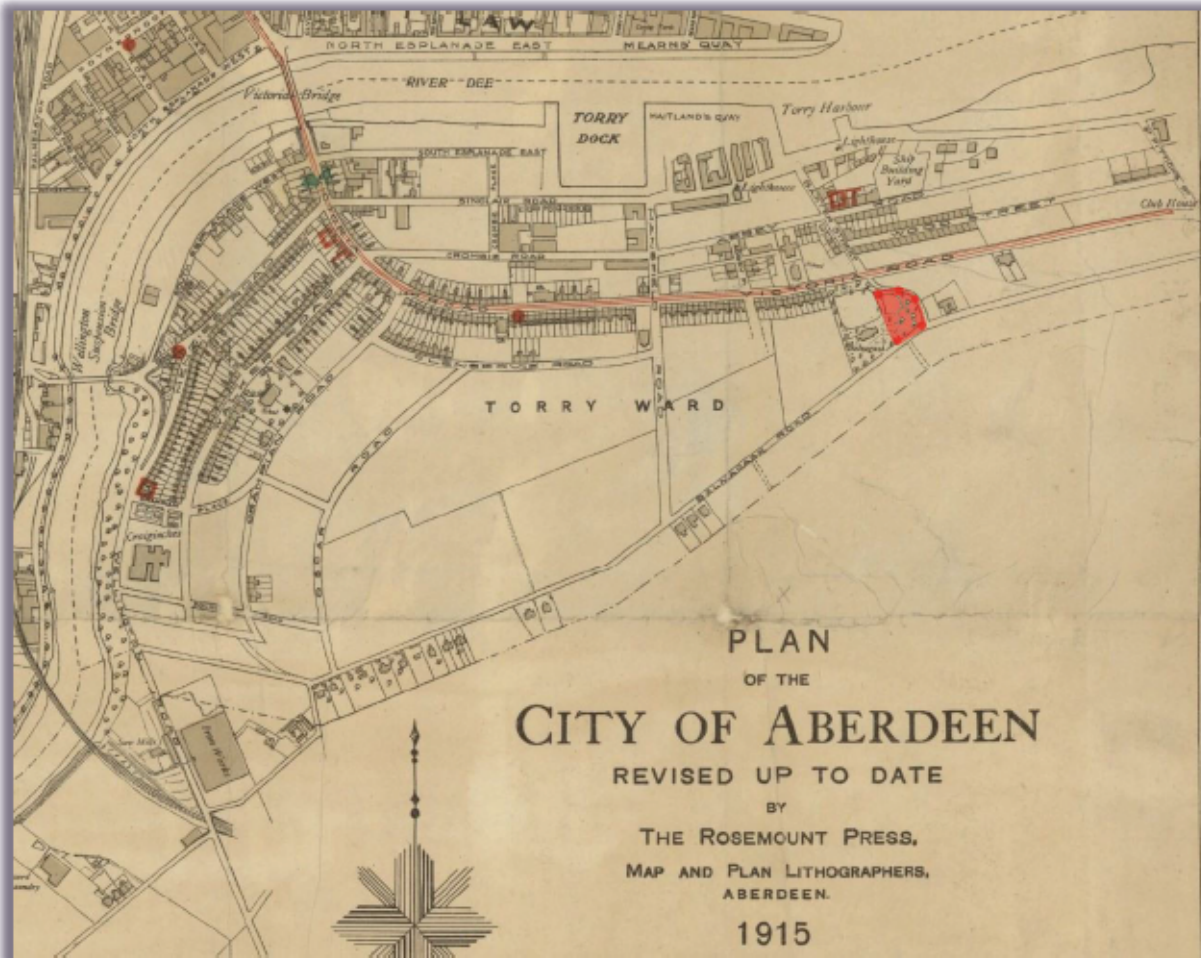
Illus 9 Aberdeen Town Plan of 1915 with Balnagask Motte shaded in red by author (top) and detail of map below (*copyright National Library of Scotland*)
