Report on an Archaeological Watching Brief
at Kempstone Hill, Stonehaven, AB39 3QB
CA297-2016

**Dr Robert Lenfert
Cameron Archaeology
September 14th, 2016**

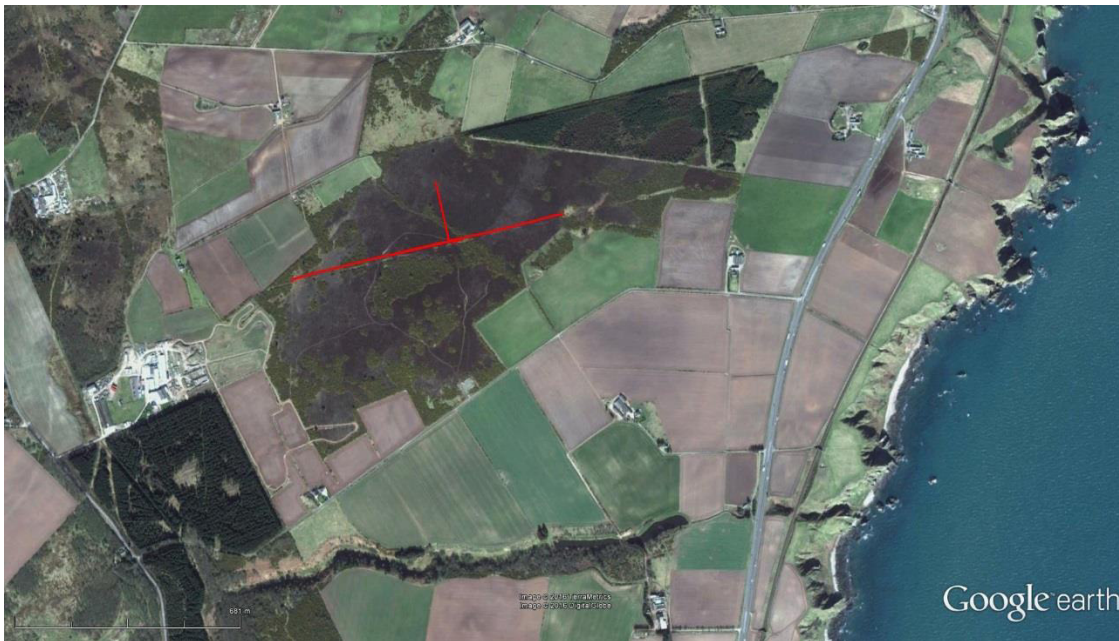
Illus 3 Aerial photo of site with GPS overlay (red) for trench containing buried cable and pole replacement corridor. Copyright Terrametrics and Digital Globe 2016.

The trench dimensions, obtained using handheld Garmin glonass GPS for the overall length, were 1.8m wide by 850m ENE-WSW, with a second trench running for c.155m at a right angle to the main corridor (Illus 3). At this central junction or 'T', a larger sub-rectangular area of topsoil was cleared which was 10m wide by 20m in length to facilitate machine and contractor access in wheeled vehicles.

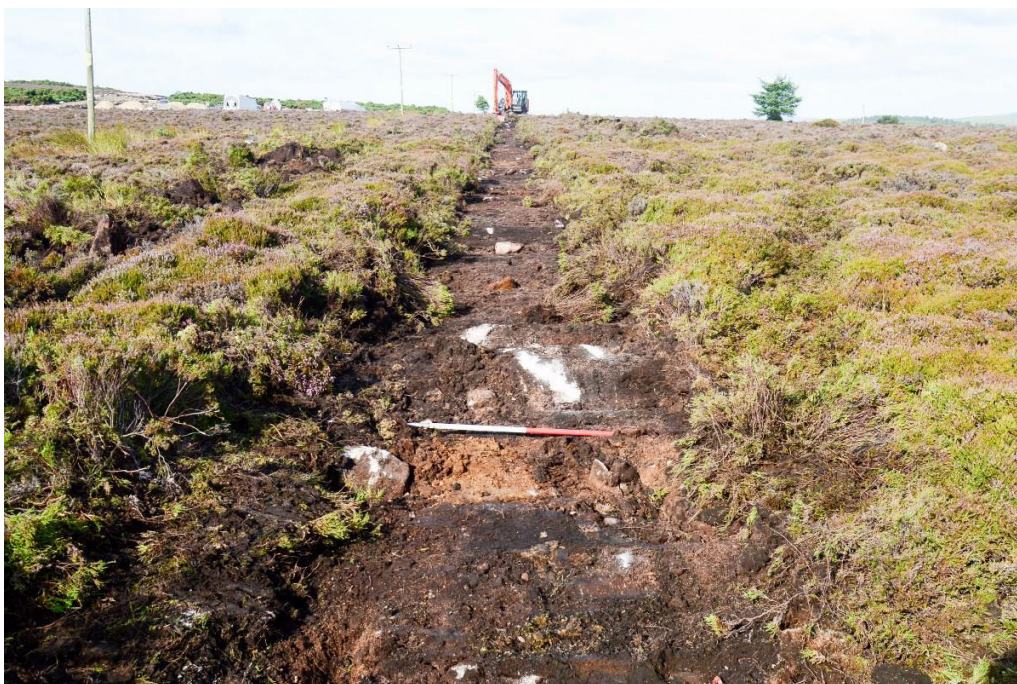
Illus 5 West facing view of corridor during topsoil removal.

Topsoil stripping (Illus 5) was carried out on the 8th and 9th of August 2016 with a 1.8m wide toothless bucket attached to a 13-ton excavator. This initial clearing was quickly followed by a 20-ton excavator using a 1m deep v-shaped trenching bucket. Any potential archaeological deposits were hand cleaned while soils and spoil closely inspected prior to trenching. Dark humic or peaty topsoils typically extended to a depth of 0.1 to 0.3m which in turn overlaid a natural mid brown sandy-silty clay subsoil with gritty inclusions.

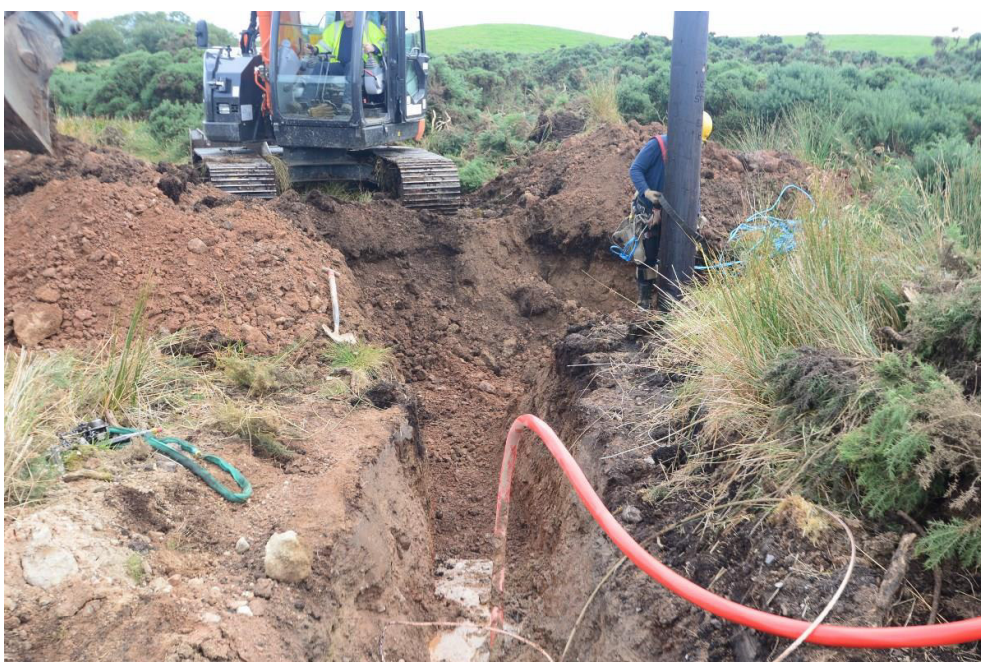
Illus 6 Insertion of new utility pole at eastern extent of project corridor. This particular pole required the most soil removal for completion while the remainder required substantially less ground disturbance.

Following the initial stripping and trenching, on August 24th 2016, two teams from Scottish and Southern Energy (SSE) arrived onsite to remove and replace seven utility poles along the corridor (Illus 6, 7). While this activity produced relatively little disturbance by utilizing existing holes, some digging was necessary around the bases to allow removal and replacement. This second phase did not produce any archaeological remains.
