**Broadford Works, Maberly Street, Aberdeen, AB25 1NB  
Level 2 Standing Building Recording and photographic  
survey**

**Alison Cameron  
Cameron Archaeology Ltd  
Version 2: 11 January 2017**

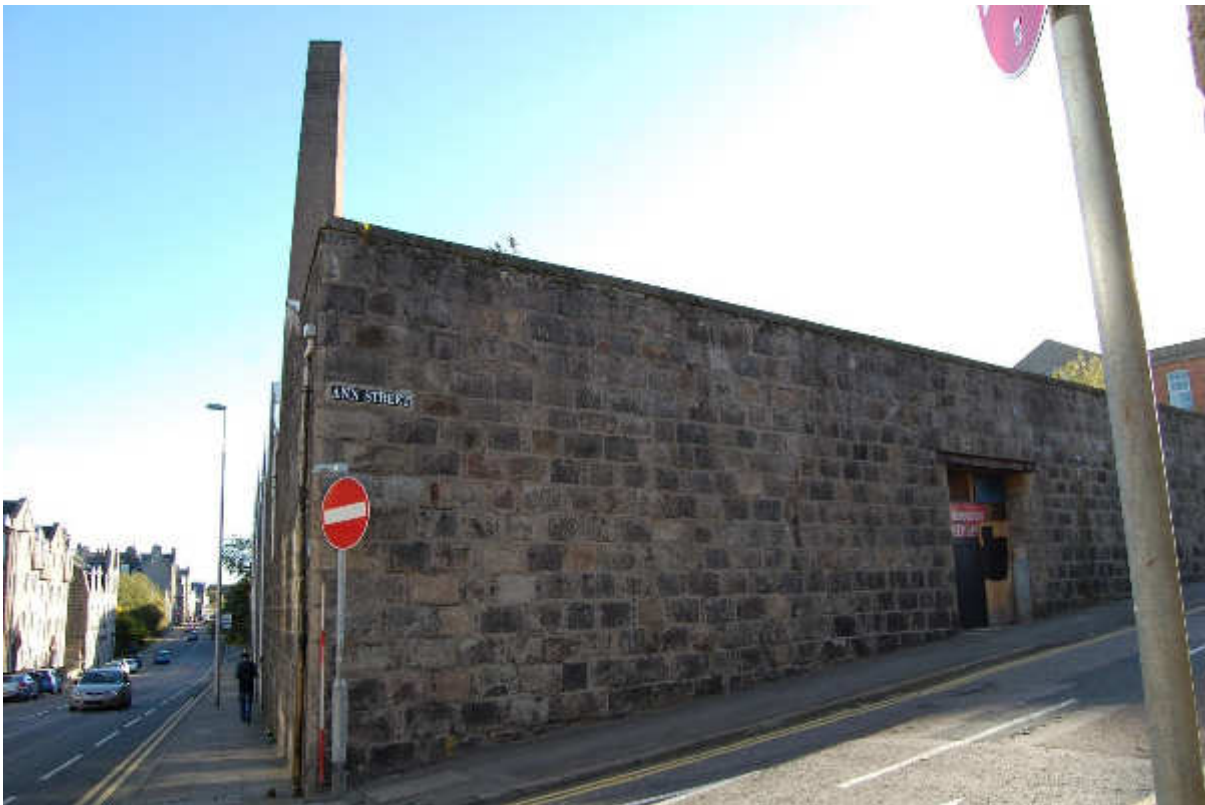
Building 23 was the north weaving shed (Building G on 1929 insurance plan; NJ90NW 125.11) built in the 19<sup>th</sup> century. It was one storey (Illus 35) and probably replaced a building which housed powerloom linen weaving pioneered by Maberly in 1824 (Watson 1992, 232). It is 55m along the Ann Street façade and 40m along the Hutcheon Street façade (Illus 36) and the wall on Ann St is 4m high with two window apertures and one door. The exterior walls are granite blocks with cherry cocking. The Hutcheon Street façade is split into 5 gables and there are three windows (W23/1, /2, /3). There is a new roof on the building.

Illus 35 Building 23 corner Ann Street and Hutcheon St showing single storey granite structure with D23/1; facing NNE

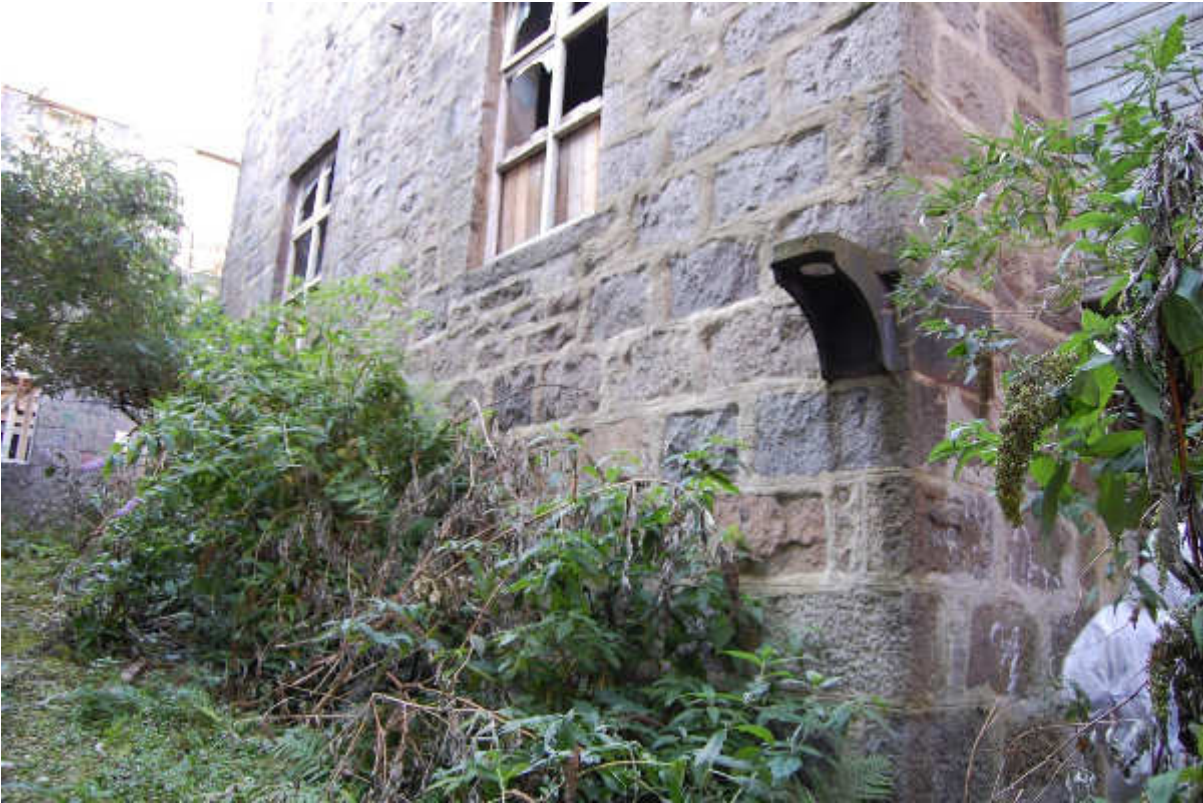
Illus 38 Building 26 SSE gable W26/2 (left) 26/3 (right) and cast iron bracket F28 (bottom right); facing NW

-Building 26. There is no access because of fire damage. Once the roofs/floors have been removed the building requires to be recorded and photographed.

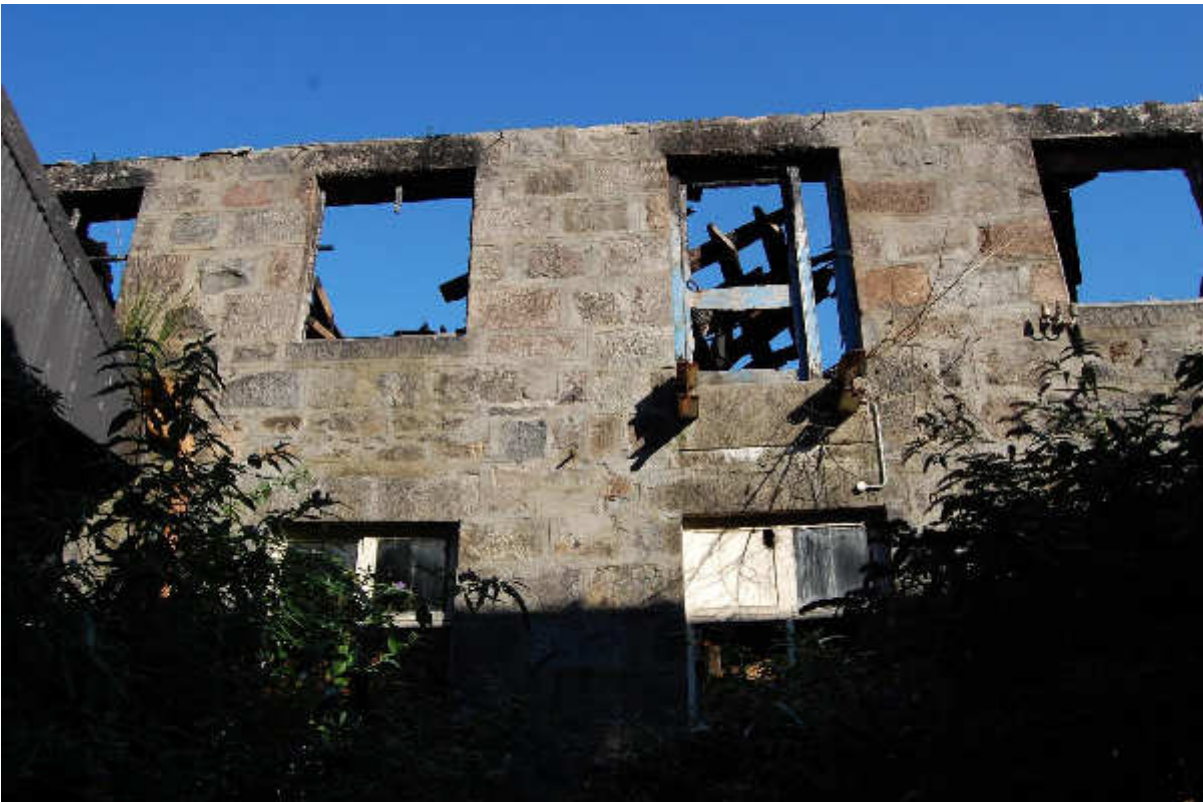
There is little access to the exterior at time of writing and no access to the interior because of former fire damage.

Illus 39 Building 26 W wall showing fire damage with W26/9, /10, D26/1, W26/12 (top L-R) and W26/16, /17 (bottom L-R); no access so far; facing E

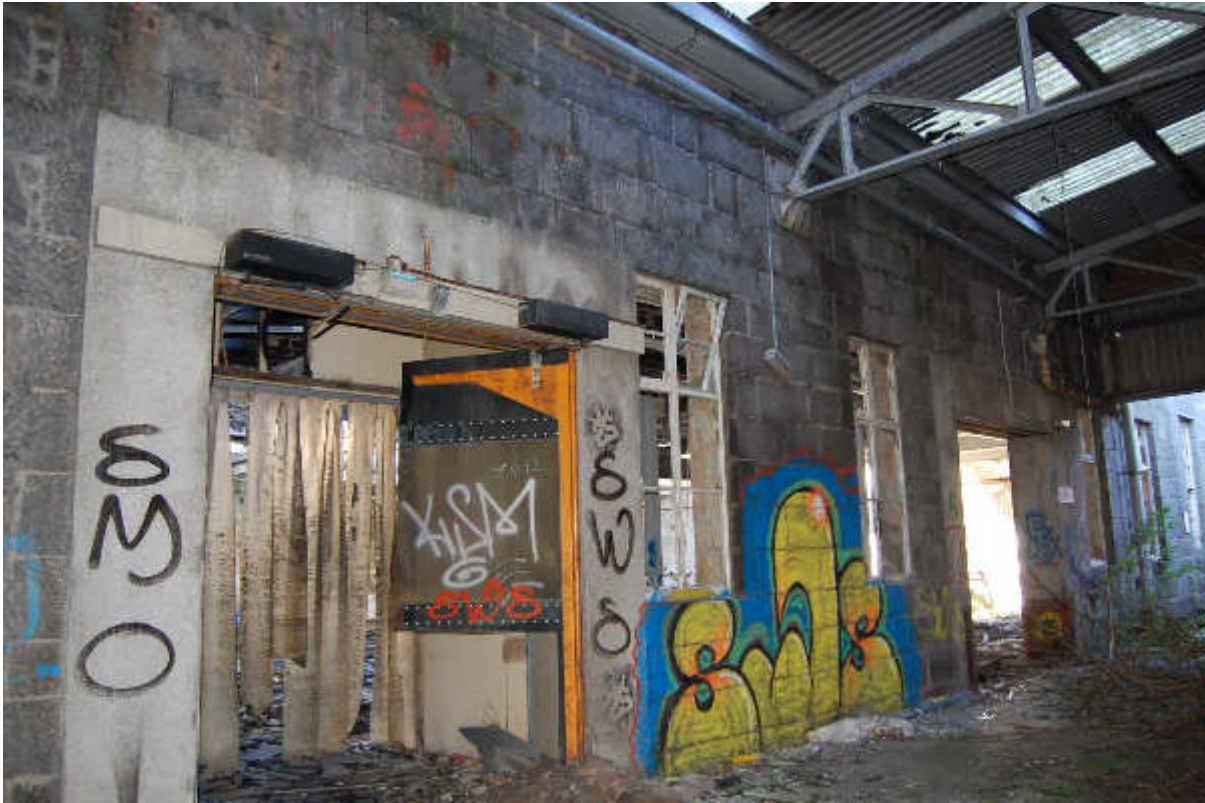
The loading bay Building 29 has been attached to the E façade of Building 30 (Illus 42).

Illus 42 Building 30 E façade D30/1, W30/2, /3, D30/4 (L-R); facing NNW

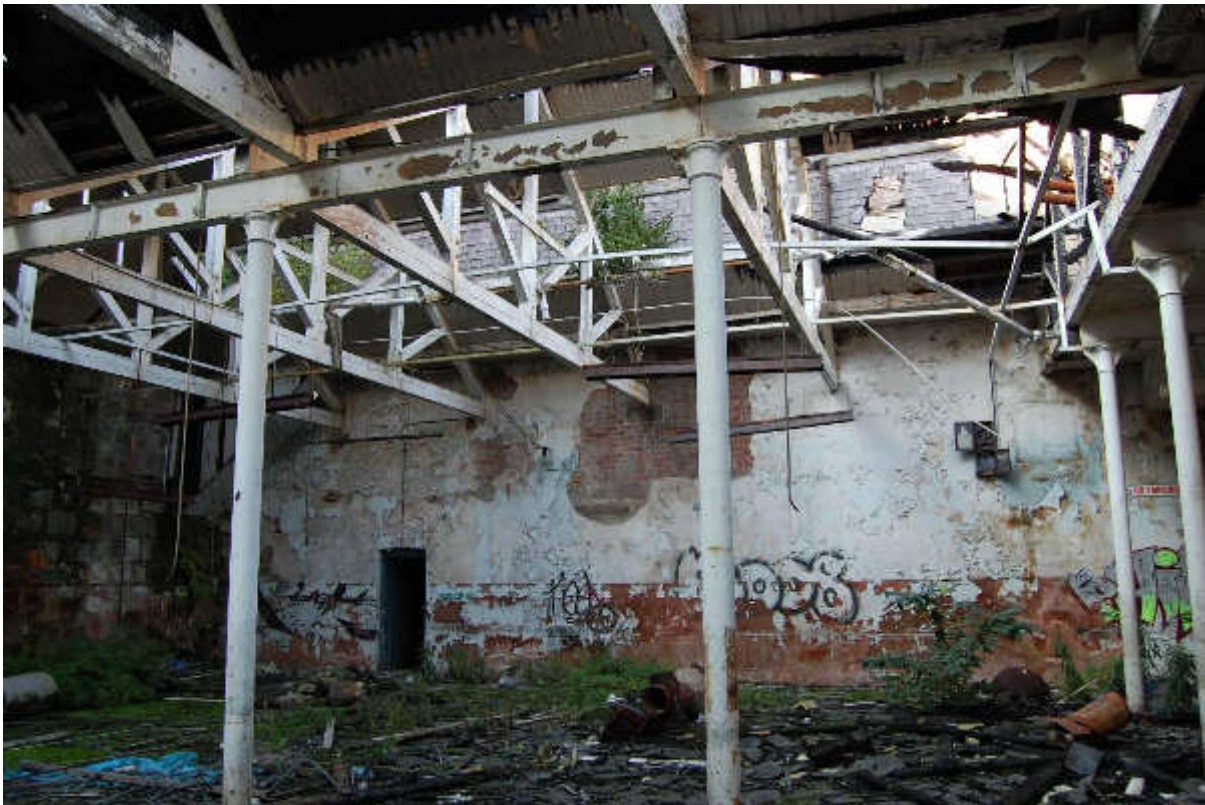
Building 30 (K on 1929 Insurance plan) was the Calendar House, built c 1870 a lofty single storey building with mezzanine (Illus 42-3) for cloth finishing (not accessed due to fire damage); calendaring is the process of finishing textiles usually by passing the textile under rollers at high temperatures and pressures. The W wall of the building is granite blocks and cherry cocking and abuts the E wall of Building 22, the N wall is of brick and abuts Building 27 and the S wall abuts the N wall of Building 32. The E wall is of granite and has a series of doors and windows with granite lintels and sills (Illus 43) mostly original to the building apart from two large Phase 2 doors (D30/1, /4) which have been inserted to allow greater access to the building. There is a series of round section cast iron columns internally (Illus 44).

Illus 44 Building 30 interior N wall with door D30/10 showing granite W wall, brick N wall and replacement roof; facing NW

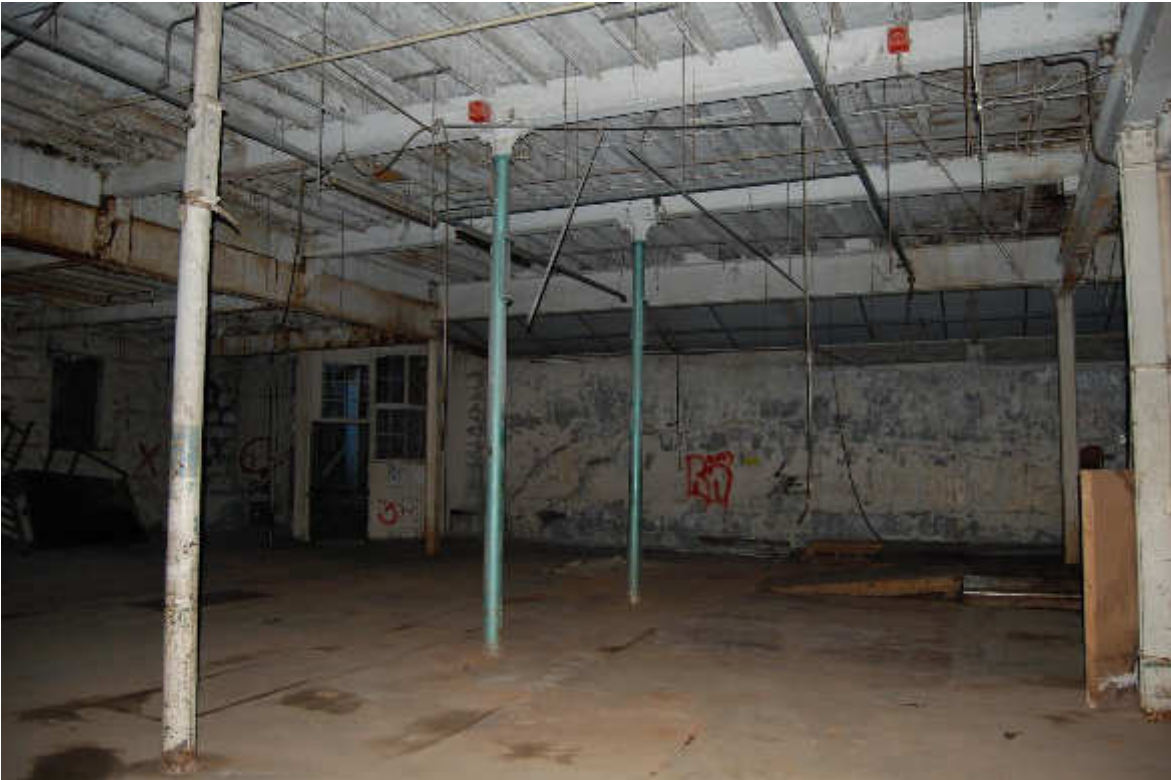
Illus 70 Building 51 interior showing round cast iron pillars, newer concrete wall (right) and replacement ceilings; facing SE

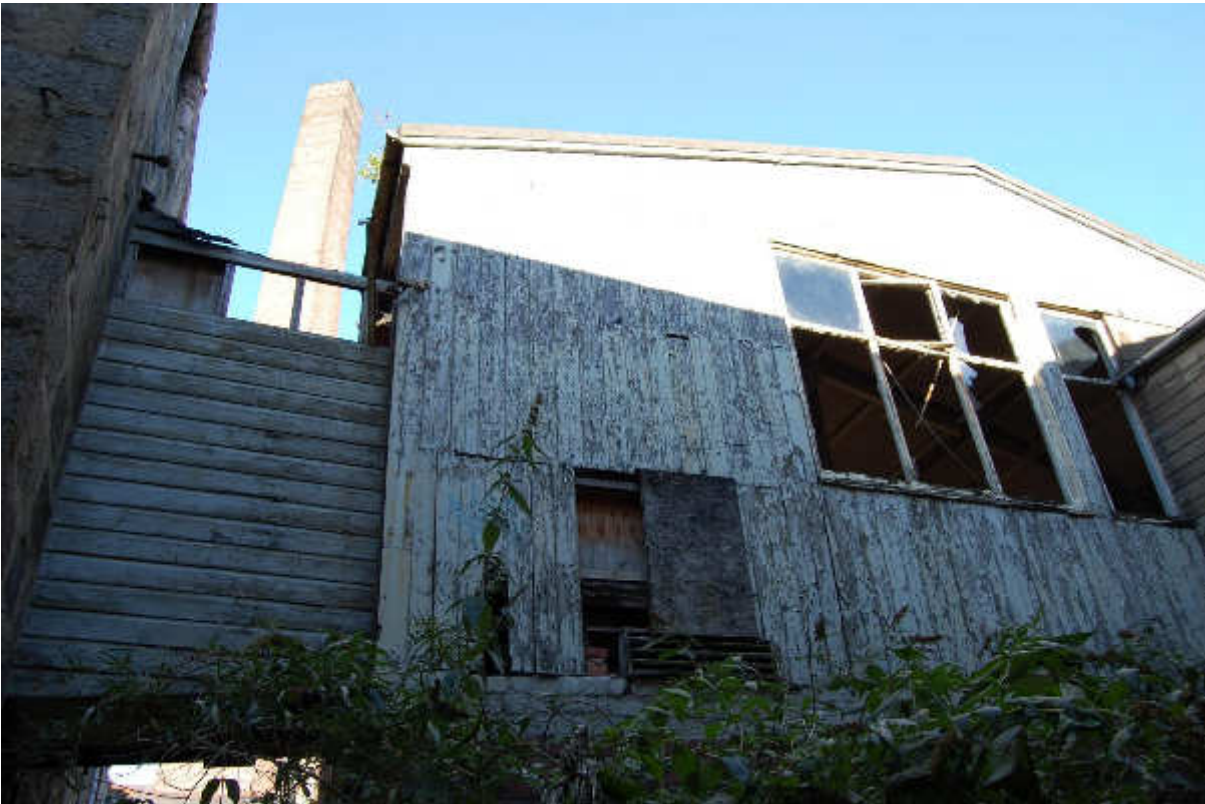
Illus 71 Building 51 wooden first floor; facing N

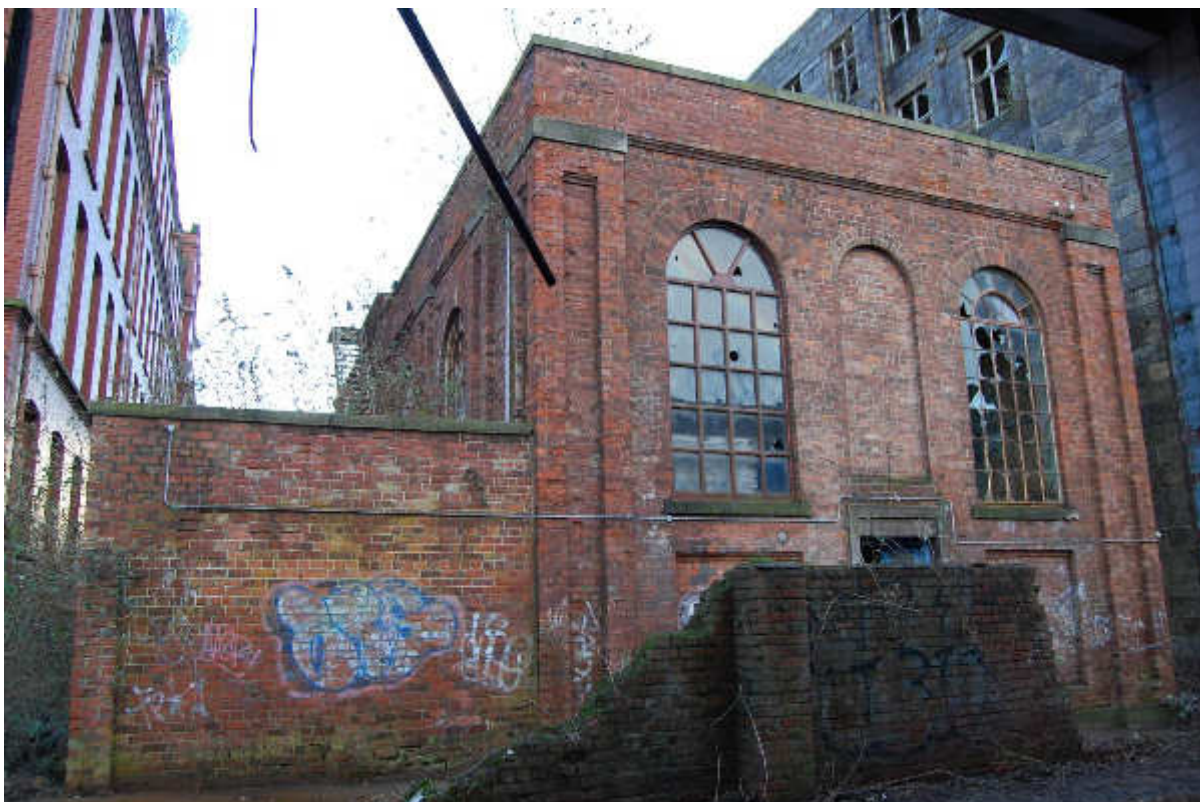
Building 54 was an engine house (CANMORE ID NJ90NW 125.14; Illus 81). It is situated between the 'New Mill' and New N and S Mills, flat-roofed with heavy cast-iron ceiling beams. It had a tandem horizontal compound engine replaced in 1933 by an electrically powered one. There was a second engine house within N weaving shed (NJ90NW 125.11). Building 54 is 22m long, 10.5m wide and 9.5m high and is constructed of a series of brick buttressed sections with windows in between. The N main façade has the main door (D54/5) and large first floor arched brick windows with granite sills. There are three blocked apertures on this facade. W54/2 is a blocked first floor window with brick arched lintel. All three first floor windows have sandstone sills and are probably all original to the building. Two ground floor windows (W53/4 and /6) are probably original to the building as they have sandstone sills. They are blocked with brick. The ground floor door had granite mouldings.

Only North elevation completely accessible as other facades are overgrown and there is only small gaps between this building and the adjacent structures. It is constructed of red brick with exterior buttressing on a grey granite pedestal foundation. Central upper window and lower windows brick lintels and sandstone sills and have been bricked up (54/2, 54/4, 54/6). Two upper windows (54/1, 54/3) have arched brick lintel and granite sills and ground floor door (54/5) has granite facings. Arched windows have been blocked on the E and W facades but there is little access to these aspects. The two windows on the S façade have semi-circular cast iron sills (Illus 82). There are ceramic tiles on the interior (Illus 83) but the interior is largely inaccessible at time of writing.

Illus 81 Building 54 N façade with wall F18 (left); the stub wall in the foreground is the remains of the S wall of Building 52; facing S.

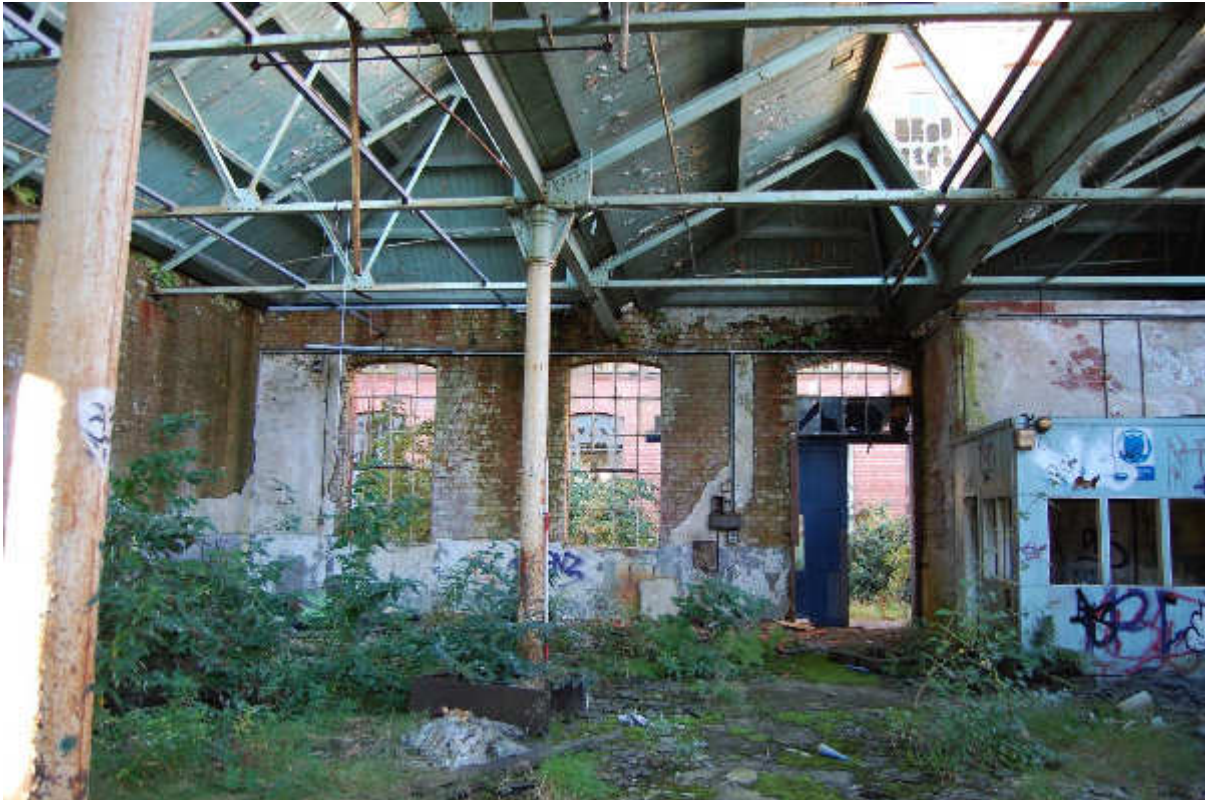
Illus 115 Building 90 interior SW wall showing cast iron pillars and roof beams with more recent replacement roof; facing SW

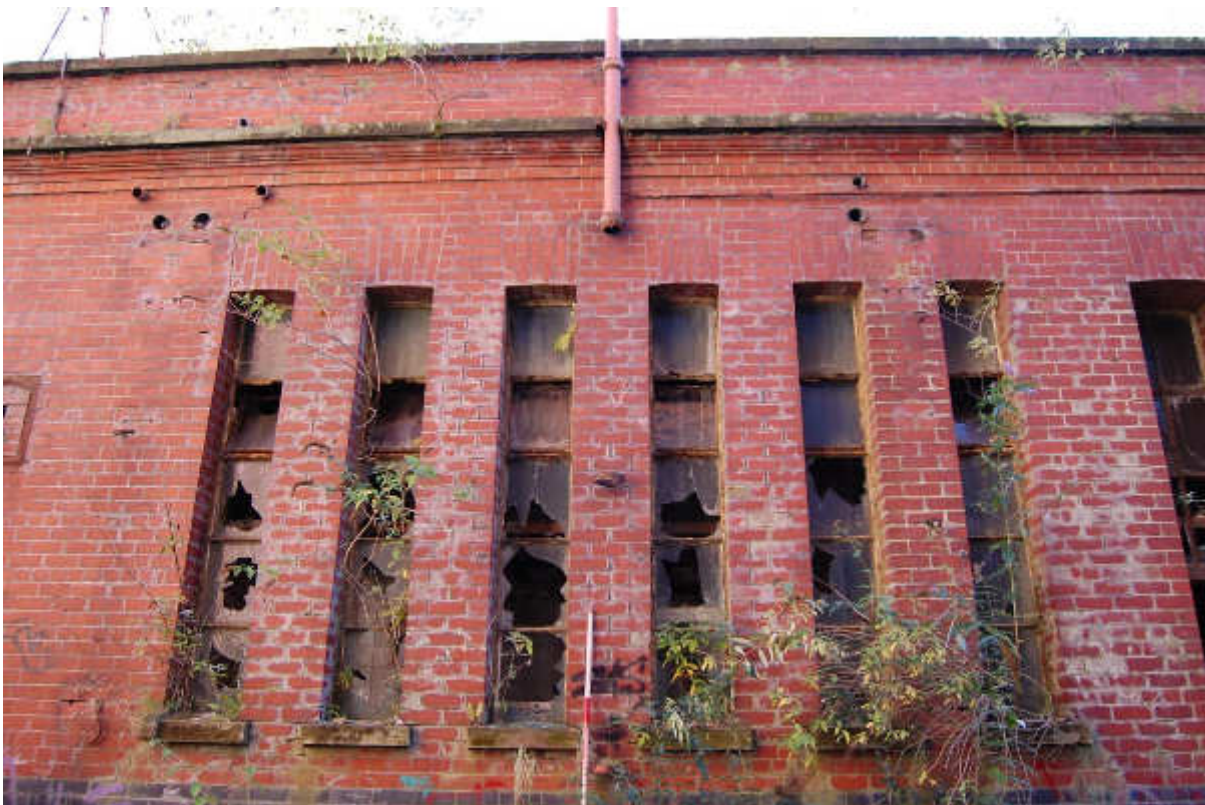
Illus 116 Building 90 W façade windows W90/11-/6 (L-R); facing ENE

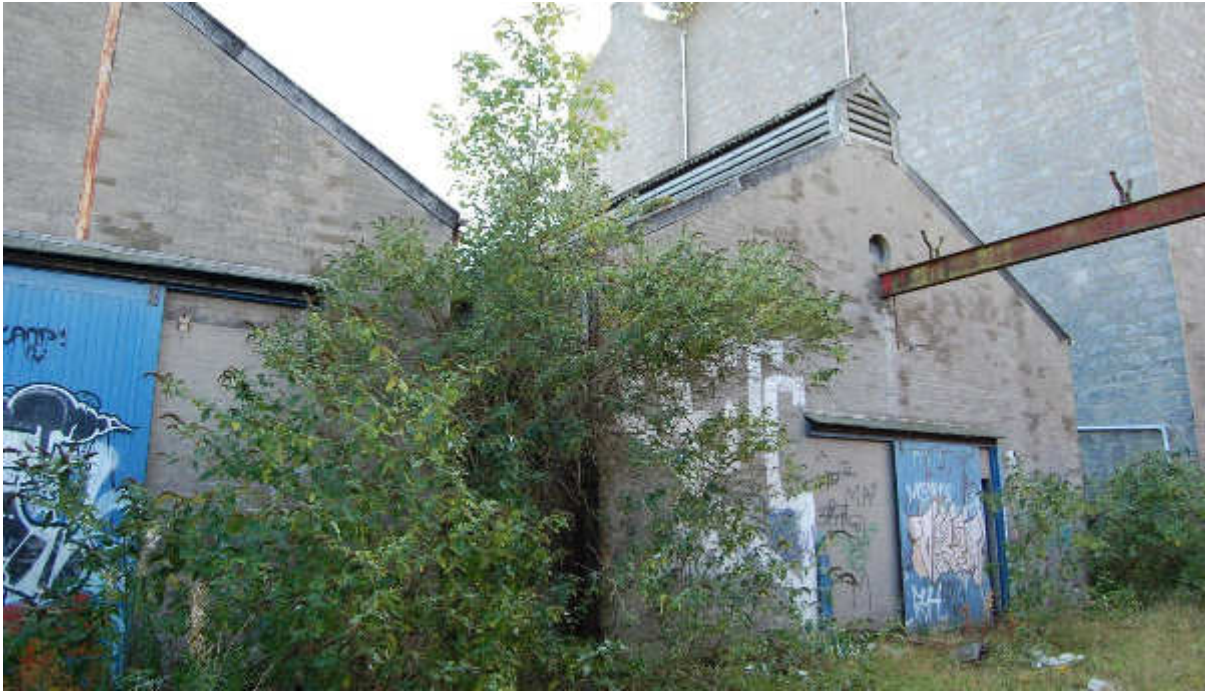
Buildings 93 and 94 were the waste cleaning houses and dust store originally built in 1913 (CANMORE ID NJ90NW 125.7; Illus 123-4). These concrete brick sheds are a replacement for the original buildings and were served by cart tracks F45 and F63 (Illus 125).

Illus 123 Building 93 (left) and 94 (centre) with Building 68 E wall (right); facing SW

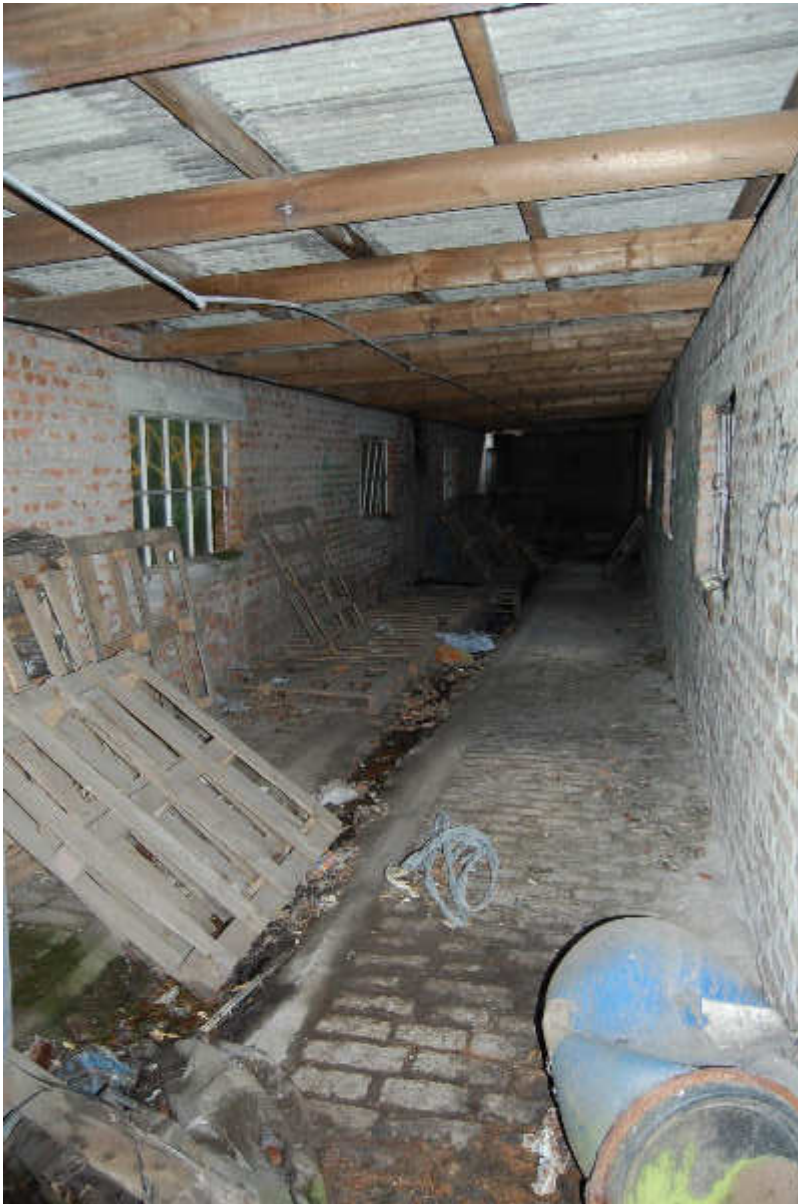
Unnumbered on the overall plan labelled '83A' on undated plan of fire hydrants (held at Cameron and Ross; Illus 135). Building 102 is a N-S brick-built building 26m long and 3.5m wide attached on to the S wall of Building 83. It has windows down each long wall and concrete tile roof. The lintels are brick and there is a cobbled path (F38) on the interior with a concrete gully down the centre (F39). There are several cast iron tracks to the building and it was used to test fire hoses with the run off going into the adjacent West Burn F41. There is an undated plan held at Cameron and Ross where this building is labelled 'hose testing'.

Illus 135 Building 102 hose pipe testing facility showing concrete gully (F39) with cobbled path either side (F38); facing SSE

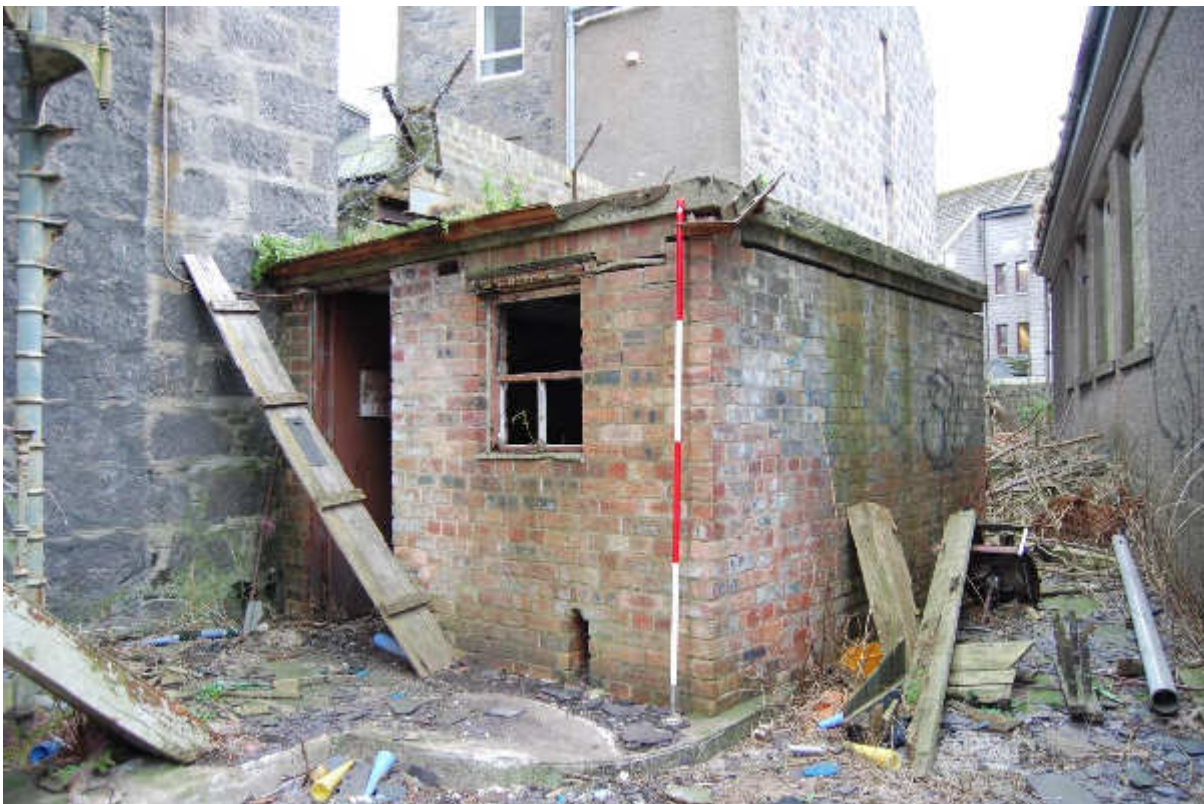
Unnumbered on the overall plan, labelled '3A' on undated plan of fire hydrants (held at Cameron and Ross). This small brick building 3.9m long and 3.2m wide is built into the SE site boundary wall at the SW corner of Building 69. It is single storey and constructed of older red brick with repairs to the E and S walls with modern grey brick (Illus 136) or use of two types of brick during construction. The walls are 0.24m thick and the bricks an average of 23cm long, 7cm high and 10cm wide. The lintel of W103/1 is cast iron, the sills concrete and brick. It has a shuttered, reinforced concrete flat roof, concrete floor and set on a concrete platform. There is an aperture F42 on the N wall, possible to hold a cast iron beam. The building has wooden racks (Illus 137) on the interior but was probably originally built to hold heavy machinery, suggested by the sign on the exterior of door D103/1 'Safe working load 5cwts' and the reinforced concrete floor and ceiling.

Illus 136 Building 103; facing S

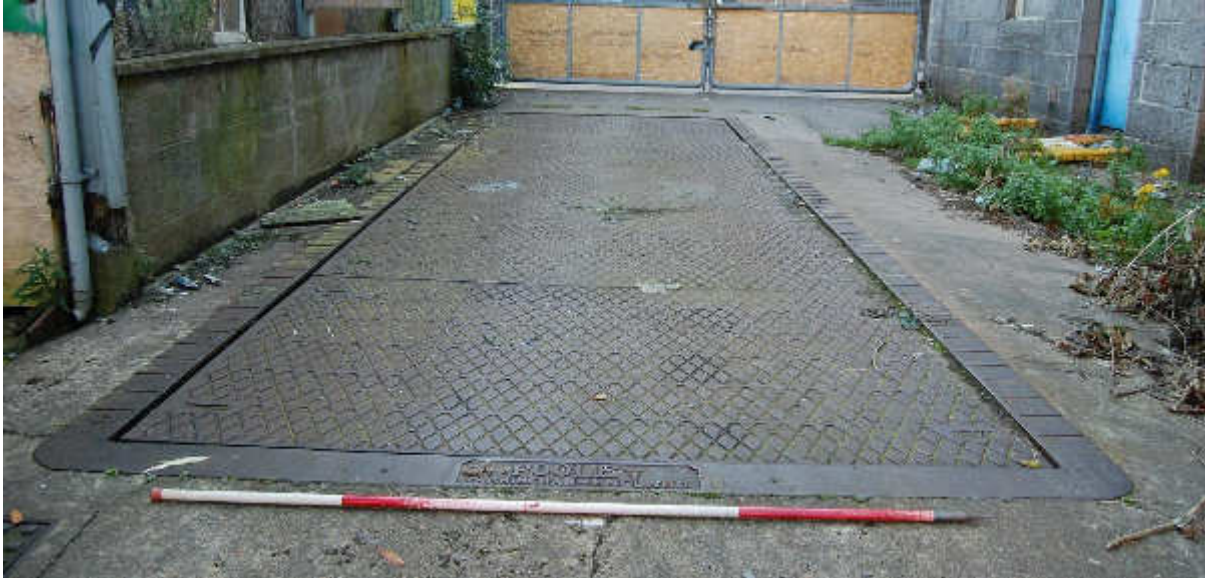
Weighbridge between Buildings 1 and 7 (Illus 140) on the S Maberly St side within main gate. Structure labelled 'Pooley, Birmingham, England' (Illus 141). Henry Pooley and Son Albion Foundry, Liverpool and 72 John Bright Street, Birmingham.

Illus 140 Weighbridge F23; facing SSE

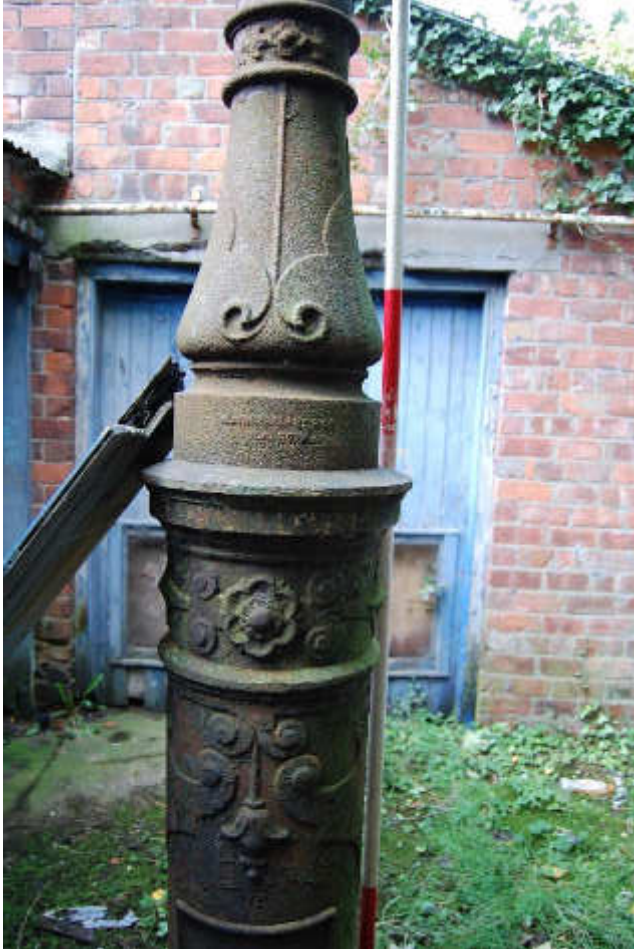
Cast iron lamp stand (Illus 144) on the E side of Building 102 with maker's mark 'MACFARLANE & CO/GLASGOW' (Illus 145). It is corroded with no paint remaining and has flower and scroll decoration similar to F17.

Illus 144 F33 cast iron lamp stand E of Building 102; facing S

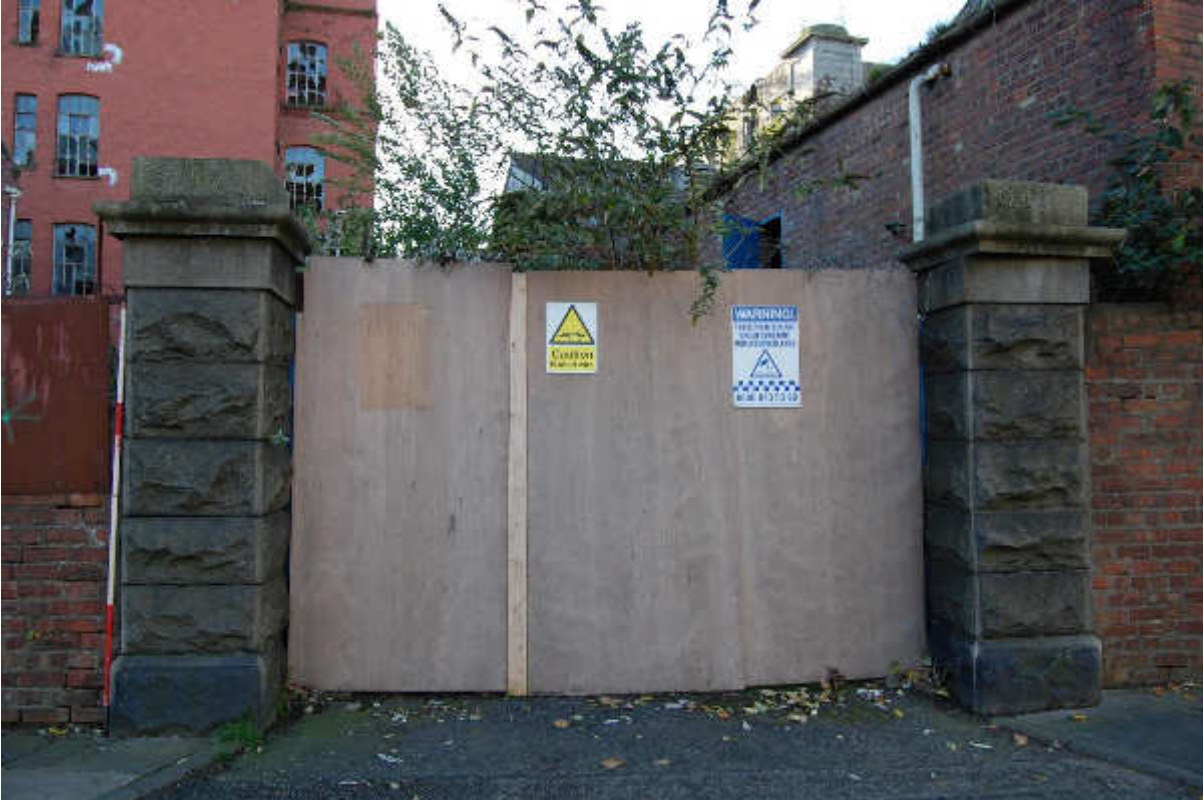
Gate on the frontage of Hutcheon Street with two gate piers constructed of rusticated granite columns (Illus 146).

Illus 146 F34 Hutcheon St gate with rusticated granite gate piers; facing S

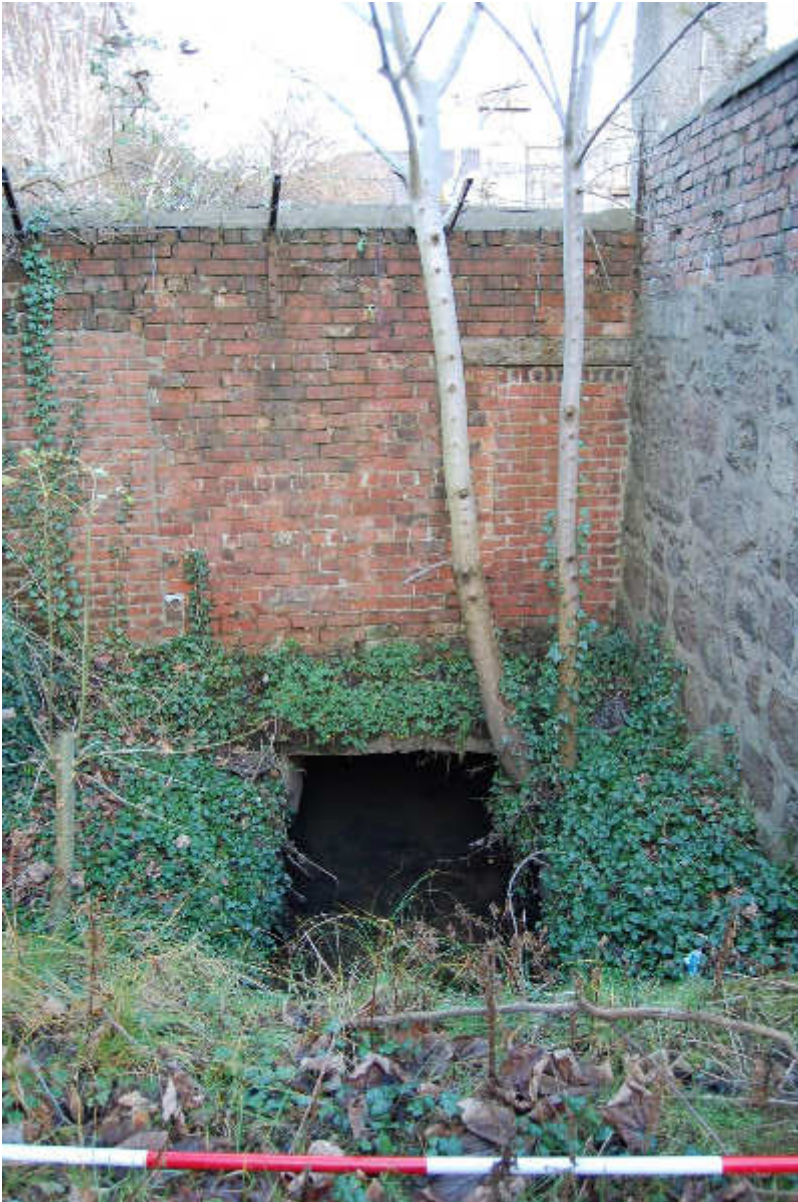
Culvert F41 is the West Burn which was the Works water supply. It is visible at the N edge of the site (Illus 147) but is culverted throughout the site. There is little access at this time but future works may allow access to record this feature.

Illus 147 Culvert F41 with N brick boundary wall with Hutcheon Street (centre) stone E boundary wall (right) with blocked apertures DHS/2 (left) and DHS/1 (right) and low blocked aperture in between; facing NNW
