**Longside, Old Rayne, Inch, Aberdeenshire, AB52 6SU**  
**Report on Level 1 Standing Building Survey**

**Alison Cameron**  
**Cameron Archaeology**  
**24 January 2017**

A Level 1 standing building survey was carried out on 18 January 2017. A full photographic survey was carried out and architects plans and elevations checked and annotated.

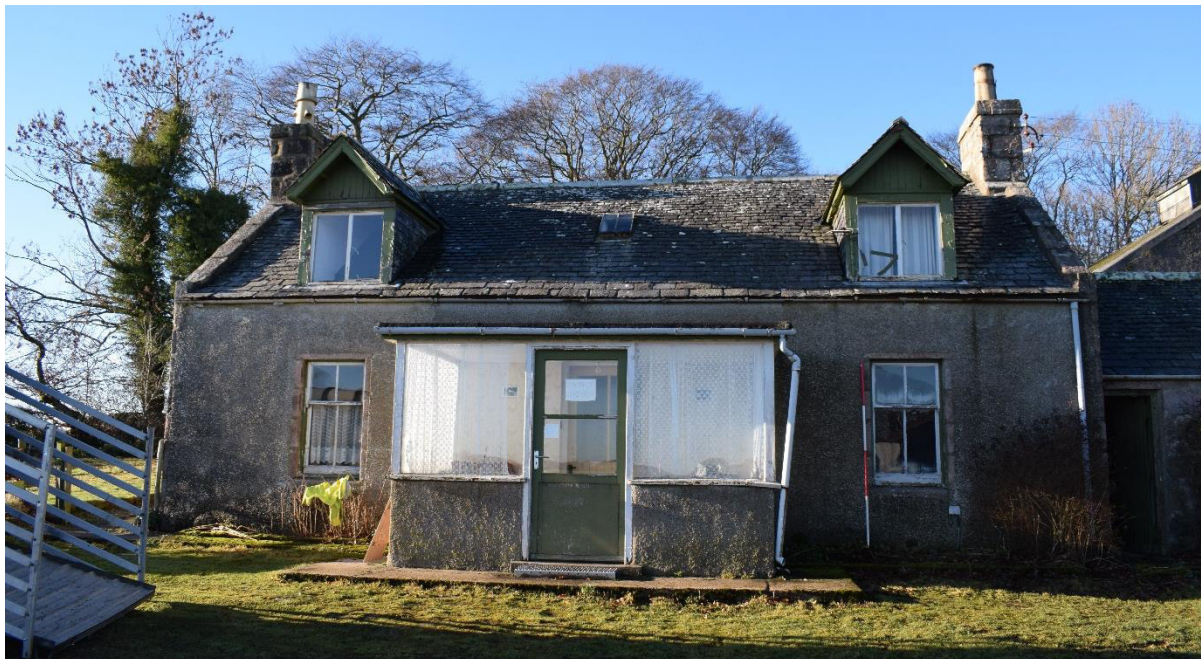
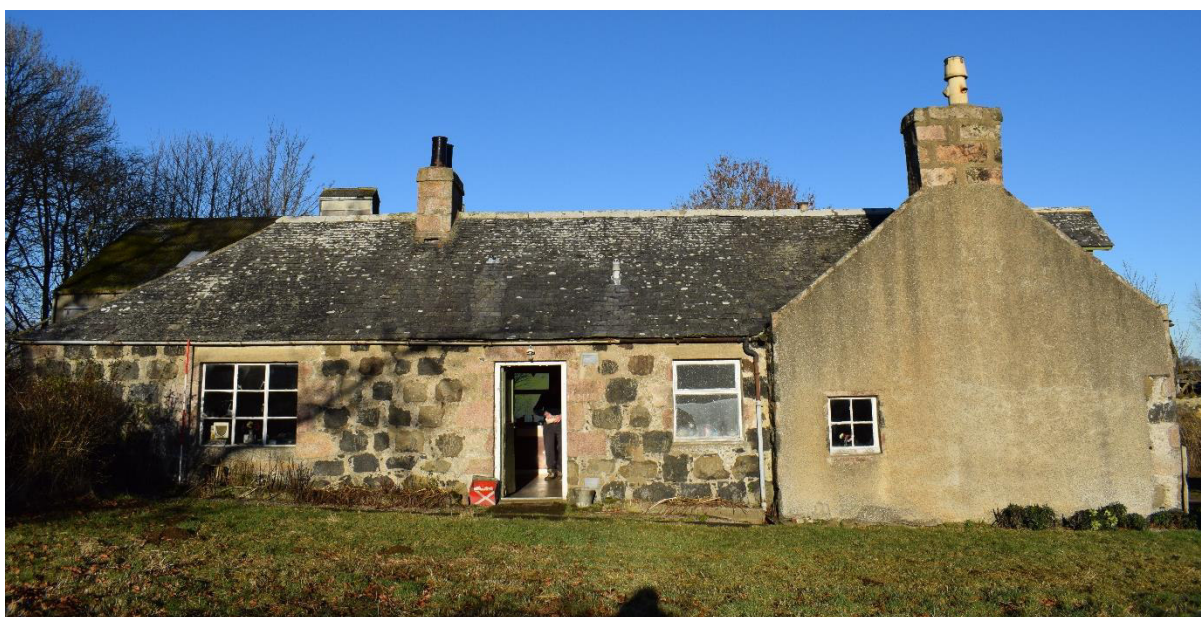
Cover: top Structure 1 ESE façade, facing WNW; bottom SSW façade Structure 2 (left) Structure 1 (right); facing NNE

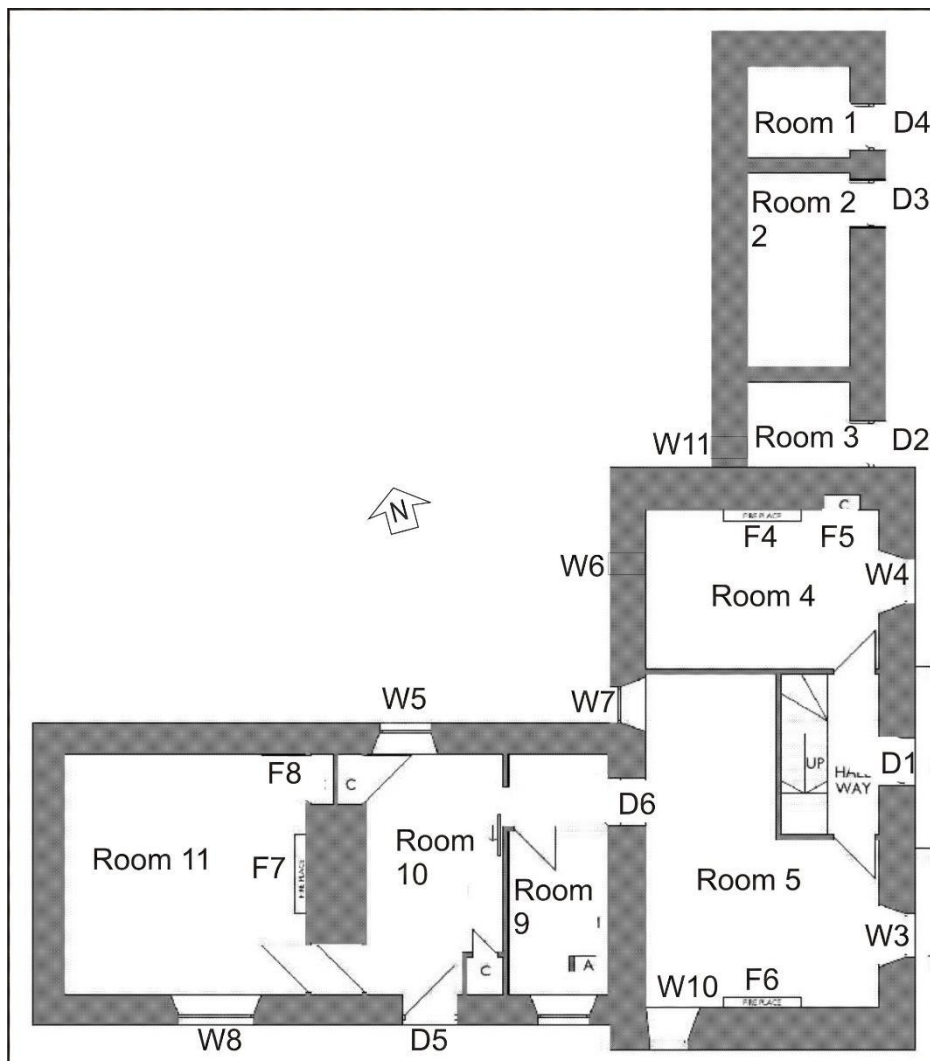
Illus 2 Ground floor plan annotated with numbers used in this survey (copyright Colin Thompson)

A level 1 standing building survey was carried out on 18 January 2017. Three structures were recorded photographically and architects plans and elevations (Illus 2-7) checked and annotated. Structure 1 is a rectangular two storey cottage with frontage facing ESE. Structure 2 is a one storey extension added to the W side of Structure 1 and Structure 3 a one storey extension added to the N side of Structure 1.

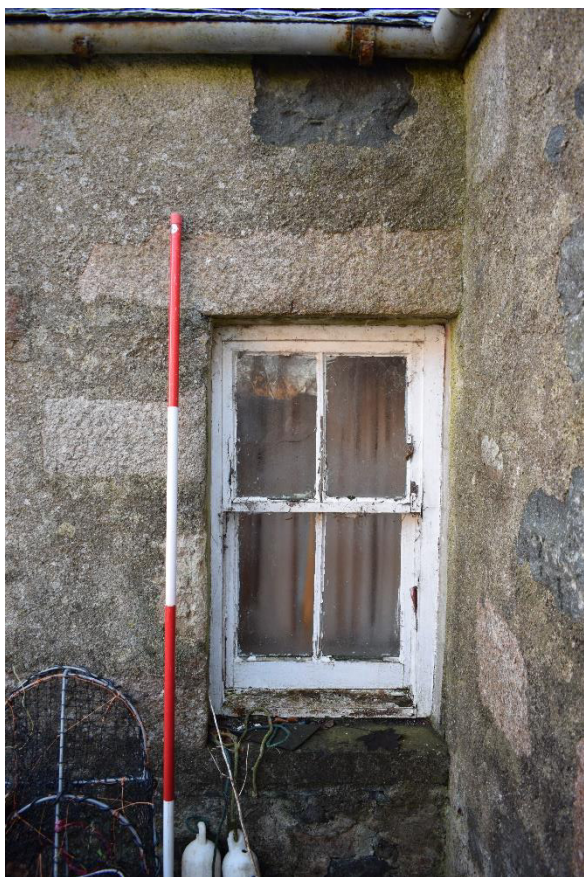
Illus 8 Structure 1 WNW wall W7 showing Structure 2 built over the lintel of this window; facing ESE

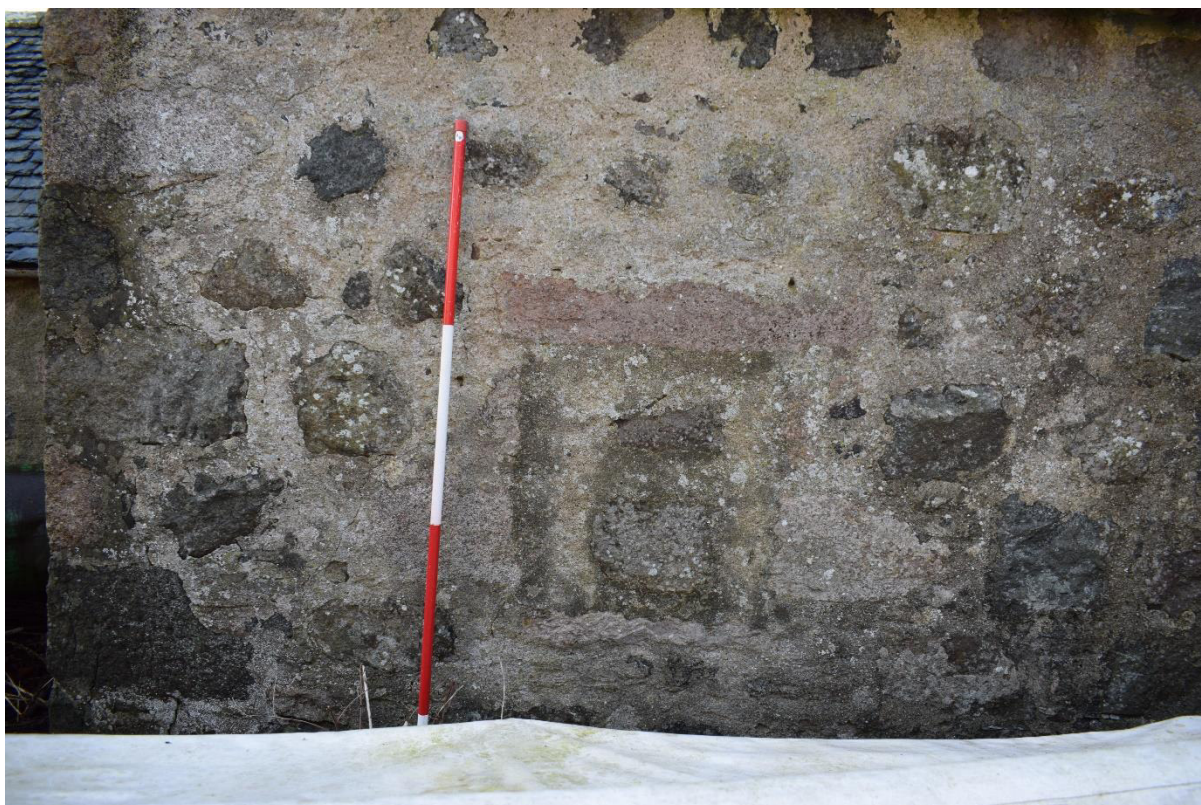
Structure 1 is a rectangular two storey cottage 9.4m N-S and 6m W-E. It is constructed of granite rubble harled on the S and E facades; the walls are 0.5m thick. The quoins visible are grey and pink granite as are the lintels and sills. The ESE elevation has a central door with windows either side on the ground and first floor (see cover illustration). The first floor windows are set in wooden gablets. The roof is grey slate and there is a central rooflight. The chimneys are granite and the pots are fireclay. The WNW wall has a central window which has been partially covered by the Phase 3 extension Structure 2 (Illus 8). The SSW gable is harled with one small window (W10; cover illus, bottom) and pink and grey granite quoins exposed on the SE corner. Structure 3 is attached to the NNE gable. There is a blocked window in the W wall (Illus 9).

Illus 9 Structure 1 WNW wall blocked window W6; facing ESE

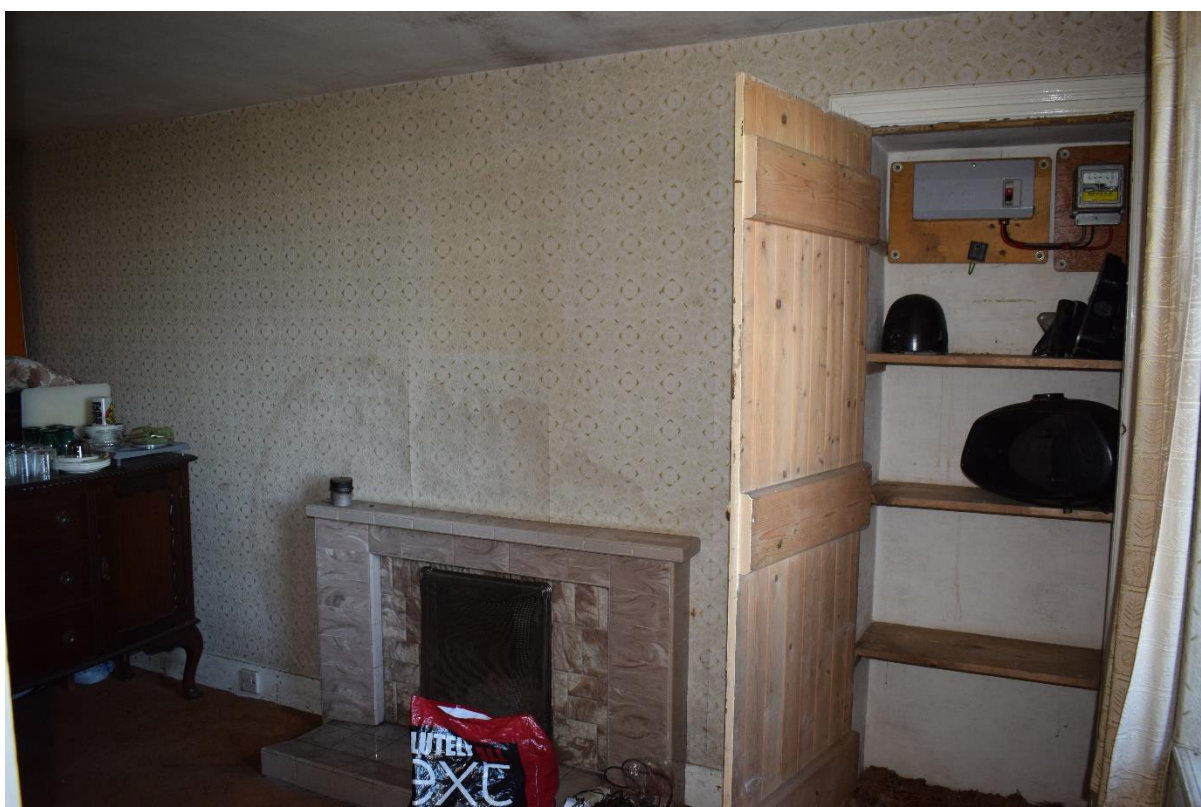
The interior has been refitted in the 1970s (Louis/Louie tenant pers comm) with tile fireplaces (eg F4; Illus 10). There are alcoves in the ground floor rooms and a central stairway to the first floor. There is 1970s wall coverings throughout (Illus 11).

Illus 10 Structure 1 Room 4 NNE wall with fireplace F4 (left) and alcove F5 (right); facing NE

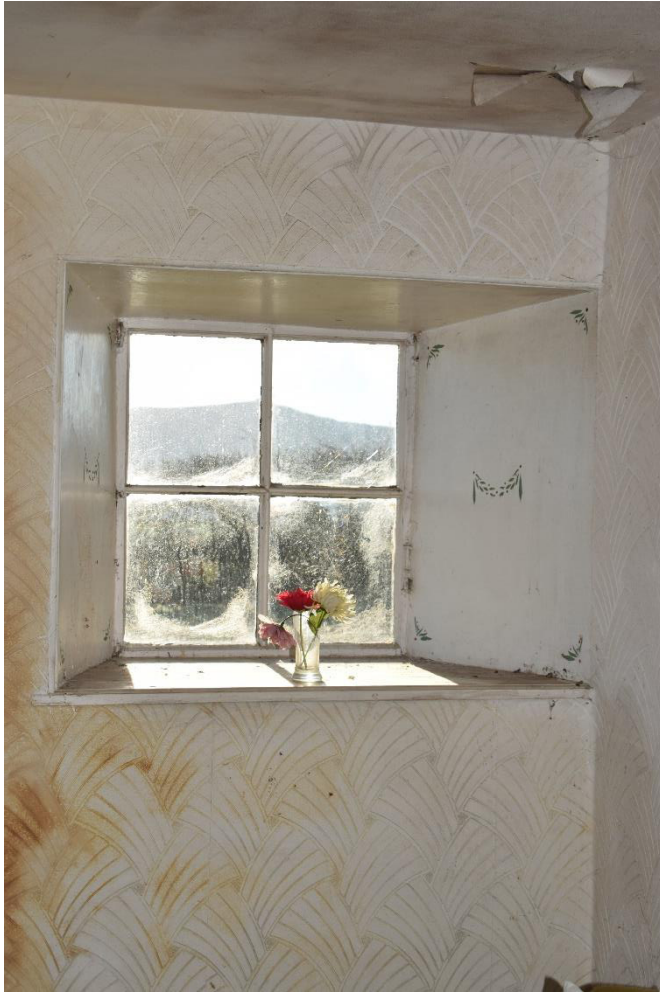
Illus 11 Room 5 WNW wall W7

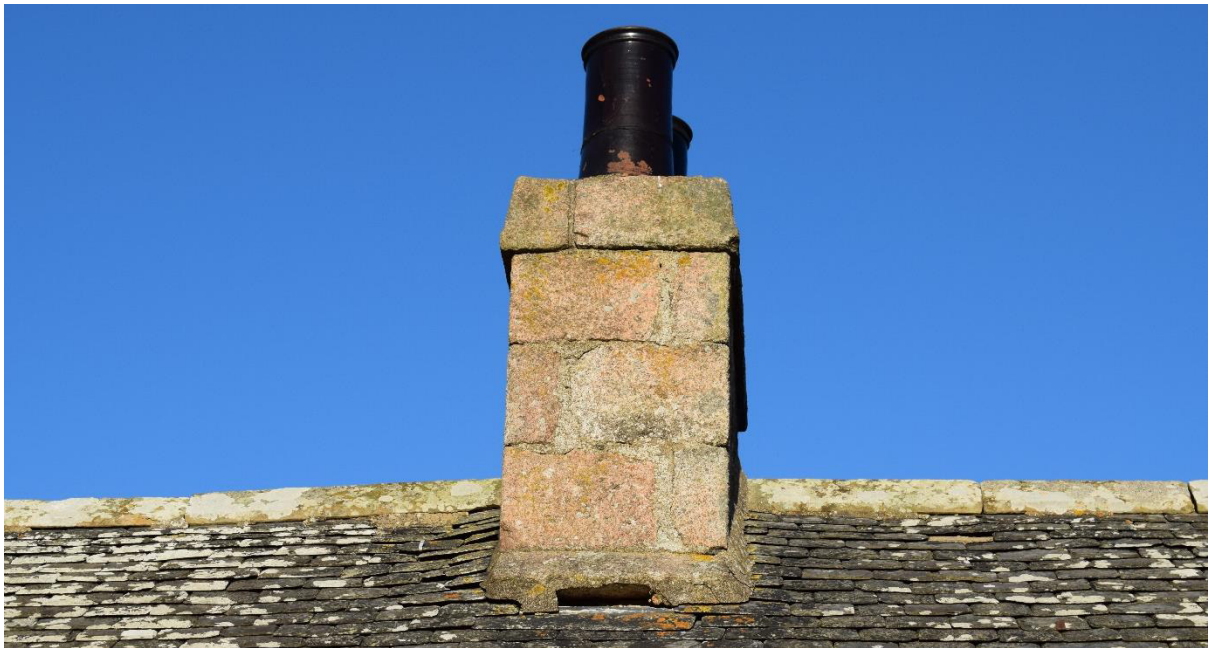
Structure 2 has been added on to the WNW side of Phase 1 Structure 1. It is 5.7m N-S and 11.15m W-E. It is constructed of grey and pink granite blocks and cherry cocking. The SSW façade has an off-centre door and there are windows on either side, one in the bathroom and one in the bedroom. There is one window in the NNE wall in the kitchen. A door (D6; Illus 2) was broken through the WNW wall of Structure 1 when this extension was built. The extension has a kitchen, bathroom and bedroom. There is a central granite chimney F2 (Illus 12) with possible black-glazed Seaton chimney pots.

Illus 12 Structure 2 granite chimney F3 with possible black-glazed Seaton chimney pot

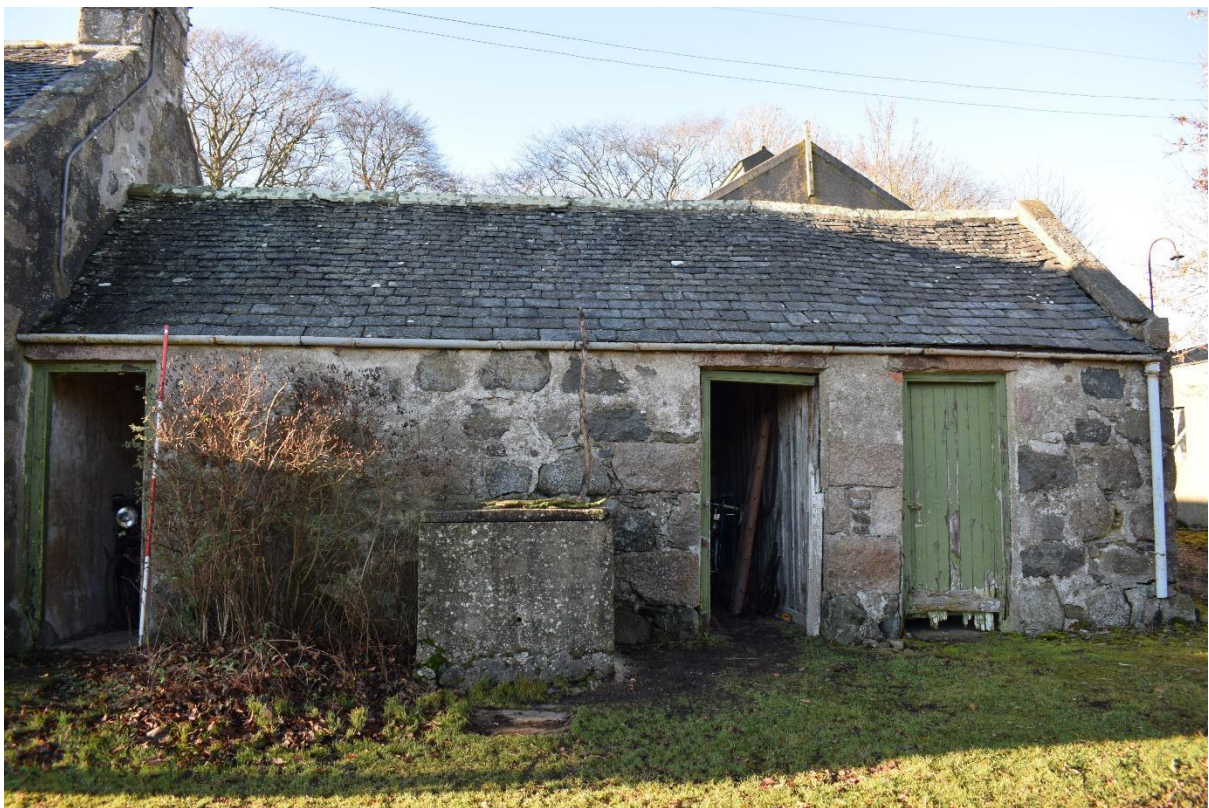
Structure 3 is a single storey extension to the N of Structure 1. It is 8.5m long and 3.35m wide and consists of three rooms each with a door on the E wall (Illus 13). The walls are 0.5m thick and constructed of granite rubble with large granite blocks for quoins and wooden door lintels. The S room has a cobbled floor. There is a small window in the W wall of the S room (W11; Illus 14). This structure has been butted on to the n wall of Structure 1 (Illus 15).

Illus 13 Structure 3 ESE façade D2 (left) D3, D4 (right); facing WNW

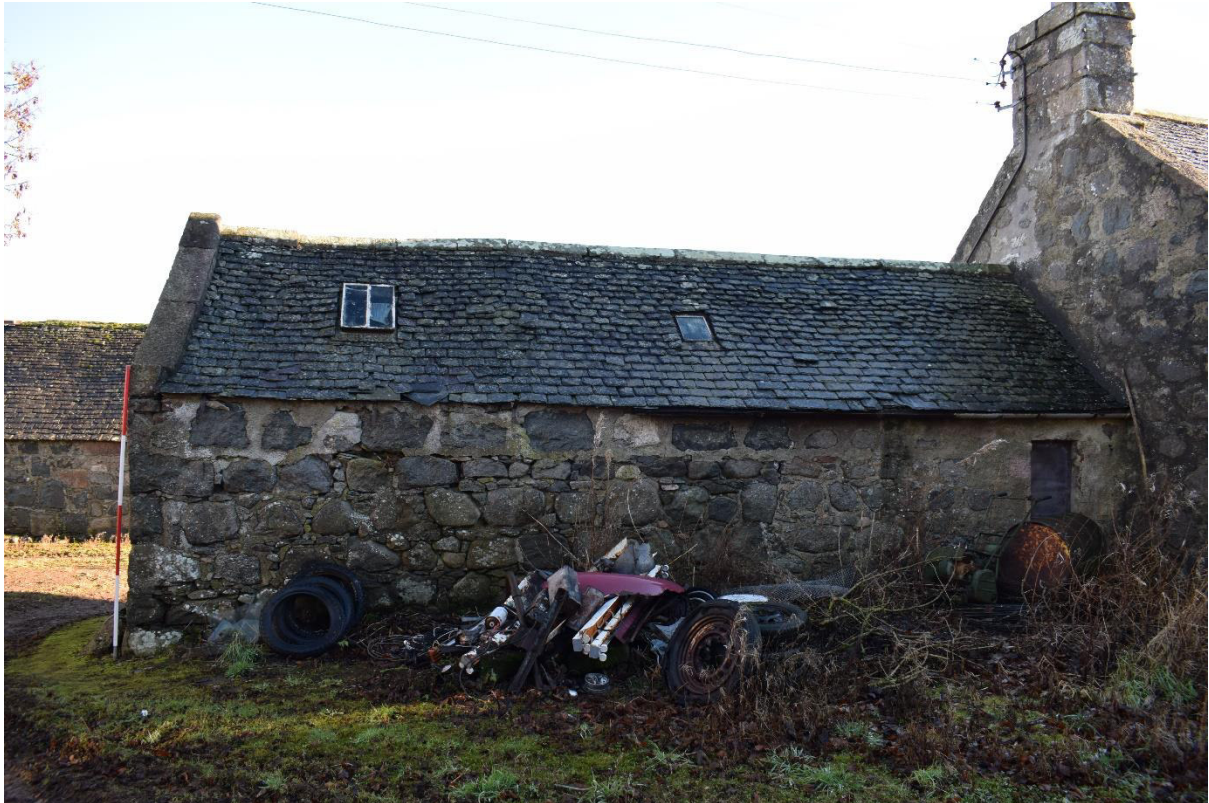
Illus 14 Structure 3 WNW façade with window W11 (right) and Structure 1 (extreme right)

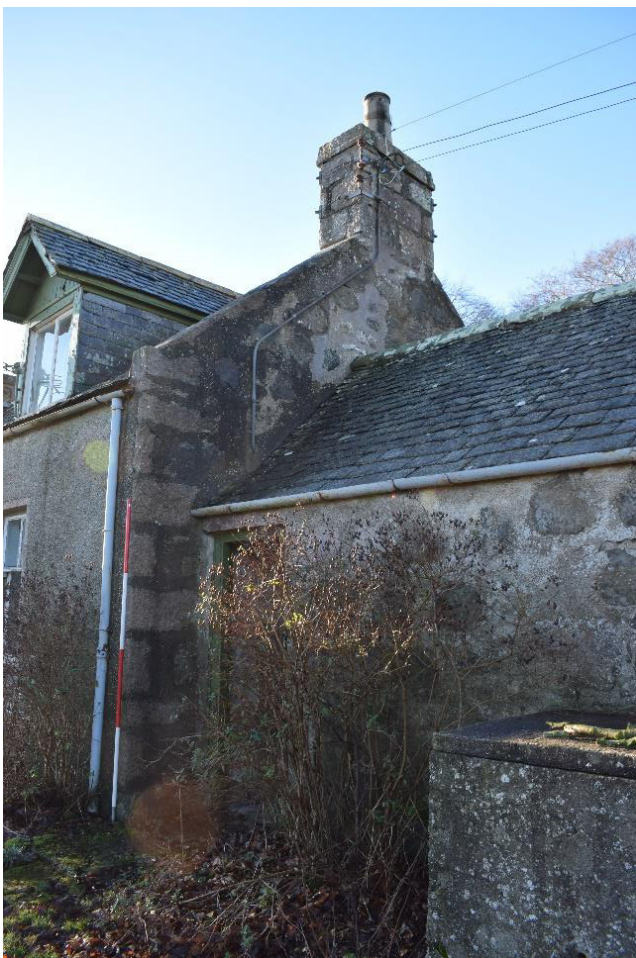
Illus 15 Junction between Structure 1 NNE gable (left) and Structure 3 (right); facing SW
