**Kingsmills, Elgin, IV30 5QG  
Report on archaeological watching brief**

**Alison Cameron  
Cameron Archaeology  
23 May 2017**

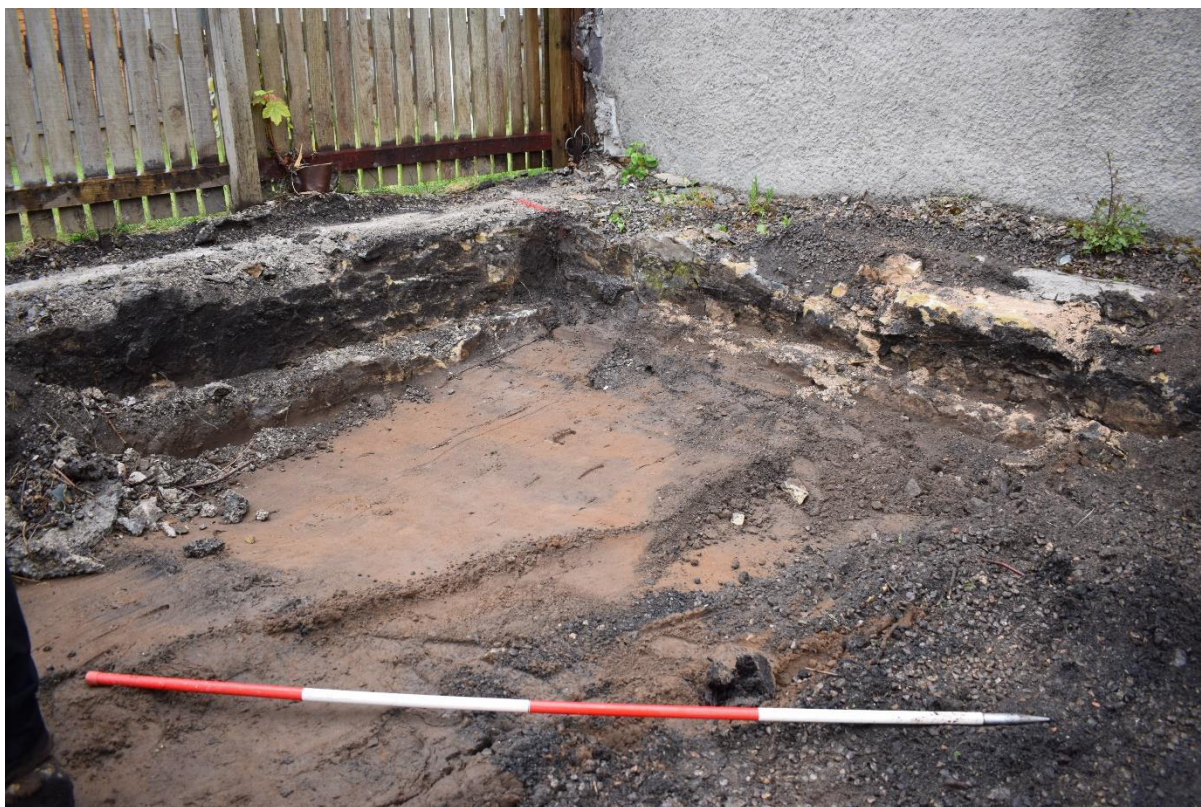
Cover: wall F1 and foundation F2; facing NE

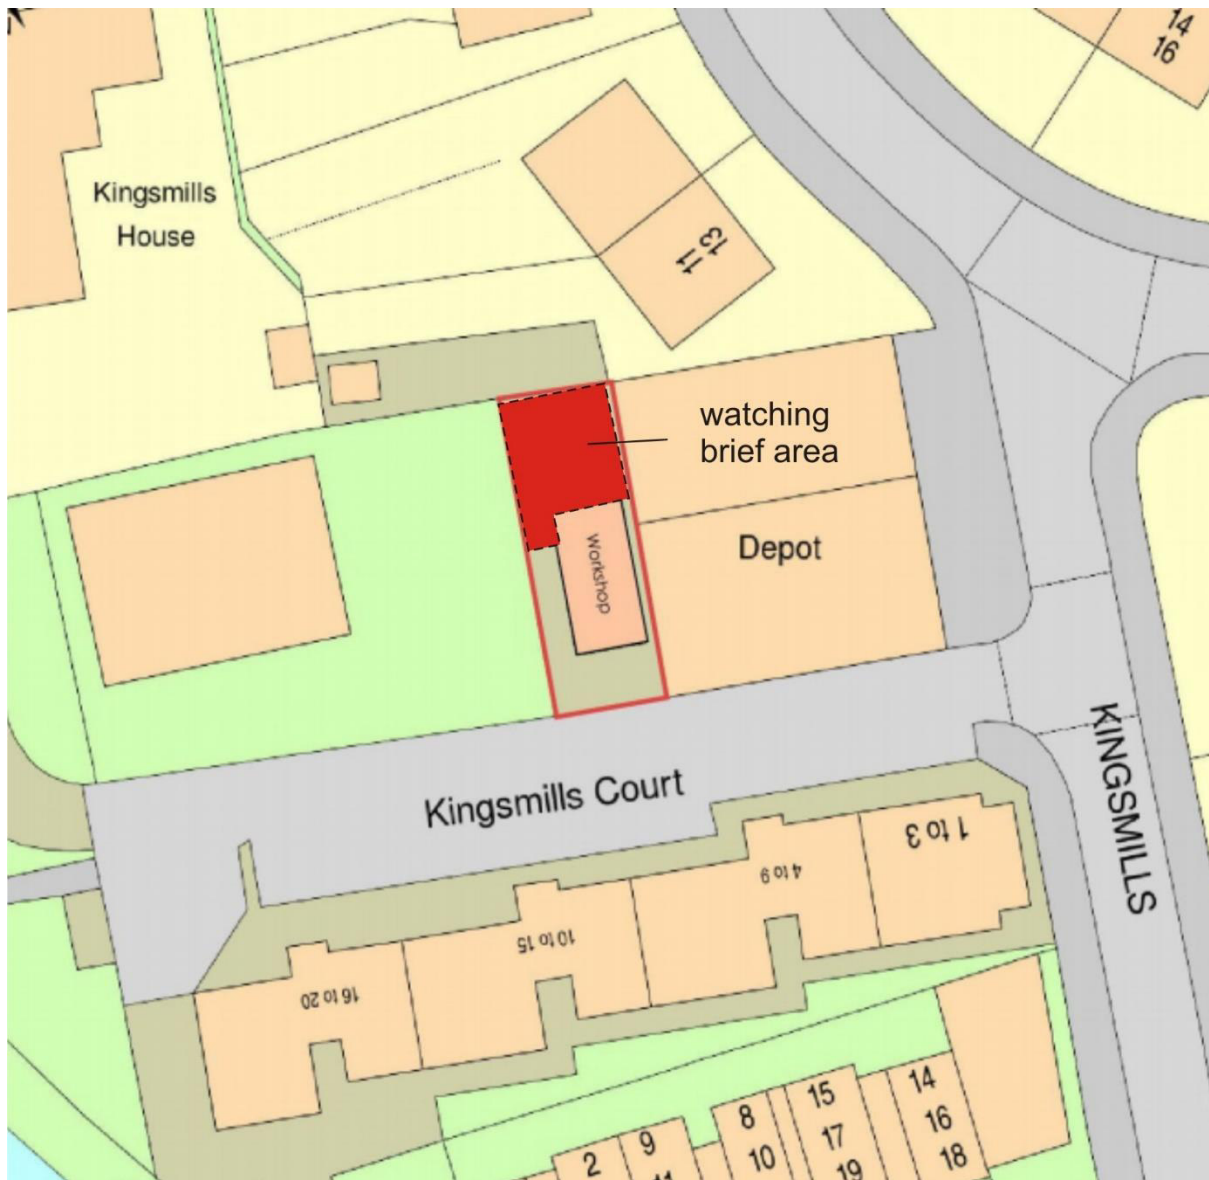
Illus 2 Plan showing location of watching brief (*copyright Glenarch Design*)

A watching brief was carried out on 20 May 2017 during the soil strip for this development (Illus 2). Three walls of a building were uncovered (Illus 3, 4). The walls were constructed of sandstone rubble, 0.5-0.5m wide, up to 0.5m deep and with a foundation 0.18m wider. 0.5m depth of clinker, wood, sanitary ware, tile, wood and rubble were removed from within building foundation F1. This is the remains of the King's Mills building seen on the Second Edition OS map (Illus 5). The subsoil was light brown sand.

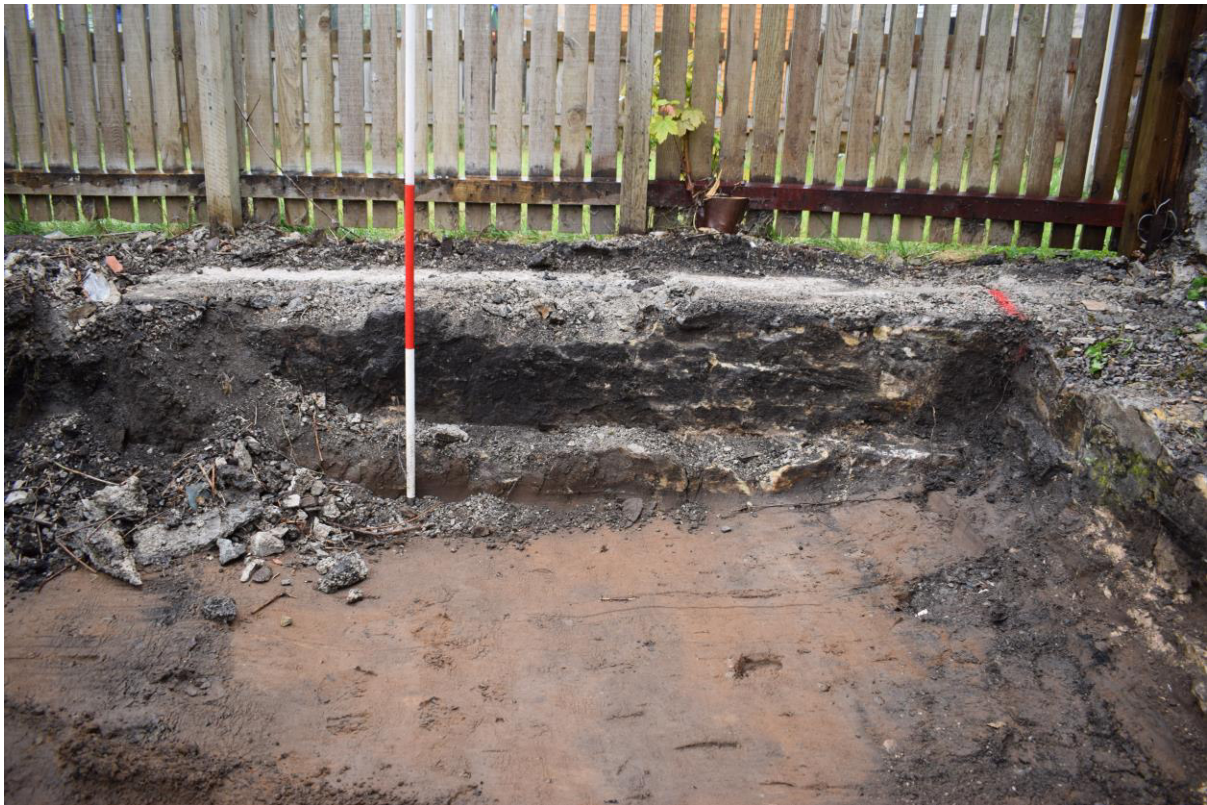
Illus 4 North wall F1 and foundation F2 showing sand natural subsoil; facing N

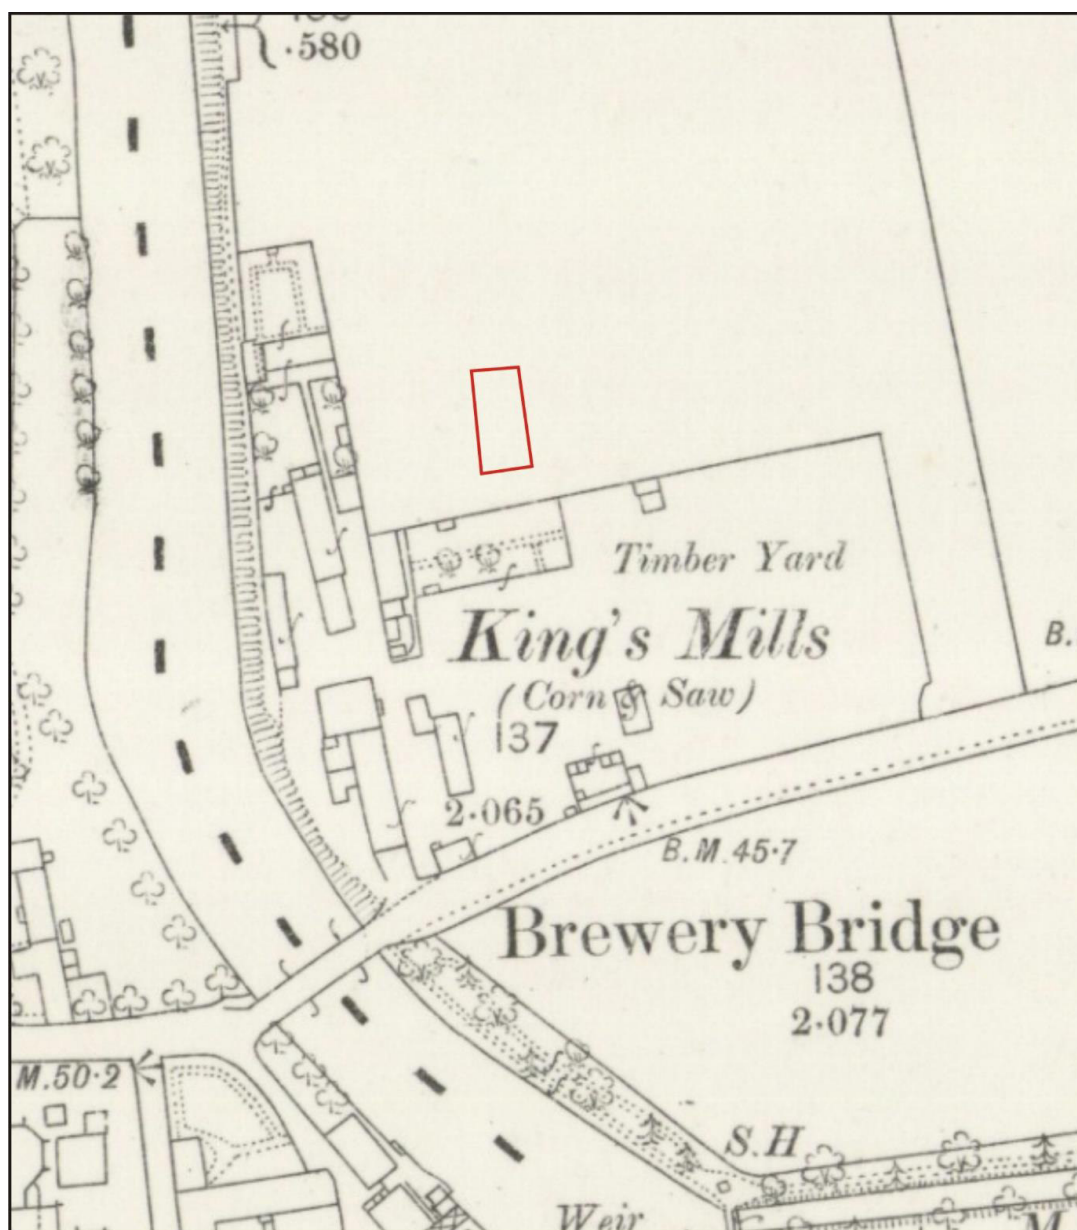
- 2.7 The site is in fields N of King's Mills by the First Edition OS map (Illus 3). The site is now surrounded by housing.

Illus 6 First Edition OS map showing site outline in red (copyright National Library of Scotland) Elgin Sheet VII.12 (Combined) Survey date: 1870 Publication date: 1873

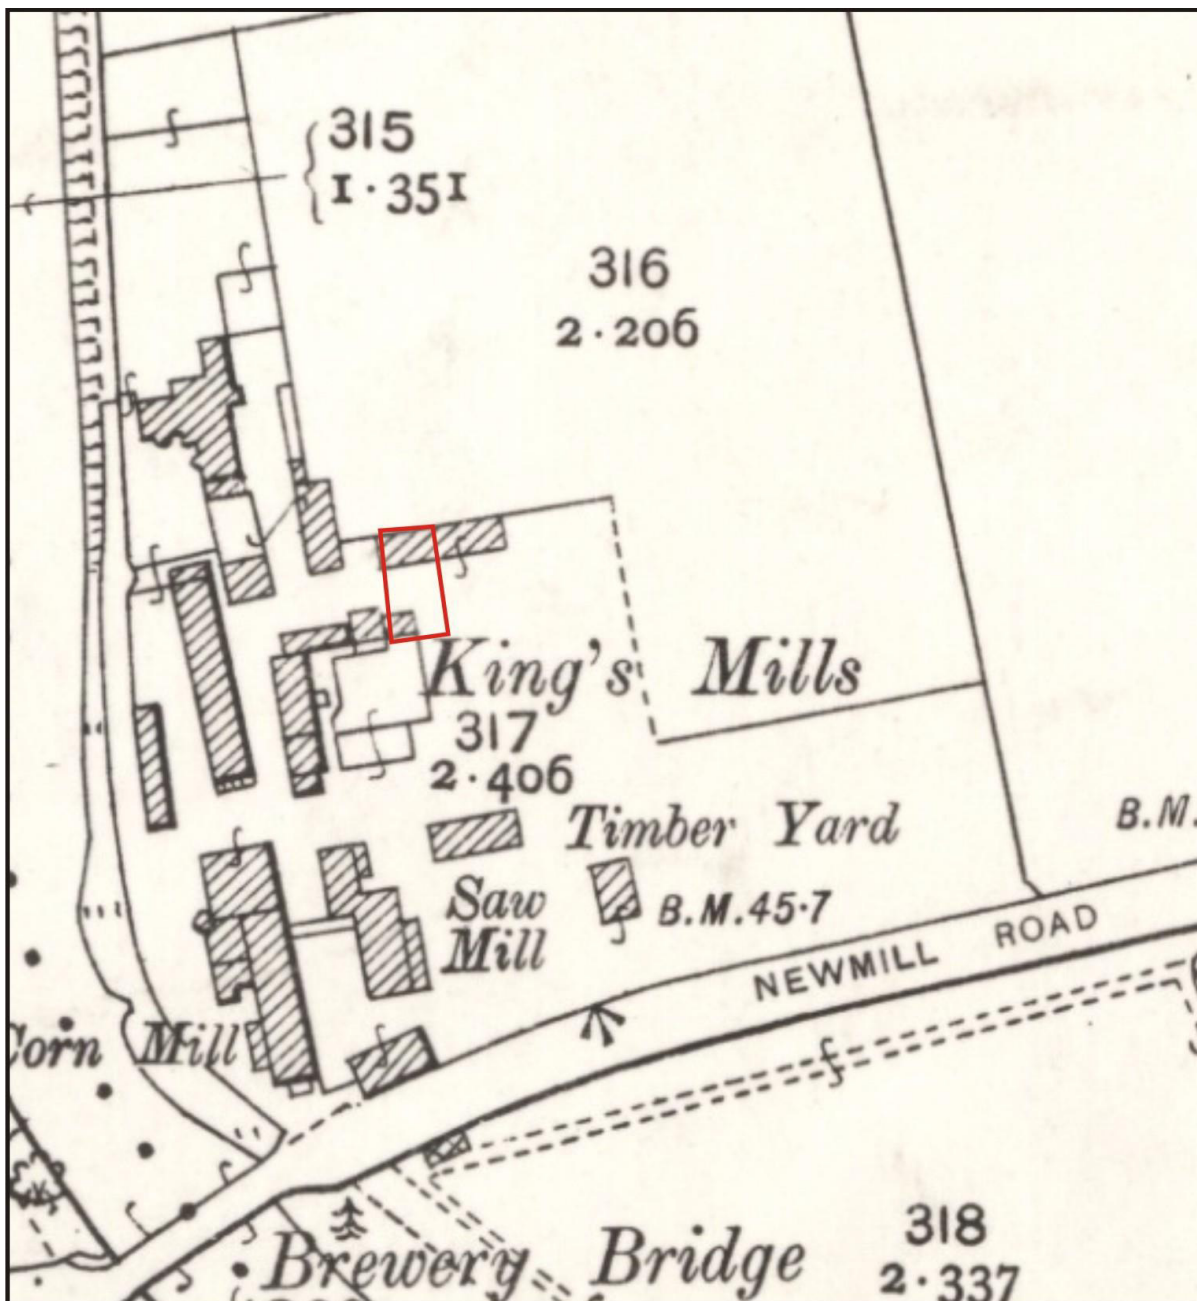
- 2.5 The site was within the grounds of the King's Mills (HER NJ26SW0189) by the Second Edition OS map (Illus 4). They are corn and saw mills which first appear on the Robert Ray's map of 1838 on which it is annotated 'steam mill' and comprises an L-plan and a rectangular building. The mills do not appear on the John Wood map of 1822 so are presumed to have been constructed after that date. The OS 1st edition map of 1846 shows a group of nine buildings with a timber yard to the east. Further expansion took place in the later 19th century with additional buildings shown on the OS 2nd edition map. By the late 1960s the timber yard had been infilled with buildings, and the main Kings Mill building had been converted to a public house and a number of structures added in its east side. Other buildings have been demolished or converted, but by the mid 1980s most of the structures built in the 1960s east of the public house had been pulled down. Building recording was carried out by AOC in 2011. The present buildings on the site comprise an L-plan public house to the south with a linear wing to the north now occupied by three terraced houses which still show evidence of the former mill openings. An historic building survey was undertaken of the former mill building at Kingsmills in Elgin prior to its demolition in advance of works associated with the Flood Alleviation Scheme in the city. The former mill was constructed in the mid 19th century and was converted into a pub. The area to the north was then later converted into three two-storey tenements houses (Nos 28, 30 and 32 Newmills Road). A detailed photographic and written record of the buildings was undertaken together with a plan and section through the building and an exterior elevation survey of the main elevations, which revealed a number of former openings and features associated with its original use as a mill (AOC 2013).

Illus 7 Second Edition OS map (copyright National Library of Scotland) Elginshire 007.12 (includes: Elgin; Spynie; St Andrews Lhanbryd) Publication date: 1905 Revised: 1904
