**Midmar Church, Midmar, AB51 7NA
Installation of SSE cabling
Data Structure Report**

**Alison Cameron
Cameron Archaeology Ltd
15 September 2017**

A watching brief was maintained on 11-13 September 2017 during the excavation of trenches by SSE for a new electricity supply. Trenches were excavated from the existing electric pole to the church. No archaeological features or finds were recorded and the trench has now been backfilled.

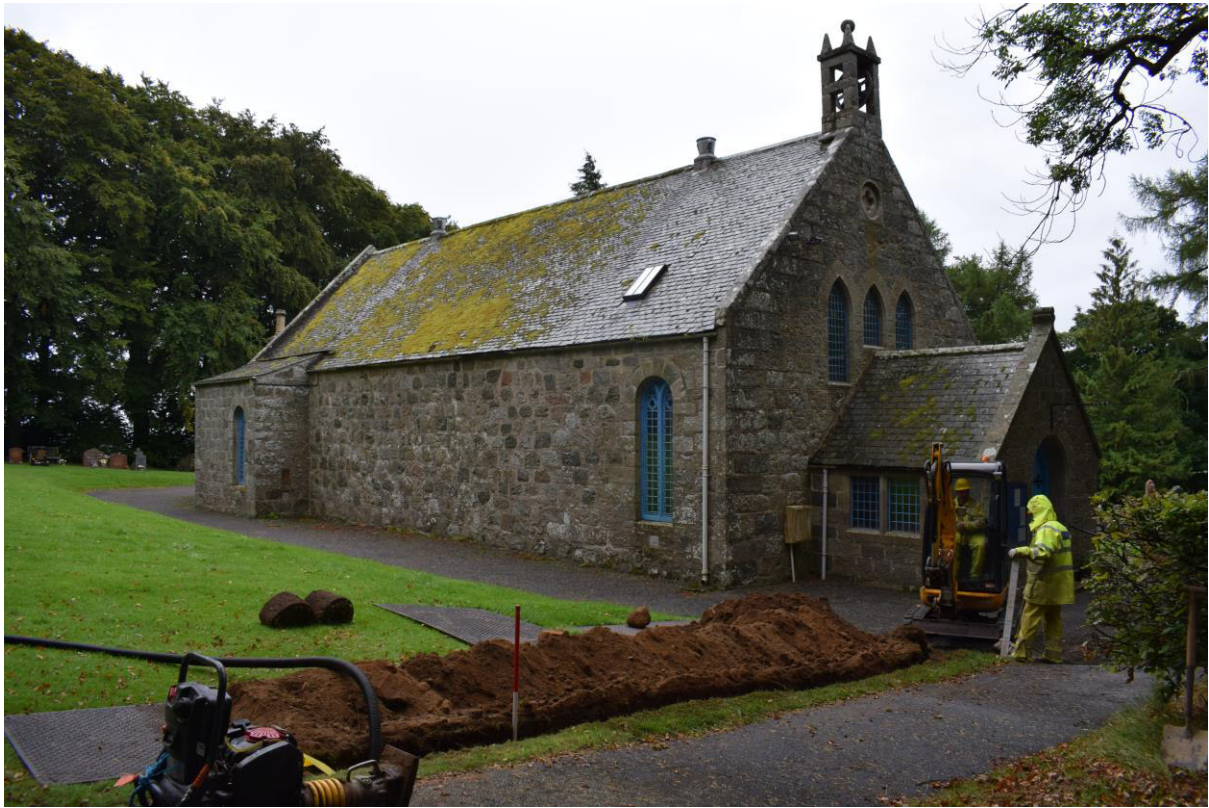
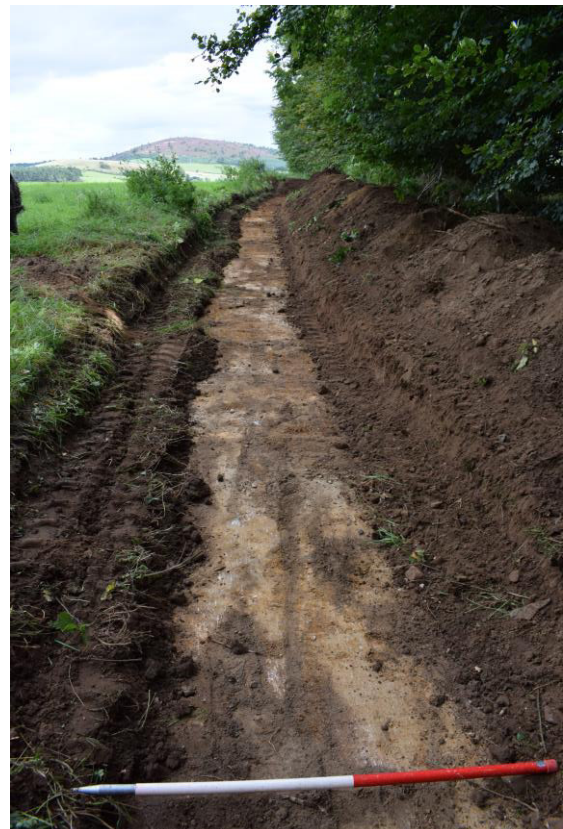
Cover (top) Trench 3 with Midmar Church and stone circle (left background); (bottom) Trench 1 in field showing plough marks in natural subsoil; facing E

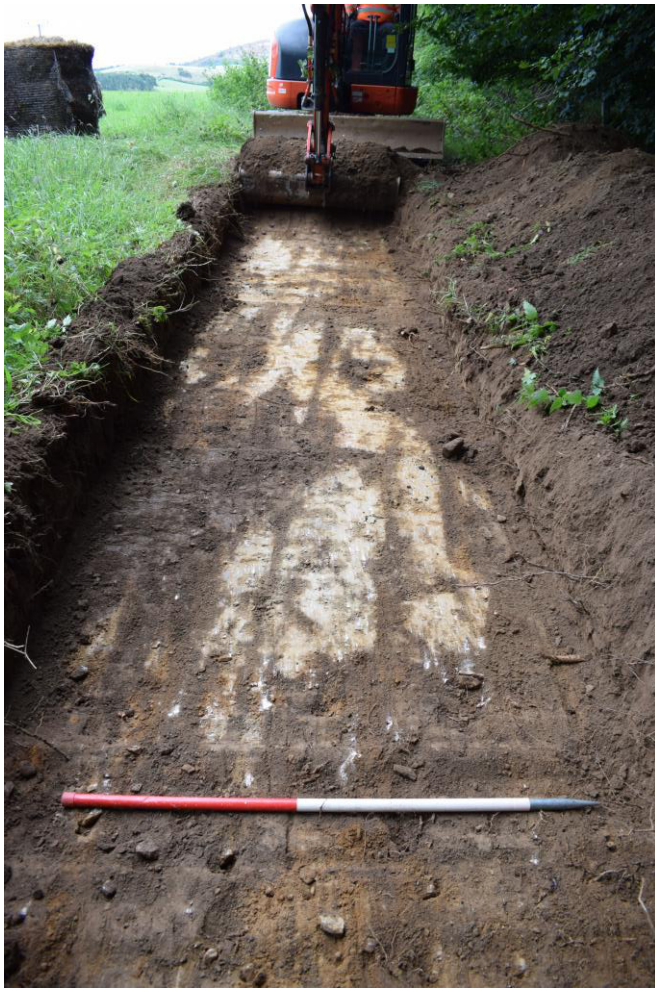
Trench 1 was 1.5m wide and excavated to the level of the subsoil. The plough soil was 0.2m deep and the subsoil was contact sand and gravels. There were plough scores in the natural subsoil (Illus 3).

Illus 3 Trench 1 showing compact sand natural subsoil with plough marks; facing E

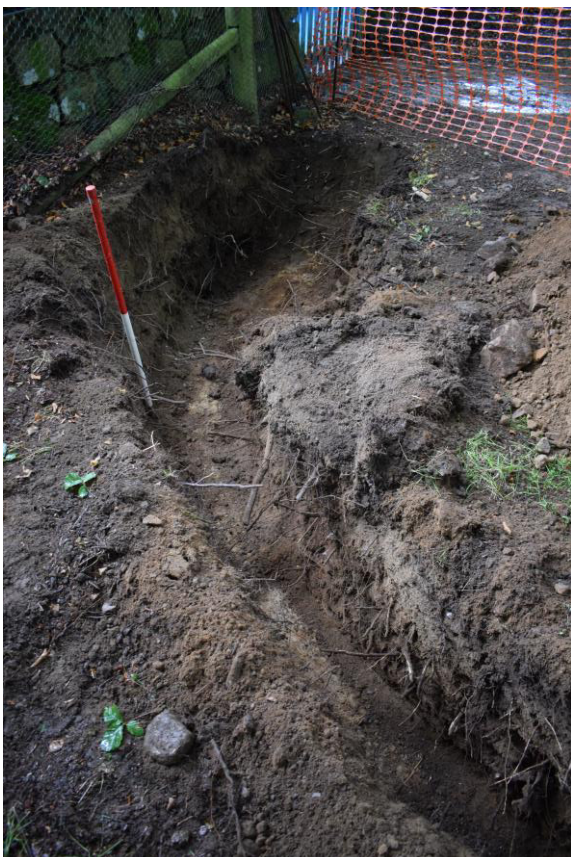
Trench 2 was dug within the mature trees on the N side of the graveyard. The subsoil was loose light brown sand and the topsoil was 0.1m deep. It was light, dry, rooty loam.

Illus 4 Trench 2 showing shallow, dry, rooty topsoil; facing SW

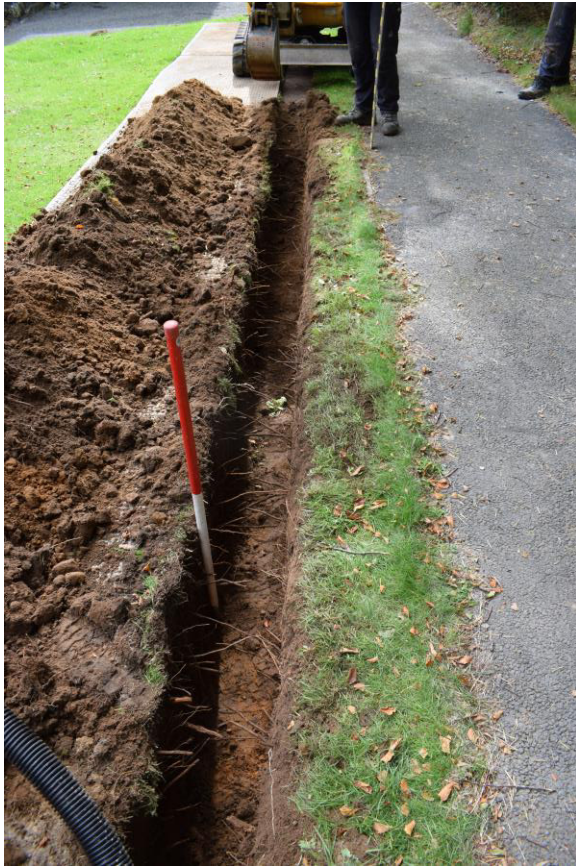
Trench 3 was dug on the E side of the path (under which the existing electric supply runs). The N end of this trench had 0.2m topsoil in top of compact sand natural; the S end of the trench had 0.5m topsoil on top of sand subsoil. The section between the lawn and the church had been excavated previously and consisted of made up layers of soil and gravel.

Illus 5 Trench 3 showing sandy natural subsoil; the existing electric supply is under the path (right); facing S
