**Site Adjacent to Rathen West Church, Rathen,
Fraserburgh, AB43 8UL
Data Structure Report**

**Alison Cameron
Cameron Archaeology Ltd
20 September 2017**

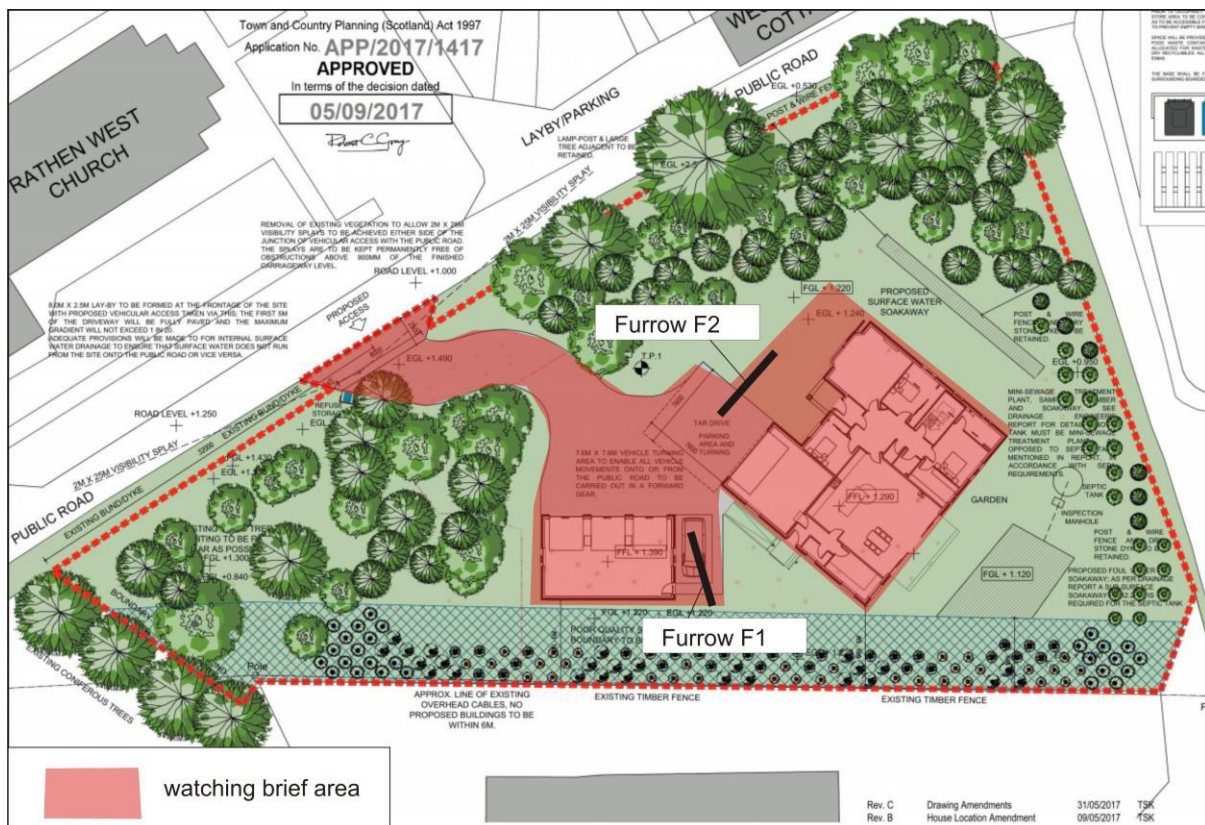
Illus 2 Site plan showing area of watching brief and furrows F1 and F2 (copyright Claymore Homes)

The remains of two shallow furrows (F1 and F2, Illus 2) were identified, one NNW-SSE and one SW-NE. No other archaeological finds or features were identified and it is therefore recommended that no further archaeological work is required during the current planning application.

Feature no	Description
F1	NNW-SSE furrow 1m wide, 0.1m deep, filled with light brown sandy loam
F2	NE-SW furrow 1.2m wide, 0.1m deep, filled with light brown sandy loam

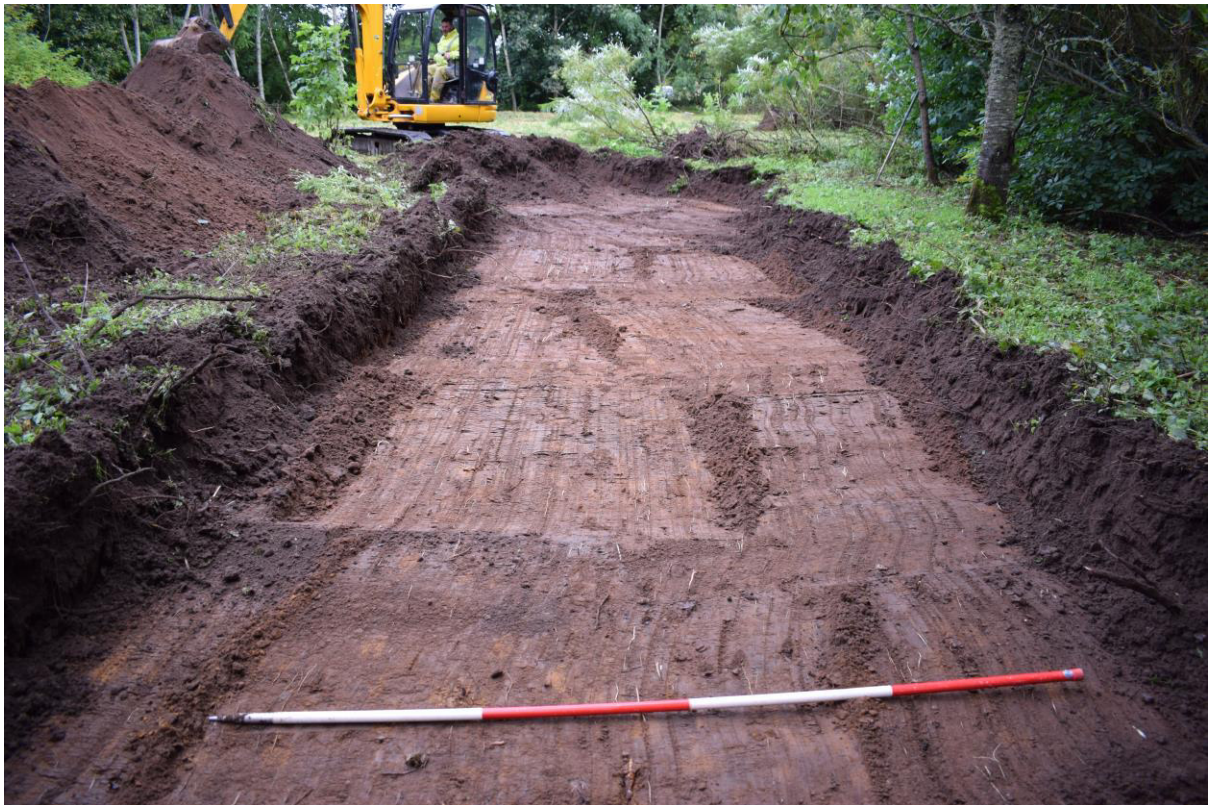
Illus 3 Soil strip of proposed garage area; facing NE

The client used a 5 ton tracked machine with ditching bucket to clear areas of the site to natural subsoil. This included the full extent of the proposed garage, house and driveway including removing the drystone dyke adjacent to the road on the N of the property, the new access (Illus 2-4). The topsoil was up to 0.7m deep and the subsoil was rusty brown sand and gravel.
