# Little Cairnie Hospital, Forfar Road, Arbroath, DD11 3RA Report on Level 1 Standing Building Survey

**Alison Cameron  
Cameron Archaeology  
24 January 2018**

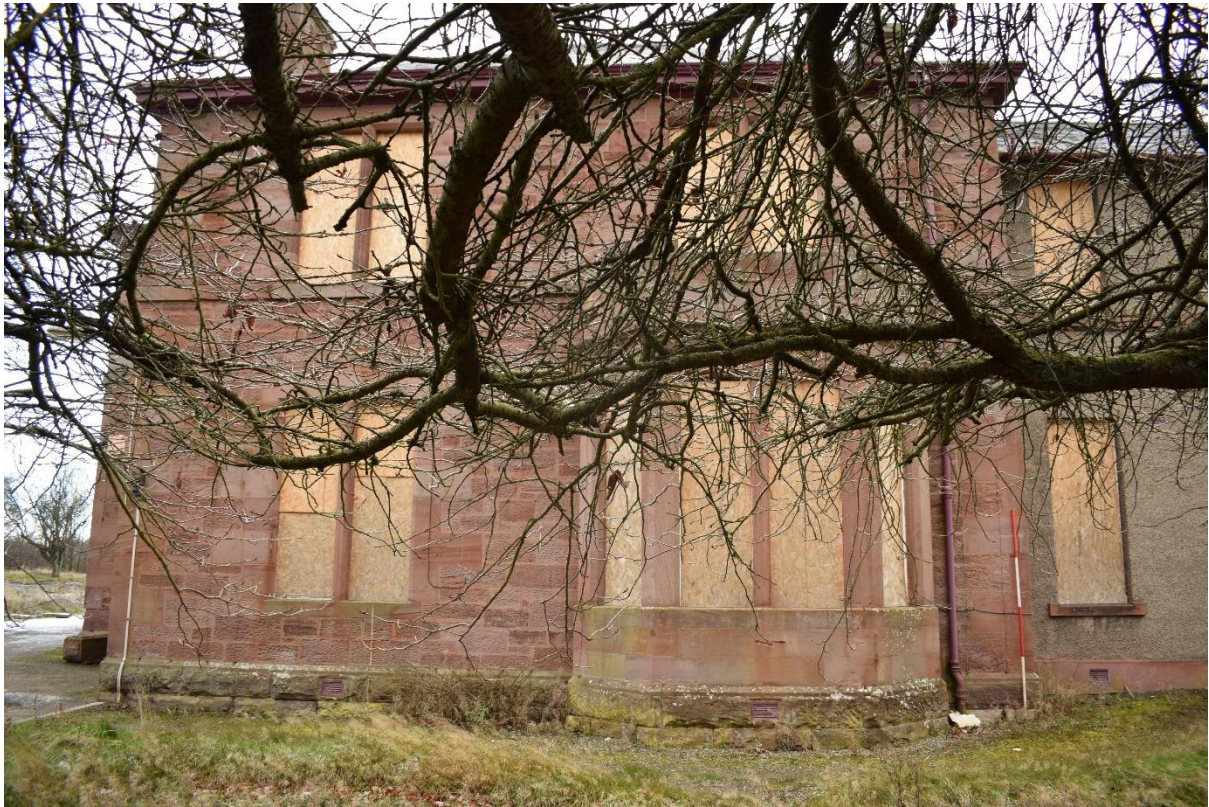
Illus 8 Phase 1 SW façade with bay window W24 (centre); facing NW

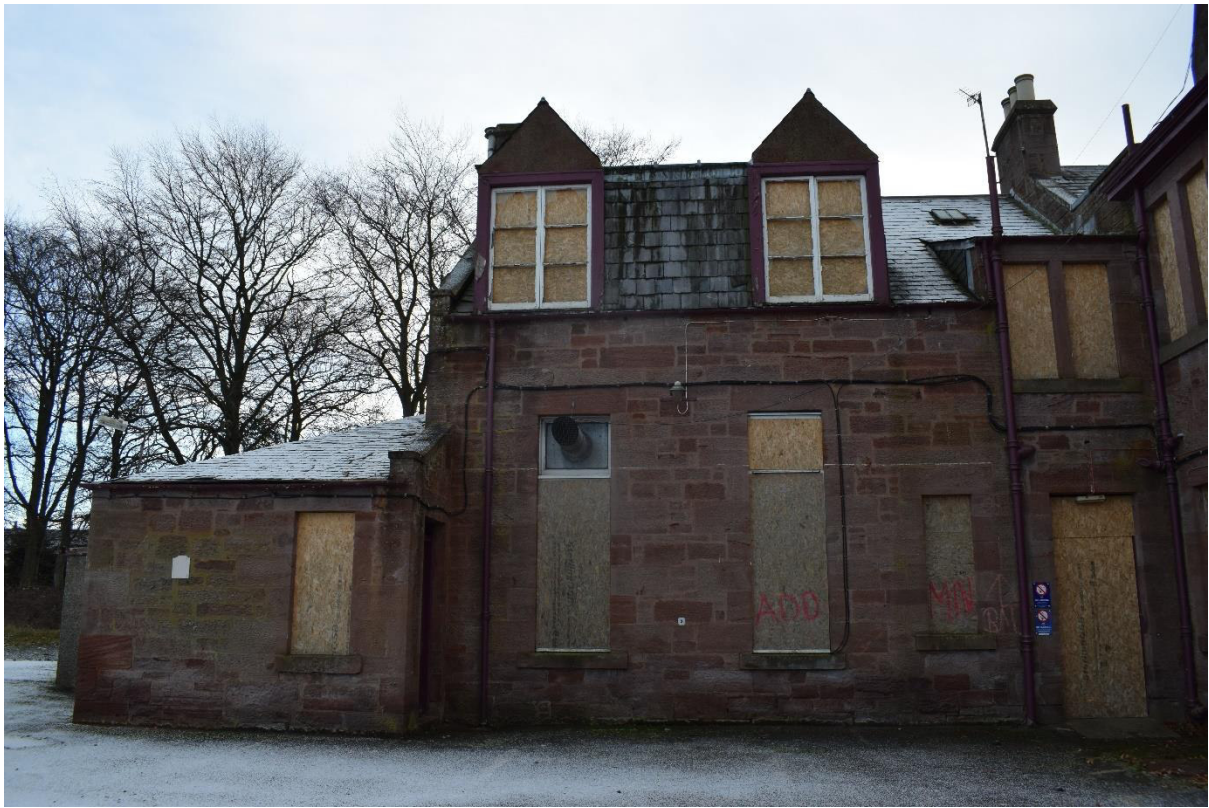
In Phase 2 a rectangular addition was added to the NE wall (Rooms 51, 52 and 55; Illus 9, 15) also constructed of sandstone and then a large rectangular block was added to the SE wall (ground floor Rooms 5-16 and first floor rooms 33-44); it was constructed of brick with concrete lintels and sill and is harled throughout (Illus 15, 16). This was probably added in the mid 20<sup>th</sup> century. Small additions on the NE end include Rooms 53 and 54 and a switch room (no access); these are all harled and added in the mid-late 20<sup>th</sup> century (Illus 15). There are concrete bases (F10 and F11; Illus 2) for buildings which have been demolished.

Illus 9 Phase 1 NE wing; the lintels and sills and stonework are identical to the main building and so considered built in one phase; facing SE

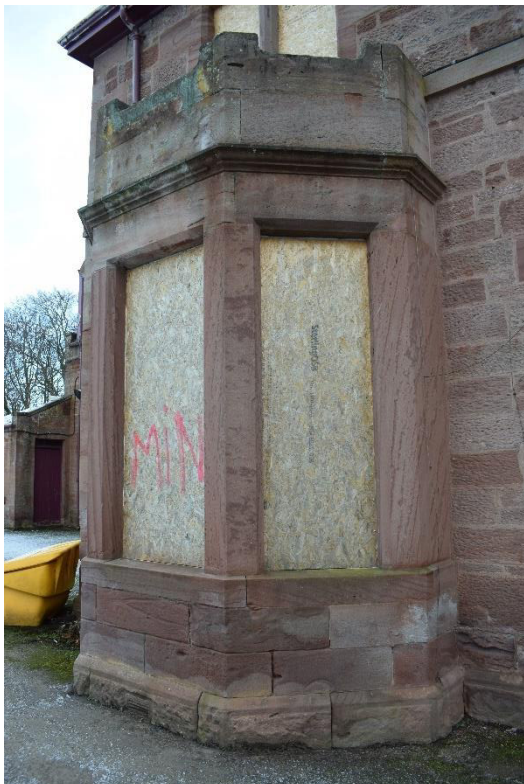
Illus 10 Bay window W10 showing sandstone block construction, rusticated sandstone base course and crenellated top; facing E

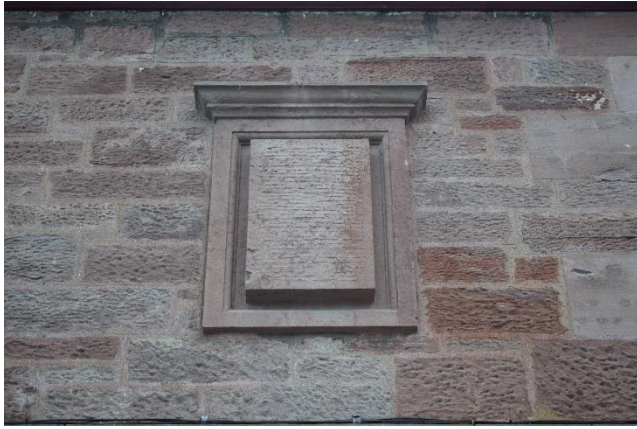
There is a sandstone housing for a plaque on the exterior of the first floor NW wall adjacent to window W8 (F8; Illus 11).

Illus 11 Housing for plaque, F8; facing SE

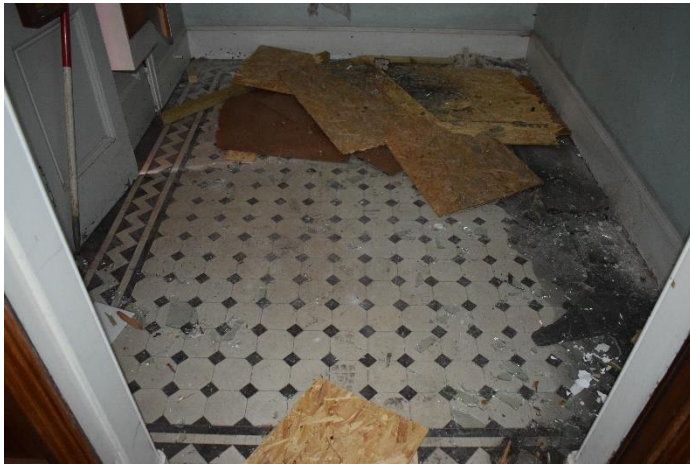
Illus 12 Room 1 tiles floor; facing NW

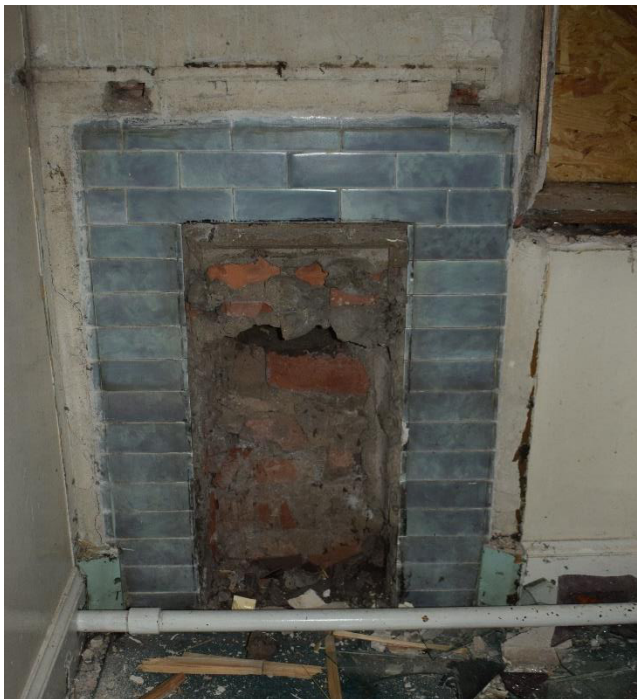
Illus 13 Room 26 Fireplace F14; facing NW

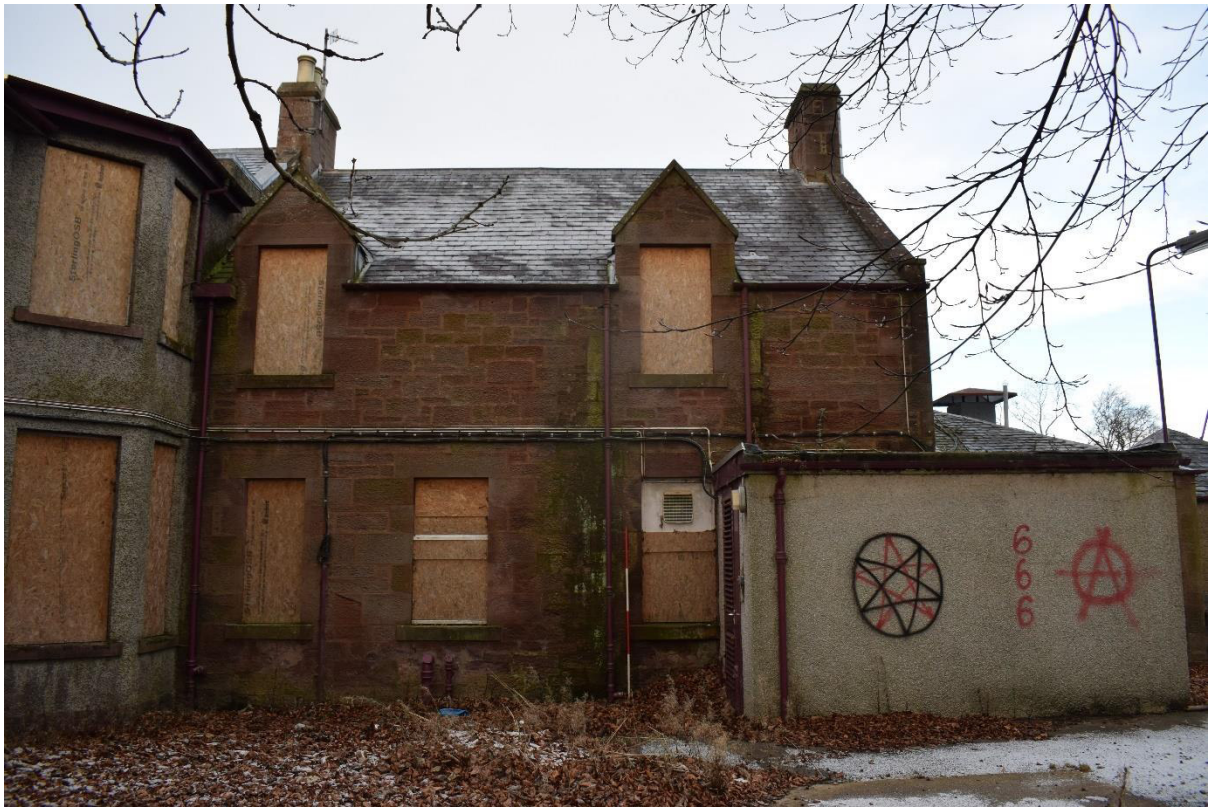
Illus 14 Phase 1 NE wing (centre) with Phase 3 SW extension (left) and Phase 4 switch room (right); facing NW

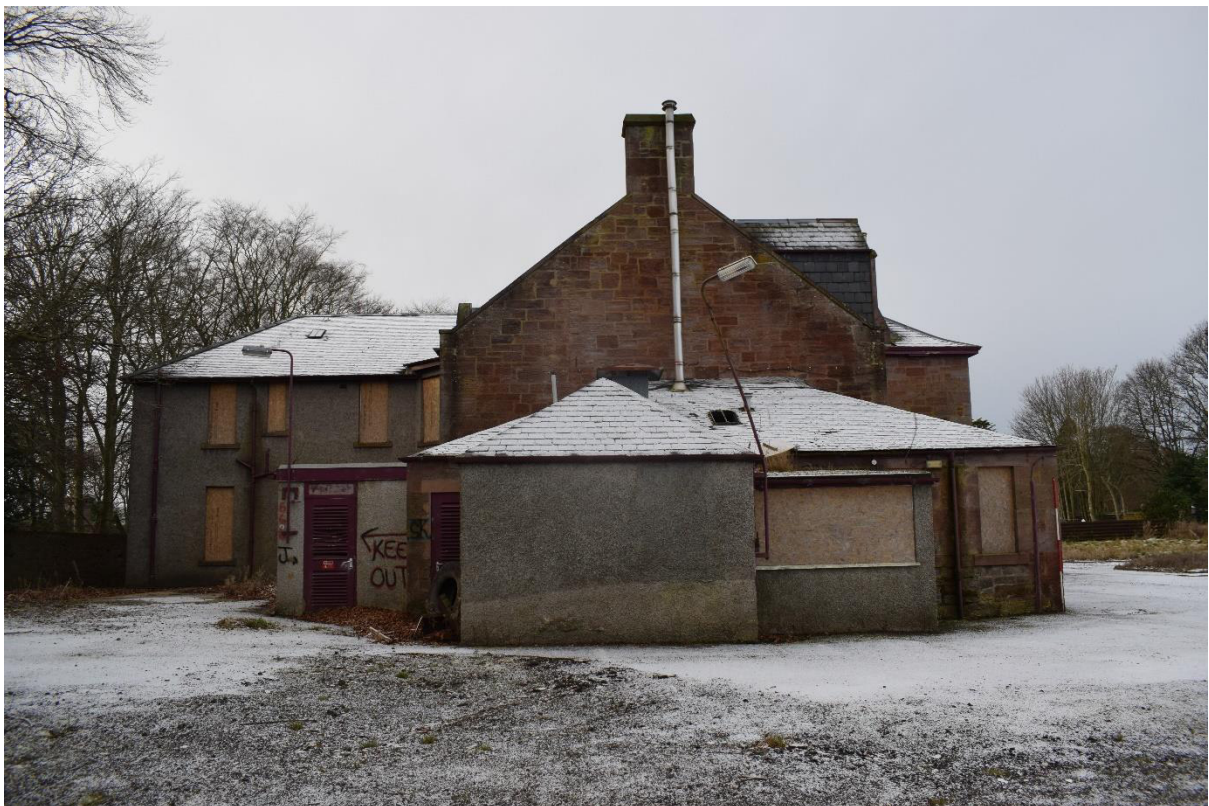
Illus 15 Phase 1 gable (centre), Phase 2 sandstone extension (right), Phase 3 SE extension (left), Phase 4 lean-to extensions (foreground); facing SW

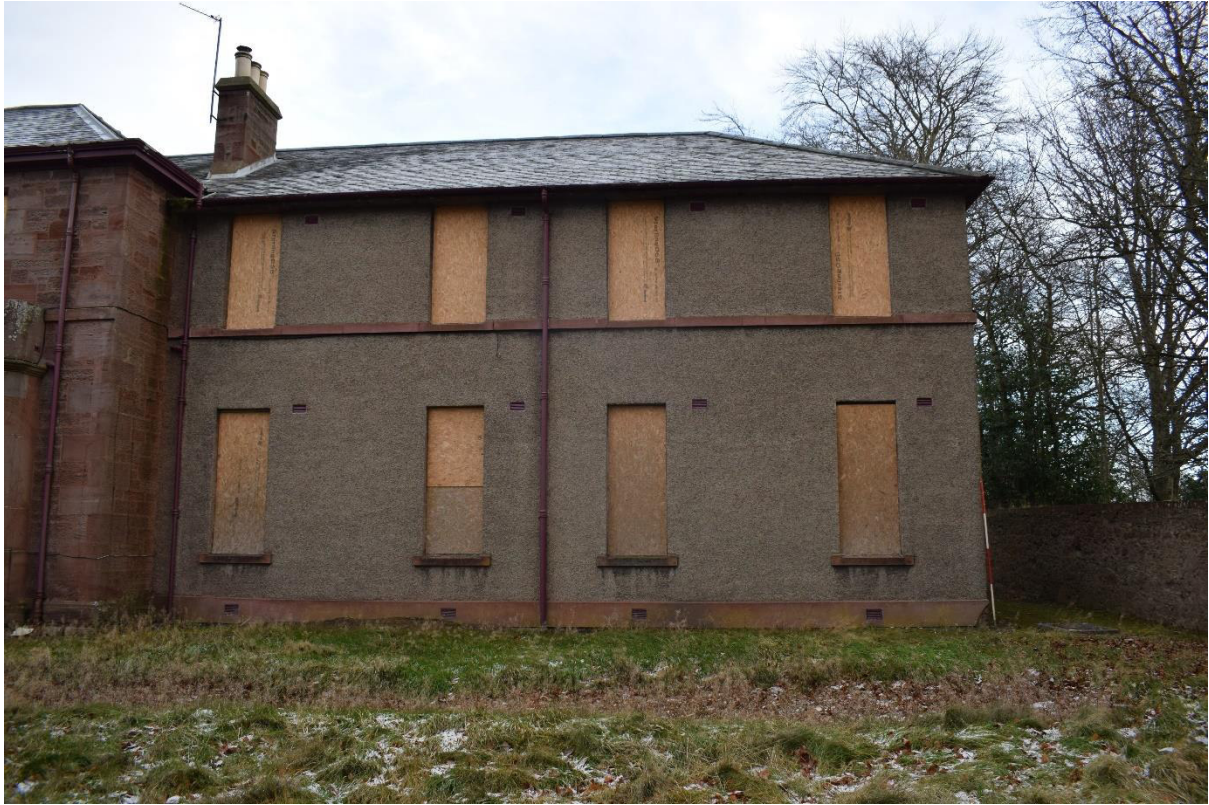
Illus 16 Phase 3 SE wing SW wall; facing NE

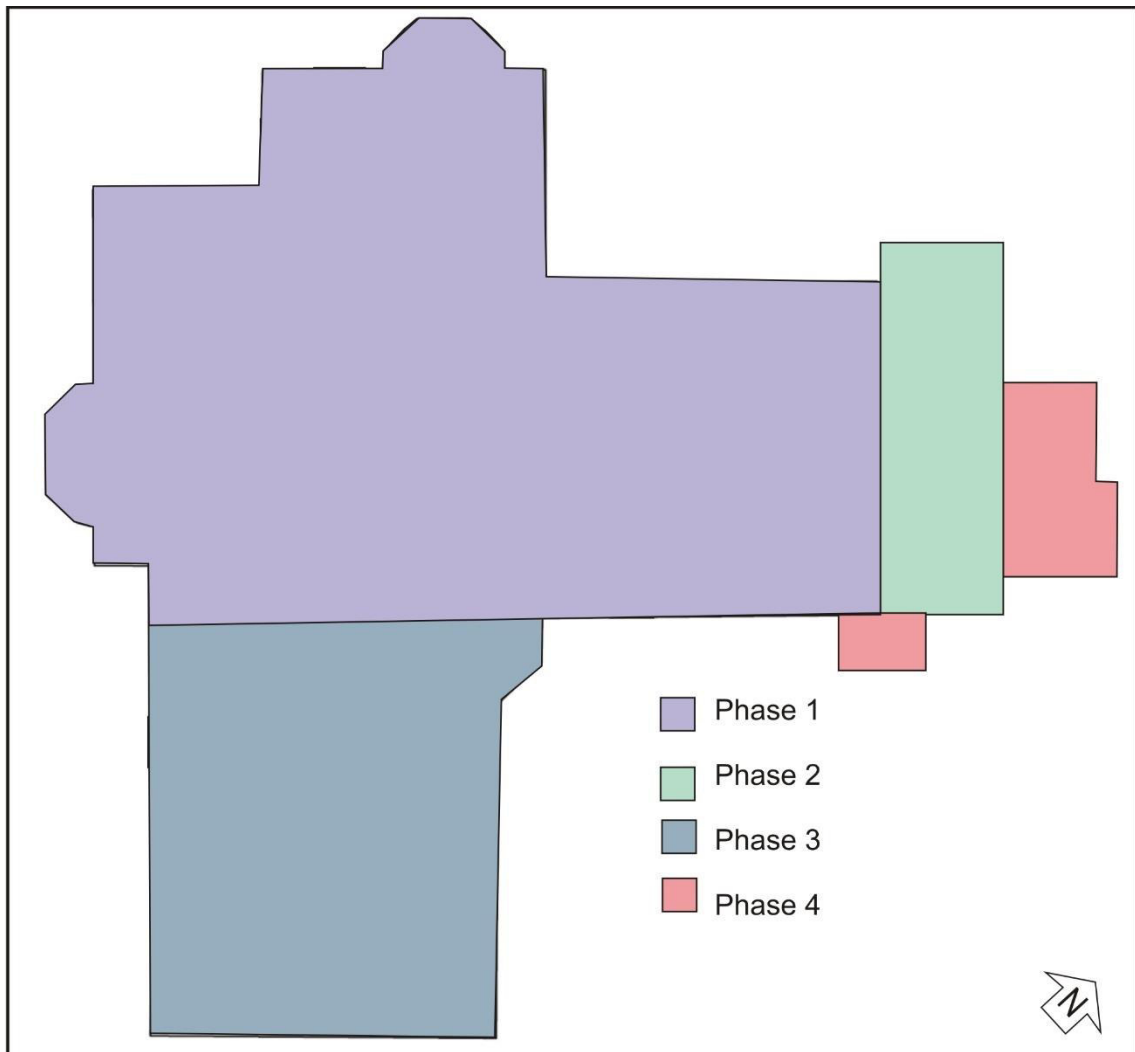
A Level 1 standing building survey was carried out on 17 January 2018. The hospital building was constructed around 1901 and at least four phases of development were recorded during this survey (Illus 17). It is recommended that no further archaeological work is required during this planning application.

Illus 17 Phase plan (from copyright Fouin + Bell)
