**MARISCHAL SQUARE, ABERDEEN, AB10 1AR**  
**Report On Archaeological Watching Brief For Trial Pits,**  
**Trenches And Pavement Works**

**Alison Cameron and  
Dr Robert Lenfert  
Cameron Archaeology  
3 March 2018**

This report details an archaeological watching brief which took place between 2014 and 2018 (Illus 2) during the test pits, trenches and pavement works on a parcel of land previously occupied by Aberdeen City Council headquarters, St Nicholas House, demolished 2013-4 and by CHAP adjacent to Provost Skene's House. A mixed use development including office, hotel, retail, restaurant, leisure, civic space including car parking, access, landscaping, infrastructure and public realm improvements, Aberdeen City Council Planning application number P140698 is now complete. The site is at NJ 94198 06385 (centred), in the parish of Aberdeen and at 20-25m OD. It is bounded on the NE side by Broad Street and Marischal College, on the NW by Upperkirkgate, on the SE by Queen Street and on the SW by Flourmill Lane.

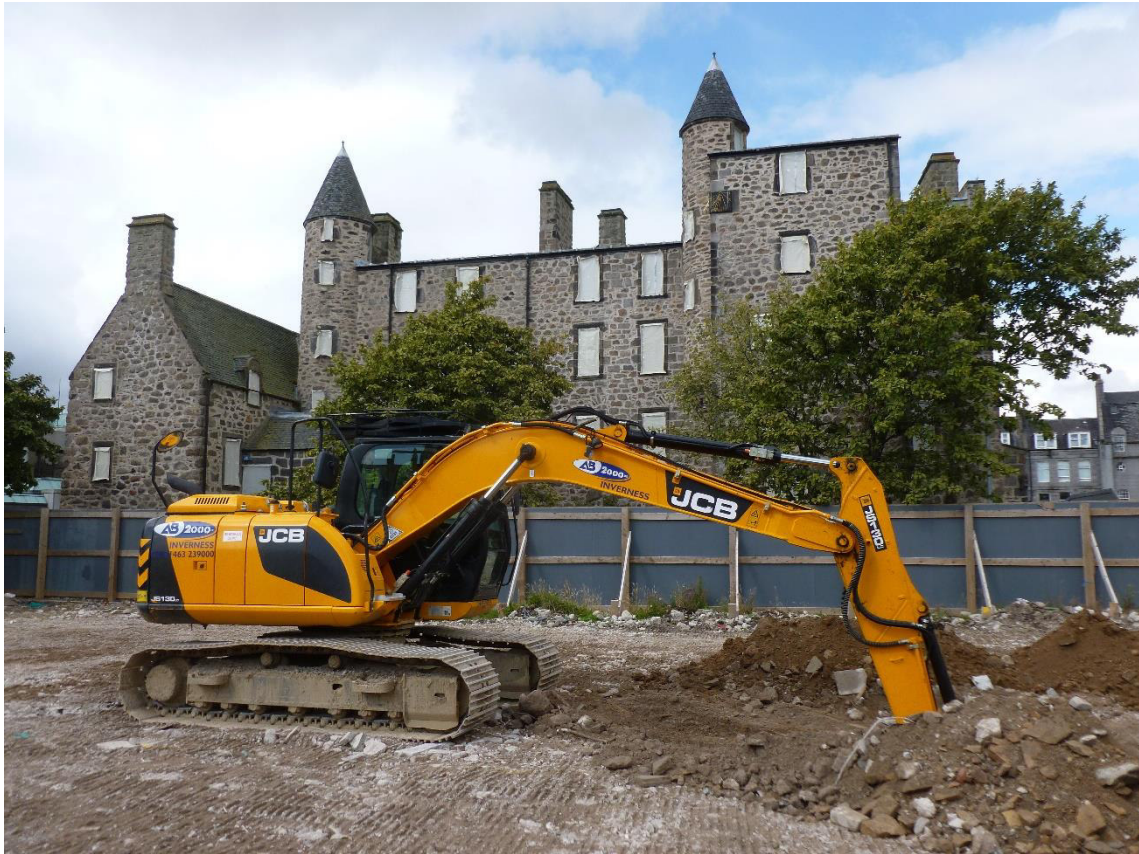
Cover Top TP08 location with Provost Skene's House in background; facing W; bottom TP04 with Marischal College in background; facing N

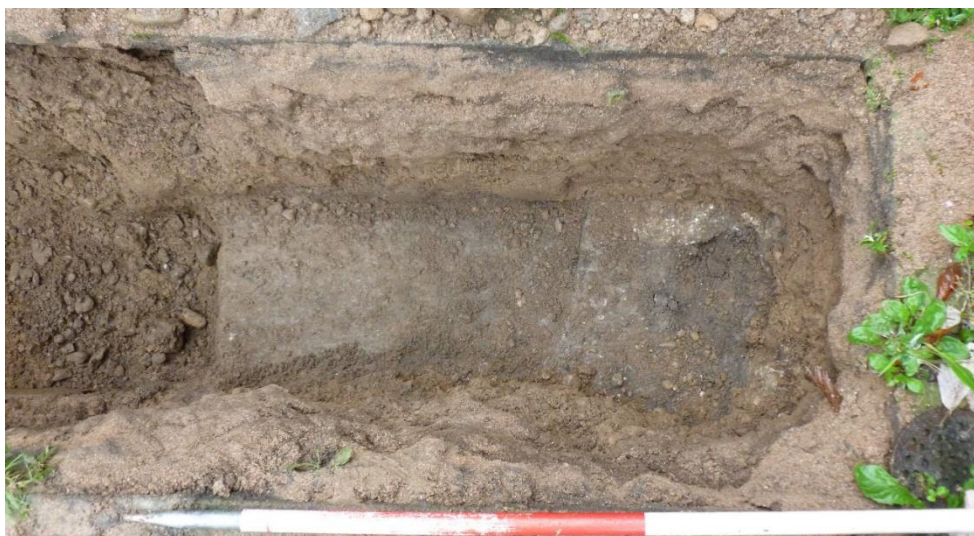
Illus 3 Trench 20 wall foundation F1 (centre) and stone slab F2 (left); facing

Trench 20 was hand-excavated by CHAP on 15 September 2014 to examine the foundation of Provost Skene's House and the associated services. Trench 20 was located adjacent to the NE gable and contained a wall foundation (F1) at the SW end of the trench and a stone slab surface (F2) associated with the wall (Illus 3, 4) were 0.7m below the current ground surface. Slab F2 was at least 0.2m thick. It was abandoned and reopened 18 June 2015 using a small tracked machine. It was completed on 14 September 2015 when Trench 22 was also opened.

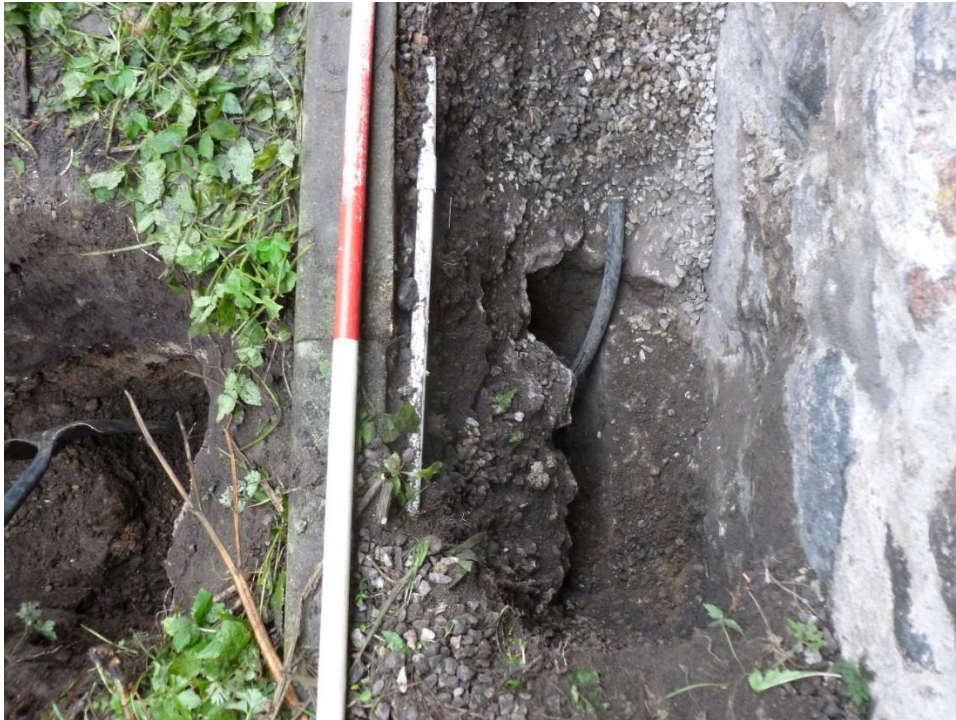
Illus 4 Trench 21 NE wall of Provost Skene's House (right), foundation F3 (centre right) with telephone cable and concrete foundation and kerbing under ranging rod; facing NE

Trench 21 was hand-excavated 15 September 2014 and was located against the NW wall of Provost Skene's House to locate services. The foundation of Provost Skene's House was uncovered. It was 0.3m-0.4m wide and the top of the foundation is 0.6m below the current ground surface (Illus 3, 5). The base of the foundation was below the level of the excavation.

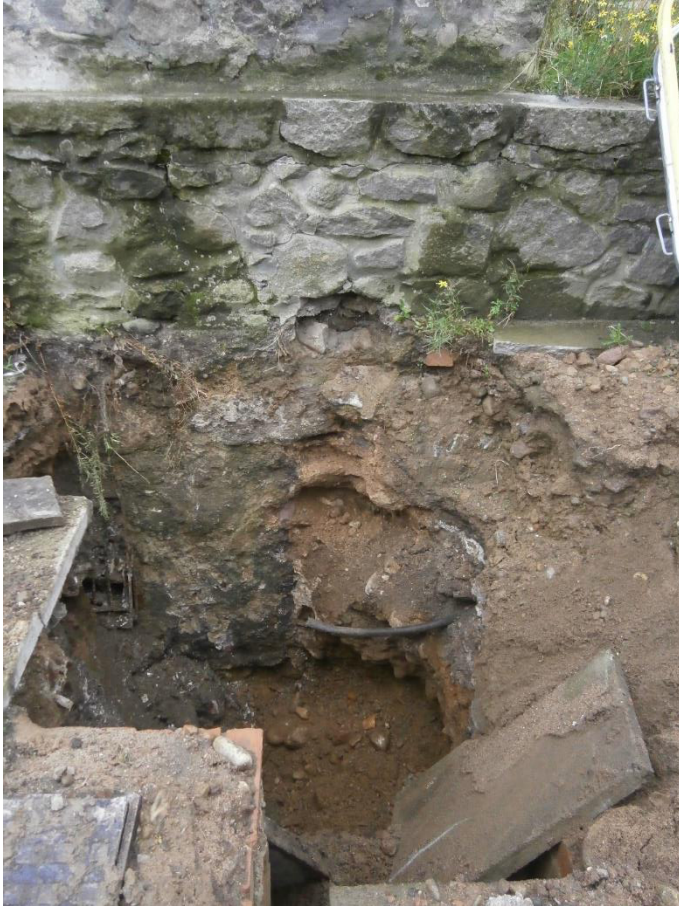
Trenches 20 and 22 were dug down to the base of wall F5 (Illus 2, 5) which is the current NE end wall of Provost Skene's House. It is a total of 2.80m deep and has large stones in base on top of rusty brown sand and stone natural subsoil.

At 90 degrees to wall F5 (Illus 5) is wall F4 which is a continuation of the NW wall of Provost Skene's House (Illus 3, 4). It formed a corner with F5 and is probably the corner of a basement which had been located under the NE wing of Provost Skene's House. It is not known when this was demolished but demolition material including stone, mortar, sand and soil filled the former basement.

Illus 5 TP20 showing wall F5 with natural subsoil below and wall scar F5 (centre) which has been removed by machine; facing SW

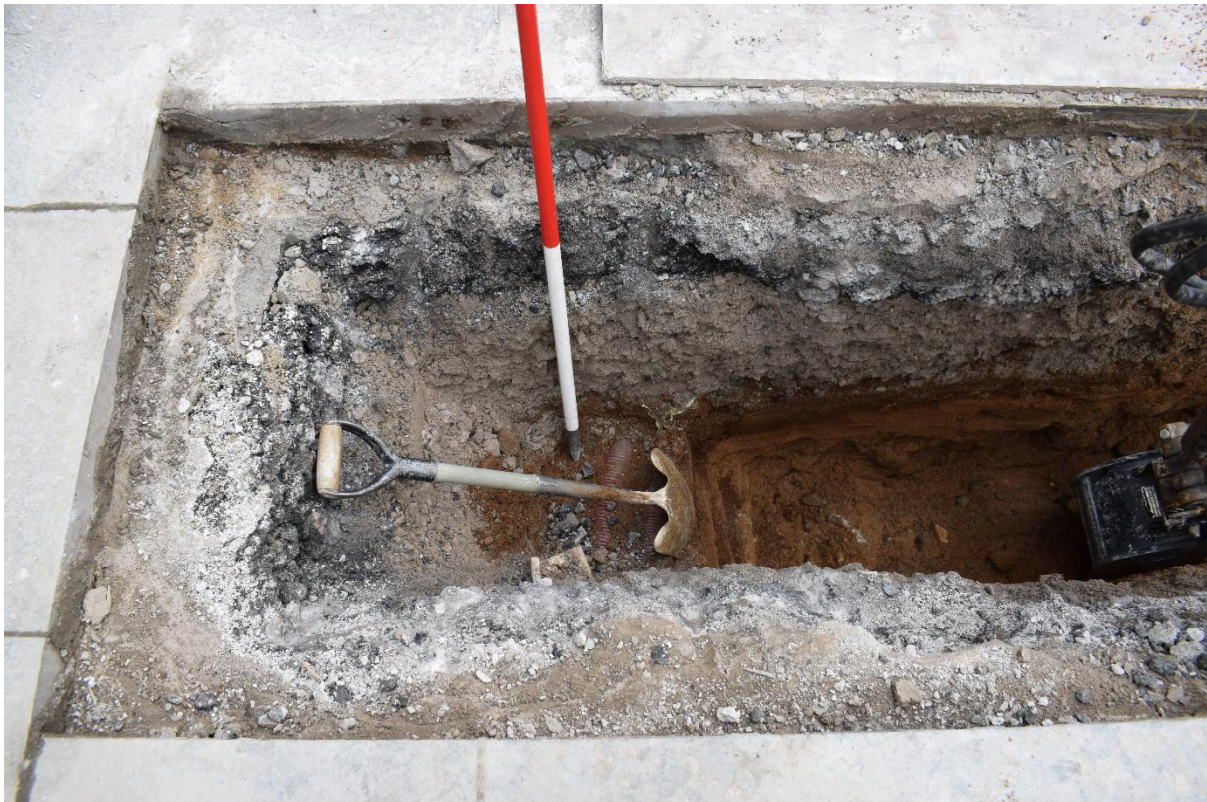
A watching brief was carried out from 3-6 October 2016 during the excavation of an exploratory trench in Broad Street (Illus 8, 9). The trench was dug with mini digger and ditching bucket to 1.2m deep, 1m wide and 13.5m long. At the NE end of the trench the natural subsoil was recorded at 0.75m below the current street level; above that is a sterile gravel backfill which was infilled in 2009-10 when the current paving was installed. The SW end of the trench was deeper and a wall F1 was probably the wall of a 19<sup>th</sup>-century tenement. It was 0.3m deep and dug into the natural subsoil at the NE side. The area to the SW of F1 (Illus 8) was filled with mortar, brick and was probably an infilled cellar.

Illus 9 NE end of trench showing natural pebble and sand natural at 0.75m deep and cabling (left)

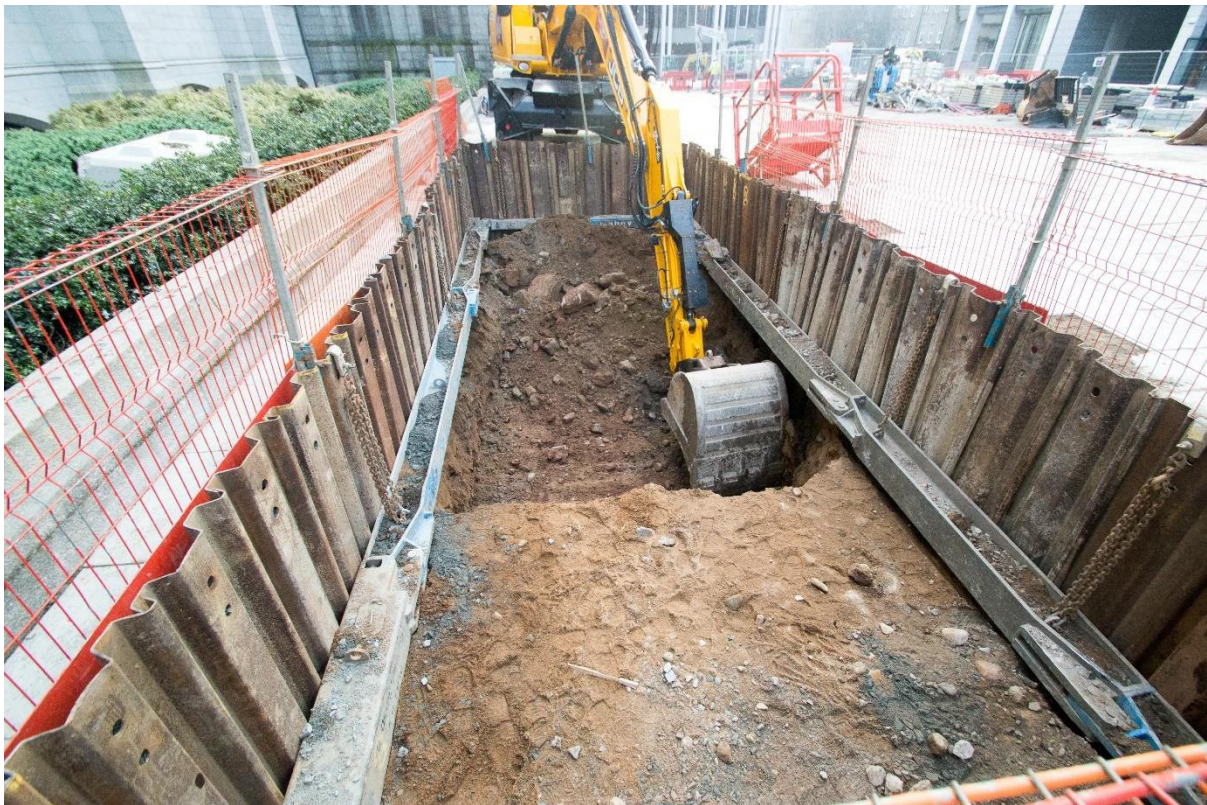
From February 21st-23rd, 2018, a rectangular sump measuring approximately 10m in length by 3.45m in width and 4.3m in depth was excavated near the current Robert the Bruce statue on Broad Street as part of a water feature installation (Illus 6). Although the upper fills contained dressed stone from historic demolition of the 19<sup>th</sup>-century buildings which lined the street, little else of archaeological significance was noted beyond two pieces of cut animal bone. These were identified approximately 1m down below the modern surface. Below this level, a reddish-brown silty clay subsoil with angular stone inclusions remained consistent to the full depth of the excavation. Although the necessary shuttering prevented a clear inspection of the trench sections, the excavation was closely monitored as it progressed down in the central areas. No other finds or features were noted.

Illus 11 Trench for fountain; Facing SE

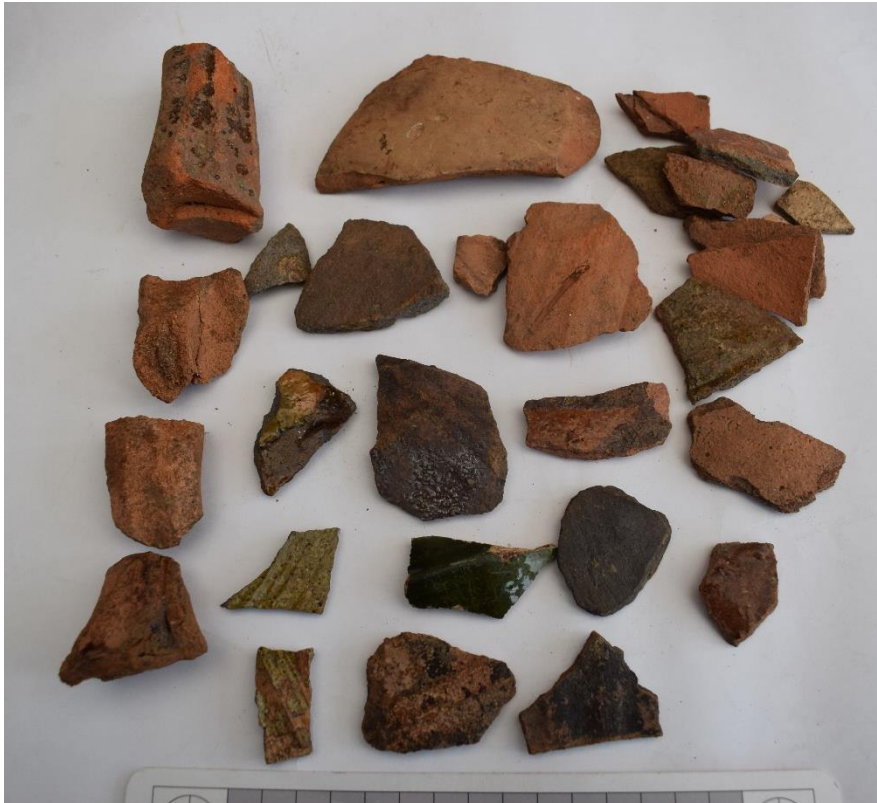
A small number of medieval pottery sherds (Illus 12) and mammal bone (Illus 13) were recovered from watching briefs in Broad Street. Midden material has been found on several excavations in areas around Broad Street and it is likely that this has been redeposited from one of these areas. The pottery is mainly of 13<sup>th</sup>-14<sup>th</sup> century type and East Coast redwares but there is a sherd of Scarborough-type ware and a number of non-local earthenwares. The bones consist of several horns including one which has been cut (Illus 14), as well as several long bones mostly split radially for the removal of marrow (Illus 15). There is a young ?sheep/goat long bone which has transverse cuts suggesting the removal of flesh or skin (Illus 16-17).

Illus 12 Medieval pottery recovered from watching briefs in Broad Street, mainly local 13<sup>th</sup>-14<sup>th</sup> century but sherds of Scarborough-type ware and other non-local earthenwares

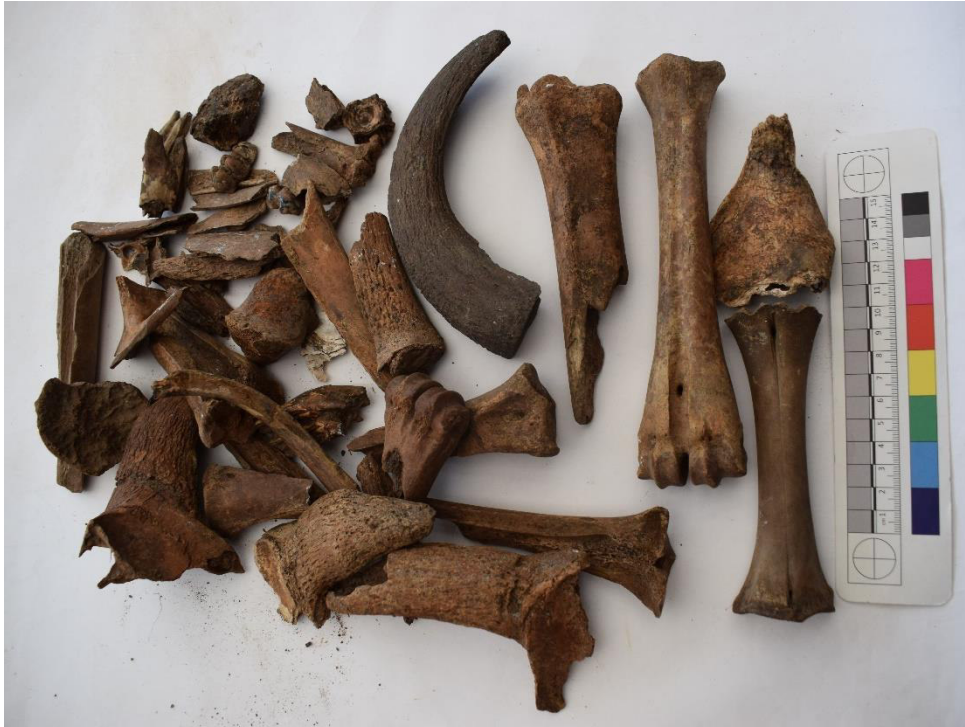
Illus 13 Mammal bone from watching briefs in Broad Street

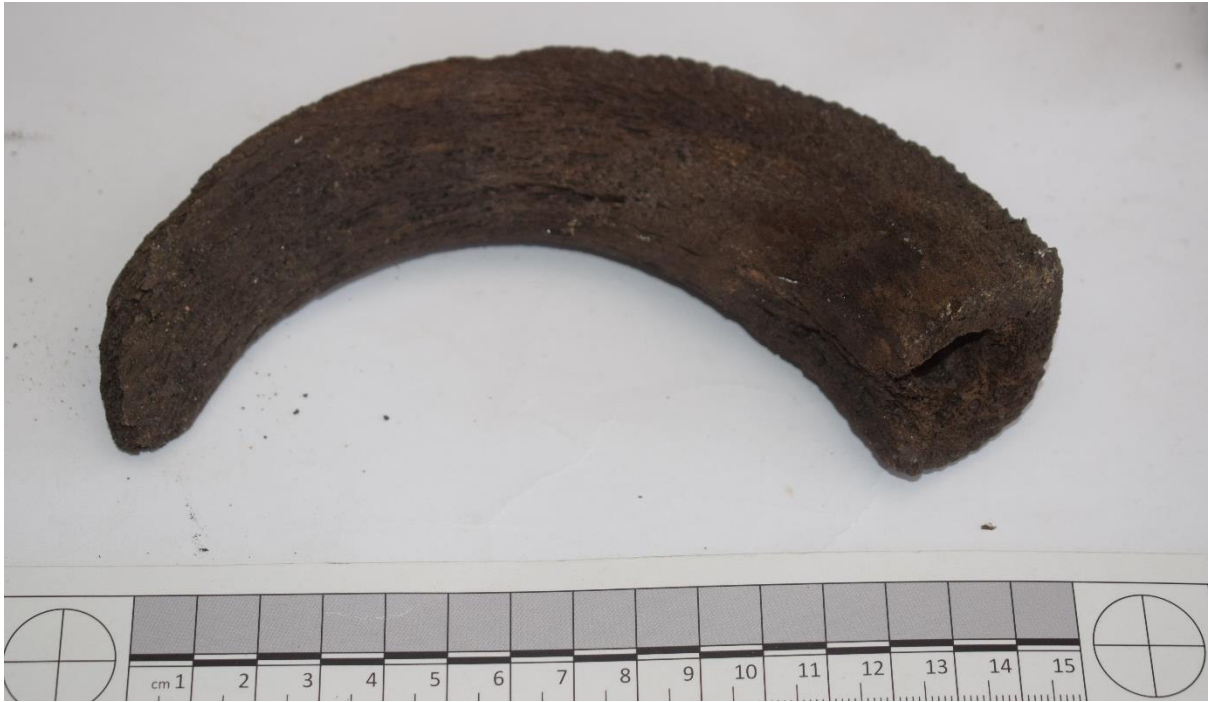
Illus 14 Cut horn

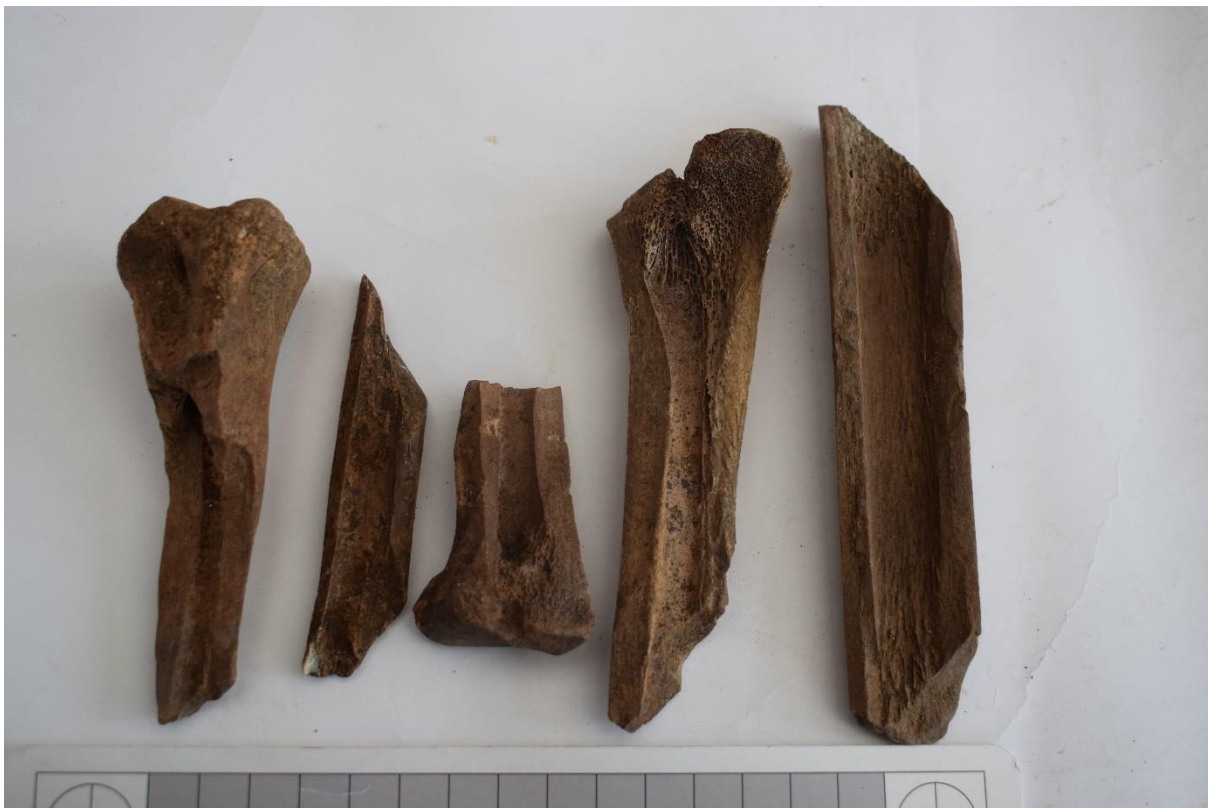
Illus 15 Long bones split radially for removal of marrow

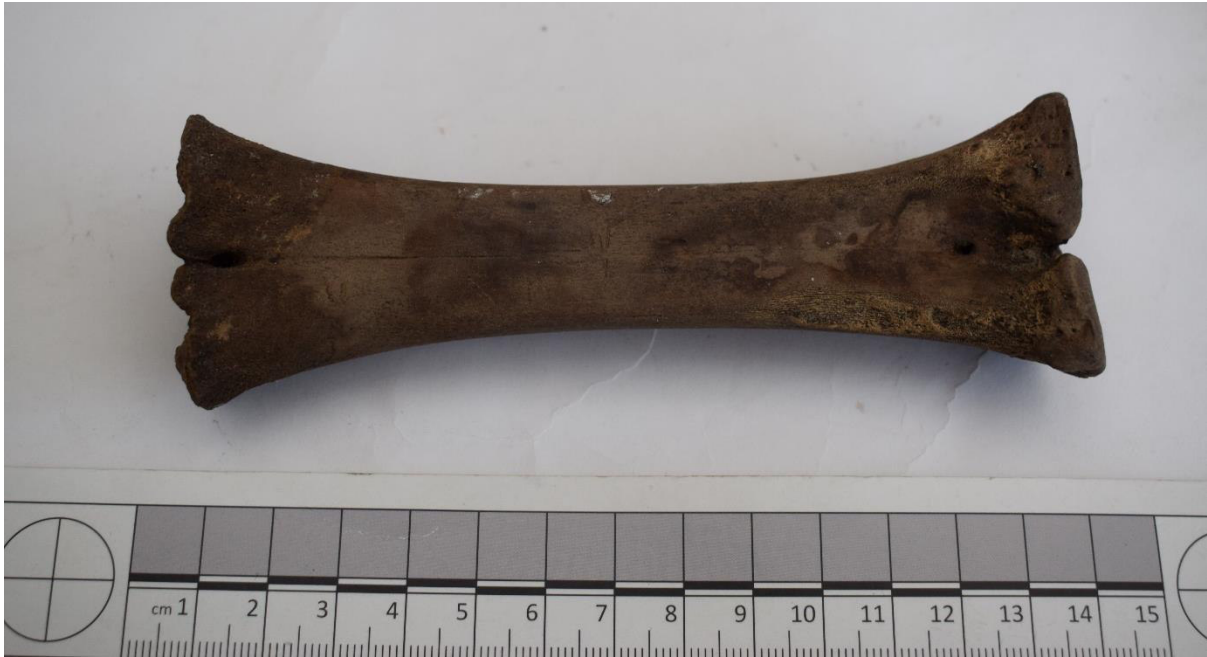
Illus 16 Young ?sheep/goat long bone with skinning cuts

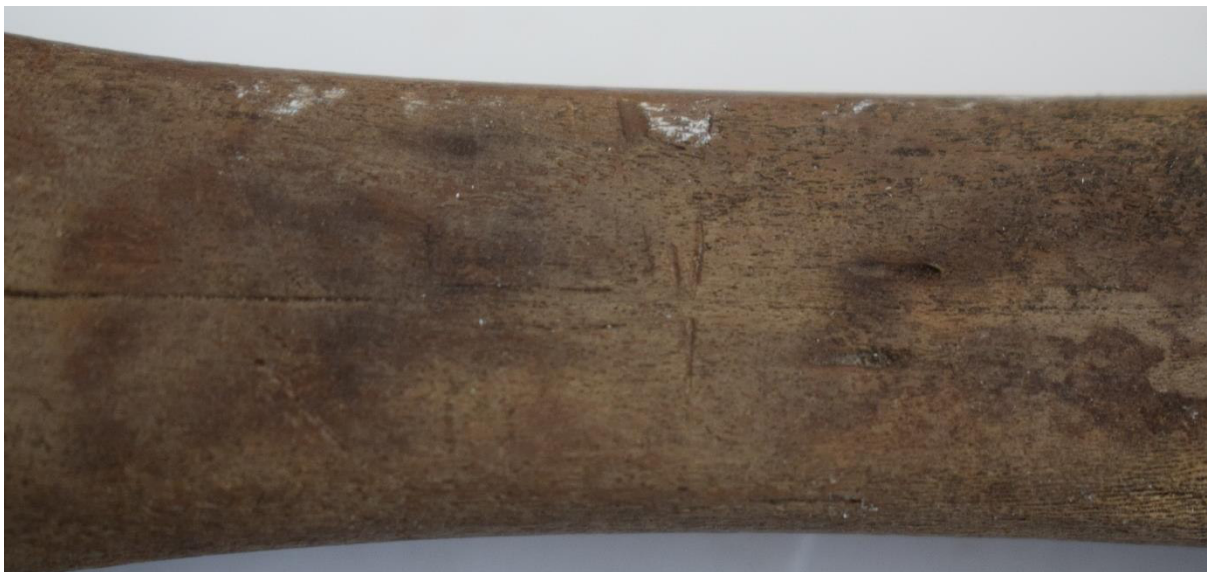
Illus 17 Young ?sheep/goat long bone with skinning cuts
