**Whiteside Farm, Netherley, Stonehaven, AB39 3QU**  
**Report on Level 1 Standing Building Survey**

**Alison Cameron**  
**Cameron Archaeology**  
**18 March 2018**

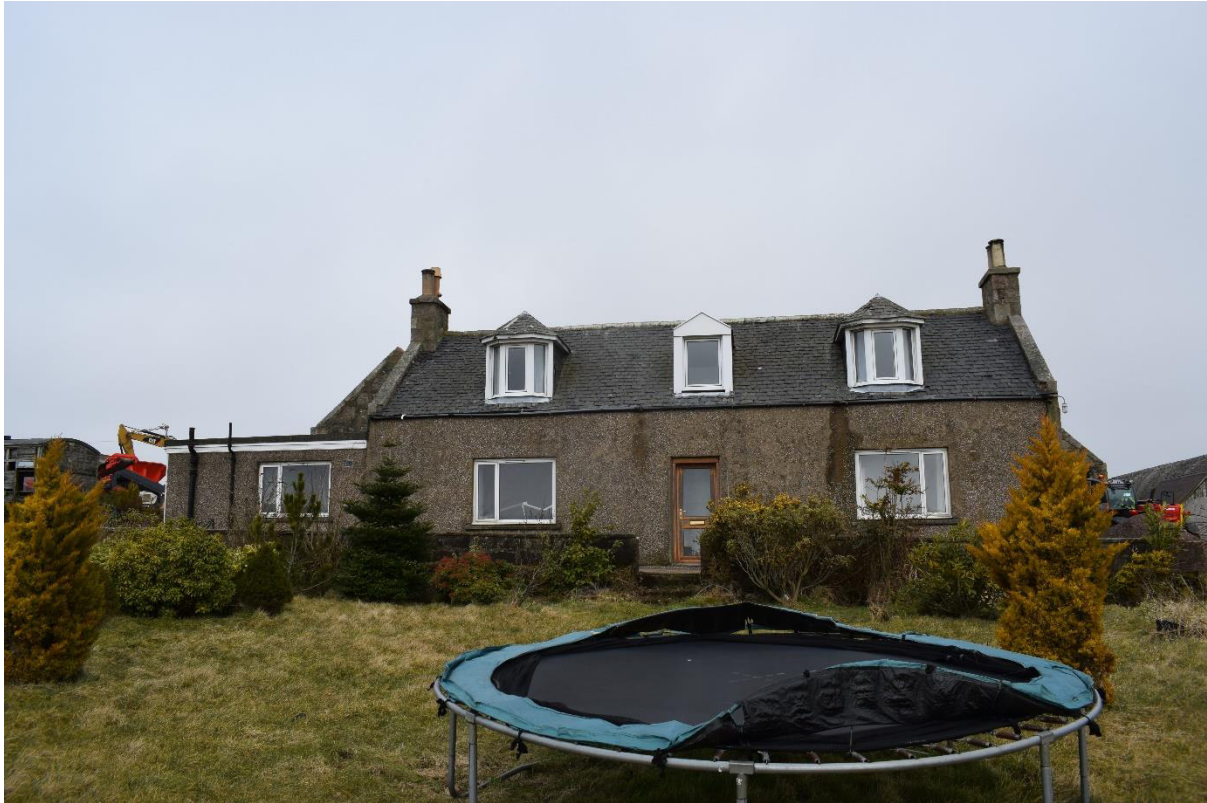
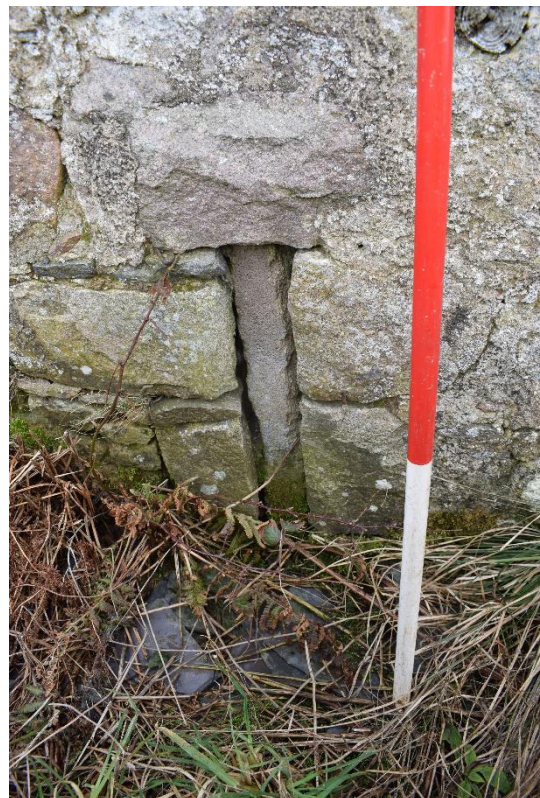
Cover: top Building 1 SE façade; facing NW. Bottom: Slit aperture F2 for attachment of horsemill mechanism; facing NE

There was a circular horsemill on the SW side of this building on the OS maps (Illus 19,20); there is a stone block with metal fittings (F1) and a rectangular slit aperture 0.11m wide and 0.7m high (F2; see cover photo) which are probably associated with this construction. F2 is probably an aperture for connecting the horse-mill mechanism into the milling mechanism within the building.

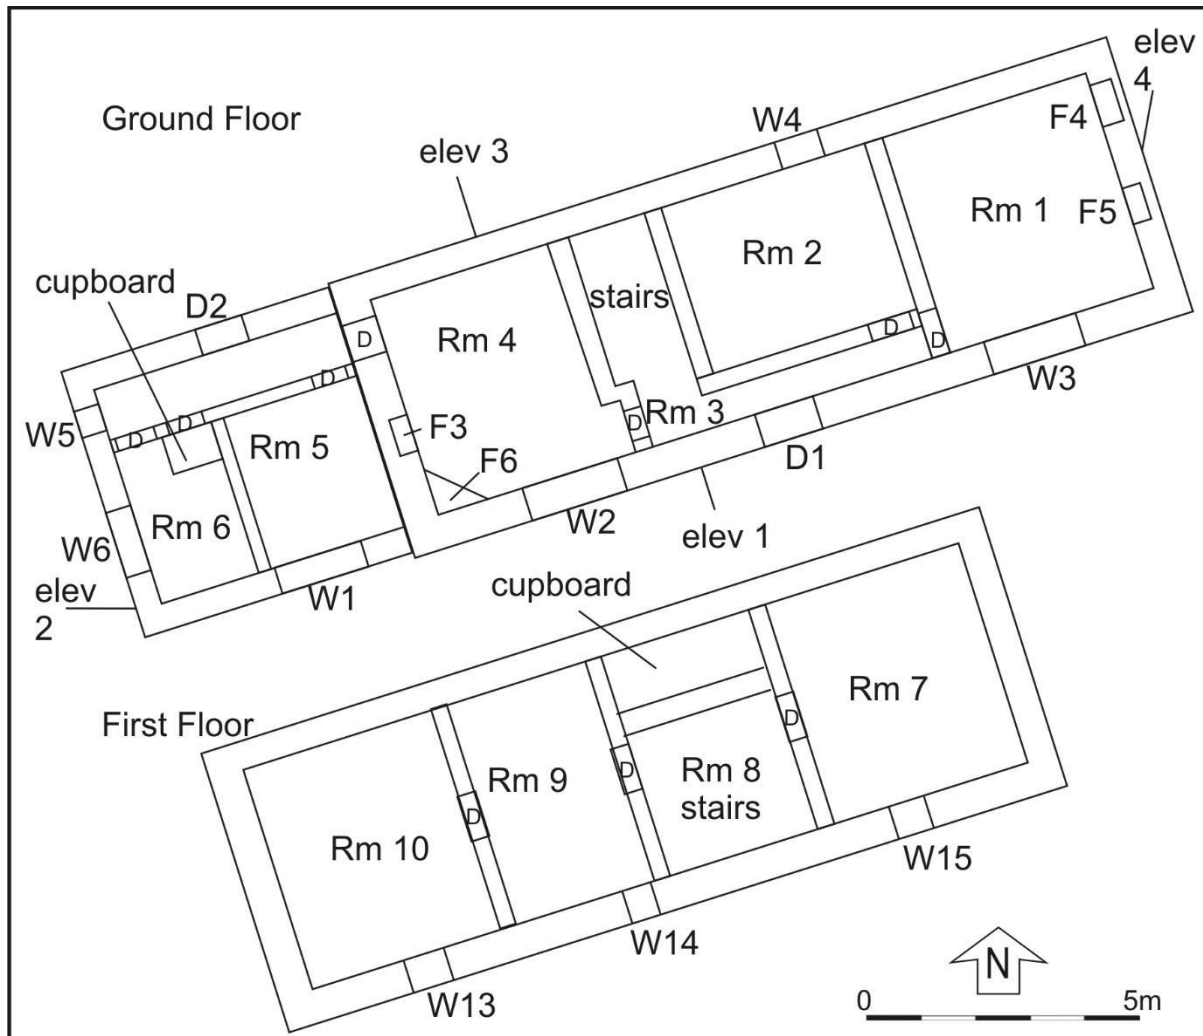
Illus 3 Building 1 ground and first floor plans annotated with numbers used in this survey (from copyright Mackie Ramsay Taylor Architects)

Building 1 is a farmhouse measuring 15m long and 5.2m wide constructed of granite; the building is harled but window W4 has granite sill, jambs and lintel. The building is two storey with the main façade on the SE with central door (D1) large windows in Rooms 12 (reception room) and Room 4 (former kitchen) and dormers in the attic rooms (Rooms 7, 8, 9). There is a new Phase 3 extension on the SW end (Rooms 5 and 6) with kitchen, bathroom and back door (D2).

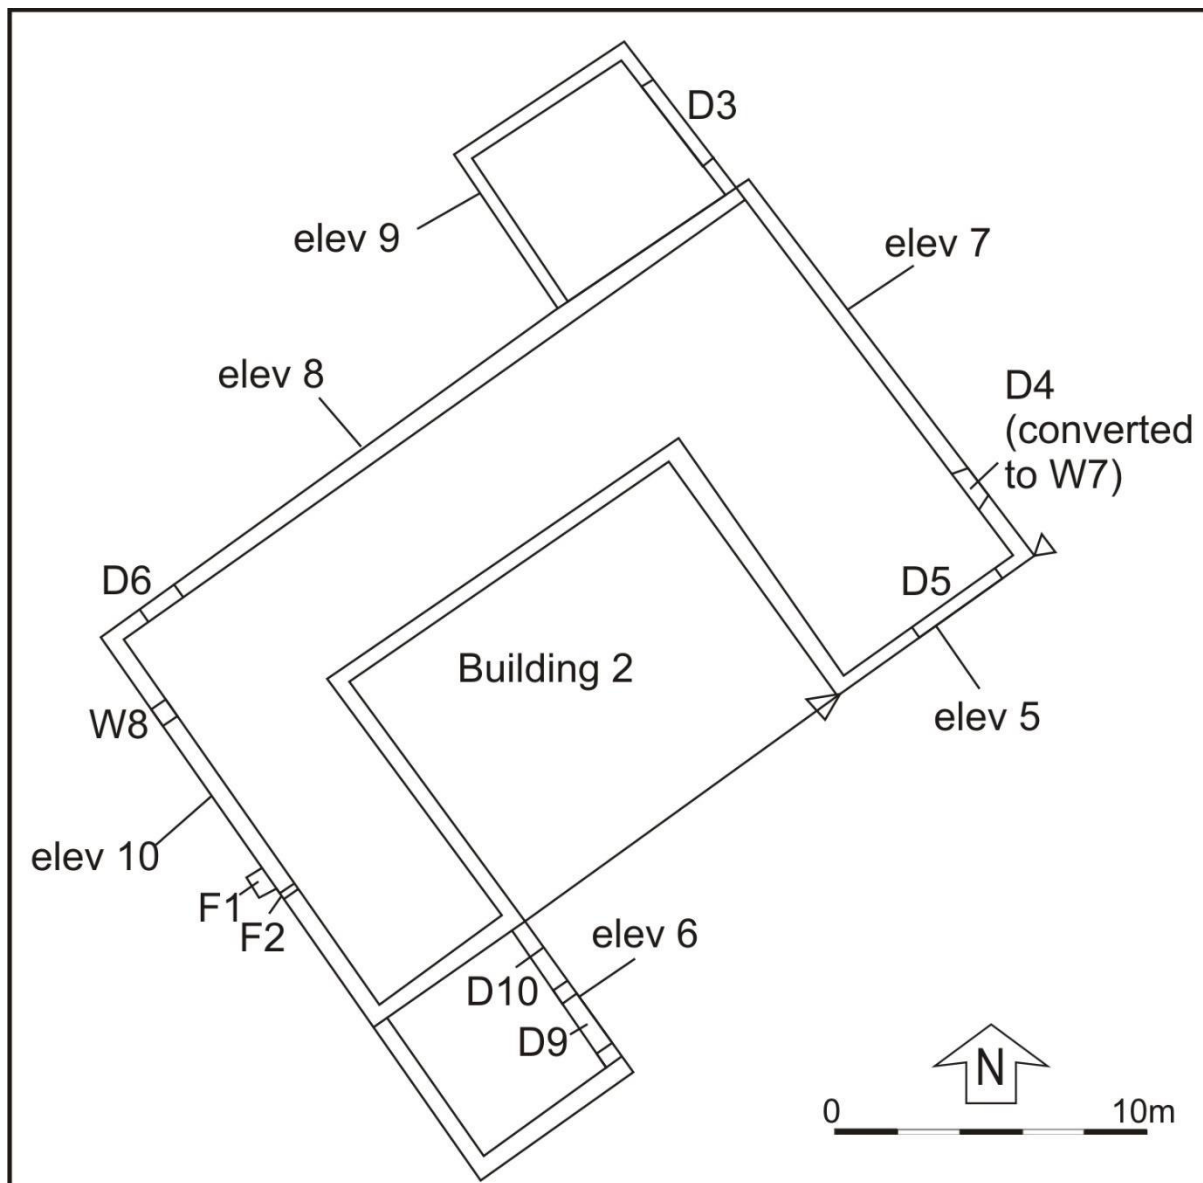
Illus 5 Building 2 plan annotated with numbers used in this survey (from copyright Mackie Ramsay Taylor Architects)

Building 2 is a C-shaped steading 19.2m NW-SE and 21.6m SW-NE (Illus 7, 8). There was little access into the interior of the building. The building is constructed of fieldstone including granite, sandstone and quartz and the apertures are tooled granite. A cartshed with two large doors (D9 and D10; Illus 9) was added to the SE end of the SW wing in Phase 2 and a small building added to the NW end of the NE wing also in Phase 2 (Illus 10). The courtyard was enclosed in the late 20<sup>th</sup> century.

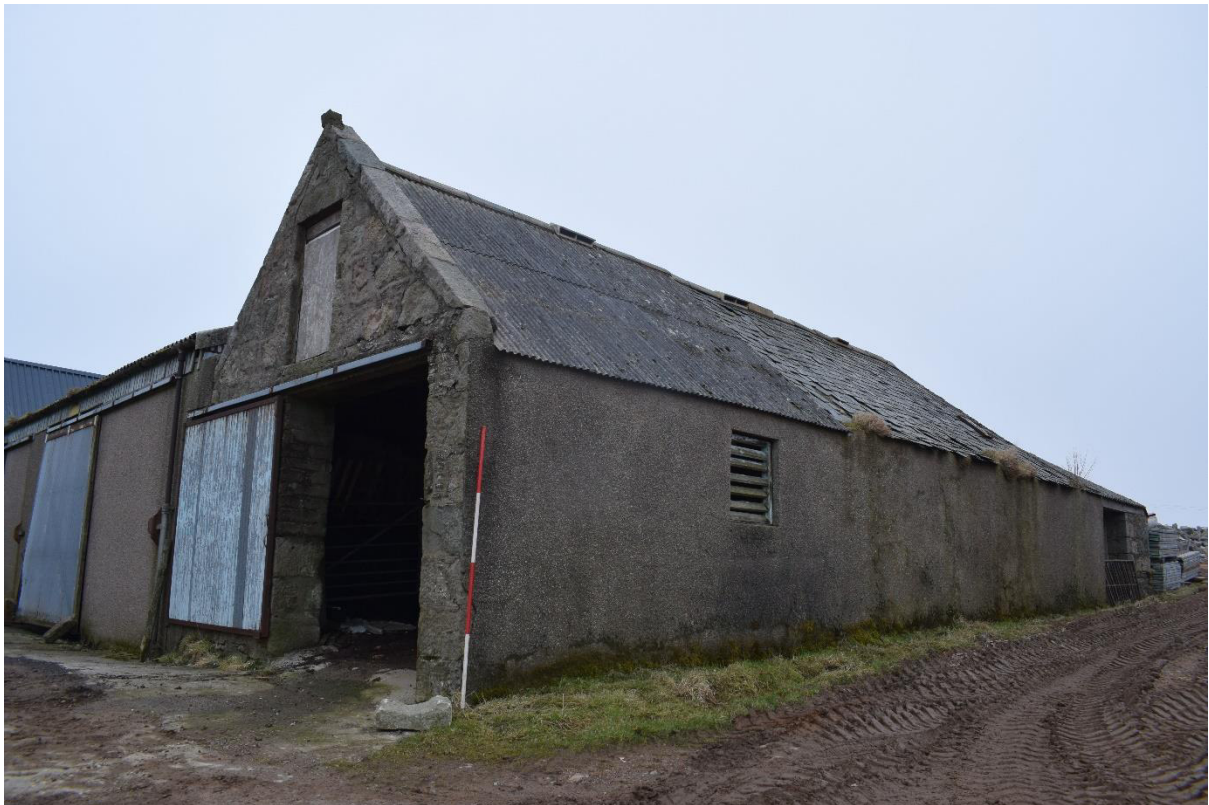
Illus 7 Building 2 NE wing SE gable door D5 with W9 above (left) and W7 (centre); facing NW

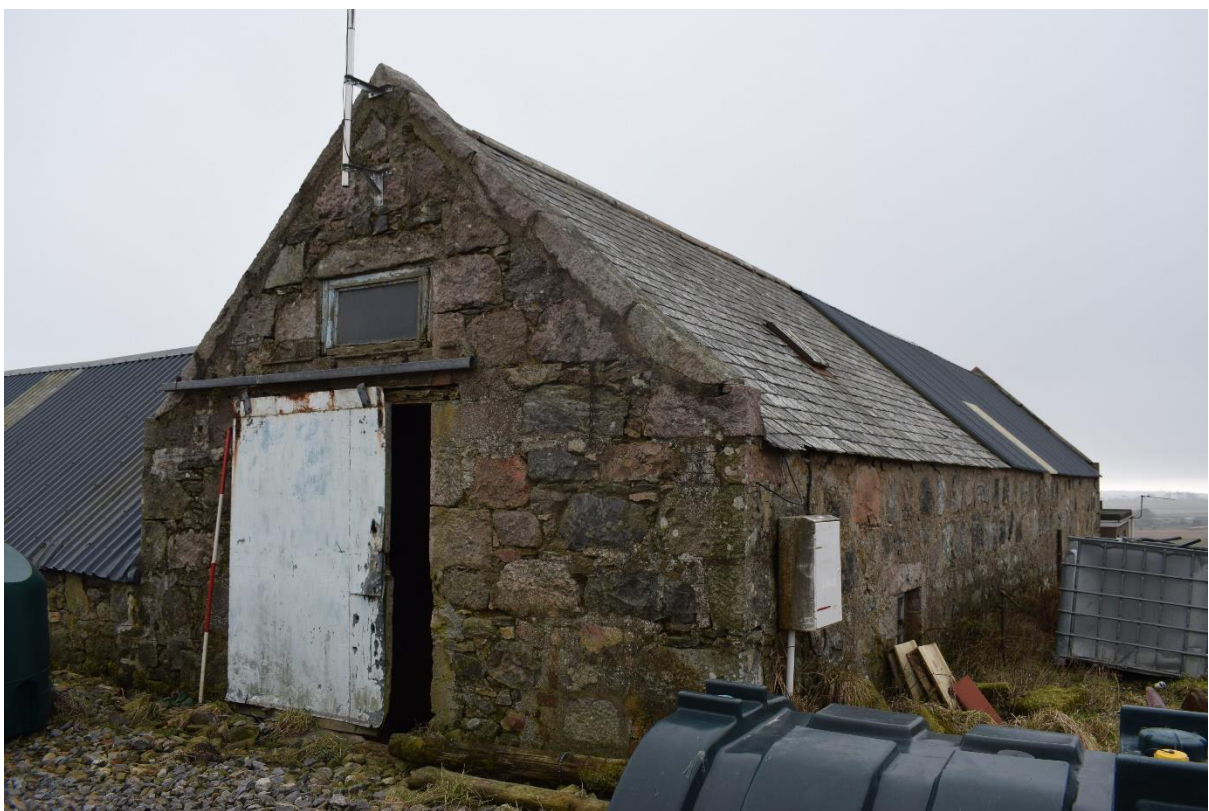
Illus 8 Building 2 SW wing NW gable with D6 and W10 above; facing SE

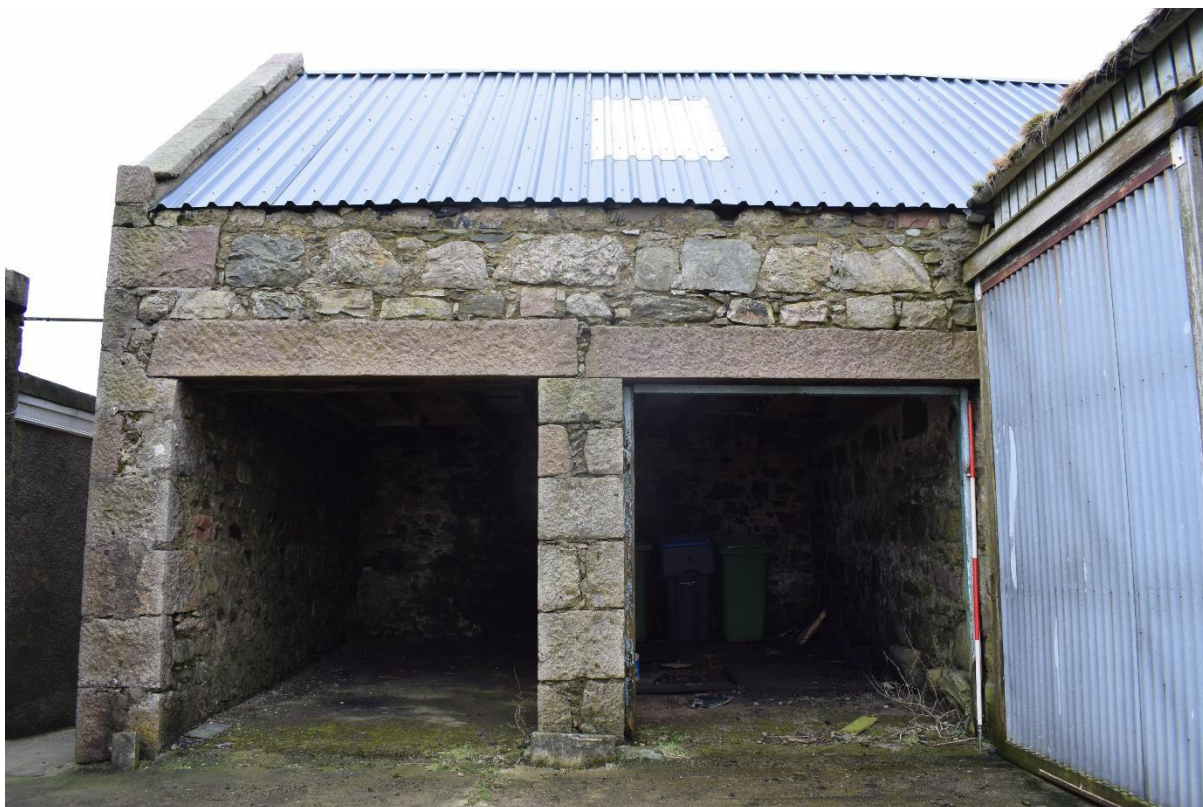
Illus 9 Phase 2 cartshed added on to SE end of SW wing with D9 (left) and D10 (right); facing SW

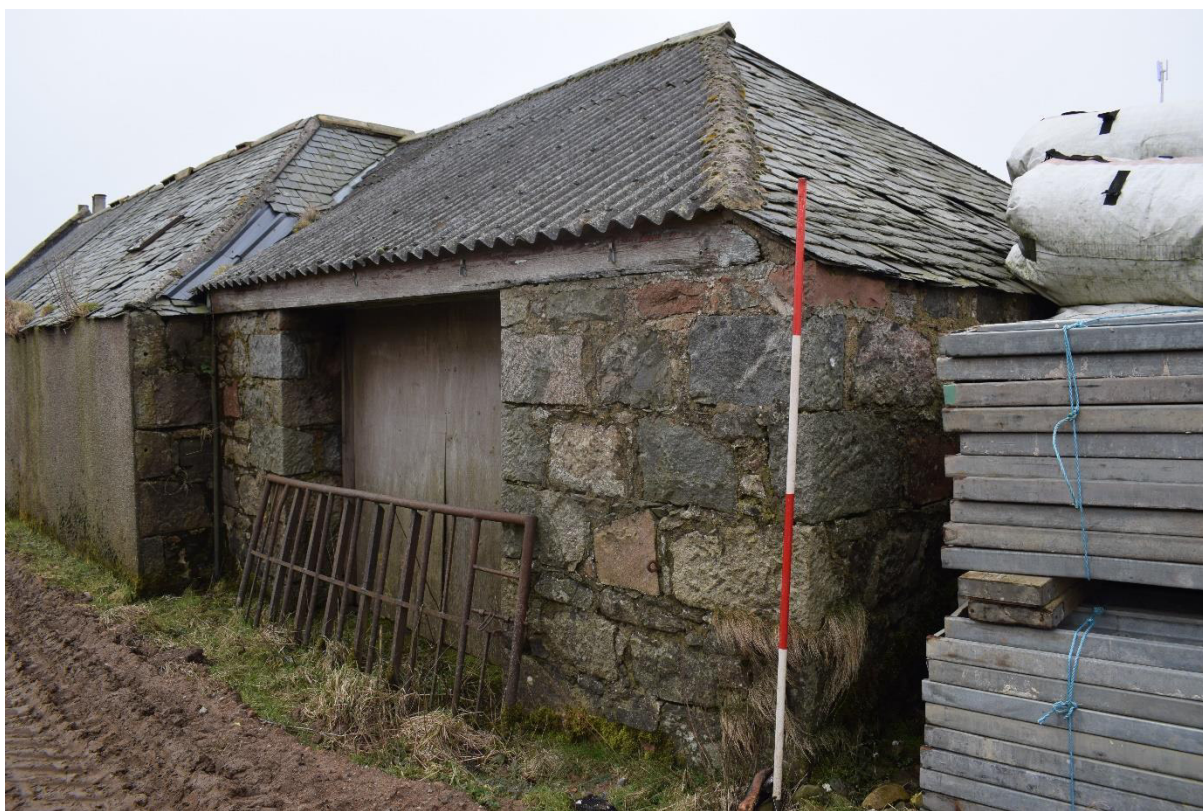
Illus 10 Phase 2 extension to NW end of NE wing with D3 (centre); facing S

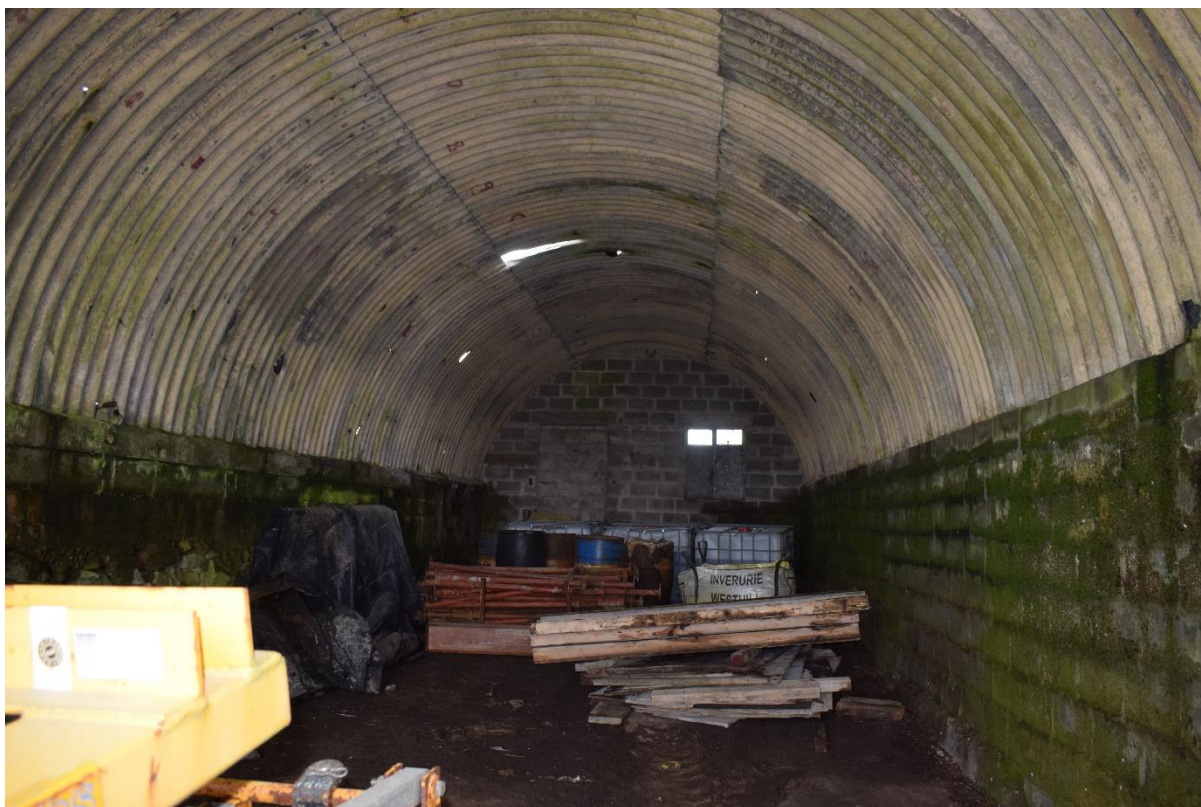
Illus 12 Building 3 interior; facing NW

Building 3 is a stone, concrete block and asbestos sheeting Nissen-type building (Illus 11, 12). It is 17.9m NW-SE and 5.7m NE-SW. The SE end of the SW wall is constructed of piled stones (Illus 13) on the interior and exterior but the remainder of the walls are concrete block (Illus 14). The roof is concrete asbestos corrugated roofing material. There is a door on the SE end and a small window in the NW wall; the NW wall had a larger door but this has been blocked and there is harling over the scar (Illus 15).

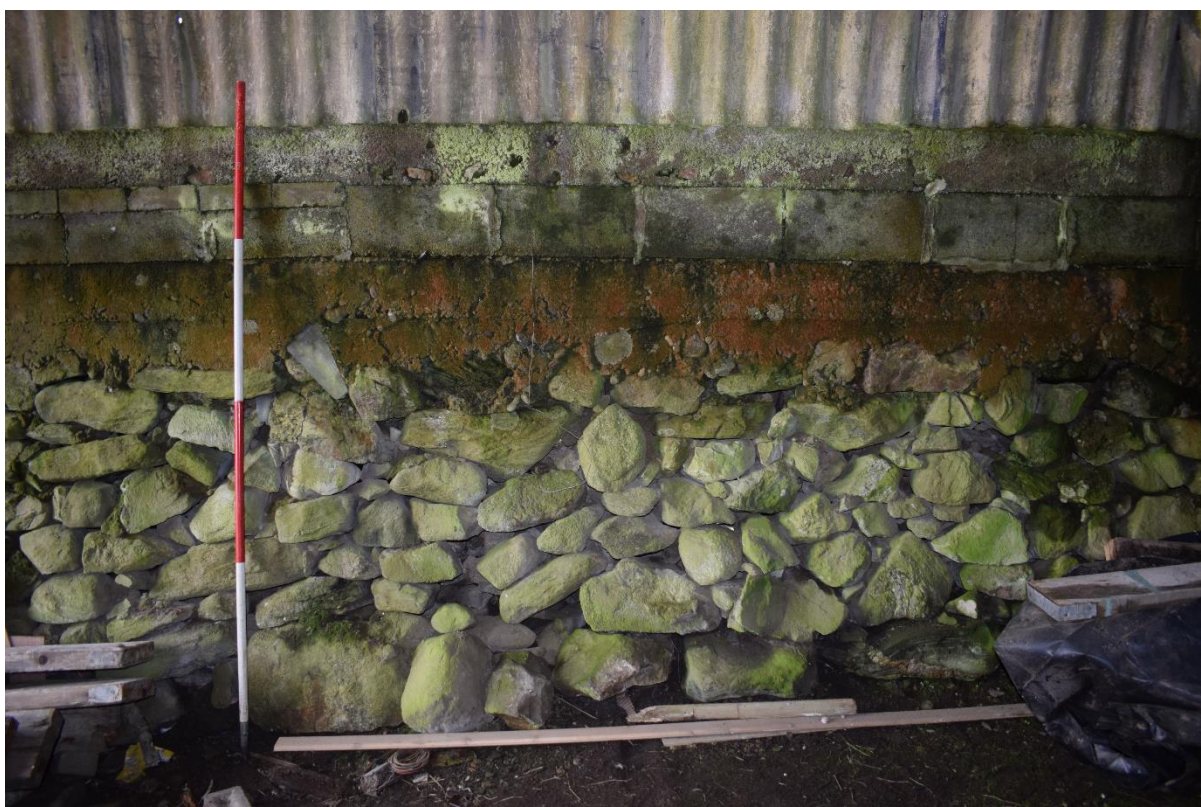
Illus 13 Building 3 SW wall with banked up stone walls; facing SW

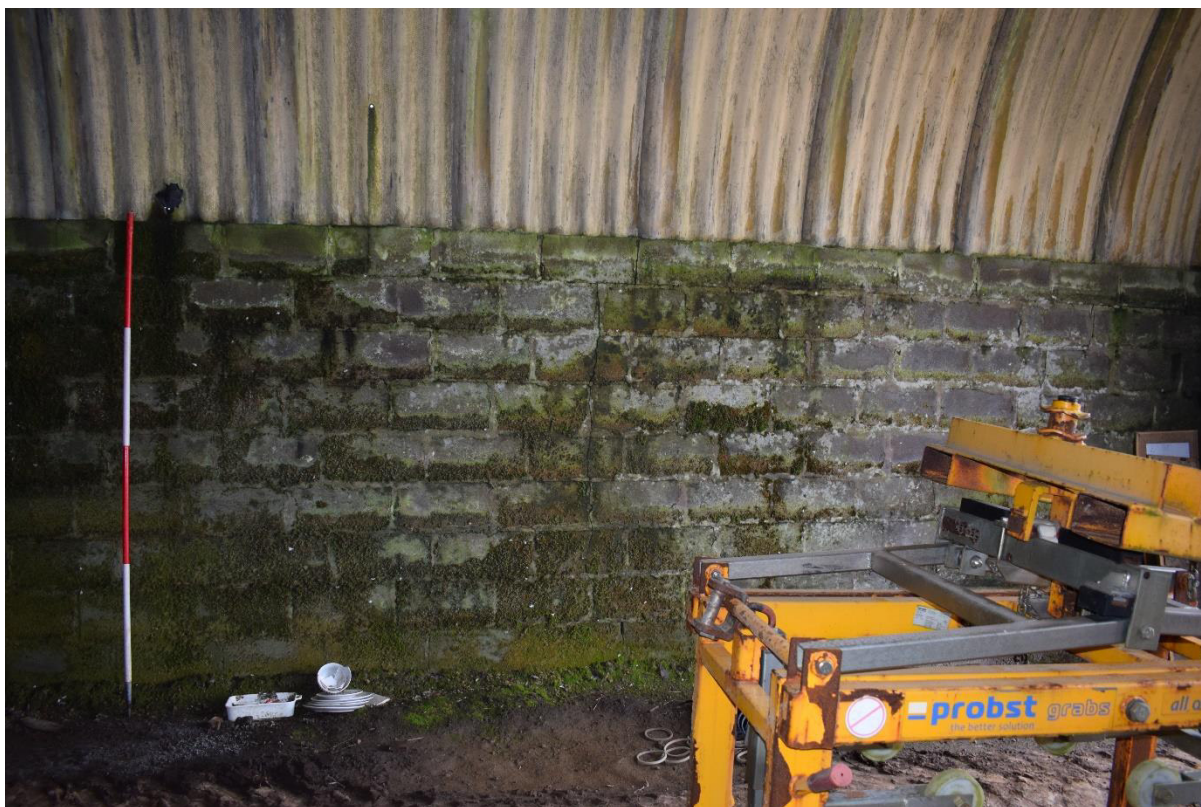
Illus 14 Building 3 NE wall showing concrete block construction; facing NE

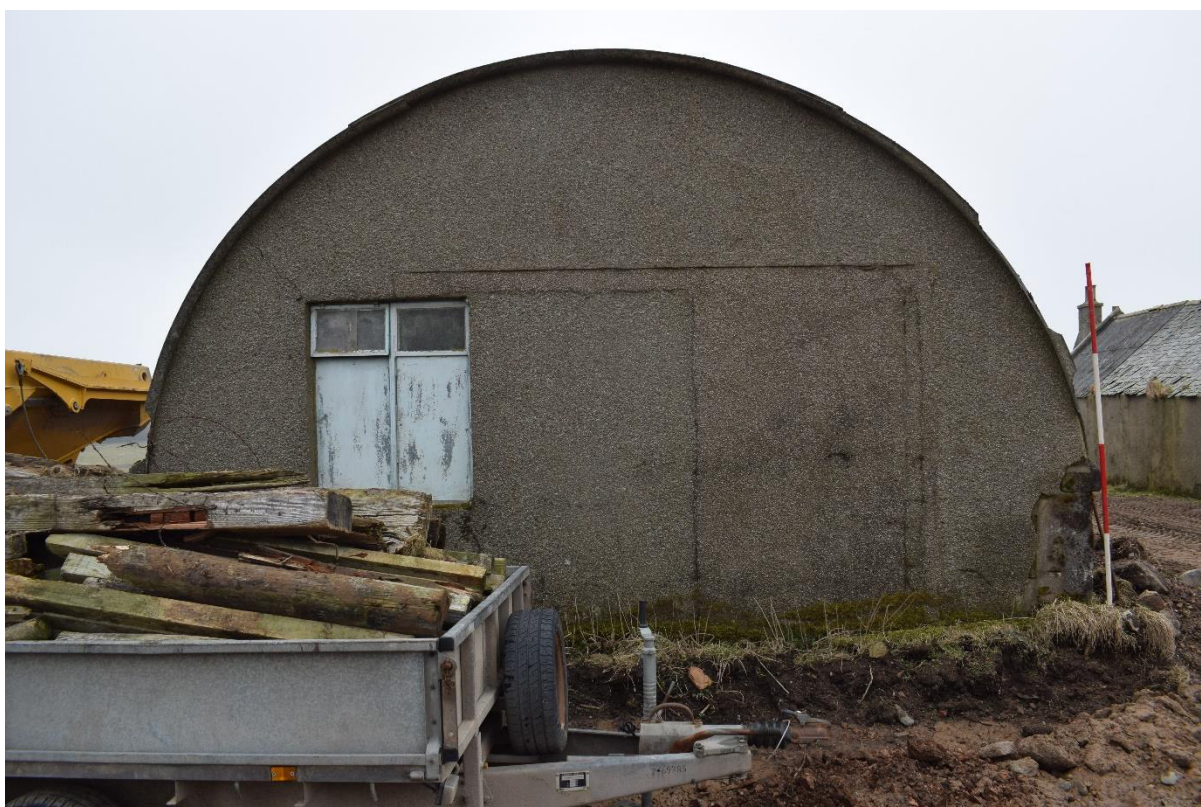
Illus 15 Building 3 NW wall with W11 and blocked door D7; facing SE

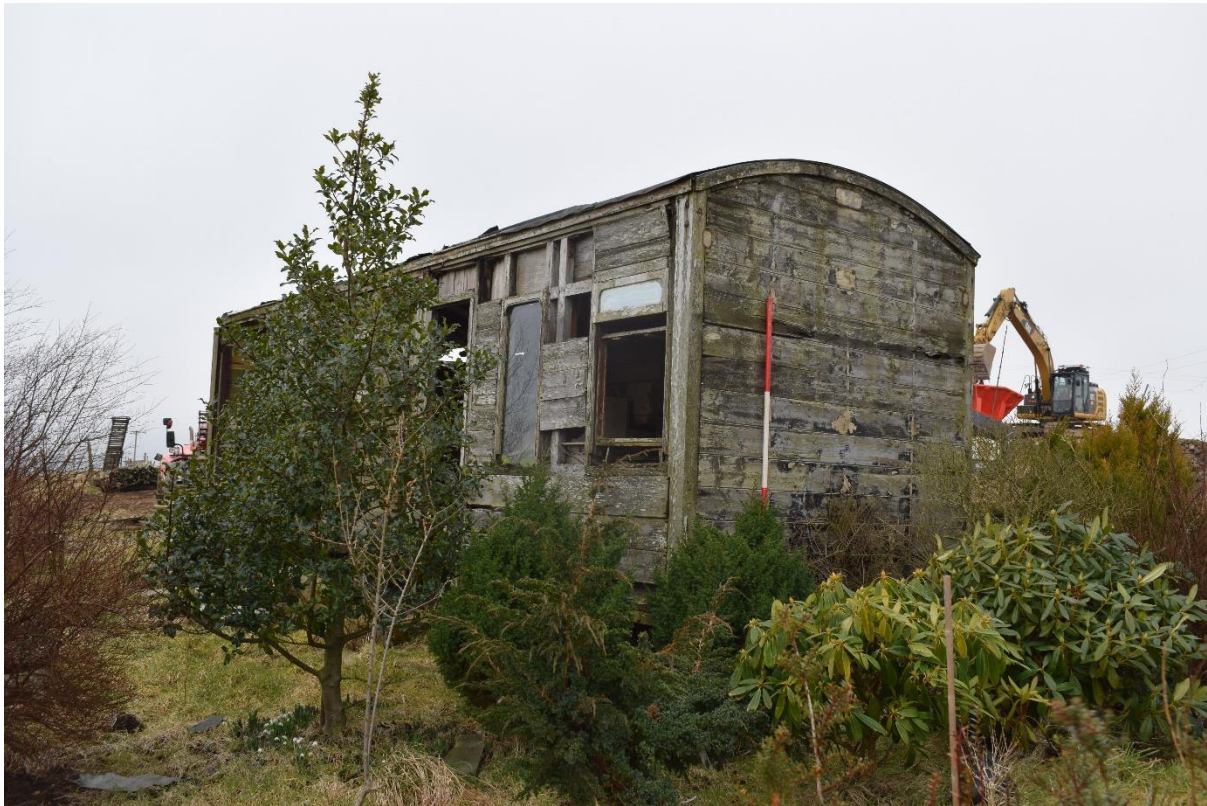
Illus 16 Building 4 wooden carriage; facing NW

Building 4 is the remains of a wooden carriage; it was photographically recorded only (Illus 16, 17).

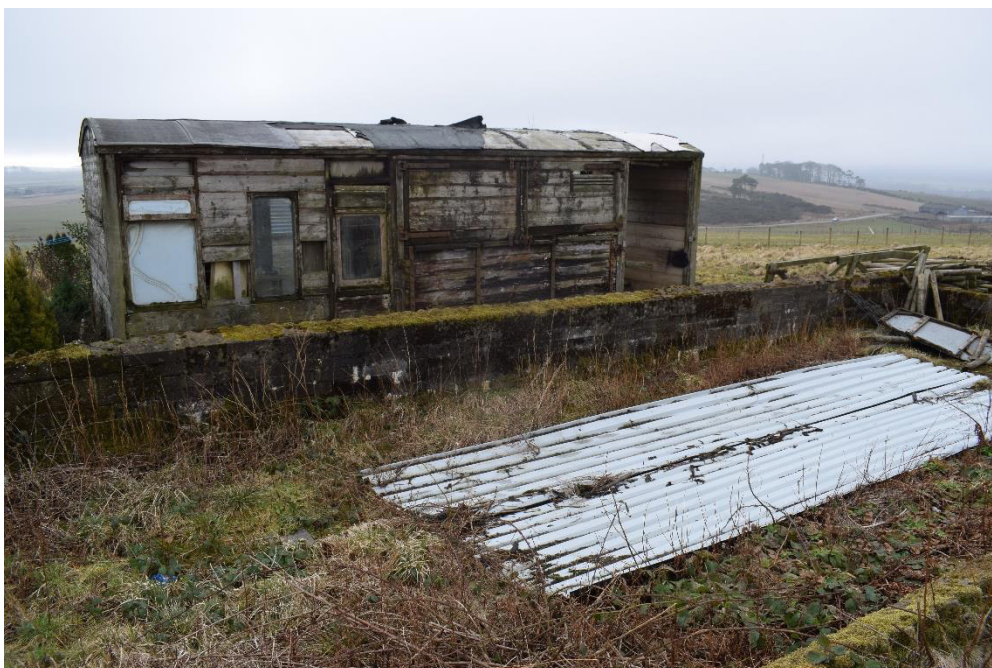
Illus 17 Building 4 (top) and concrete base of Building 5 (bottom); facing S

Building 5 is the concrete base of a ruined Dutch barn (Illus 17).

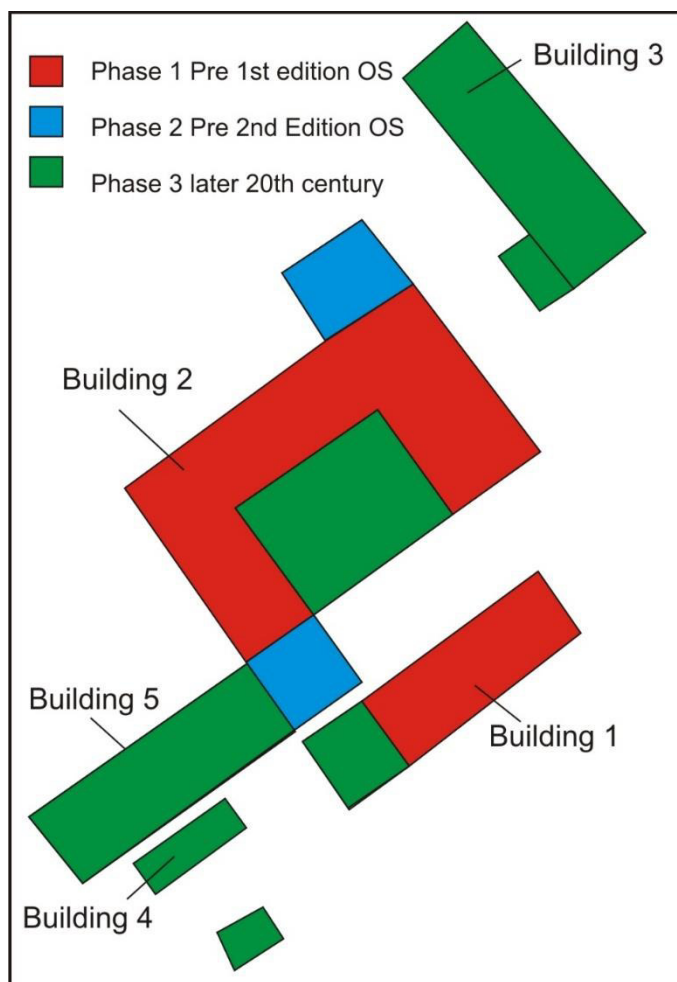
Illus 18 Phase plan showing main building phases recorded during this survey (from copyright Mackie Ramsay Taylor Architects)

A Level 1 standing building survey was carried out on 14 March 2018. The farmhouse and C-shaped steading were probably built on the early-mid 19<sup>th</sup> century and then extensions added in Phase 2, prior to the Second Edition OS map (Illus 18). At that date there was a circular horse-mill attached to the SW of the steading. Later buildings and extensions were added up to the late 20<sup>th</sup> century.

A Level 1 standing building survey was carried out on 14 March 2018. The farmhouse and C-shaped steading were probably built on the early-mid 19<sup>th</sup> century and then extensions added in Phase 2, prior to the Second Edition OS map (Illus 18). Later buildings and extensions were added up to the late 20<sup>th</sup> century.

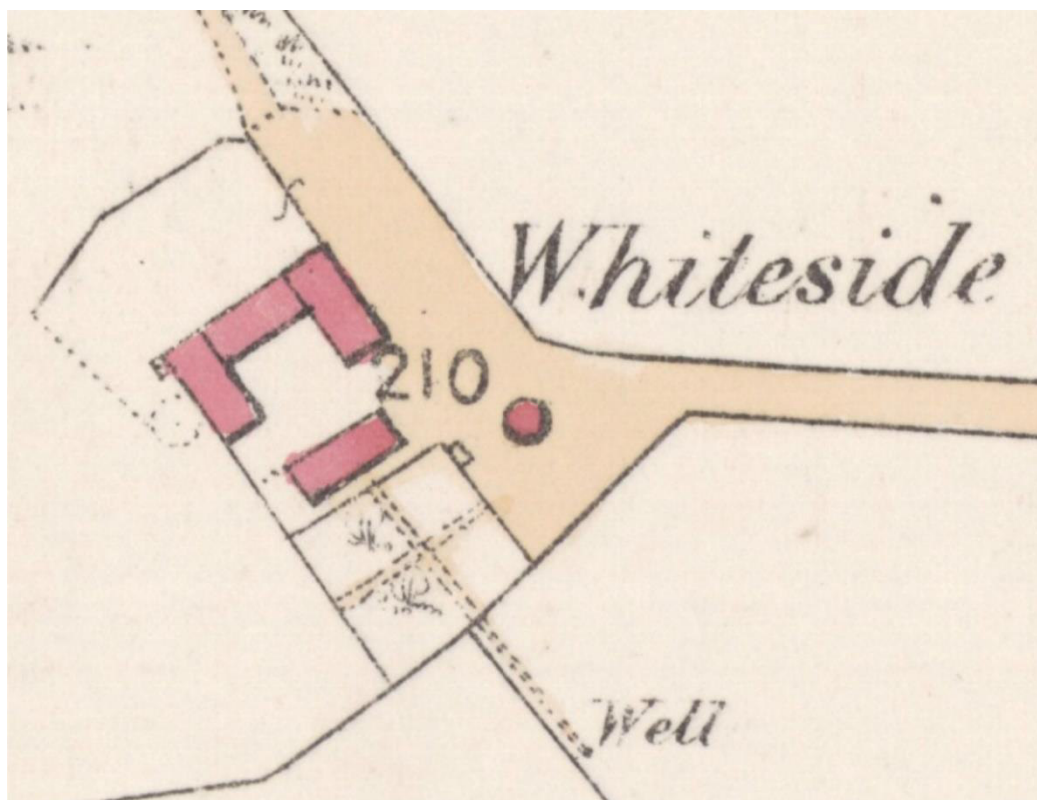
Illus 19 First Edition Ordnance Survey map showing Whiteside Farm. Kincardineshire VII.11 (Fetteresso) Survey date: 1865 Publication date: 1866 (copyright National Library of Scotland)

Whiteside is a 19<sup>th</sup>-century farmstead which is not on HES Pastmap or Aberdeenshire Council Sites and Monuments Record (HER). On the First Edition OS map (Illus 19) it is a C-shaped steading aligned NW-SE with a rectangular building at the open end of the C with garden to the SE and circular structure to the E. By the Second Edition OS map (Illus 20) the SW arm of the C-shaped steading has been extended and a building attached to the NW, a circular horse mill attached to the SW of this steading and a small building erected to the SE and the circular building is still extant and two small buildings constructed nearby to the NE of the garden.
