**Phase B, Northwoods Housing Development, Mintlaw,
AB42 4AF
Data Structure Report**

**Alison Cameron
Cameron Archaeology
29 March 2018**

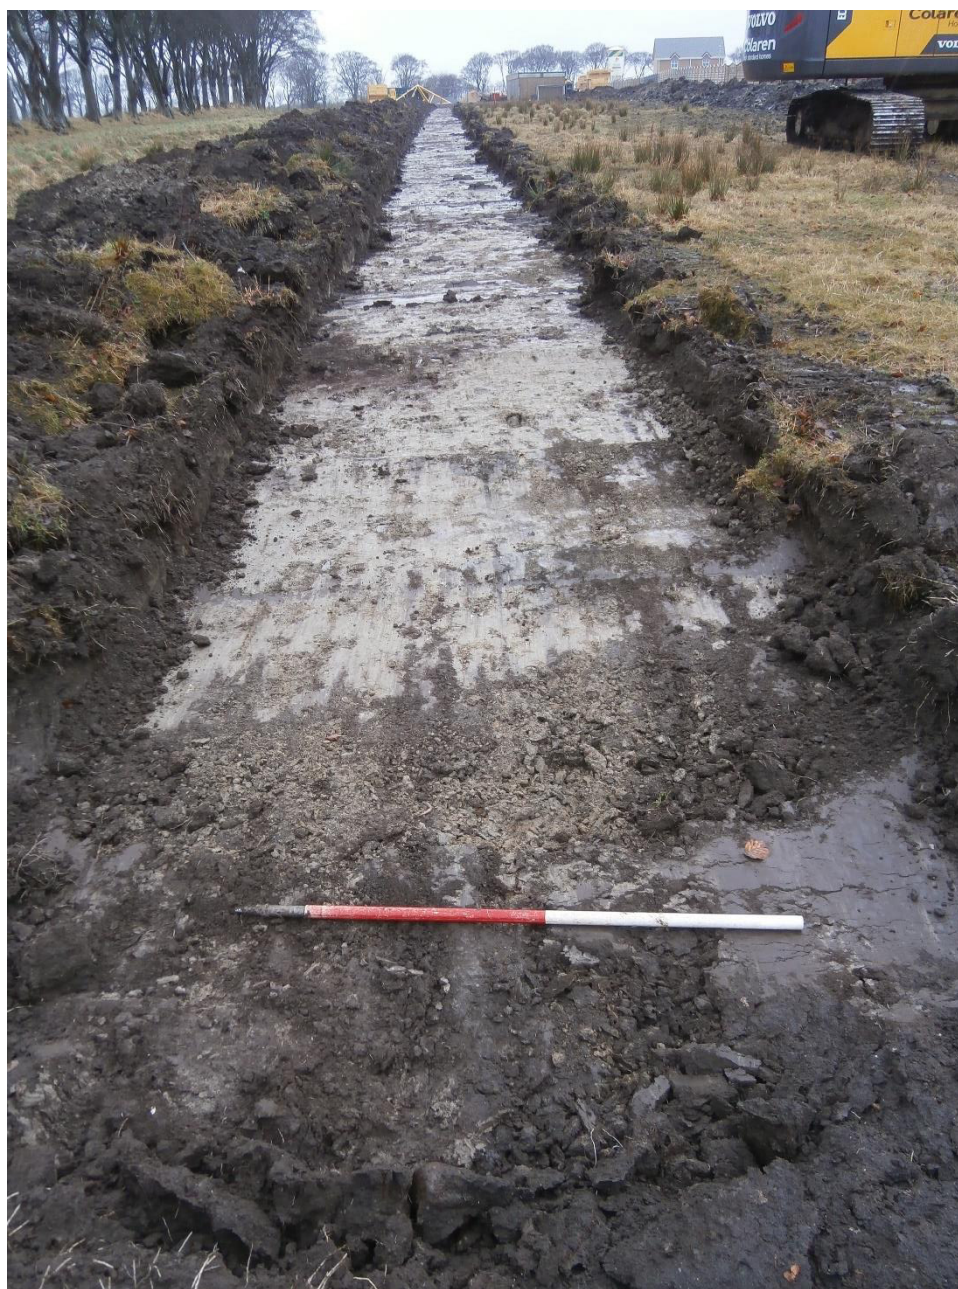
Cover: Trench 6 S end showing foundation trench for stone field boundary identified on OS maps; facing NNW

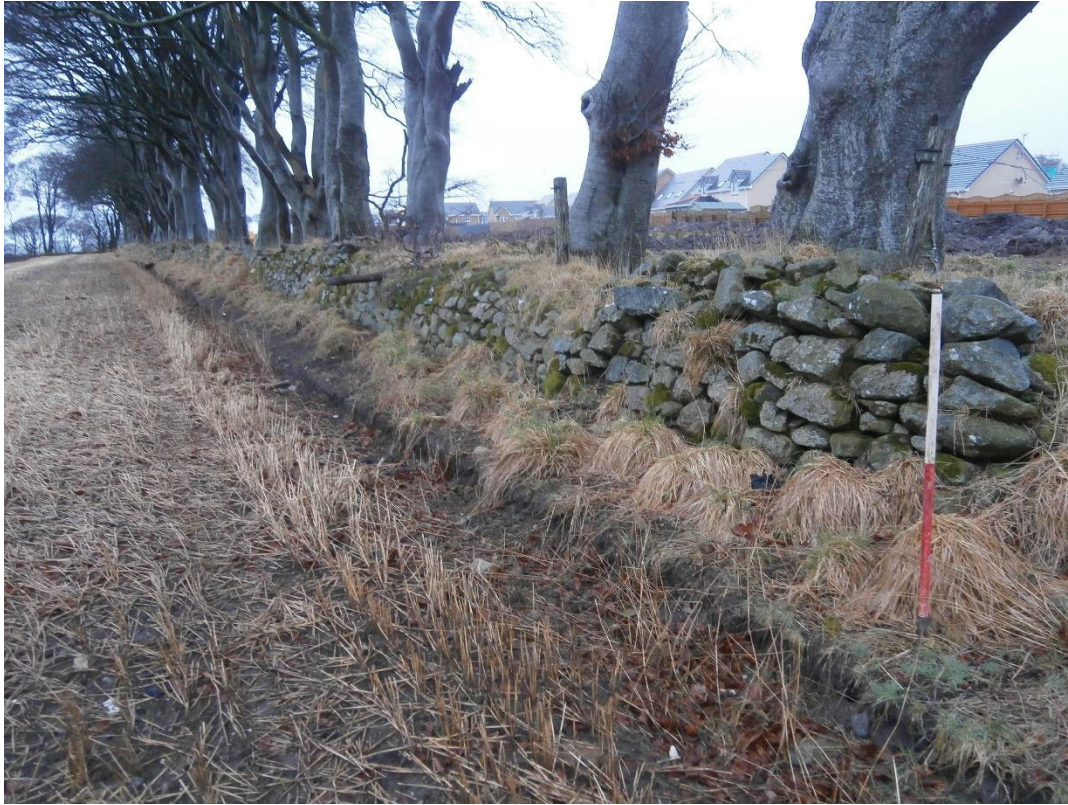
The foundation for a former stone boundary dyke was identified in Trenches 5 and 6 and an area around it 20 x 15m was opened up (Tr 5A) to check the area around it. Stone and ceramic field drains were numerous throughout the S half of the site which has always been very wet and borders an area of known deep peat (Hamish Watson, pers comm). Some areas had standing water especially the W end of Trenches 11-14) and Trench 14 was abandoned as it was filling up with water. The N area of Trenches 18-20 also had standing water and there were bunds of soil in this area which slightly limited the choice of trench locations.

Illus 3 Drystone dyke between Trenches 6 and 7; facing NNE

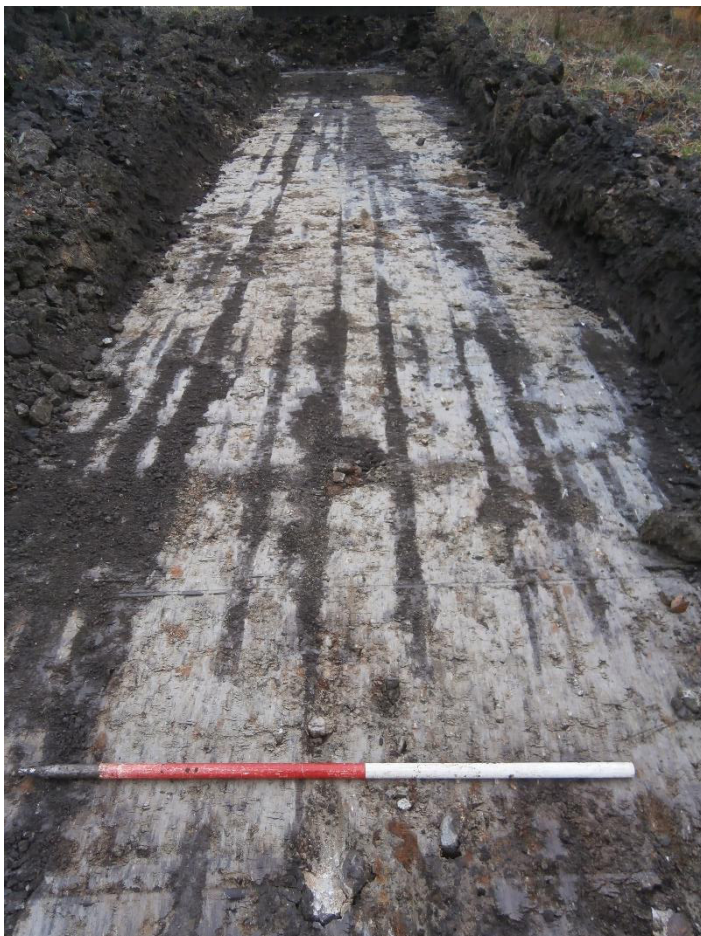
The topsoil over the whole proposed development area was very shallow (0.1-0.2m) and post-medieval agriculture had greatly affected the compact clay natural subsoil beneath. Modern plough scores were seen in the natural subsoil in all trenches.

Illus 4 Tr 5 shallow topsoil, plough scores in natural compact clay subsoil; facing NNW

No archaeological finds or features were identified and it is therefore recommended that no further archaeological work is required during the proposed development.
