**Inverharroch, Lower Cabrach, Huntly,  
Moray, AB54 4EU  
Data Structure report**

**Alison Cameron  
Cameron Archaeology Ltd  
18 October 2018**

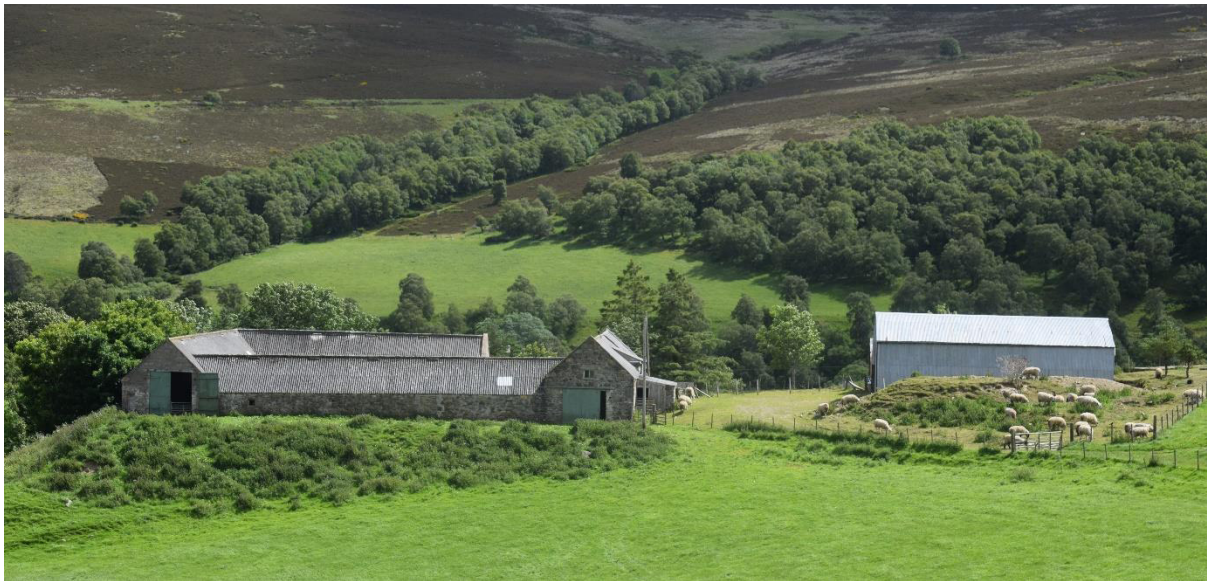
Illus 3 Location of Inverharroch from A941 showing it atop a man-made platform; facing E

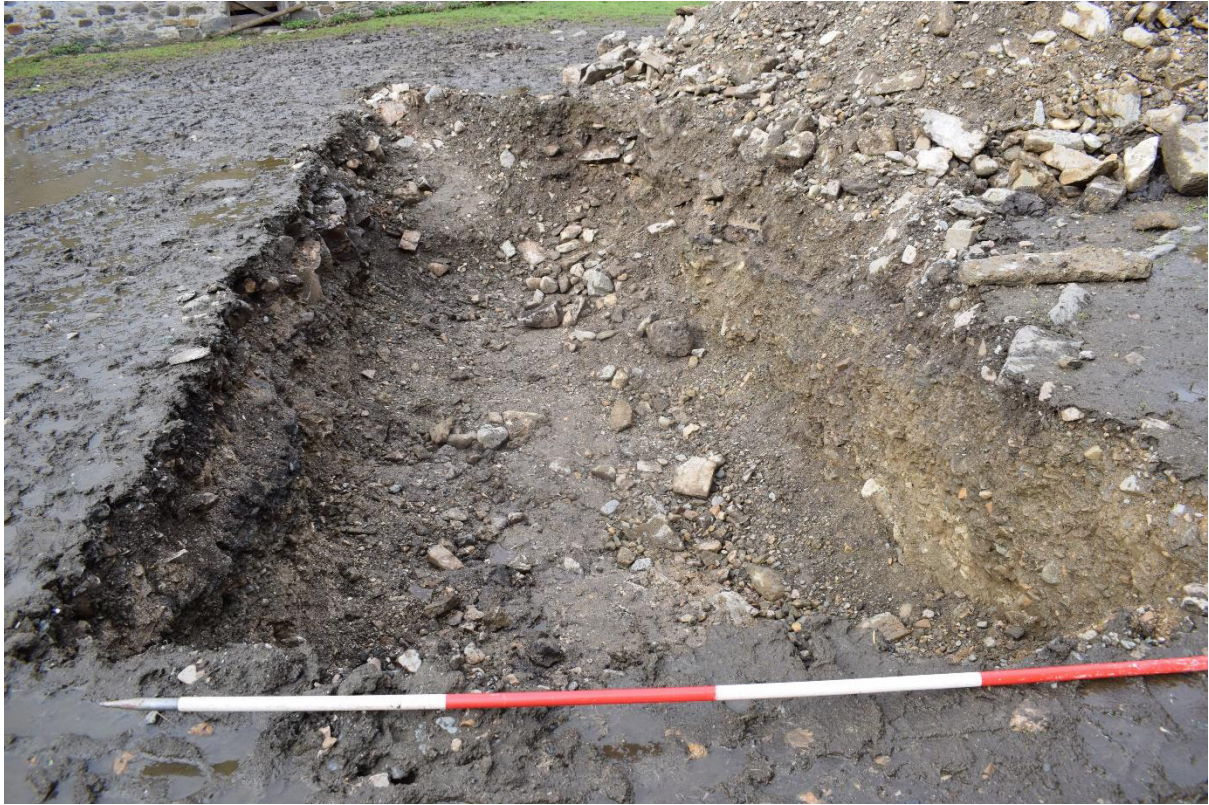
Trench 1 was dug within the courtyard to target geophysical anomaly which appeared circular. The trench was dug down through 1.5m of loose gravel and dumped stone (Illus 5) and no archaeological features were identified. A large stone with socket was removed and photographed. The trench was too dangerous to enter and was therefore backfilled. It has been determined that there was a sunken midden within the courtyard (Colin MacKenzie pers com) and this was therefore the backfill of that sunken midden area.

Illus 5 Trench 1; facing S

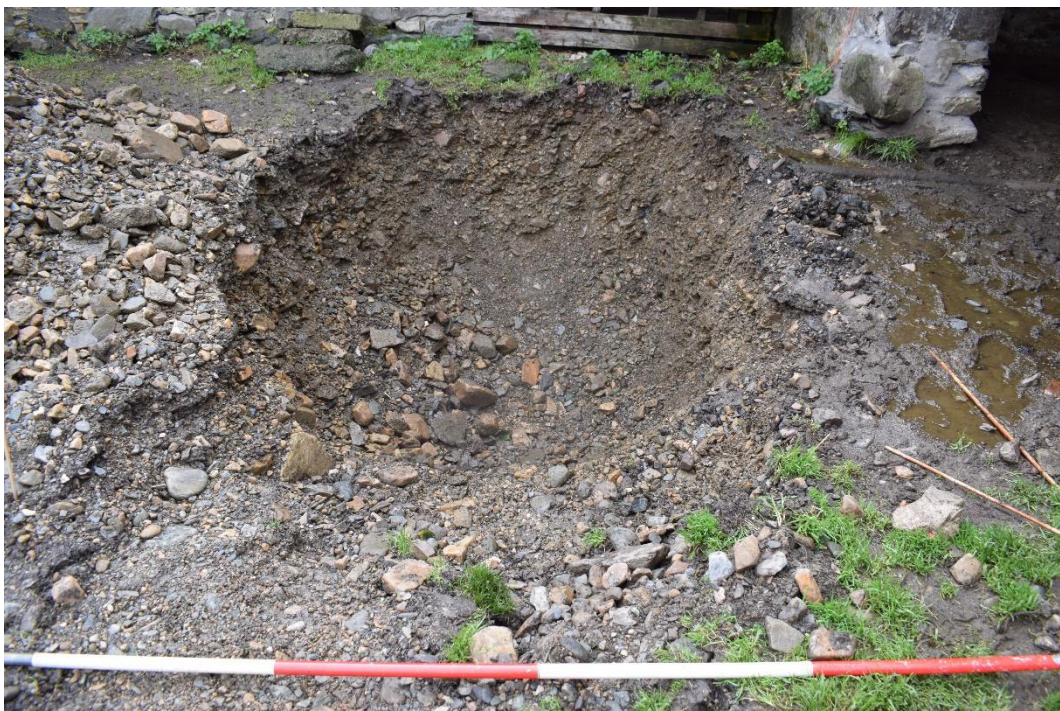
Trench 2 was dug within the courtyard to target geophysical anomaly which appeared to be a possible wall/foundation. The trench was dug down through 1.2m of loose gravel and dumped stone (Illus 6) and no archaeological features were identified. The trench was too dangerous to enter and was therefore backfilled. It has been determined that there was a sunken midden within the courtyard (Colin MacKenzie pers com) and this was therefore the backfill of that sunken midden area.

Illus 6 Trench 2; facing SW

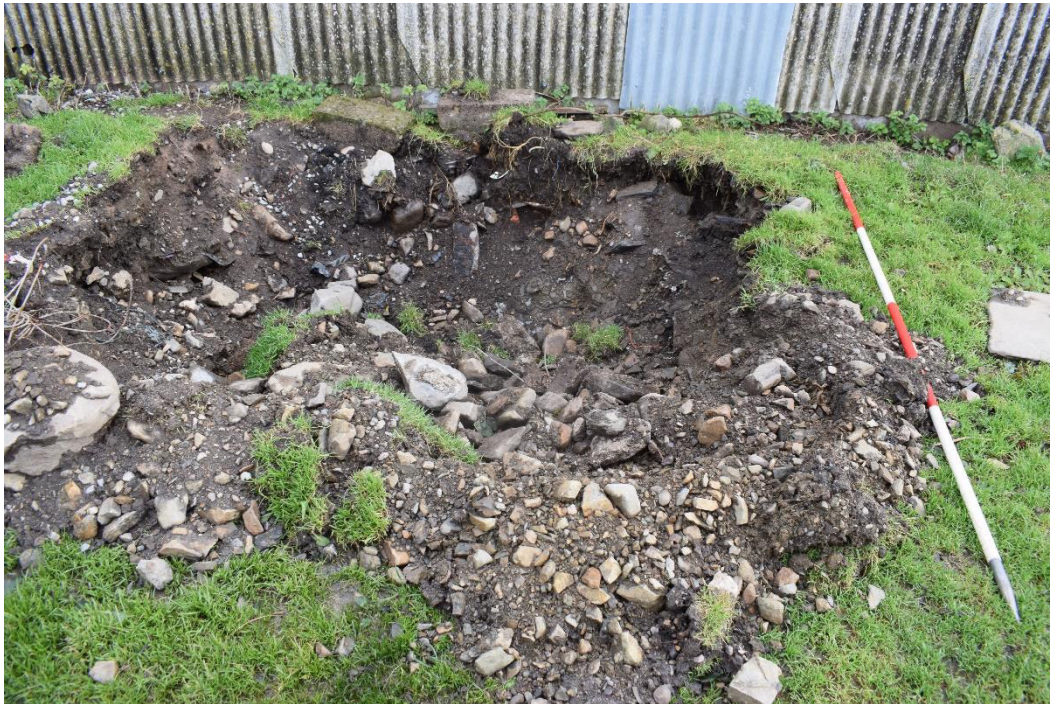
Trench 3 was located over a possible archaeological anomaly. The trench was full of modern dumped rubbish and was recorded and backfilled (Illus 7).

Illus 7 Trench 3; facing SE

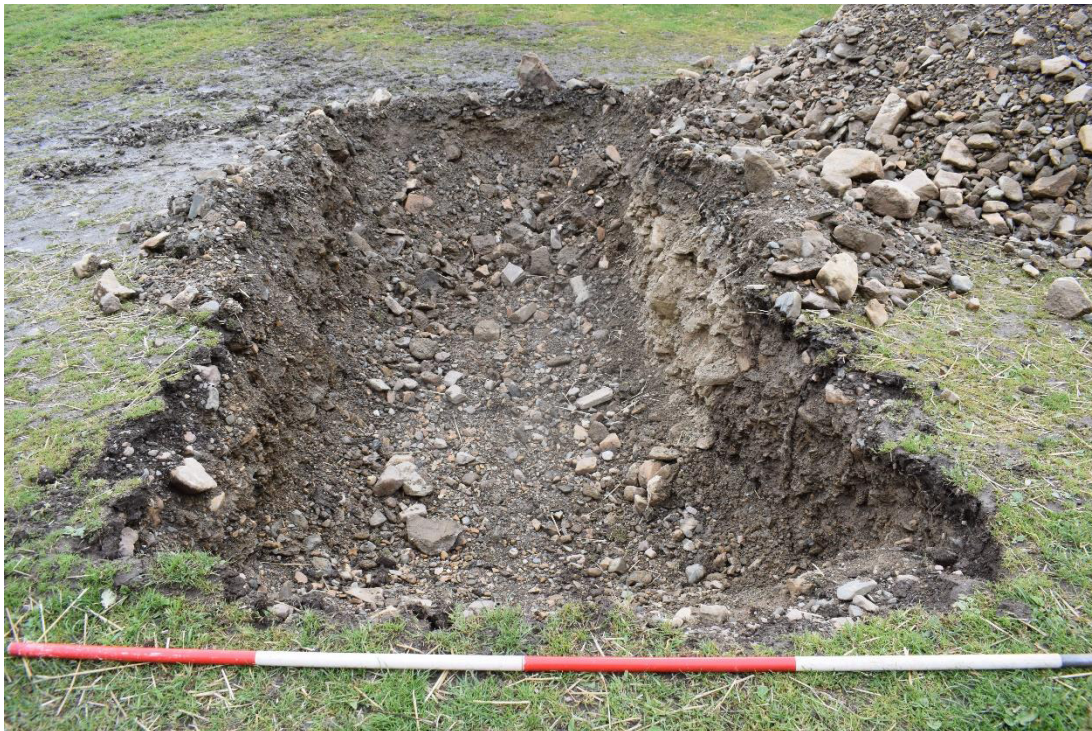
Trench 4 was located over a possible archaeological anomaly. The trench was full of modern dumped rubbish and was recorded and backfilled (Illus 8).

Illus 8 Trench 4; facing SW

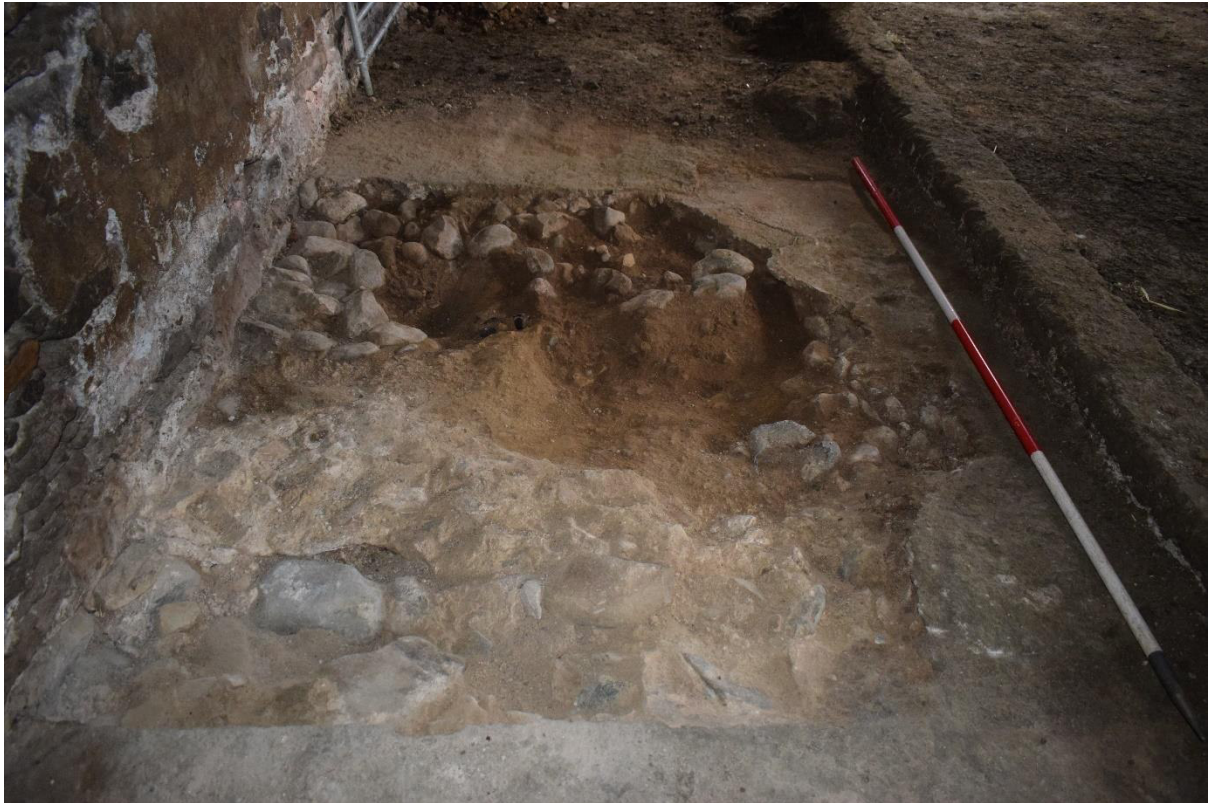
Trench 5 was located on the SE side of the bothy in the NE wing of the steading. There was a wall foundation 504 (Illus 10) which was the foundation for the SE wall of the bothy and waterwashed cobbles in the SE end of the trench. These has been disturbed and a section were removed; underneath was a rusty brown sand which had been subjected to heat and was mixed with glass and ceramics which had become fused (Illus 11). The bottle glass is probably mid 19<sup>th</sup> century in date (Colin MacKenzie pers com).

Illus 10 Trench 5 wall foundation 504 (foreground), cobbles 506 (top); facing SE

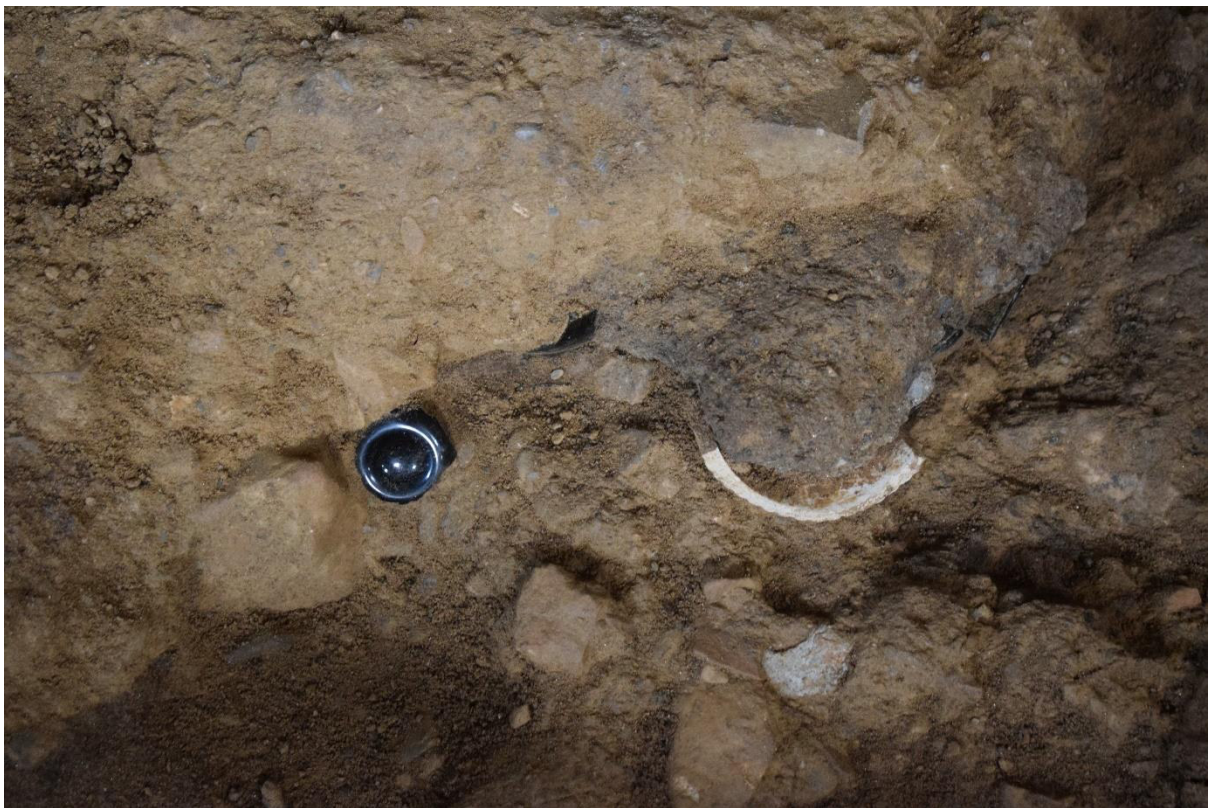
Illus 11 Trench 5 fused sand, glass and pottery under cobbles 506; facing NE

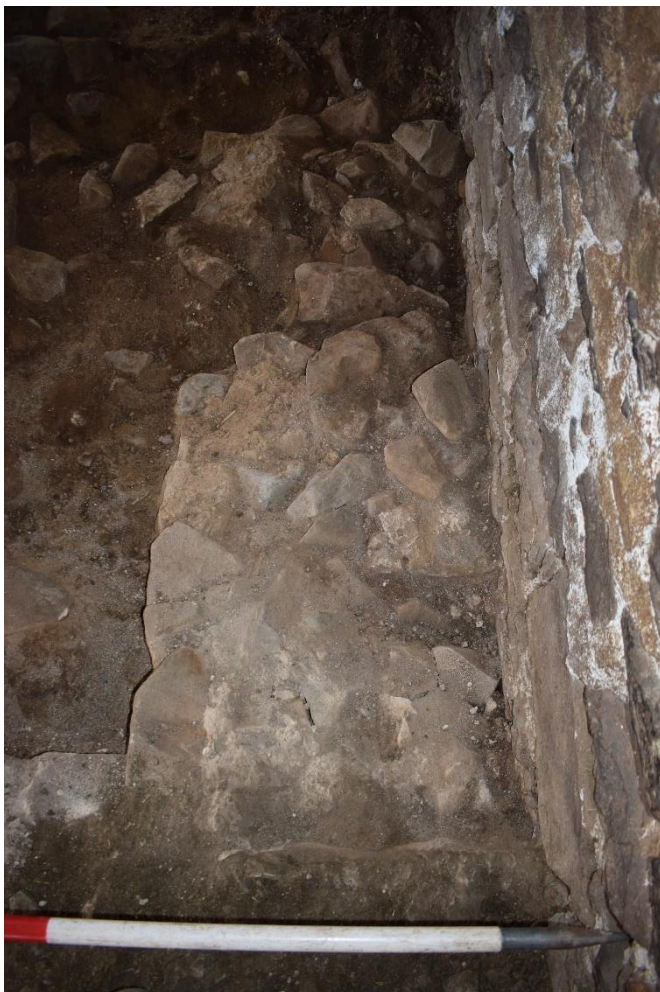
Illus 14 Wall foundation 601 for animal feeder; facing NW

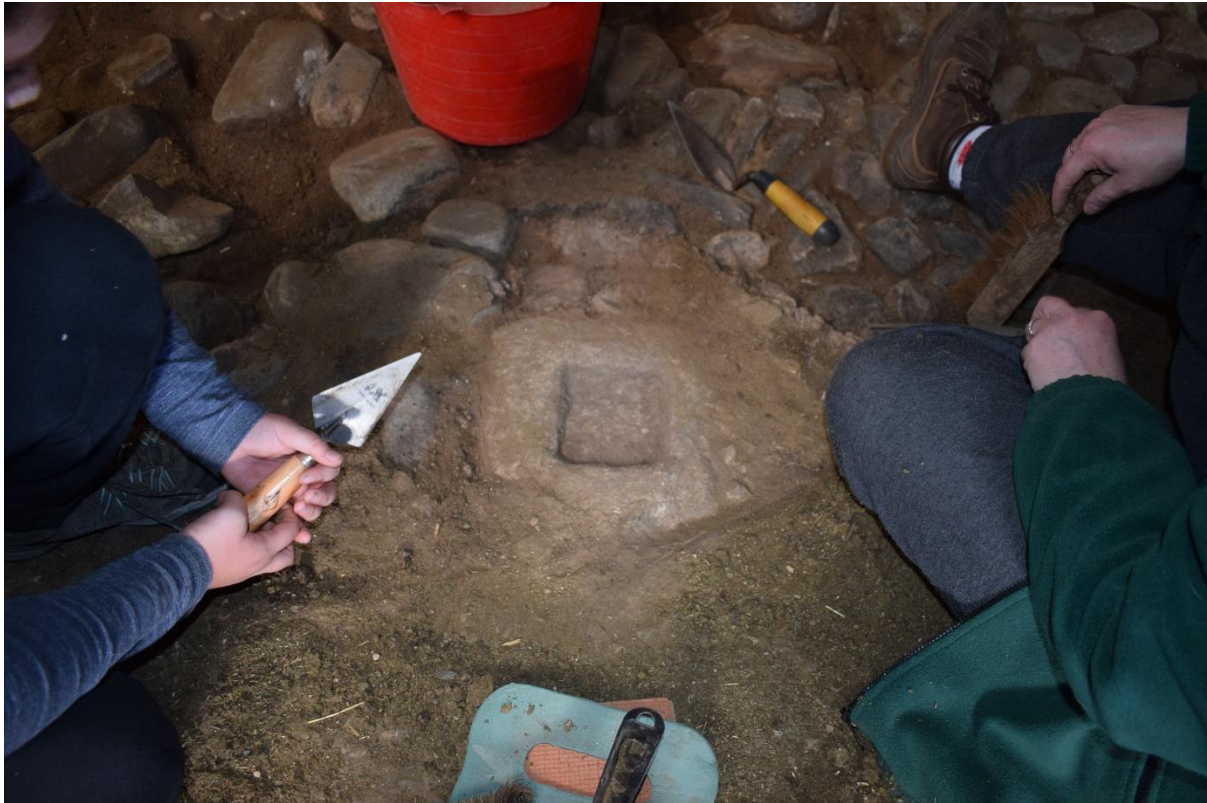
Illus 15 Mum and son uncovering post socket in concrete 610; facing NE

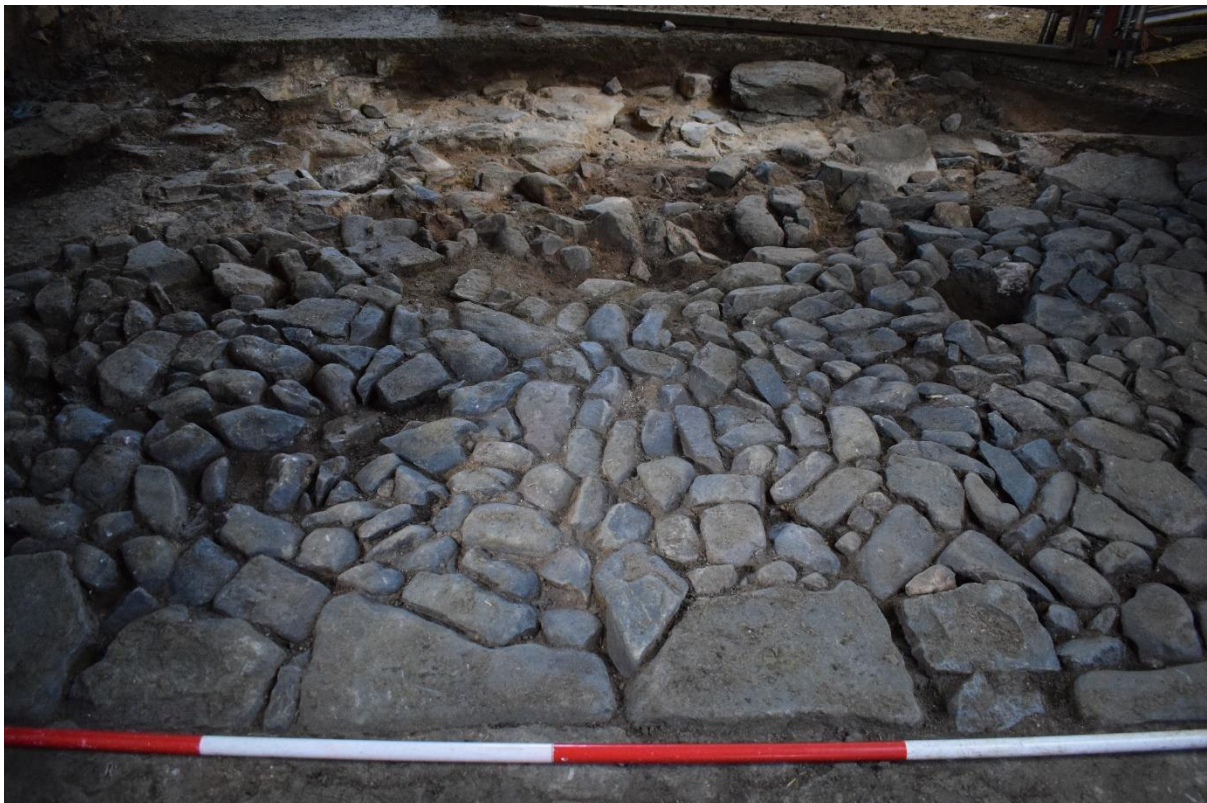
Trench 7 was located at the NE end of the NW wing of the farm. A wall foundation (Illus 17) was uncovered which had been the gable wall of the NW wing, dividing it from the NE wing. Cobbled surfaces (Illus 16) were recorded as well as post-holes. All were 19<sup>th</sup> century or later. The SW edge of the cobbled surface 701 was edged with larger stones.

Illus 16 Trench 7 cobbled surface 701 edges with larger flat stones; facing NE

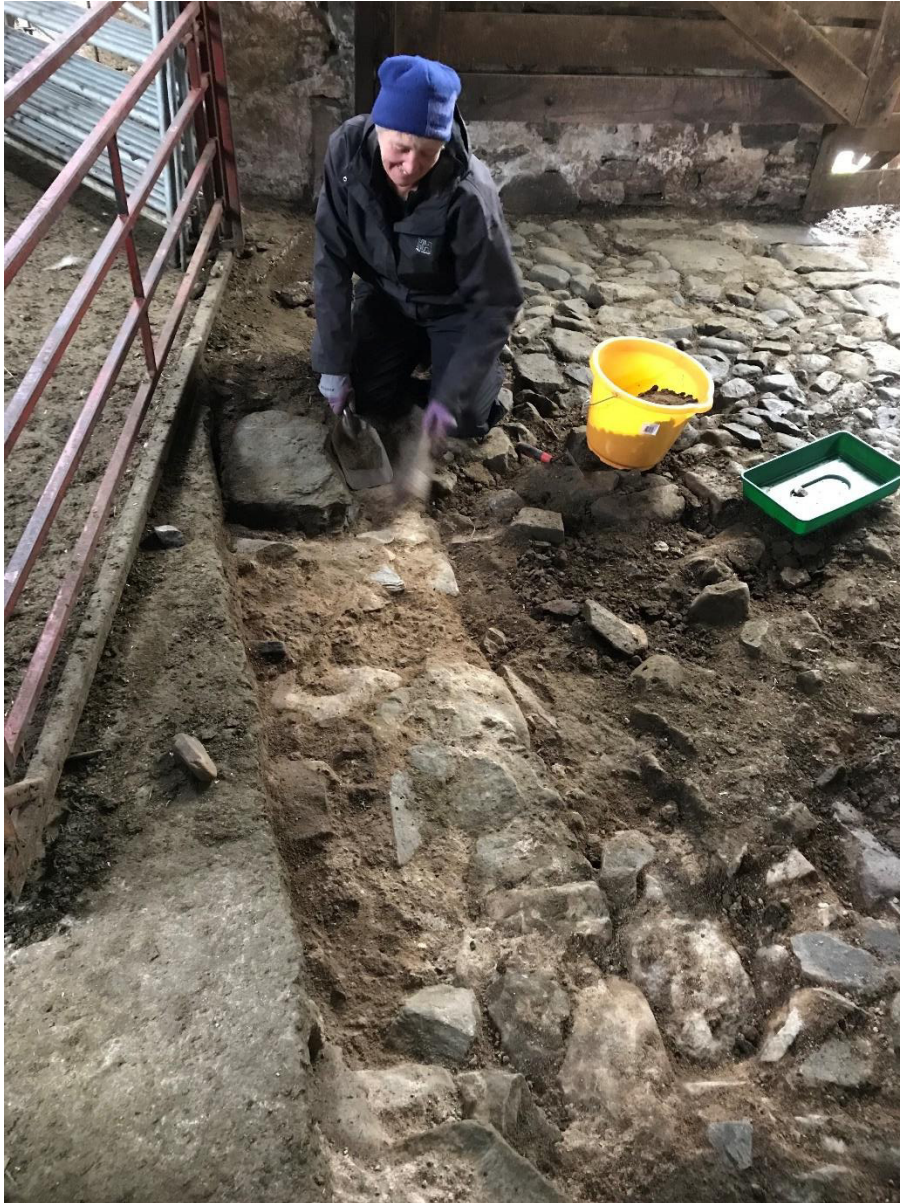
Illus 17 Trench 7 wall foundation 703; facing SE

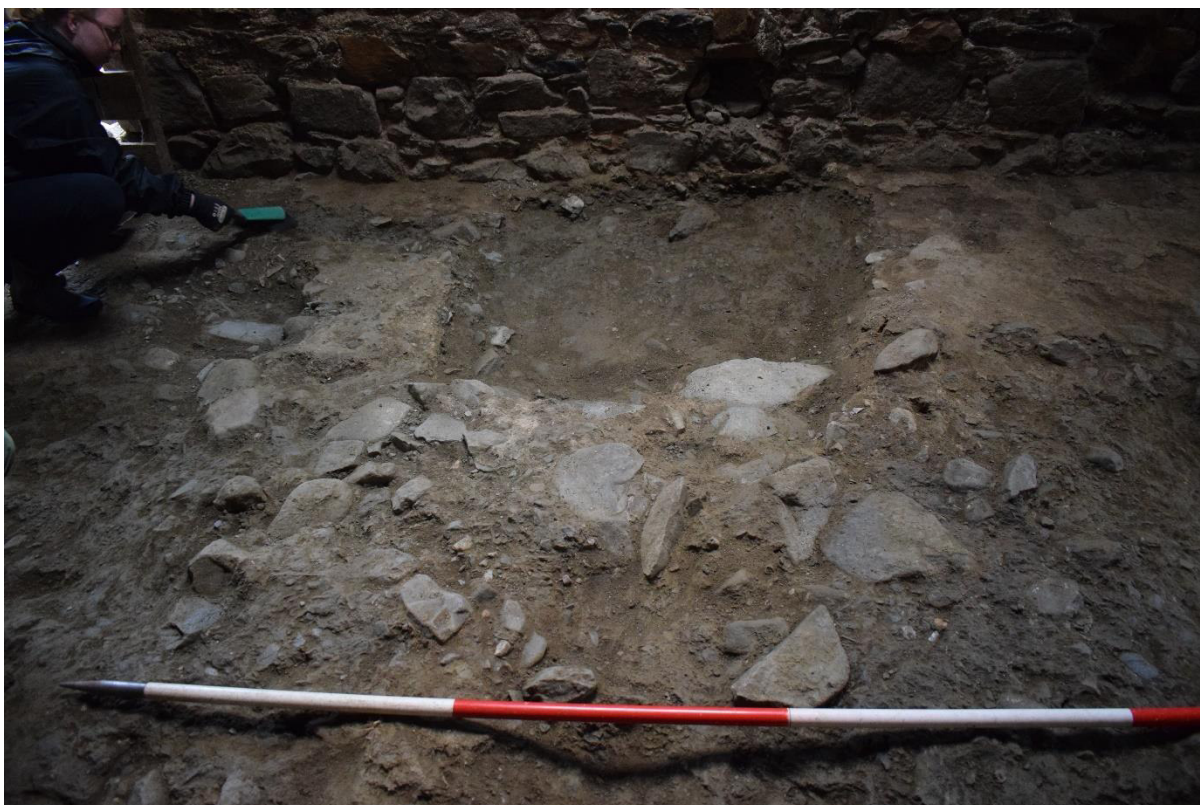
Trench 8 was located in the NW wing on the inner wall. A linear stone wall foundation was uncovered (802; Illus 18). It is likely that this was an internal fitting within the building such as a feeder. A small trench under the wall in this trench revealed that there are no substantial foundations below ground level; the buildings are built onto a large stone foundation but the ground level round about has been reduced leaving the foundations above ground level.

Illus 18 Trench 8 wall foundation 802 with possible patch of mortar floor 801 (top left); facing SE

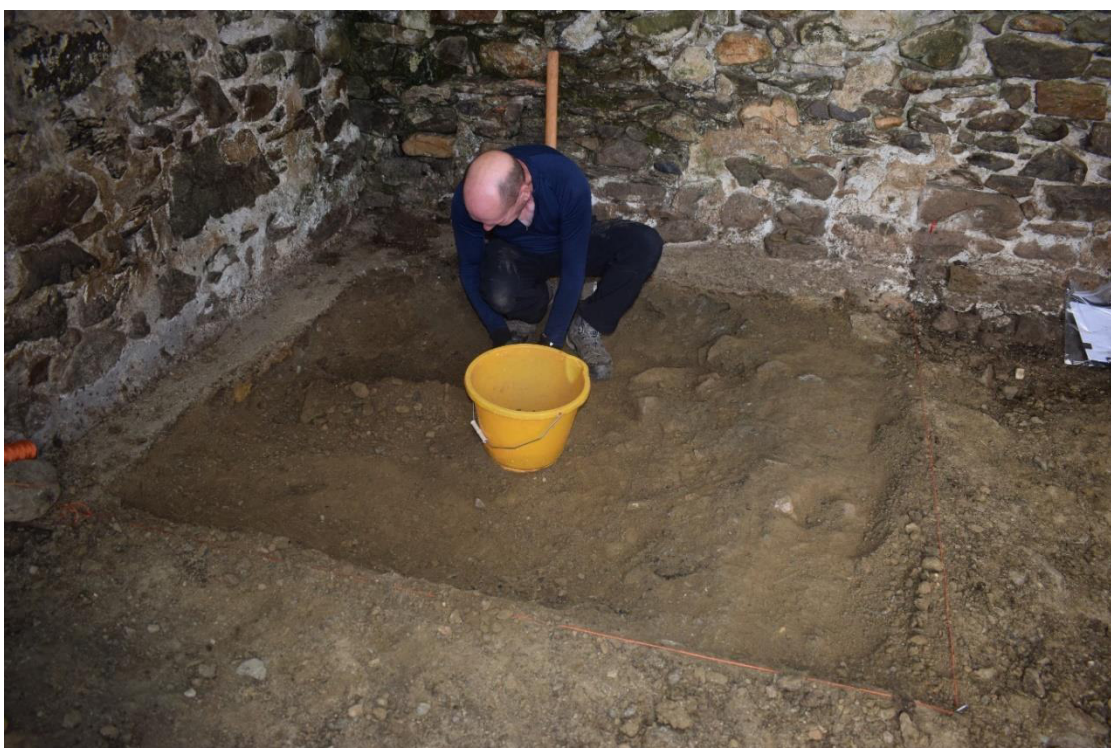
Trench 9 was located in the SW corner of the NW wing to look at the relationship between the mains walls of the building to determine if this is the oldest section of the building. The soils were so compact that only 10m depth (Illus 19) was removed but no archaeological features were identified and finds were sparse and modern.

Illus 19 Trench 9; facing W
