Bellevue, 22 Chapel Brae, Braemar, AB35 5YT

Report on Level 2 Standing Building Survey

Aberdeenshire Planning references 2018/1716 and 2018/1733

**Alison Cameron
Cameron Archaeology
28 September 2018**

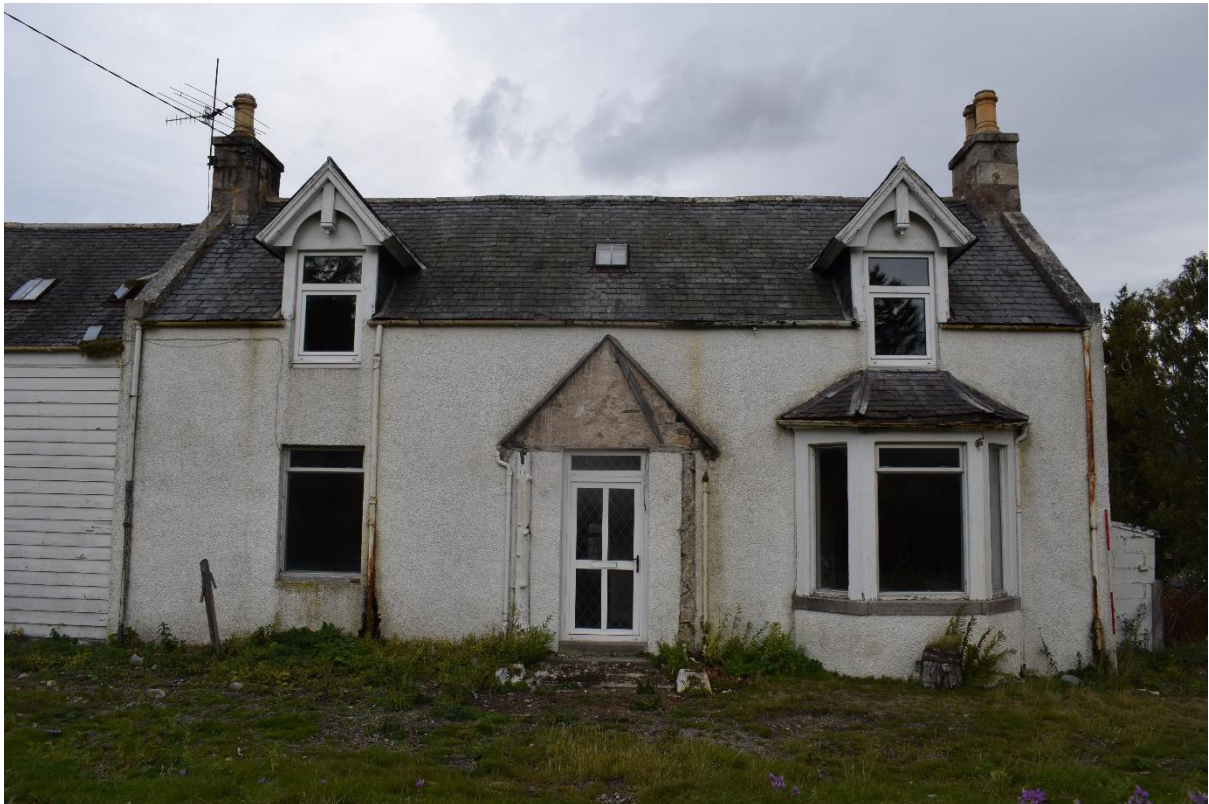
Cover: Phase 1 cottage front (south) façade; facing N

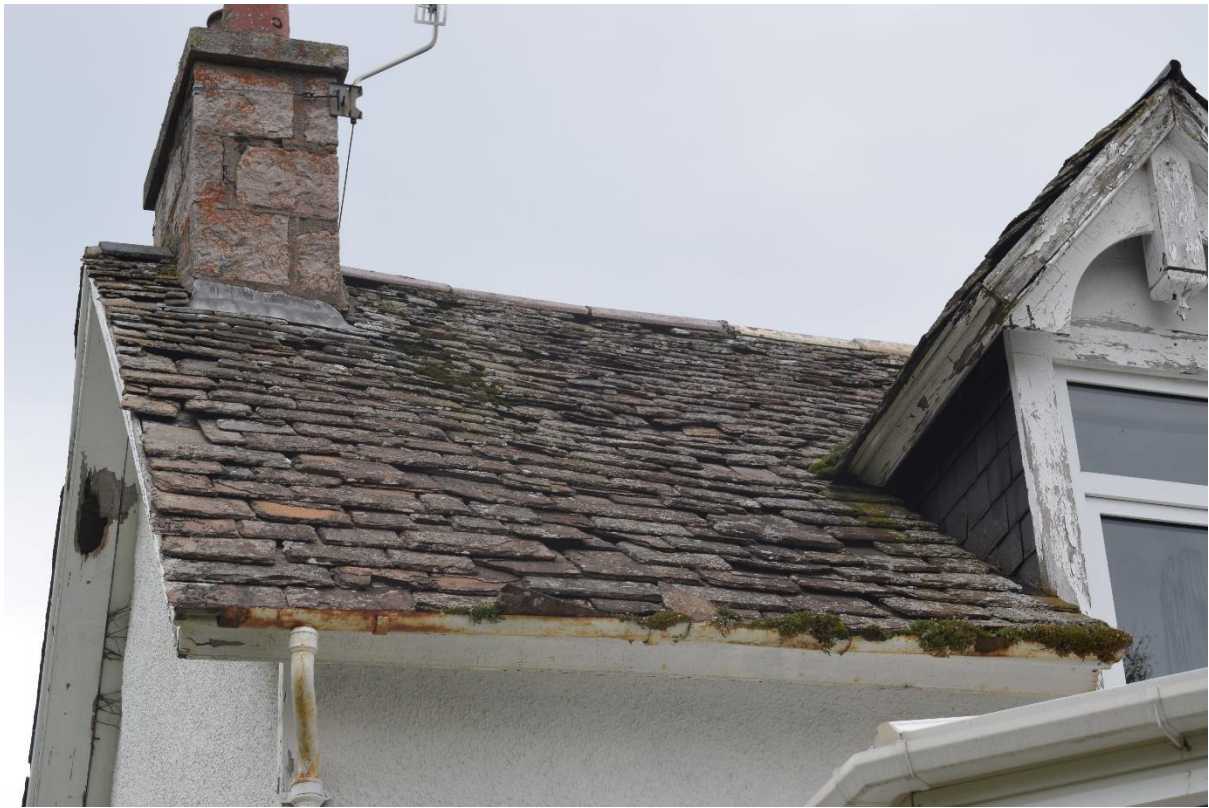
Illus 2 Grey stone roof tiles on Room 13 W facing roof; facing ESE

The Phase 2 extension (Room 1 on the ground floor and Rooms 13 and 14 on the first floor) onto the N is constructed of fieldstone with granite lintels, sill and chimneys with some stone roof tiles which have been replaced with grey slate. Phase 3 (Rooms 6 and 20) is a two-storey wooden extension onto the W of the main house; it has a grey slate roof. Phase 4 (Rooms 7, 8, 10) is single-storey wood extension to the W, Phase 5 a wood extension to the N of the Phases 3 and 4 building and Phase 6 is a modern conservatory (Room 12). These rooms are discussed in detail below.

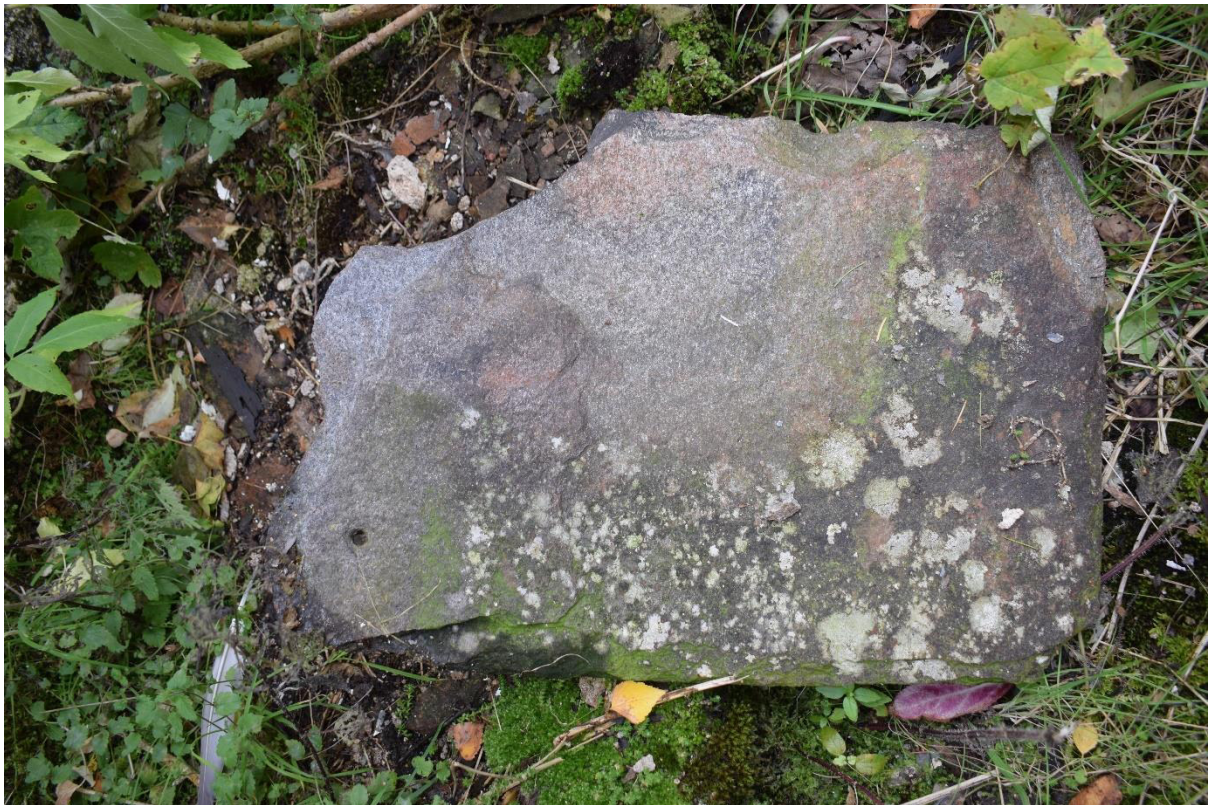
Illus 3 Stone roof tile

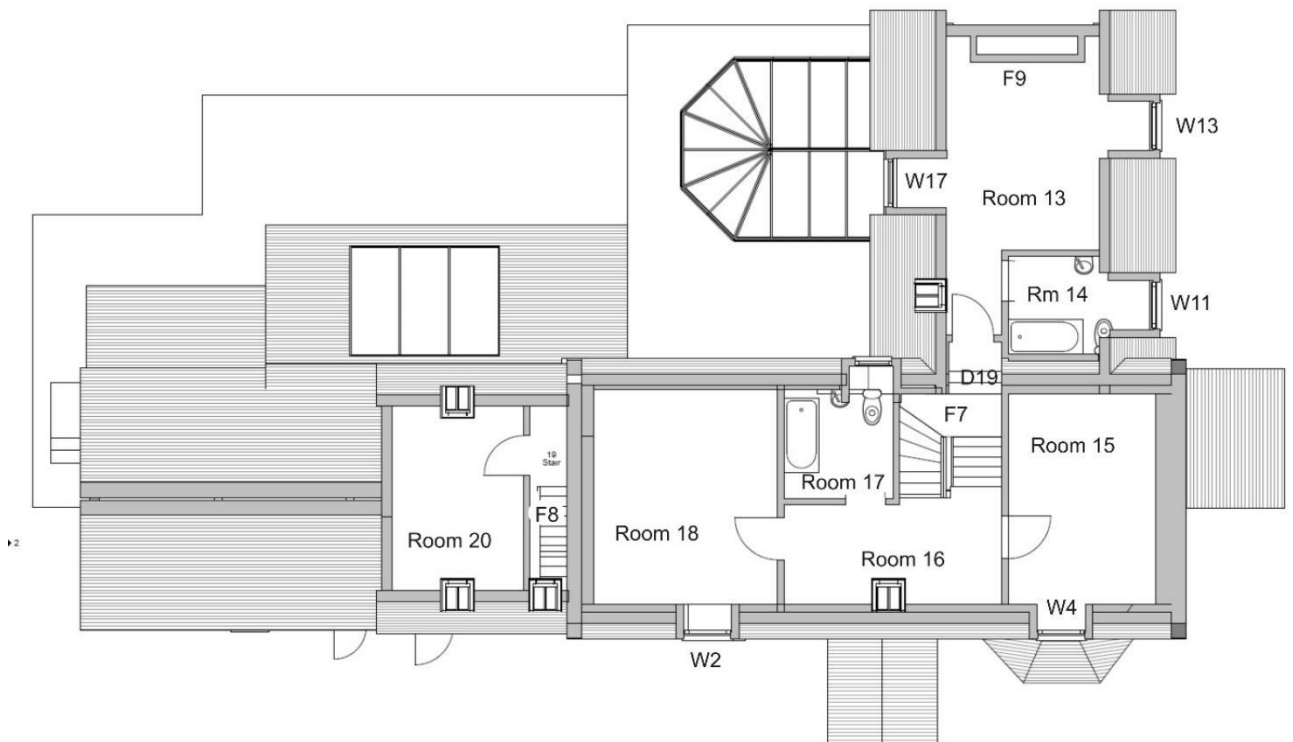
Illus 5 Plan of first floor annotated with numbers used in this survey (copyright Jam Studio)

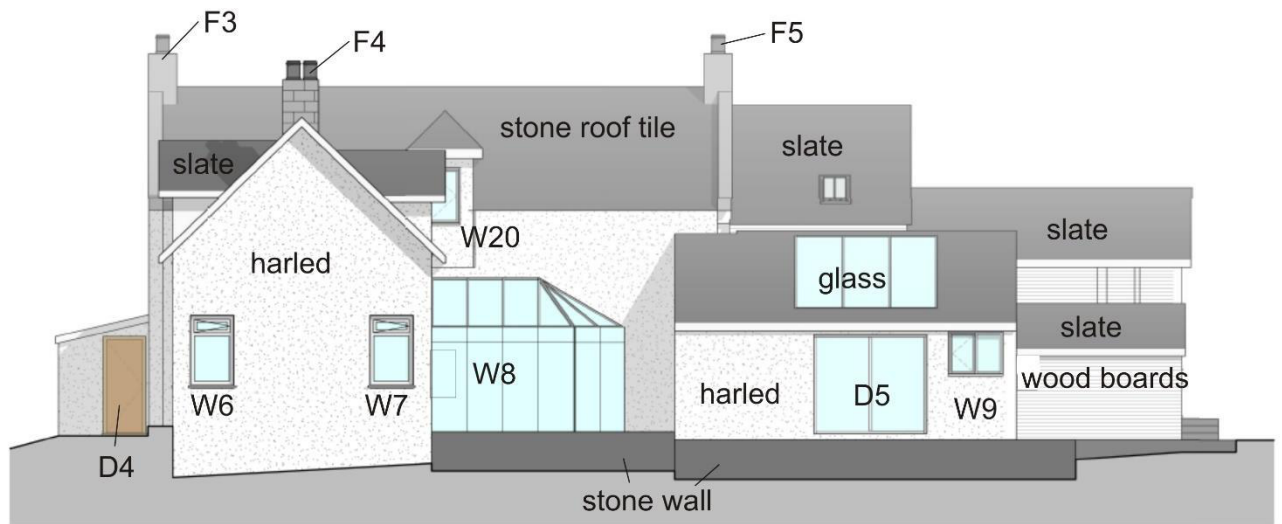
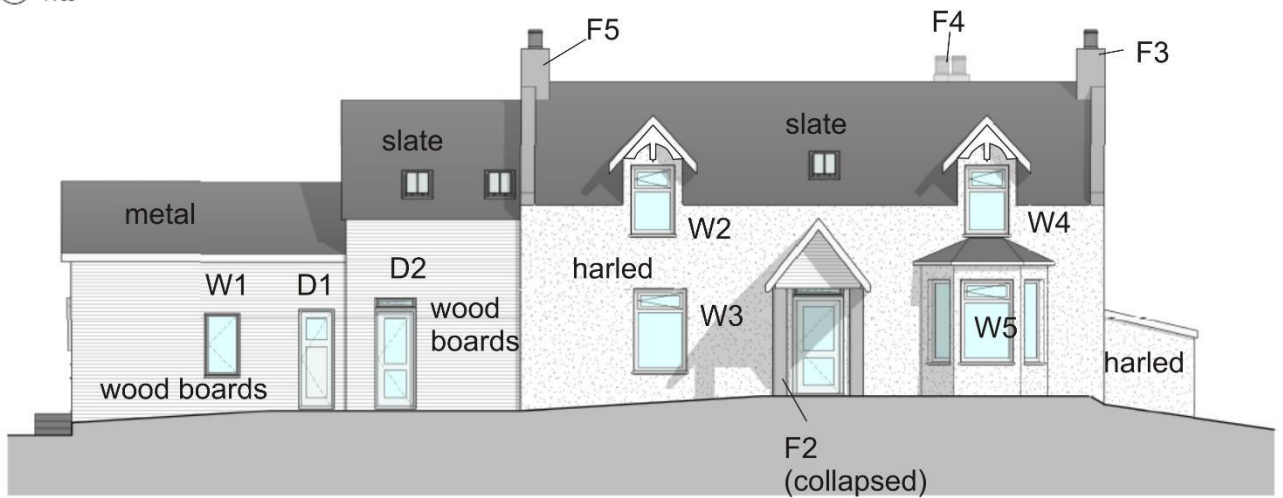
Illus 6 N and S elevations annotated with numbers used in this survey. The decorative wood hoodmoulds above W2 and W4 have been hand-drawn from the photographs taken from the ground floor. (copyright Jam Studio)

The Phase 1 building (Rooms 2-5 on the ground floor and 15-18 on the first floor) is 12.6 x 5.6m in size and constructed of granite and fieldstone. The roof of this building has probably been covered with grey stone roof tiles (Illus 2, 3) of graduated size and these survive on the N façade and on some of the Phase 2 roof. Very little of the original building can be seen as it is mainly harled. There are decorative wooden hoodmoulds above windows W2, W4, W11, W13 and W17, the first floor windows on the Phase 1 cottage (Illus cover, 6, 7 and 9).

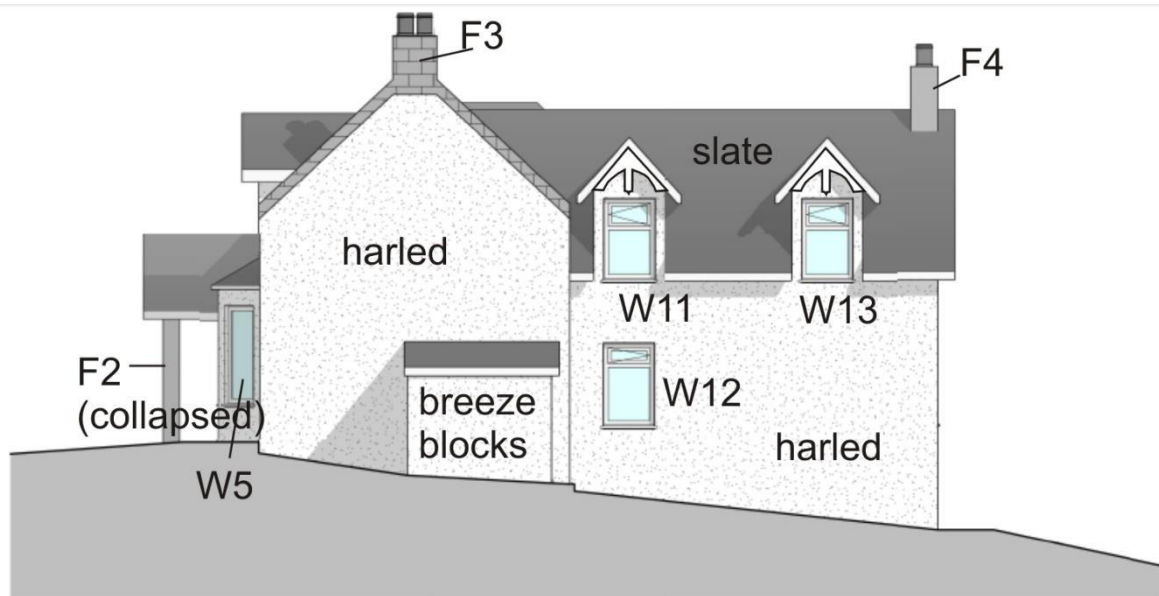
Illus 7 W and E elevations annotated with numbers used in this survey. The decorative wood hoodmoulds above W11, W13 and W17 have been hand-drawn from the photographs taken from the ground floor. (copyright Jam Studio)

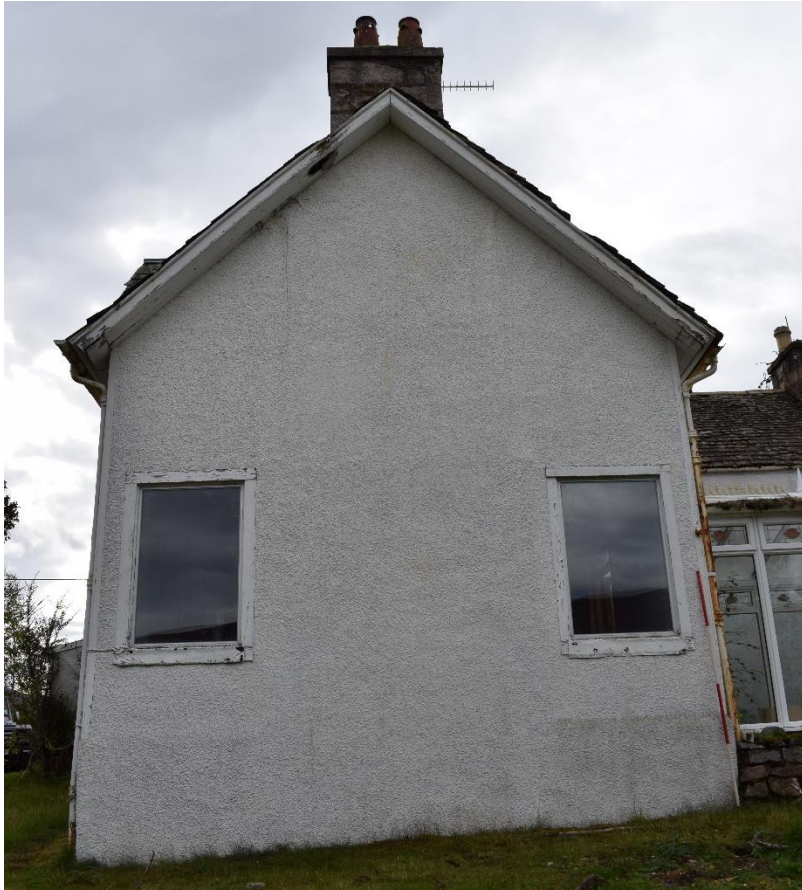
Illus 8 Room 1 N gable with W6 and W7 and chimney F4 above; facing S

Room 1 is the Phase 2 living room at the NE corner of the house; it is 6.6 x 4.2m in size with a large central fireplace (F1; Illus 10) on the N wall flanked by two large picture windows (W6 and W7). These windows were originally longer and the infill scars (which have been harled over) can be seen on the external façade (Illus 8, 9). This room was added between the First and Second Edition OS maps.

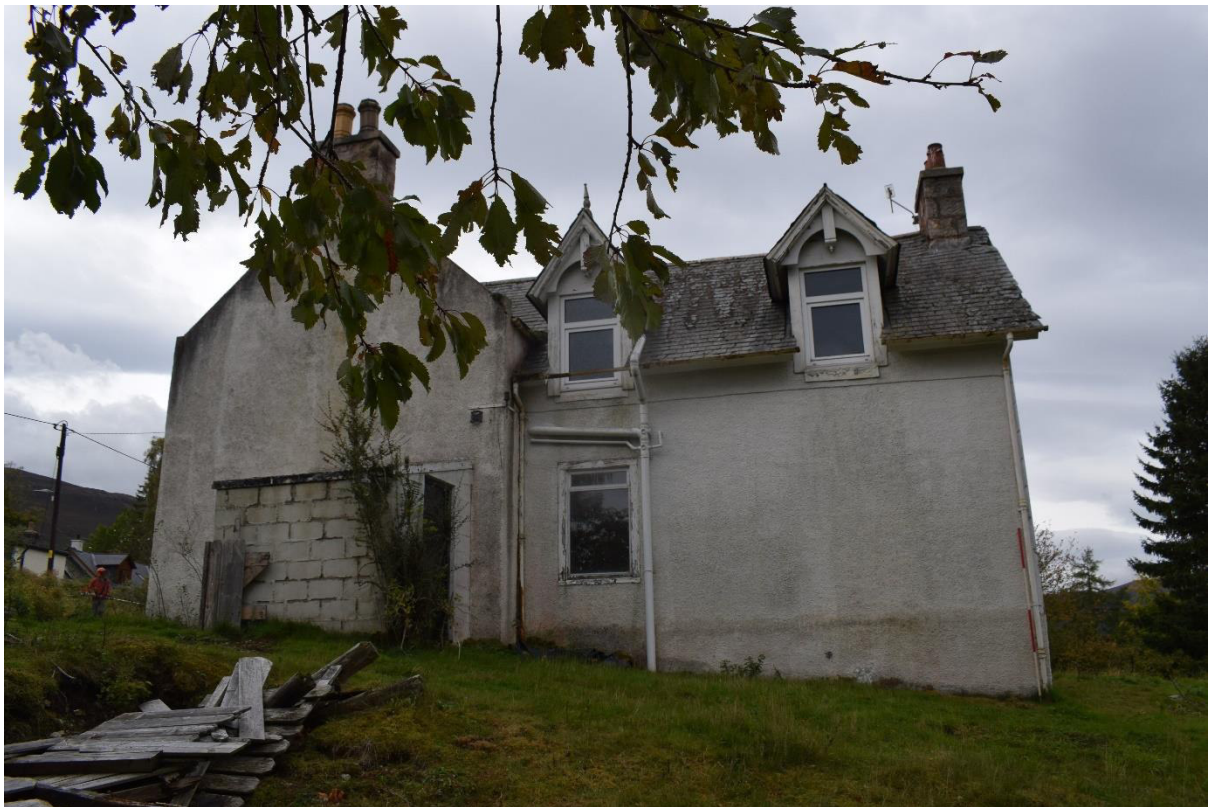
Illus 9 Room 1 (Phase 2) added on to the N of the Phase 1 cottage (left); facing W

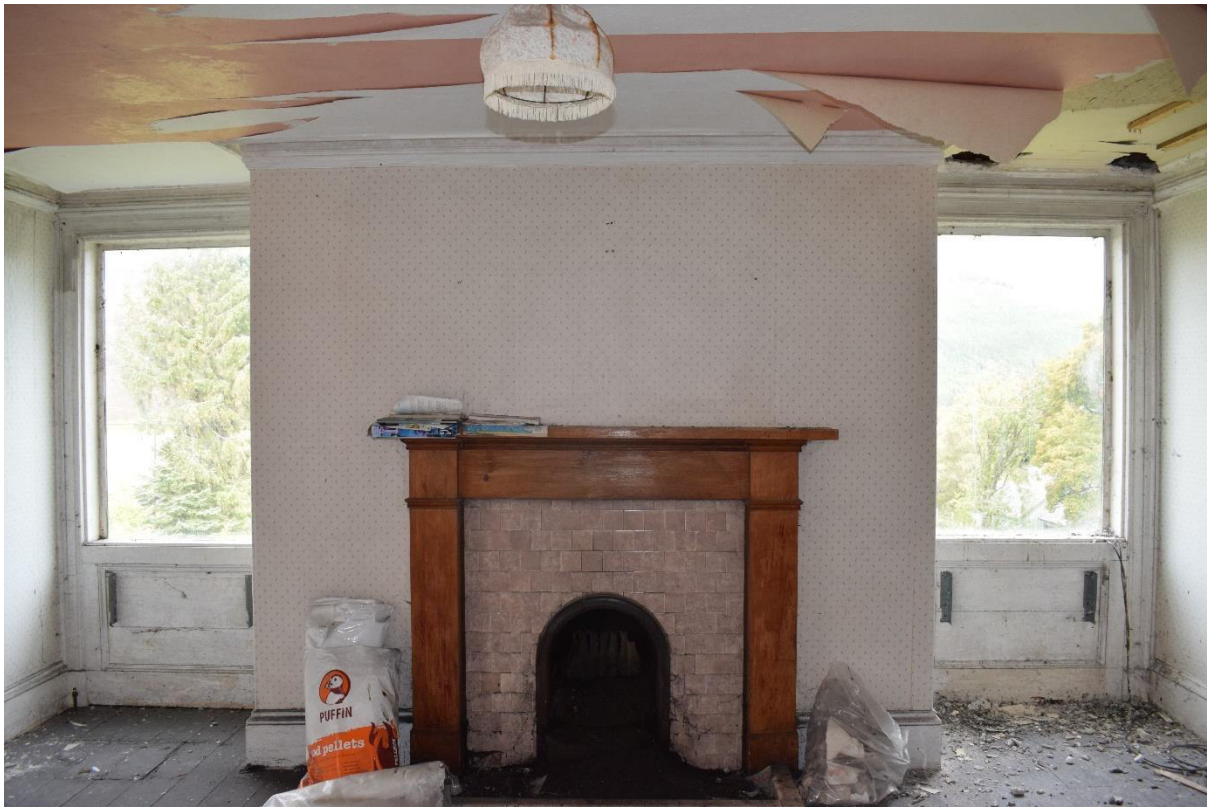
Illus 10 Room 1 N wall W7, fireplace F1, W8; facing N

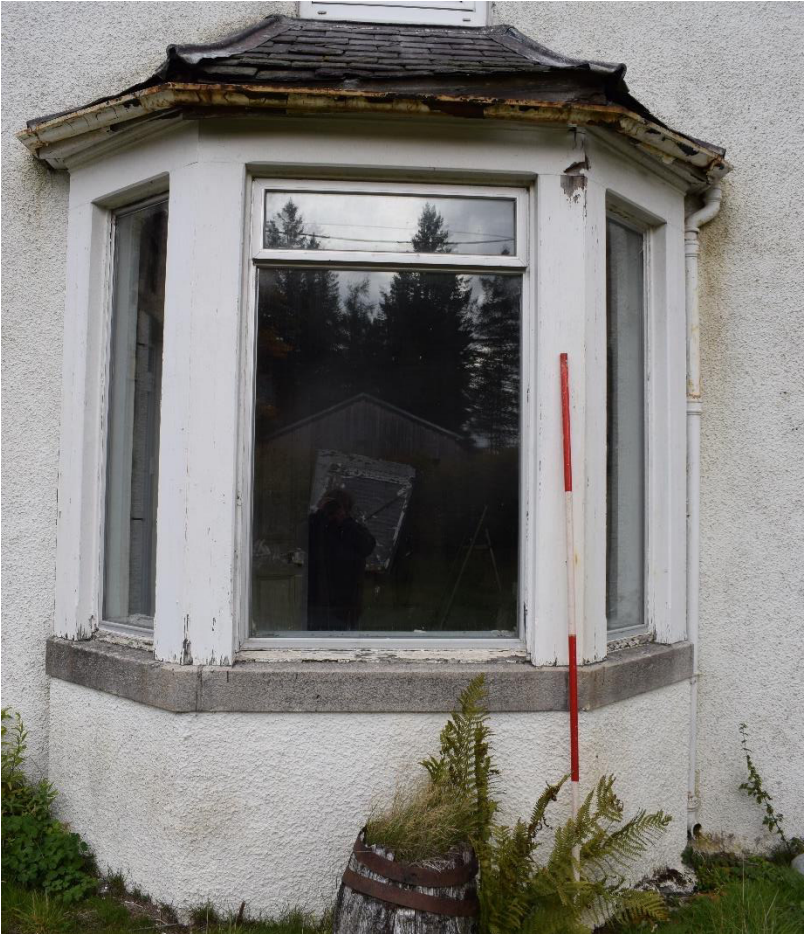
Illus 11 Room 2 Phase 2 bay window W5

Room 2 is the SE room of the Phase 1 cottage. It is 3.15 x 5.5m in size and has a bay window (W5) on the S wall which was added between the First and Second OS map dates. There is a door to the hall on the W wall and an alcove (F6; Illus 11) at the N end of the E wall. The walls are 0.5m thick. There is simple corncicing around this room (Illus 12).

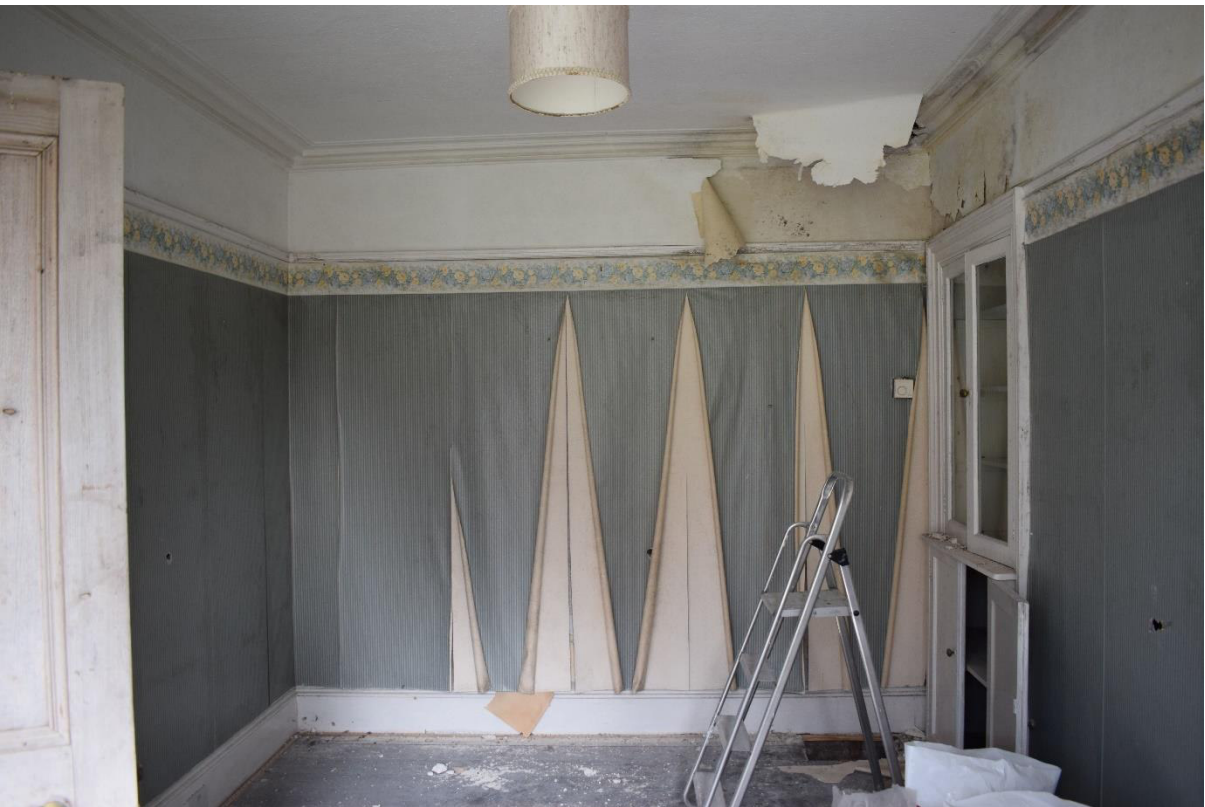
Illus 12 Room 2 N wall showing corning; facing N

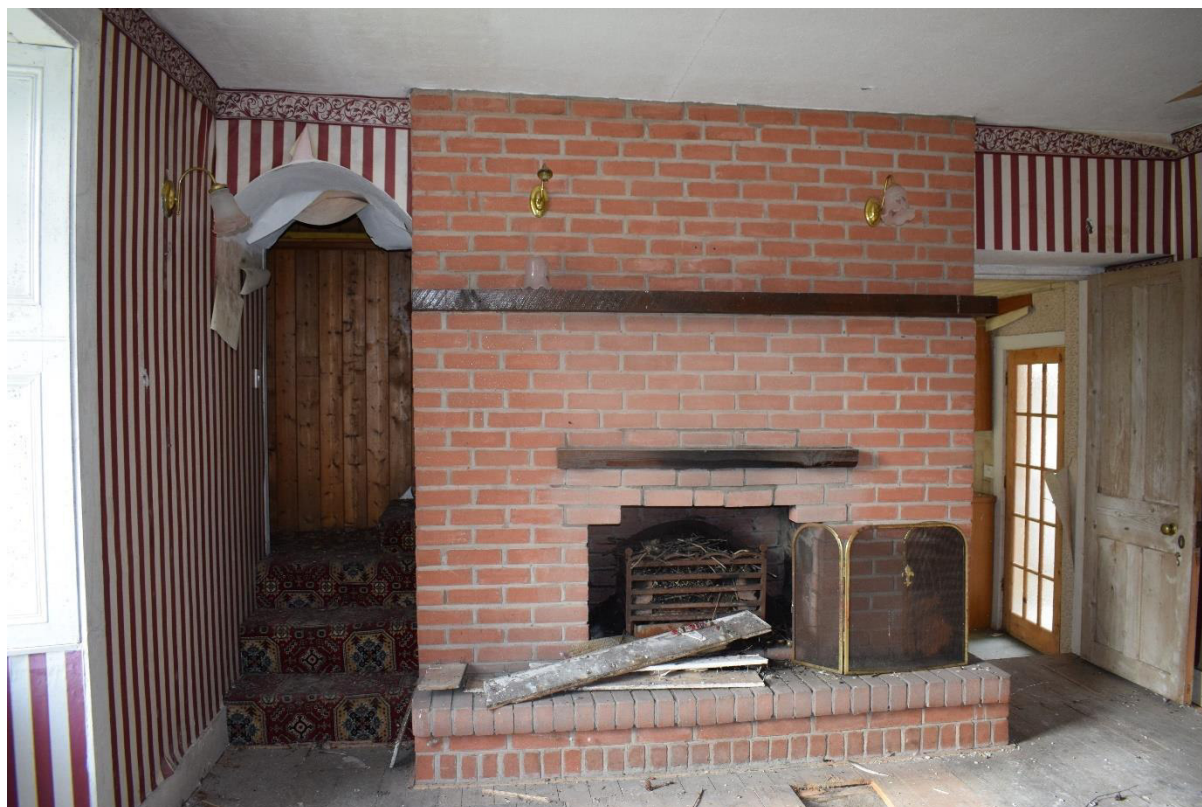
Illus 13 Room 5 W wall, originally the W wall of the phase 1 cottage, with 1970s (?) fireplace F10 and door to upstairs room (left); facing W

Room 5 is the W Phase 1 room, a maximum of 4.4 x 4.5m in size with window W3 on the S wall, door to the hall on the E wall. There is a door to the Phase 3 kitchen (Room 6) at the N end of the W wall (with steps down) and a door to stairs F8 (Illus 13) which lead to the first floor bedroom Room 20.

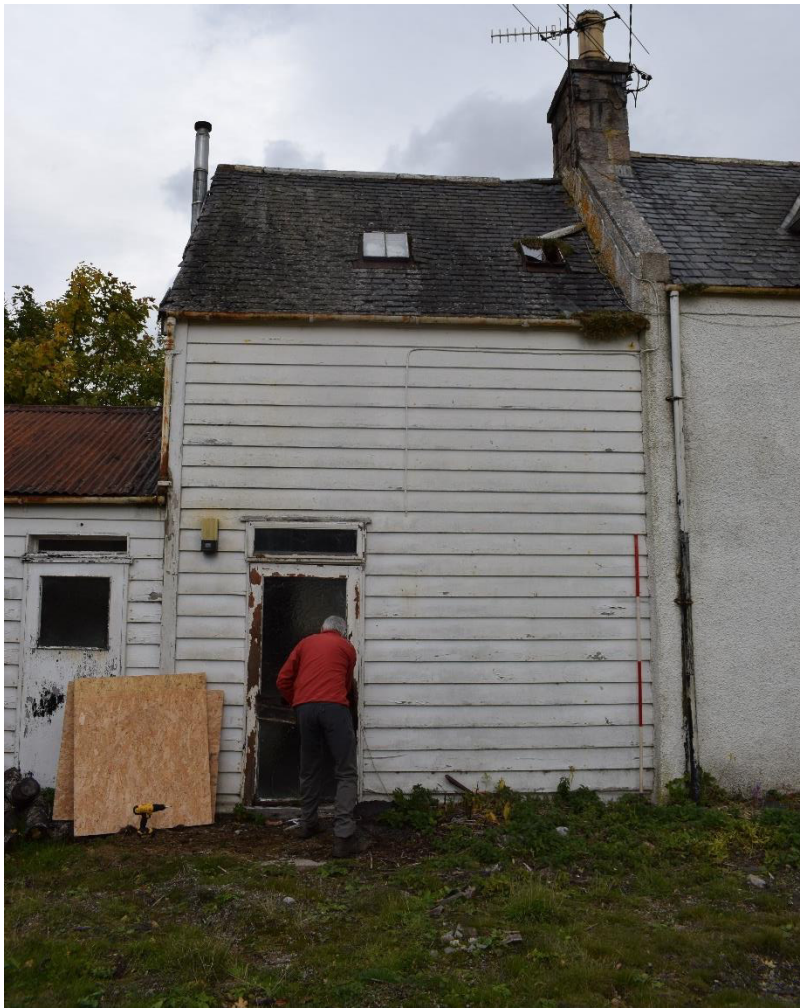
Illus 14 Phase 3 wood paneled S façade with D2 and grey slate roof; facing N

Room 6 is the kitchen of the Phase 3 house (Illus 14). This section of the building is timber clad. The kitchen is 5.2 x 3.5m in size with large recessed cooking area on the W wall (Illus 15), door to the S façade D2, door (D20) and window (W18) in the N wall leading to Phase 5 sunroom (Room 11). There is a door to Room 7 in the W wall and to Room 5 in the E wall.

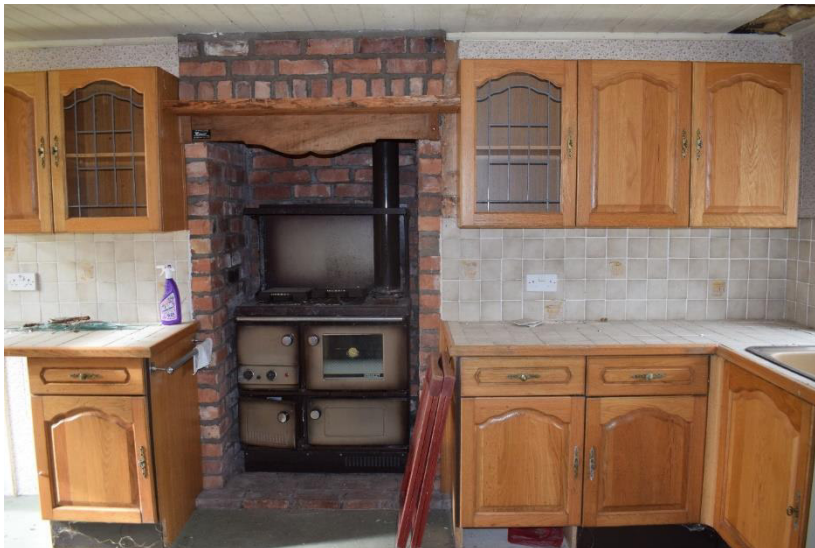
Illus 15 Room 6 kitchen W wall; facing W

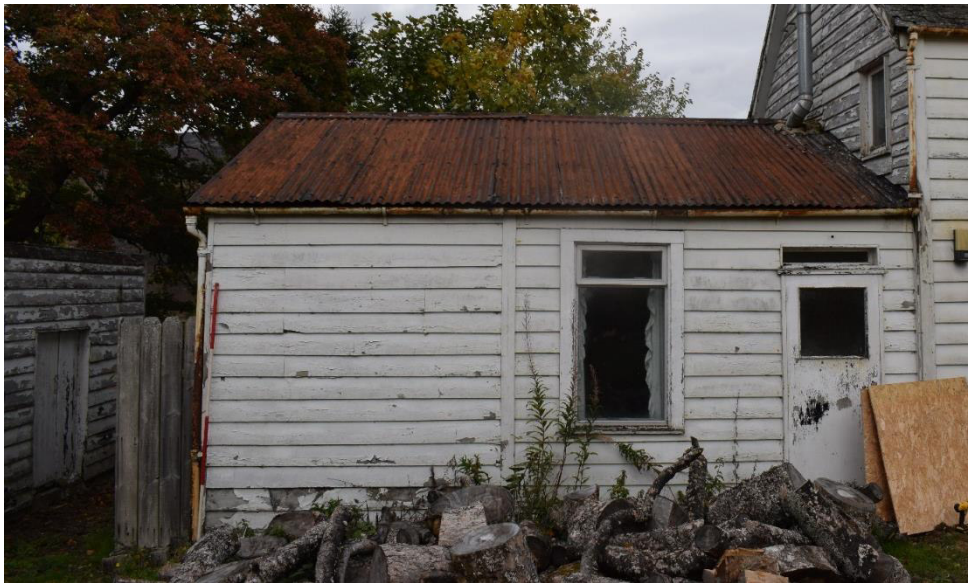
Illus 16 Phase 4 metal-roofed wood-panelled extension with W1 and D1; facing N

Room 7 is Phase 4 reception room 2.7 x max 3.5m wide with door (D10) and window (W1) (Illus 16) on the S wall, door to Room 10 on the W wall and small window to the N (W19).

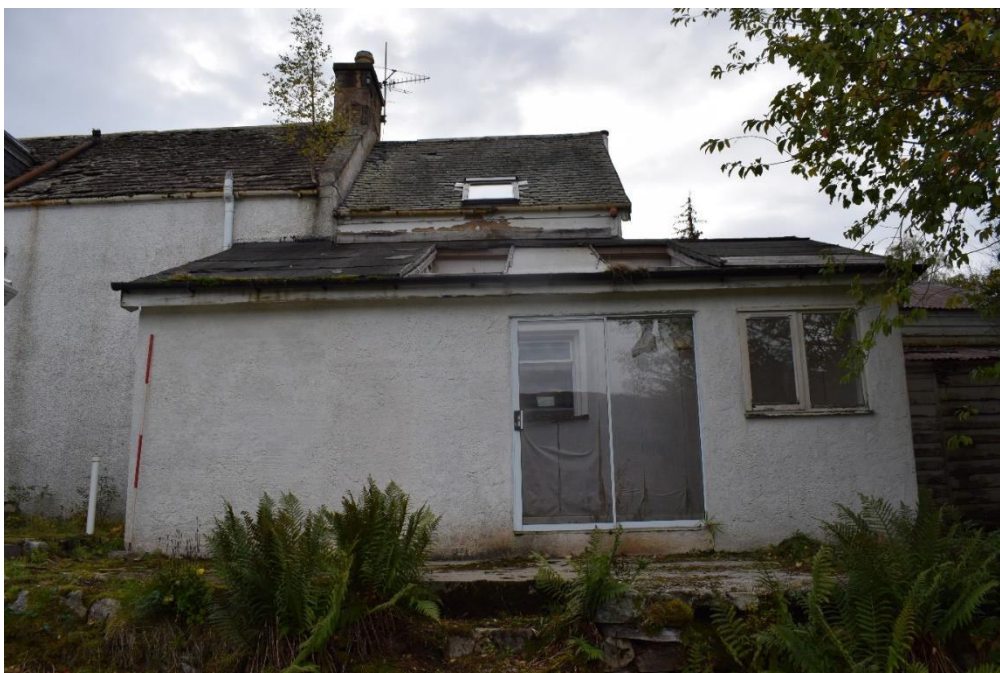
Illus 17 Room 11 N wall; facing S

Room 11 is a Phase 5 sunroom built using plywood and glass (Illus 17). It is 7 x 2.5m in size and accessed from Room 6 kitchen by door D20 (although there was no access to the interior of this room during the survey).

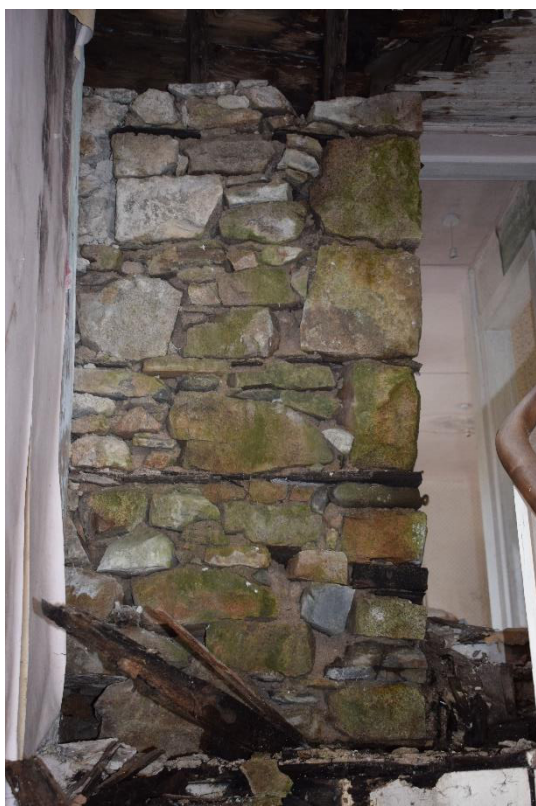
Illus 18 View of stonework for D19 halfway up stairs (not accessible as roof above has collapsed) showing possible first floor window in N wall of Phase 1 cottage; facing N

Room 16 is the first floor hall with stair F7, door which may have been a Phase 1 window on the N wall (D19), bathroom Room 17 on the N wall and doors to bedrooms Room 15 on the E wall and Room 18 on the W wall. Details and measurements are taken from the scale plan as there is no access to this room.

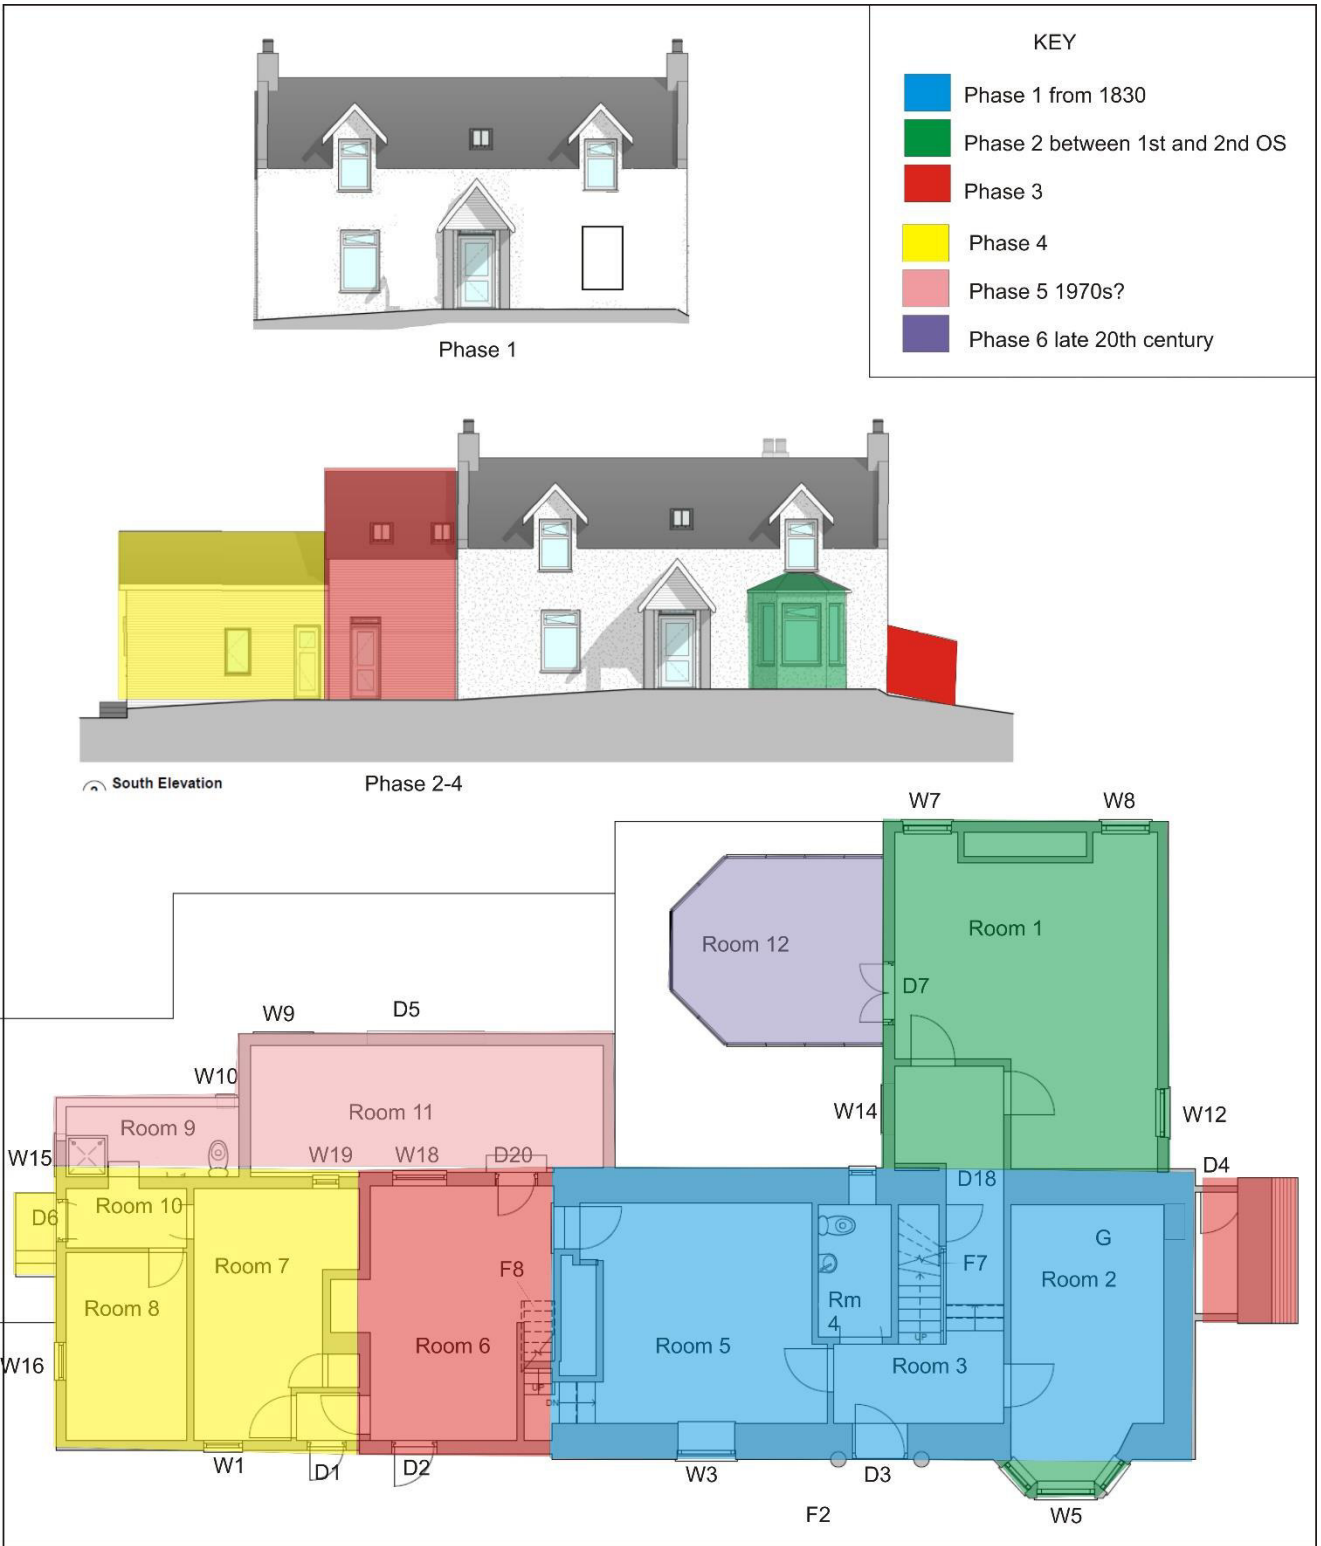
Illus 19 Phase plan showing main phases of development of this building (copyright JamStudio)

A Level 2 standing building survey was carried out on 25 September 2018. At least six phases of construction (Illus 19) were recorded in this cottage which dates back to at least 1830AD (Ken Manson, current owner, pers comm) who has deeds to this effect. The stone cottage was originally rectangular and a stone extension to the N was added between the First and Second Ordnance survey dates. There are early stone roof tiles on the Phase 1 and 2 roofs, although some have been replaced with grey slates. The Phase 3 extension on the W of the building is in wood with a slate roof and a further wood extension with a metal roof on the W side of the cottage; both were added in the early to mid 20th century period. Onto the N two rooms including a bathroom and sunroom were added in the mid 20th century and a conservatory added in the late 20th century.
