**Land at Drummargettie North of Mains of Monaltrie  
Crathie, Aberdeenshire CA368  
Report on a Level 1 Standing Building Survey**

**Dr Robert Lenfert  
Cameron Archaeology  
27-10-2017**

## **SUMMARY**

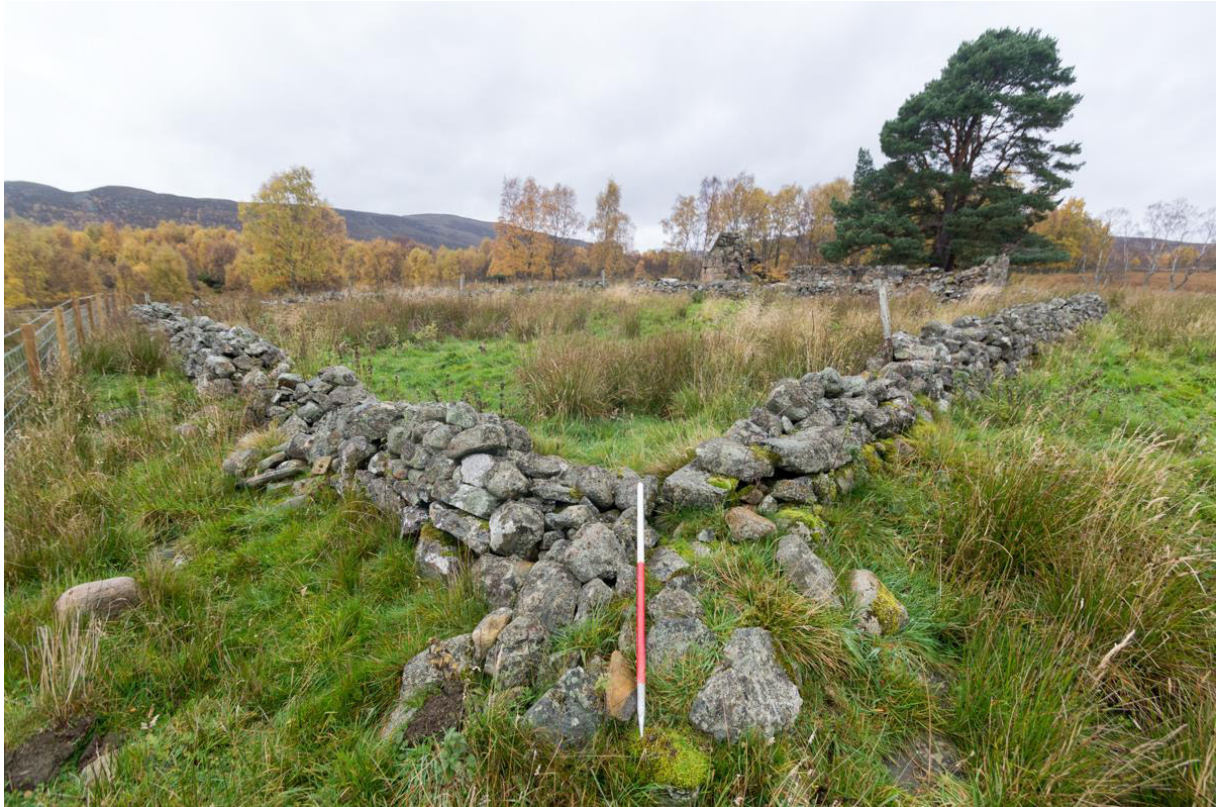
Illus 7: WNW view looking across the sheep fank.

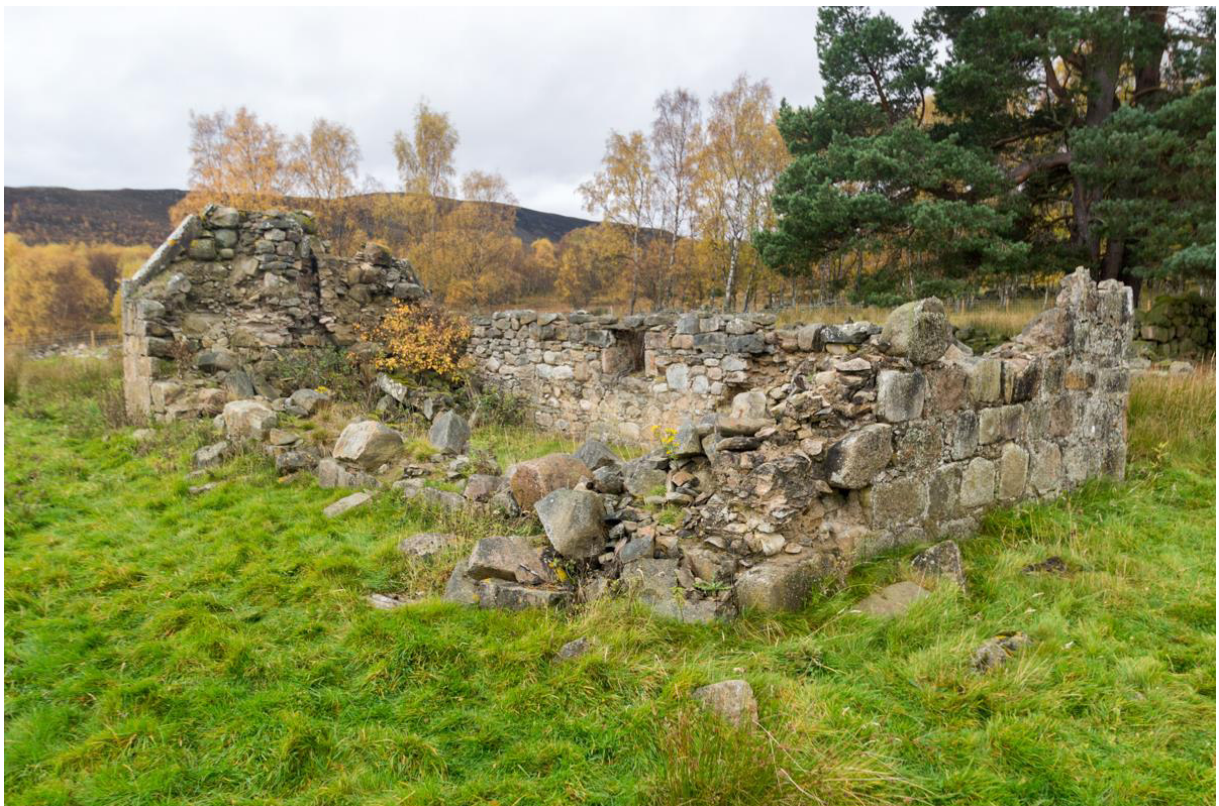
Illus 8: Longhouse A – view looking W. Note central window (W1) on NW facing wall and infilled double-wall construction visible in foreground corner.

Longhouse A (Illus 4&8) survives as the better preserved of the two house structures. The longhouse is aligned roughly parallel with the sheep fank, and sits 3-4m to the NW. The rectangular structure measures 12.5m on the long axis by 5.25m on the short axis, and stands to a maximum height of 3.2m on the SW short axis. On the SW axis is a hearth and chimney, surrounded by tumbled stone and moderate vegetation which prevents a full examination of the internal walling in that particular part of the house. The walling (a double-wall infilled construction) consists of a mix of both rough-worked rectangular sandstone blocks and natural unworked rounded stones of local origin with lime mortar pointing and flat, tabular stonework 'chinking' used as shims in any gaps too large to fill with mortar alone. The finer examples of stonework can be seen on the corner sections, particularly the W corner. The walling averages 0.8m in width, up to

1.0m around the chimney area. The NW wall on the long axis stands some 1.5m in maximum height, with a centrally located single window 0.63m high by 0.4m wide with a lintel still in place, though no walling survives above the lintel. The NE wall on the short axis of Longhouse A is now reduced to 1.5m high with a considerable amount of collapsed rubble piled up inside against the wall. This may have been intentional to prevent collapse onto any people or livestock. The stone rubble appears to come from the SE wall on the long axis, which is now largely robbed out to ground level with the exception of the SW corner where 5-6 courses of stone still remain.

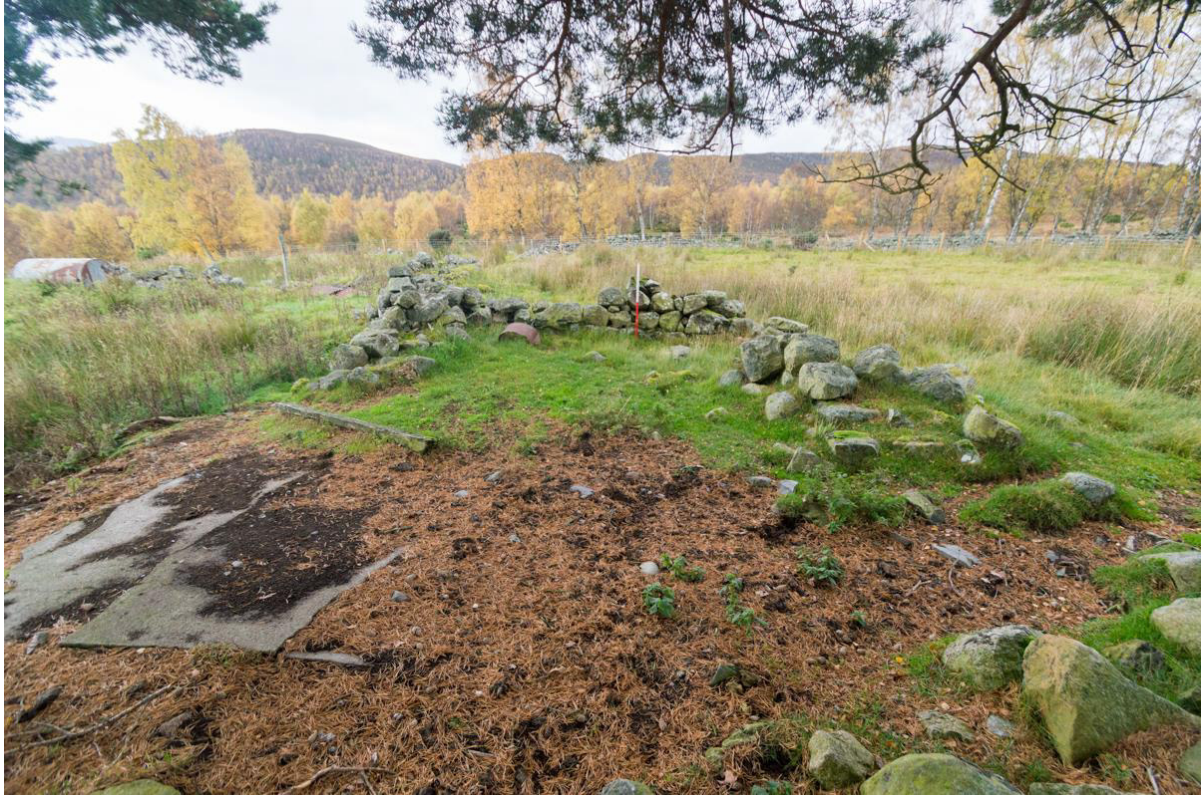
Illus 9: Heavily robbed-out Longhouse B - view looking SW.

To the NE, a series of low kerbing abuts Longhouse B, which, in comparison to Longhouse A, now survives in largely ruinous condition, with the majority of stonework robbed out, perhaps for the repair of Longhouse A or the repair or construction of the stone dyke which stands just outside the property boundary on the west side.

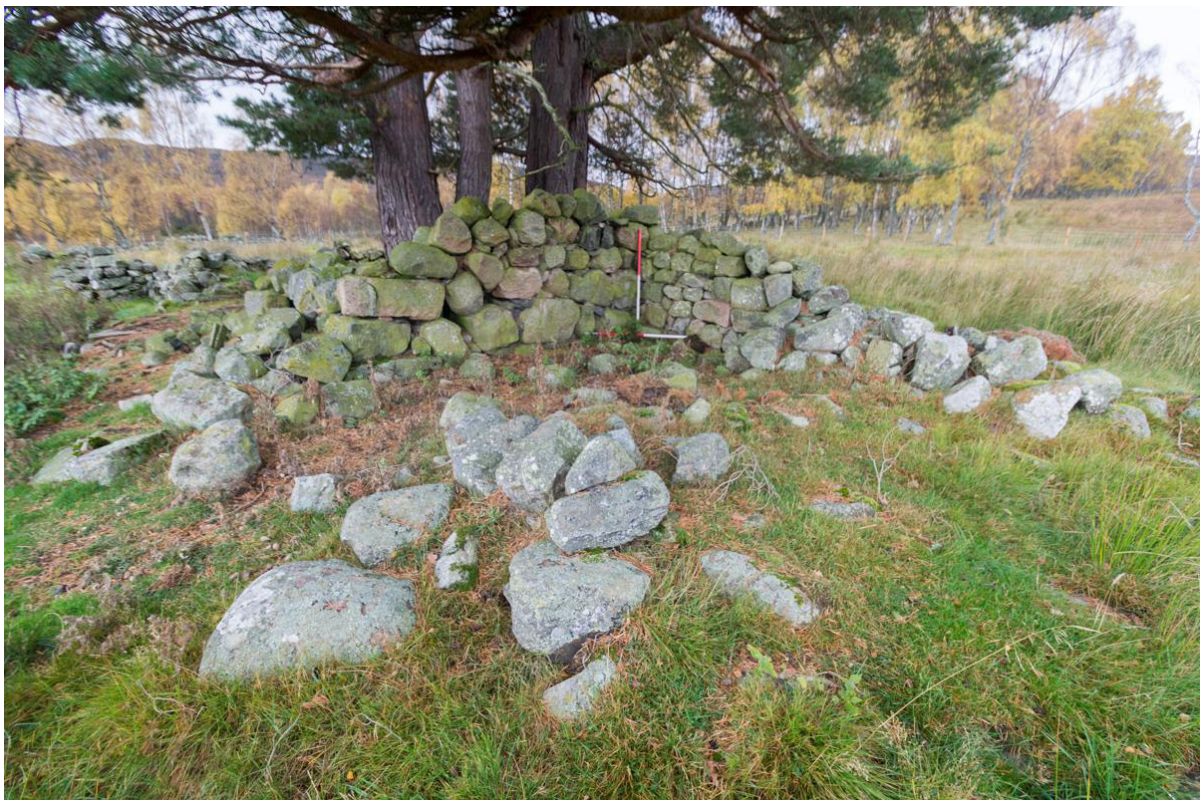
Illus 10: NE extension or possible byre connected to Longhouse B – possible 'Phase II'.

Longhouse B (Illus 10 & 12), along with Longhouse A and a small outbuilding to the west, are shown as roofed on the 1866 first edition map, with Longhouse B the larger of the two structures. This appears to include the possible byre at the NE end of Longhouse B which in combination measures 15m on the long axis by 5.25m again on the short axis, indicating that both longhouses were built to the same width, but the length of B was extended by the addition of the outbuilding. Immediately to the SW lies the low foundations of a second sheep fank or enclosure (Illus 8) measuring 12.5m wide by 21.5m on the long axis. It is either truncated or intentionally abuts the drystone dyke on the west boundary, which now lies immediately beyond the barbed wire fence marking the modern plot boundary. This enclosure now stands as a single course of stone measuring 0.75m in width and c. 0.25m high, and is now incomplete and missing at the end closest to Longhouse B. There is however a low connecting wall of equal height which continues past the enclosure to connect to the SW corner of Longhouse B, indicating that at some point there was a passage or doorway, which is borne out by a slight gap in the stonework.

By the revision date of 1900 for the second edition map, the enclosure next to Longhouse B is now depicted as unroofed. The possible byre in Illustration 7 is poorly made and lacks mortar, suggesting that the structure visible at the time of this survey is perhaps a later construction or, if contemporary with Longhouse B, indeed a roughly constructed byre not intended for human habitation, rather more as a windbreak or shelter for livestock.

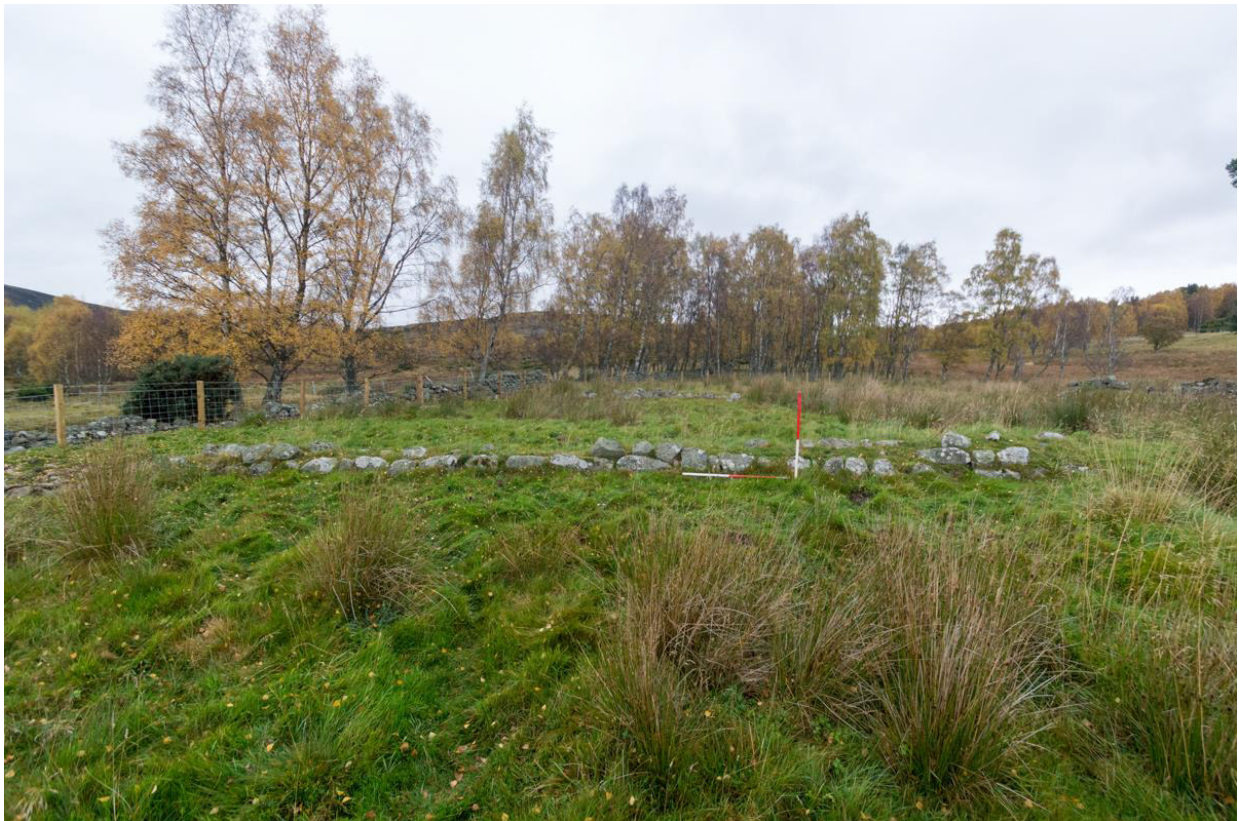
Illus 11: Enclosure to south-west of Longhouse B, looking north-west.

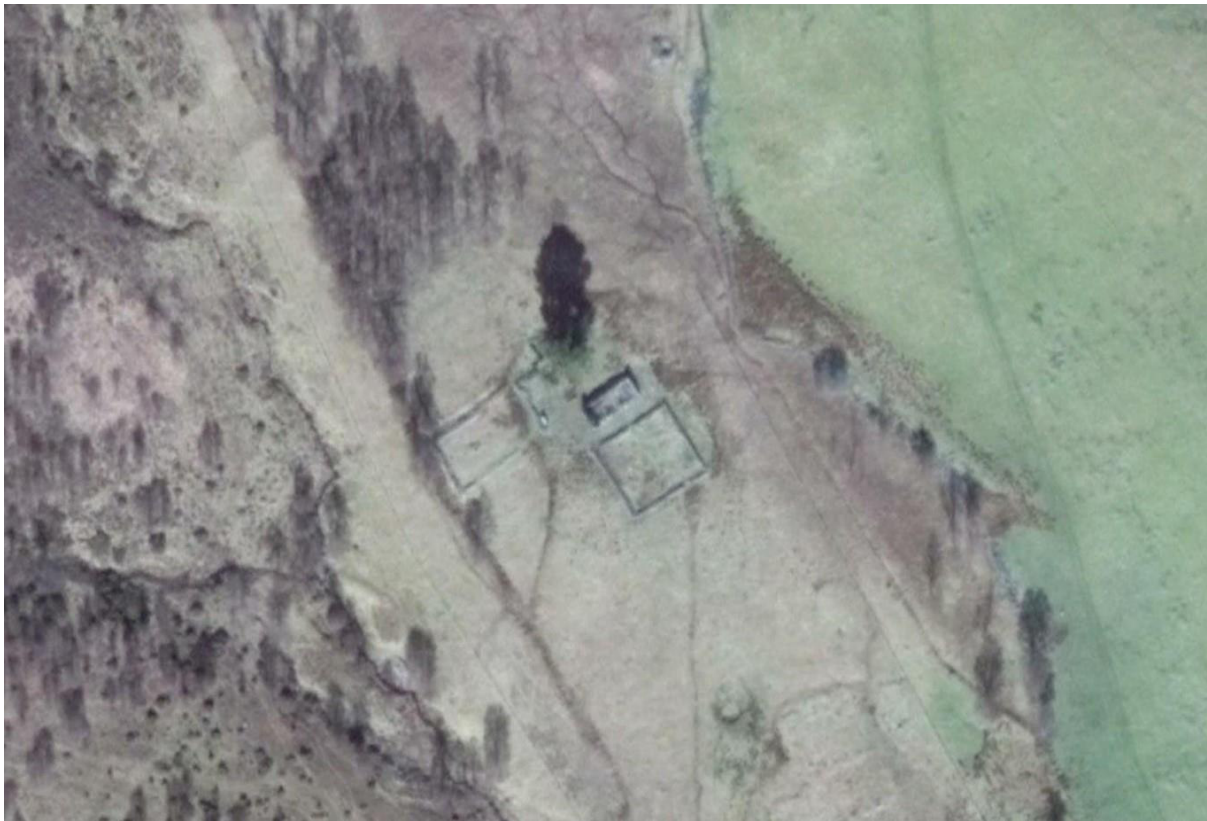
Illus 18: Aerial view of Drummargettie. This photo indicates that several grass-covered foundations exist in the lower right of the frame (outside of the project area) which are not currently on any records.

It is recommended that a watching brief take place during future groundworks to identify any earlier foundations that may exist around Longhouse B and the west enclosure, and clarify those in existence beyond Longhouse A.
