**Torry Battery, Greyhope Road, Aberdeen AB11 5HB  
Data Structure Report (DSR) for trenches 5.12.18**

**Alison Cameron  
Cameron Archaeology Ltd  
11 December 2018**

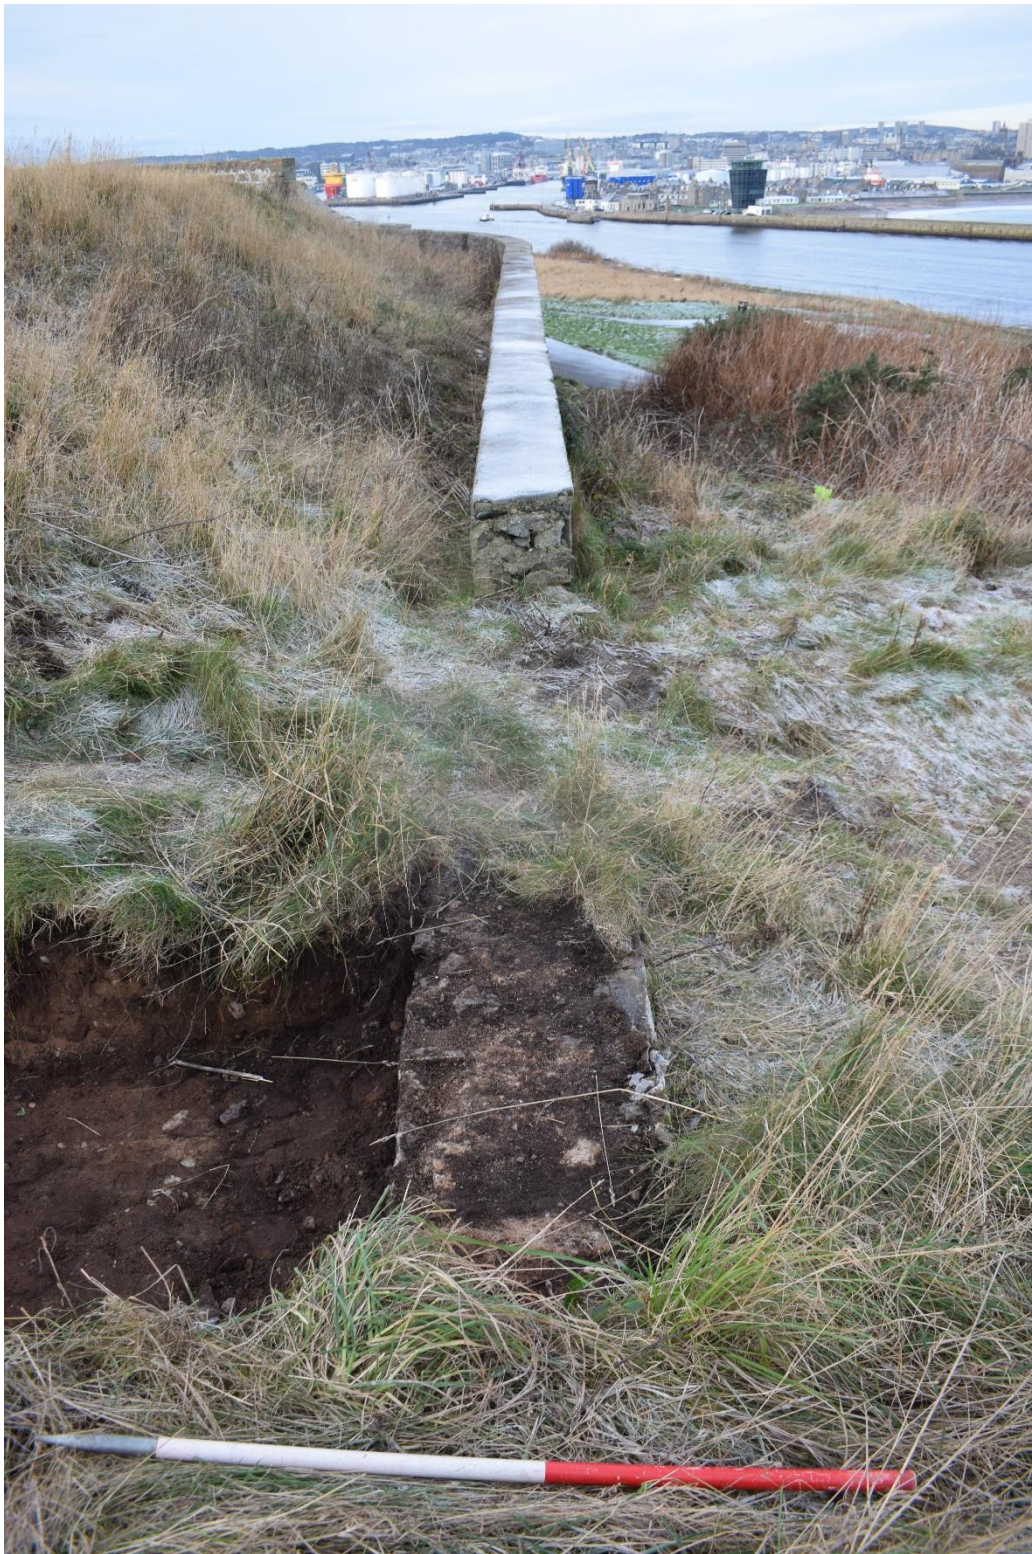
Cover: Trench 3 with wall 301 facing W

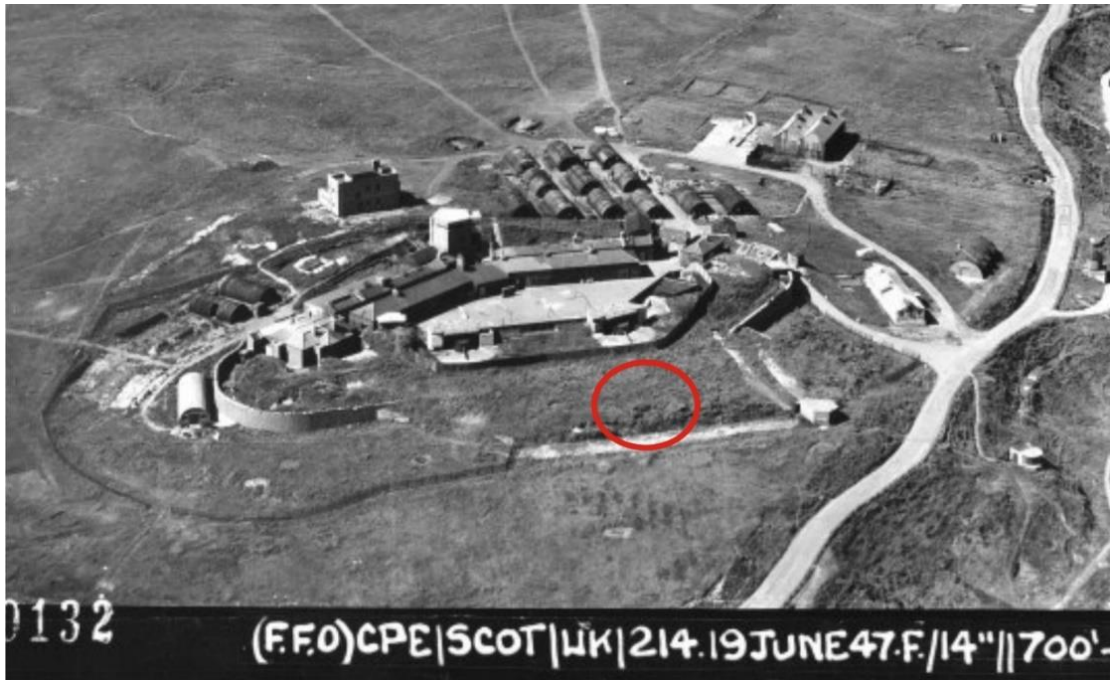
Illus 5 1947 aerial photograph showing approximate proposed site for container (copyright HES)

2.4 The pillbox (called a blockhouse) is shown on a plan of the proposed infantry defences of Torry Battery dated 31 May 1913 (The National Archives WO 78/5198) (NJ90NE 22.01; Illus 4). It is shown as a coffin-shaped structure with seven firing embrasures, at the corner of a barbed wire entanglement covering the front of the battery. The pillbox visible on the 1945 and 1947 aerial photographs (Illus 5) appears to be of the same shape. This is in the approximate location of the proposed container but this may have been buried or destroyed since the 1947 aerial photos.

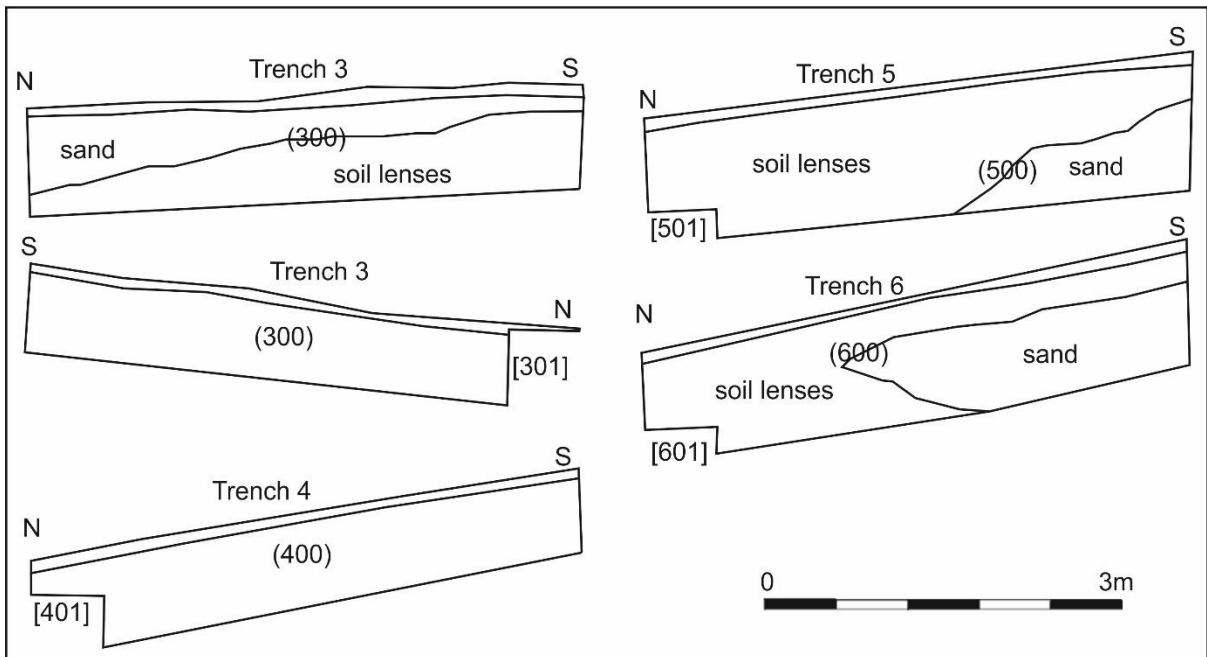
Illus 8 Trench sections

The curtain wall is 0.6m wide constructed of granite blocks and rubble with cream mortar. The base of the wall was not reached in any trench as the foundations for the proposed development are shallow. Over the wall were layers and lenses of soil and dumped sand. No other archaeological features or finds were recorded.

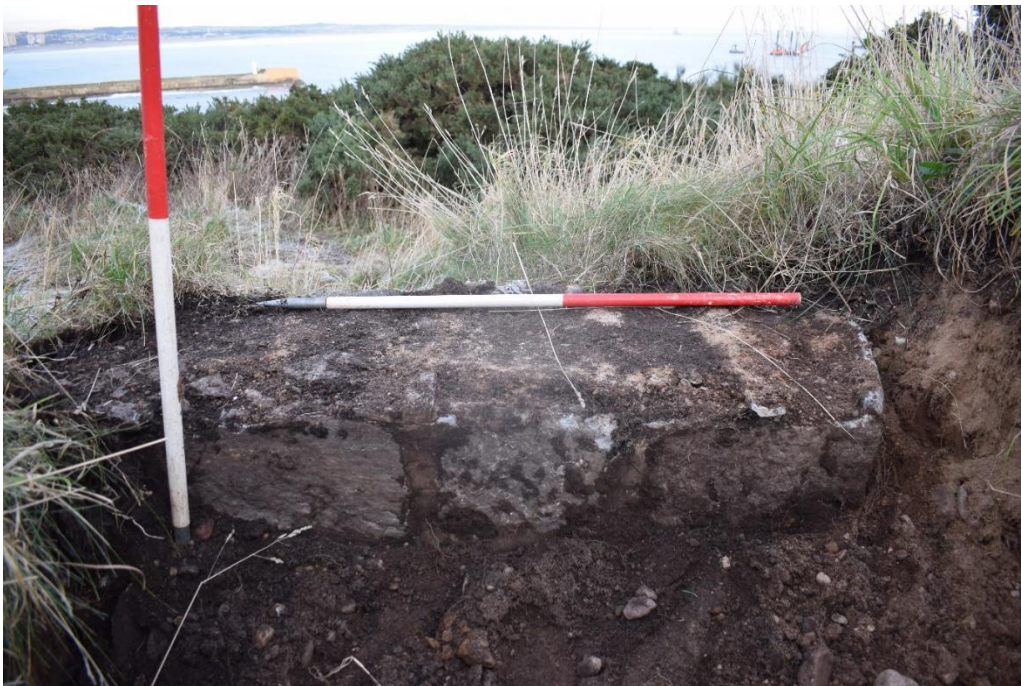
Trench 3 was dug to 0.7m deep; at the N end was a wall [301] 0.6m wide and constructed of granite blocks and rubble and cream mortar. There was a gun slit [303] at the E end of the wall. The full width of this slit was not revealed as it was partially outwith the excavated trench.

Illus 9 Trench 3 wall 301 showing granite block and mortar construction; facing N

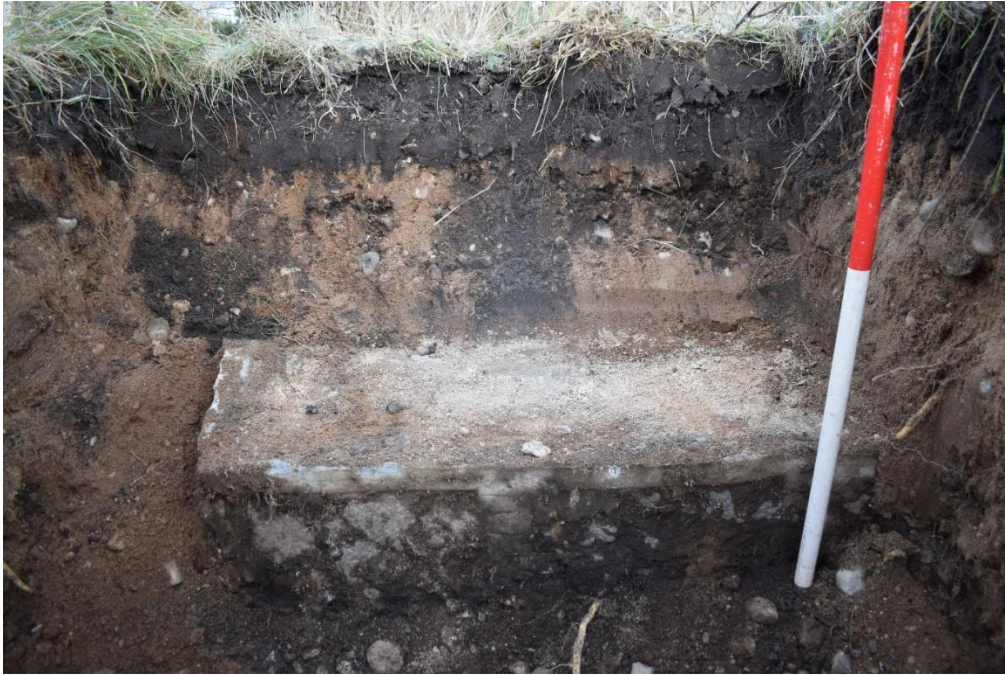
Trench 4 was dug to 0.8m deep; at the N end was a wall [401] constructed of granite blocks and rubble and cream mortar. There was a gun slit [403] in the W end of the wall. The full width of the wall and the gun slit were not revealed as they were partially outwith the excavated trench.

Illus 10 Trench 3 wall 301 showing granite block and mortar construction; facing N

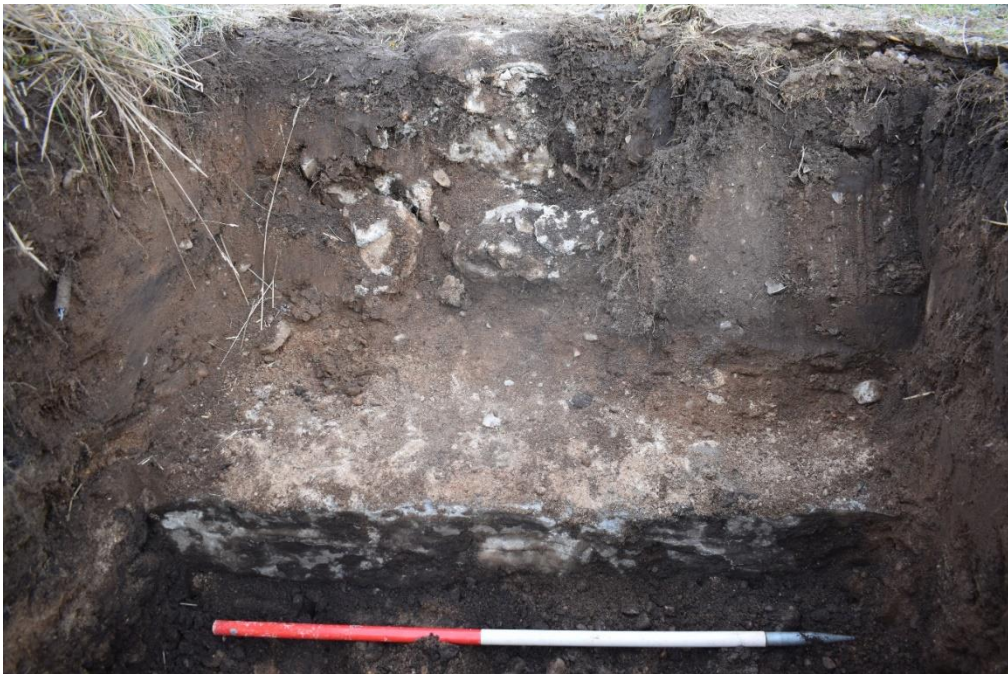
At the N end of Trench 5 was a solid section of the curtain wall (501) which was stone and mortar built. Above the wall was a poured concrete base built on a stone foundation (503); it was located above the demolished wall and therefore clearly a later feature which held a wooden post, possibly something like a flag-pole.

Illus 11 Wall 501 (bottom) with concrete base 503 on stone base (above); facing N

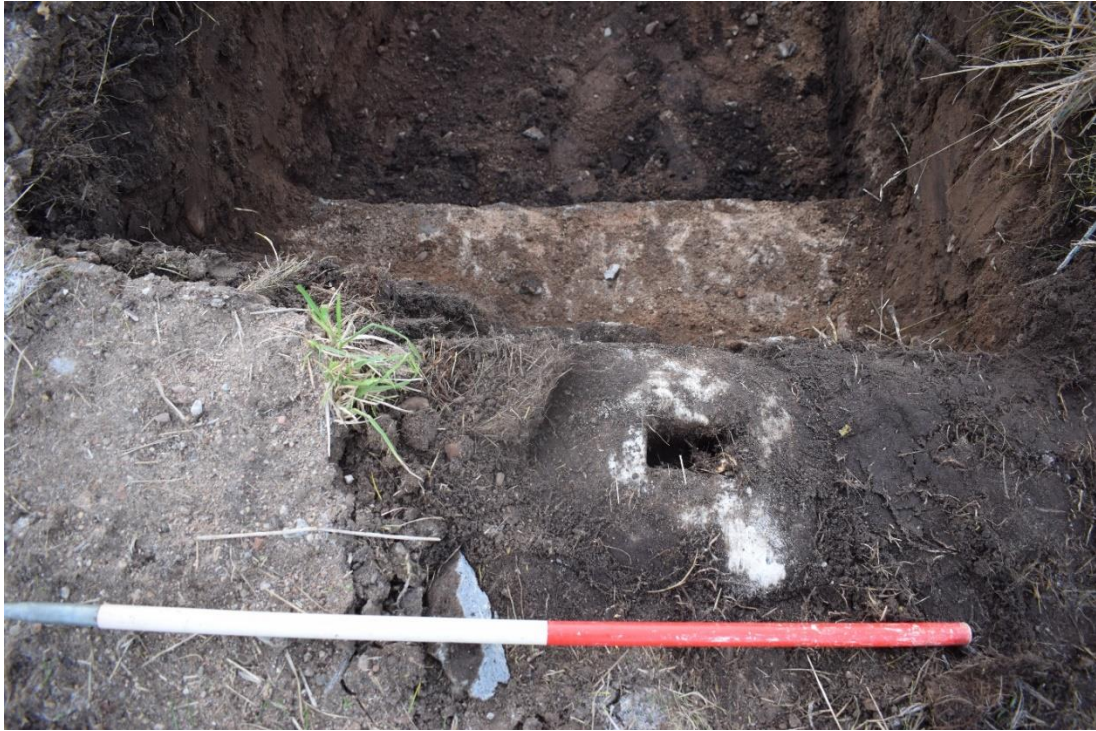
Illus 12 Concrete base 503 (bottom) with wall 501 (top); facing S

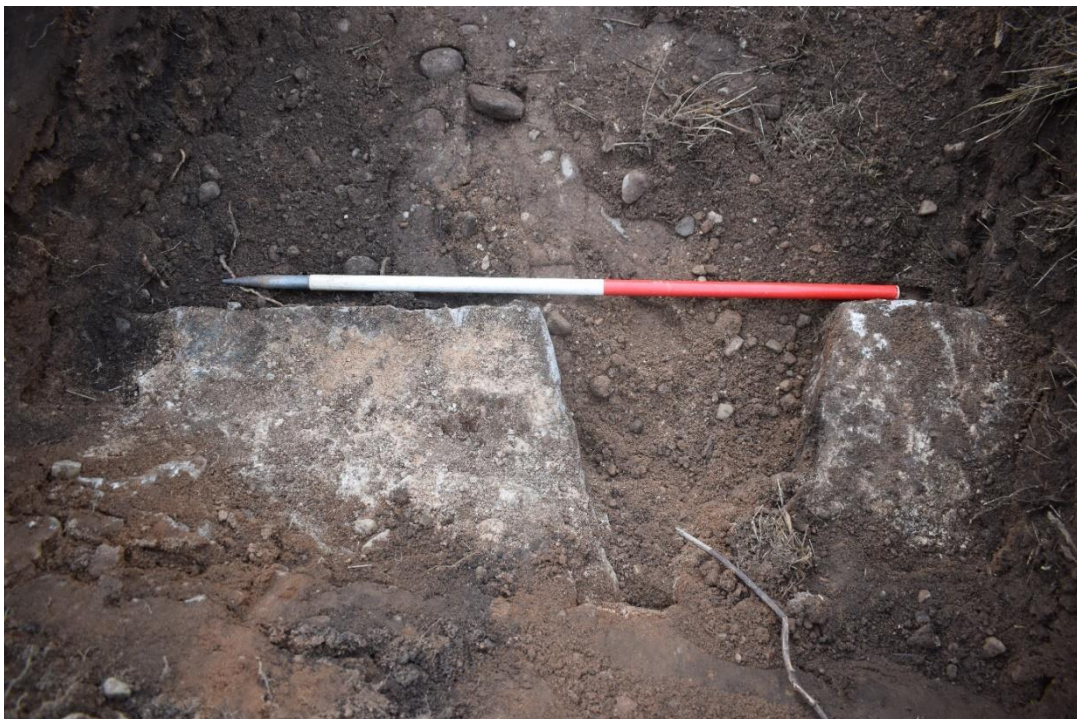
Trench 6 was dug to 1.1m deep; at the N end was a wall [601] constructed of granite blocks and rubble and cream mortar. There was a gun slit in the exposed wall section [603]. The full width of the wall was not revealed but the gun slit was 0.24-0.46m wide.

Illus 13 Wall 601 with gun slit 603; facing S
