**Kirkton Farm Steading, Kirkton Road, Inverkeilor,
Arbroath, DD11 5SA
Report on Level 2 Standing Building Survey
Angus Council planning ref 18/00117/PPPL**

**Alison Cameron
Cameron Archaeology
4 January 2019**

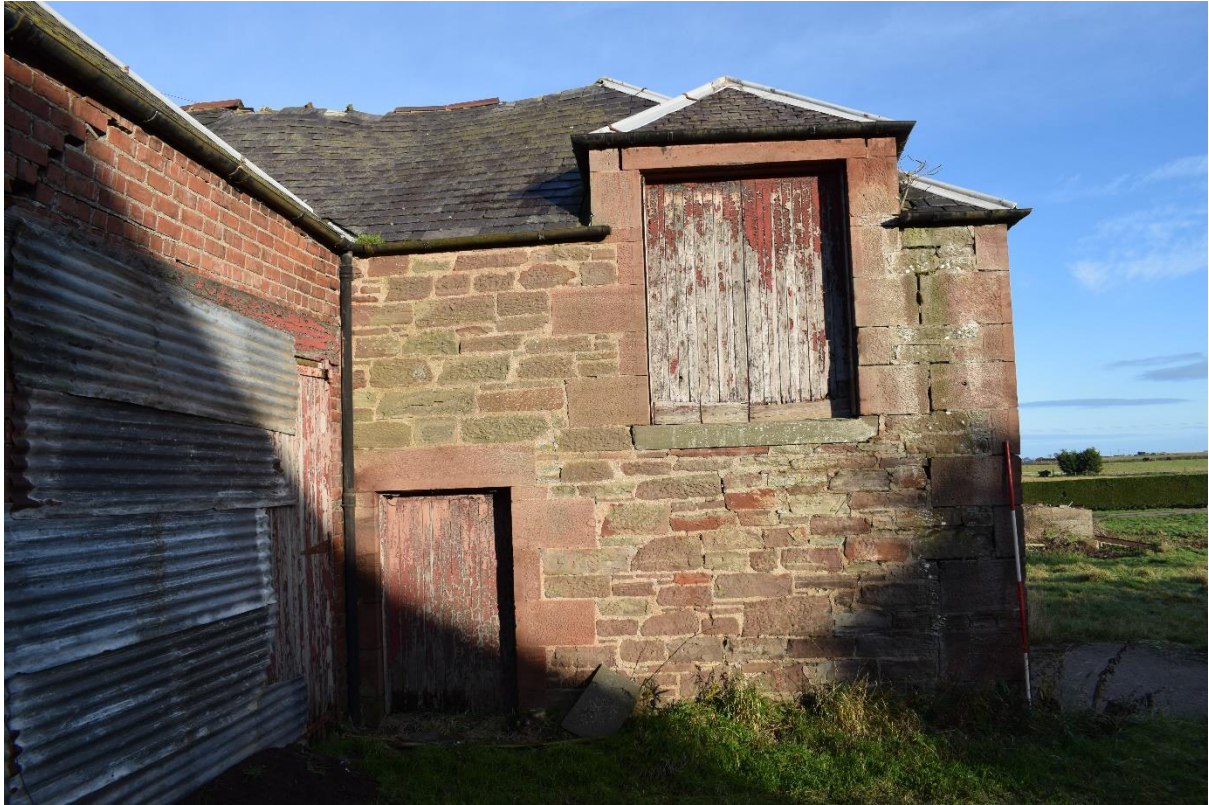
Cover: (top) SW façade Room 6B; facing NE. (bottom) 1771 date stone on NNW gable Building 2; facing SSE

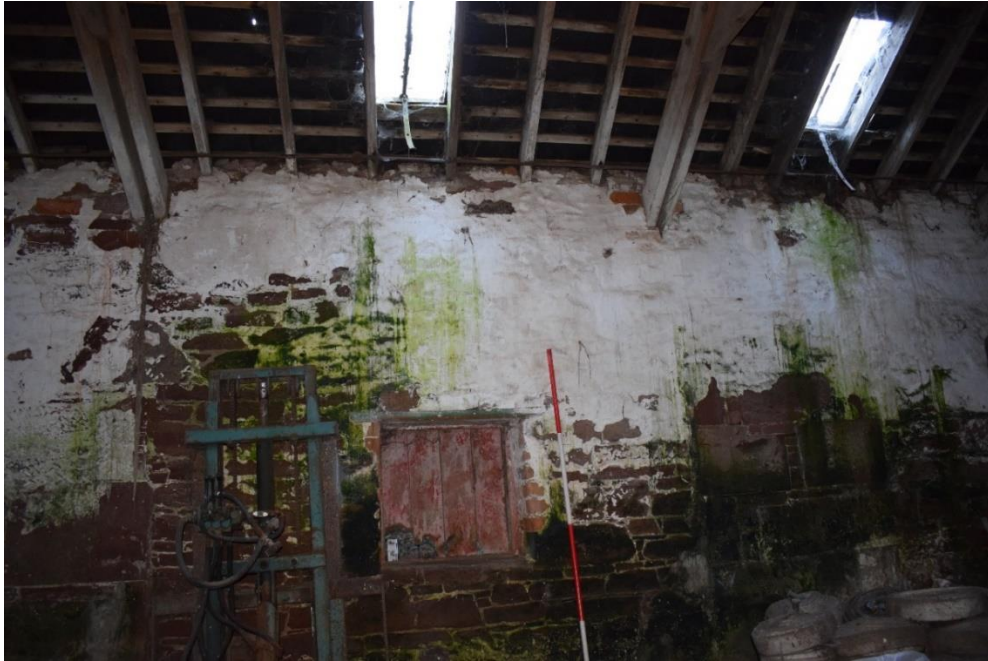
Phase 1 includes Rooms 3, 6, 7A, 8 and 9. Room 3 is on the SE side of the courtyard and is 18.7m long and 5.8m wide; it has a large door to the central courtyard (D25; Illus 3) which has been blocked and replaced by a small window (W11) and three smaller doors to the courtyard (D24, D26 and D27) and one to the SE (D23). After Room 6A was added to the SE side, upper windows were added (W3 and W12). There is a large door in the NE wall (D28) and a window (W6). Room 1 was originally built as an agricultural building and continued in agricultural use with alterations including blocking doors in the NW wall and opening larger doors in the SE wall for machine access presumably around the time that the courtyard (Room 2) was enclosed.

Illus 3 Building 1 Room 3 NW wall D25 with red sandstone facing, blocked with stone and whitewashed and small window W11 added; facing SE

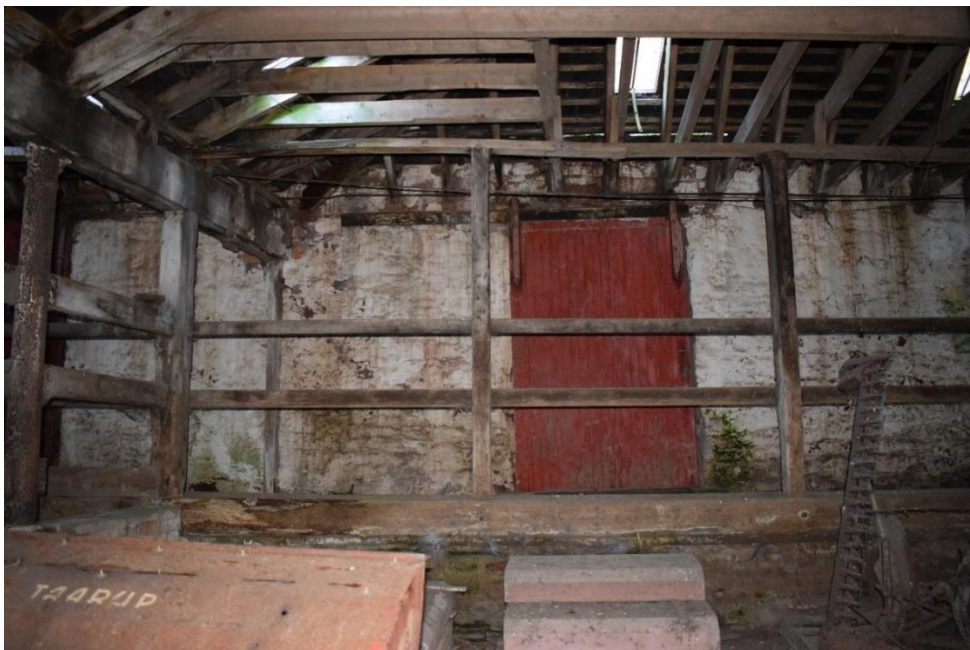
Rooms 6 A and B is 29.8m long and 5.2m wide but has been extended to the SE in Phase 2. The original room had two doors to the courtyard (D16, D17) and access to the exterior (D18). There is no access to most of this room now as it is infested with pigeons with piles of faeces on the floor. There was a circular horsemill attached to the SW wall of this building on the First Edition OS map (Illus 44) and so the original use of the room was as a mill but the SW wall of Room 6A has been rebuilt and plastered for later use for housing animals and so there is now no trace of the apertures for the horsemill. The current owner remembers the threshing mill in use in the loft of Rooms 6A and B with a hammer mill on the ground floor which turned the grain into meal for feeding the cattle. There was an electric mill from the 1940s in Room 10. There was no commercial use of the mill during the memory of the current owner.

Illus 4 Room 6A NE wall door to courtyard D16 showing sunken midden wall and wooden trough (foreground); facing SW

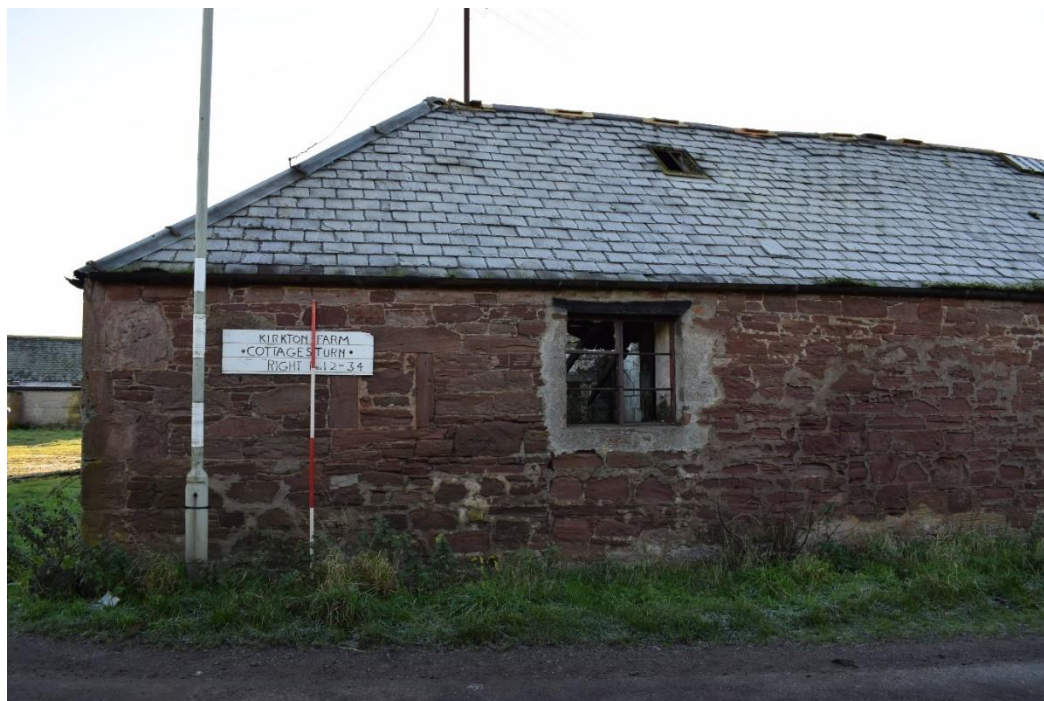
Room 7A was probably constructed in Phase 1 for a bothy (domestic use). It is 5.9m wide and 7.2m long with small window in the NW wall (W1; Illus 5) and windows added to the NW wall (W2; Illus 5) and the NE wall (W5) in Phase 3. There is no access to the interior of this structure as it is overgrown and so it was not possible to check for evidence of fireplaces or other internal structures. Later a concrete block structure was added to the SE side (Room 7b; see below).

Illus 5 Building 1 Room 7A NW wall W1 (left blocked with red sandstone) and W2 inserted in Phase 3; facing SE

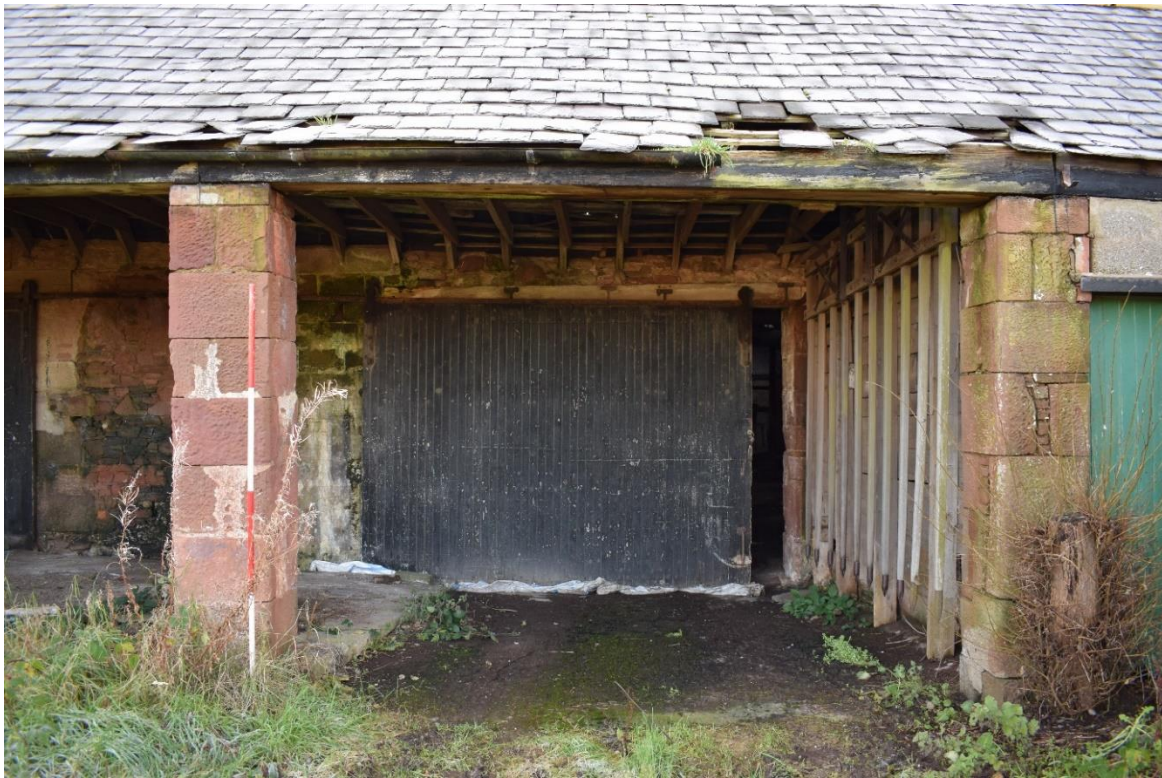
Room 1 is on the NE side of the courtyard; it has three large cart doors (D1, D2 and D3; Illus 6) on the NE wall constructed with pillars of tooled sandstone. Each door is 2.9m wide and 2.55m high. There was originally a fourth door to the NW which was infilled when Room 7B was constructed and two smaller doors constructed (D6 and D8) but there is no access to this area as it is overgrown. At the SE end of the NW wall of Room 1 there is a small infill door D35. The room would have formed the NE entrance to the courtyard for carts and horses and was then enclosed when the courtyard was roofed.

Illus 6 Building 1 Room 1 NE wall cart door D3; facing SW

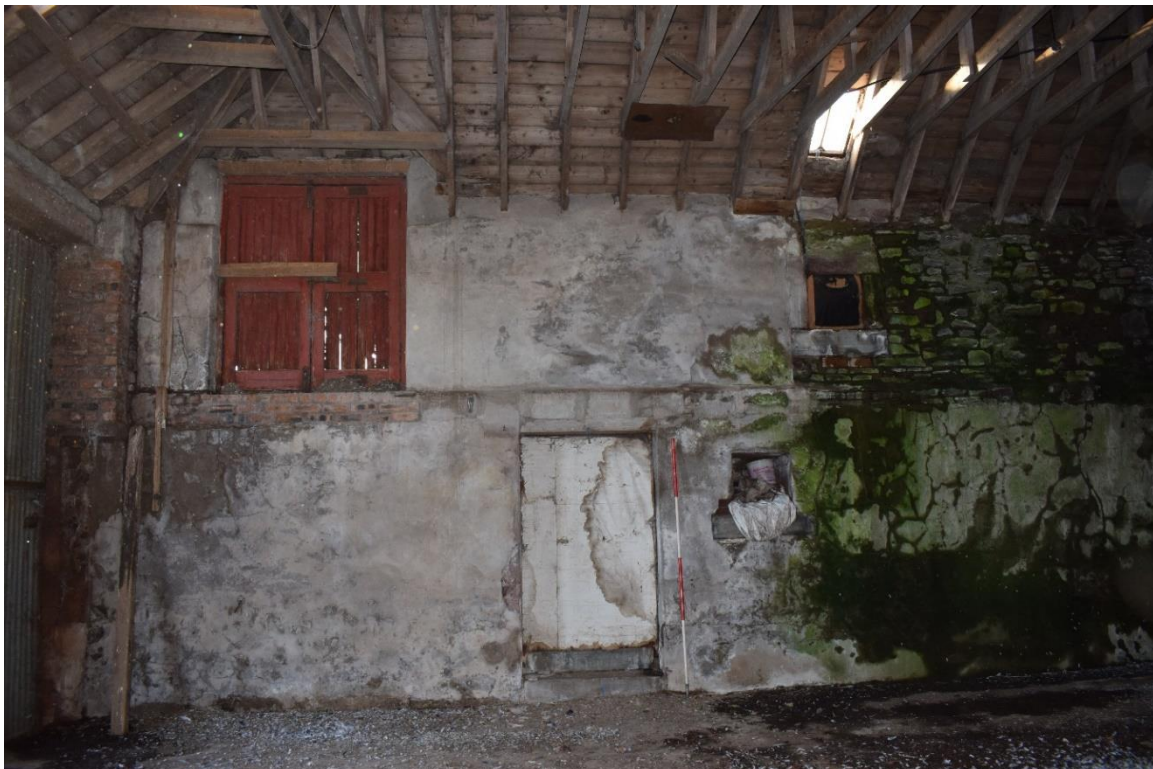
Room 6B was built onto the SE side of Room 3 in the S corner of the farm. It has large doors on the SE wall; D21 is 4m wide and 4m high and D22 is 3.4m wide and 1.9m high and ground floor D20 and first floor door D37 and on the SW wall (Illus 7). There are upper windows in this wall (W9 and W10) and windows on the NW wall (W3 and W12). These were all later blocked with modern red brick. The room was originally part of the mill structure but was adapted for agricultural use with large tractor doors on the SE wall.

Illus 7 SW wall Room 6B with D3 (top left) D20 (right); facing SW

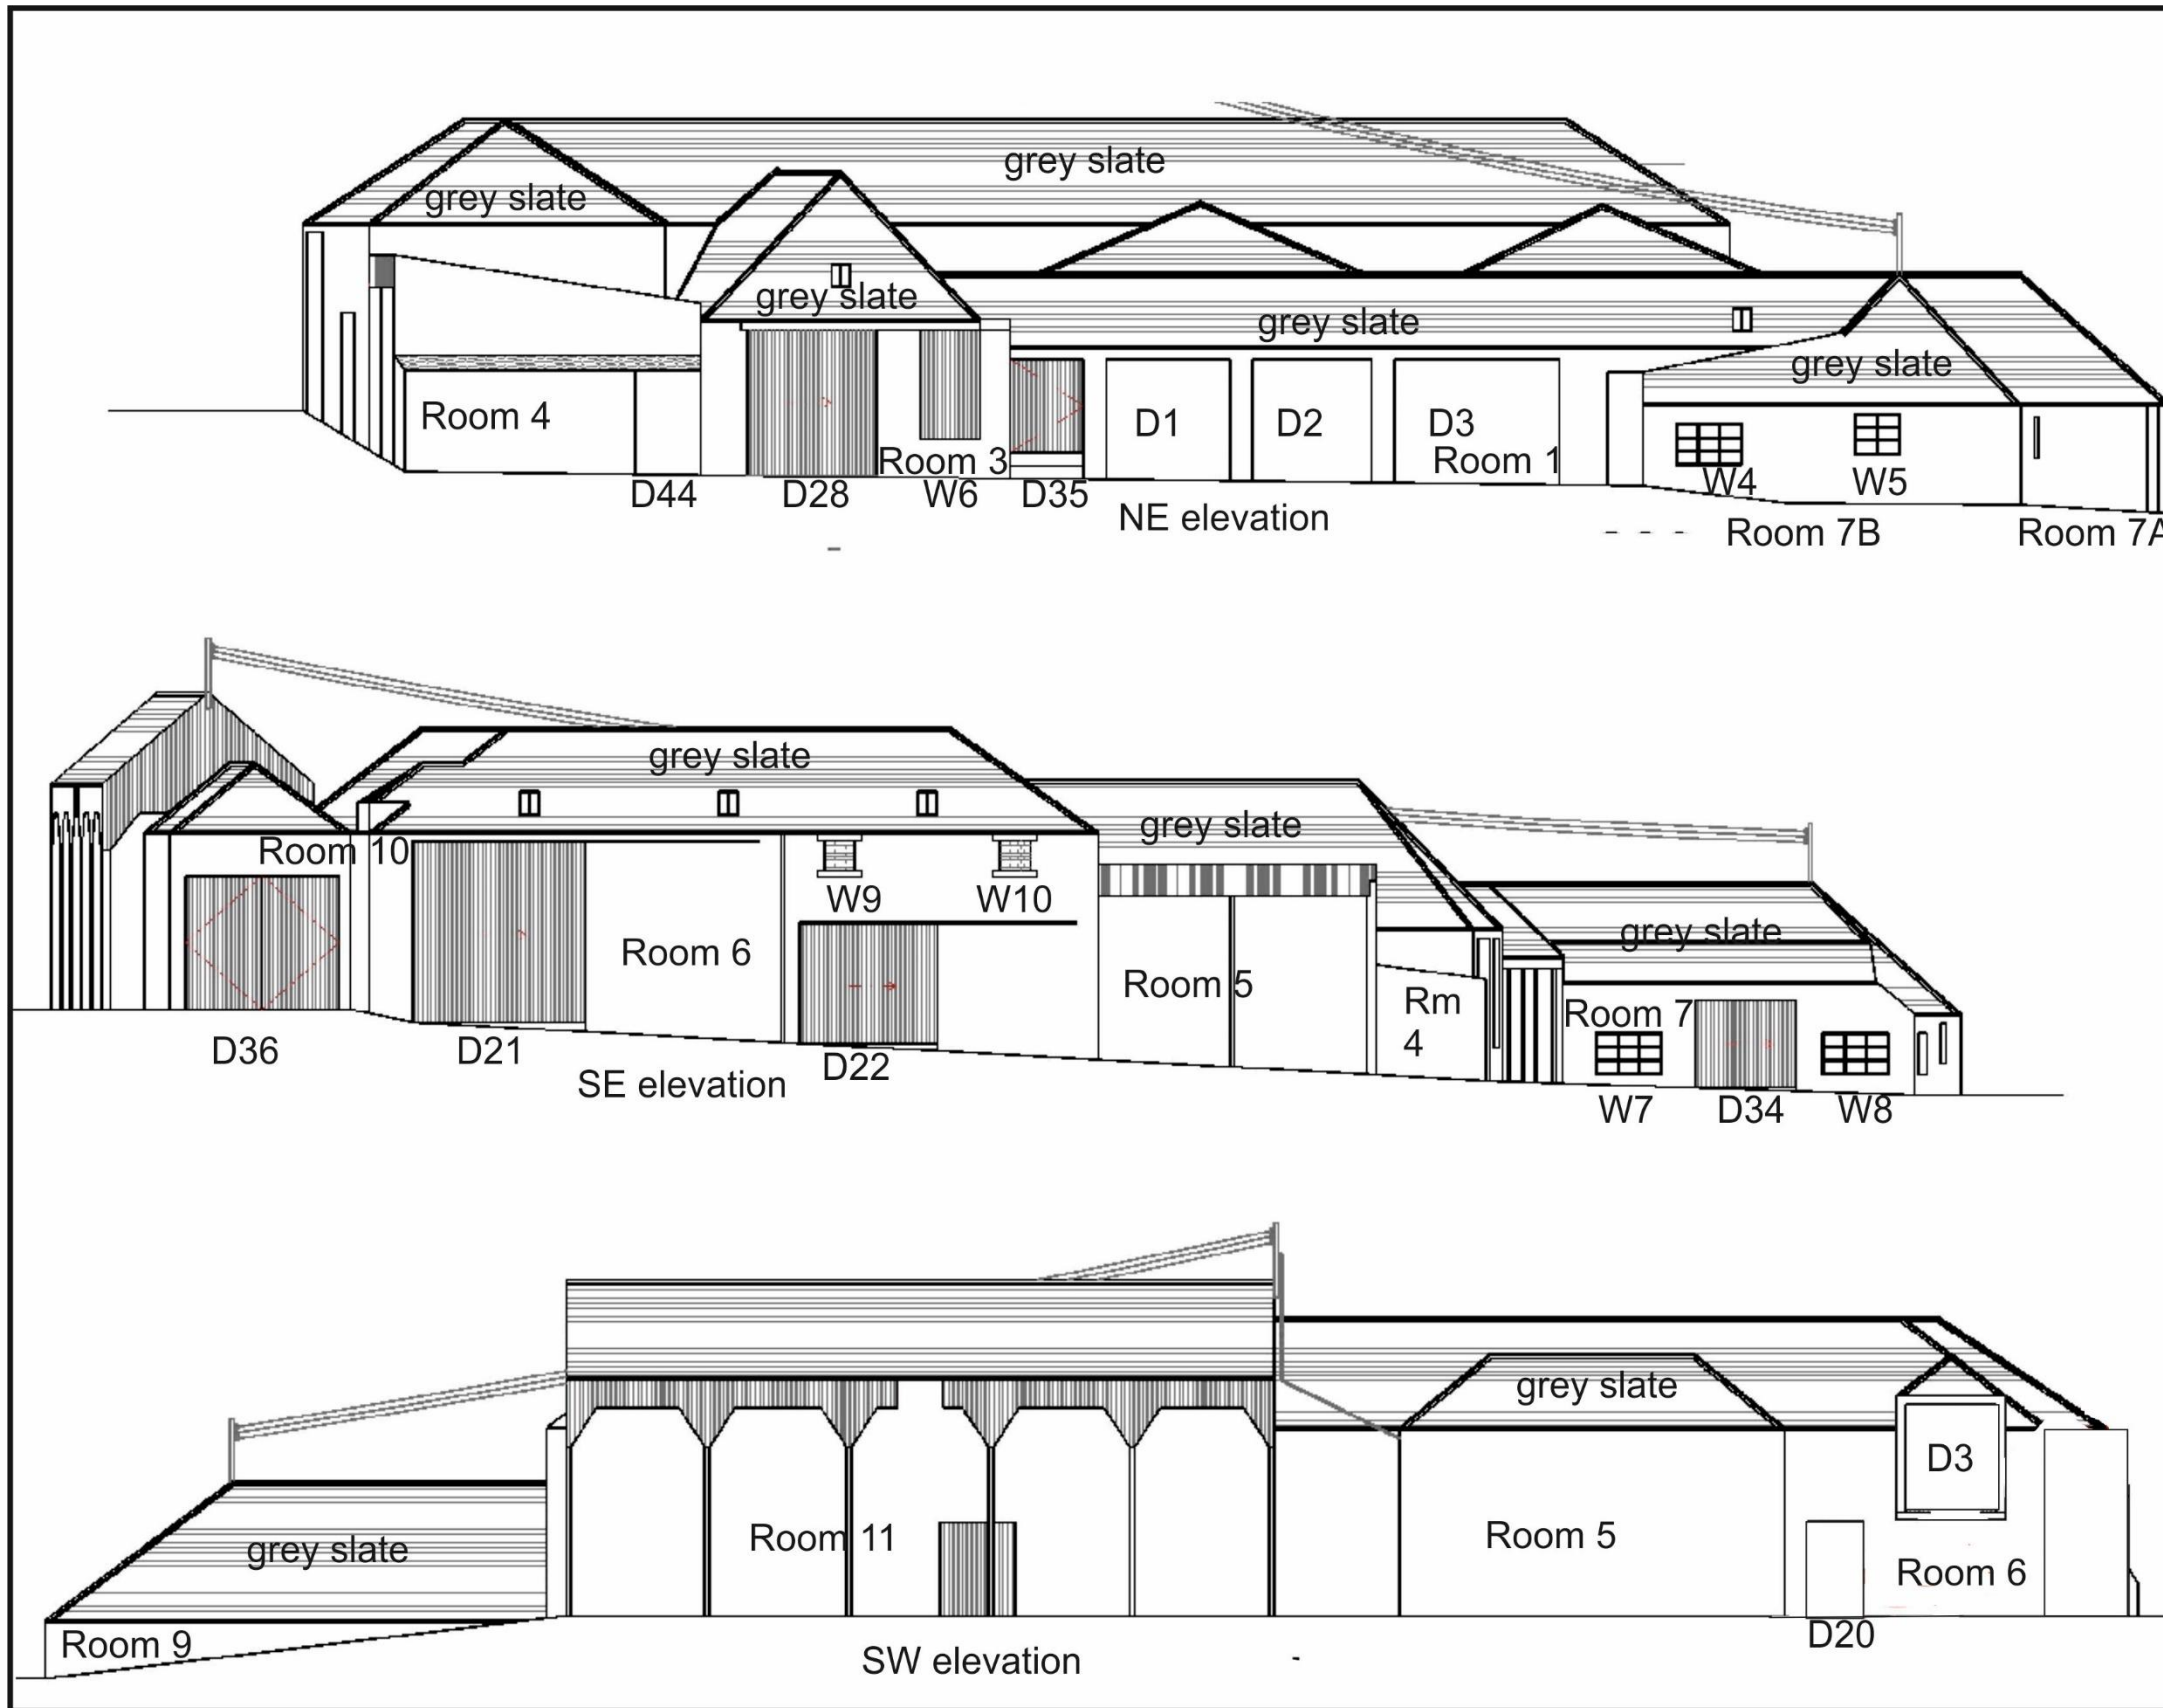
Illus 8 Building 1 annotated with numbers used in this survey including room, door, window, feature, elevation and section numbers
(from copyright Bell Ingram Design)

Illus 9 Building 1 main elevations annotated with numbers used in this survey (copyright Bell Ingram Design)

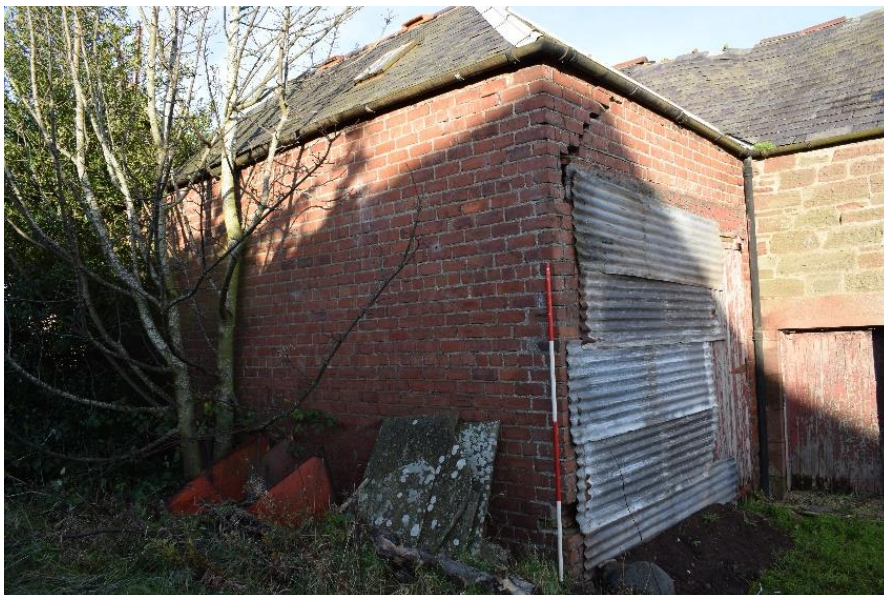
Room 10 is a red brick extension on the SW of the farm (Illus 10); it is originally the site of a circular horse mill seen on the First Edition OS map (Illus 44). There is no access to this building as the area is overgrown and the doors blocked.

Illus 10 Building 1 Room 10 red brick extension; facing N

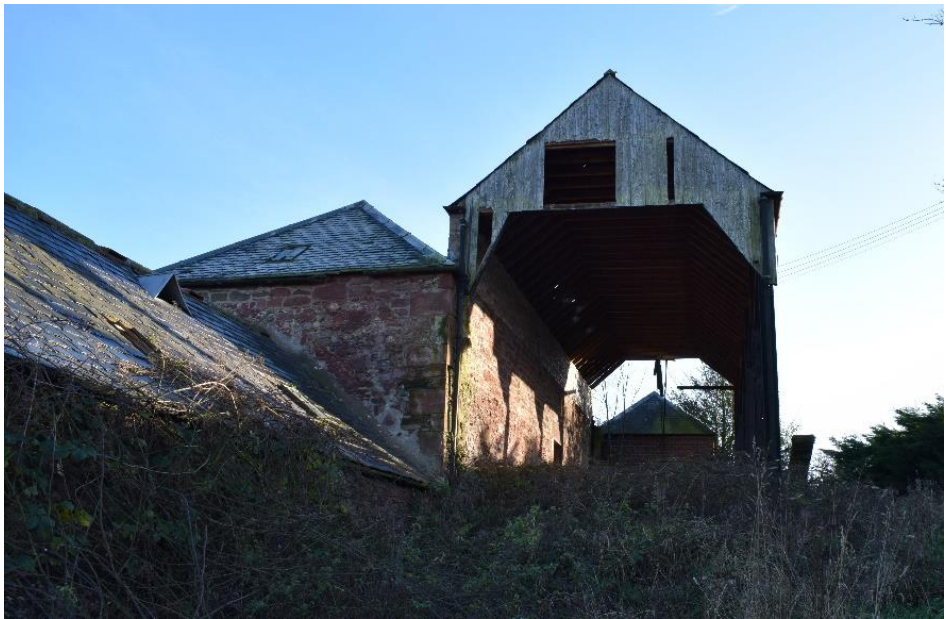
Room 11 is a wooden Dutch barn attached to the SW wall of Room 6A (Illus 11). There is no access to this building as the area is overgrown but there is a blocked door between this room and Room 6A (D19). It is approximately 5 x 16m in size.

Illus 11 Building 1 Room 11 overgrown Dutch barn; facing SE

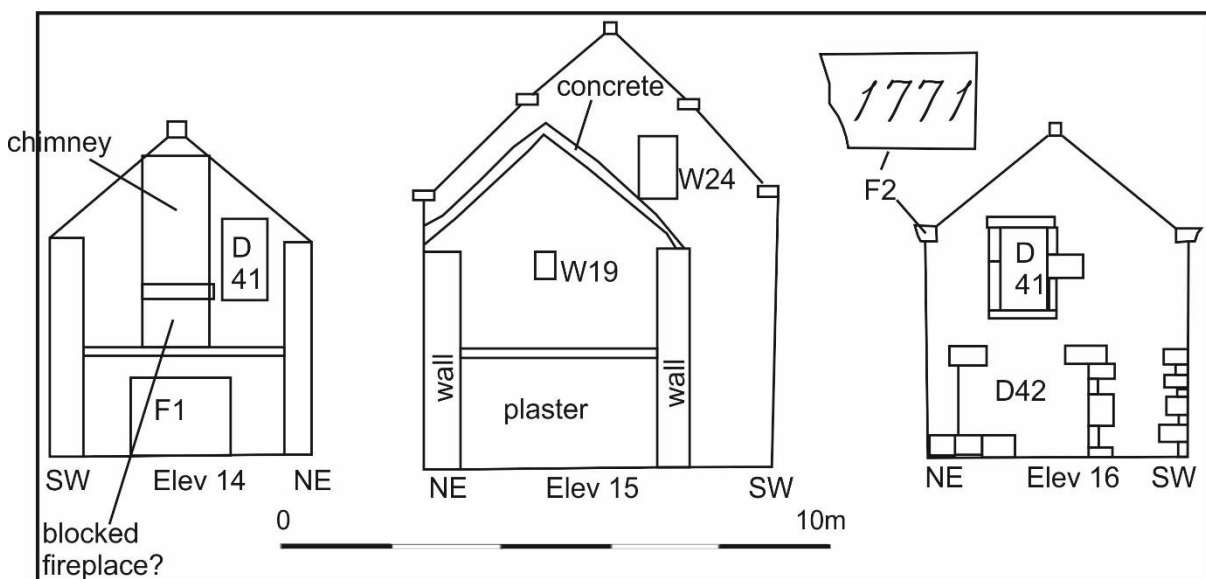
Building 2 (Illus 16-25) was mainly constructed in Phase 1 with Building 2A added in Phase 2 (Illus 20), prior to the First Edition OS map (Illus 44). It is 19.4m long and 6m wide and is mainly constructed of red sandstone; there is no roof surviving and much of the ENE wall has been demolished prior to this survey. It was originally two storeys but the building had been knocked into one room by the 1940s and was in use for housing cattle (current owner pers comm). There are small (0.6 x 0.78m) ground and first floor windows in the WSW wall (W14-18; Illus 21). W15, 17 and 18 have been blocked with stone and soil has been built up on the exterior (WSW) side of this wall to allow access to the neighbouring property. W14 and W16 remained open and are blocked with plywood. The building was two storeys and the level of the first floor can be seen as a scar on the wall (Illus 21). The ENE wall is mainly demolished but a section remains in the centre with two doors (D39, D40) and a large much later door opened in the NNW end of the wall (D38). The NNW gable is intact and has a dated skewput (F3, 1771; Illus 18, 25).

Illus 18 Building 2 elevations 14-16 annotated with numbers used in this survey

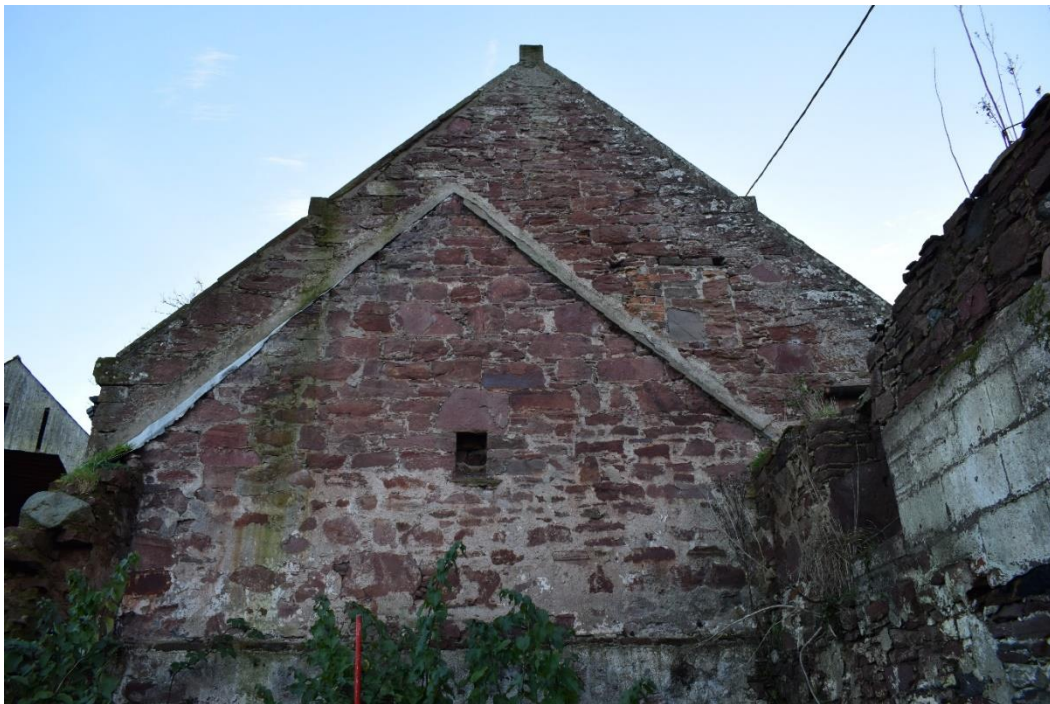
Illus 20 Building 2 gable (bottom) Building 2A gable (above); facing SSE

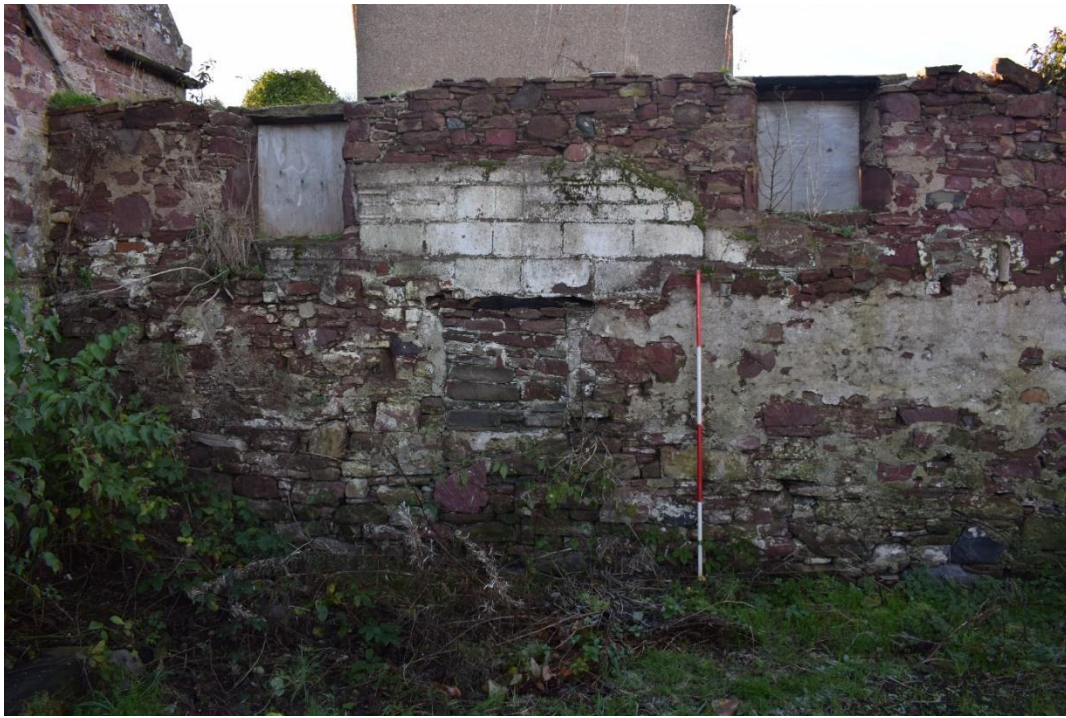
Illus 21 Building 2 WSW wall W14 and W16 (top) W15 below infilled with stone; facing WSW

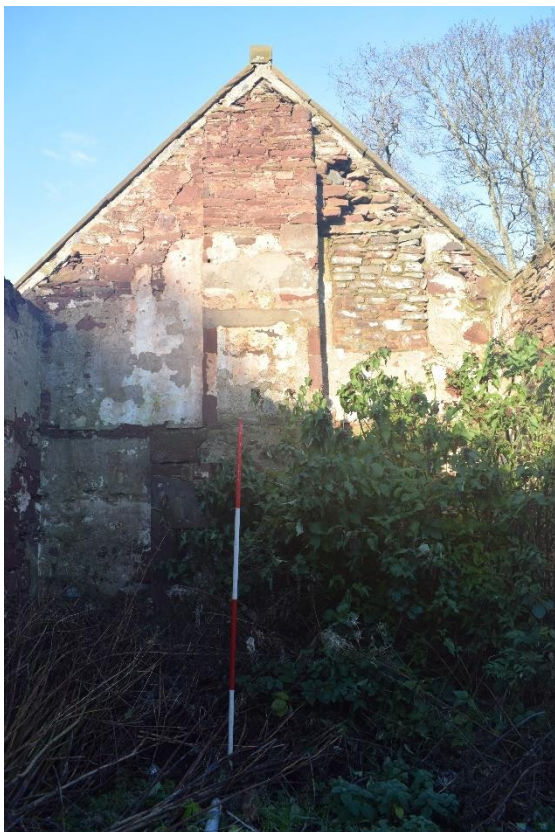
After D41 and D42 were blocked with red sandstone in the NNW wall, a chimney was added and a fireplace on the ground floor (F1; Illus 22) and probably also a fireplace on the first floor although this has been blocked and plastered over (Illus 17, 18, 22).

Illus 22 Interior of NNW gable with chimney (centre), D41 (top right) showing overgrown interior; facing NNW

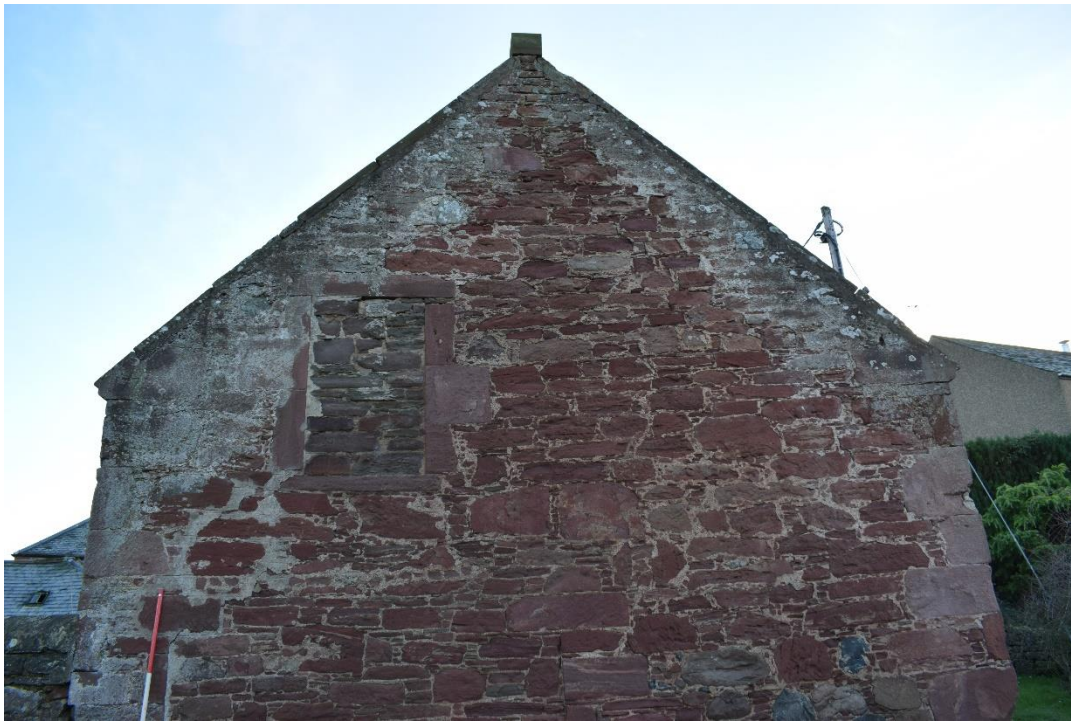
Illus 23 NNW gable upper section showing D41 (top left) with dated skewputt F3 (left); facing SSE

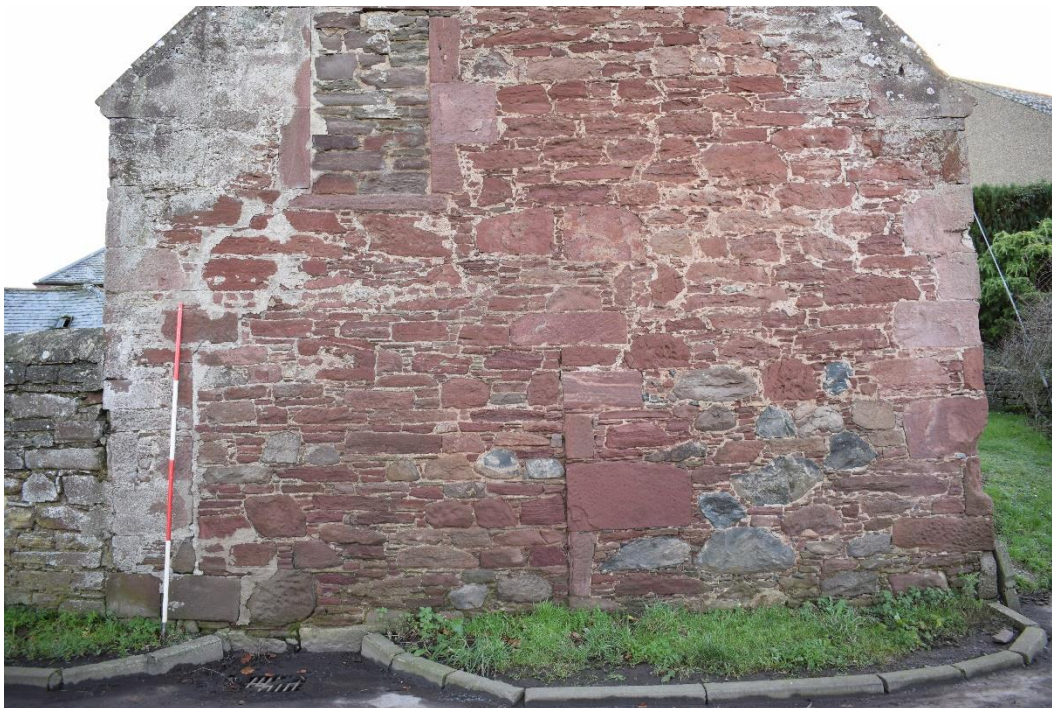
Illus 24 NNW gable lower section showing D41 (top left) with dated skewputt F3 (left) and blocked D42 (bottom); facing SSE

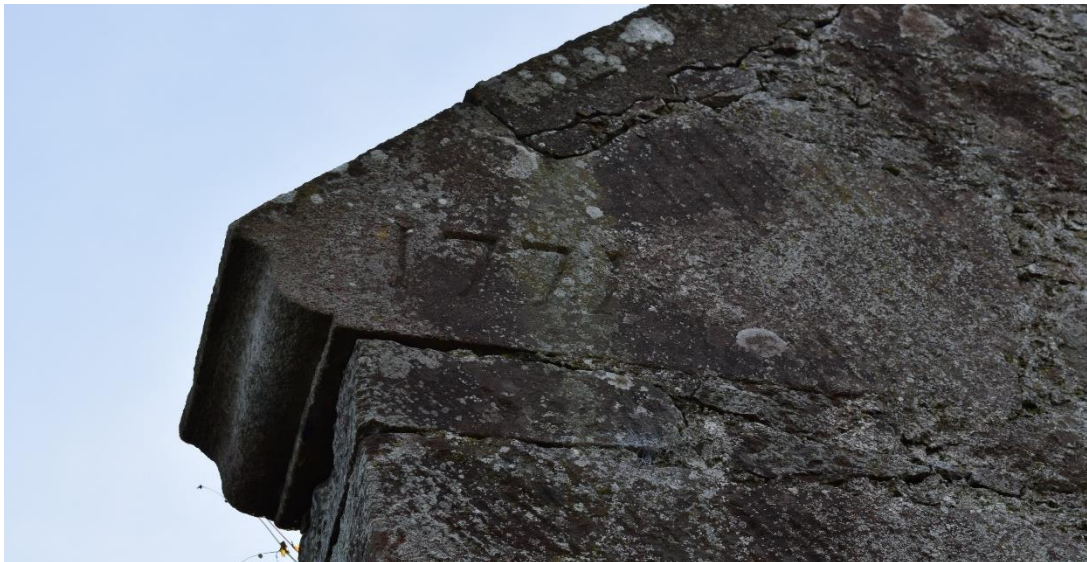
Illus 25 Detail of grey sandstone tooled skewputt with 1771 inscribed; facing SSE

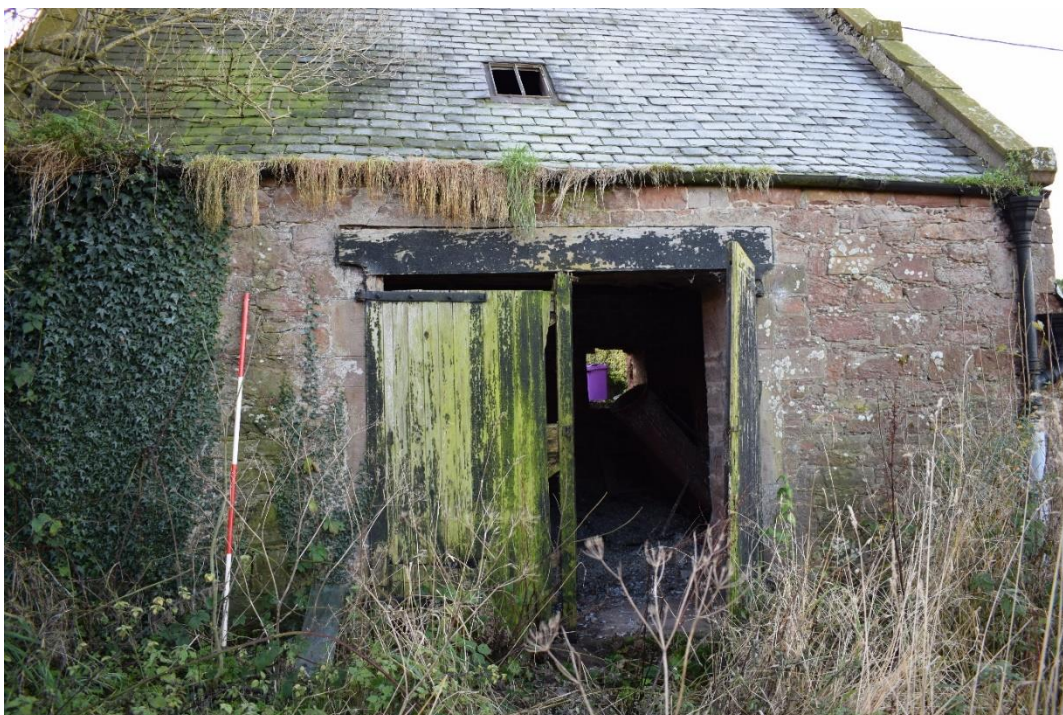
Building 2A (Illus 16, 26, 27) was added on to the SSE end of Building 2 in Phase 2. It is a single storey building consisting of one room 8 x 8m in size with 1m thick walls constructed of pink and grey sandstone rubble with grey slate roof. There is a door (D43) in the ENE wall and a window (W13) on the WSW façade. There is a small aperture in the upper levels of the NNW wall (W19) between Buildings 2A and 2. There is no access to the interior of this building as it is infested with pigeons and the floor is piled with bird faeces.

Illus 26 Building 2A ENE wall D43; facing WSW

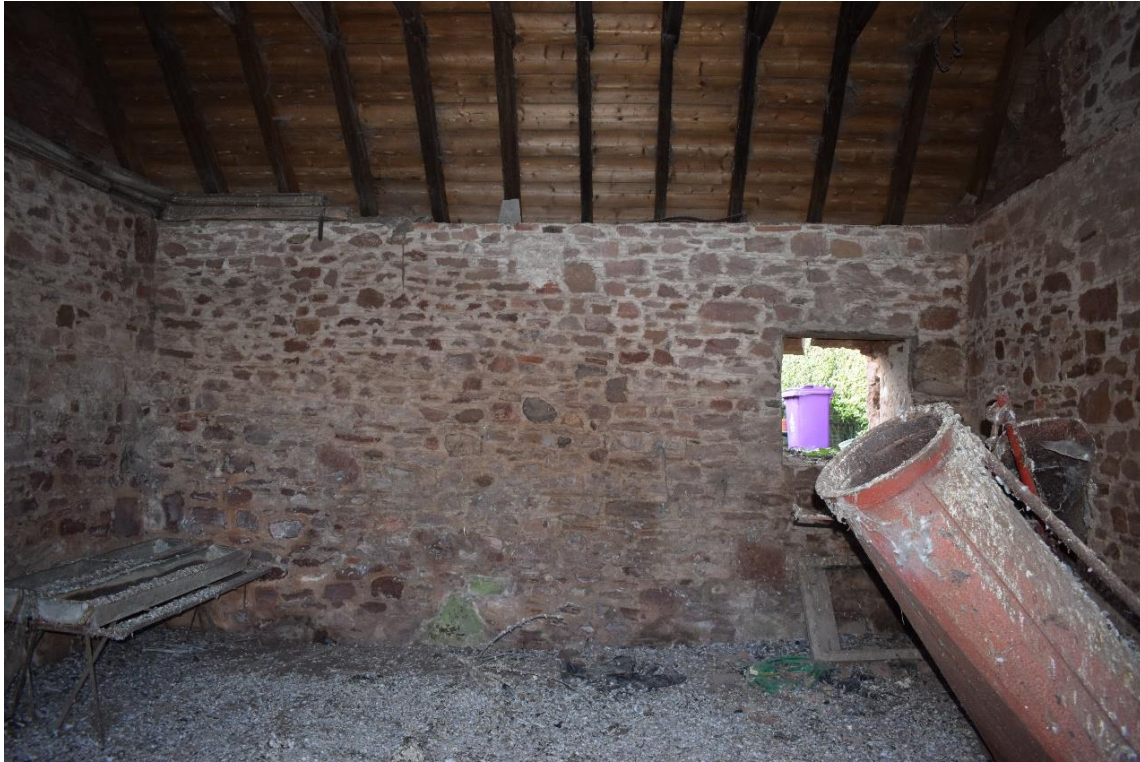
Illus 27 Building 2A WSW wall photographed through door with W13 (right); facing WSW

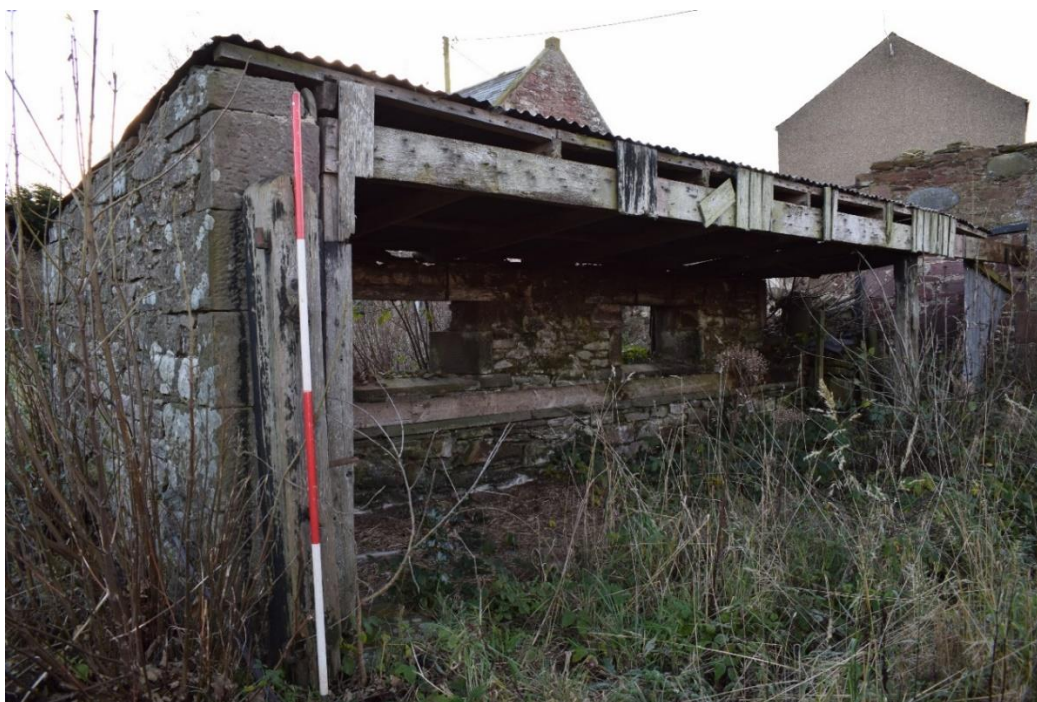
Building 3 (Illus 16, 28, 29) is 7m long and 2.5m wide with grey sandstone stone walls on the SSE and ENE façade and a wood superstructure on the NNW and WSW wall. It is tied into the ENE wall of Building 2 but the stone structures are separate. There are two windows in the SSE wall (W20 and W21) but there is little access as it is overgrown and the roof and wooden structure is in poor condition.

Illus 29 Building 3; facing S

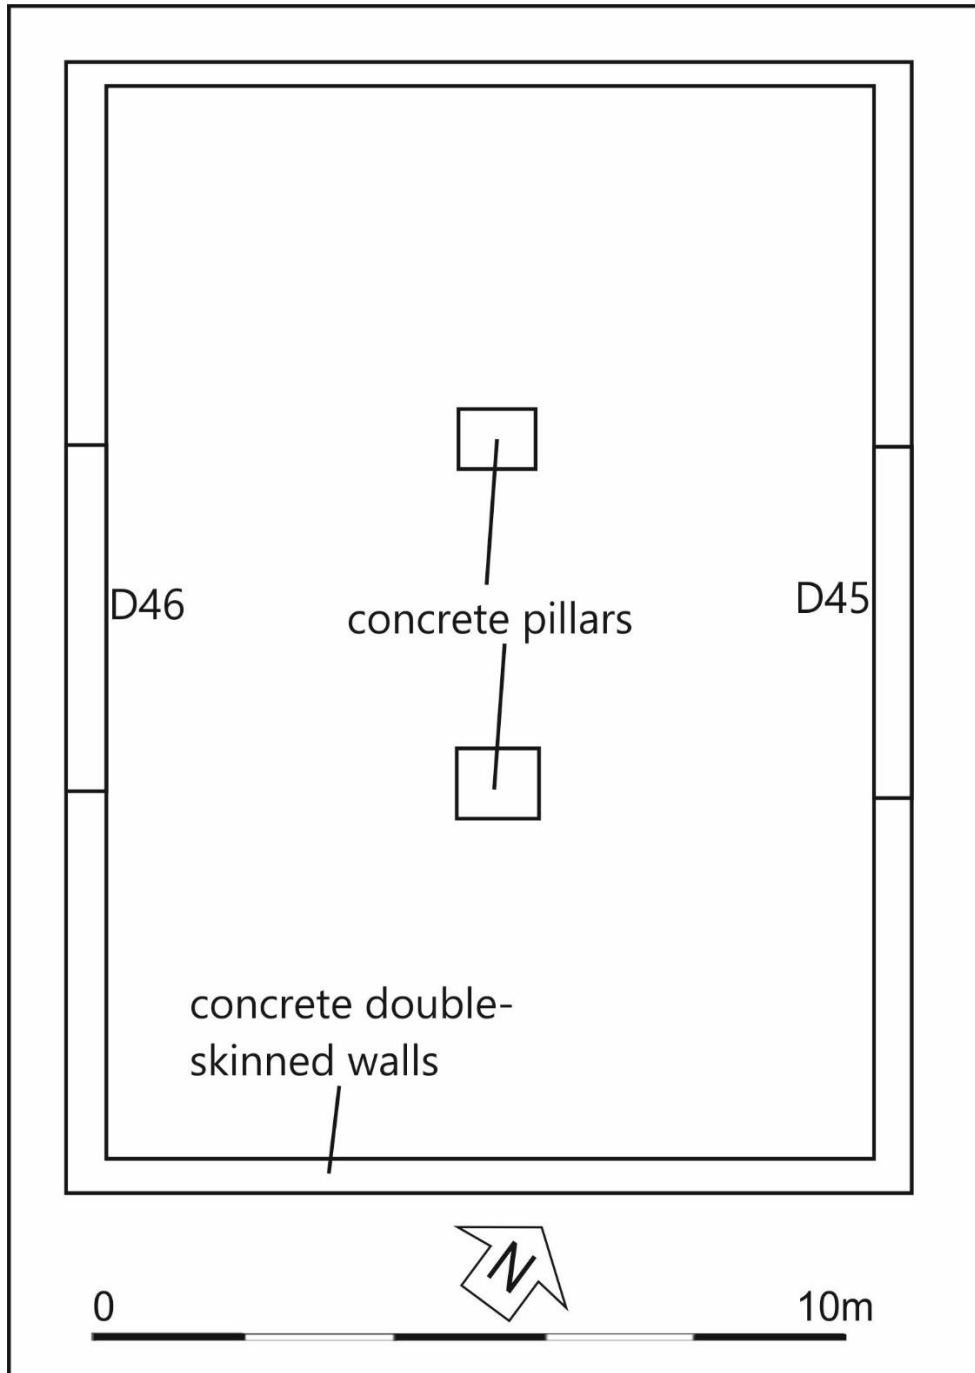
Building 4 (Illus 30-36) is a wood and concrete block shed on the NE side of the farm. The building is 14.9m long and 11m wide constructed of two skins of concrete blocks totaling 41cm thickness. The roof is wood and there are large doors in the NE and SW wall (D45, D46) which have been covered with wooden slats. These are now rotted on the NE side and the roof is in poor condition. The roof is supported internally by two concrete pillars. The building was probably constructed in the mid 20th century as a barn or storage.

Illus 30 Building 4 plan and elevations

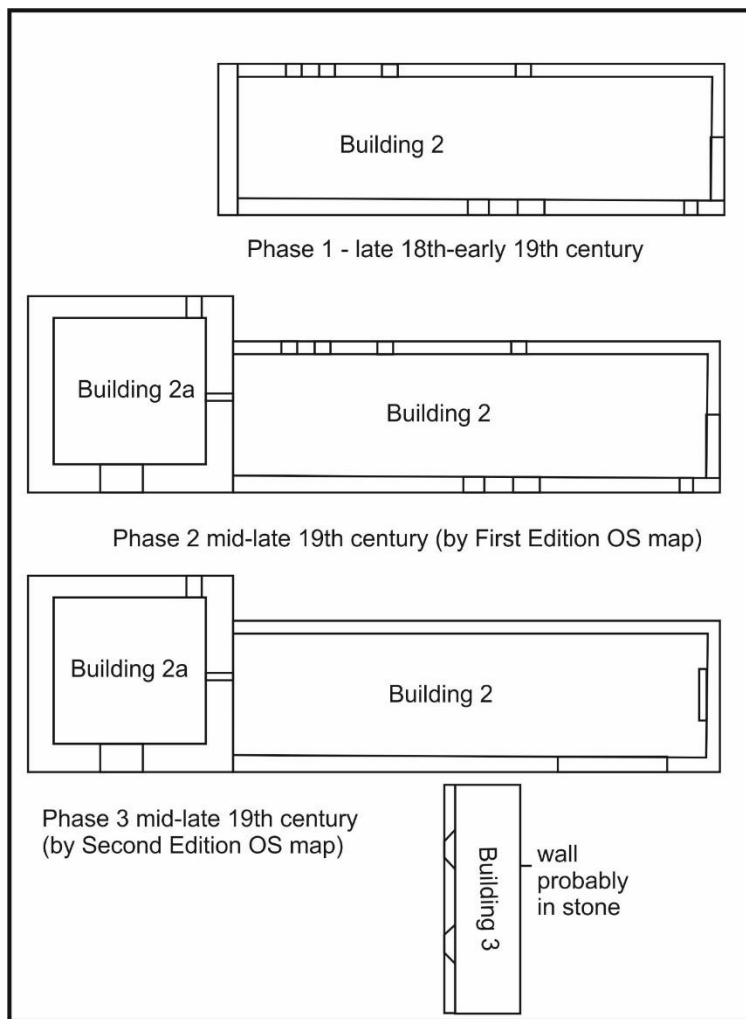
Building 2 was originally a rectangular structure; so little of the fabric remains it is not possible to determine definitely but it is likely to have been an agricultural (rather than a domestic) building. In Phase 2, prior to the First edition OS map, a square stone building (Building 2A) was added onto the SSE end, one room with 1m thick wall. Building 2 was two storey and when it went out of use it was converted for domestic use with fireplaces added at the NNW end and Building 3 added to the NE side of Building 2.

Illus 38 Buildings 2, 2a and 3 phase plan
