**Land Adjoining Benromach Distillery,
Waterford Road, Forres, IV36 3AD
Data Structure report
CA440-2018
Moray Council planning application 18/00811/APP**

**Dr Robert Lenfert, ACIfA
Cameron Archaeology
8-02-2019**

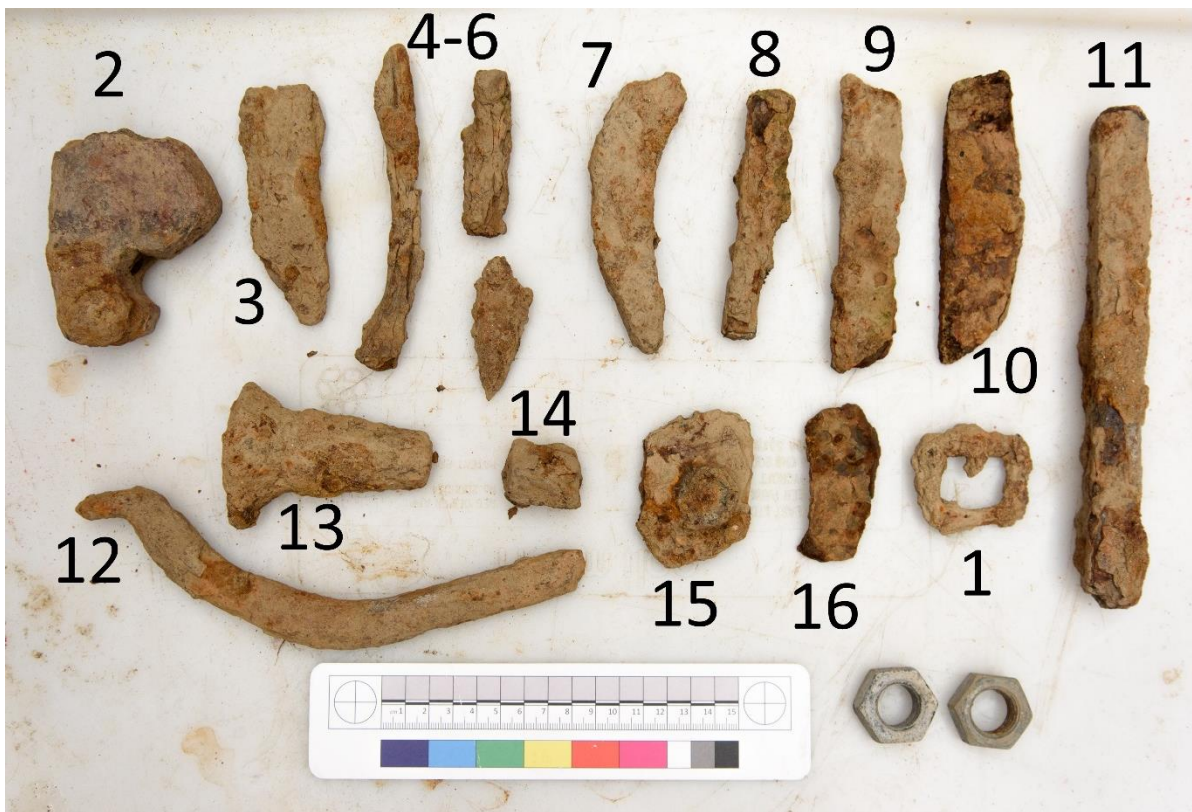
The metal detector survey produced 16 ferrous objects, the bulk of which appear to be agricultural or industrial in nature, mainly broken plough tines or teeth and bolts. The belt buckle stands apart from the rest of the finds, though it potentially may have been part of horse gear for a bridle or reins.

Illus 3 Metal detector finds. No1 is a belt buckle, possibly from horse gear or bridle. The majority appear to represent agricultural machinery or broken plough tines. Two modern galvanized nuts in lower right discounted.

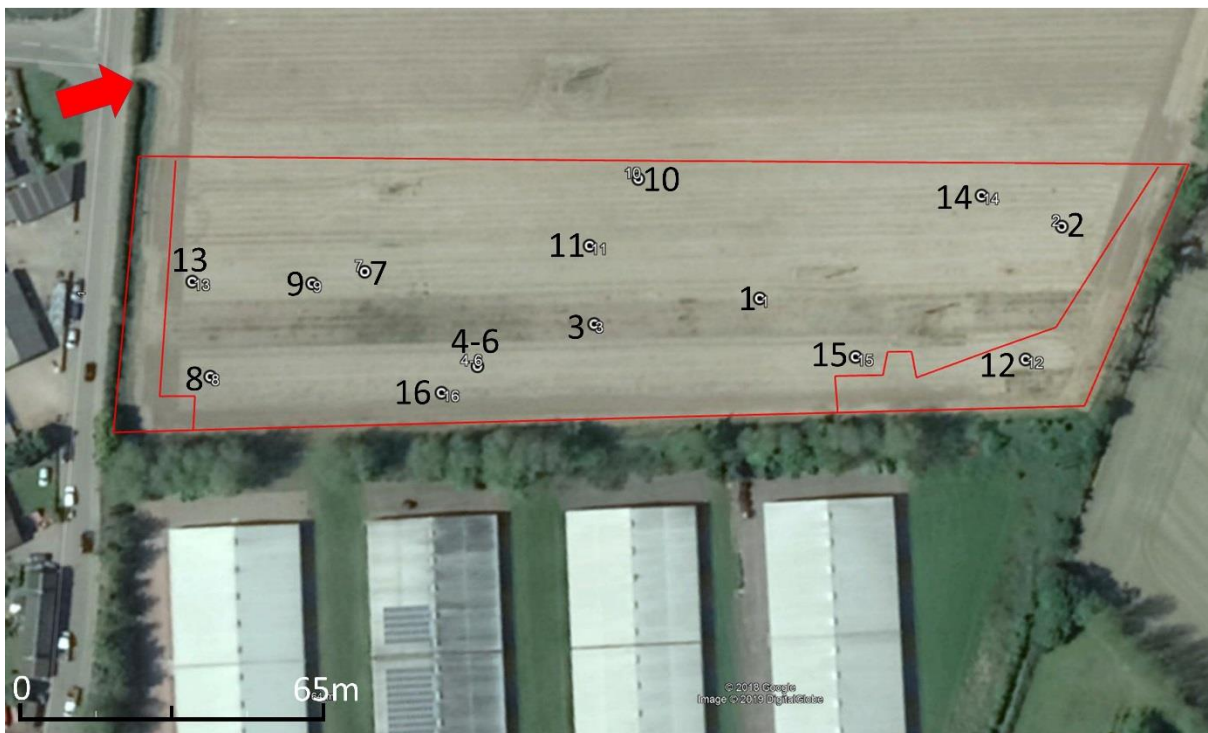
Find No	Longitude	Latitude	Grid Reference	X-axis	Y-axis
1	57.614559°	-3.622337°	NJ0317959445	303179	859445
2	57.615152°	-3.622394°	NJ0317759511	303177	859511
3	57.614238°	-3.622354°	NJ0317759409	303177	859409
4-6	57.614004°	-3.622281°	NJ0318059383	303180	859383
7	57.613824°	-3.622686°	NJ0315659364	303156	859364
8	57.613498°	-3.622417°	NJ0317159327	303171	859327
9	57.613721°	-3.622679°	NJ0315659352	303156	859352
10	57.614371°	-3.622837°	NJ0314859425	303148	859425
11	57.614256°	-3.622633°	NJ0316059412	303160	859412
12	57.615037°	-3.621952°	NJ0320359498	303203	859498
13	57.613497°	-3.622762°	NJ0315059328	303150	859328
14	57.615012°	-3.622555°	NJ0316759496	303167	859496
15	57.614719°	-3.622070°	NJ0319559463	303195	859463
16	57.613927°	-3.622211°	NJ0318459375	303184	859375

Illus 4 Numbered locations for metal detector survey findspots.
