Watching Brief, Aboyne Castle, Aboyne, AB34 5JP
Data Structure Report (DSR)
Site Code CA345-2017

Moyra Simon, MSc ACIfA
Cameron Archaeology
27 February 2019

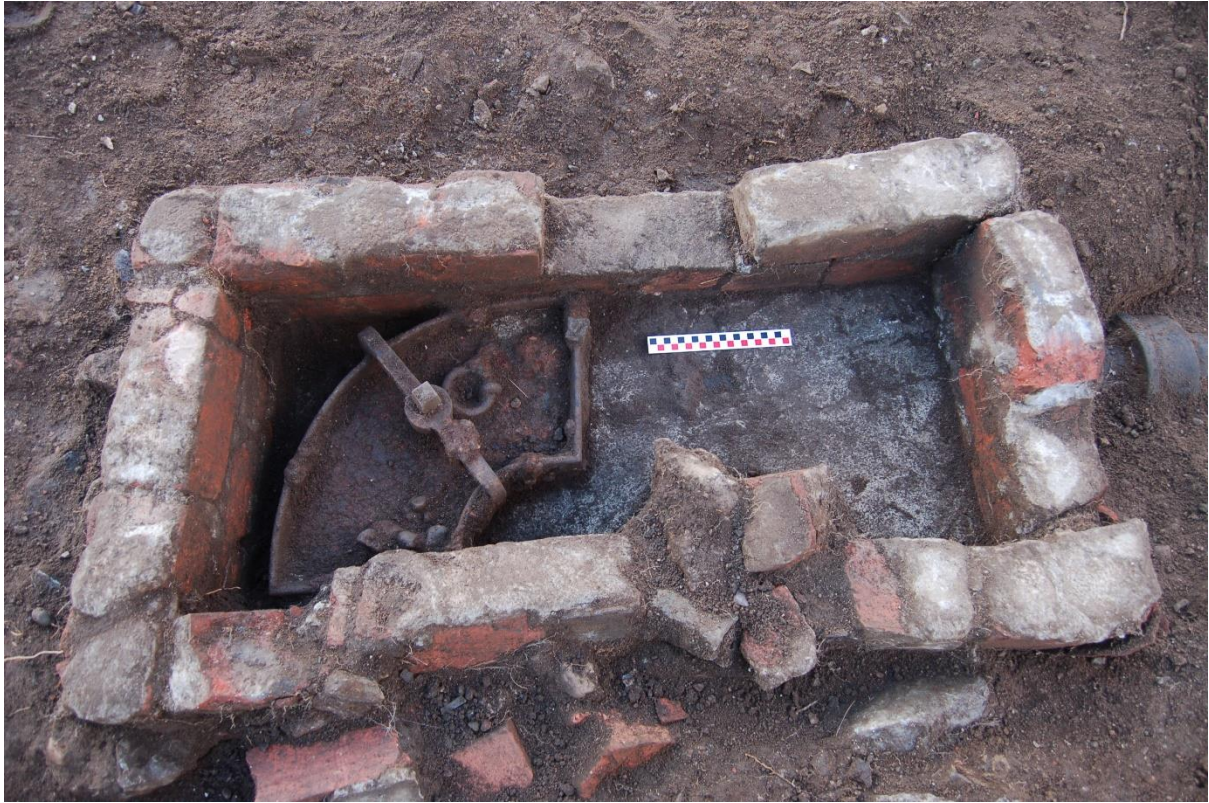
Cover, coal gas pipe inspection cover within brick housing

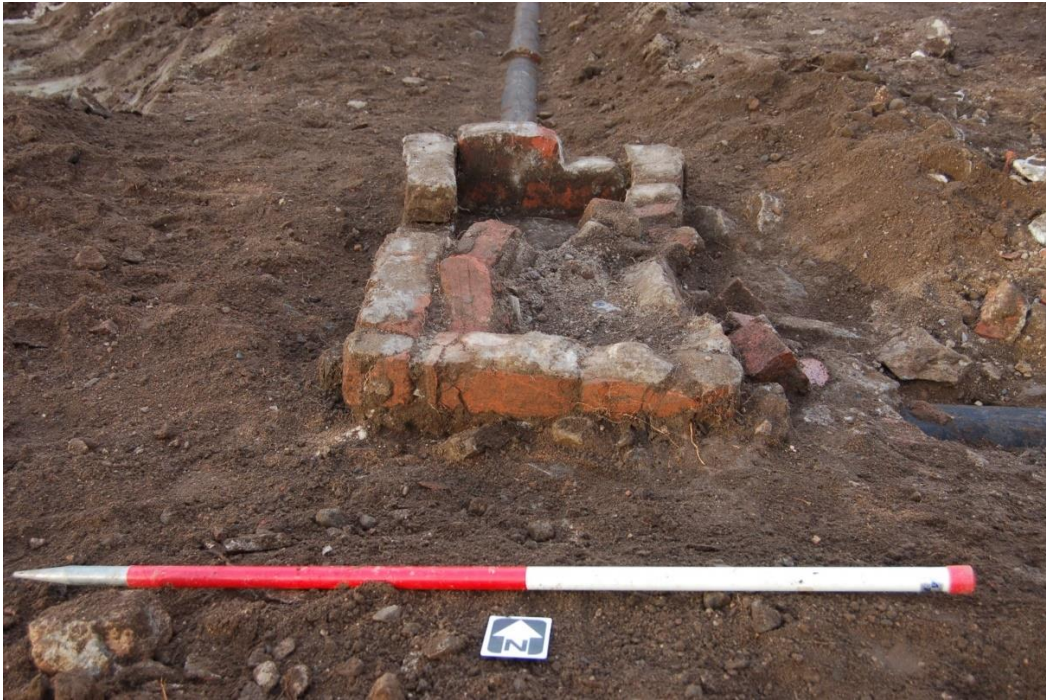
Illus 3: Features 1A (right) & 1B (rear) in association with feature 2: facing N

Two truncated sections of cast iron metal pipe ran across the courtyard area to the north west of the castle structure (Illus 2). Each pipe measured 0.15m in diameter and were made up of 1.8m sections with solid metal seals at each joint. Pipe 1B (5.0m) ran from a point in the foundations of a rubble wall (feature 7) south, into a small brick structure (feature 2). Pipe 1A (6.5m) emerged from the east side of the brick structure and ran towards the castle (Illus 3). They are thought to have carried coal gas from a production plant to the north of the castle into the building during the 19th century (*pers comm.* Alistair Aboyne).

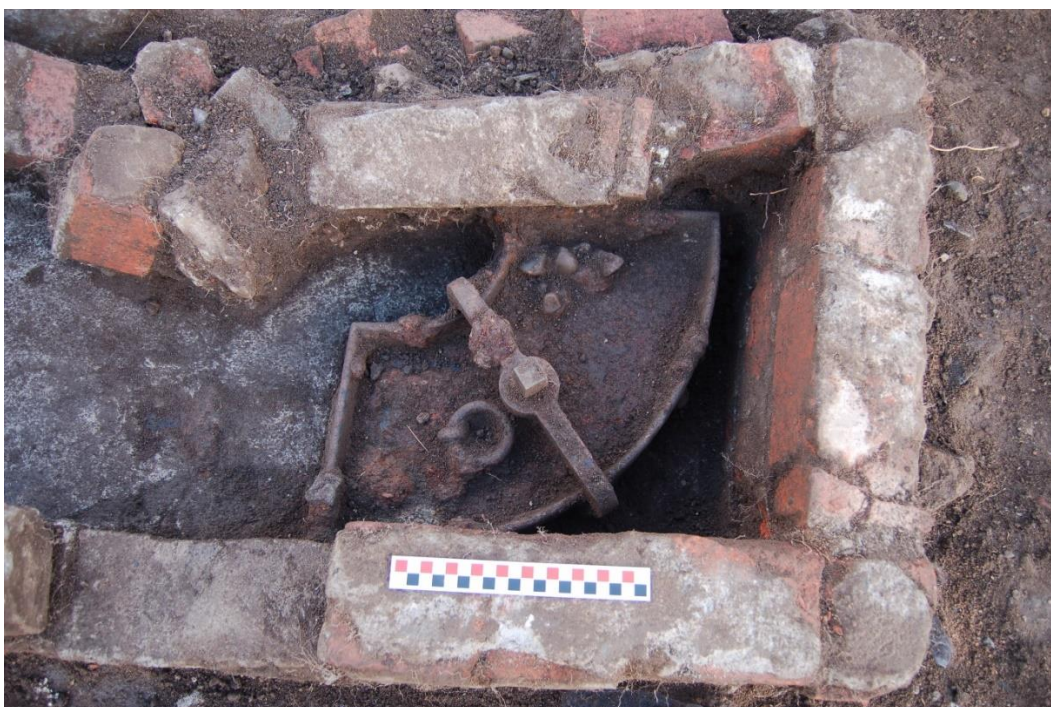
Illus 4: Feature 2: facing E

Feature 2 was a low standing brick structure measuring 1.2m by 0.6m with walls a maximum of 0.2m high. The area enclosed by the walls was floored with cement and housed a cast iron inspection hatch located in the southern half, situated over the point where pipes 1A and 1B met (Illus 4). The hatch was held in place by a metal bar with a brass locking screw (Appendix 3). There were no visible manufacturers trademarks.

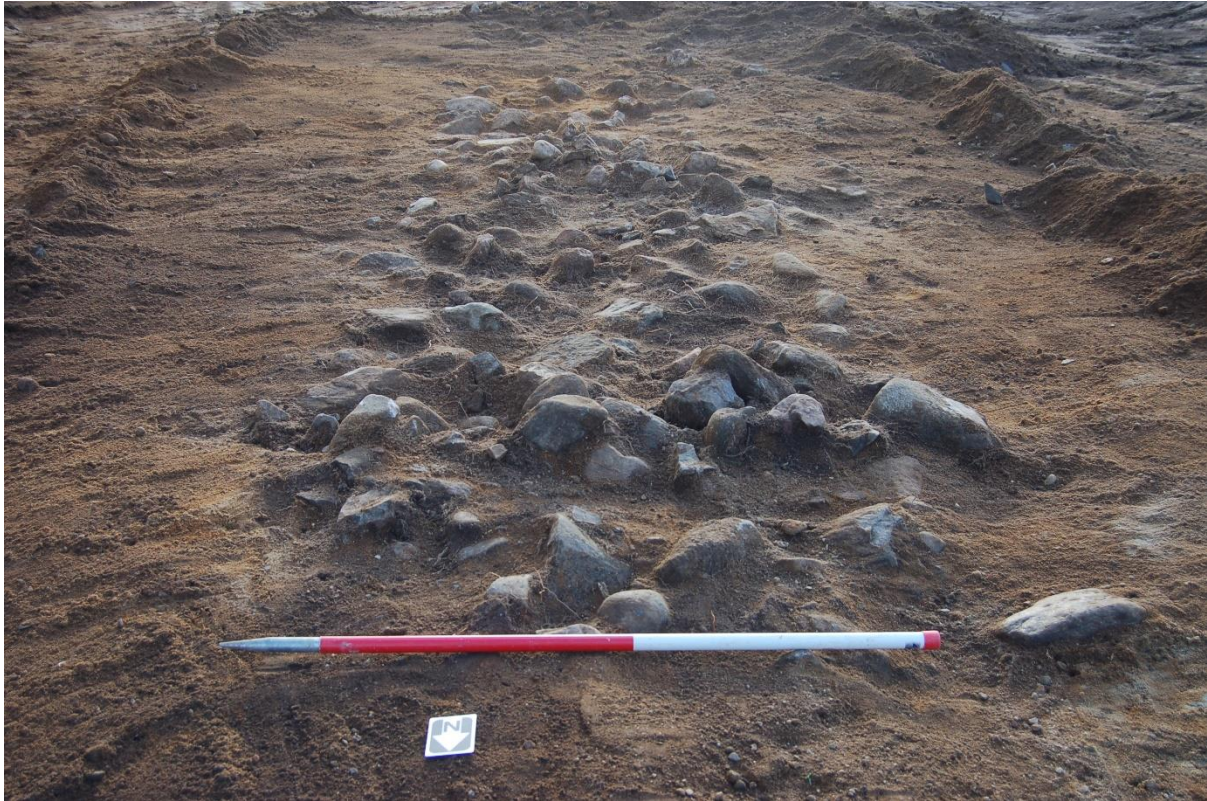
Illus 5: Feature 3: facing S

A single layer of stones covering an area 5.0m by 1.5m ran on a N-S axis parallel to the castle structure from a point 2m west of the tower (Illus 5). Individual stones ranged from 0.1m- 0.2m in diameter and appeared to have been placed to form a surface or base for other surfacing material.

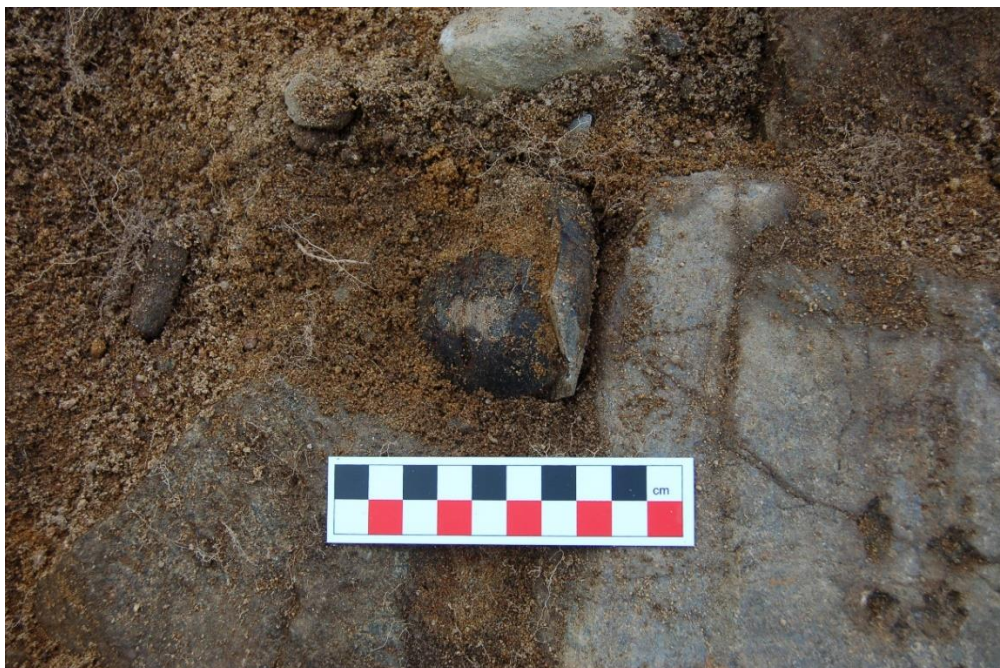
Illus 7: Blown glass bottle base in feature 3: facing W

The base of a pontil blown glass bottle lay *in situ* on top of the stones of feature 3 (Illus 7).

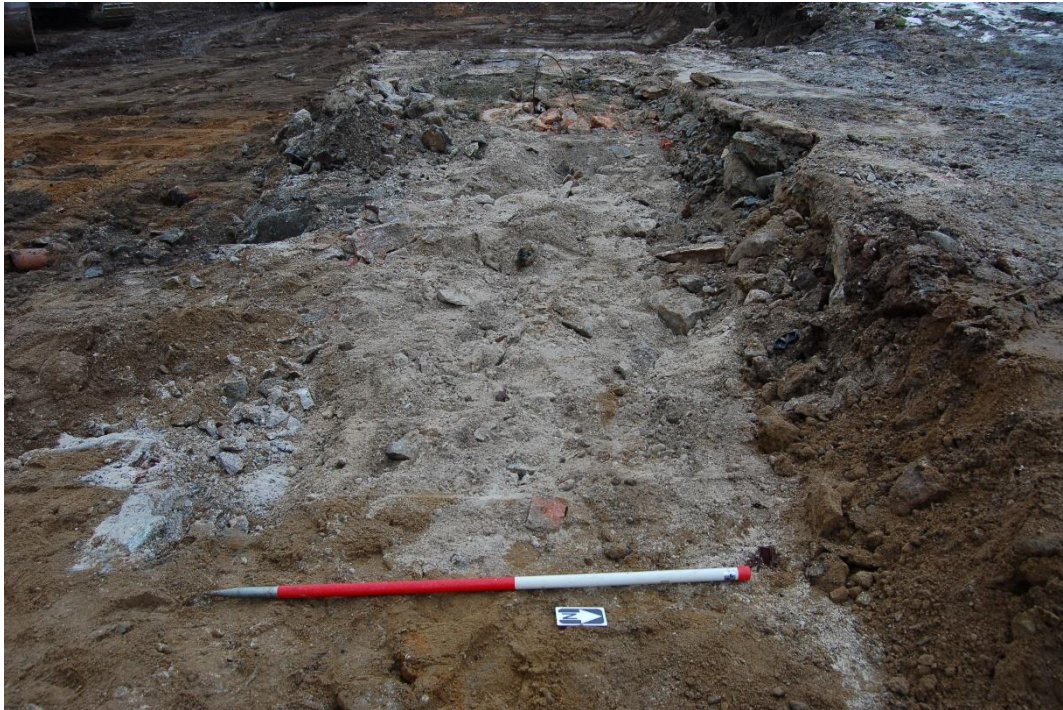
Illus 8: Feature 5: facing W

Feature 5 was the demolished foundation of a small building; the flat roofed structure noted in the HER for Aboyne Castle (Illus 8).

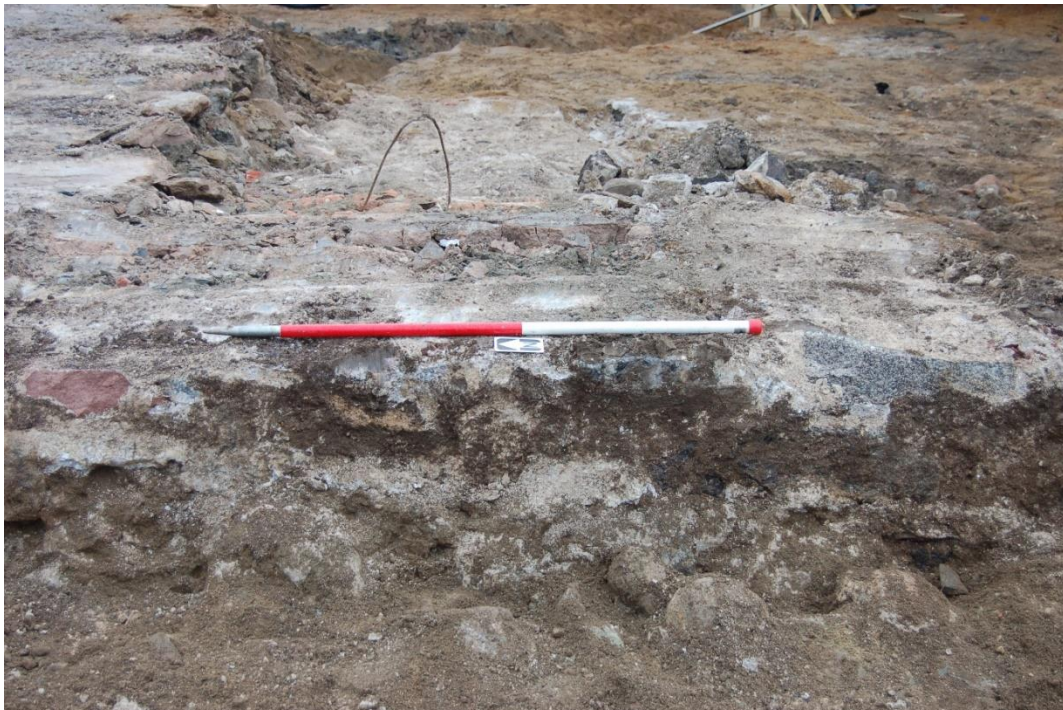
Illus 9: Feature 5 possibly incorporating part of feature 7: facing E

The demolition rubble covered an area approximately 6.5m by 4m though the building foundations had not been removed across the full 4m width. Along the W edge the foundation blocks of a rubble wall were in place. However, these may have also formed part of feature 7, a partially demolished rubble wall with rubble coping, standing to the north west of the castle tower. The rubble wall was known to incorporate feature 5.

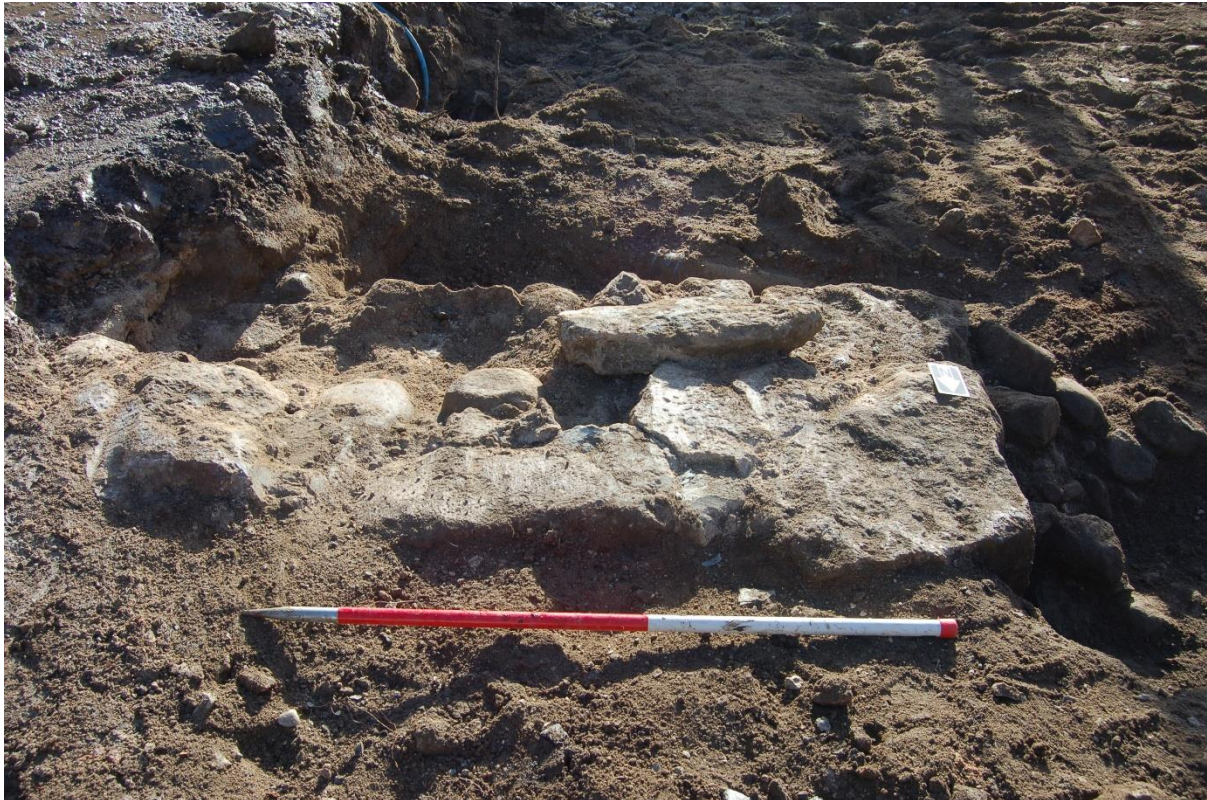
Illus 11: Feature 6: facing S

Feature 6 was a short section of stone wall with lime mortar (Illus 11) measuring 1.5m x 0.55m x 0.25m. A triangular section of plaster surface abutted the south side of this wall which had been cut through to insert a modern sewerage pipe (feature 10). Feature 6 was located within the courtyard to the NW of the castle tower, 2m immediately N of feature 5. The position corresponds to the N wall of W wing of Aboyne Castle depicted on the 2nd edition, but not the 1st edition OS map indicating it was constructed sometime between 1867 and 1899. This section of wall will remain untouched, by the proposed development.
