**Former coach house, Panmure Estate, Carnoustie,
DD7 6LW**

Report on Level 1 Standing Building Survey

Angus Council 18/00821/FULL and Ref No 18/00822/LBC

**Alison Cameron
Cameron Archaeology
4 March 2019**

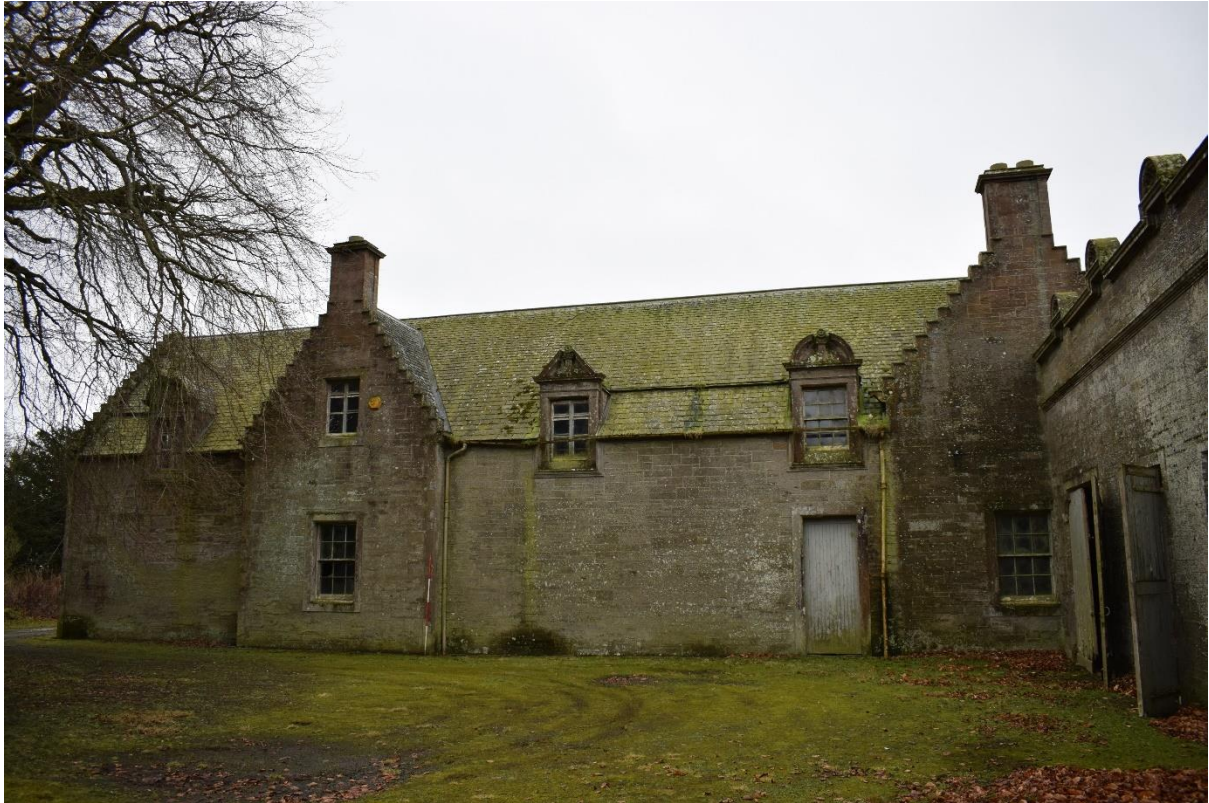
Illus 8 Stable block NNW elevation; facing SSE

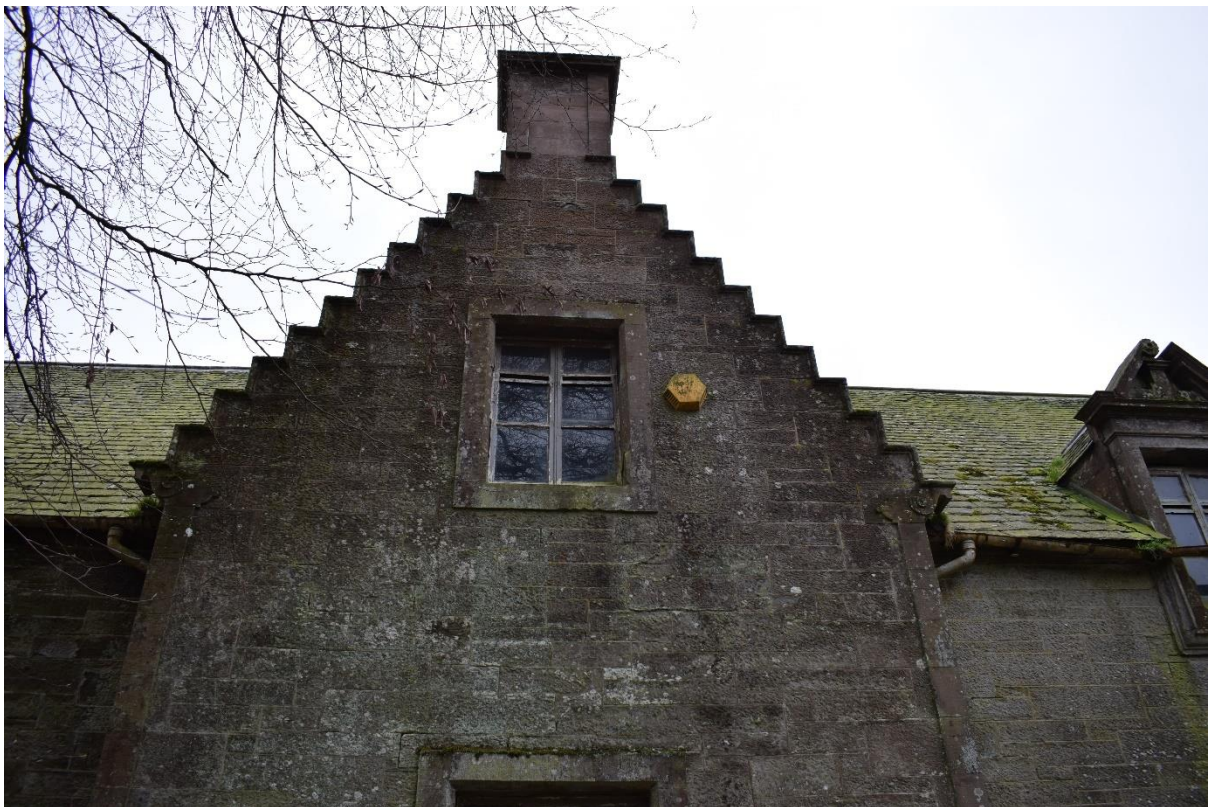
Illus 9 Stable block NNW elevation crow-step gable above W10; facing SSE

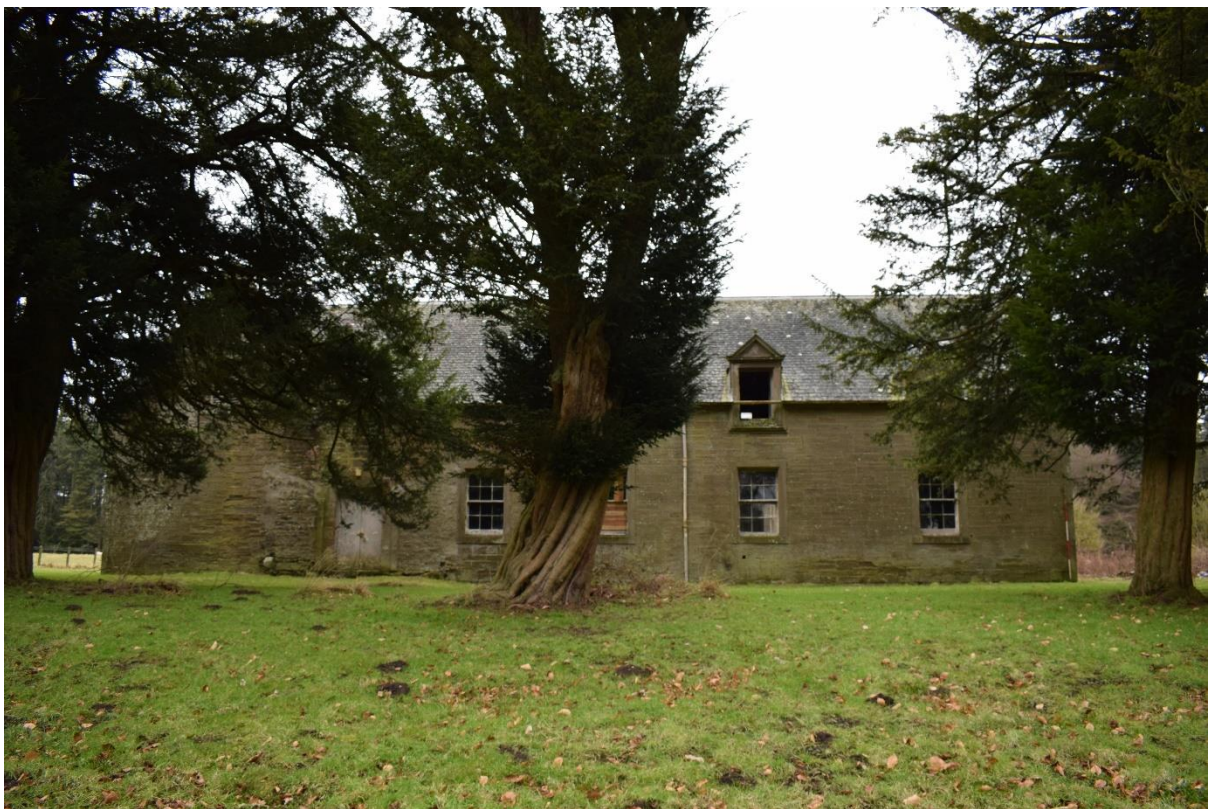
Illus 13 Stables SSE façade; facing NNW

The SSE elevation (Illus 13) has one access door with first and ground floor windows (W4-8; Illus 14) and a crow-step gable at the WSW end with first floor window W3. Two small structures were added on either side of the door D1 on the 1st, 2nd and 3rd Edition OS maps (Illus 57-59) and these have since been demolished leaving scars F24A and F24B (Illus 15); the walls of this structure can be seen as earthworks under the grass (F27 and F28).

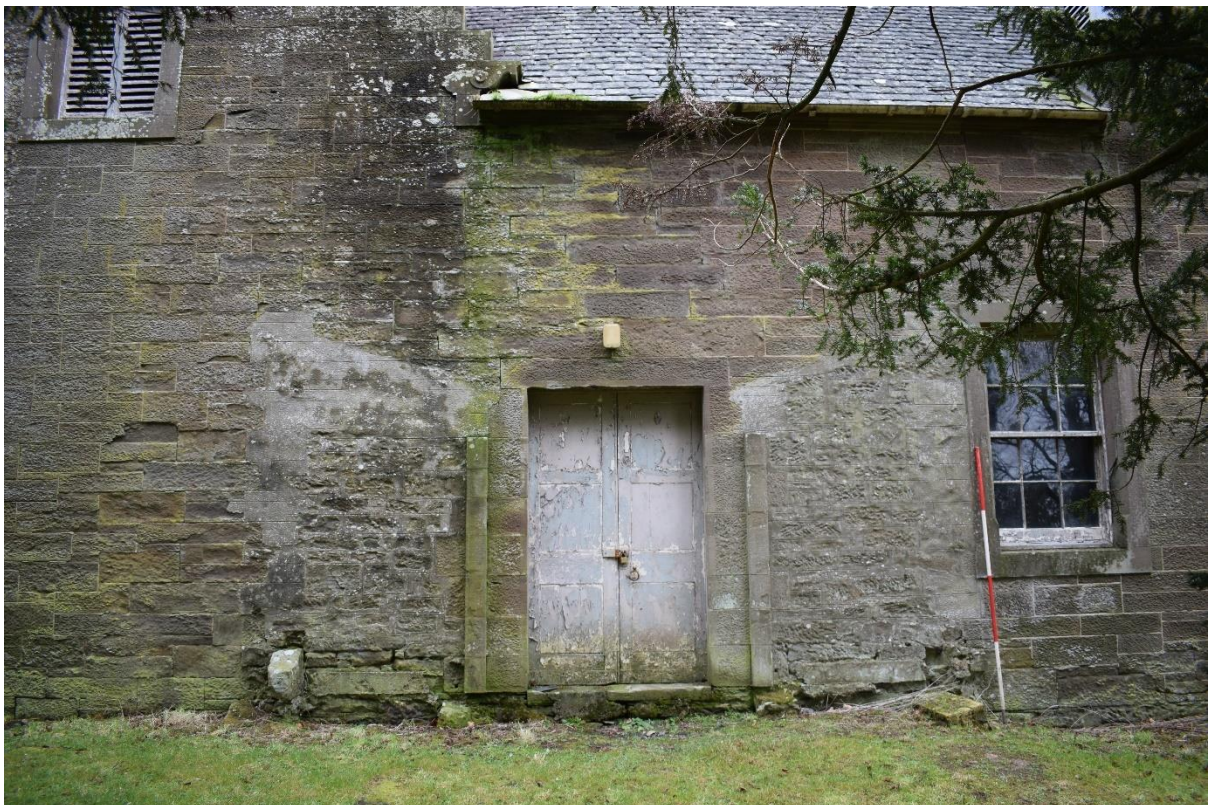
Illus 15 Stables SSE façade D1 with scars F24A (right) and F24B (left) where small extensions seen on OS maps have been removed; facing NNW

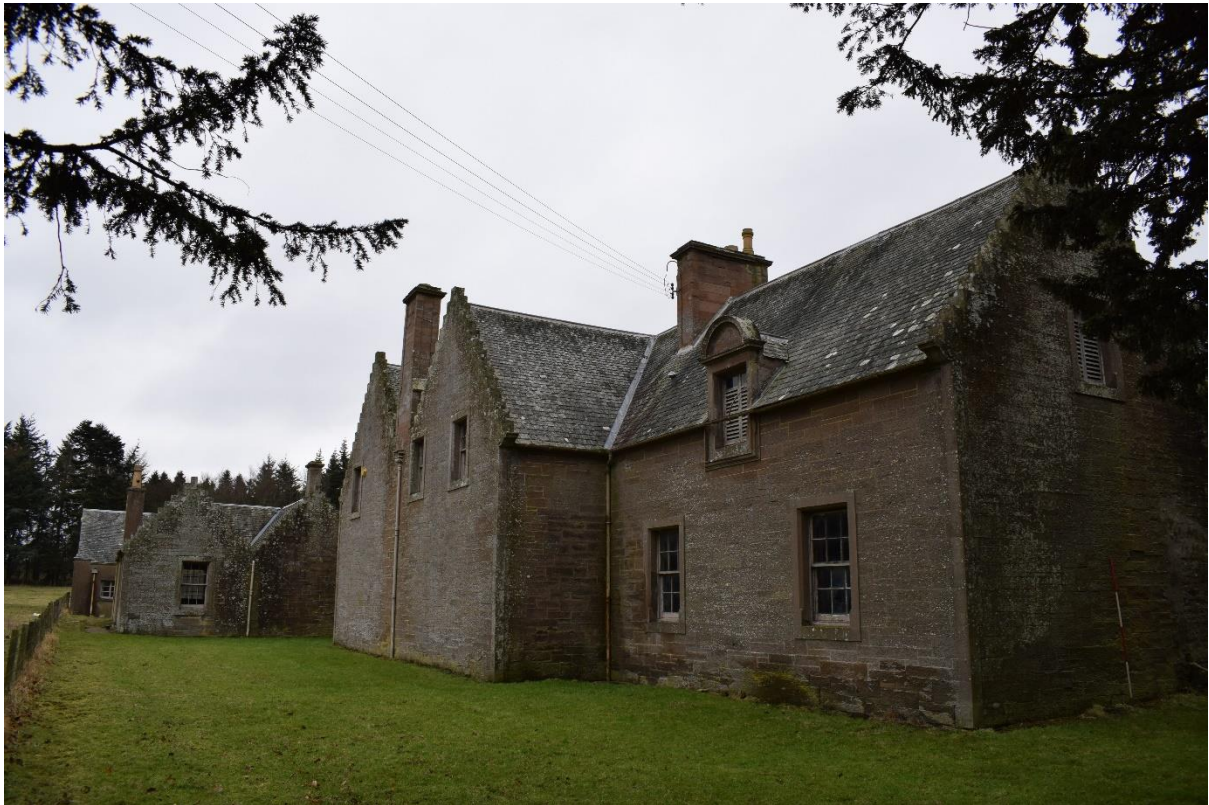
Illus 16 Stables WSW elevations with wider Room 26; facing NE

The WSW wing has exterior windows on the ground and first floor (W38-45; Illus 16). There is a cast iron hopper and down pipe (Illus 17) in the centre of the WSW wall inscribed 'FM' presumably for Fox Maule Ramsay, the 2nd Baron of Panmure who revamped the buildings in the 1850s. The WSW wing is primarily cartsheds (Room 26) with cart doors (D17, D18, D19, D20; Illus 7, 18) on the ENE wall and fireplaces F7 on the WSW wall and F8 on the NNW wall. There is a blocked door in the SSE wall (D30) which would have led to the stables and door D31 on the NNW wall which would have led to the accommodation (Rooms 9, 27 and 28 on the ground floor and Rooms 30-40 on the first floor).

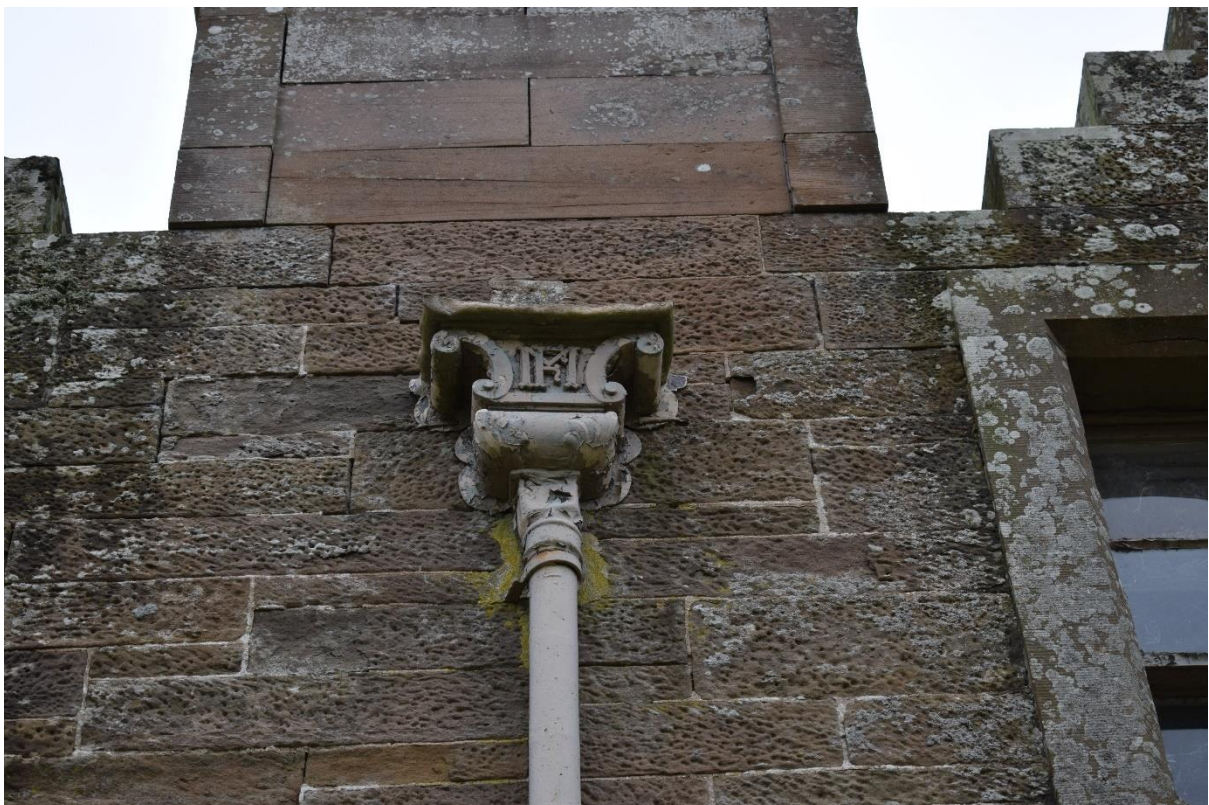
Illus 17 Stables WSW elevation Room 26 with cast iron rainwater hopper inscribed 'FM' presumably for Fox Maule Ramsay, the 2nd Baron of Panmure who revamped the buildings in the 1850s; facing ENE

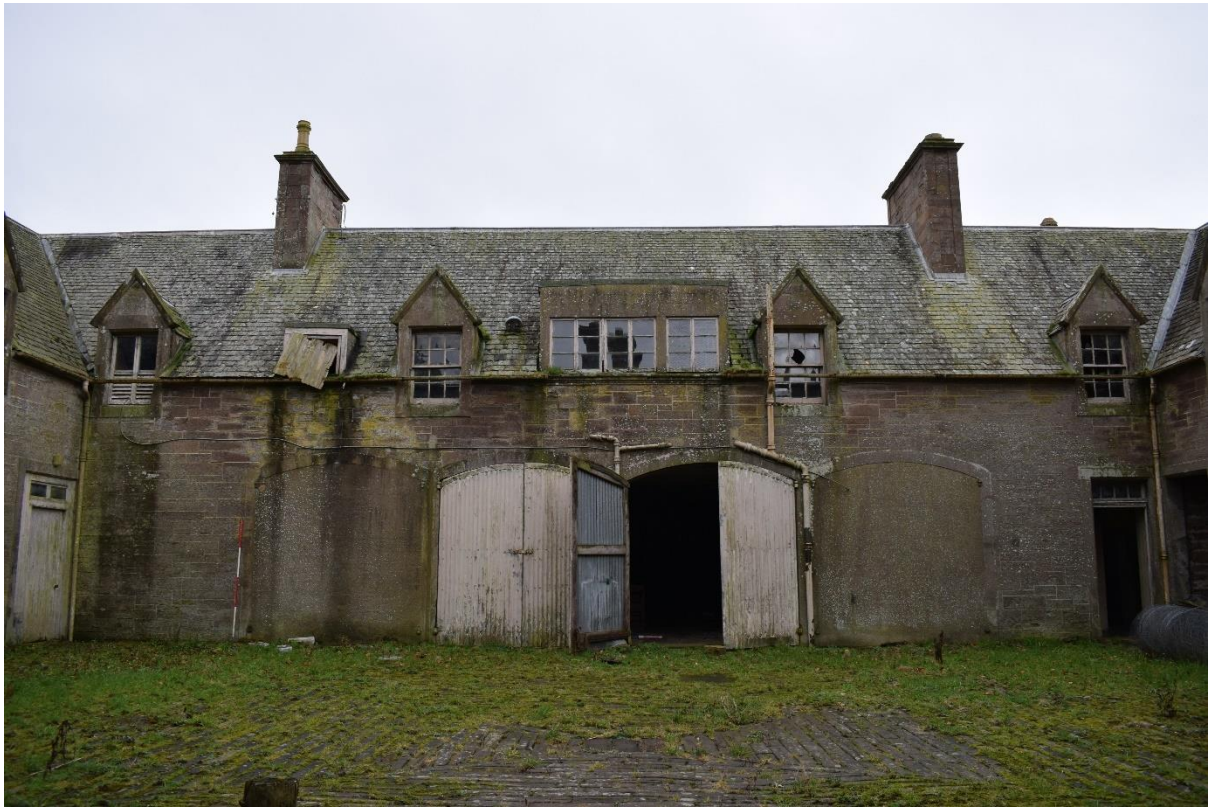
Illus 18 Stables inner courtyard WSW façade with cart doors D17, D18, D19, D20 (l-r); facing WSW

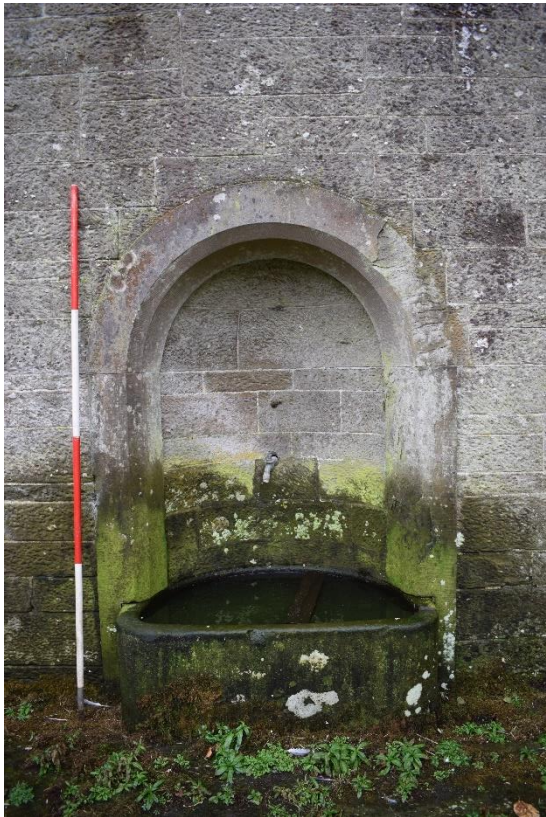
Illus 20 Sandstone and cast iron water trough F1; facing SSE

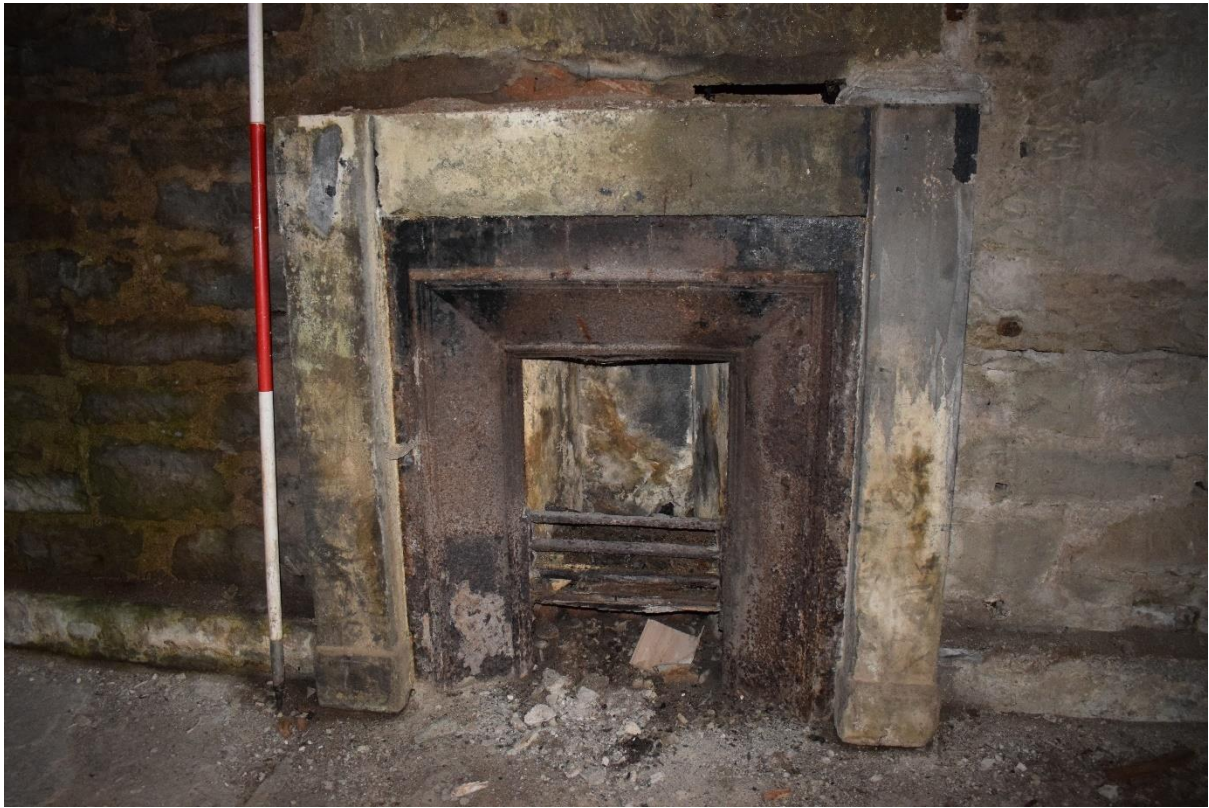
Illus 22 Room 9 WSW wall fireplace F10; facing WSW

The only accommodation that was accessible during this survey (Rooms 9, 27 and 28 on the ground floor and Rooms 30-40 on the first floor) included several rooms with fireplaces including Room 9, (F10, Illus 22), Room 38 (F26, Illus 23) and Room 40 (F12, Illus 24).

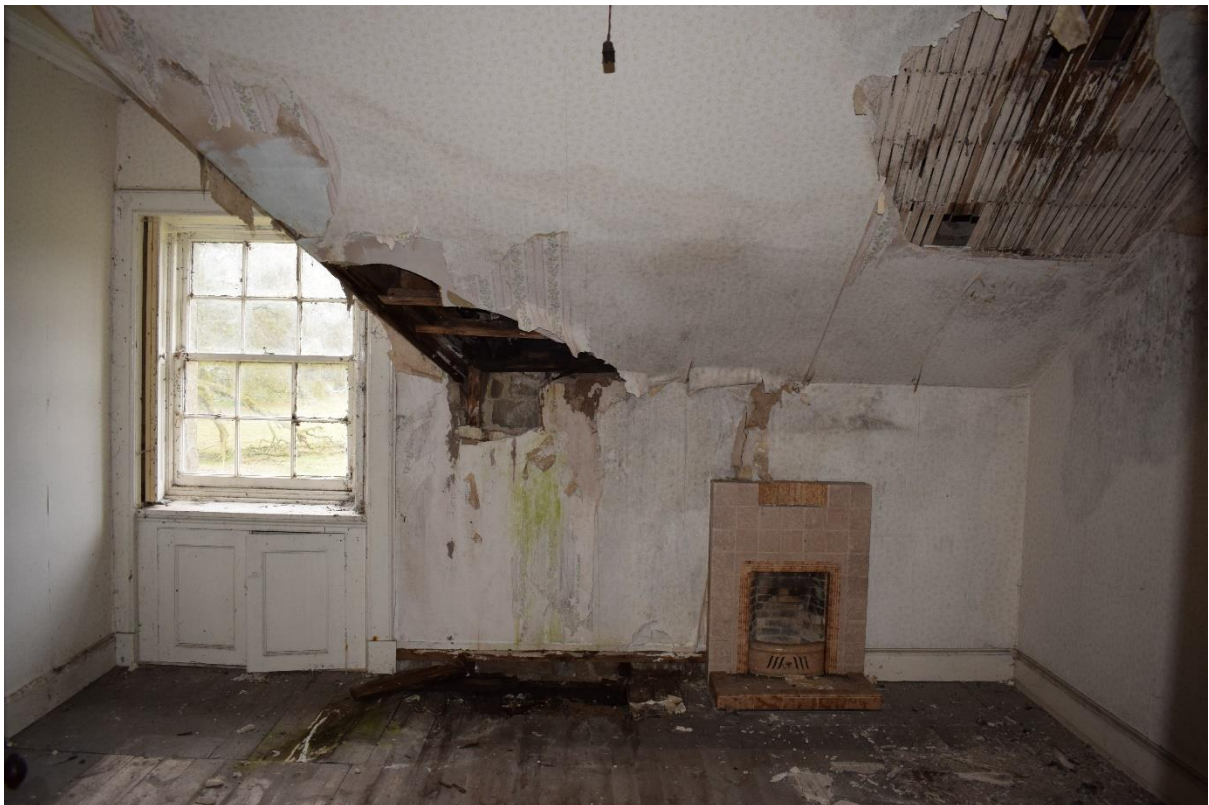
Illus 23 Room 38 WSW wall W32 (left) fireplace F26 (right); facing WSW

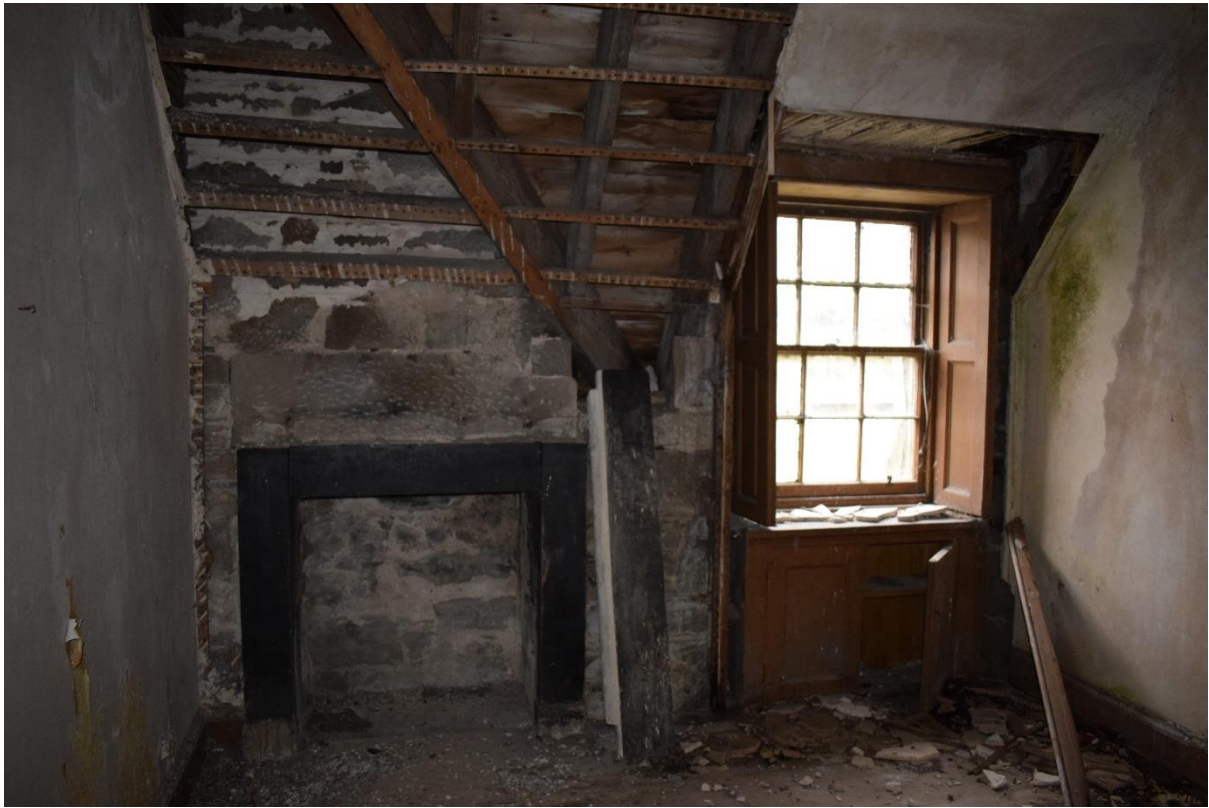
Illus 24 Room 40 NNW wall fireplace F12 (left) and W13 (right); facing NNW

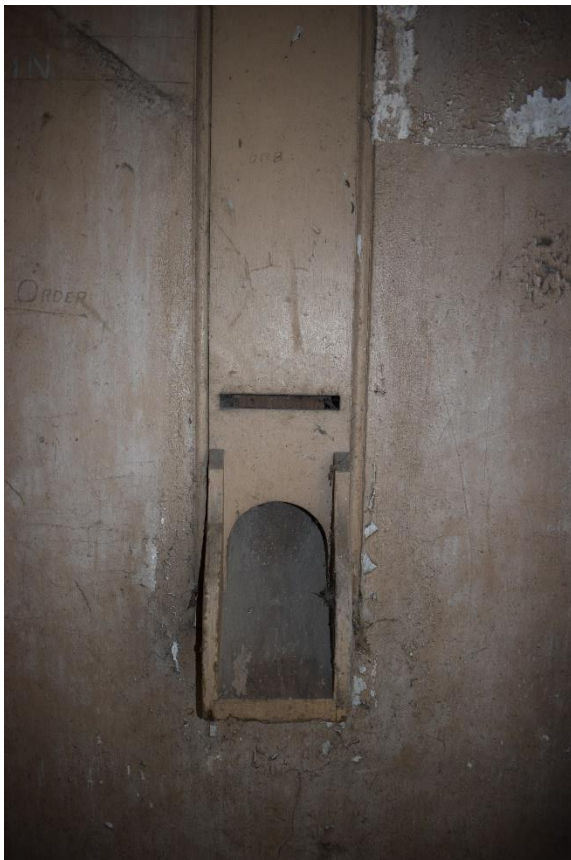
Illus 27 Room 15 cast iron chute F18; facing SSE

Three sets of stairs (Rooms 15, 19 and 28) lead up to the first floor accommodations. Rooms 15 and 19 have a narrow cast iron chute down from the first floor to the ground floor (F18/F19; Illus 27). Only the NW and WSW sections of the first floor are accessible as the floors in the ENE range are rotten and therefore inaccessible.

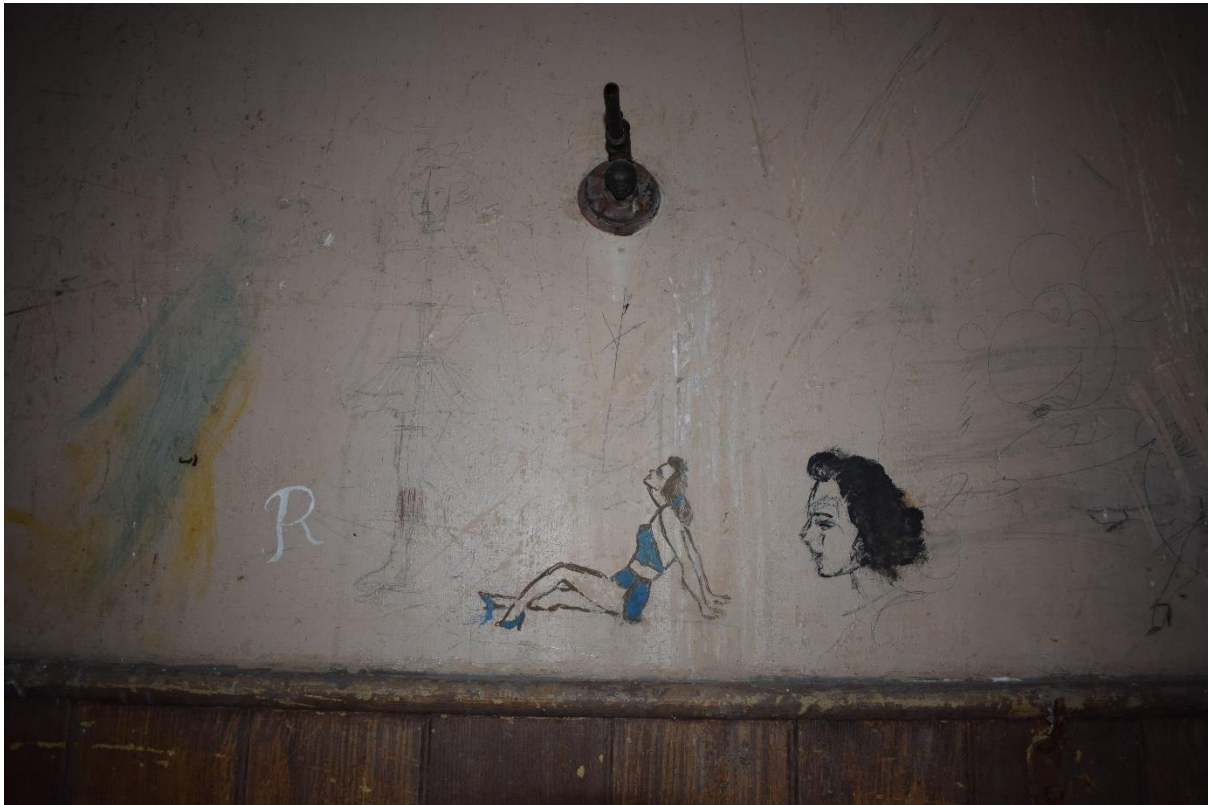
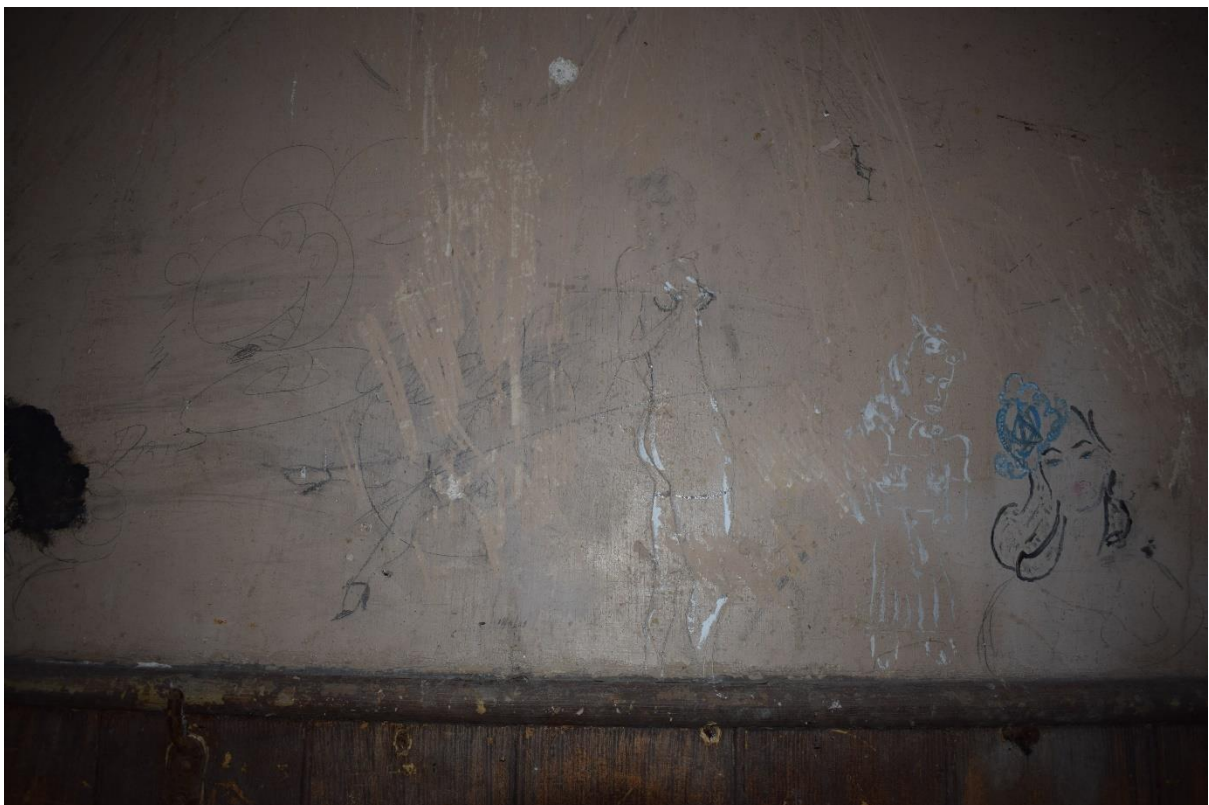
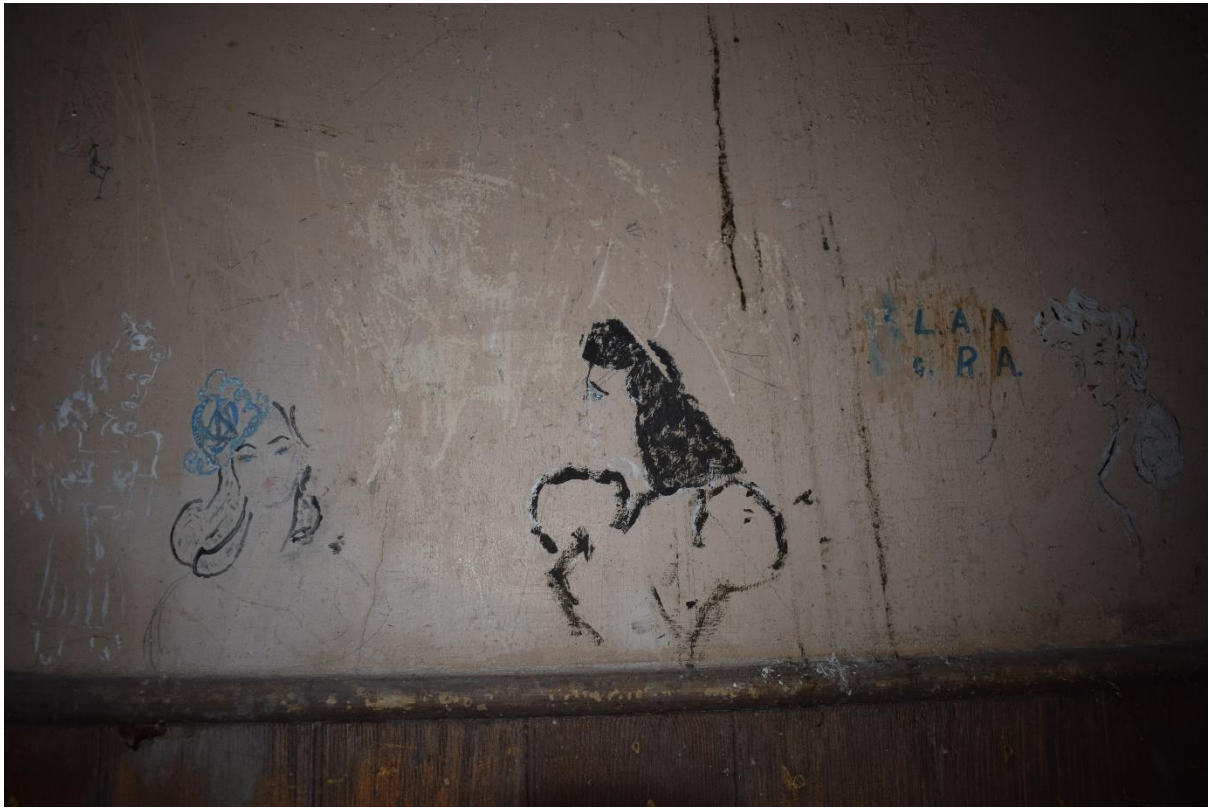
Illus 28 Room 16 NNW wall 1940s graffiti; facing NNW

Illus 29 Room 16 NNW wall 1940s graffiti; facing NNW

Illus 30 Room 16 NNW wall 1940s graffiti; facing NNW

Rooms 11, 14, 16-18, 20-25 are all stables fitted out with single stabling created with wood panel and cast-iron stalls, cast iron wall-mounted mangers and wood and cast iron feed tubs. There is a water trough (F1; Illus 6, 19, 20) on the S wall of the courtyard. Room 12 is a small room in the SE of the stables and is a wood-paneled tack room with small fireplace in the NE corner (F17; Illus 2, 25) window on the NNW wall (W11) and cast-iron saddle racks (Illus 26) on the WSW and SW walls. The NNW wall of Room 16 had painted graffiti which appears to be added to around the 1940s by the style of hair and clothes (Illus 28-30).

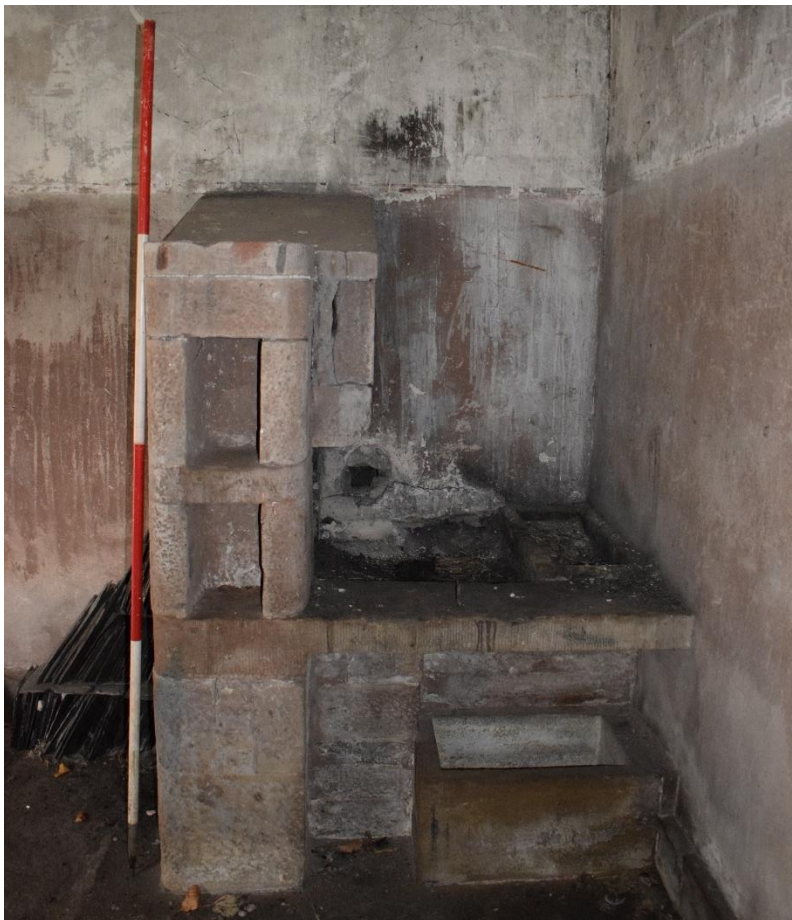
Illus 31 Room 18 kiln F20; Facing WSW

There is a kiln in the NW corner of Room 18 (F20; Illus 31). It is made from reused sandstone blocks with a cast iron tray with the remains of a fire. There is little charring on the walls and there are slates and drainage pipes in the room suggesting a small-scale industrial or domestic use.

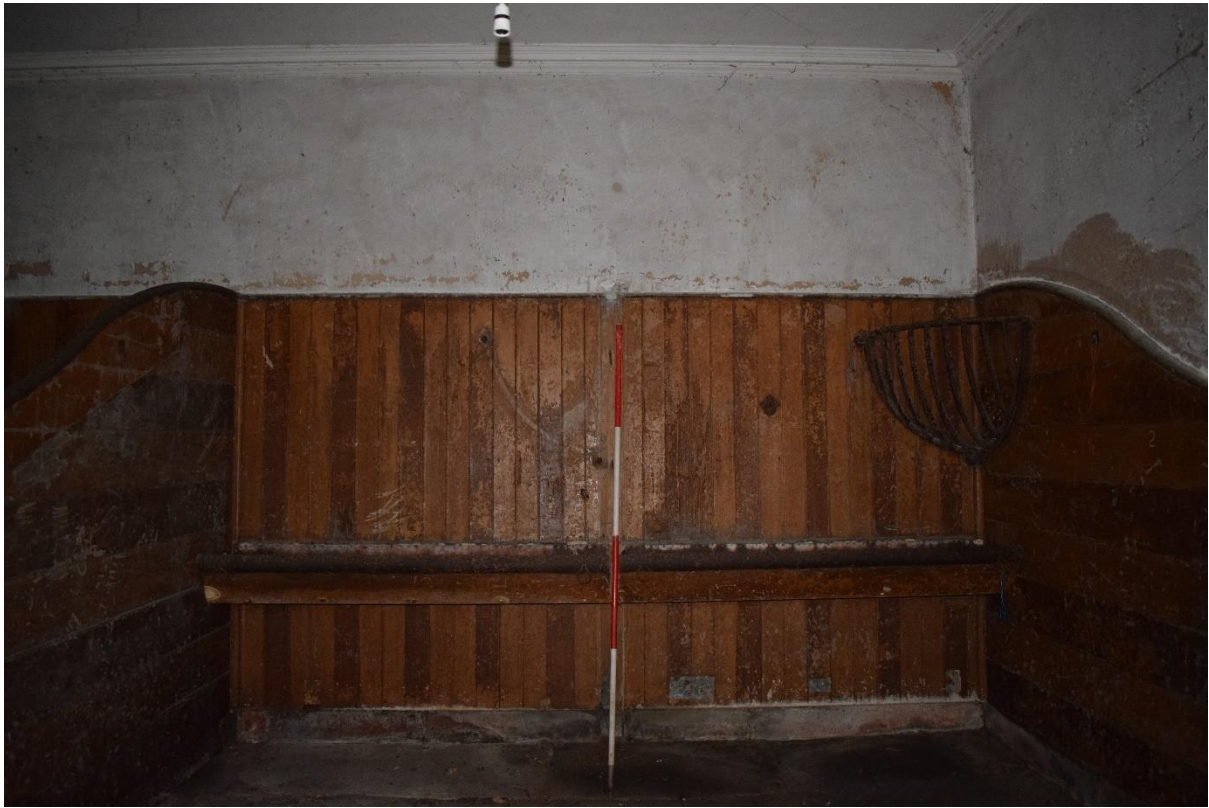
Illus 32 Room 22 NNW wall with cast iron manger (F6; right); facing NNW

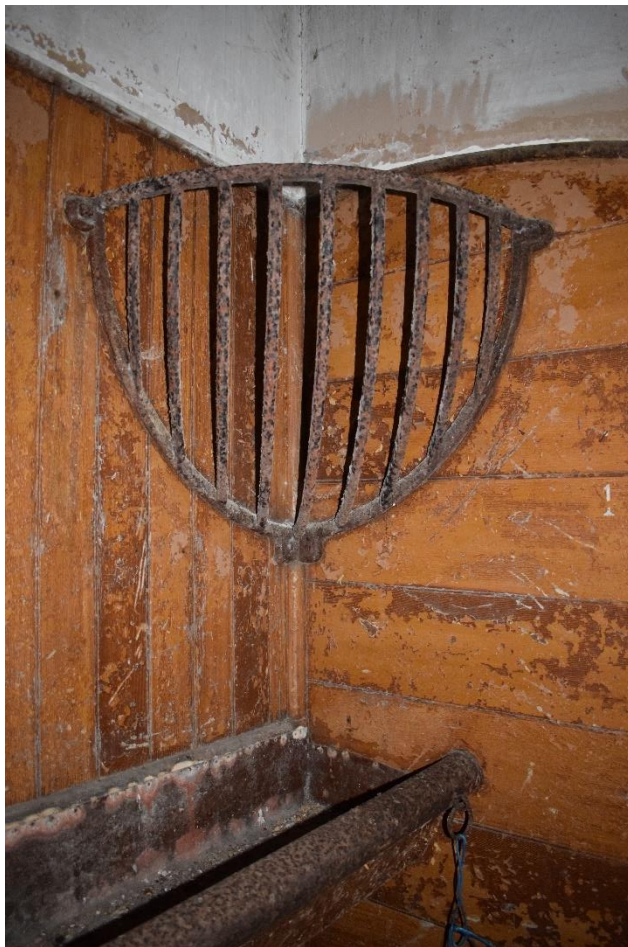
Illus 33 Cast iron manger F6 detail; facing NE

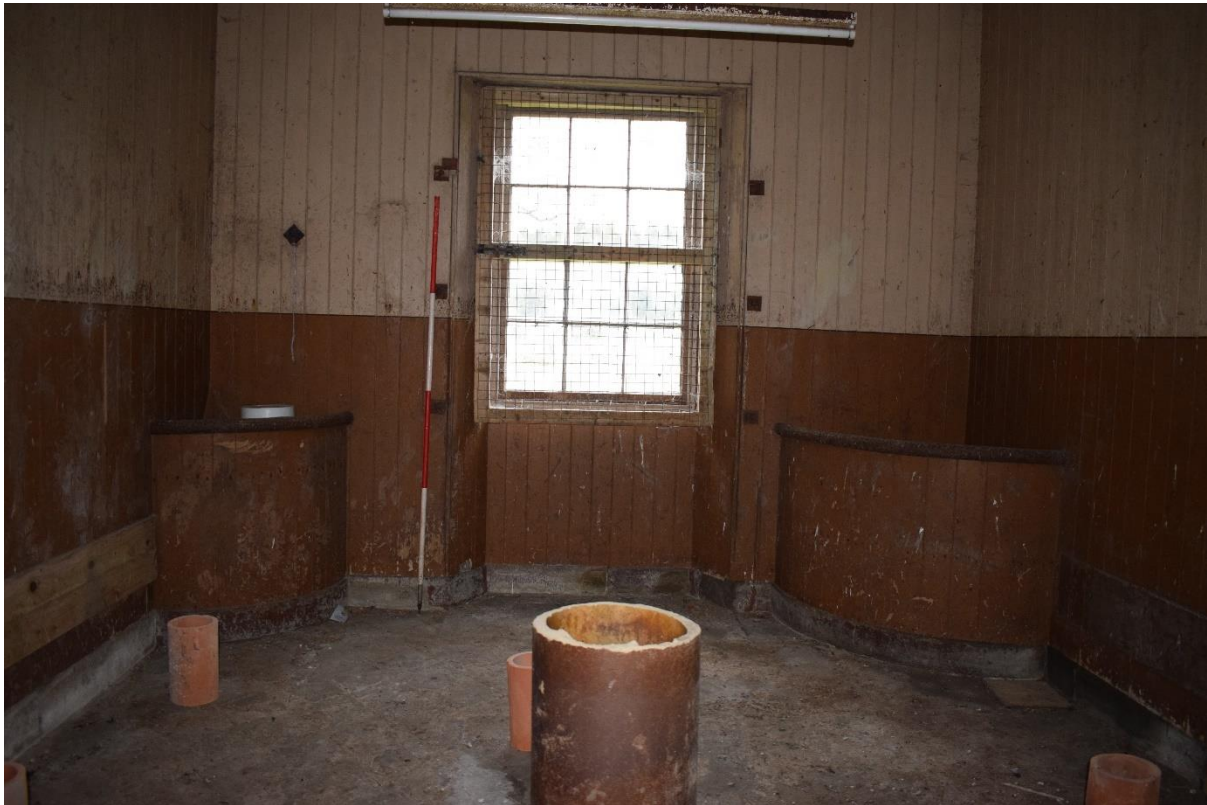
Illus 34 Room 24 stables WSW wall with W36 (centre) and wood and cast iron feed tubs F2 (left) and F3 (right); facing WSW

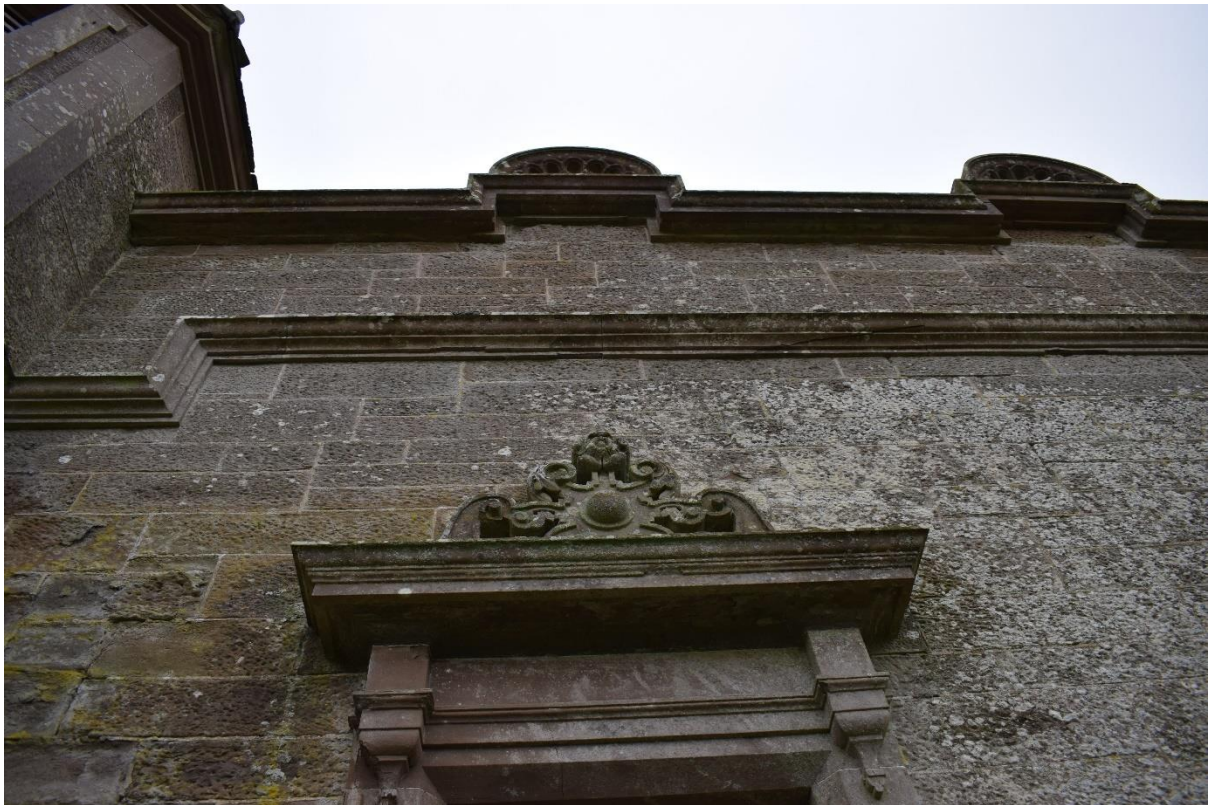
Illus 39 Room 1 NNW wall with pink sandstone portico above W18 and crenellations; facing SSE

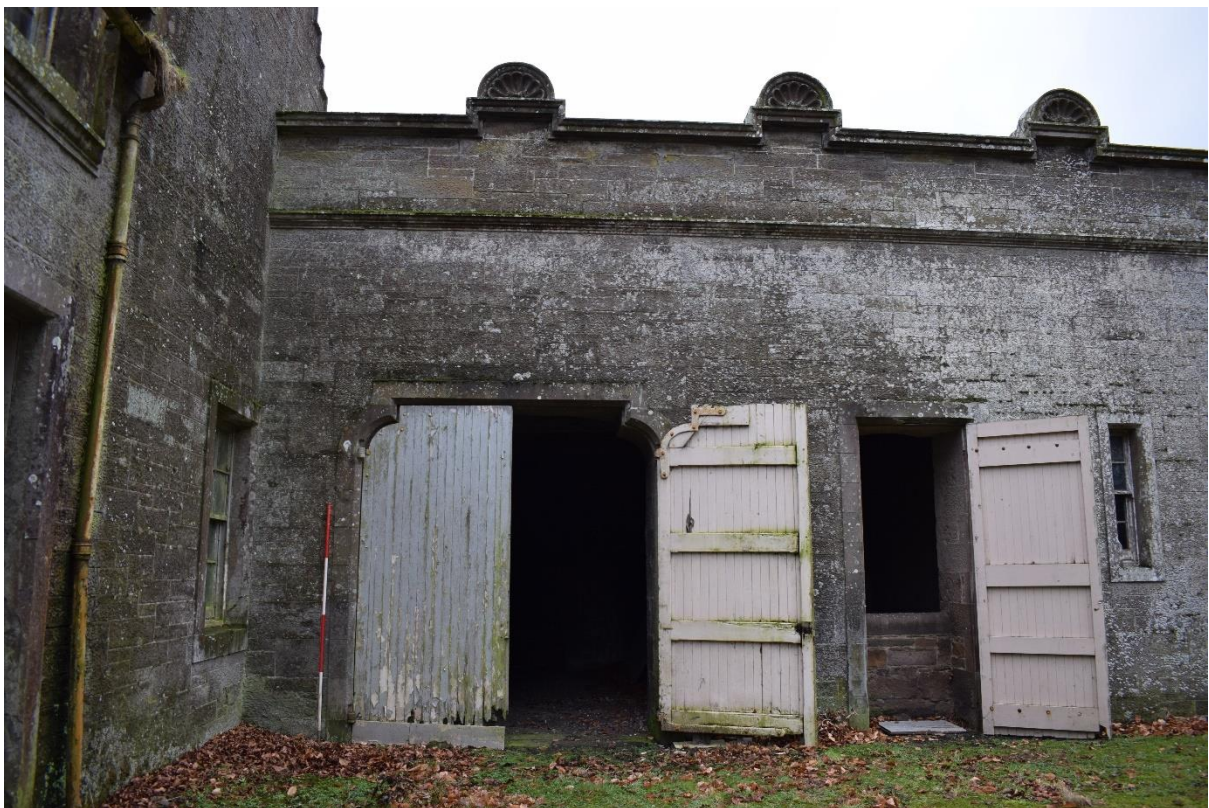
Illus 40 N building doors D5 and D6 with a string course above and a corniced crenellated parapet with segmental pediments; facing WSW

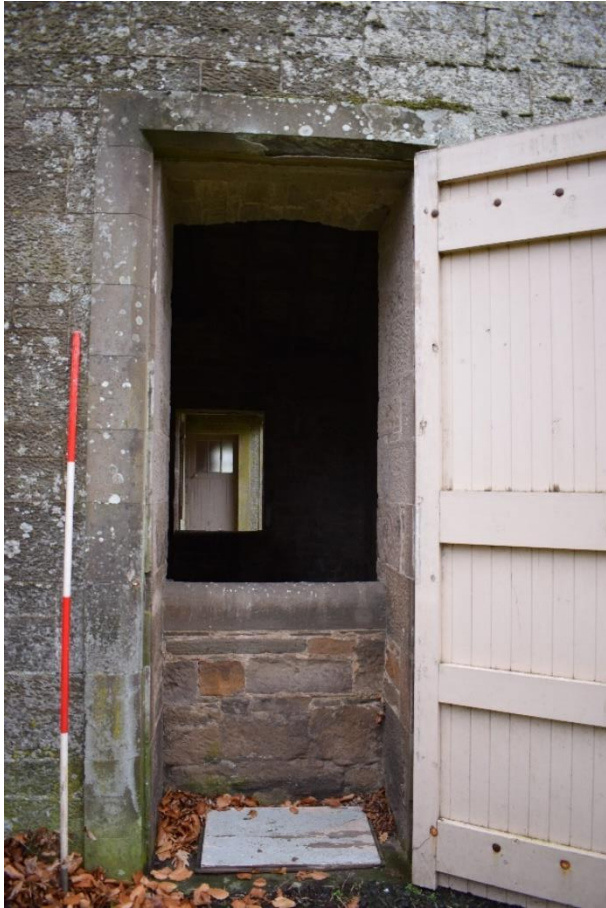
Illus 41 D6 with low wall inserted across opening to form window; facing WSW

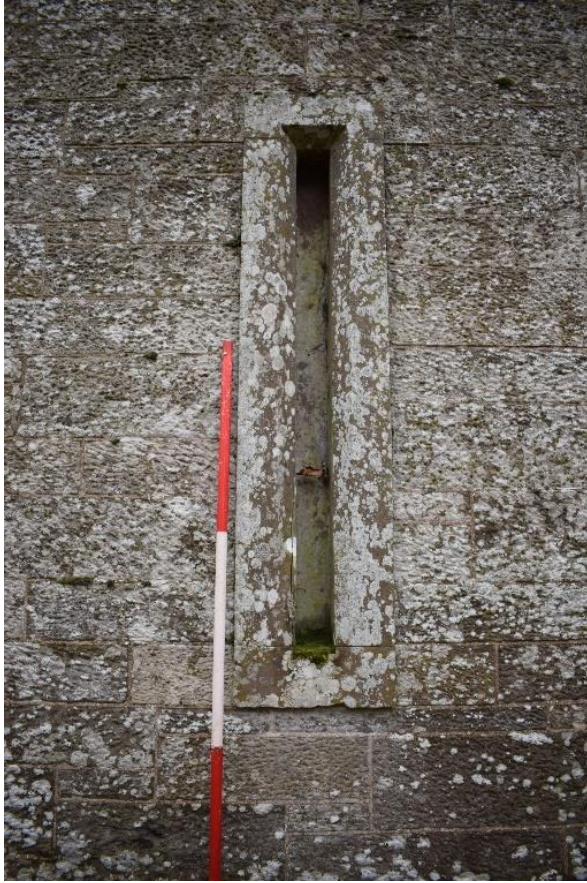
Illus 43 Arrow slit opening W47; facing WSW

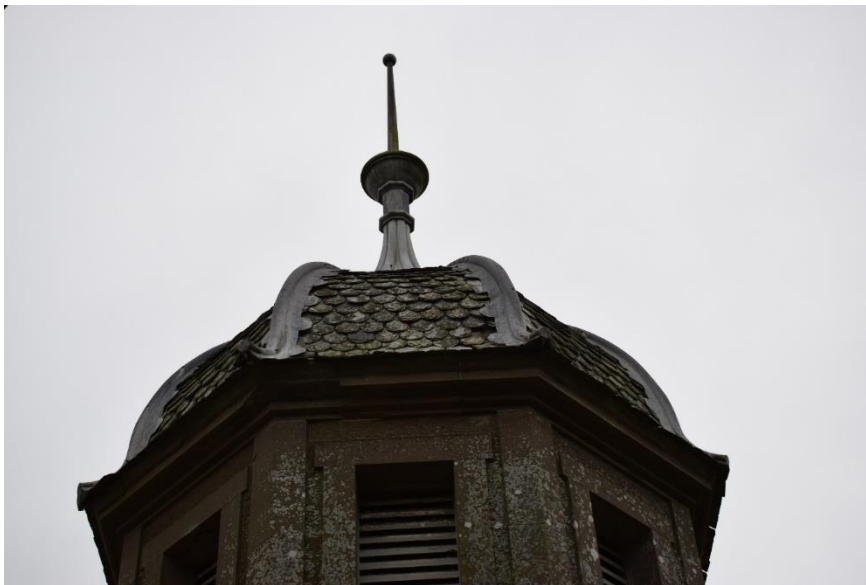
Illus 44 Detail of fish-scale slated ogee roof with ball and spike finial on roof of Room 43; facing NW

The N wing (Illus 4, 37-53) consists of Rooms 1-8. Rooms 1 and 3 may be part of the original kitchen of the 17th-century house (Buildings at Risk online) but there have been substantial alterations to the building in the mid 19th century. The NNW wall of Room 1 has dormer-headed windows W18-W20 with crenellation above (Illus 39). It is likely that the ENE wall was also constructed in this phase with cart doors D5 and D7, small door D6 (Illus 40-1) and arrow slit windows W46-W50 (Illus 42-3). The octagonal tower (Rooms 42, 43) may also have been added in this phase. It is 3.9m diameter with door in the SSE wall (D32) and two other ground floor windows (W17 and W51) in Room 42. There are seven first floor louvered windows (W14-16, W21-24) on the first floor Room 43 and the building has a grey fish-scale leaded ogee roof (Illus 44-5).

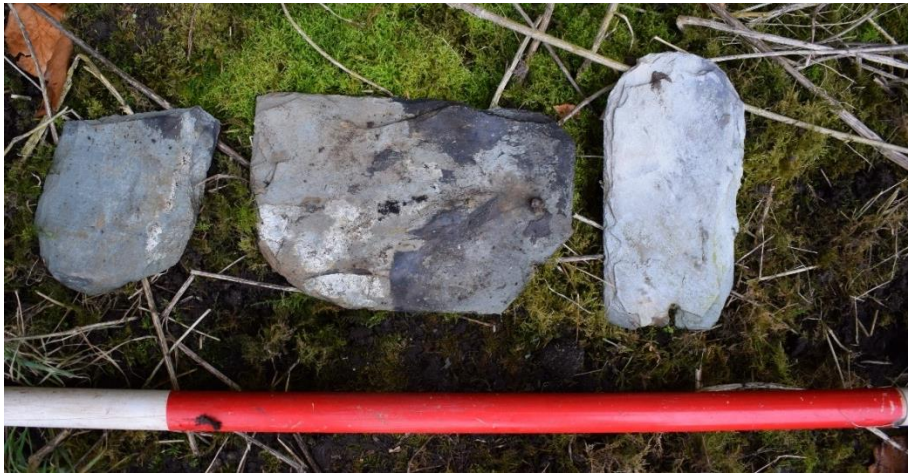
Illus 45 Examples of fallen fish-scale slates

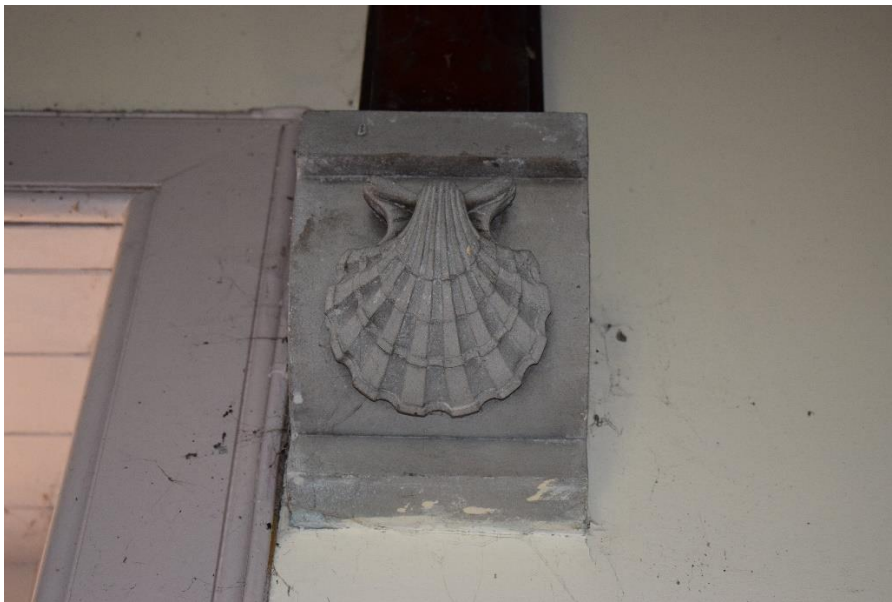
Illus 46 Scallop corbel Room 1; facing S

The interior of Room 1 was remodeled, probably in the mid 19th century and it has a wood hammerbeam roof with sandstone corbels with scallop decoration (Illus 46) and wood paneling throughout. There is a large sandstone fireplace on the E wall (F30; Illus 47) with central scallop motif. Room 2 is a concrete extension with mainly bathroom facilities and Room 3 is a kitchen with window (W25) on the N wall but the small windows on the E wall have been plastered over when the room was converted to a kitchen.
