**Former coach house, Panmure Estate, Carnoustie,
DD7 6LW**

Report on Level 1 Standing Building Survey

Angus Council 18/00821/FULL and Ref No 18/00822/LBC

**Alison Cameron
Cameron Archaeology
4 March 2019**

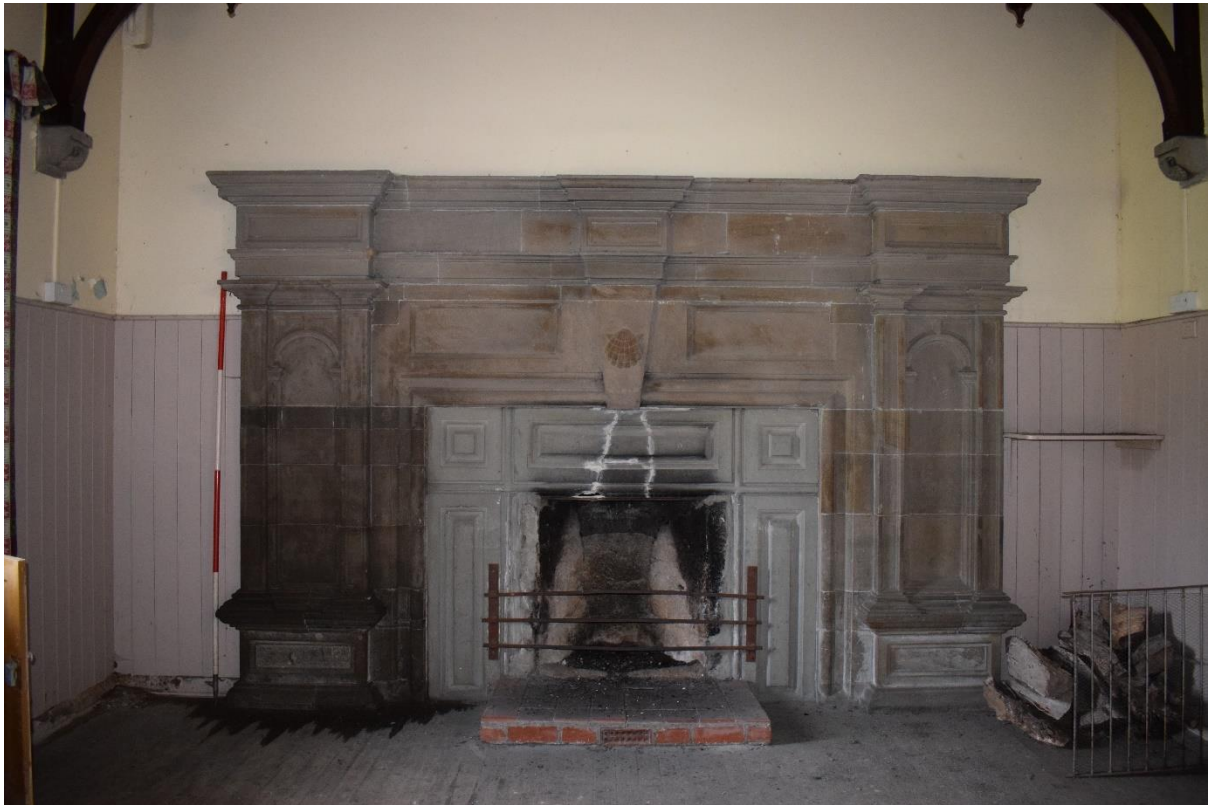
Illus 47 Room 1 fireplace F30 with central scallop motif showing timber hammerbeam roof and stone corbels; facing E

The interior of Room 1 was remodeled, probably in the mid 19th century and it has a wood hammerbeam roof with sandstone corbels with scallop decoration (Illus 46) and wood paneling throughout. There is a large sandstone fireplace on the E wall (F30; Illus 47) with central scallop motif. Room 2 is a concrete extension with mainly bathroom facilities and Room 3 is a kitchen with window (W25) on the N wall but the small windows on the E wall have been plastered over when the room was converted to a kitchen.

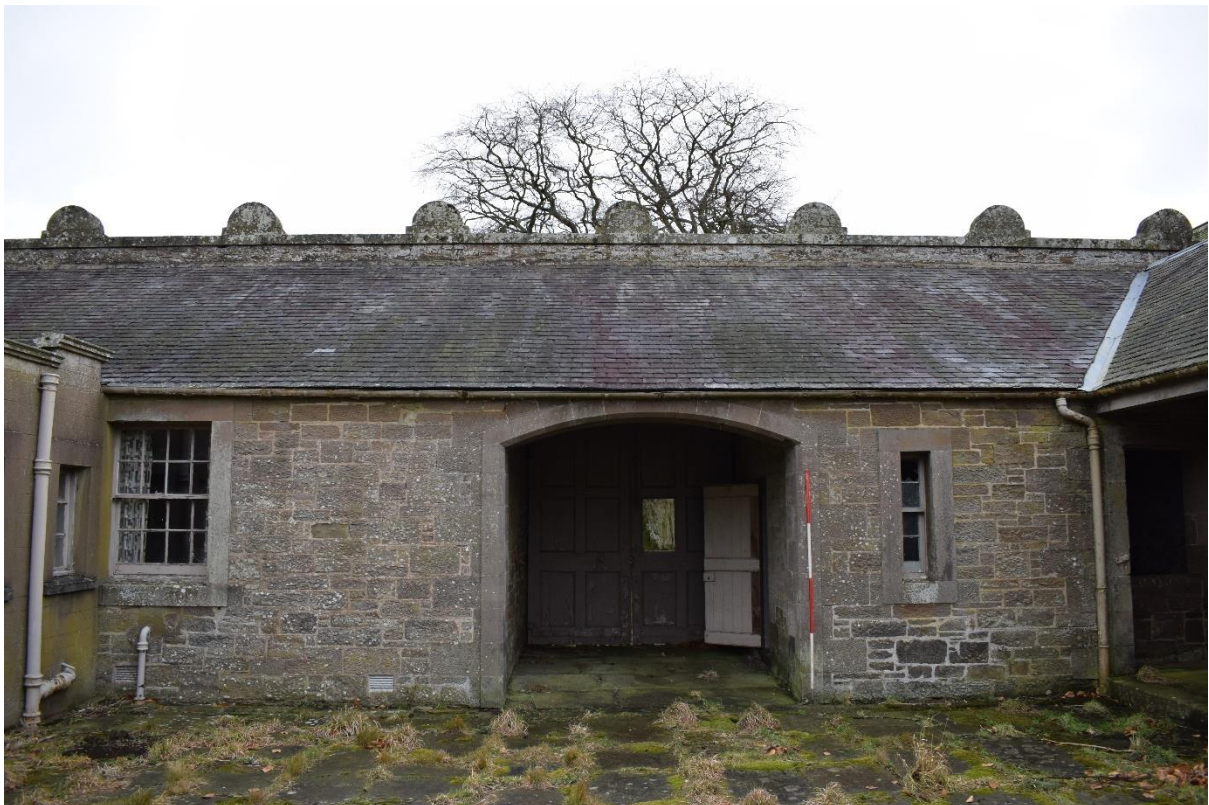
Illus 48 WSW courtyard ENE wall D3 (centre) with W25 (left) partially covered by concrete extension and W26 (right); facing ENE

There is a cart door (D3/D7; Illus 48) which gives access into the courtyard which is now external and on the WSW side of the building. This courtyard would originally have been internal (see 1st, 2nd and 3rd Edition OS maps; Illus 57-59). Rooms 7 and 8 are built onto the NW corner of the stable building and they have a M-profile crow-step gable (Illus 49) on the SSE facade with one window (W1). The WSW wall of Room 7 has been harled when the remains of the House were blown up in 1955 as was the WSW wall of Room 1 (Illus 50-2). Concrete extensions to the N end of Room 7 and Room 2 were added in the early to mid 20th century and may have been part of Panmure House before it was demolished or an extension after the demolition to create toilet and kitchen facilities for the hall (Room 1). Room 7 has windows on the WSW wall (W27, W28) and Room 2 has four windows (W53-56) and door (D8).

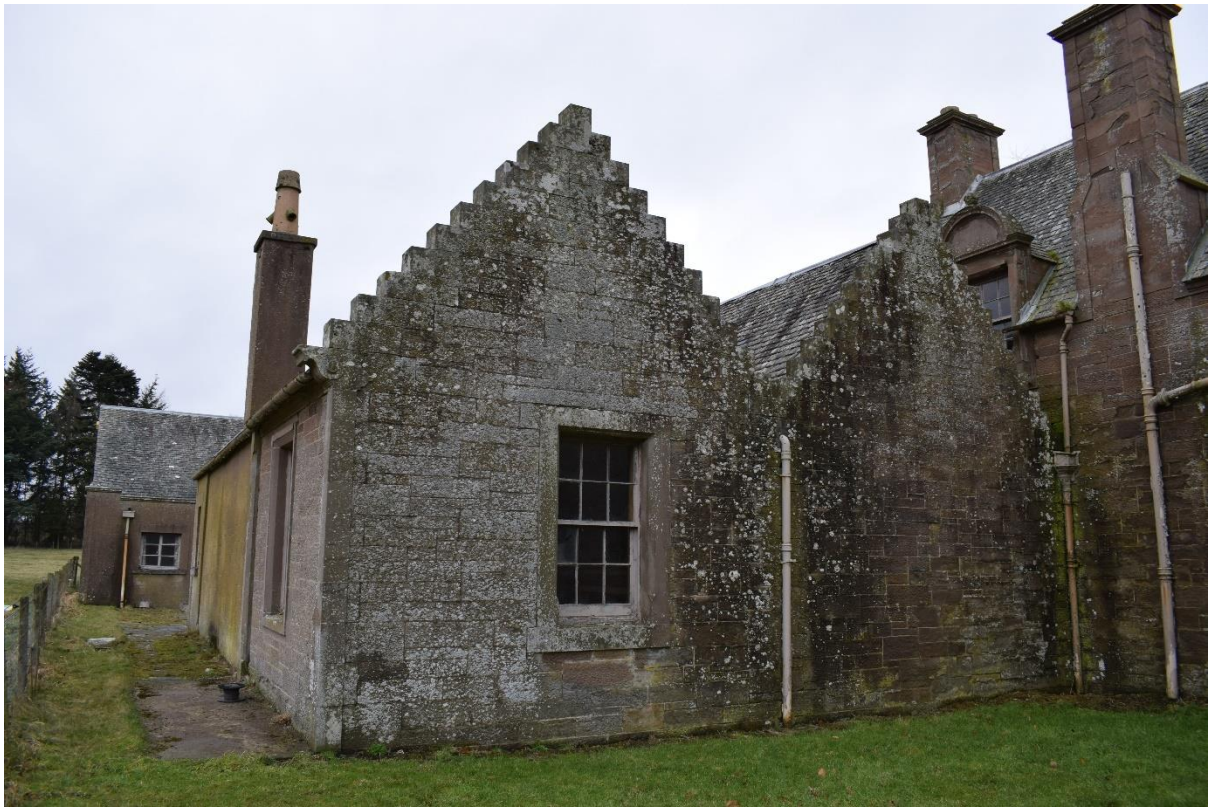
Illus 49 Rooms 6 and 7 WSW M-gabled crow-stepped extension with W1 (left); facing N

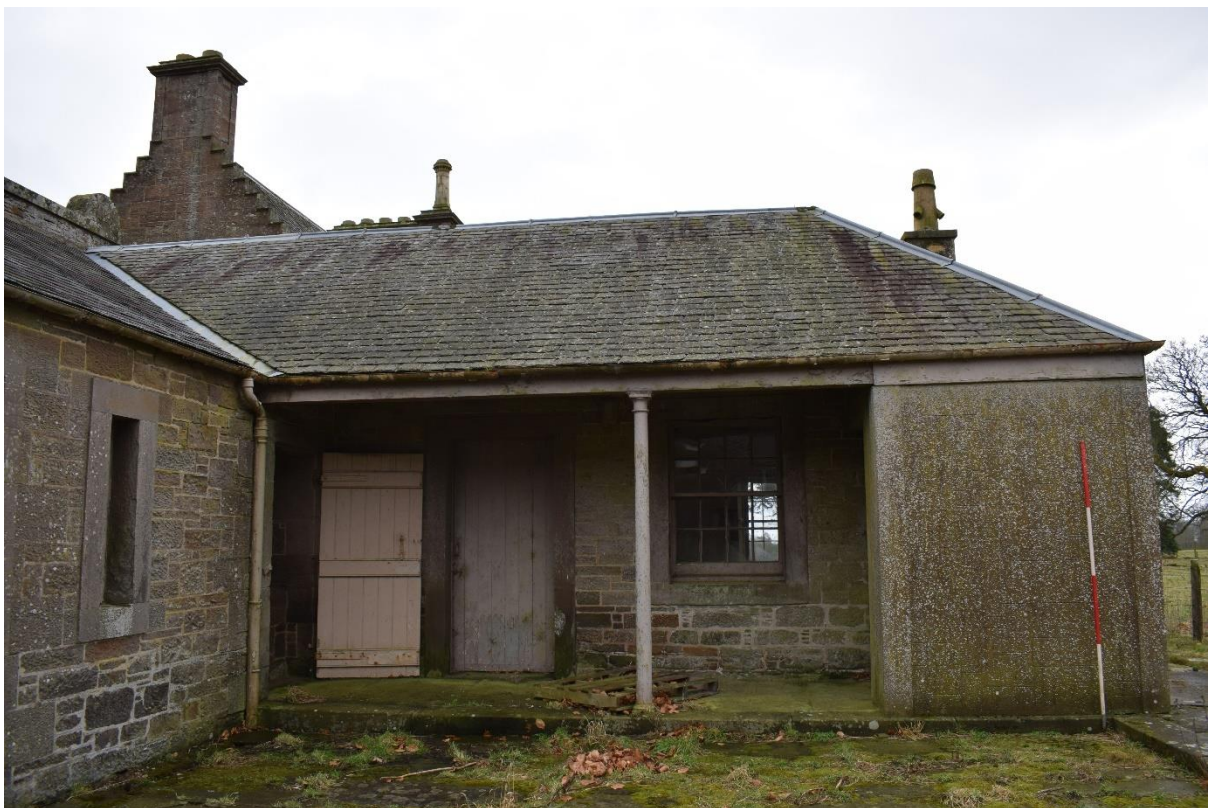
Illus 50 WSW courtyard SSE wall D10 (centre) W57 (right) showing harled wall (right) where remainder of courtyard was demolished in 1955; facing SSE

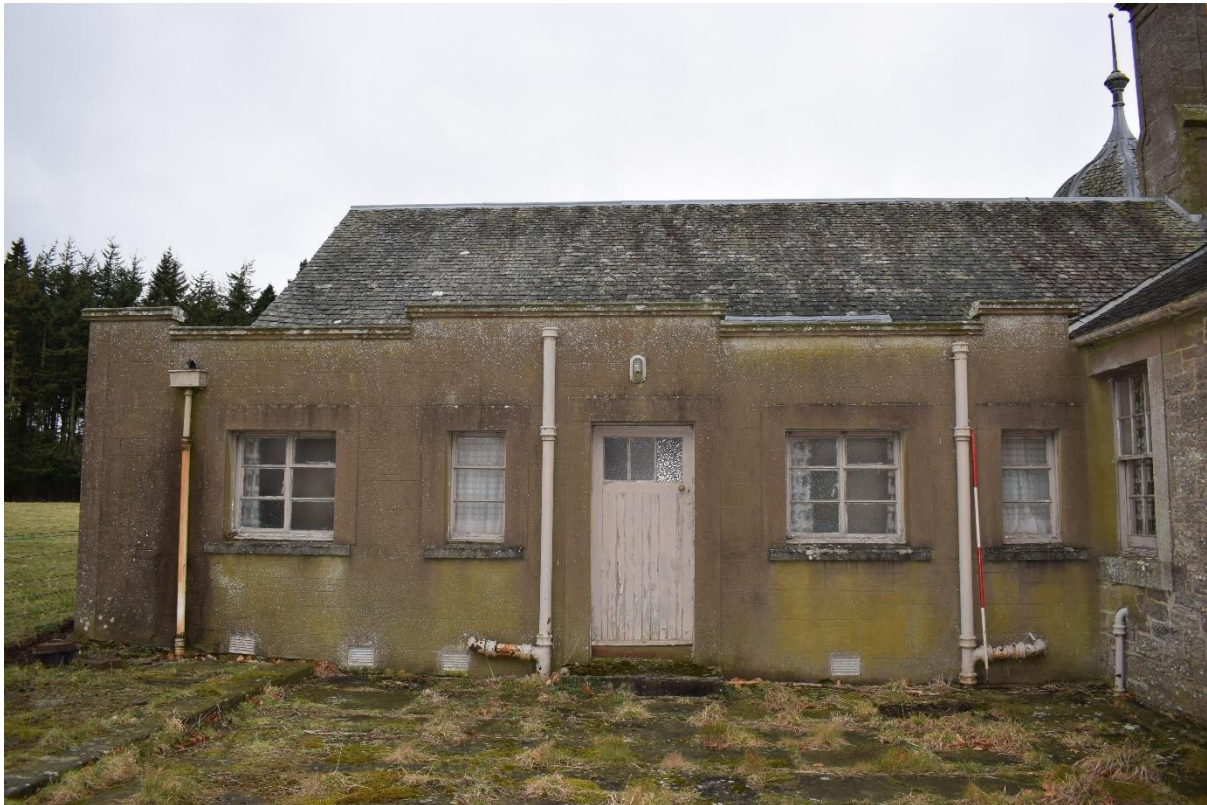
Illus 51 WSW courtyard NNW wall concrete extension W53, W54, D8, W55, W25 (l-r); the wall at the left of this photograph has been harled following the demolition of the rest of the adjoining house in 1955; facing NNW

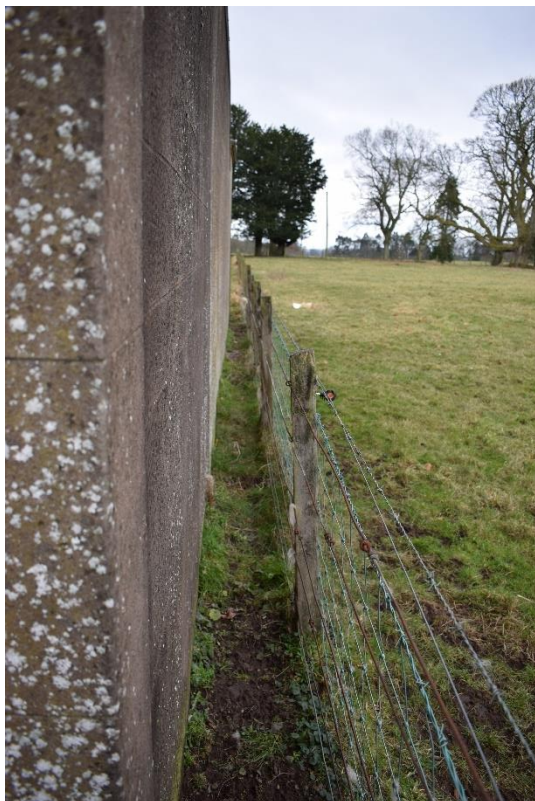
Illus 52 WSW wall Room 1 rendered after the demolition of Panmure House in 1955 (note there is no access to this side of the house); facing SSE

There is evidence of repair to the WSW side of the house after the House was blown up in 1955 but there appear to be no later additions.

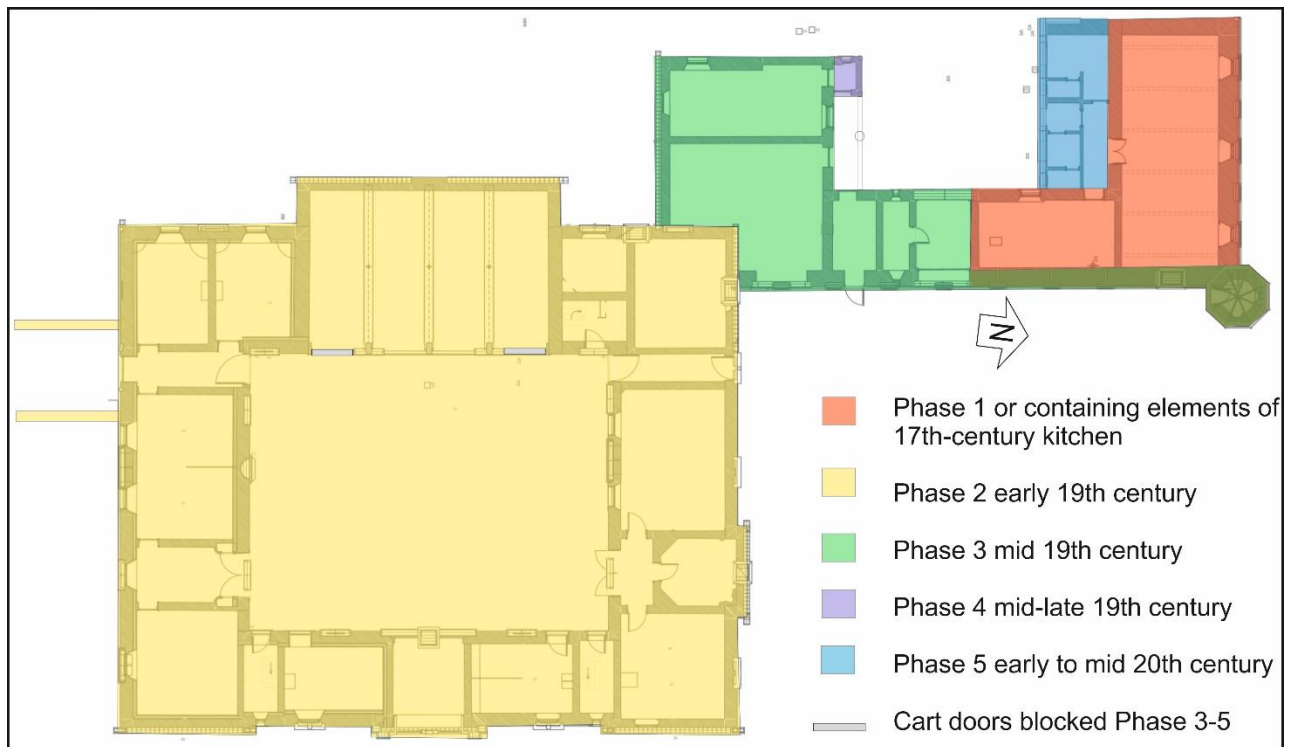
Illus 54 Phase plan showing main phases of developments of the buildings (copyright Building Workshop)

A Level 1 standing building survey was carried out on 12 February and 4 March 2019 and at least 5 phases of development were detected with other minor alterations (Illus 55). The house was originally 17th century but no evidence from this early period was detected during the survey. The N wing may have its origins from that period but was substantially rebuilt in the mid 19th century. The stable block was built in the 19th century and is changed very little since that period. The stable fittings such as stalls, mangers, feed tubs and other fittings appear to be original and the accommodation may have been added in the late 19th or early 20th century. Two of the four cart doors on the WSW side of the courtyard were blocked up in brick in the 20th century. The graffiti in Room 16 which appears to date to the 1940s suggests that the buildings were still in use for horses at that period.
