Linlathen, Broughty Ferry, Dundee, DD5 3GL
Report on an Archaeological Evaluation
Phases 1-3 - Cameron Archaeology CA288
(Planning Application 18/00115/FULM & PPA-180-2057)

Dr Robert Lenfert, ACIfA
Cameron Archaeology
17 May 2019

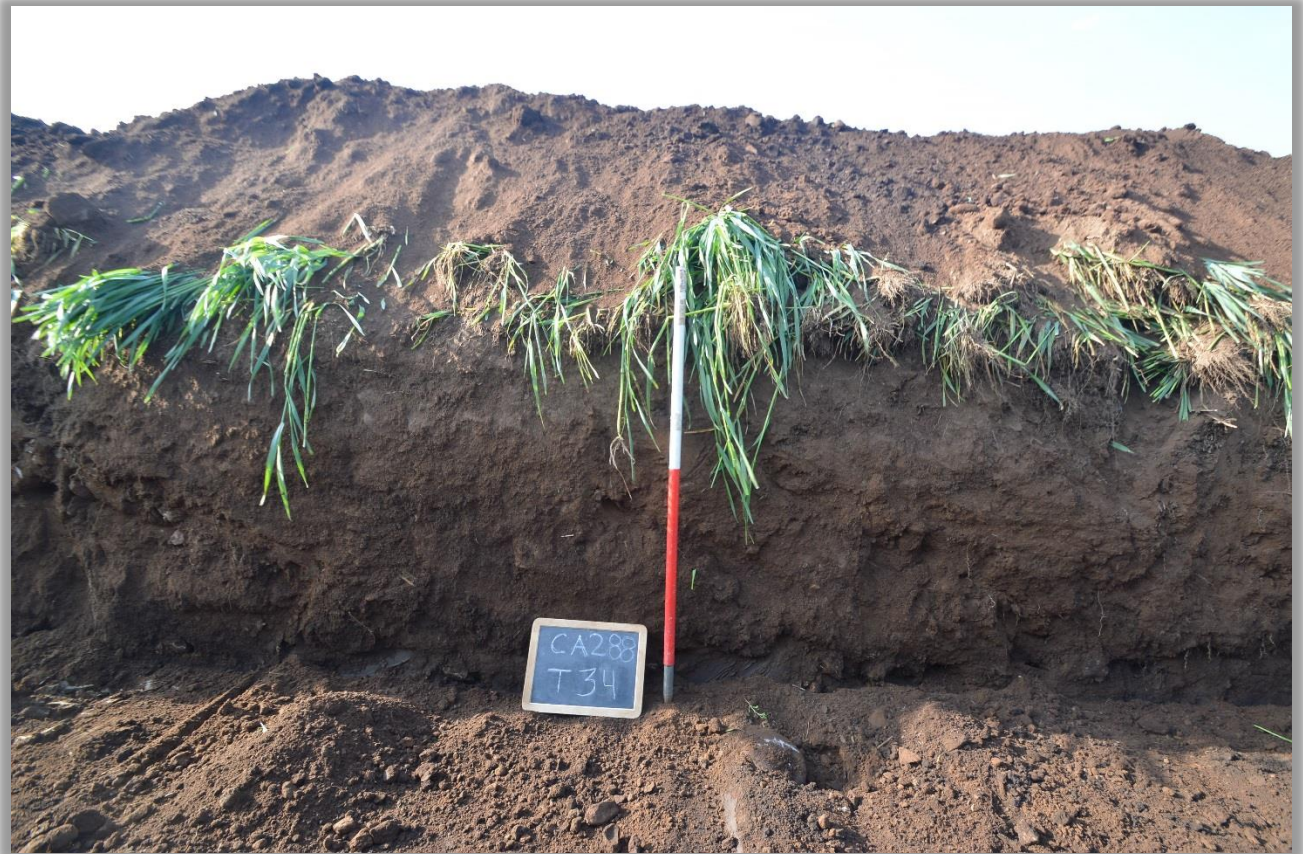
Cover: Section within Trench 34 indicating the maximum level of site topsoil depth.

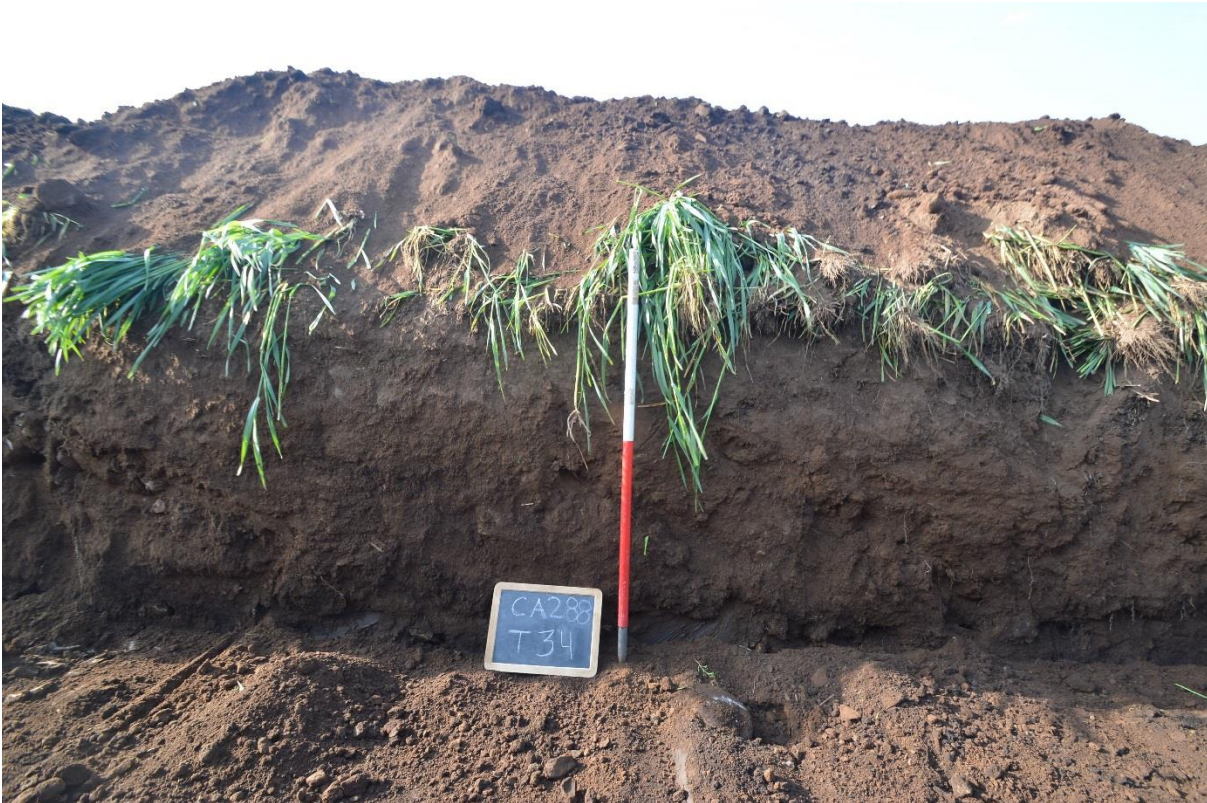
Illus 3 Maximum topsoil depth located in Trench 34 reaching c.0.8m in a small natural hollow on the W perimeter of the site.

30	89m x 0.42m	3001/3002
31	84m x 0.37m	3101/3102
32	75m x 0.41m	3201/3202
33	62m x 0.38m	3301/3302
34	62m x 0.80m	3401/3402 (deepest topsoil depth reached on site)
35	61m x 0.36m	3501/3502
36	56m x 0.36m	3601/3602
37	57m x 0.37m	3701/3702
38	57m x 0.34m	3801/3802
39	53m x 0.39m	3901/3902
40	87m x 0.41m	4001/4002 modern plough scars visible
41	123m x 0.46m	4101/4102
42	127m x 0.42m	4201/4202 Longest trench dug to cover machine track corridor due south of T23-32 for crop avoidance
43	119m x 0.42m	4301/4302

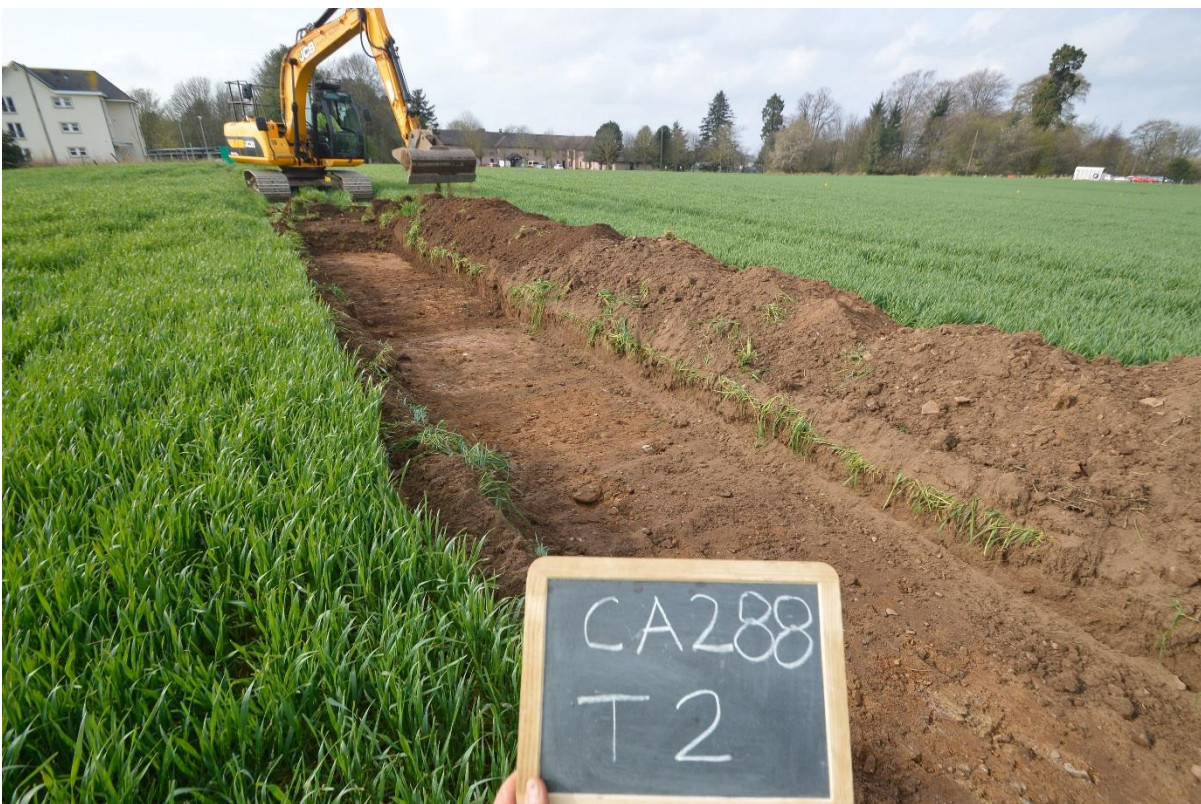
Illus 4 Trench 2 in progress.
